## INVESTIGATION SUPPLEMENTAL DOCUMENTATION

On January 23, 2019, at 1143 Pacific standard time, a Bell 206L-3, N8227J, collided with trees while maneuvering near the Siskiyou Summit south of Ashland, Oregon. The airline transport pilot, the sole pilot, was fatally injured; the helicopter sustained substantial damage. The helicopter was registered to HeliFleet LLC and operated by Erickson Helicopters Inc., under the provision of 14 Code of Federal Regulations Part 91. Marginal visual meteorological conditions prevailed in the area of the accident and a company visual flight rules flight plan had been opened. The local area time-building flight originated from the Medford Airport, Medford, Oregon, at 0920.

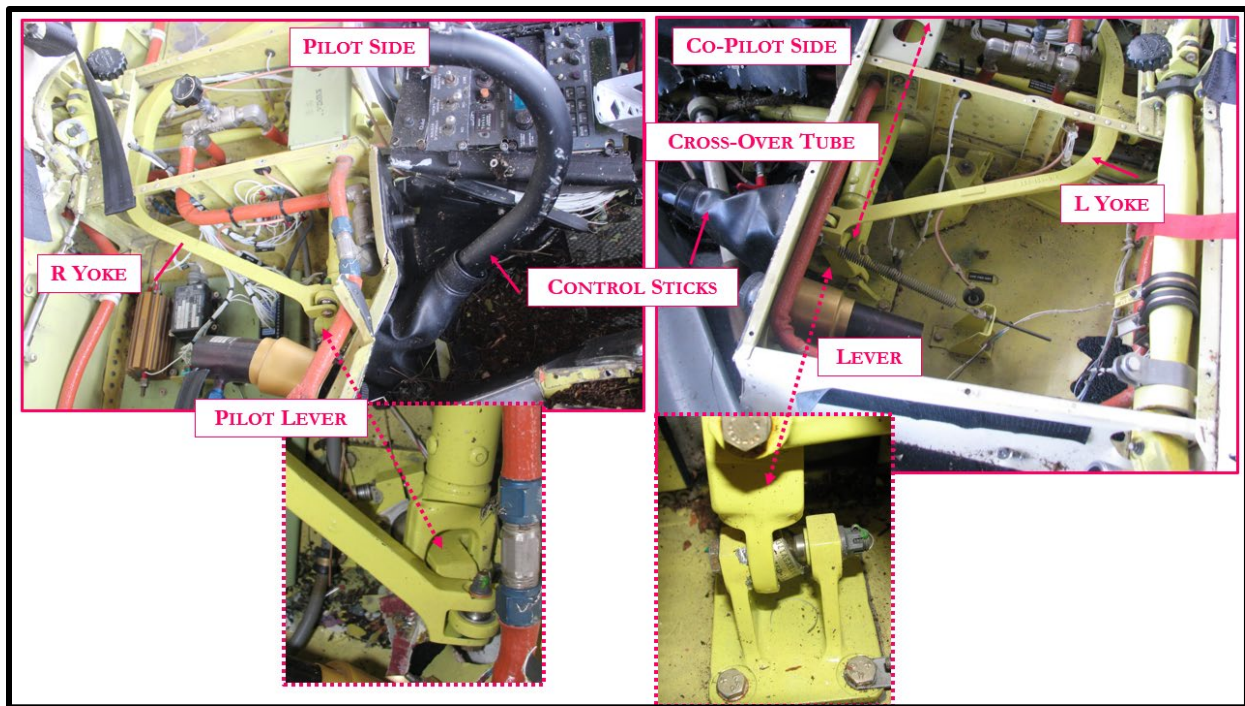
Figure 6: Cyclic Controls

Examination of the cyclic revealed that the control sticks were intact and connected to their respective yoke attach points at the upper bearing in their levers. The lower bearing on the co-pilot's lever was displaced; there were corresponding shiny marks on the outboard structure support and the outboard lever. Removal of the lever revealed that the bearing was displaced in the housing and had sustained a gouge on the outer race. A sliver of circular metal was found under the bearing, consistent with it being a shaving from the bearing.

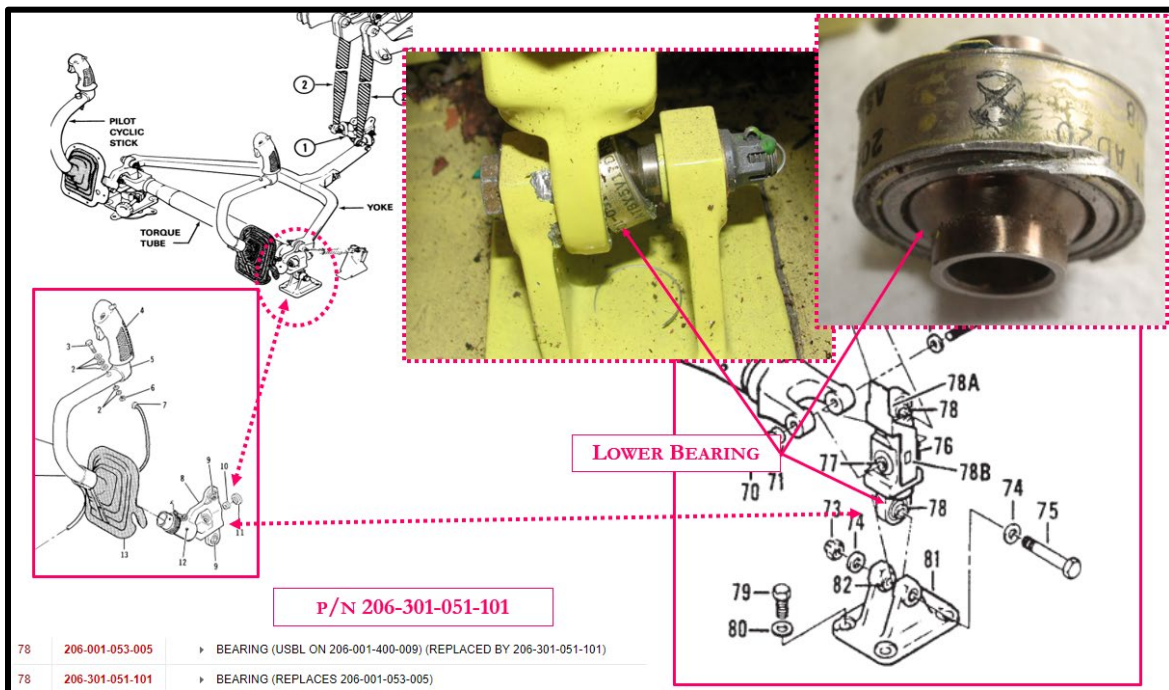
Figure 7: Co-Pilot Cyclic Control

The bearing listed the following information:  
 206-301-051-101 (j/n01095 HT AD20)  
 Astro ATBY5V17DHS 5-13-83 AD8

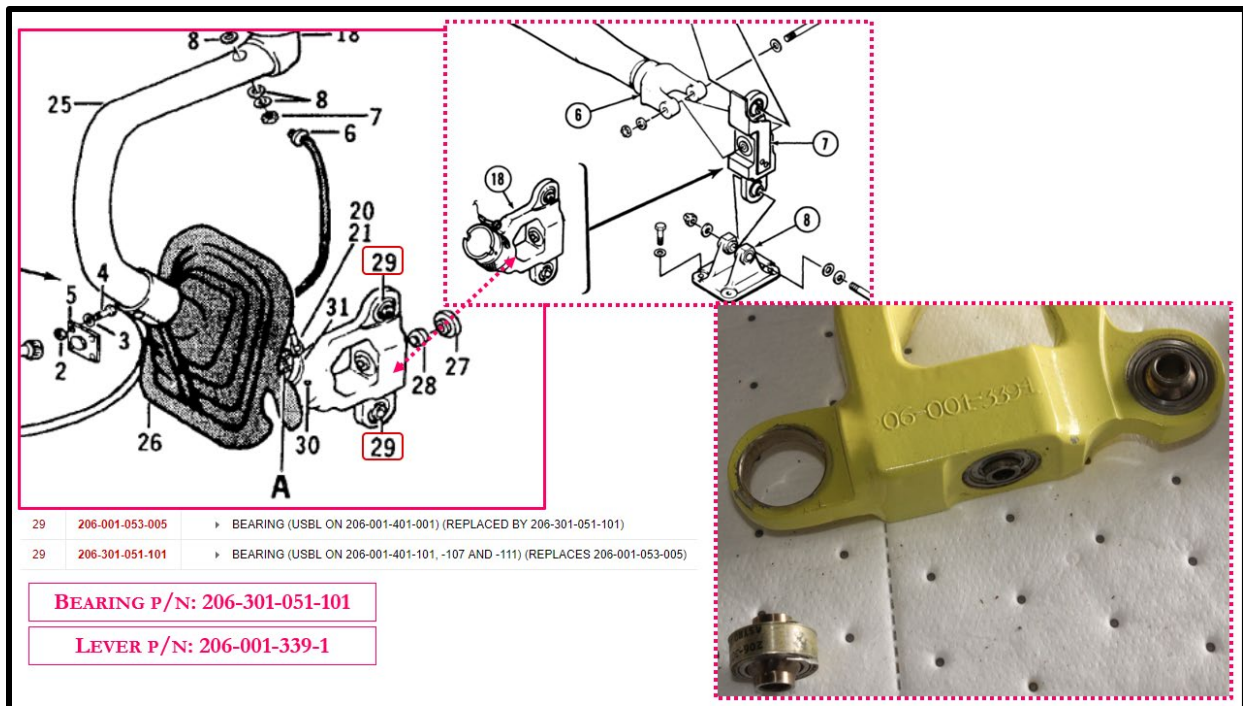
Figure 8: Co-Pilot Cyclic Lever

The lever was stamped with the following information:  
 206-001-339-1

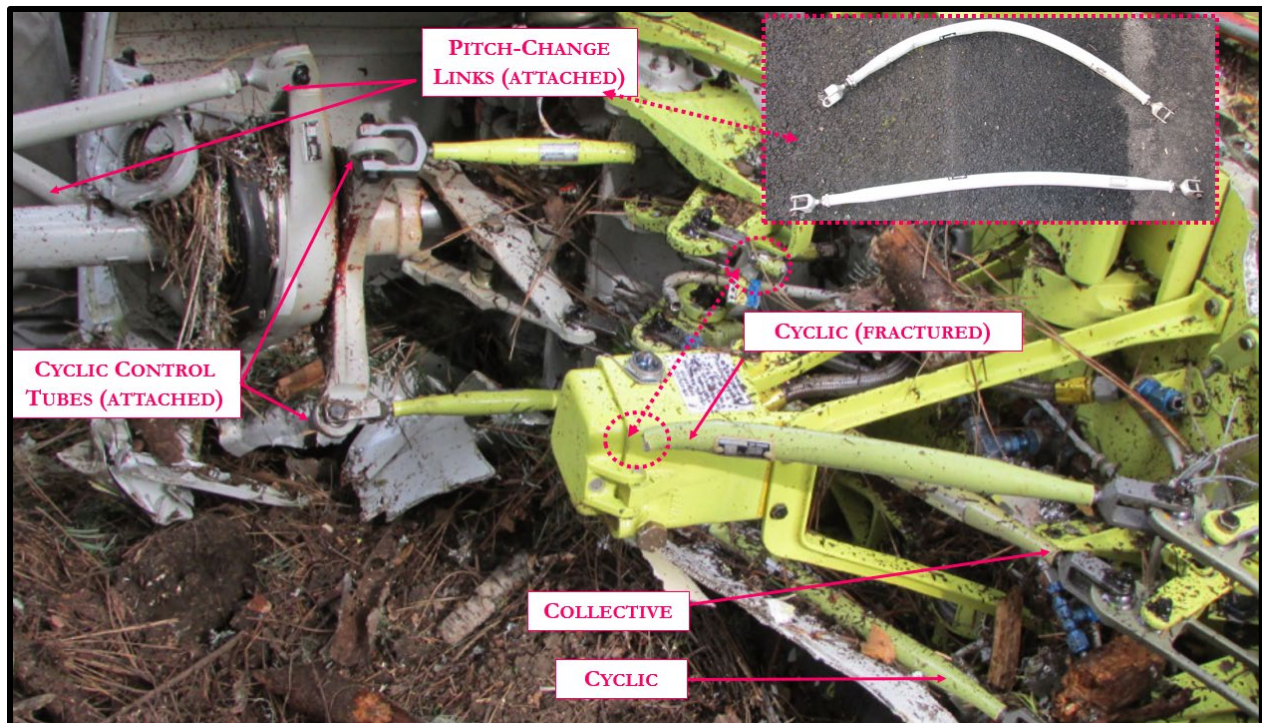
Figure 9: Control Tubes from servos to Mast as seen at Accident Site

The yoke remained attached to the mixer and the right and left cyclic control tubes. The two vertical cyclic pushrods within the broom closet remained attached at the mixer and were severed for recovery purposes. From the upper cuts, the control tubes were continuous to the servos, which remained attached to their respective support brackets. The right control tube was detached at the bellcrank for recovery; the left control tube was broken from the servo to the bellcrank. The rod end remained attached to the bellcrank and the fracture surface was consistent with overload. Both FAA inspectors and Erickson personnel reported that all the remainder of the control tubes were connected at the accident site and disconnected for recovery purposes, which included the pitch change links being connected at the rotating swash plate and rotor blade pitch horns.

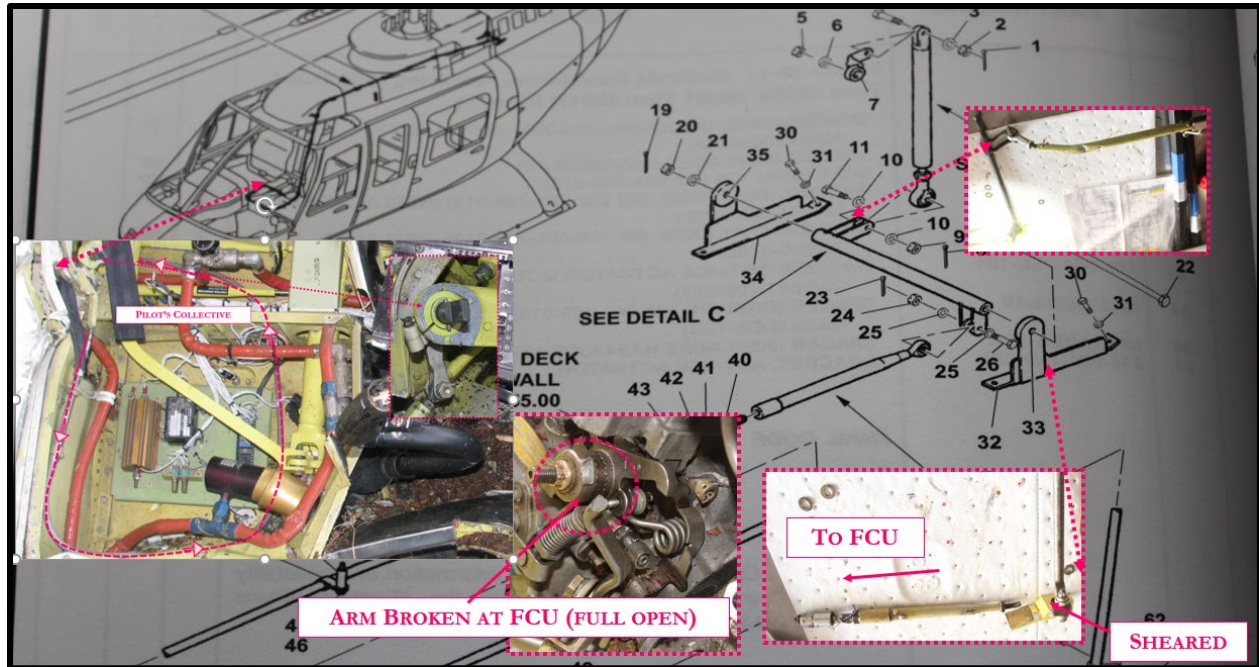
Figure 11: Collective Throttle Control

The pilot's collective was severed at the base. The collective's control tube and flexible cable were severed in the area of the upper broom closet for recovery. Continuity of the throttle could not be established due to numerous fractures in the control tube linkages and the FCU arm was broken free; all fracture surfaces were consistent with overstress and indicative of having been connected at the time of impact. were predominately intact from the collective stick to the point of attachment at the hydraulic actuator on top of the fuselage.

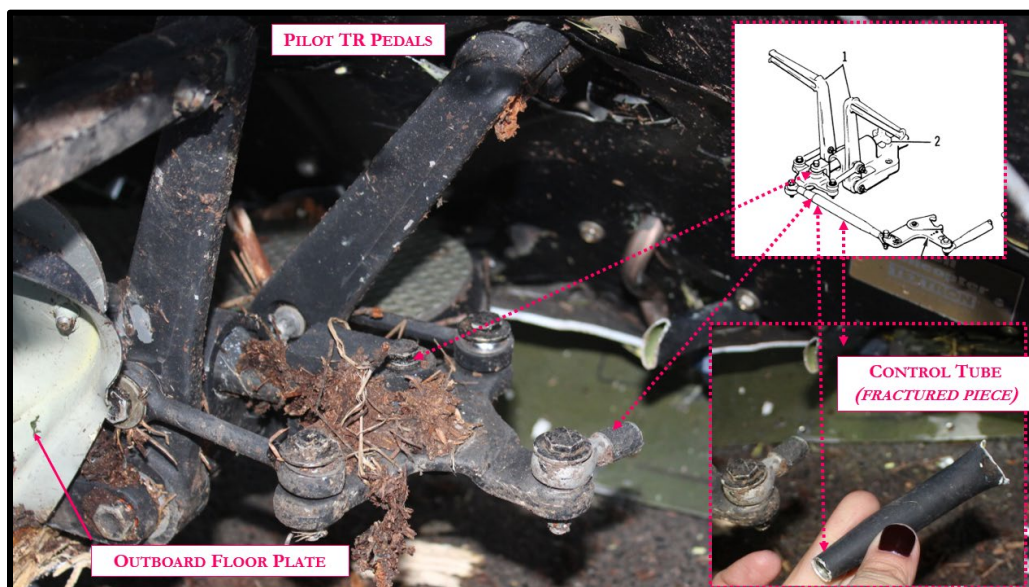
Figure 12: Pilot's Tail Rotor Controls

The pilot's anti-torque pedals were intact to the bellcrank. The outboard foot plate/doubler was pushed upward consistent with the severity of the impact from the forward right of the helicopter. An approximate 4 in portion of the control tube had separated and was found within the wreckage.

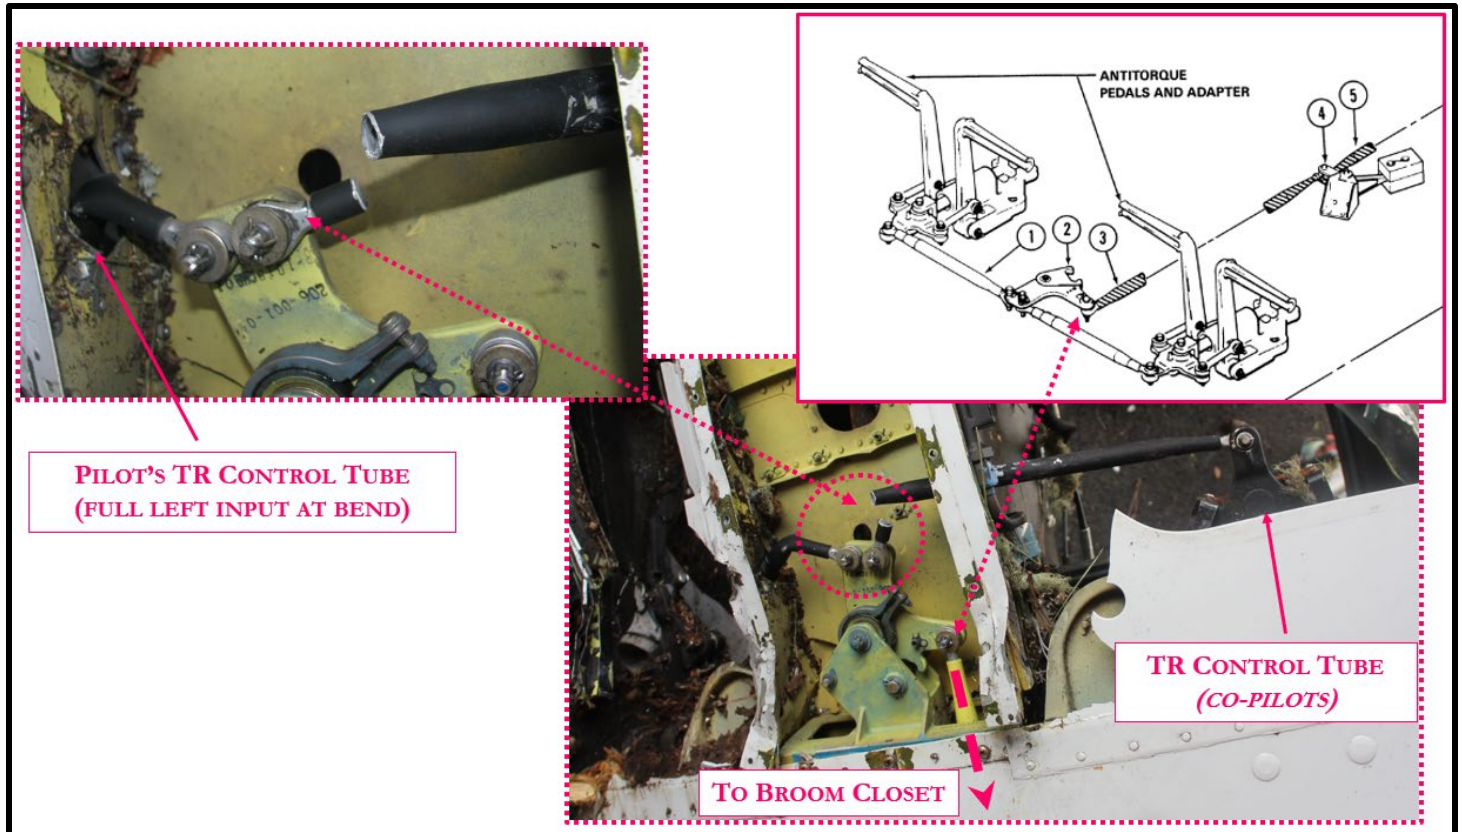
Figure 13: Tail Rotor Control Tubes

The control tube from the co-pilot's bellcrank to the joint bellcrank was fractured at the rod end. When aligning the bends and fractures in the control tubes with the surrounding fuselage structure, the pedals were consistent with being a full right pedal input at the time of impact. The pushrod from the bellcrank continuing aft to the broom closet could not be completely examined due to crush damage of the fuselage preventing visual exposure. The tail rotor anti-torque and elevator controls exhibited control tube and support fractures in areas of airframe damage and fracture.

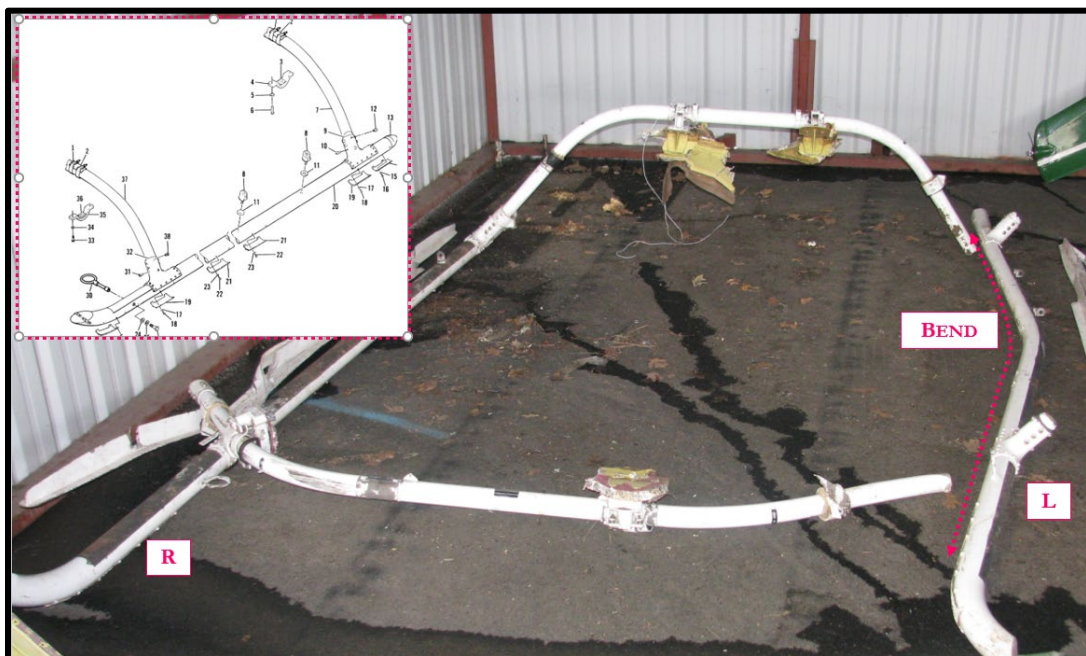
Figure 14: Landing Skids

The skids were splayed flat at the front crossbar. The left skid had a bend between the supports

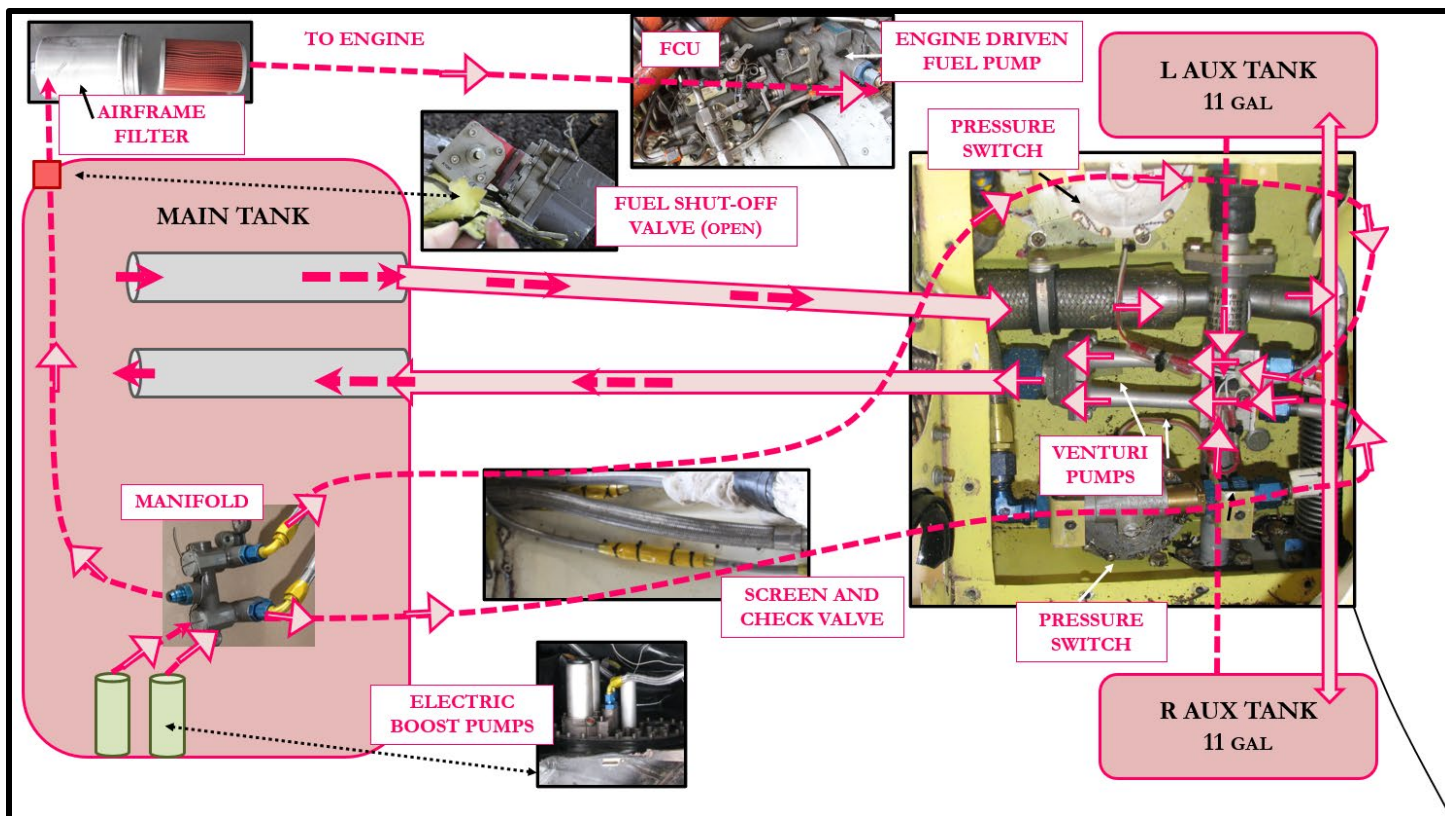
Figure 17: Fuel Examination

The fuel valve was observed to be in the Open position. The airframe fuel filter was empty of fuel when examined; no particulate was observed in the bottom of the fuel filter canister and the paper filter was also clean. Fuel line connections on the floor between the forward fuel cells and the main (aft) fuel cell were not fractured. The ejector pump assembly and flow switches between the two forward fuel cells were intact. The forward fuel cells were unbreached and contained fuel. It was reported by Erickson that fuel was removed from the fuel cells during recovery and approximately 27 gallons of fuel was removed from both forward and main (aft) cells. The boost pump plate remained attached to the main fuel cell and the pumps appeared to be intact. The main fuel cell was observed to be torn near the boost pump plate in an area of airframe fracturing.

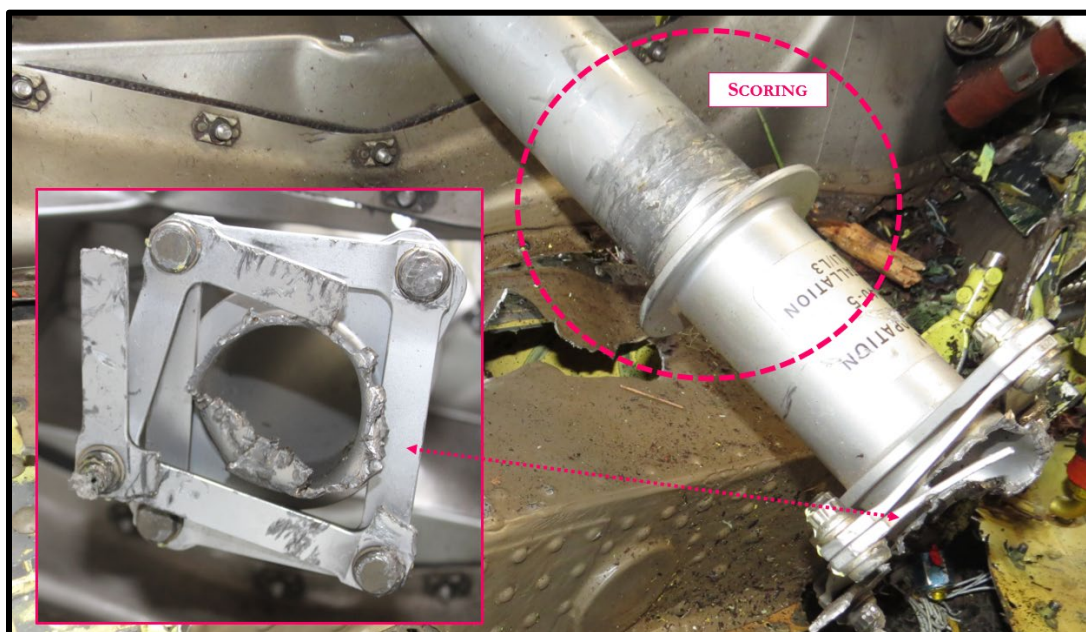
Figure 18: KaFlex Shaft (aft coupling)

The main rotor hub assembly, which remained attached to the mast, was rotated by hand and corresponding free rotation was observed at the main driveshaft input flange on the main transmission. The KaFlex main driveshaft forward coupling was fractured just forward of the freewheeling unit. The aft coupling was fractured with rotational overstress features with rubbing and rotational scoring observed on the KaFlex shaft just aft of the coupling consistent with it making contact with the firewall while turning. The freewheeling unit operated properly when tested by hand while still installed on the helicopter, rotating freely in the drive direction and continuing to rotate when the #4 turbine wheel was stopped by hand through the exhaust.

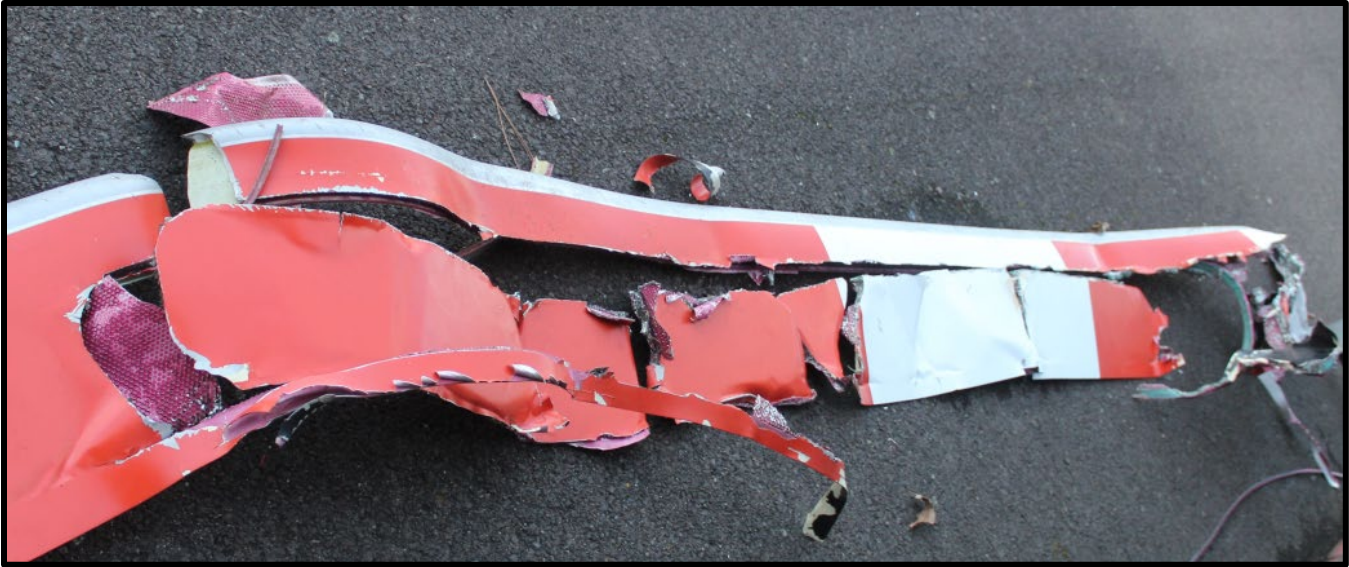
*Figure 19: One Main Rotor Blade*

The main rotor blades were both attached to the hub and the hub was attached to the mast. Both blades were severed chordwise approximately 5-7 feet outboard of the hub. The mast had approximately a 20-degree bend located parallel to yolk static stops. One pitch change tube was severed in half.

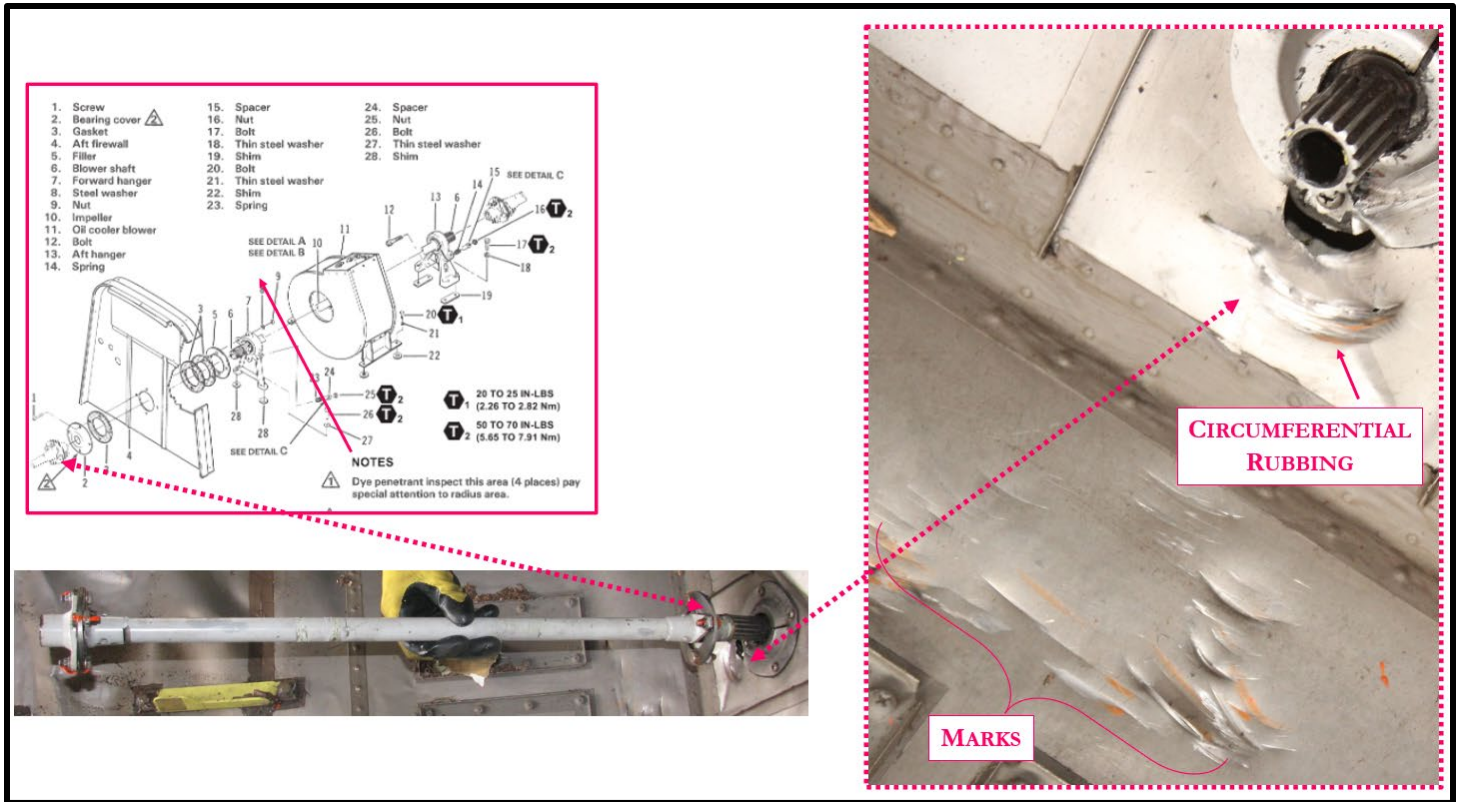
Figure 21: Tail Rotor Drive Shaft (under engine)

The tail rotor driveshaft under the engine was intact and remained connected to the engine gearbox on the forward end and had disconnected from the aft end at the oil cooler shaft. Rotation scoring on the shaft was observed from contact with engine parts from above, consistent with occurring during impact when the shaft was turning and deformation of structure enabled contact between the shaft and engine parts. Damage to the splines at the oil cooler were observed, consistent with impact. The oil cooler shaft rotated freely by hand. All aluminum tail rotor driveshaft segments on the tailboom and aft fuselage were intact; the Thomas couplings and hanger bearings were intact. The tail rotor gearbox rotated freely and corresponding rotation of the tail rotor blades was observed, demonstrating drive continuity within the tail rotor gearbox. The gearbox support case with attached tail rotor gearbox had separated from the aft tailboom consistent with impact forces.
