## **NATIONAL TRANSPORTATION SAFETY BOARD**

### **WRECKAGE EXAMINATION SUMMARY**

**WPR19LA078**

Location: Socorro, New Mexico  
Date: February 1, 2019  
Aircraft: N536RH, RANS S-12XL

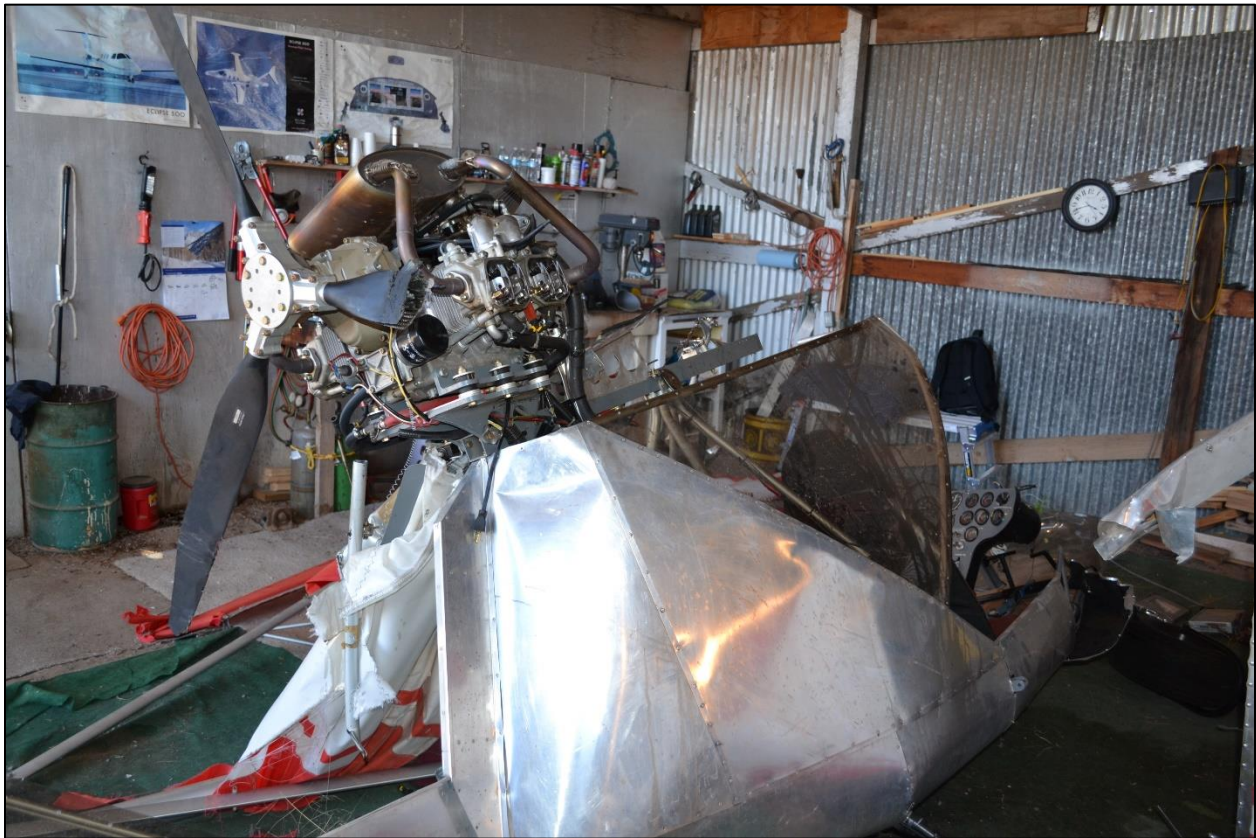
The engine remained attached to the fuselage by its mount. The propeller assembly remained attached to the engine and one blade was separated near its shank. The propeller blades showed damage consistent with rotation at impact. The engine control cables had impact damage and control continuity was attained. The carburetors were loose from their mounting brackets and induction attachment and remained intact. The carburetor bowls were removed, and no debris was noted in the bowls. The internal carburetor components were undamaged. Fuel was noted in the left carburetor bowl. The fuel pump lines from the engine to the shutoff valve remained intact and undamaged. The fuel shutoff valve was in the open position and fuel was noted in the lines. No fuel filter was found in the fuel system. The upper spark plugs were removed from the cylinders and revealed light amounts of combustion deposits. The electrodes showed no wear. The cylinder valve covers were removed, and the cylinder overhead components were undamaged and had a light residue of clear oil. The crankshaft was rotated easily by hand through the propeller assembly. During rotation fuel flowed freely from the fuel pump, thumb compression was established from each cylinder, rocker valve movement and gear continuity was established. During rotation of the crankshaft, ignition spark was obtained from each ignition lead.

Figure 1-Engine and propeller assembly attached to the airframe.

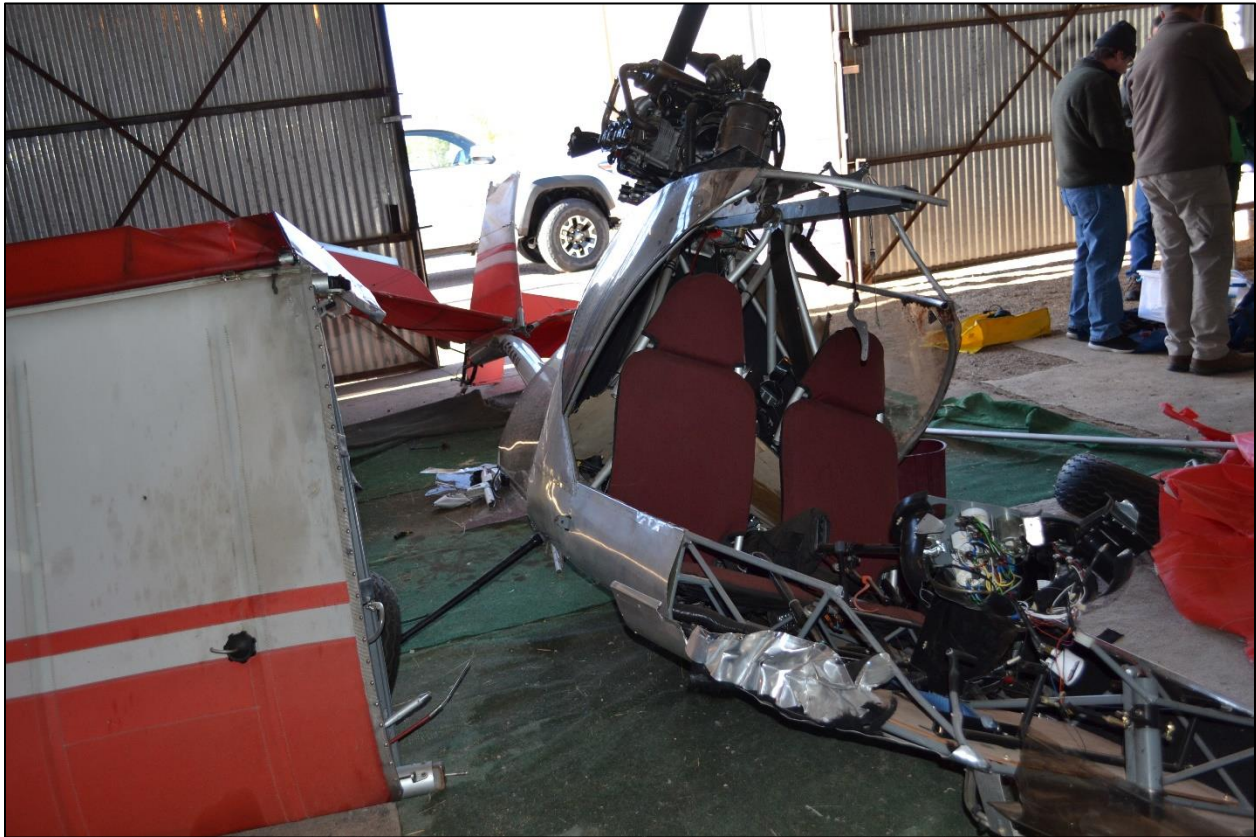
The right wing remained intact and was separated during the recovery of the wreckage. The right flap and aileron control continuity was established. The left wing remained partially attached to the fuselage and was substantially damaged. The left wing outboard section was damaged and separated into several sections. The left wing tank separated from the wing and remained attached to its fuel lines. All internal left wing structure was noted. The left aileron and flap control continuity was established through broken control tubes and control cables.

Figure 2-Main wreckage and cabin area.

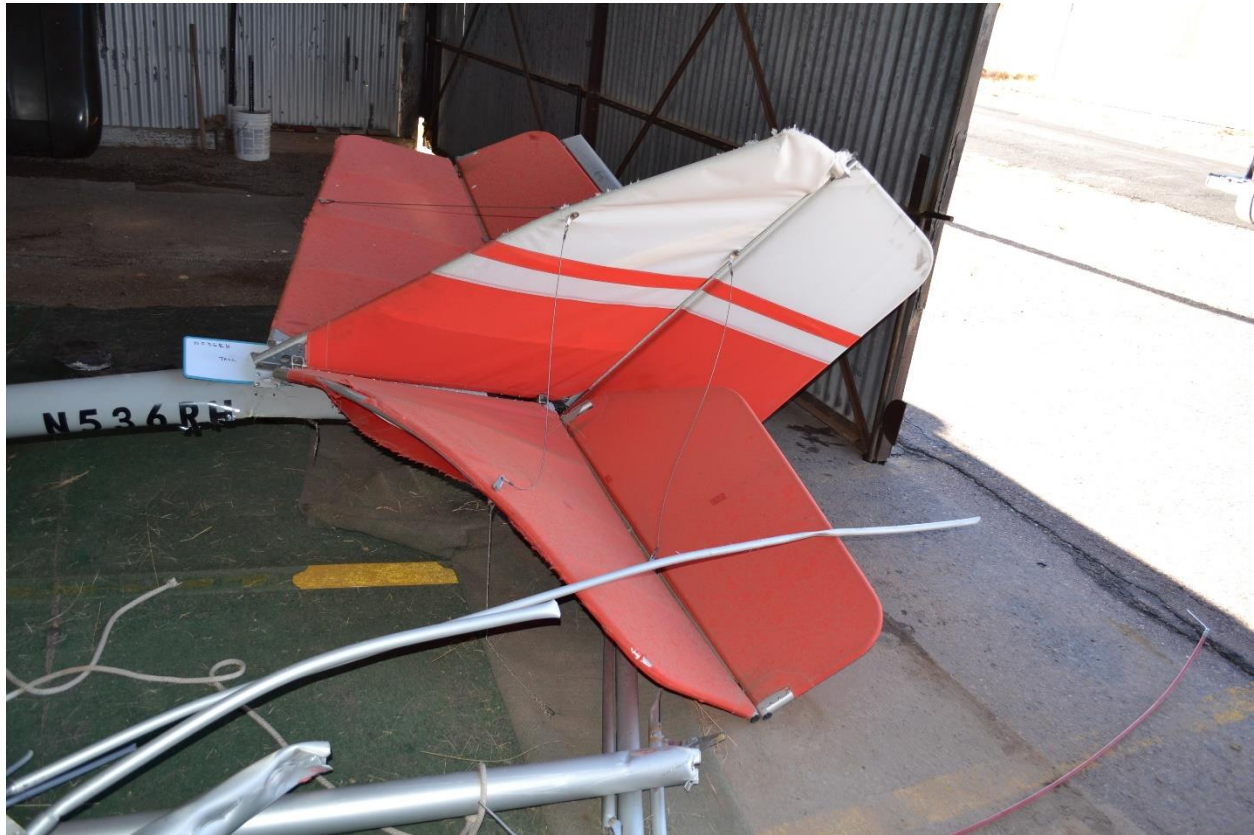
The empennage had impact damage. The vertical stabilizer was damaged near the top. The left horizontal stabilizer leading edge was bent, and its lower support cable separated with signatures consistent with tension overload. The horizontal stabilizer leading edge was positioned (rigged) to the lower attachment hole. The tailboom was bent near the empennage. Elevator and rudder control continuity was established through to the cabin area.

Figure 3-Empennage
