**Photo 1 – N506PH as seen at the accident site. Photo courtesy of the FAA.**

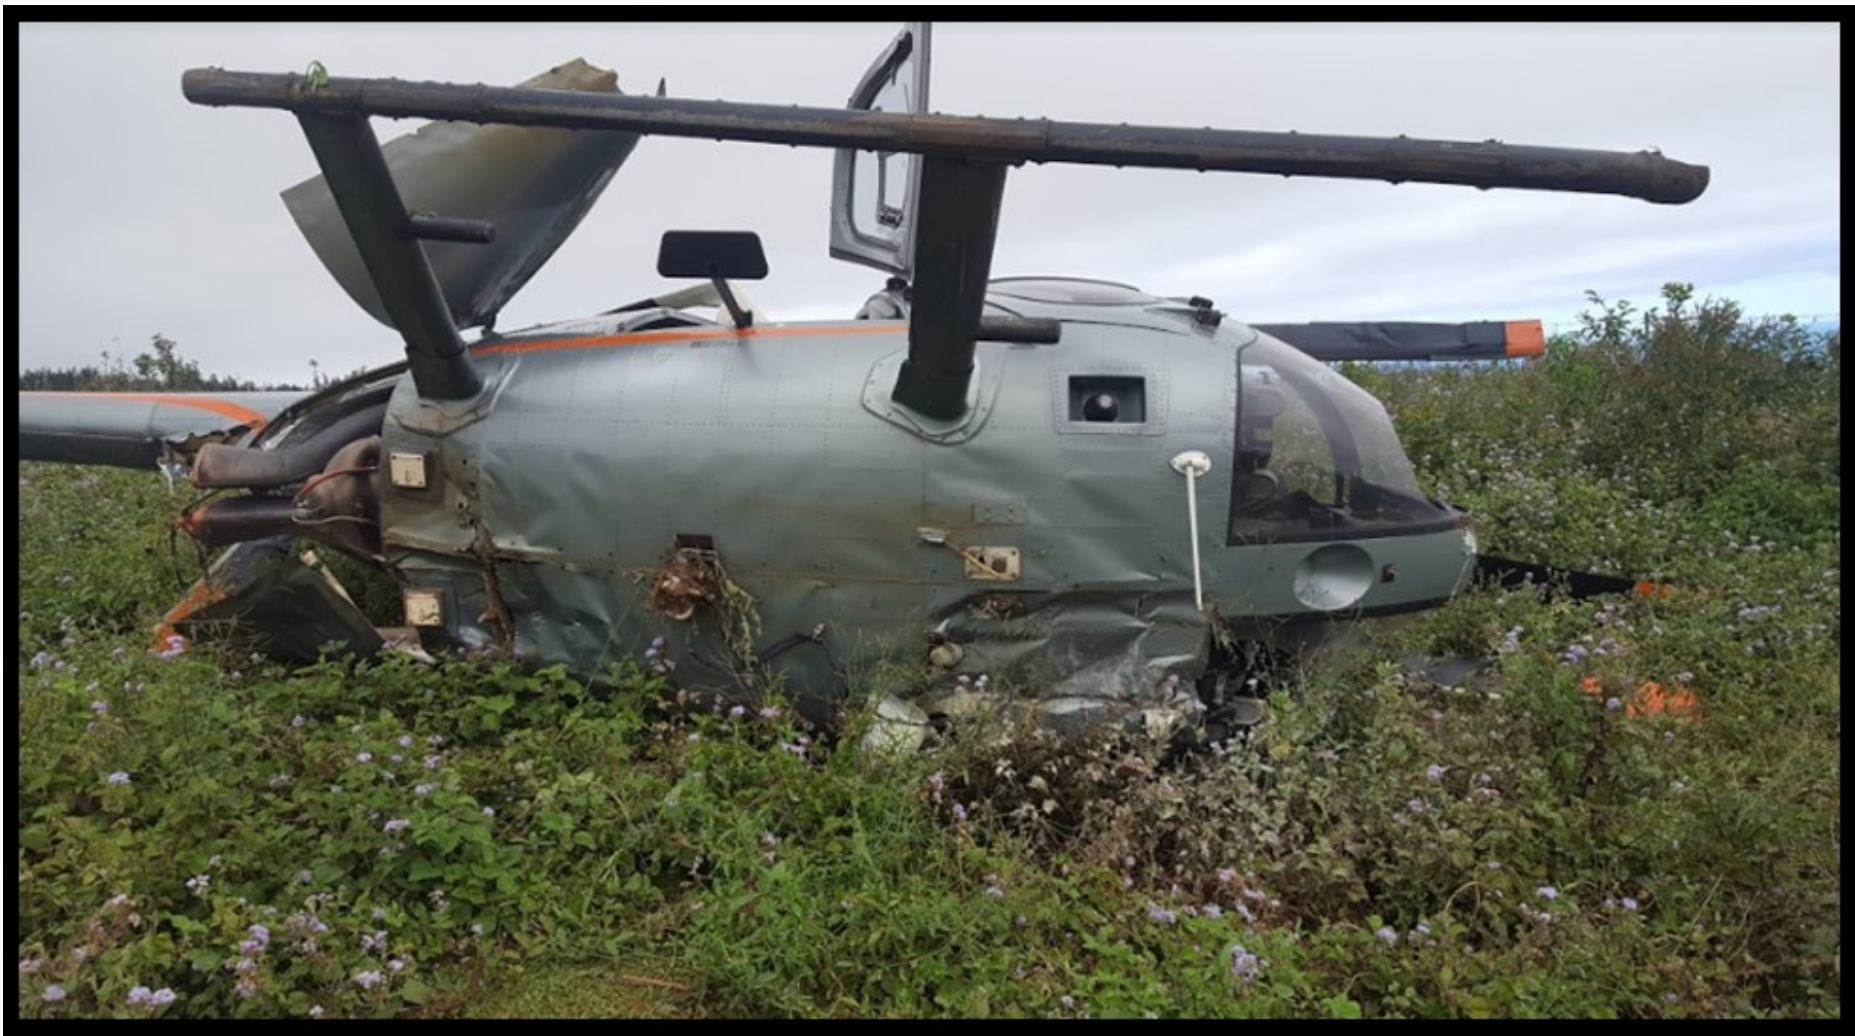
**Photo 2- N506PH at the accident site. Photo courtesy of the FAA.**

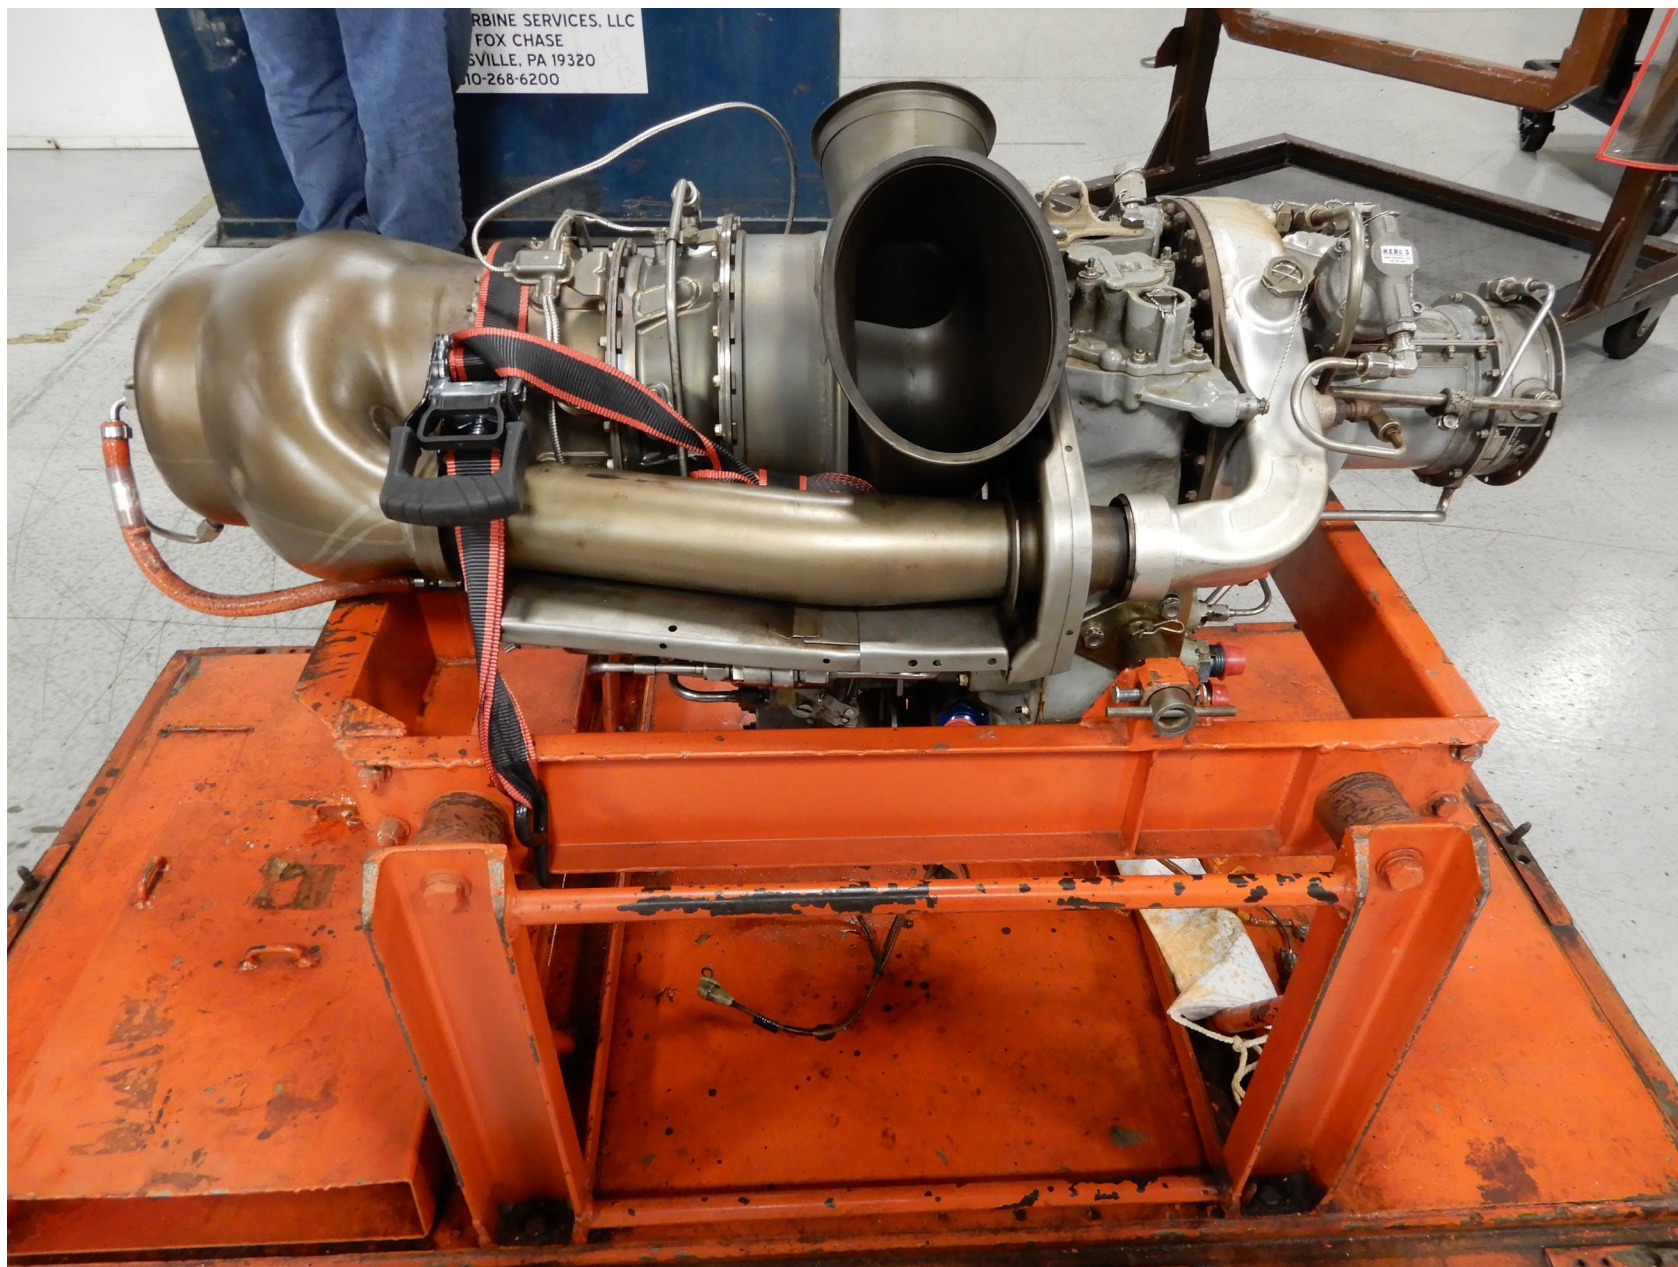
**Photo 3 – Engine from N506PH, as received at the service center.**

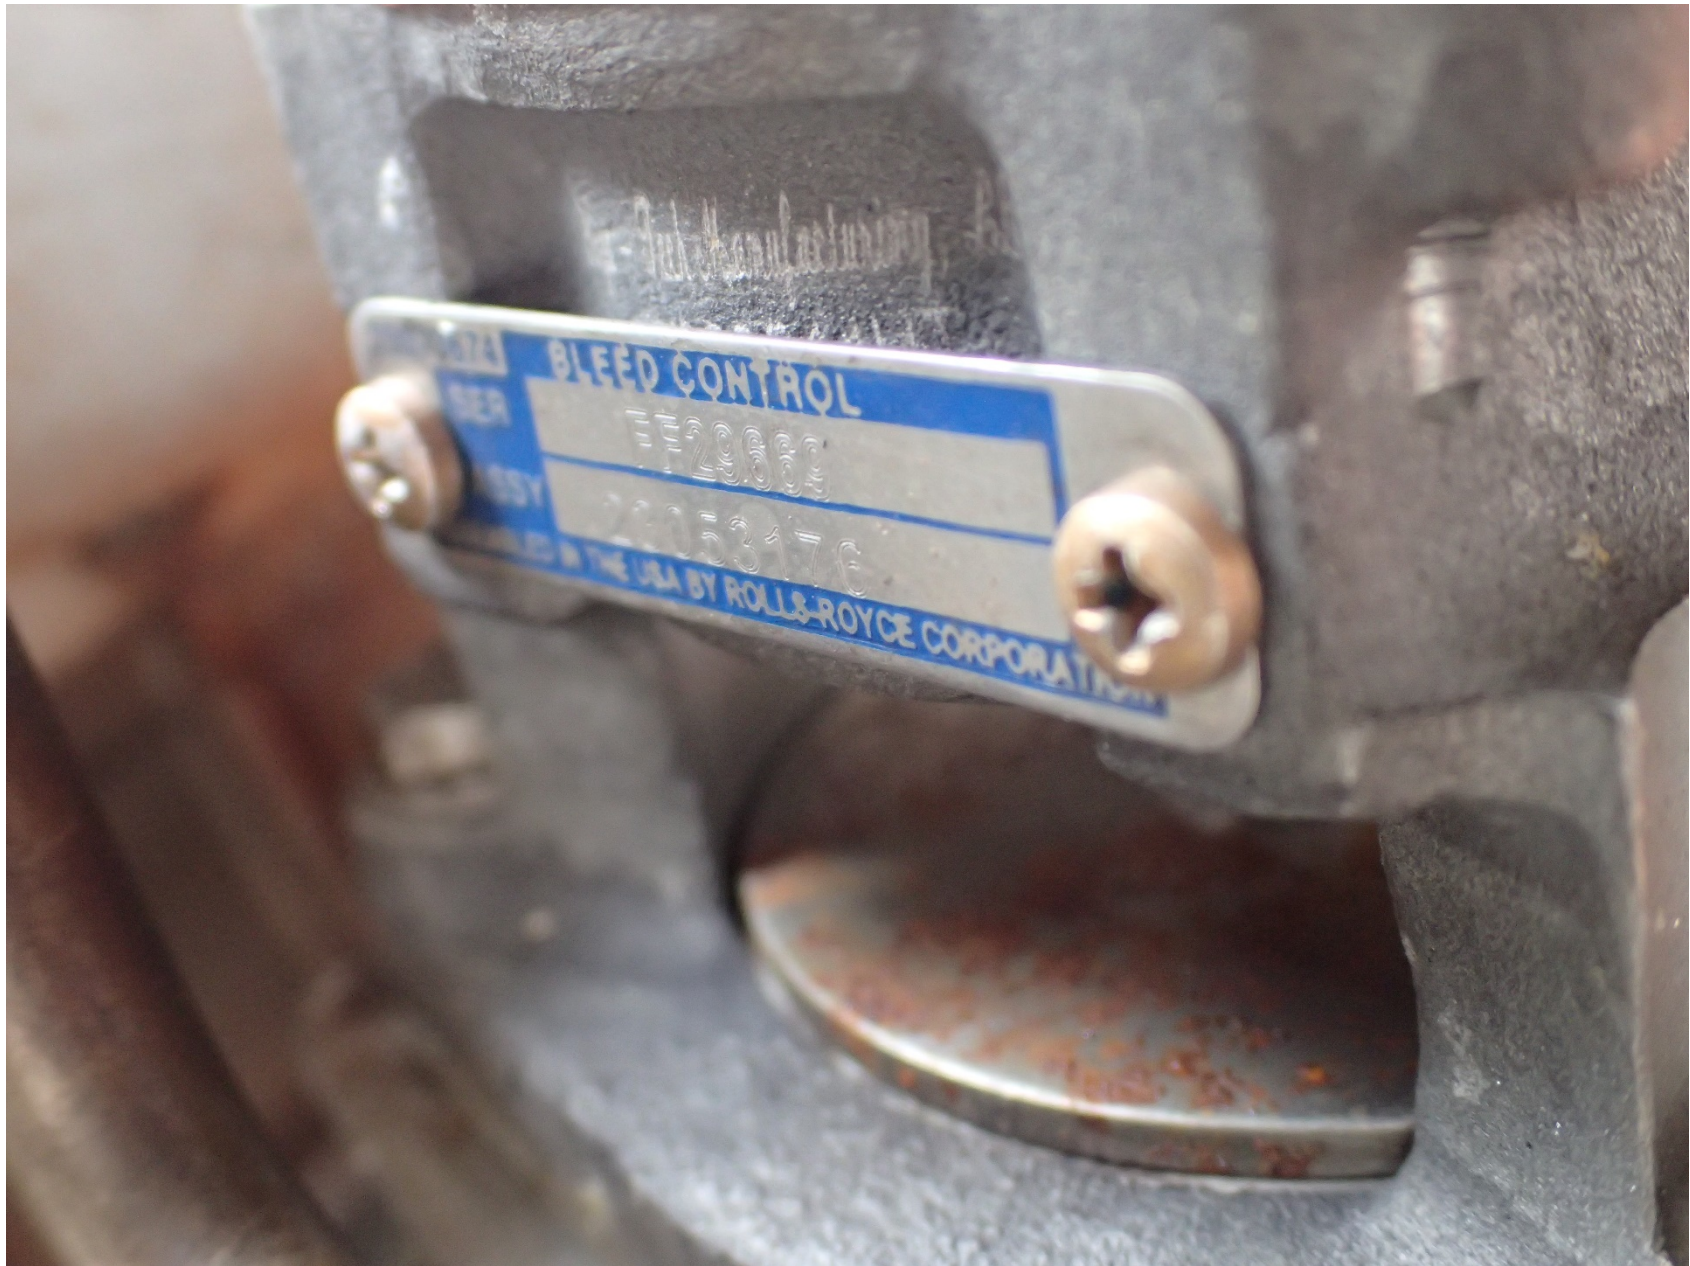
**Photo 4 - Bleed valve assembly mounted on engine showing valve in the closed position.**

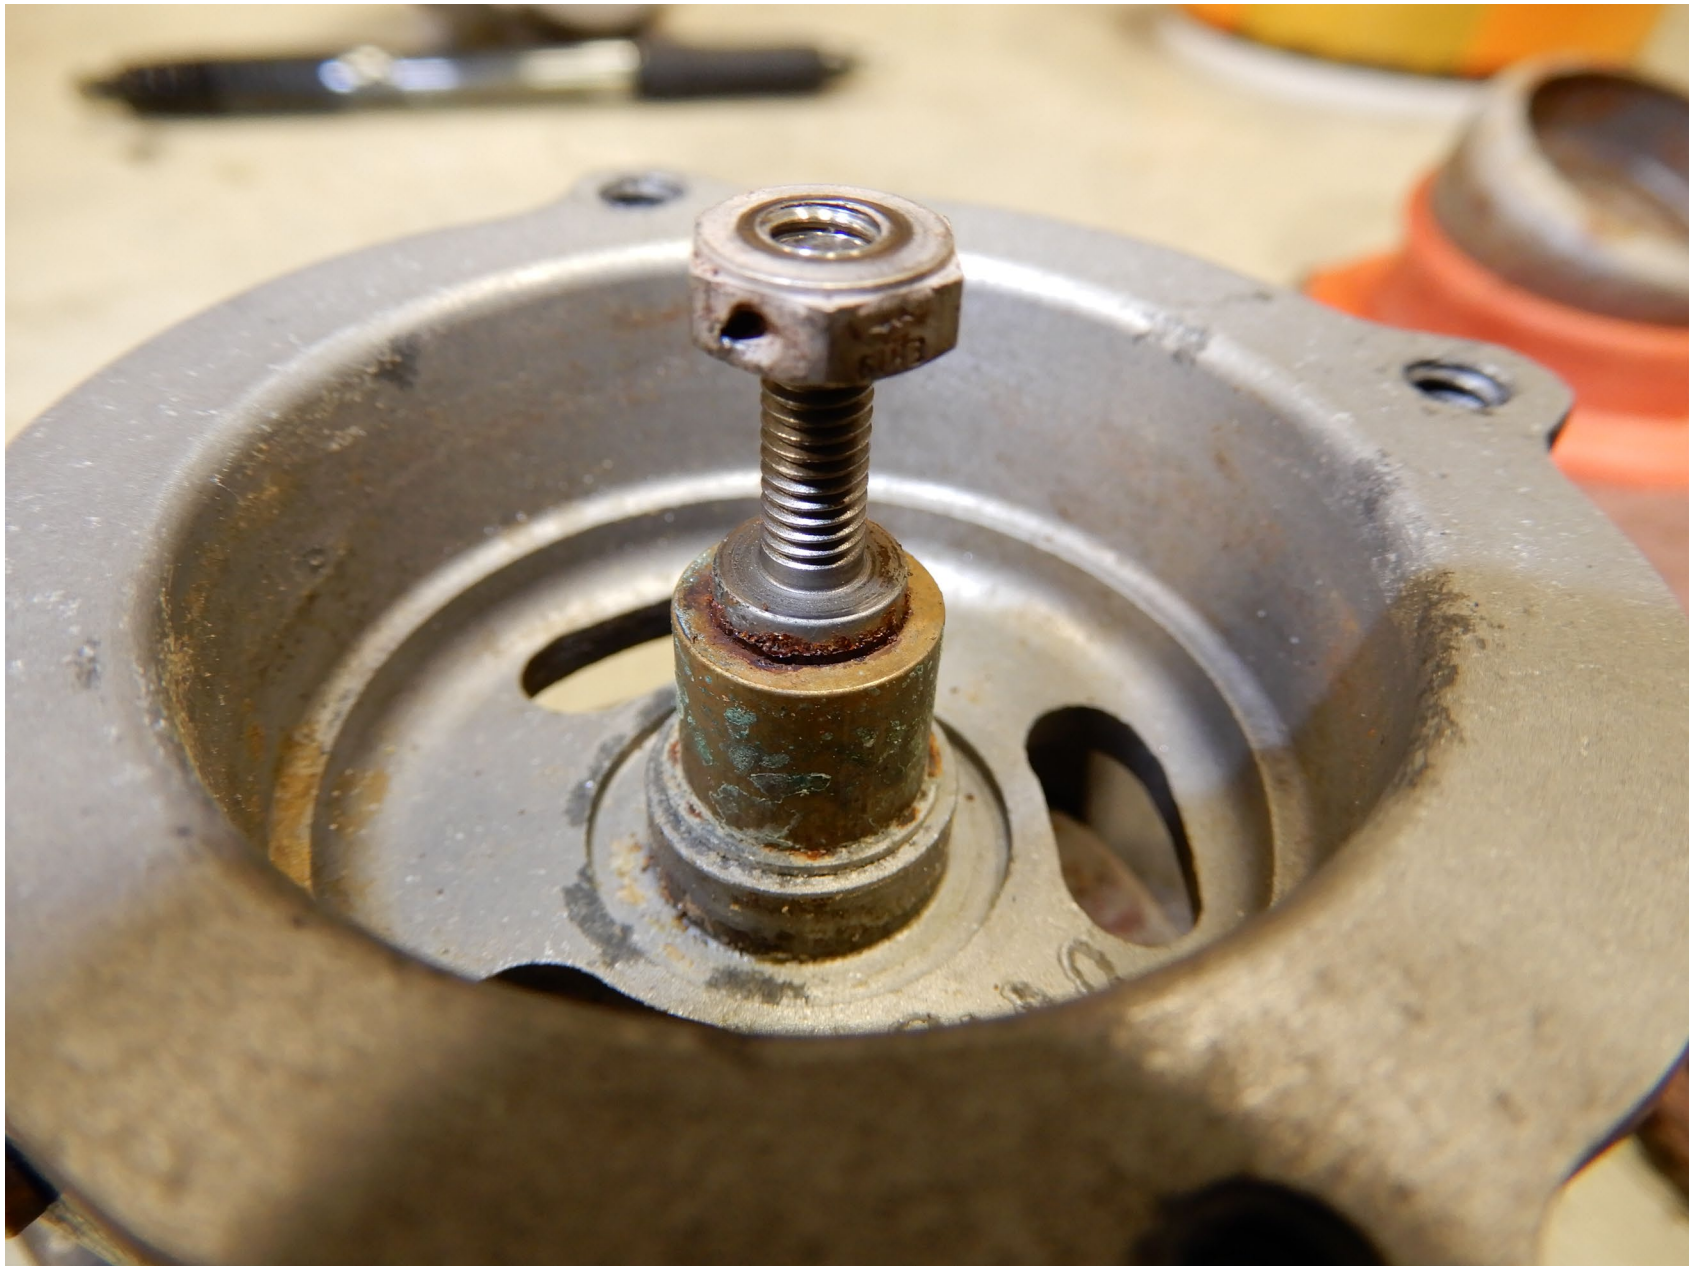
**Photo 5 – Accident compressor bleed valve assembly, showing corrosion on valve and guide.**

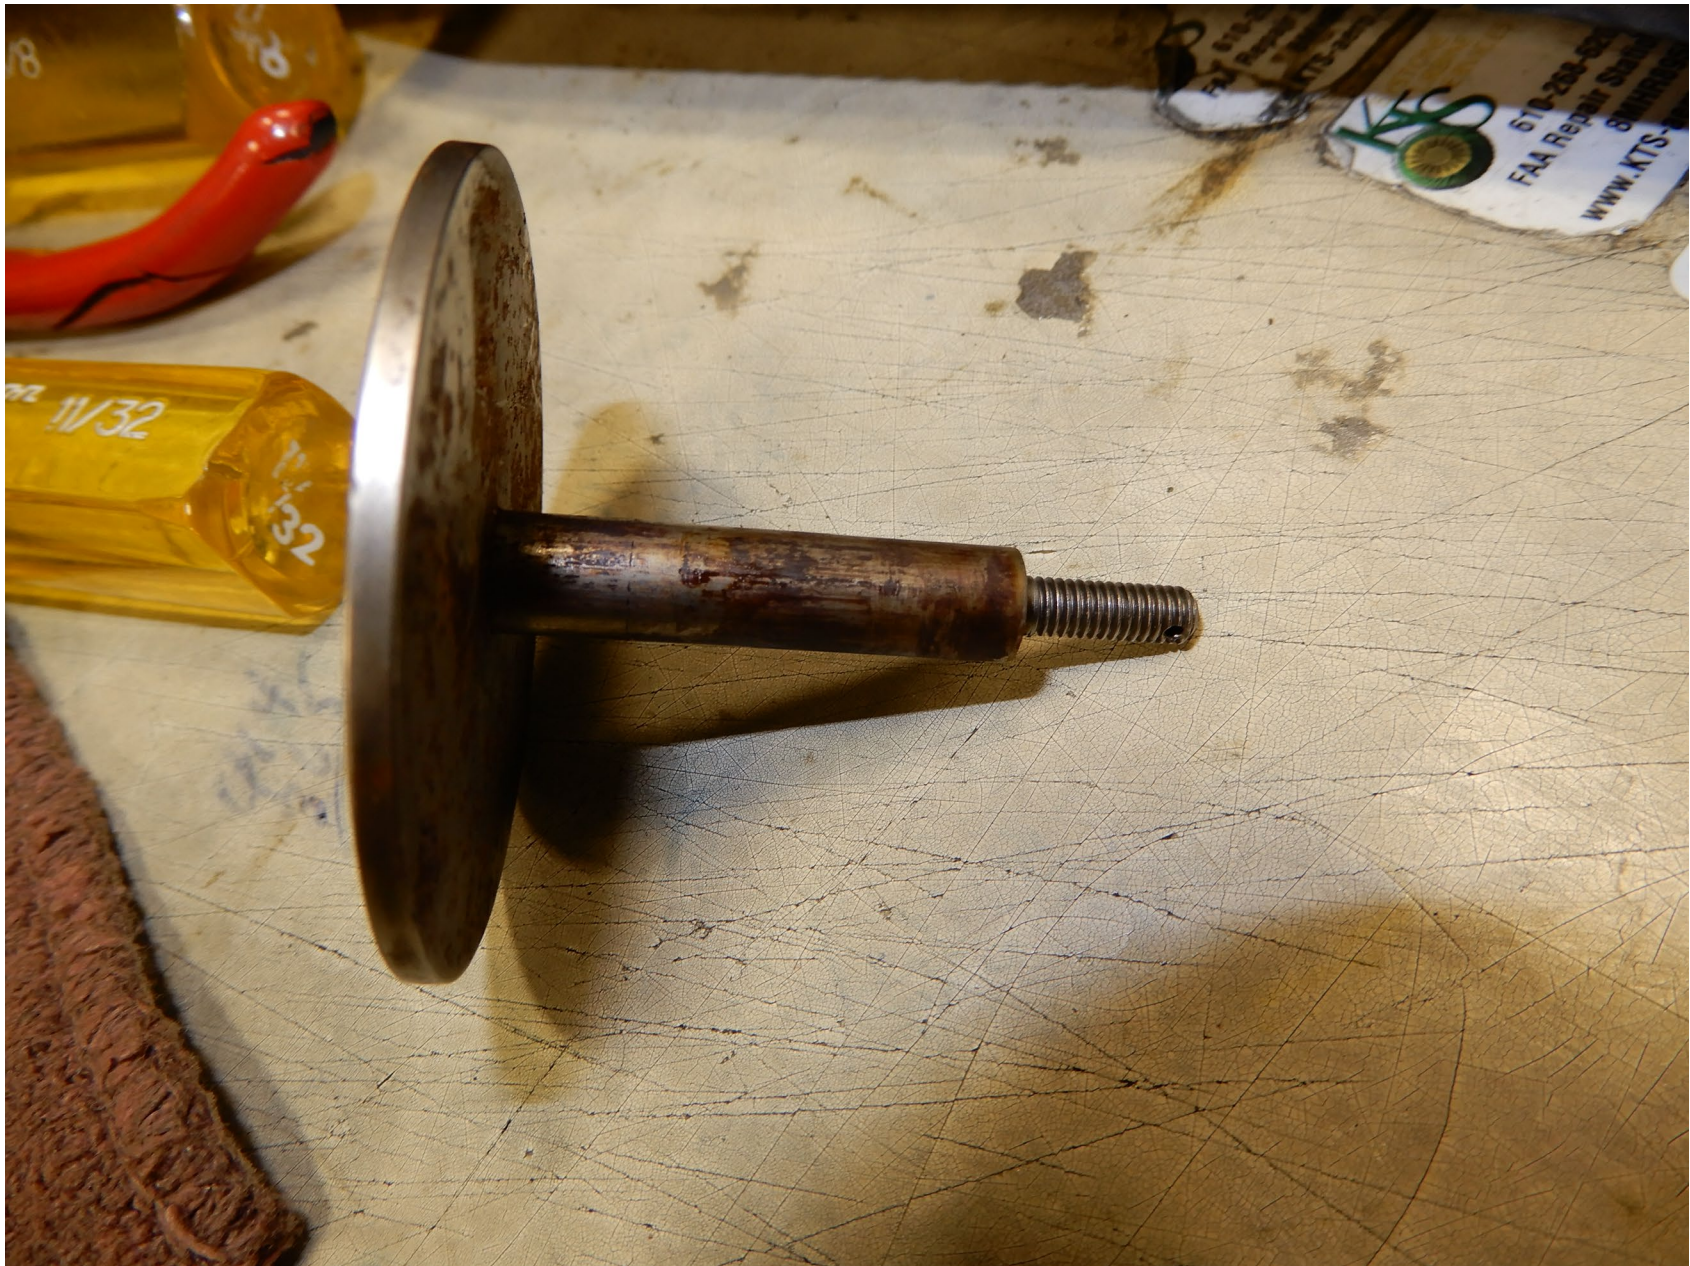
**Photo 6 – Accident compressor bleed valve, showing corrosion build up on valve stem.**

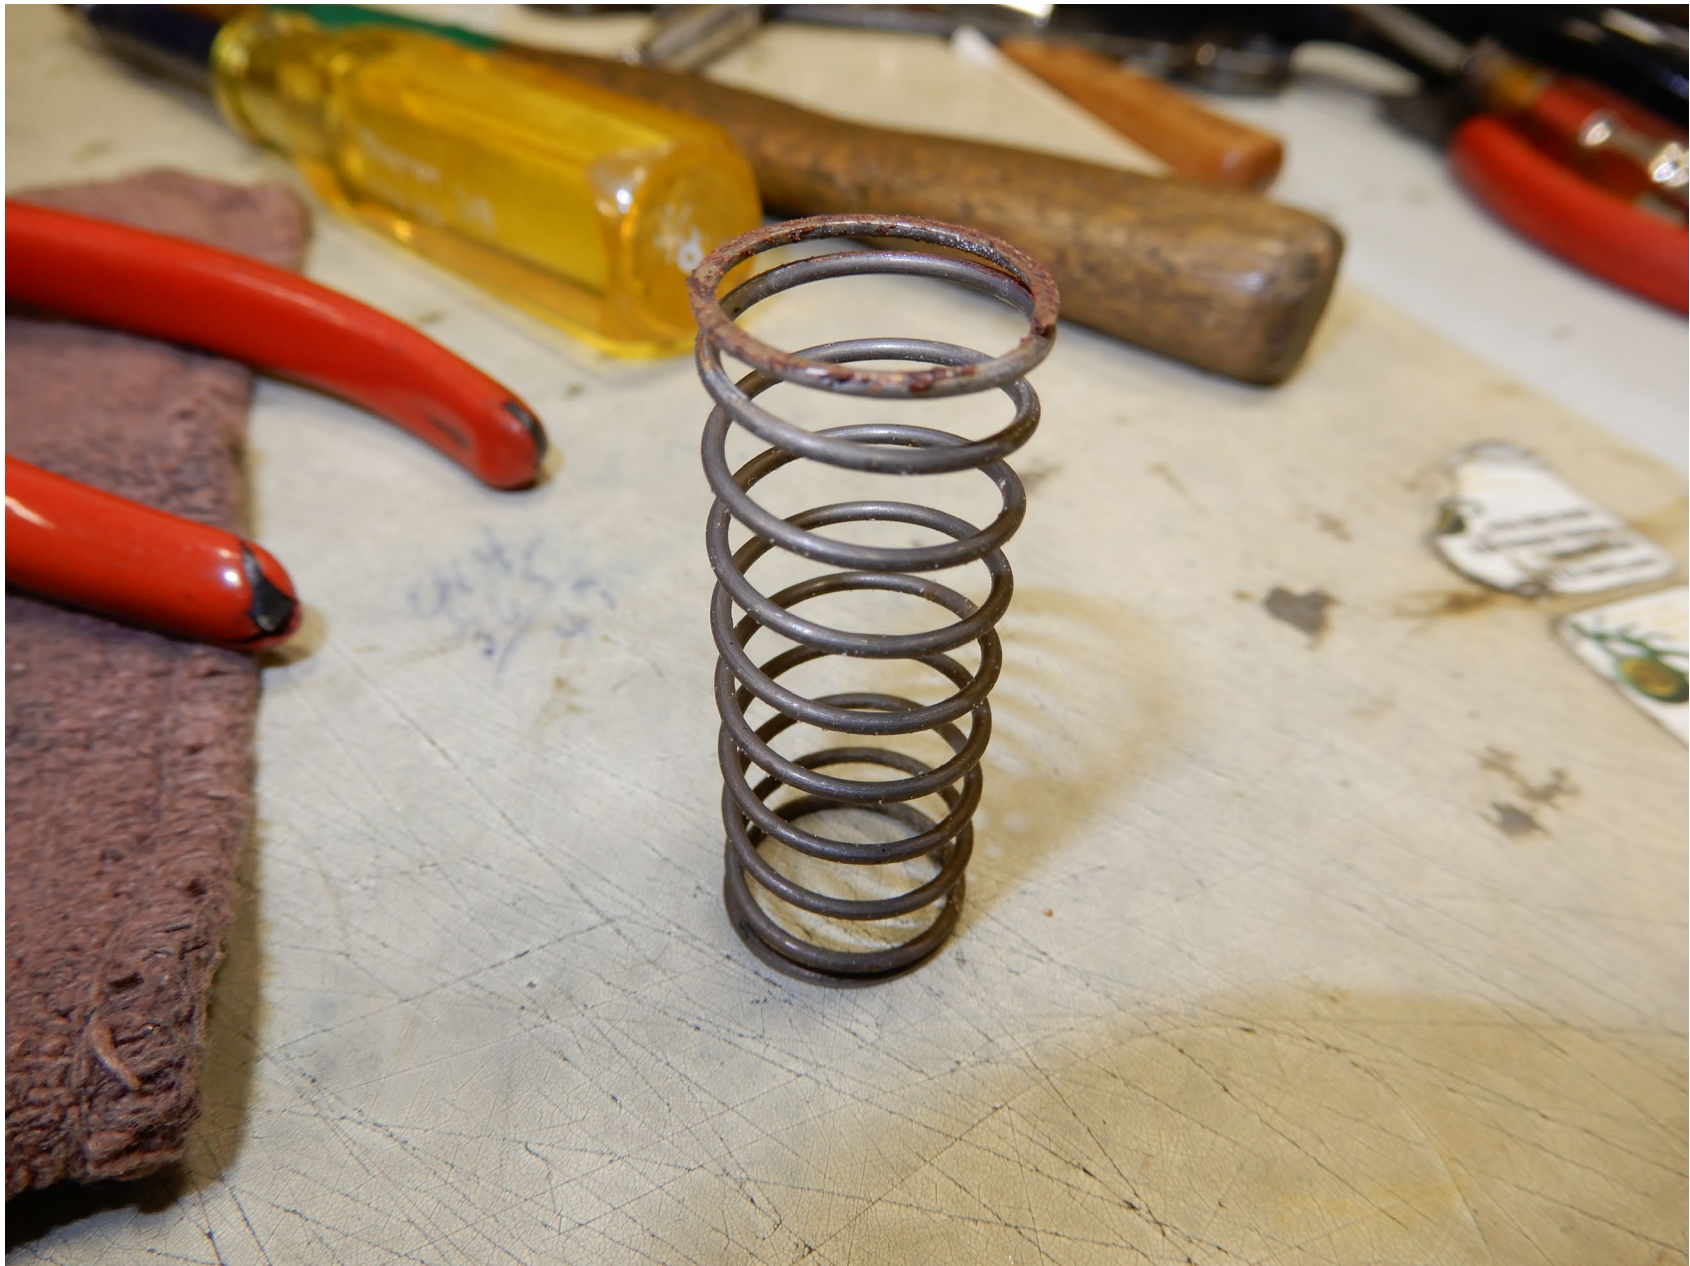
**Photo 7 – Bleed valve spring, showing corrosion on top of spring.**

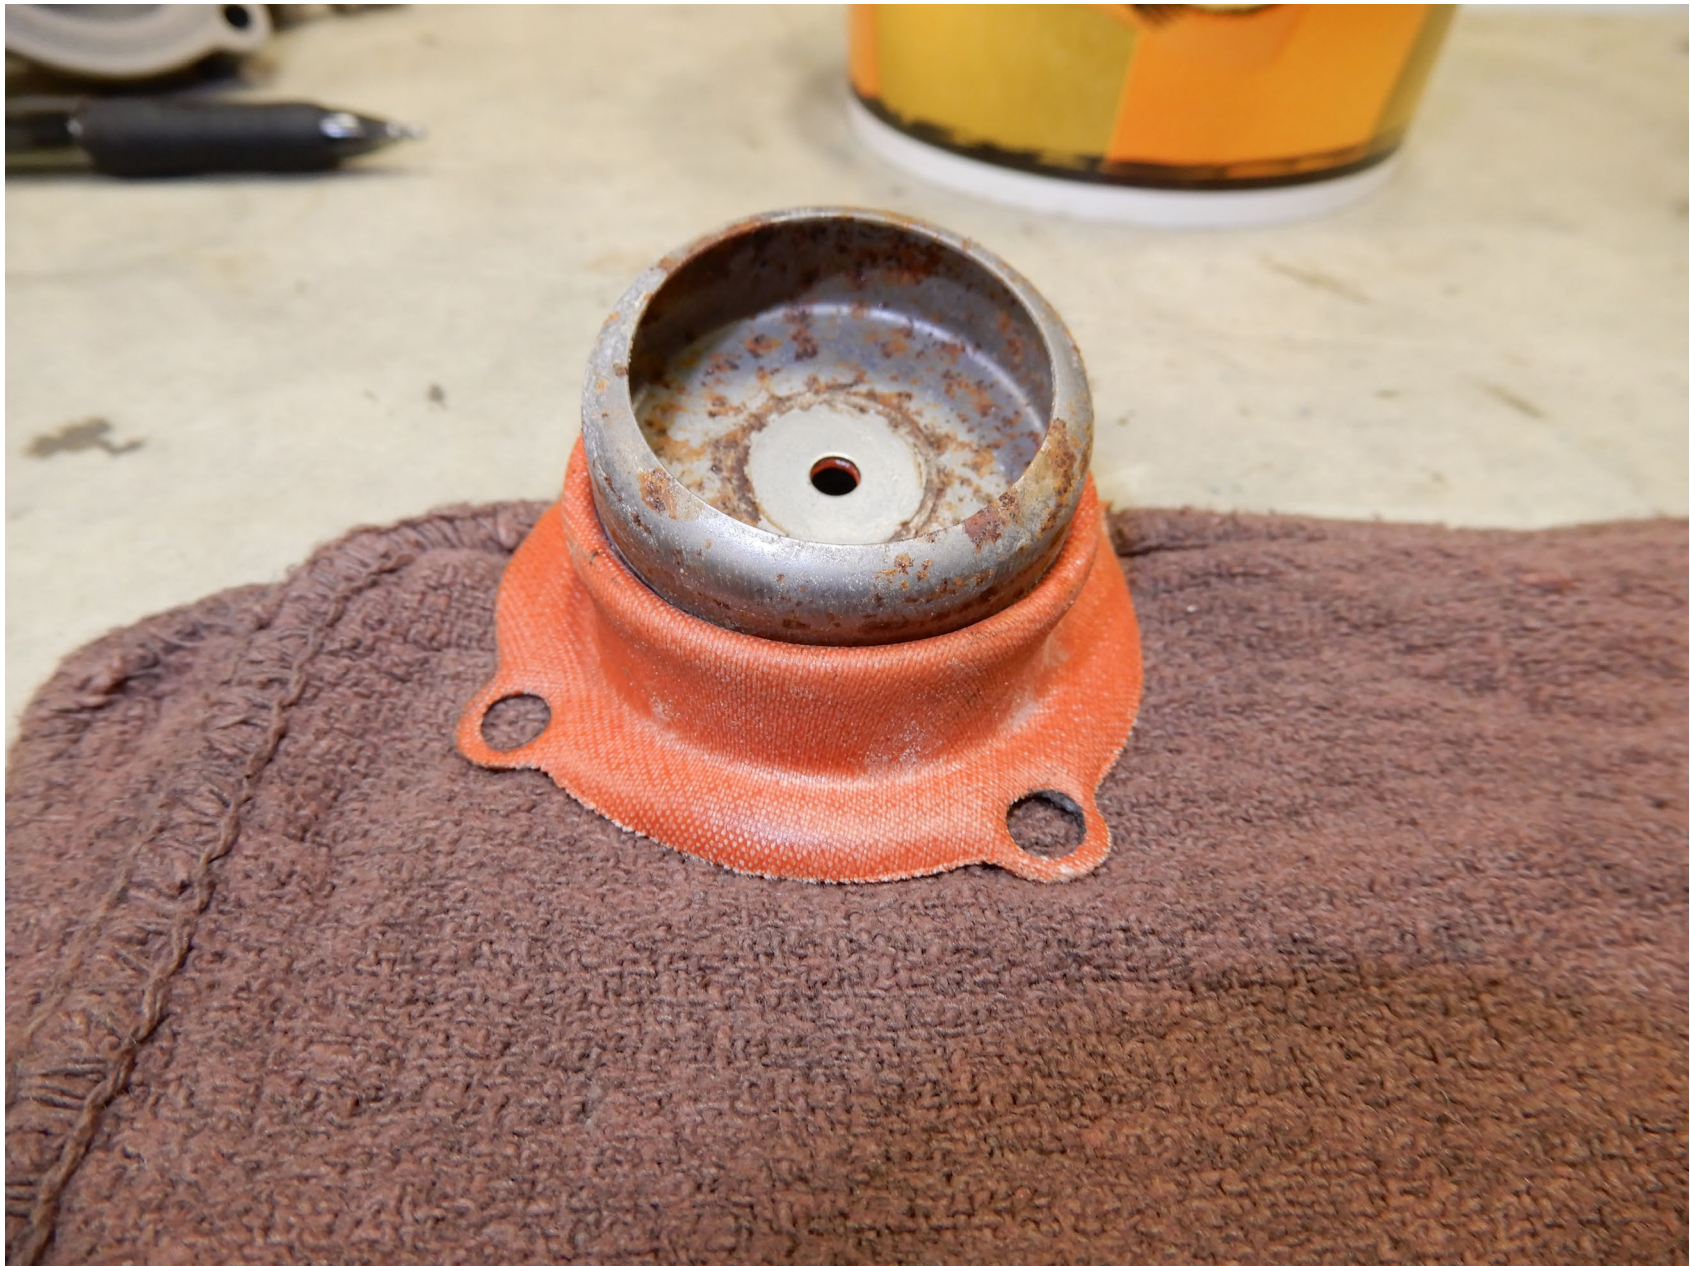
**Photo 8 – Bleed valve bellows, showing corrosion.**
