## **NATIONAL TRANSPORTATION SAFETY BOARD**

# **AIRFRAME AND ENGINE EXAMINATION**

**WPR19LA087**

Location: Kukuiahaele, Hawaii  
Date: February 21, 2019  
Aircraft: MD Helicopters 369E / N506PH  
NTSB IIC: Fabian Salazar

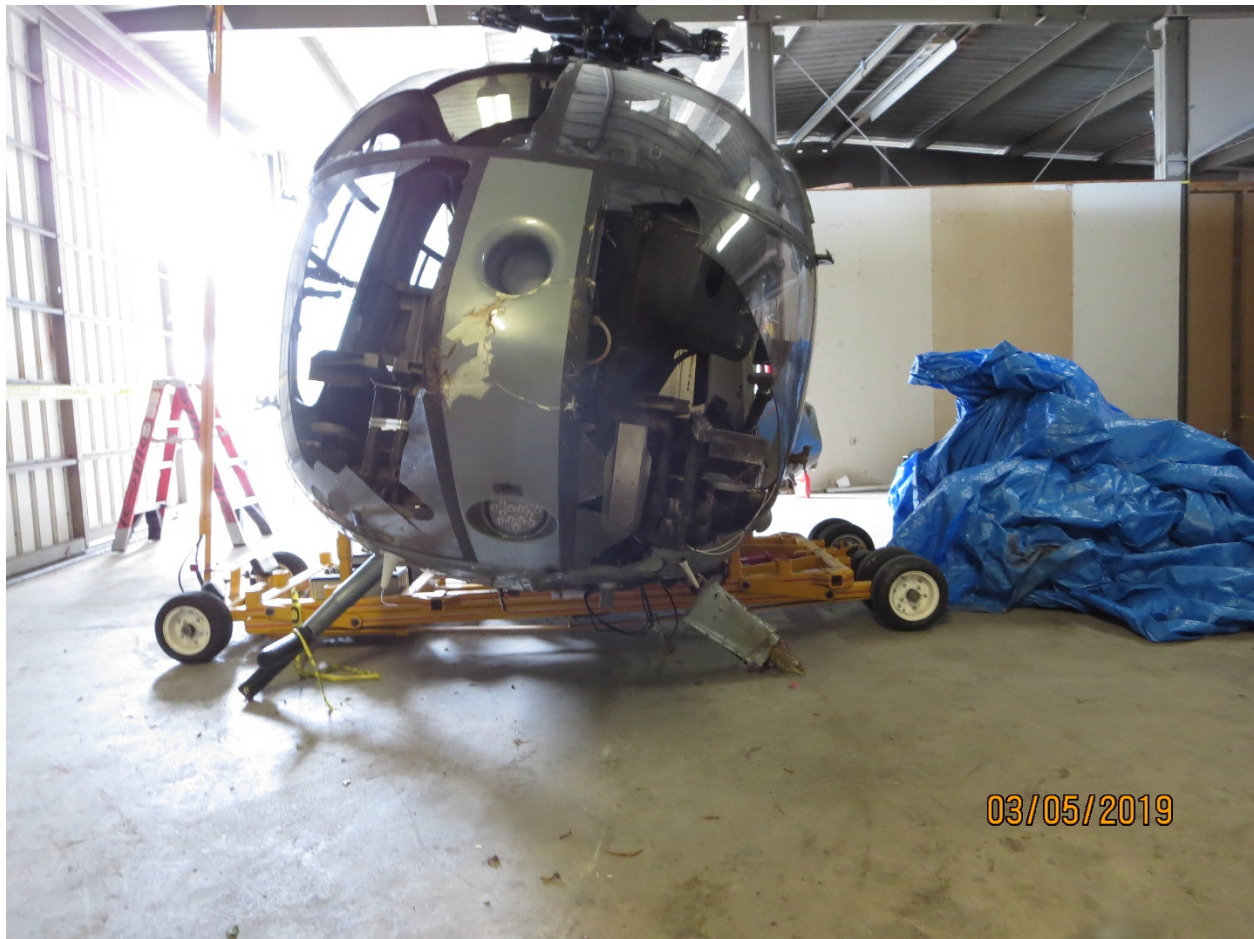
The helicopter had come to rest on its left side, on a generally flat open area. The right windshield and lower chin bubbles were fractured including the composite section between the

Figure 1. Front view of N506PH. Photo courtesy of MD Helicopters.

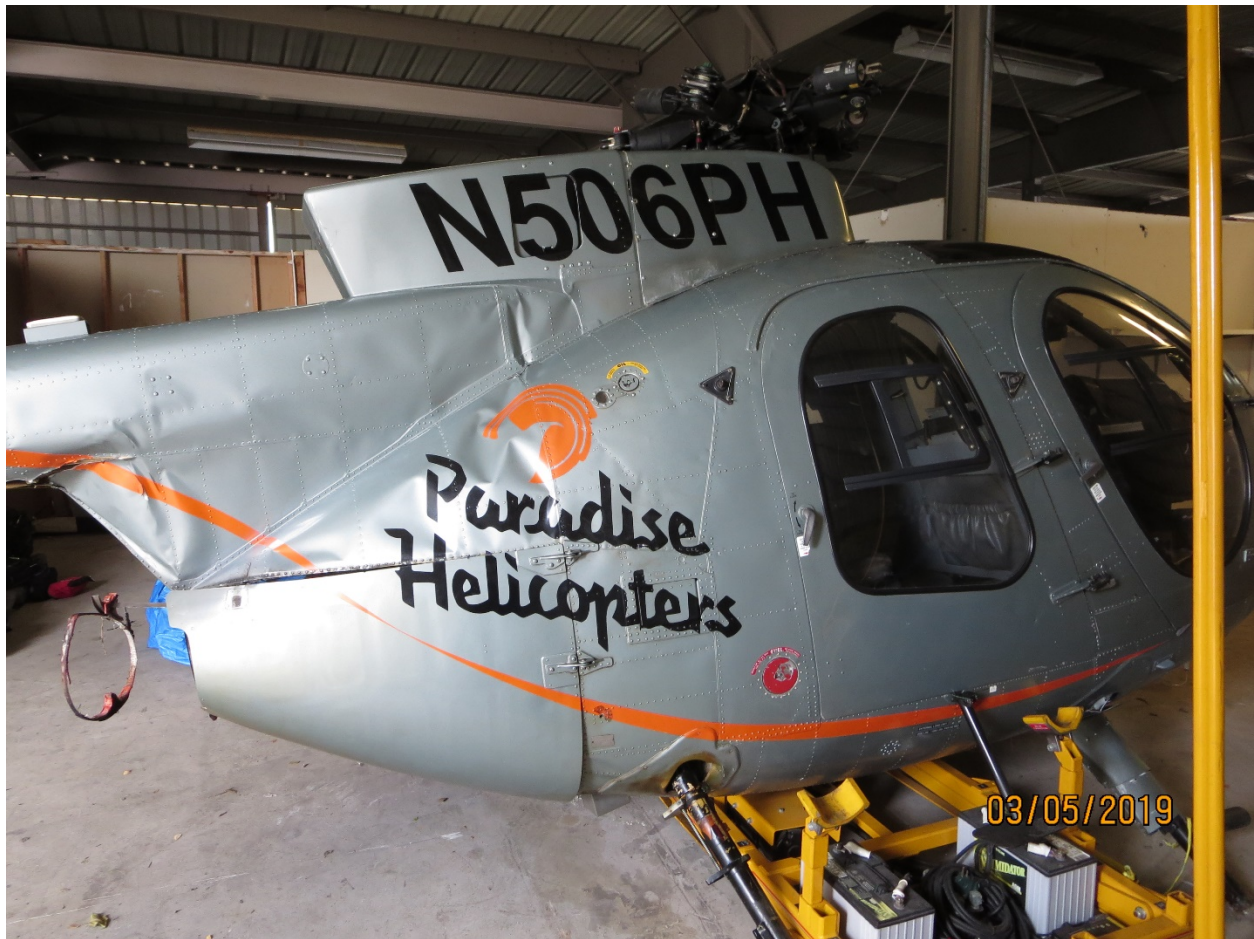
Figure 2. Right-side view of N506PH. Photo courtesy of MD Helicopters.

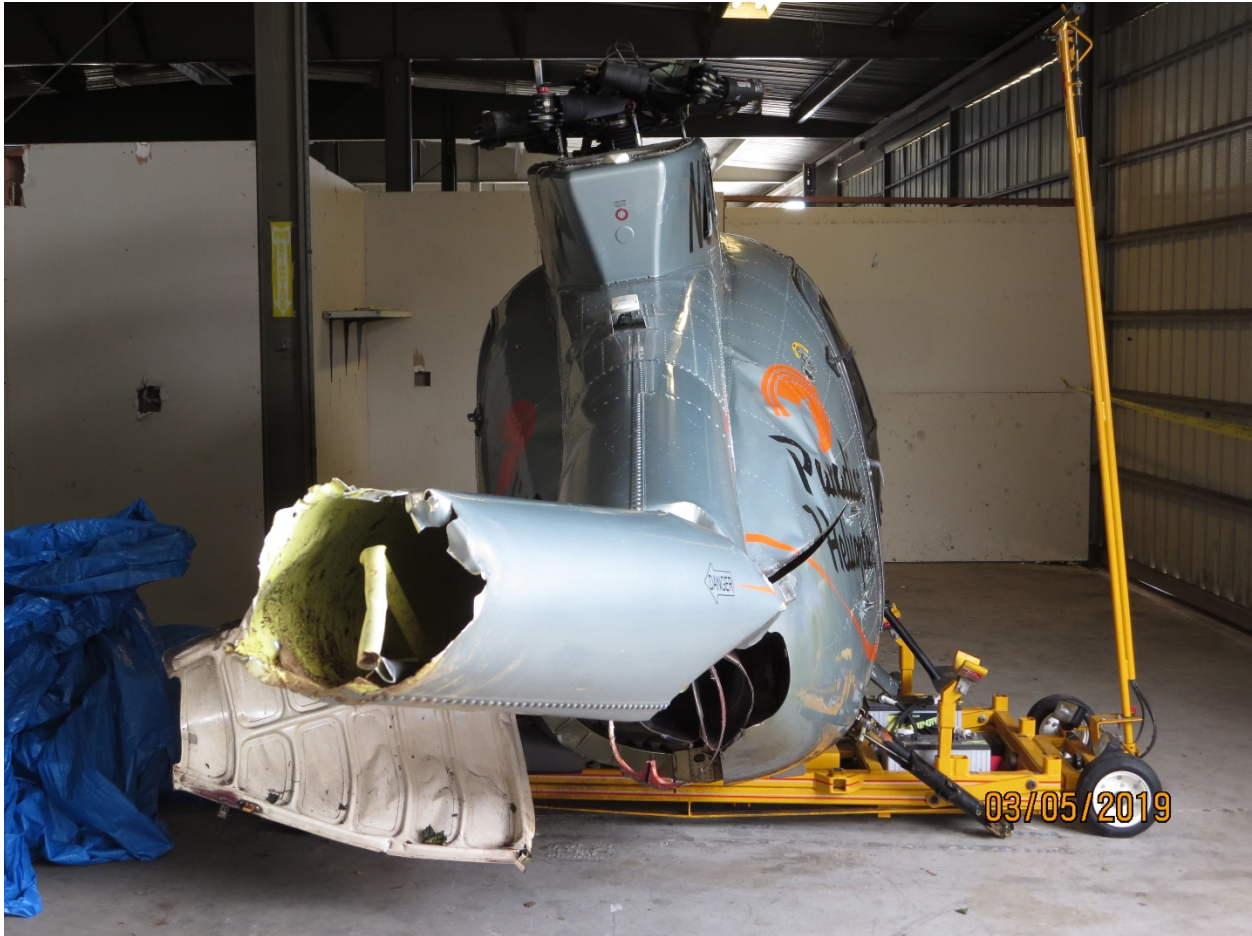
The tailboom sustained substantial damage with separation just forward of the empennage. A section of the tailboom bent upward about 20 inches inboard of the separation point. The tail rotor control tube and the tail rotor drive shaft were fractured at the same area as the break in the tailboom.

Figure 3. Rear view of N506PH. Photo courtesy of MD Helicopters.

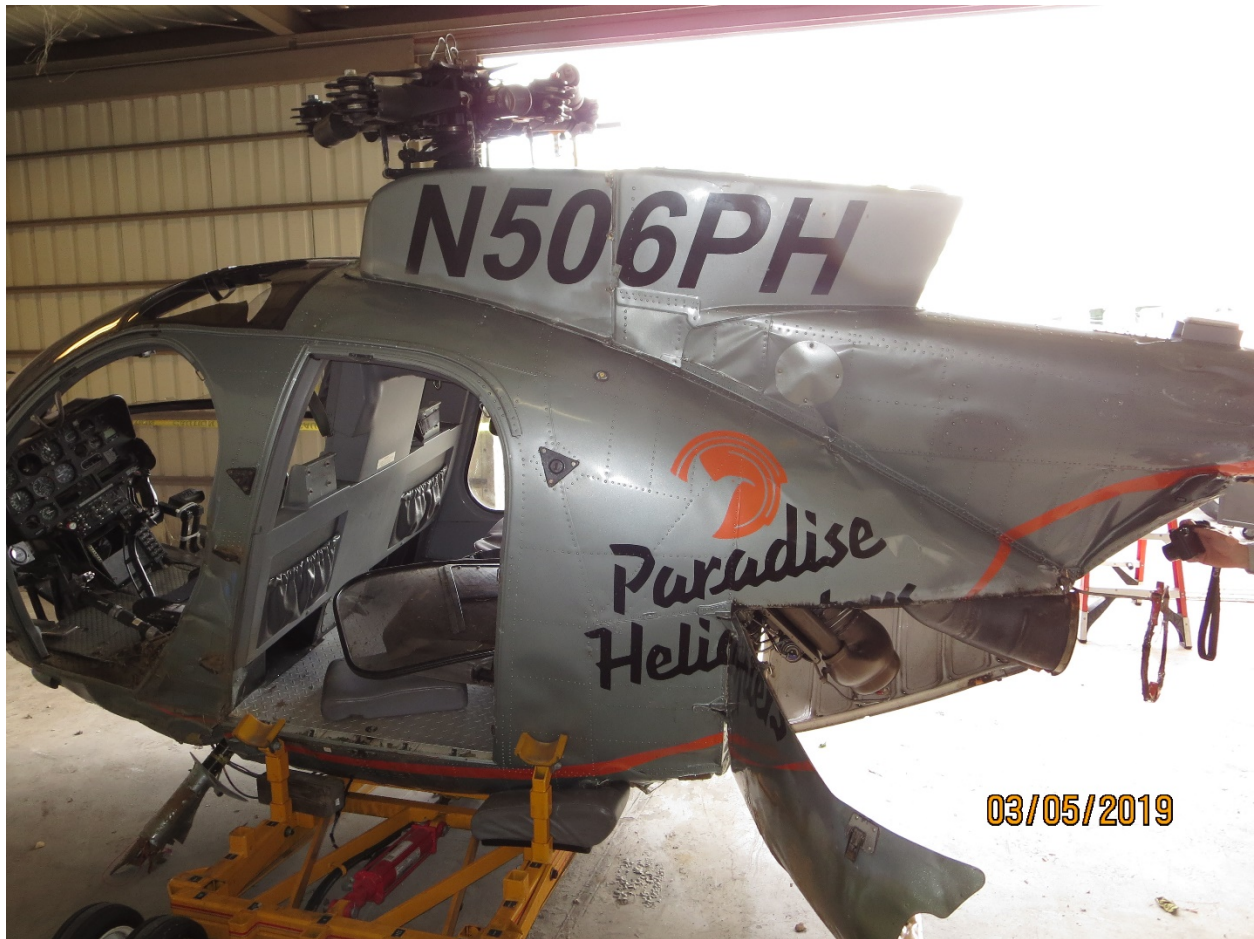
The left side of the fuselage and the tailboom exhibited denting and wrinkling of the skin above the engine bay. The left-underside fuselage exhibited substantial damage with crushing and denting of the sheet metal. The left-side rear passenger door and the left-side pilot's door were removed for recovery. The left-side skid separated from the front strut at the upper and lower strut union, and at the upper attachment point of the rear strut. The left-side rear strut separated from the fuselage along with the left skid.

Figure 4. Left-side view of N506PH. Photo courtesy of MD Helicopters.

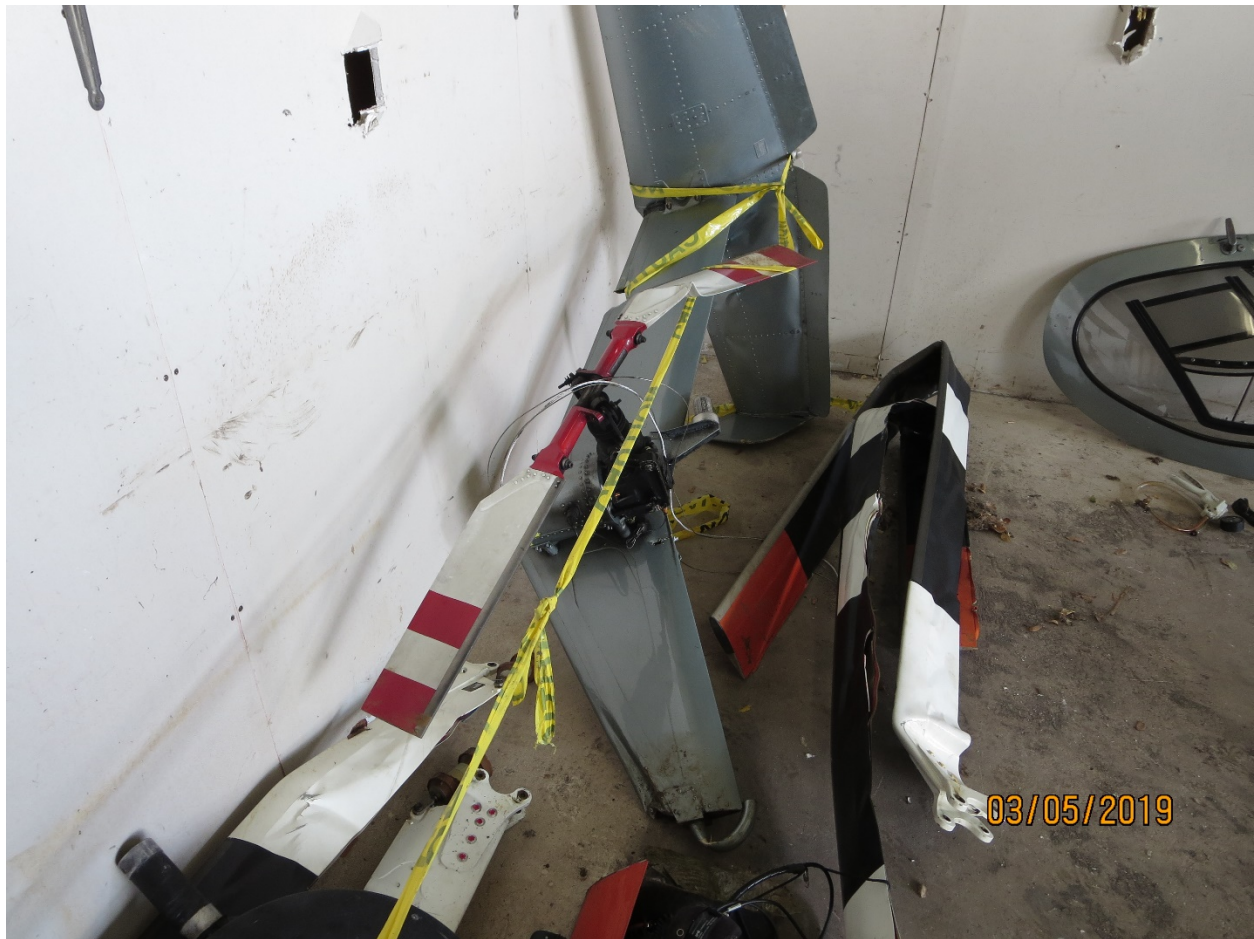
The empennage separated from the tailboom and was in the wreckage. The right side of the T-tail exhibited crushing and downward bending. The tail rotor and gear box remained attached to the end of the tailboom. One tail rotor blade was bent chordwise toward the tailboom about 12 inches from the root of the blade. The other blade exhibited minor damage. The vertical stabilizer exhibited damage on the leading edge consistent with contact by one or more main rotor blades. The lower vertical stabilizer and the stinger exhibited denting and bending along with dirt staining, consistent with contact with the ground. The tail rotor gearbox chip detector was clean and free of metal shavings. The oil from the gearbox was clear and bright.

Figure 5. View of the empennage, and tail rotor assembly. Photo courtesy of MD Helicopters.

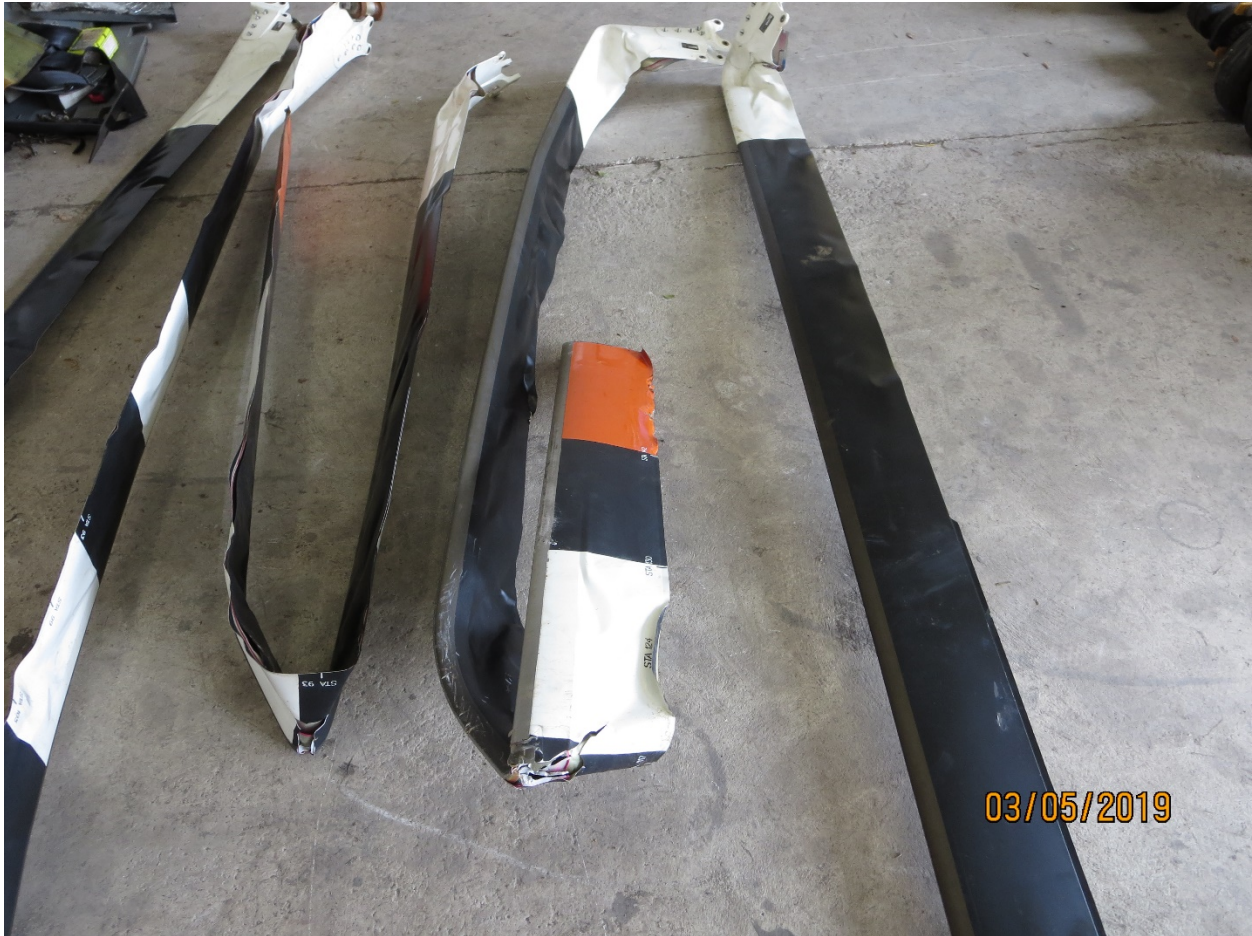
The main rotor system remained attached to the transmission and the transmission remained attached to the fuselage. The five-blade main rotor assembly exhibited substantial damage to all rotor blades. All blades exhibited significant chord-wise bending at different locations of each blade. The red, and white, blade dampers separated in two but remained attached at both ends. The blue, yellow, and green blade dampers remained intact and attached at both ends. All blade grips exhibited evidence of contacting the rotor hub at the aft or retreating end. All pitch change links, from the swash plate to the pitch horns remained attached at both ends.

Figure 6. Main rotor blades. Photo courtesy of MD Helicopters.

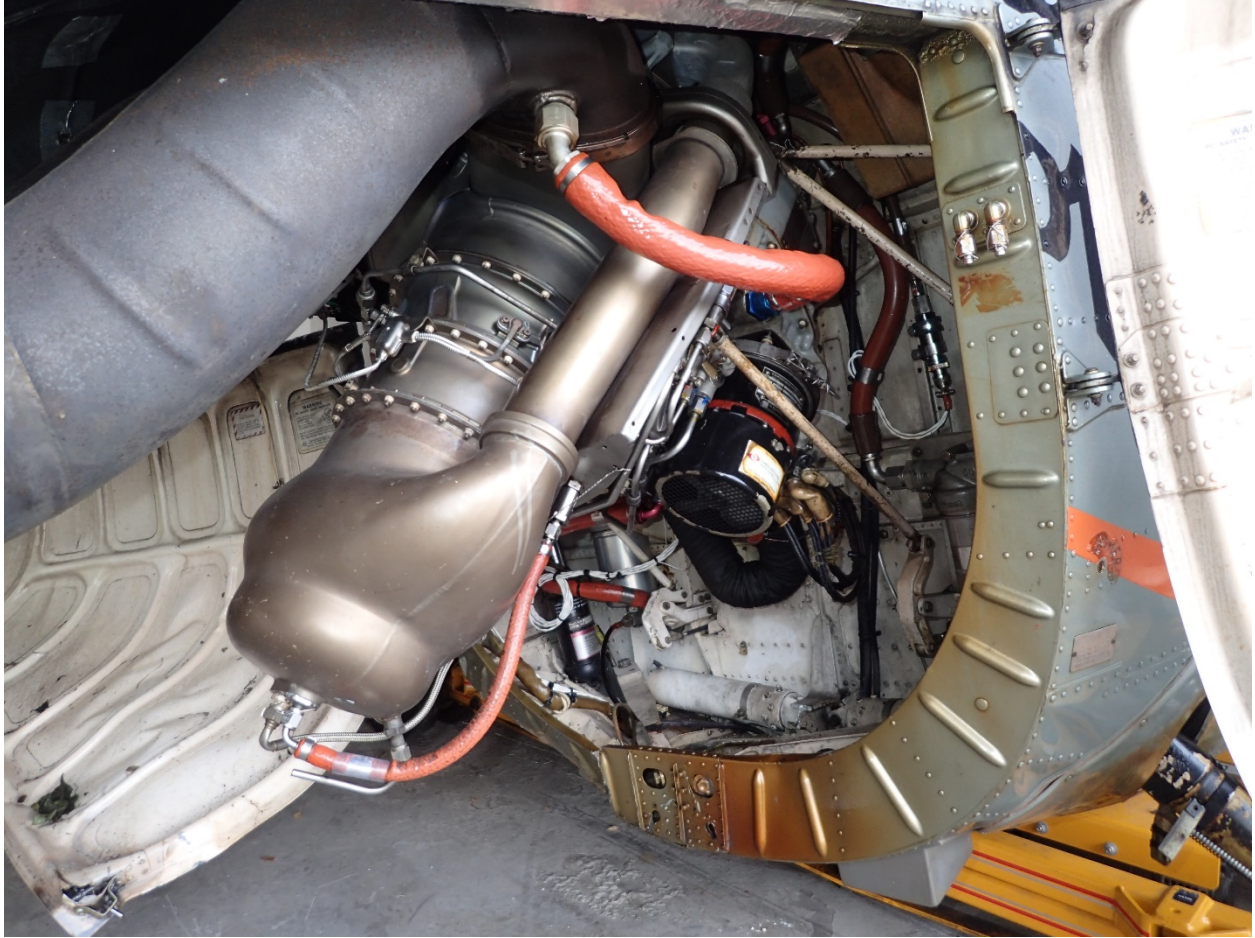
Figure 7. Right-side view of the engine. Photo courtesy of Rolls-Royce.

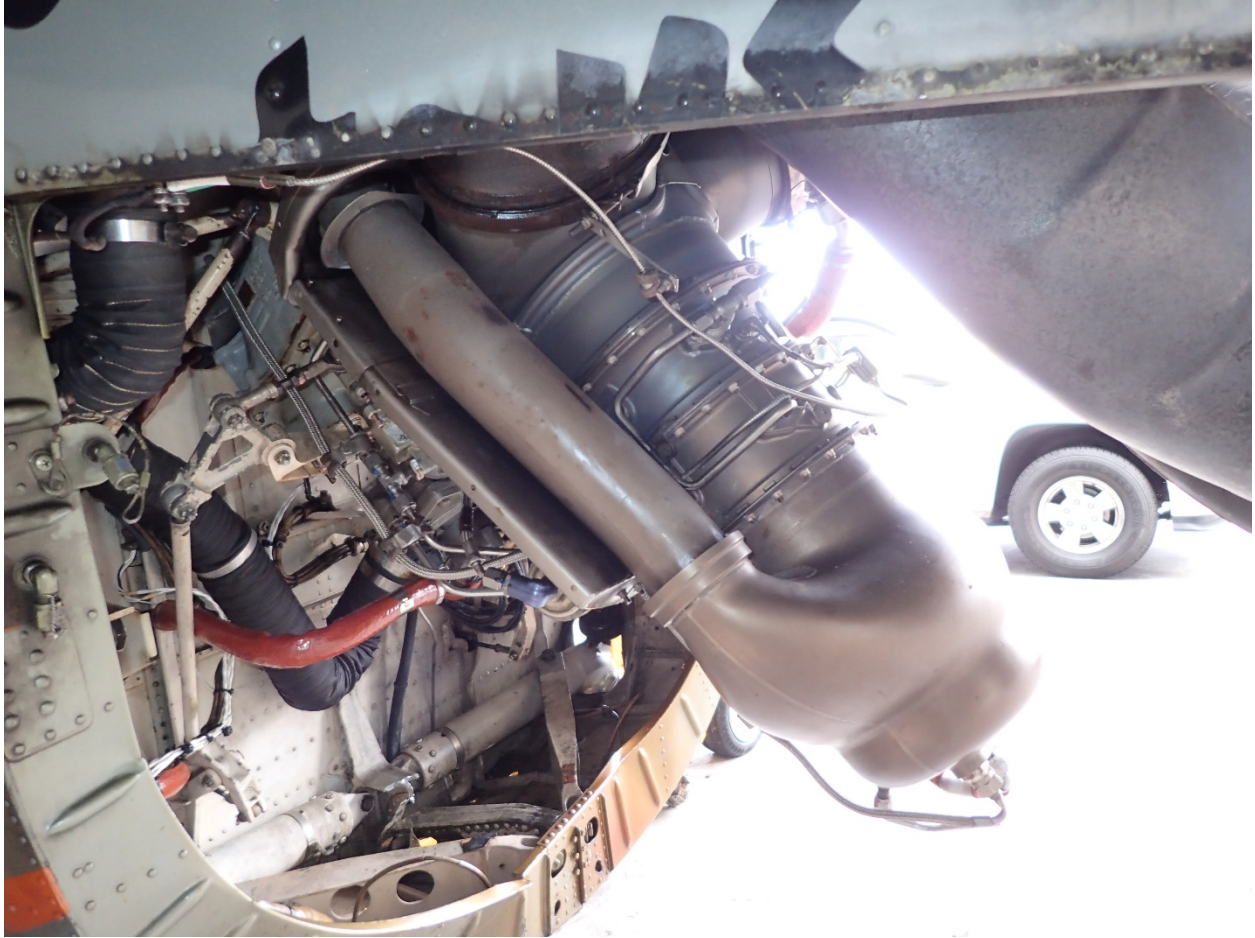
Figure 8. Left-side view of the engine. Photo courtesy of Rolls-Royce.

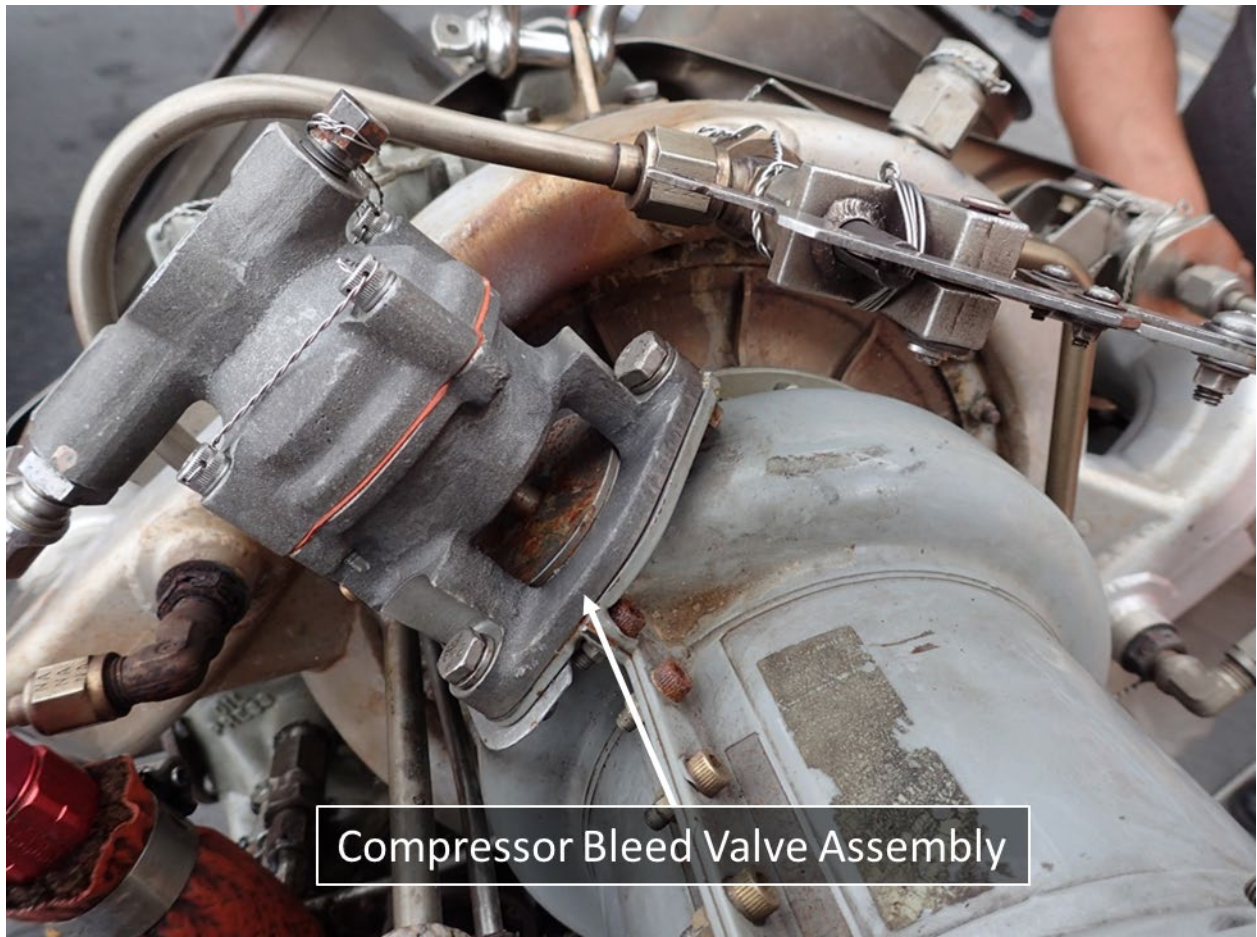
The engine remained attached to the fuselage by the engine mounts. The engine bay area was not compromised by impact. Upon examination it was observed that the compressor bleed valve was stuck in the closed position and had evidence of corrosion on the valve. The engine was removed from the helicopter to be shipped to a Rolls-Royce authorized service center.

Figure 9. Top of engine view, showing the compressor bleed valve assembly. Photo courtesy of Rolls-Royce.

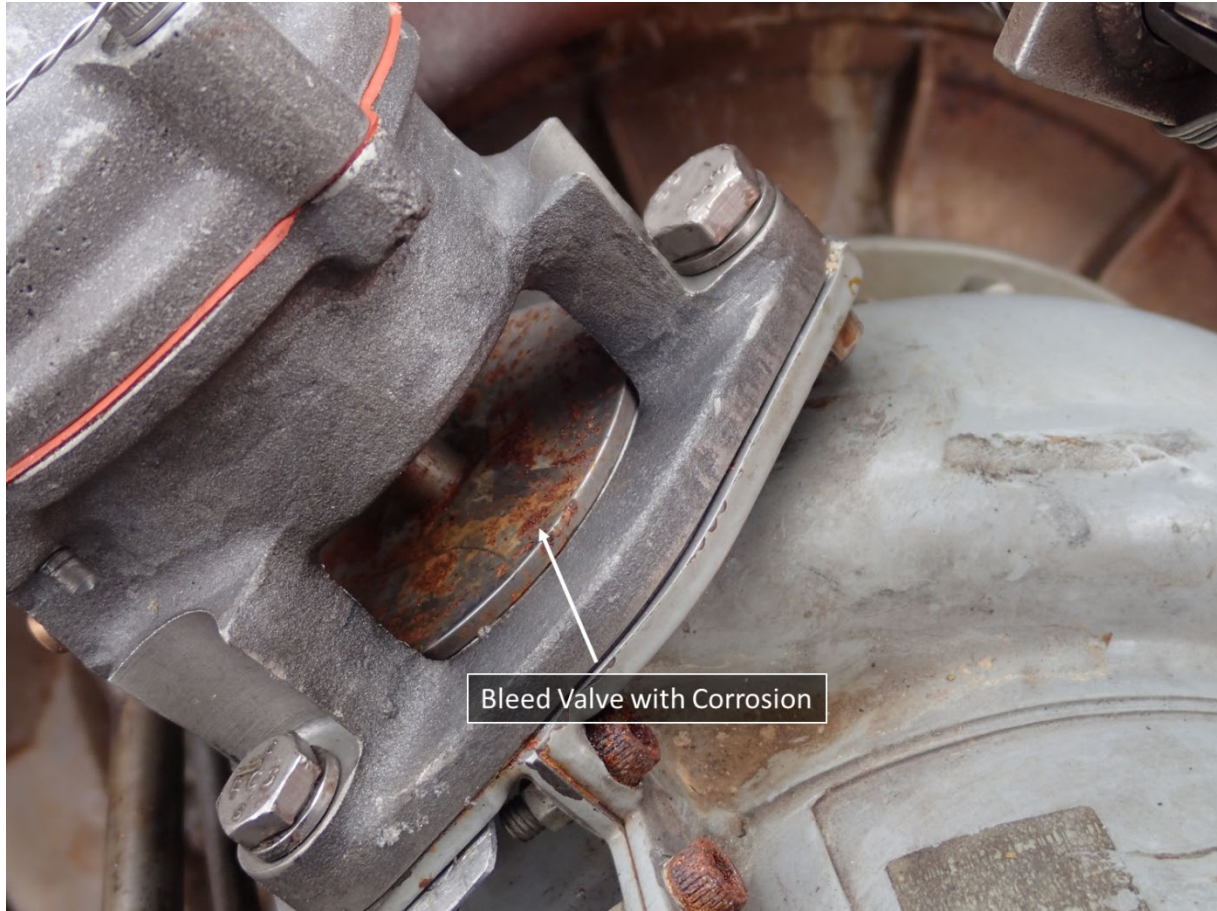
The accident bleed valve (serial number FF-29669) was examined by members of KTS, Rolls-Royce Engines and the IIC. The bleed valve was discovered to be constructed using Federal Aviation Administration Parts Manufacturing Approval (PMA) components. Before teardown, the bleed valve was visually examined and exhibited corrosion on the outer surfaces of the valve and the bushing. The two hex-head bolts securing the outer cases of the compressor, and nearest the bleed valve exhibited corrosion on the head of the bolts. The bleed valve assembly was then disassembled. The KTS employee had difficulty removing the valve from the bushing and was forced to use a mallet to tap the valve out. The valve exhibited a build up of corrosion on the stem and the inside of the bushing. The bushing and valve were measured using calibrated pins and rings owned by KTS. According to KTS, the bushing was 0.307" and the valve stem was 0.3079." Other internal components, including the spring and bellows, exhibited corrosion on their surfaces. Photos of the bleed valve taken on March 5<sup>th</sup> show corrosion but there were no

The accident valve and bushing were shipped to the NTSB materials laboratory where the corrosion was examined and found to contain a chemical that was consistent with Ardrex 6367, an engine wash compound used by the operator.

Figure 10. View of the compressor bleed valve, showing corrosion on the valve. Photo courtesy of Rolls-Royce.

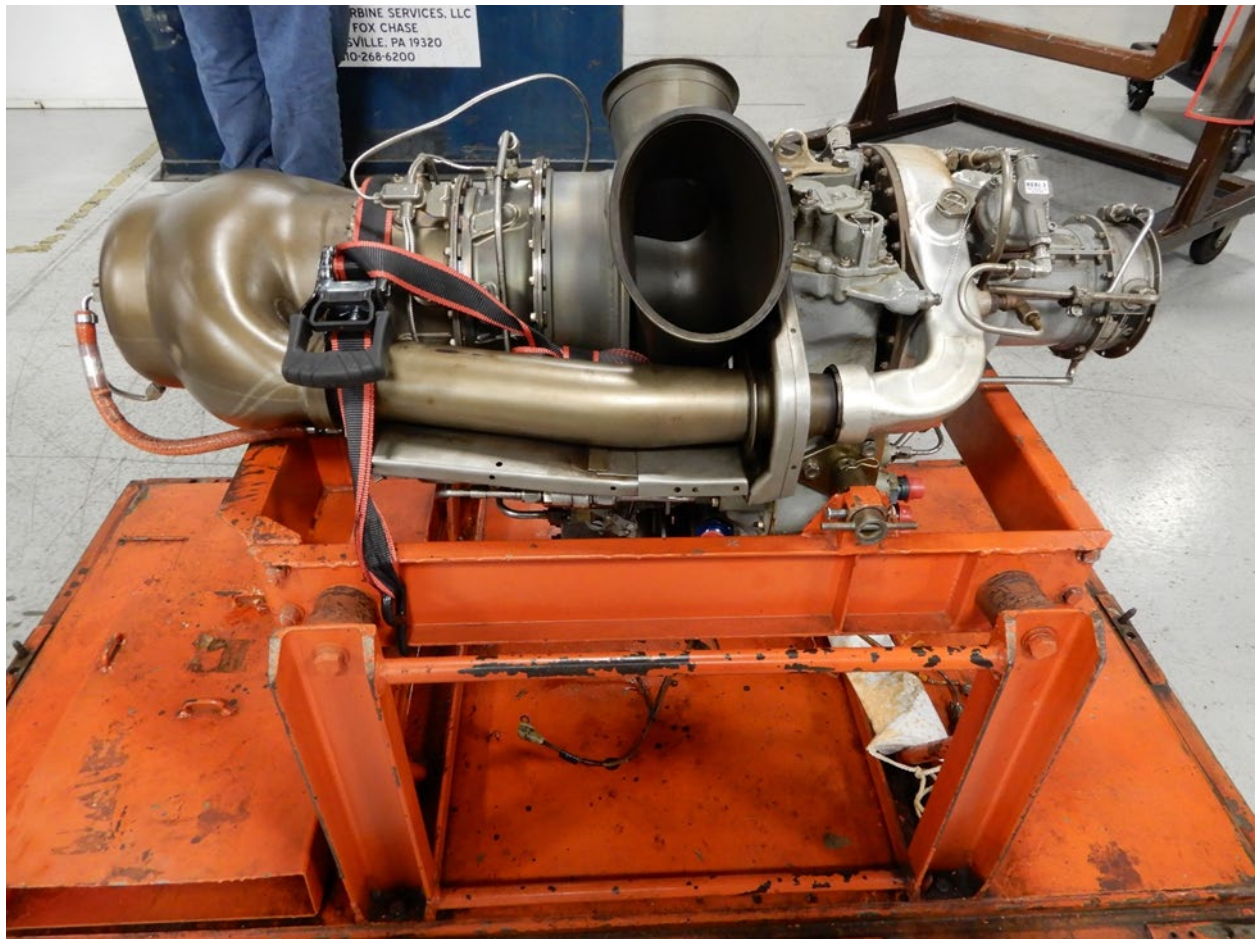
The engine was received by Keystone Turbine Services (KTS), Coatesville, Pennsylvania. The IIC and party members were present when the engine shipping container was opened. The engine was not damaged while in transit. The compressor bleed valve was observed to still be in the closed position. The engine was further examined by employees of KTS and Rolls-Royce where it was determined that a "run as received" test run would be conducted using the accident bleed valve and manually opening it for the test run. The test run occurred on May 15, 2019.

Figure 11. The engine as it was received at the service center. Photo NTSB
