# NATIONAL TRANSPORTATION SAFETY BOARD

## MATERIALS LABORATORY FACTUAL REPORT

Report No. 20-011

Place : Laramie, Wyoming  
Date : February 10, 2019  
Vehicle : Lancair IV-P, N549CJ  
NTSB No. : WPR19LA088  
Investigator : Zoe Keliher, AS-WPR

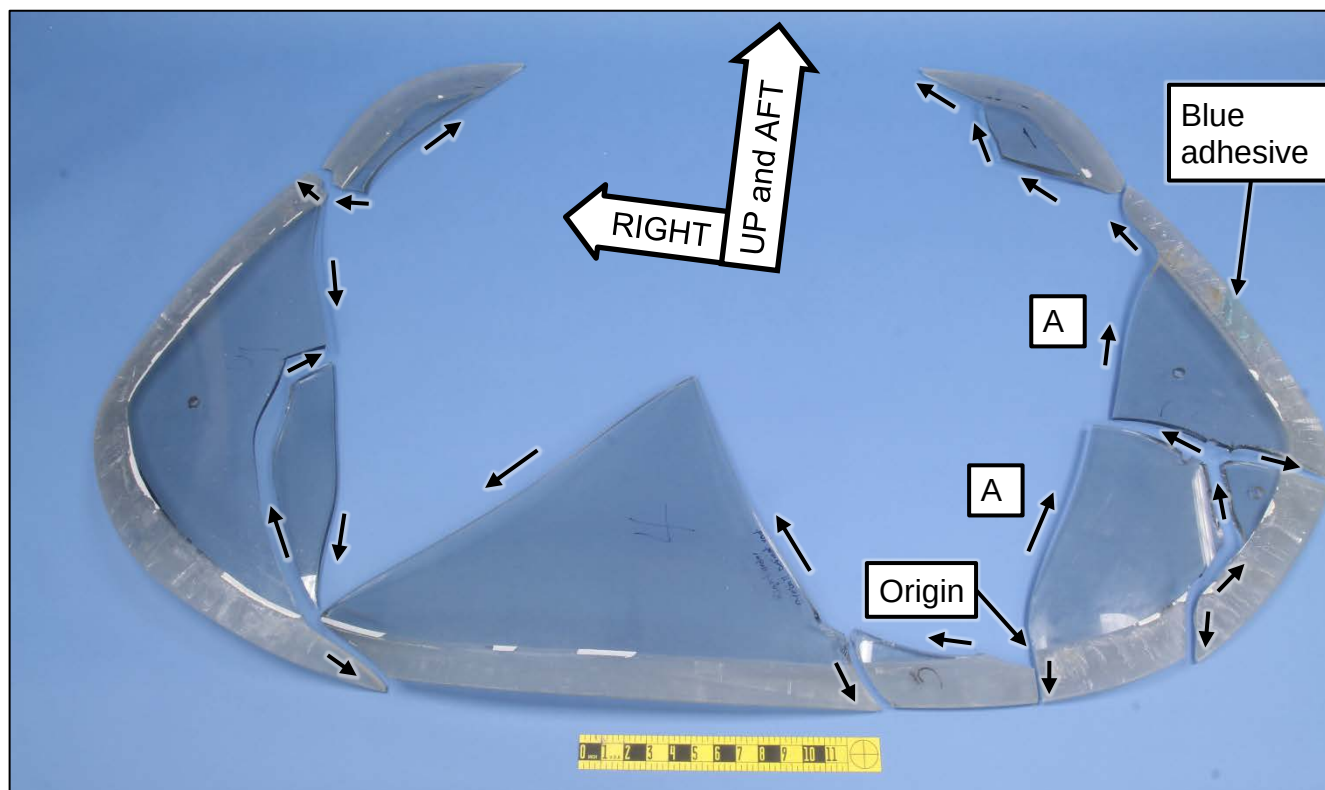
An overall view of the submitted windshield pieces is shown in figure 1. Made of cast acrylic, the windshield had fractured in flight, and the middle and upper portions were missing from the recovered pieces. Each piece was examined visually, and unlabeled arrows in figure 1 indicate fracture directions determined from the visual examination. One fracture that emanated forward to aft at the left side of the windshield is labeled fracture A for reference in figure 1, and the location of the origin associated with fracture A is also indicated.

Figure 1. Overall view of the submitted windshield pieces. Unlabeled arrows indicate fracture propagation directions.

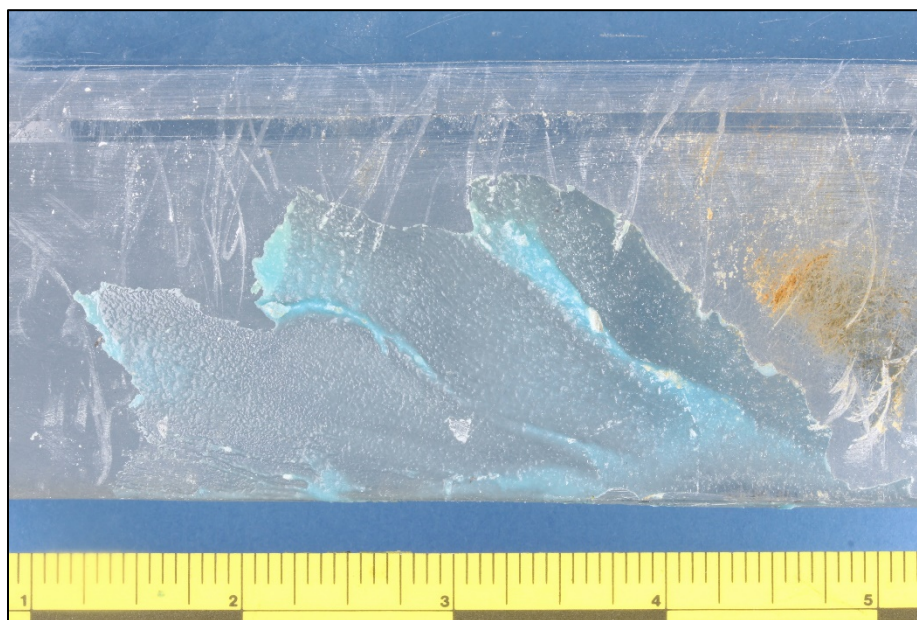
The outer edge of the windshield had a white appearance consistent with a roughening process used during the windshield installation process before bonding to the windshield frame. The bond surface on the windshield frame showed minimal visual evidence of adhesive material. An area of blue adhesive was observed on the exterior surface on the left side at the location shown in figure 1, and a closer view of the adhesive remnant is shown in figure 2. On the interior face of the windshield, circular areas consistent with epoxy resin remained in isolated areas on the bonded edge such as the forward edge near the fracture A origin as shown in figure 3. The remnants of resin had a smooth rippled appearance consistent with void surfaces.

Figure 2. Area of blue adhesive on the exterior surface of the bond area on the left side of the windshield.

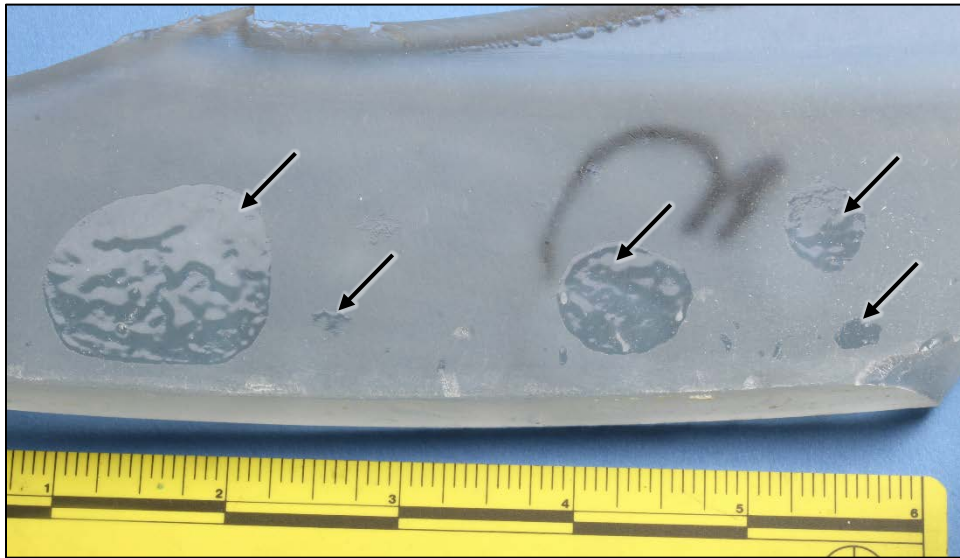
Figure 3. Areas of epoxy on the interior surface of the bond area at the lower forward edge of the windshield.

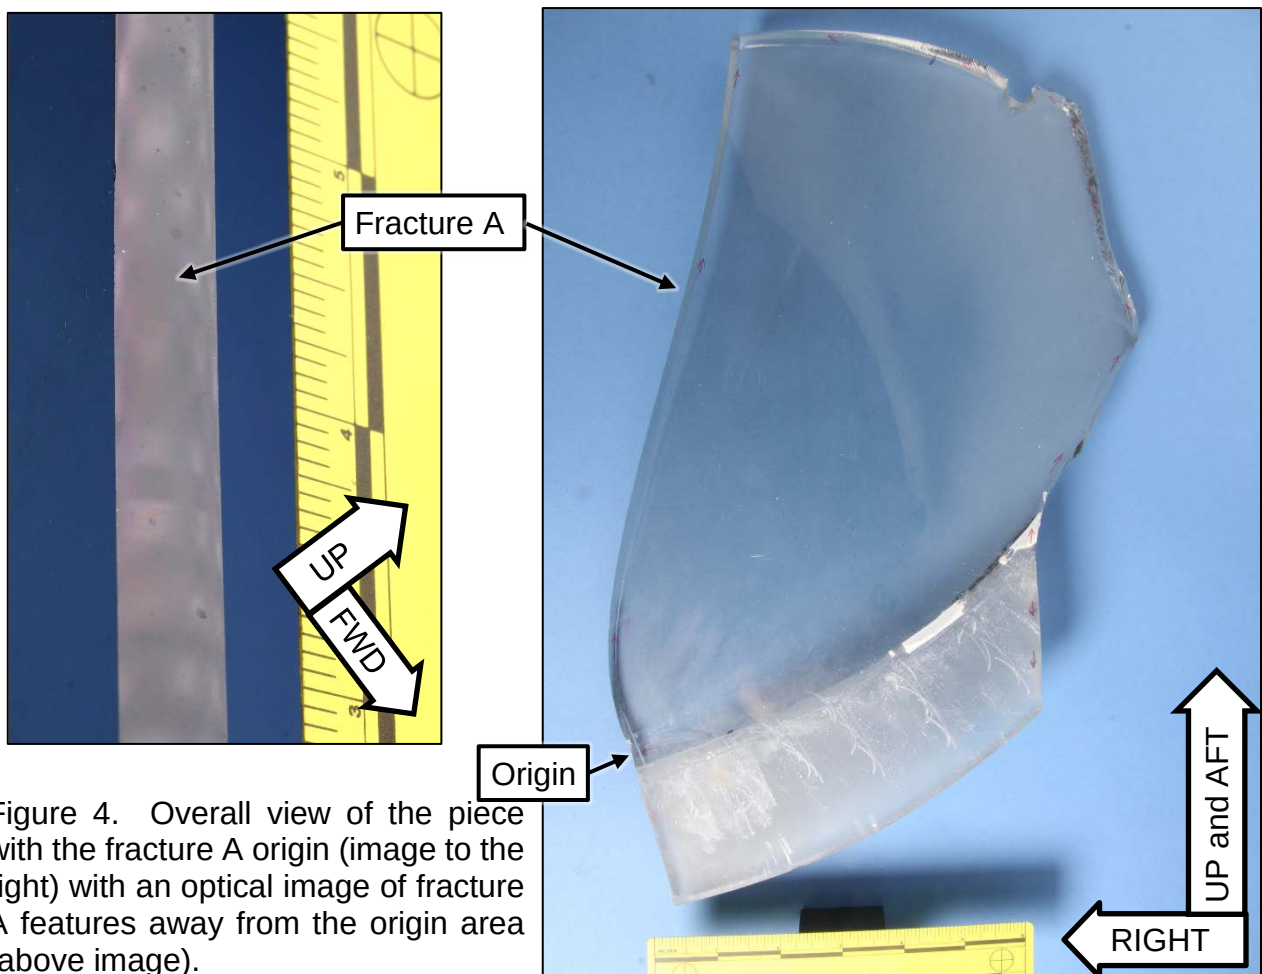
Most of the windshield fractures had fracture planes that varied across the thickness with curving hackles turning toward the interior or exterior surface, features consistent with fracture under a combination of tension and bending loads. However, fracture A had smooth mirror-like fracture features along most of the fracture surface in a flat plane perpendicular to the interior and exterior surfaces consistent with fracture under primarily tension loads. A view of typical mirror-like fracture features away from the origin area on fracture A is shown in figure 4.

Figure 4. Overall view of the piece with the fracture A origin (image to the right) with an optical image of fracture A features away from the origin area (above image).

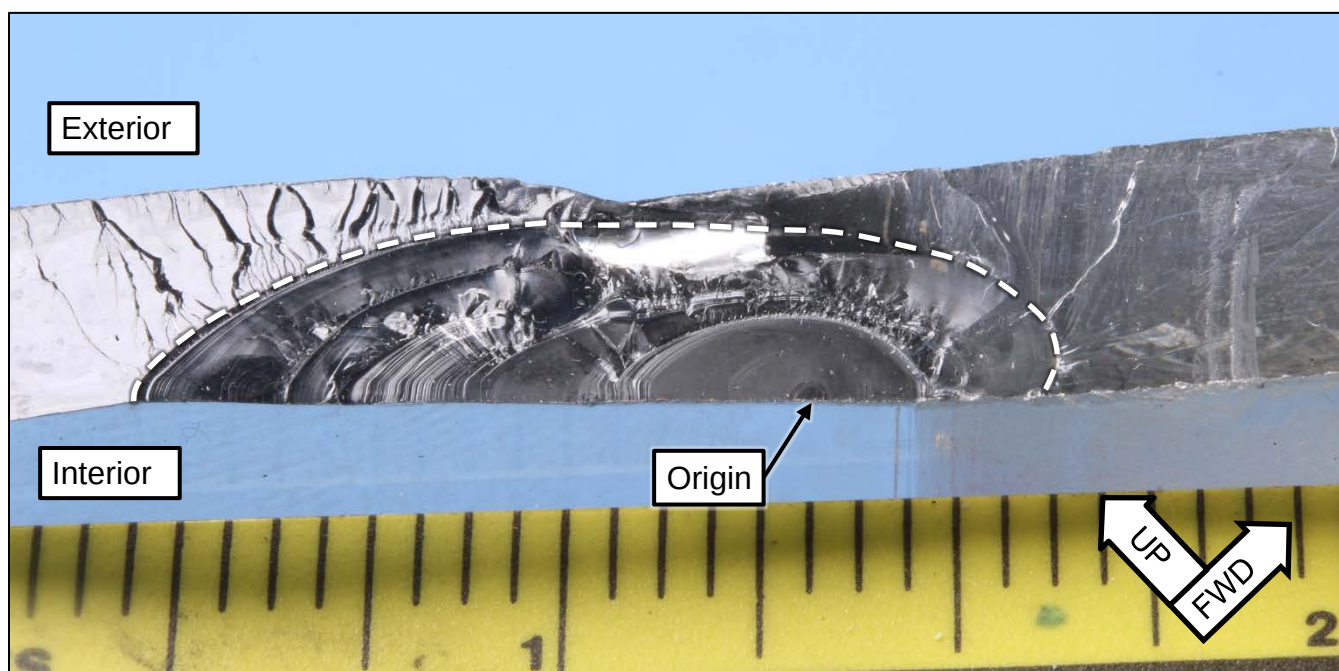
The fracture features including rib marks, hackles, and Wallner lines<sup>1</sup> were observed on the fracture A fracture surface emanating from an origin area located near the forward lower end of fracture A adjacent to the bonded edge as indicated in figure 4. An overall view of the fracture features at the origin area is shown in figure 5. A portion of the fracture surface had curving rib marks and with a somewhat hazy fracture surface with no evidence of Wallner lines, features consistent with preexisting progressive crack growth. A dashed line in figure 5 indicates the boundary of progressive crack growth features. The crack origin was located at the interior surface as shown in figure 5.

Figure 5. Optical image of fracture features at the origin of fracture A. A dashed line indicates the boundary of features consistent with progressive crack growth.

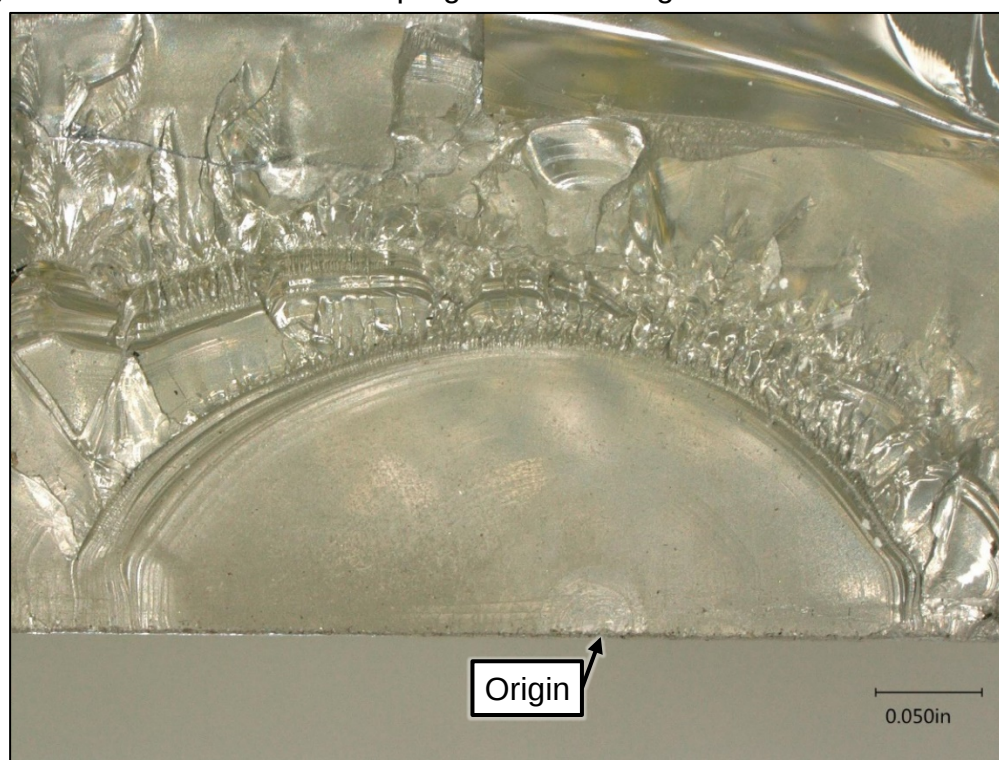
Closer views of the origin area are shown in figures 6 and 7. A thumbnail-shaped area had relatively smooth features with an absence of hackle features. Rib marks consistent with progressive crack growth were observed emanating from an origin area at the interior surface as indicated in figure 6. At higher magnifications as shown in figure 7, rib marks emanated from a small crack that was oriented transverse to the fracture plane. Unlabeled arrows in figure 7 indicate local crack growth directions for fracture A emanating from the small transverse crack.

Figure 6. Optical image of the origin area at higher magnification.

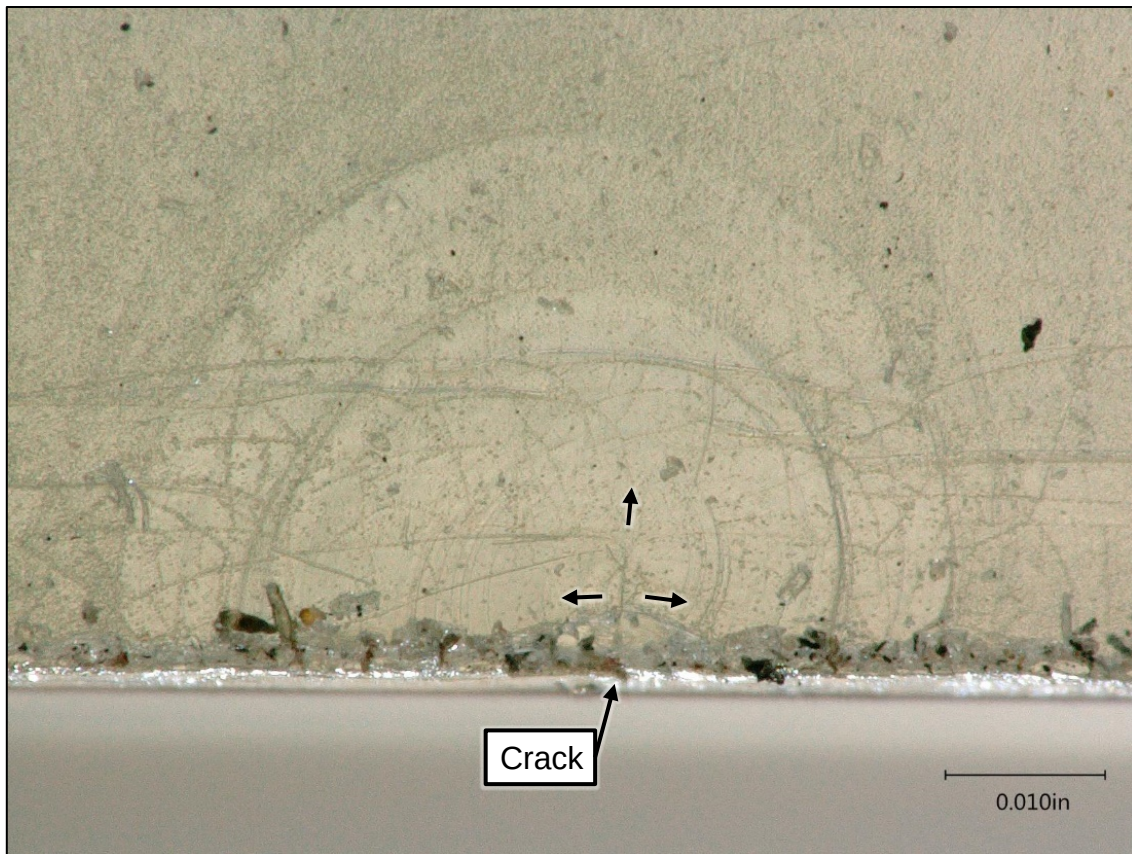
Figure 7. Optical image of the fracture A origin at higher magnification. Unlabeled arrows indicate local directions of crack growth emanating from a surface crack oriented perpendicular to fracture A.

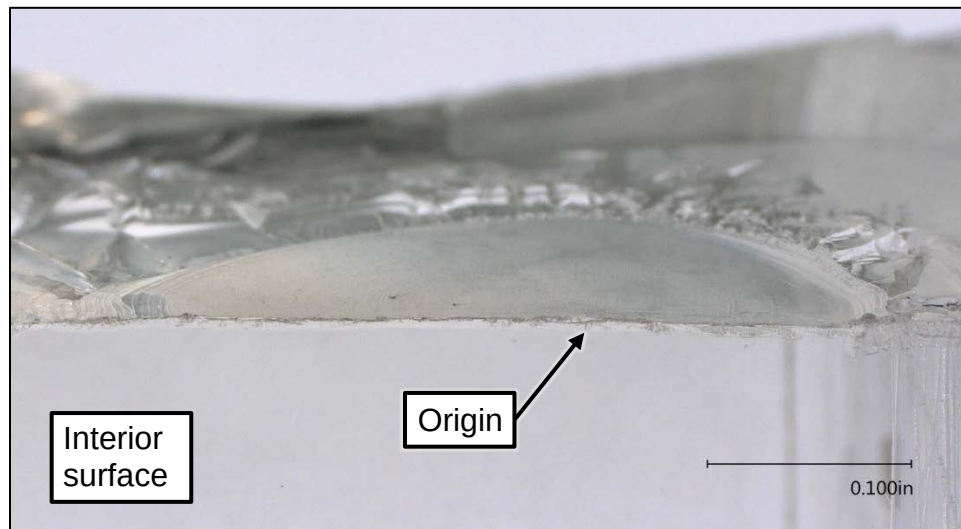
Oblique views of the origin area showing the interior surface adjacent to the fracture A origin area are shown in figures 8 and 9. The surface adjacent to the fracture appeared disturbed consistent with a surface scratch. An unlabeled bracket in figure 9 indicates the area of the surface disturbed by the scratch. The transverse crack associated with the fracture A origin was located within the width of the surface scratch.

Figure 8. Oblique view of the fracture A origin area.

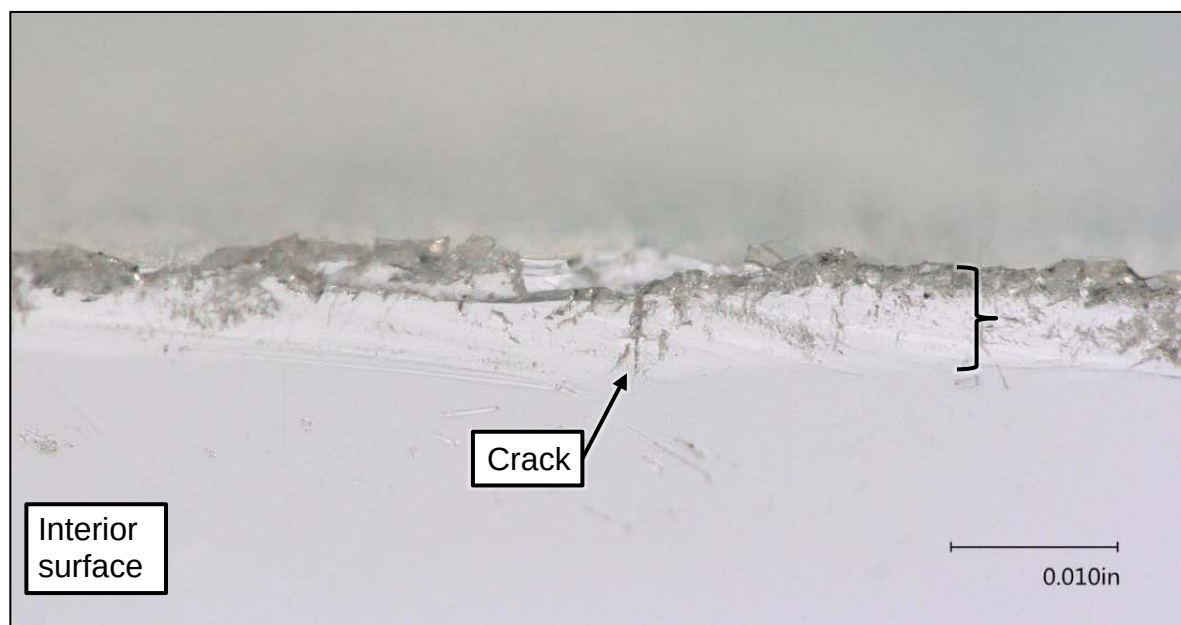
Figure 9. Interior surface of the windshield adjacent to fracture A where the transverse crack associated with the fracture origin is indicated. An unlabeled bracket indicates an area of disturbed surface adjacent to the fracture surface.

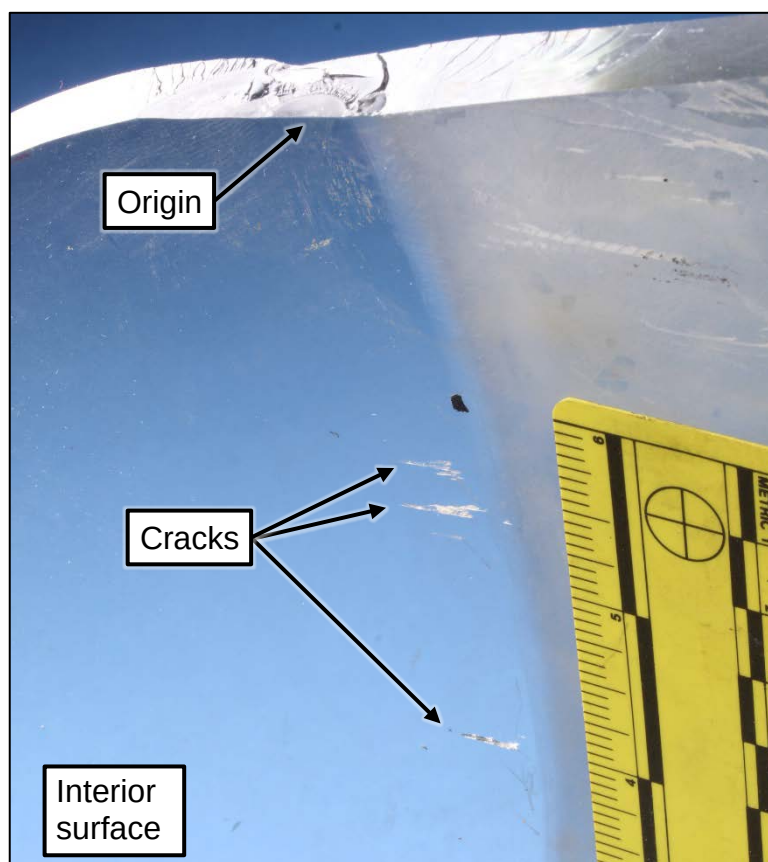
Secondary cracks were observed in the windshield to the left of the fracture A origin as shown in figure 10. The cracks were located just above the roughened bound area at the lower forward edge of the windshield, similar to the fracture A origin location. A closer view of the largest of the cracks is shown in figure 11, and reflected light was used to reveal rib markings on the crack surface. The rib markings appeared to emanate from a scratch on the interior surface of the windshield. Unlabeled arrows in figure 11 indicate several scratches observed on the interior surface above the bond line near the secondary crack.

Figure 10. Interior surface of the windshield adjacent to fracture A showing additional cracks located just above the bondline.

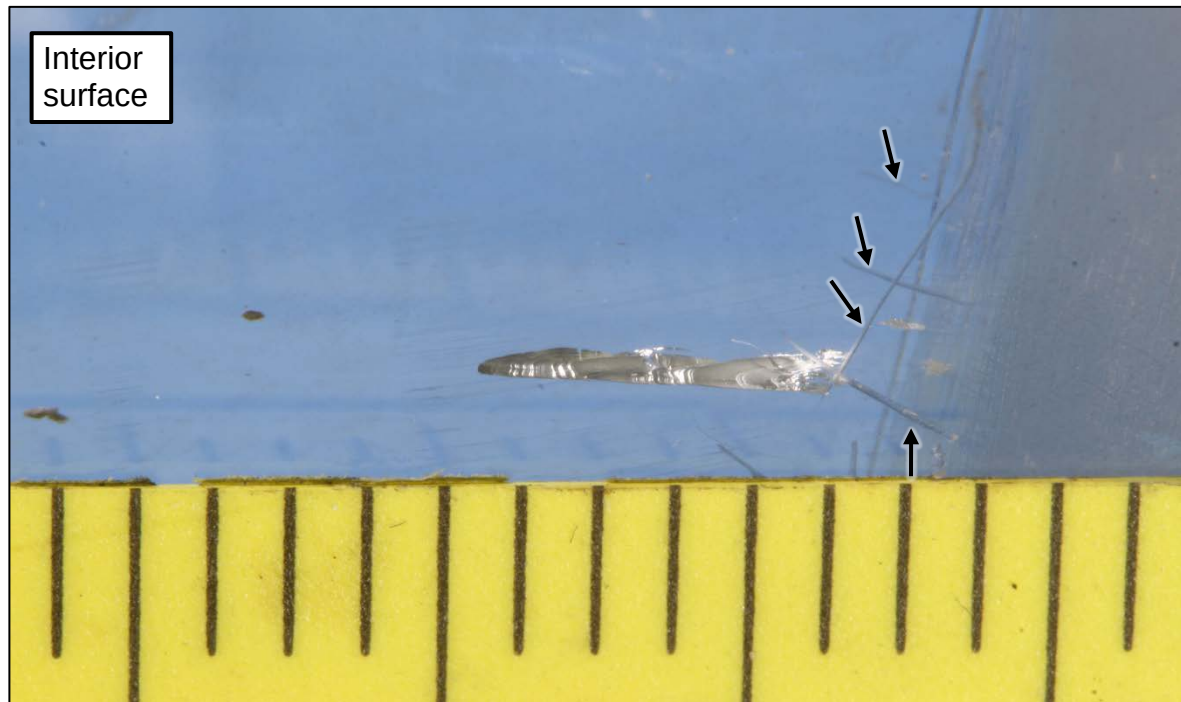
Figure 11. Closer view of one of the cracks shown in the previous figure. Unlabeled arrows indicate scratches on the interior surface, one of which appeared to coincide with the crack origin.

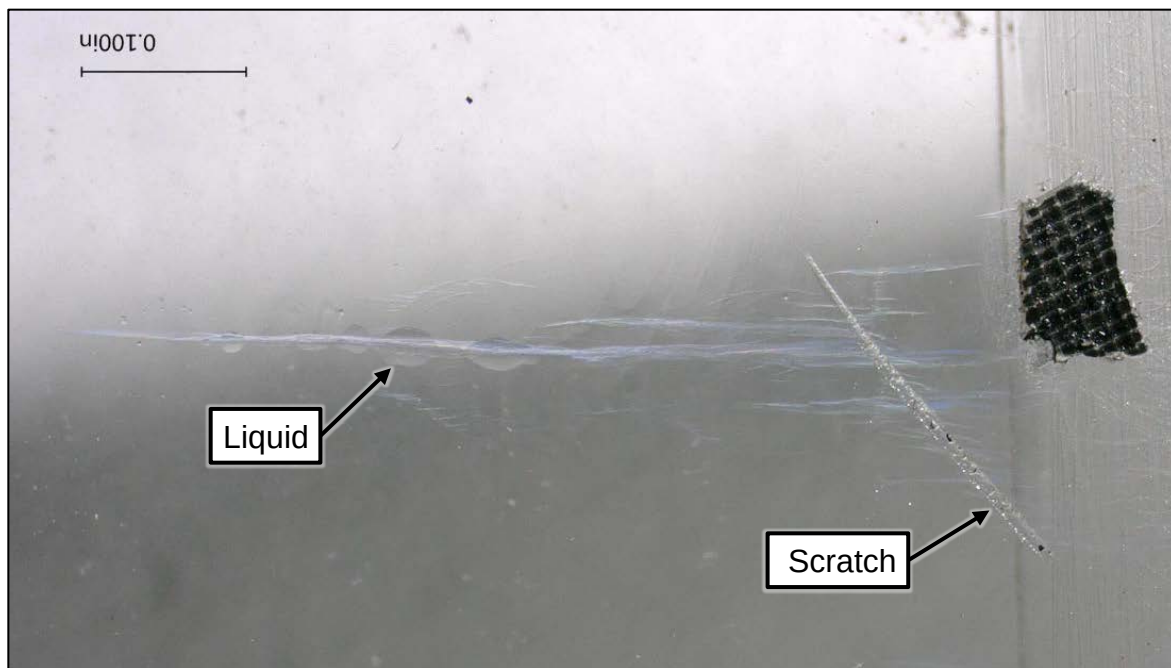
During the course of the examination of the secondary cracks, a liquid was observed emanating from some of the secondary cracks (see figure 12). The liquid was initially dabbed with a cotton-tipped swab for analysis using Fourier-transform infrared spectroscopy (FTIR), but the sample was insufficient. After the initial sample was collected, additional liquid collected on the surface.

The spectrum for the material contained the following combination of spectral peaks corresponding to particular functional groups found within the molecular structure of the material. The presence of two peaks  $\sim 2950\text{ cm}^{-1}$  and  $\sim 2920\text{ cm}^{-1}$  are indicative of a carbon-hydrogen (C-H) (aromatic) bond. The presence of a double peak at  $\sim 2280\text{ cm}^{-1}$  and  $\sim 2850\text{ cm}^{-1}$  is indicative of a carbon-hydrogen (C-H) (alkane) stretching bond. A peak at  $\sim 1725\text{ cm}^{-1}$  is indicative of a carbon-oxygen (C=O) double bond. Peaks at  $\sim 1600\text{ cm}^{-1}$  and  $\sim 1580\text{ cm}^{-1}$  are indicative of an aromatic carbon-carbon (C=C) double bond. A peak at  $\sim 1460\text{ cm}^{-1}$  is indicative of a carbon-hydrogen(3) (C-H<sub>3</sub>) bending bond. A peak at  $\sim 1380\text{ cm}^{-1}$  is indicative of a carbon-hydrogen(2) (C-H<sub>2</sub>) bending bond. A series of peaks at  $\sim 1270\text{ cm}^{-1}$ ,  $1120\text{ cm}^{-1}$ ,  $1070\text{ cm}^{-1}$  and  $1040\text{ cm}^{-1}$  is indicative of a carbon-oxygen-carbon (C-O-C) bond. A peak at  $\sim 740\text{ cm}^{-1}$  is indicative of a carbon-hydrogen (C-H) ortho aromatic bond. A peak at  $\sim 705\text{ cm}^{-1}$  is indicative of a carbon-hydrogen (C-H) meta aromatic bond. The spectrum was consistent with an ester with aromatic and straight chained groups. A spectral library search was performed on the unknown spectrum. The spectral search found a very strong match for several phthalates. Phthalates are used as plasticizers and stabilizers.

Figure 12. Additional cracks adjacent to the bondline in the vicinity of a scratch. Liquid was noted oozing from one of the cracks.

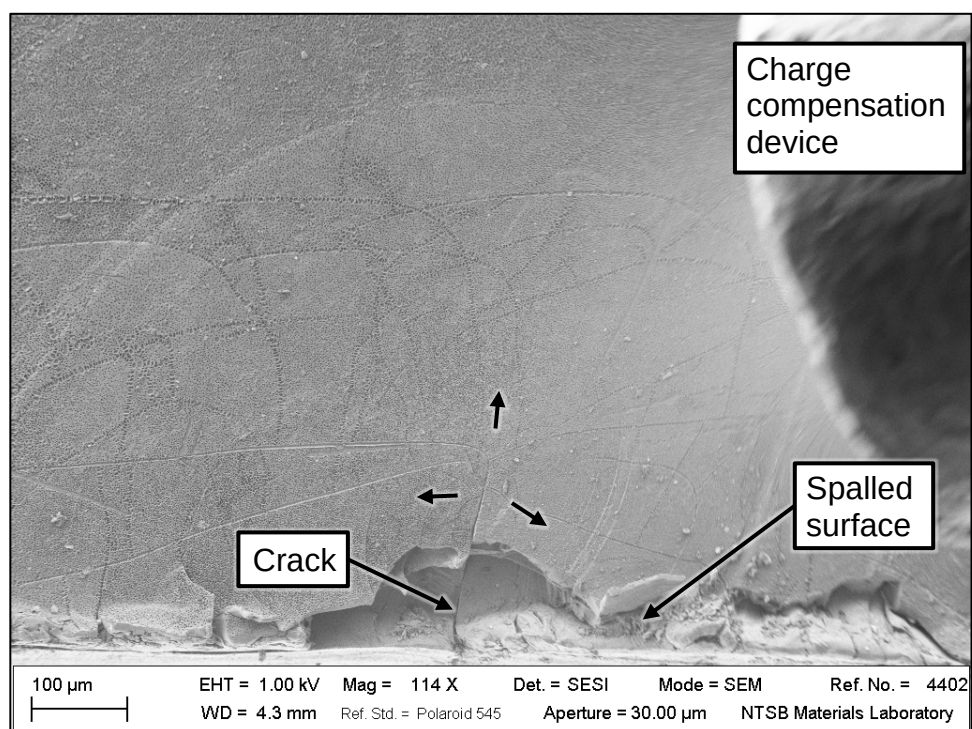
An overall SEM image of the origin area is shown in figure 13, and the origin area is shown at higher magnifications in figures 14 and 15. Fracture features emanated from the transverse crack as shown in figure 13, consistent with observations under optical microscopy. The surface adjacent to the origin area was spalled with surface material fractured and missing.

Figure 13. SEM image of the crack A origin area.

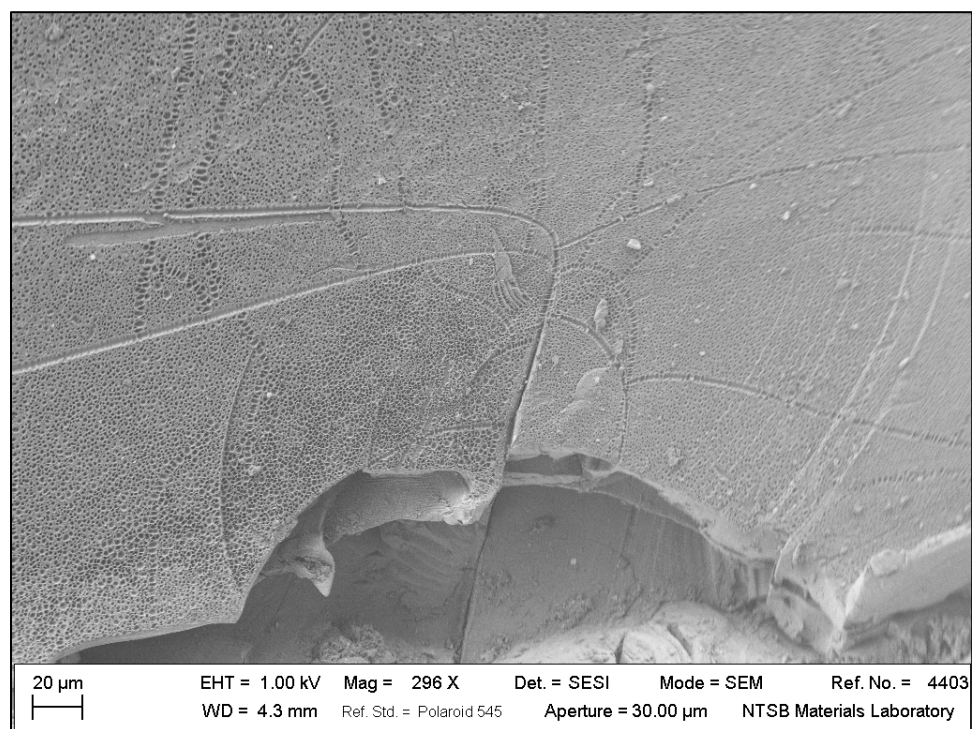
Figure 14. SEM image of the fracture A origin area at higher magnification.

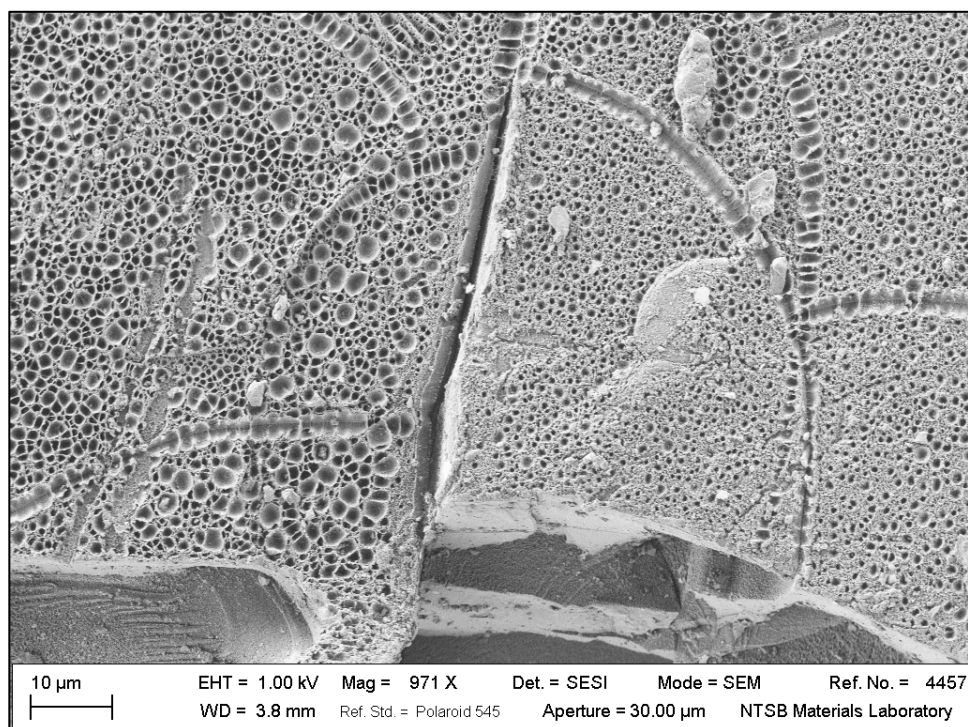
Figure 15. SEM image of the fracture A origin area at higher magnification.

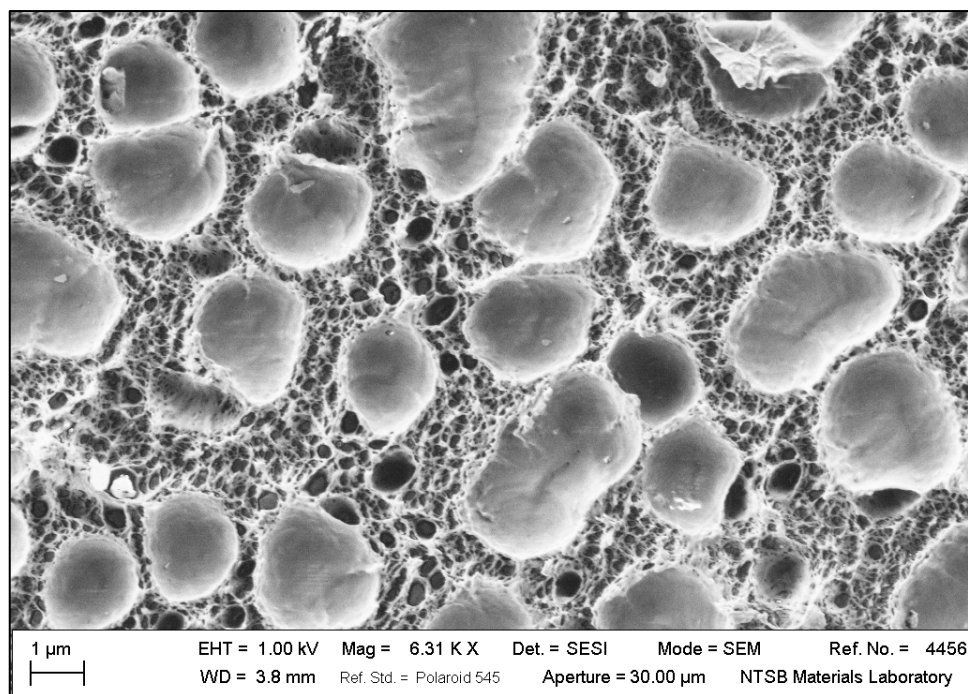
The fracture surface at the origin area consisted of a mix of large and small dimples as shown in figure 16. Around the surface, a series of the larger dimples connected in series, which appeared on the surface as curving tear lines that crossed and intersected each other particularly near the edge of the fracture adjacent to the windshield interior surface. A close view of one of these tear lines is shown in figure 17. Rib marks were also observed near the origin area as shown in figure 18. A tear line in figure 18 is shown

intersecting the rib marks at this location. Overall, the appearance of the fracture surface at the origin area was consistent with environmental stress cracking (ESC). ESC is a fracture mechanism in polymer materials that occurs when a susceptible polymer material is exposed to a combination of tensile stress and exposure to a substance that degrades the integrity of the material.

Figure 16. SEM image of fracture features near the fracture A origin area.

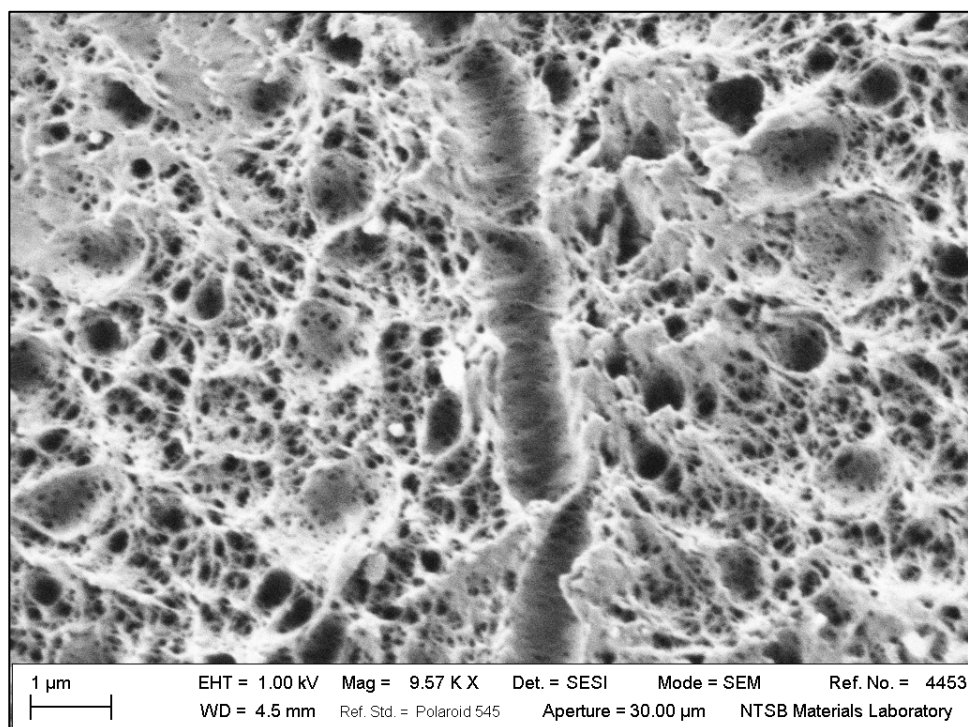
Figure 17. SEM image of a tear line near the fracture A origin.

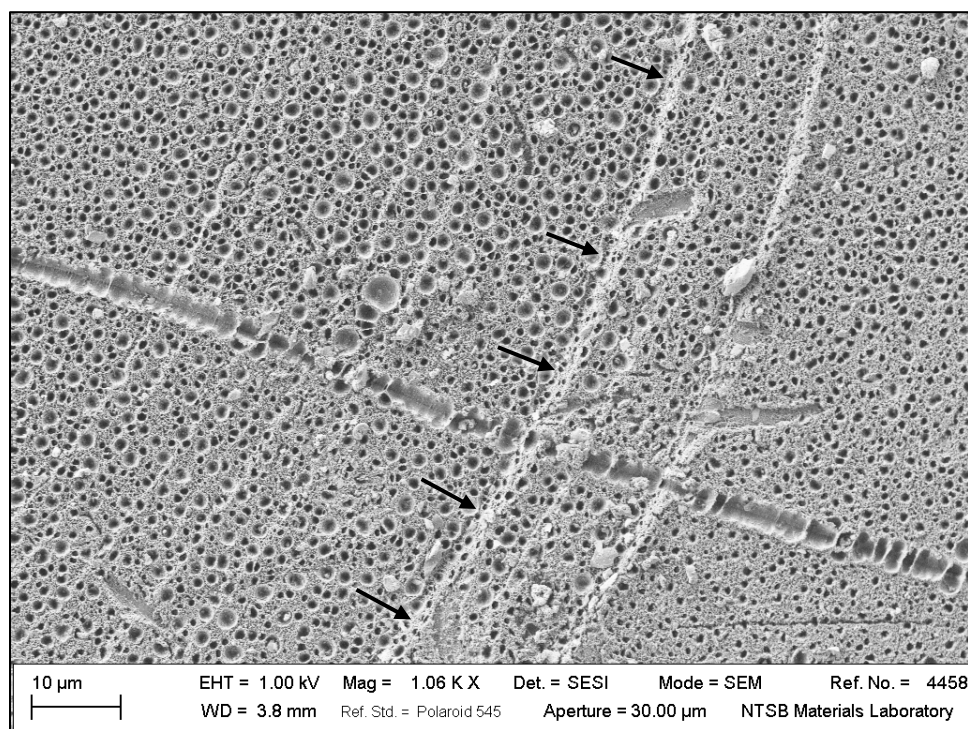
Figure 18. SEM image of a tear line and rib marks near the fracture A origin. Unlabeled arrows point to one of the rib marks.

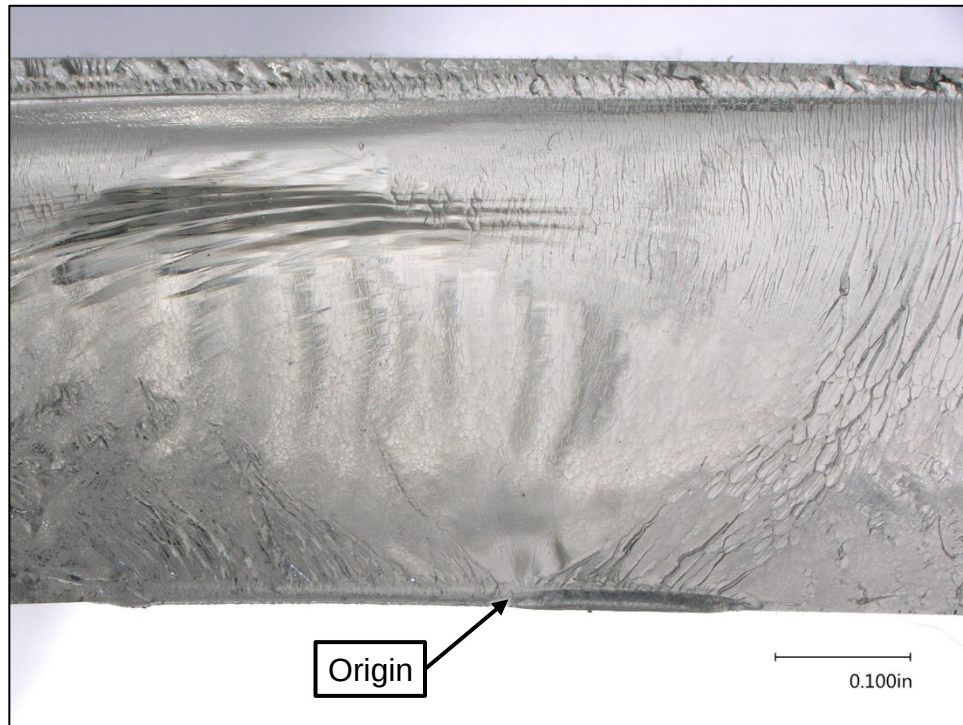
A piece of the windshield from the upper aft area away from the origin was cut into a rectangular shape, and the interior surface was scratched with a razor blade. Next, one end of the rectangular section was placed in a vice, and the opposite end was struck with a mallet to produce a bending impact fracture initiating from the surface scratch. An overall optical image of the resulting lab-induced fracture is shown in figure 19, and a closer view of the origin area is shown in figure 20. The origin area appeared relatively smooth, and parabolic marks were observed near the origin as shown in figure 20.

Figure 19. Overall optical image of the origin area of a windshield piece that was scored then fractured by impact in the lab.

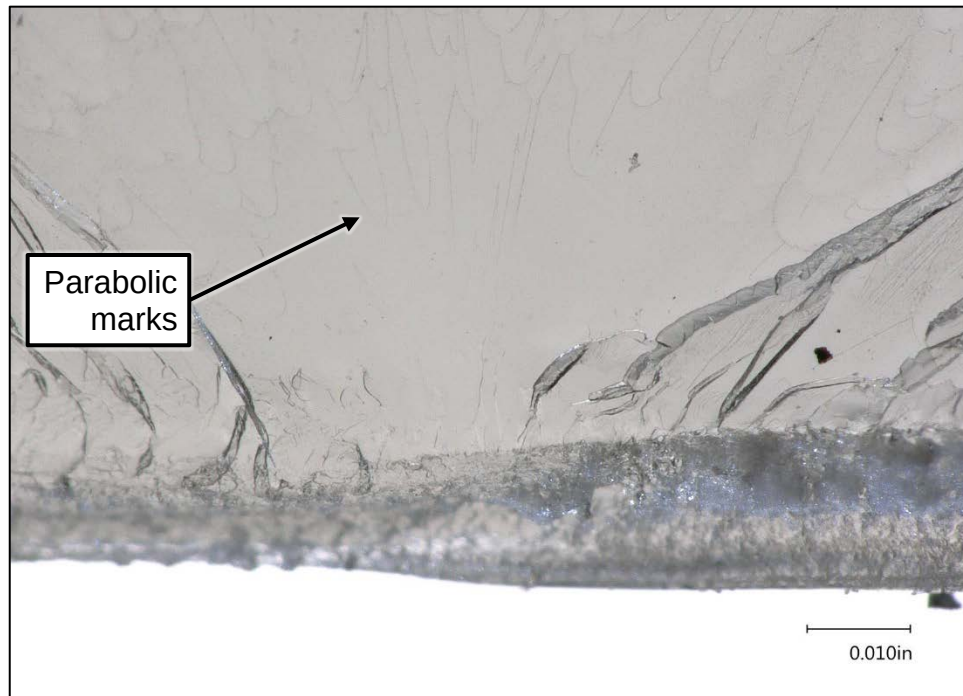
Figure 20. Closer optical image of the origin area of the lab-induced impact fracture.

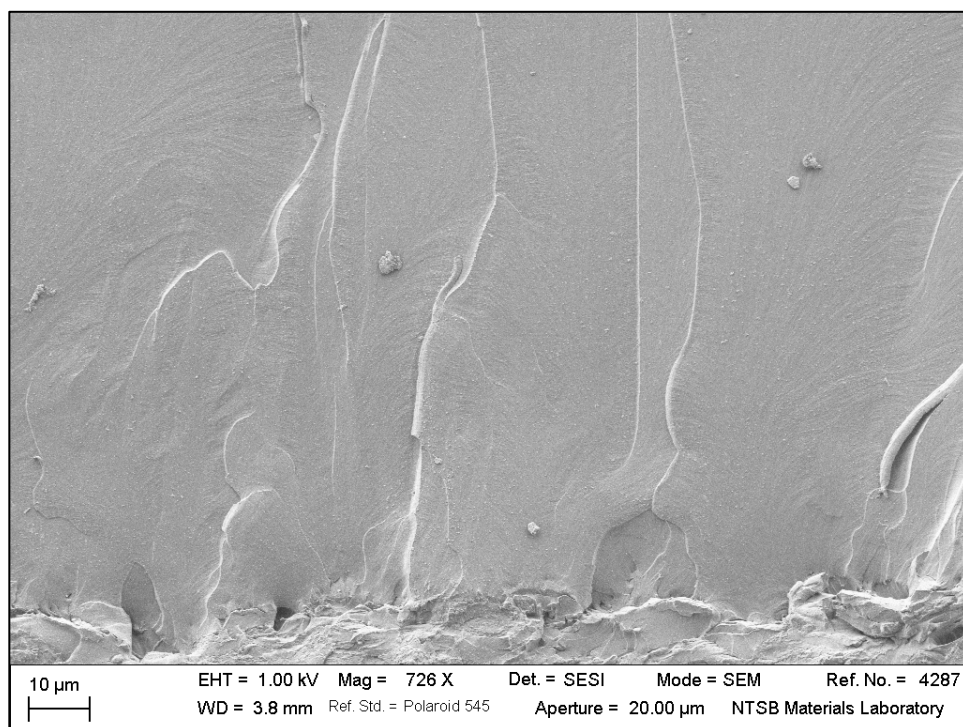
The lab-fractured piece was further examined using an SEM, and resulting images of the origin area are shown in figures 21 and 22. The origin area showed feathery features with tear ridges consistent with microductility associated with the fracture.

Figure 21. SEM image of the origin area of the lab-induced impact fracture.

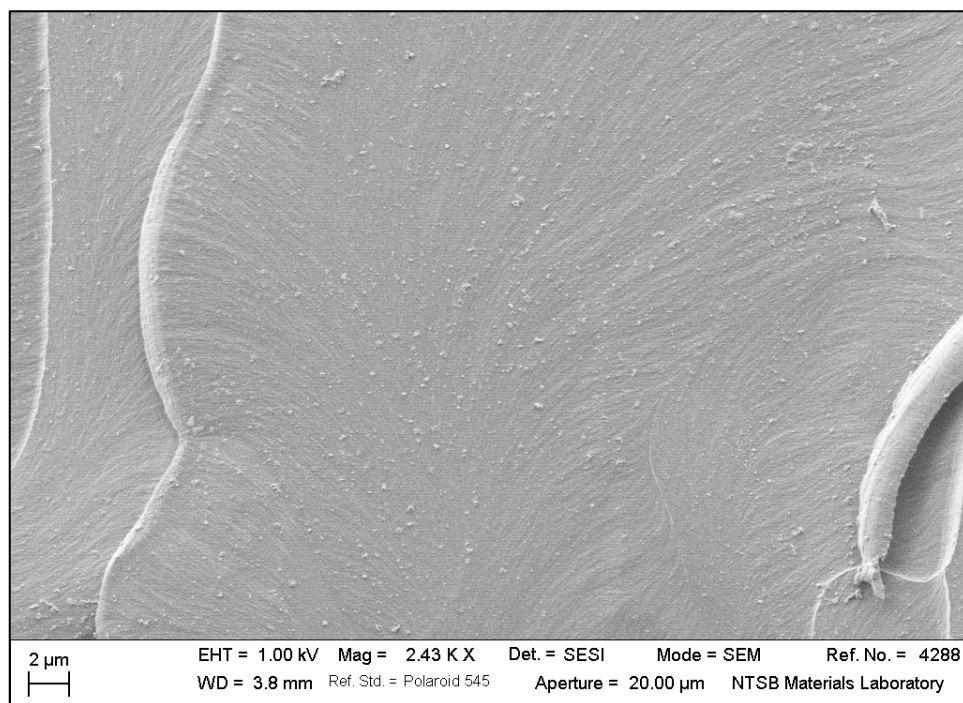
Figure 22. SEM image of feathery features near the origin area of the lab-induced impact fracture.
