## **NATIONAL TRANSPORTATION SAFETY BOARD**

# **AIRFRAME AND ENGINE EXAMINATION**

**WPR19LA097**

Aircraft: MD Helicopter 396HS, N119T

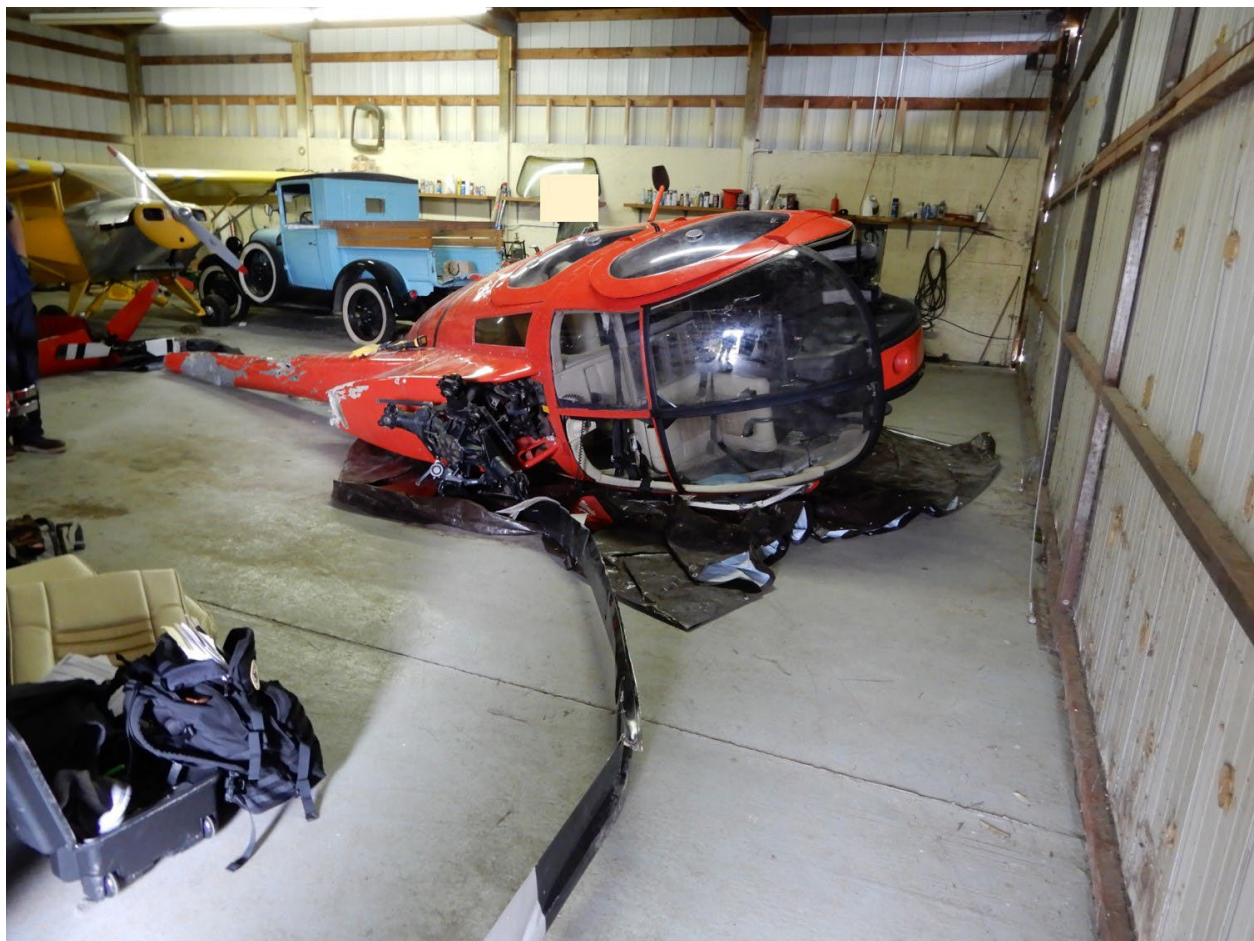
When first examined the helicopter was resting on its right side. The right-forward door remained attached the fuselage at the lower hinge and had separated from the fuselage at the top hinge. The door sustained crush damage. The right-rear door remained attached to the fuselage at both hinges and sustained some crush damage. The right-side fuselage sustained crush damage near the forward windshield frame. The lower windscreen or “chin bubble” separated and was found in the debris field. The upper wind shield remained intact and undamaged. The top-right windshield separated from the fuselage and was found in the debris field. The forward portion of the doghouse was undamaged. The rear portion of the doghouse sustained damage consistent with main rotor blade contact. The right-side engine access clamshell door was removed and displayed minor damage. The tail boom sustained damage consistent with multiple main rotor blade contacts. The fuel cell was opened via the access port at the top of the fuel cell. The fuel cell was empty. There were no breaches to the fuel cell.

Photo 1. N119T. Resting on its right side. Photo NTSB.

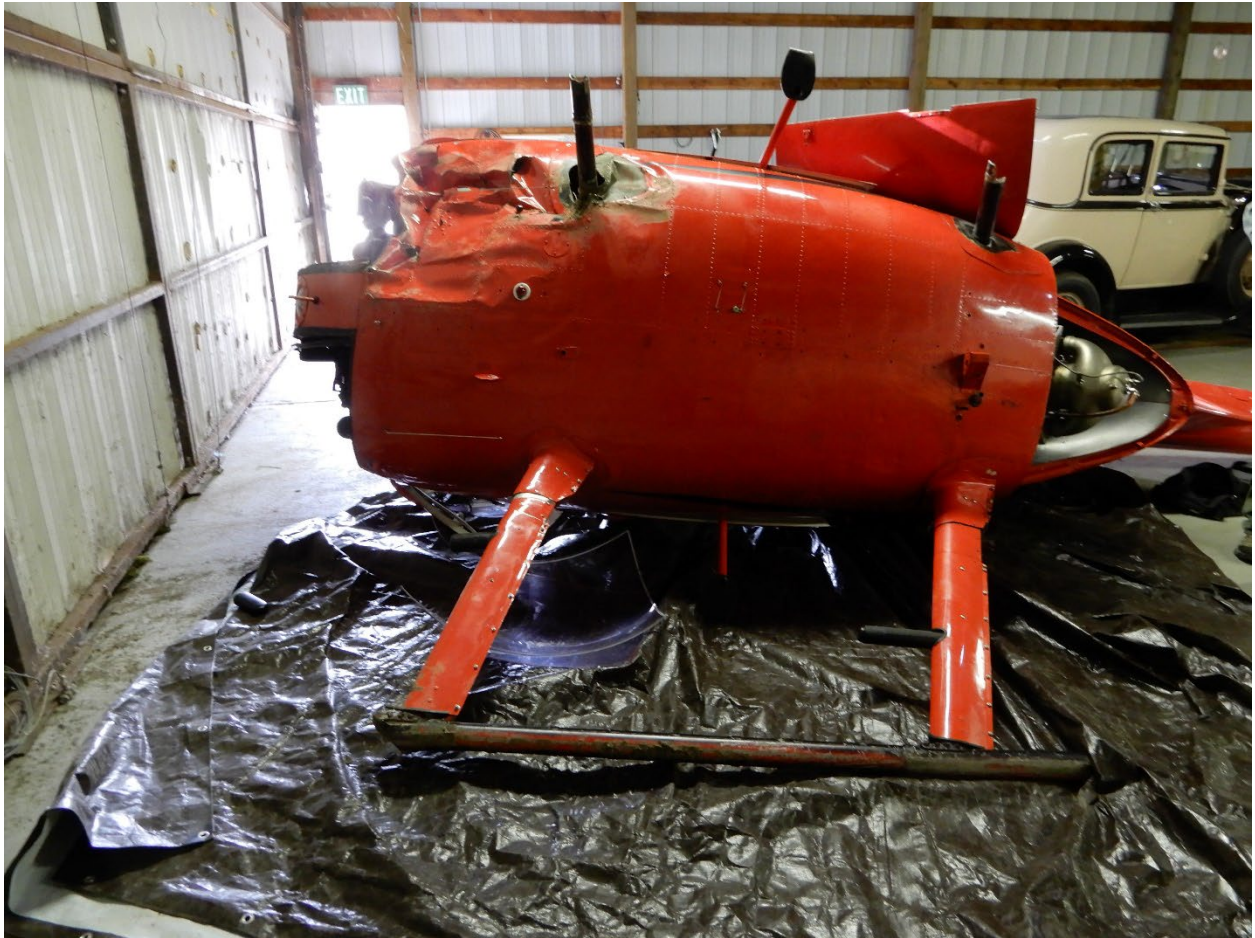
Photo 2. N119T Underside View. Photo NTSB.

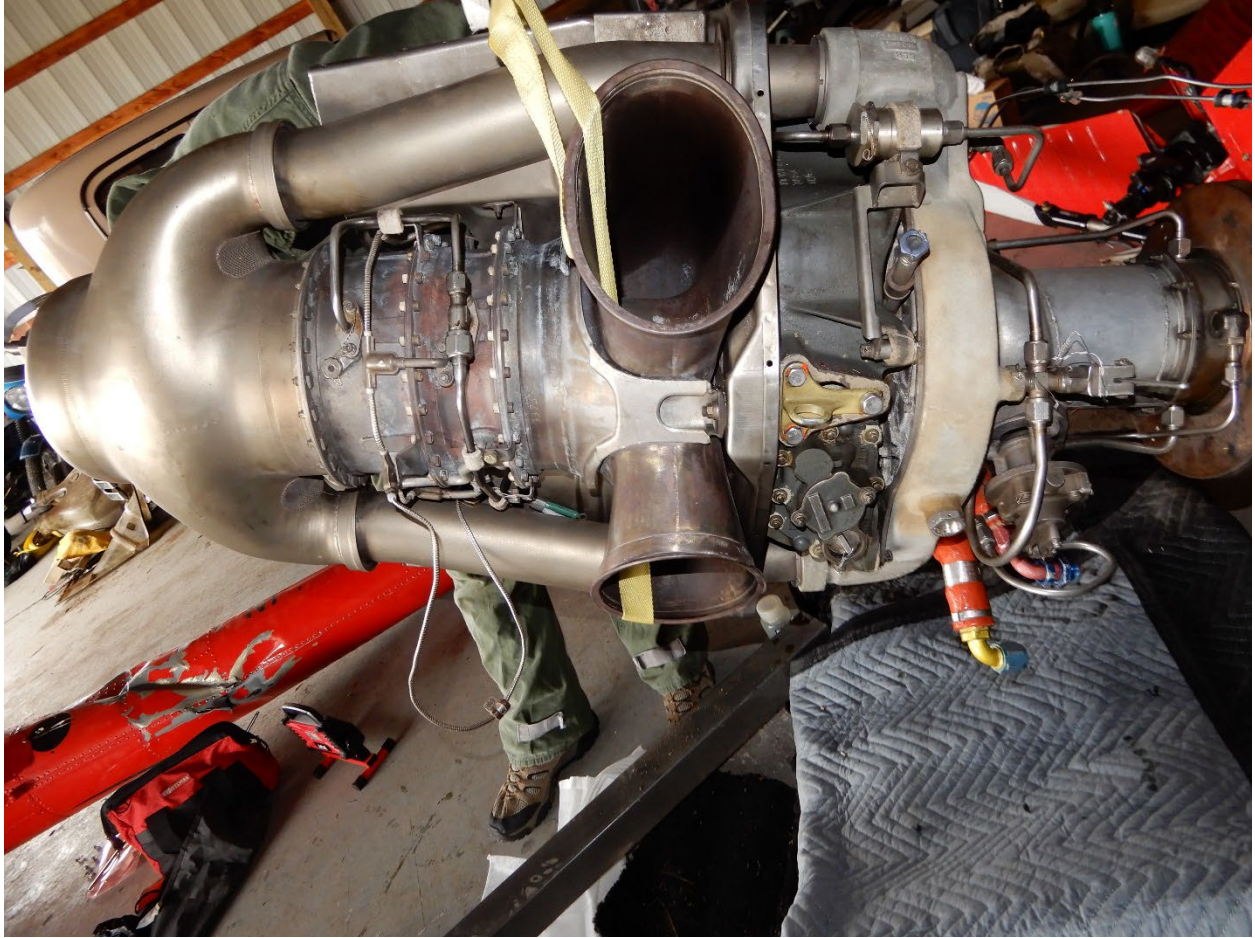
The engine was examined at the secured hangar. During the examination, the engine deice control valve was found to be disconnected and disabled. The engine turned freely at the compressor, N1 and N2 turbine wheels 1 through 4. Liquid was found in the engine mounted fuel pump filter bowl and had the sight and smell of jet fuel. No air leaks were detected in the engine fuel lines. No contaminants were found in the engine oil filter. The oil bypass button was not extended. Based on the initial examination results, it was determined the engine would be a good candidate for further examination and potential engine test run.

Photo 3. Engine Top View. Photo NTSB.
