**NATIONAL TRANSPORTATION SAFETY BOARD**

**AIRPLANE EXAMINATION**

**WPR19LA098**

**WPR19LA098**  
**Reno, Nevada**  
**March 17, 2019**  
**0815 PT**  
**Piper PA-24 – N5028P**

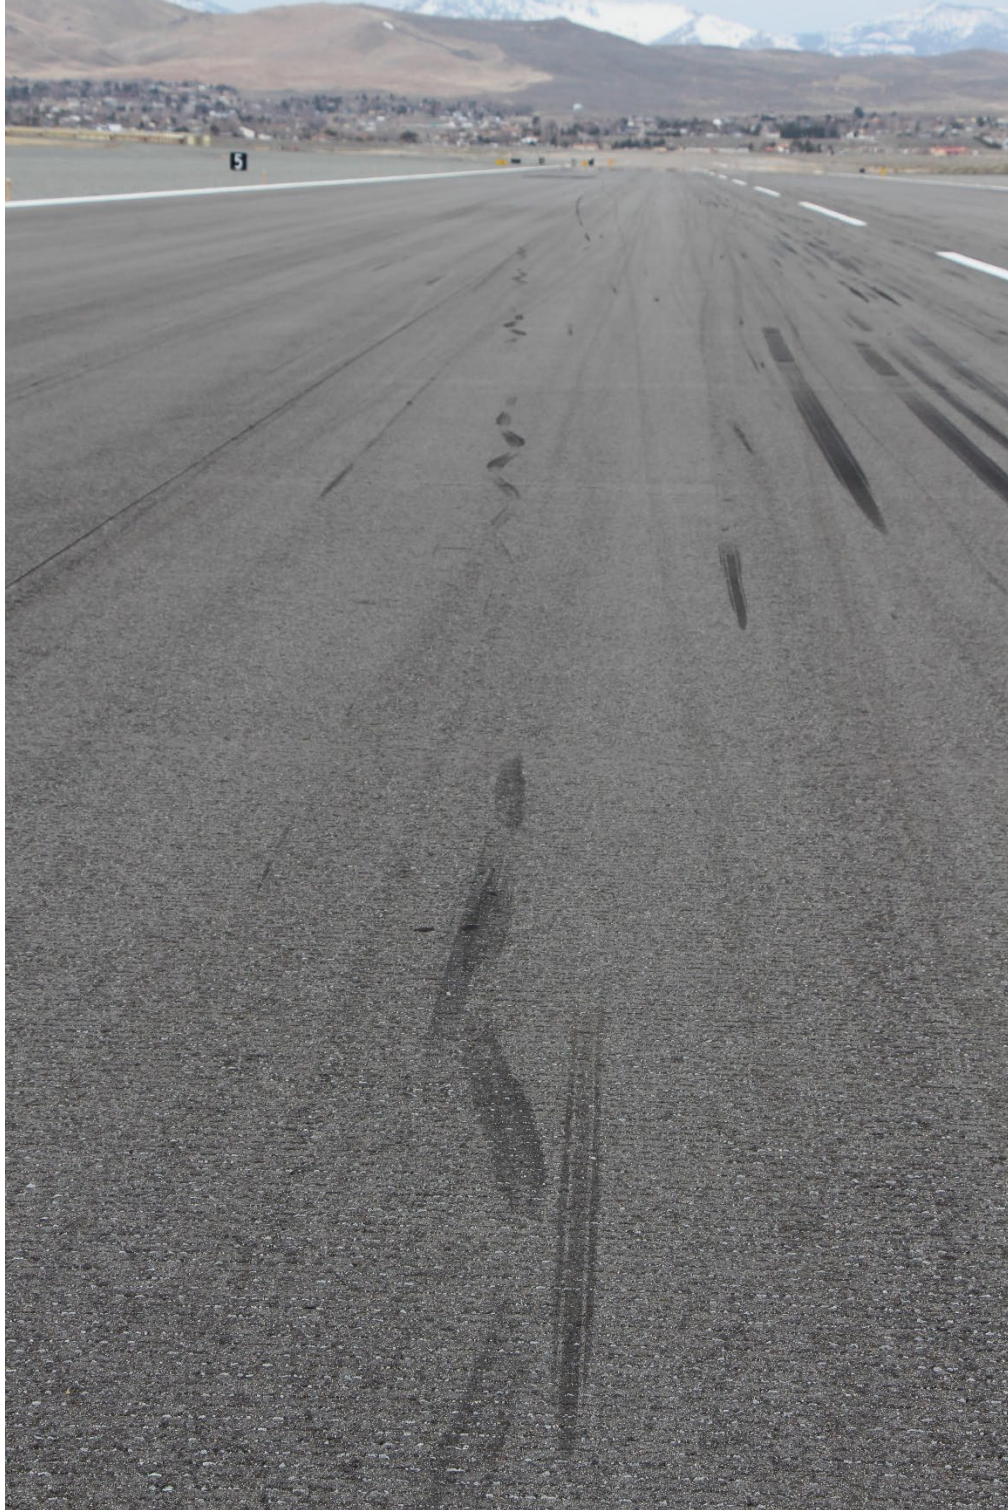
Runway tire markings were displayed along the left side of the runway centerline about taxiway B. Main landing gear tire marks arced to the right of the runway centerline and continued to the left of centerline and terminated at the left side runway edge in the direction of the runway distance remaining sign that was impacted adjacent to taxiway A2 (photograph 1).

Photograph 2: Tread Marks on Runway Originating at Taxiway B (Airport Manager)

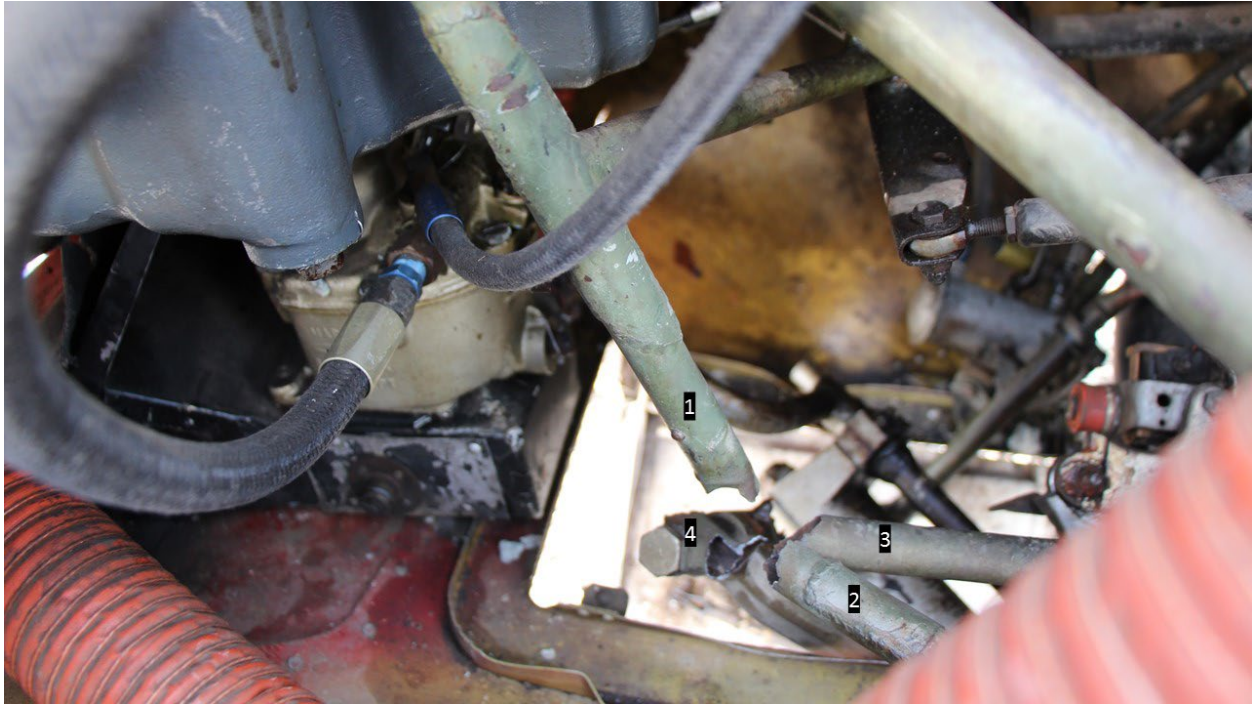
The engine mount/truss displayed multiple fractures at various tubes and both the left and right trunnions. The left NLG trunnion and engine mount tubes, marked as I, II, III, and IV (the trunnion) are shown in photograph 3 and show patchwork along tubes I and II. Tubes I, II, and III fractured at the LH NLG trunnion. Photographs 4-7 show fractures to various tubes and the NLG trunnion on the RH side.

Photograph 3: LH Engine Mount Tubes and NLG Trunnion (Nos. 1 – 4) (NTSB)

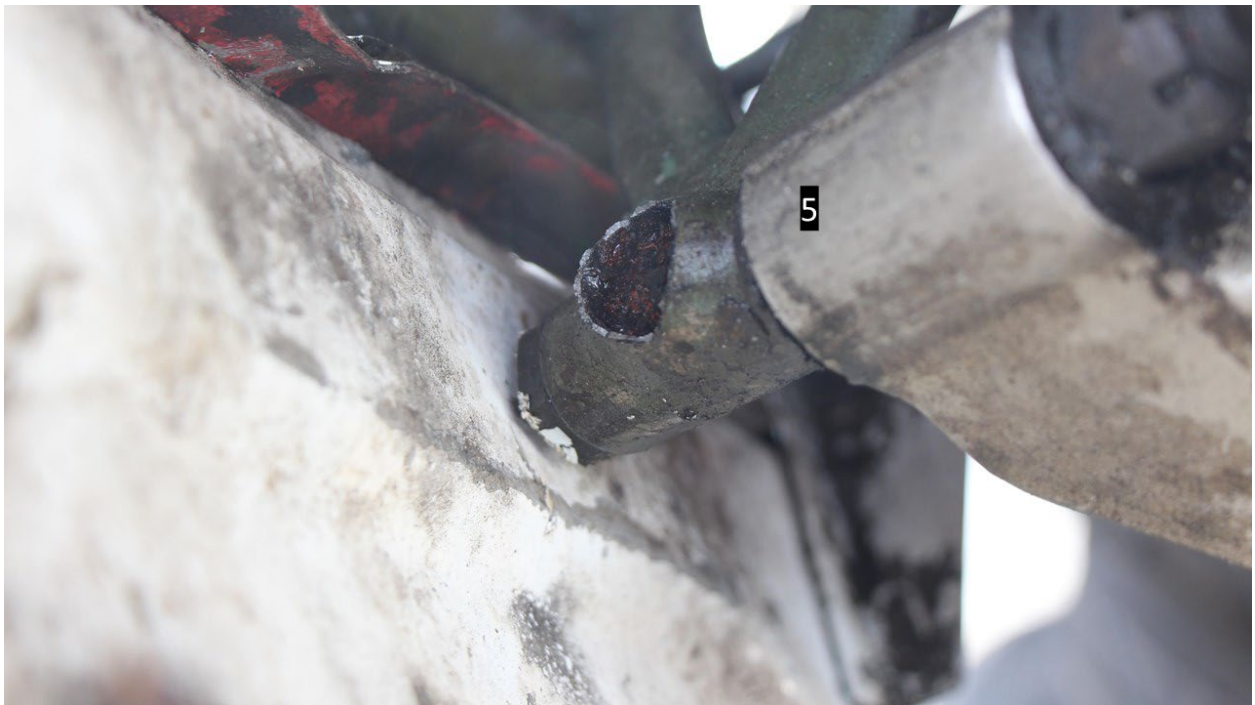
Photograph 4: RH Engine Mount and NLG Trunnion (No. 5) (NTSB)

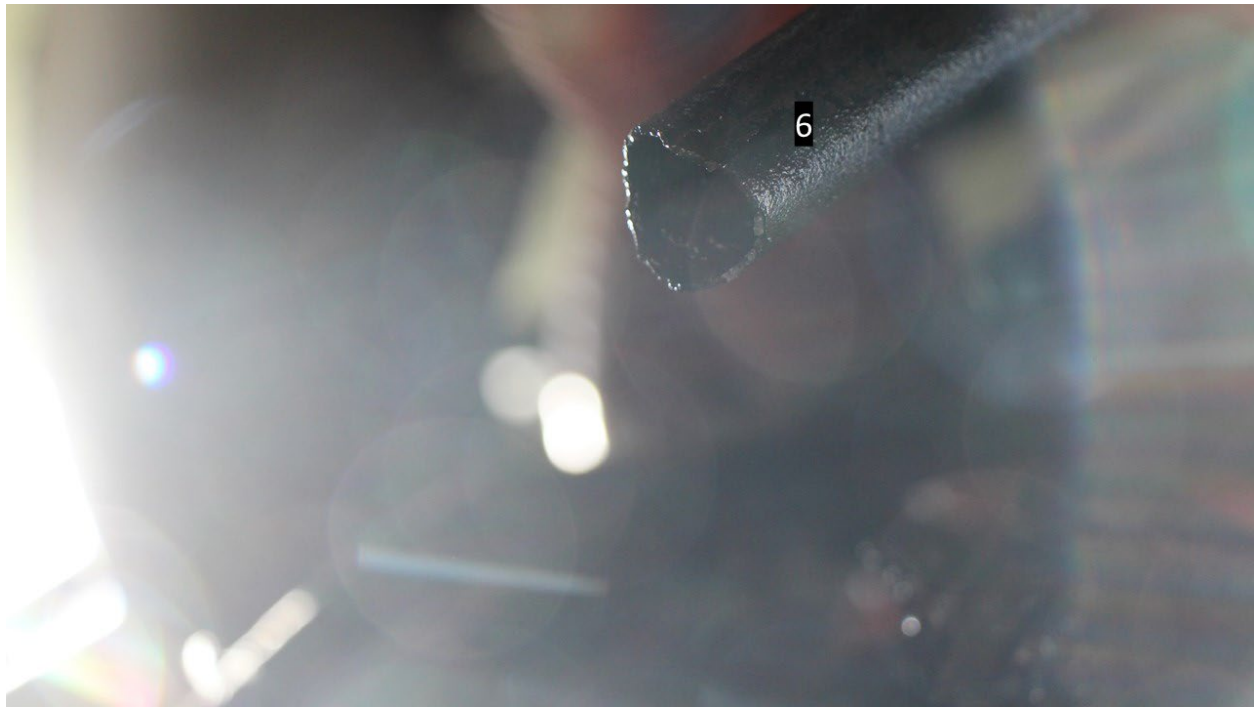
Photograph 5: RH Engine Mount Tube No. 6 (NTSB)

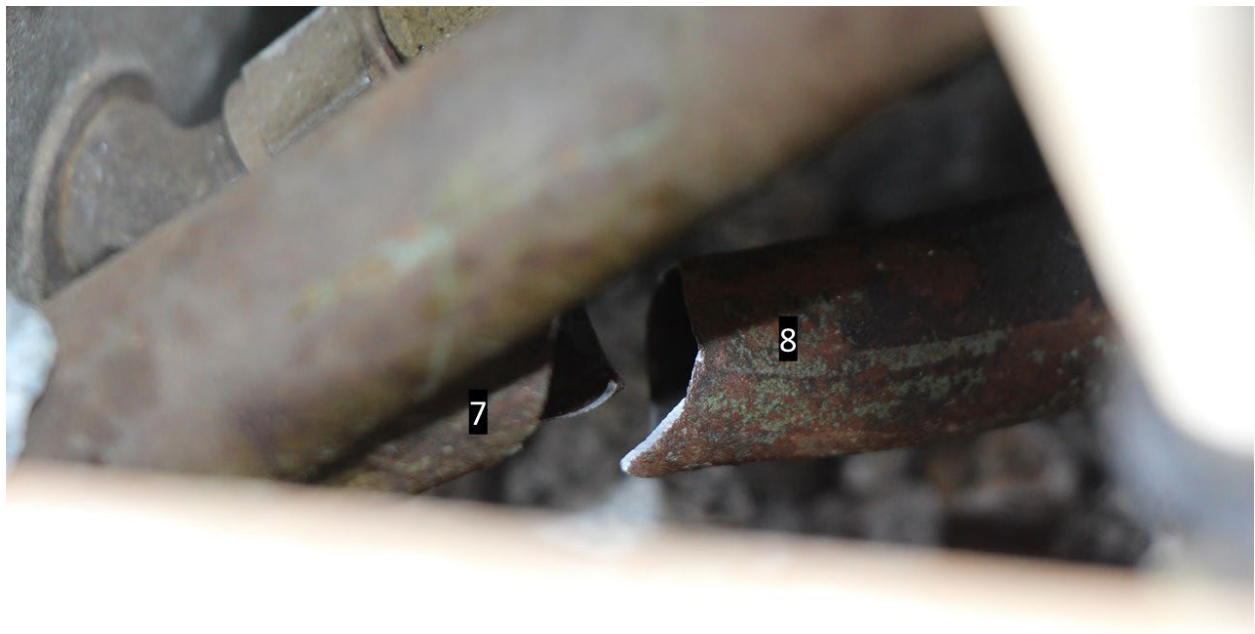
Photograph 6: RH Engine Mount at Engine Firewall; Tube Nos. 7 and 8 (NTSB)

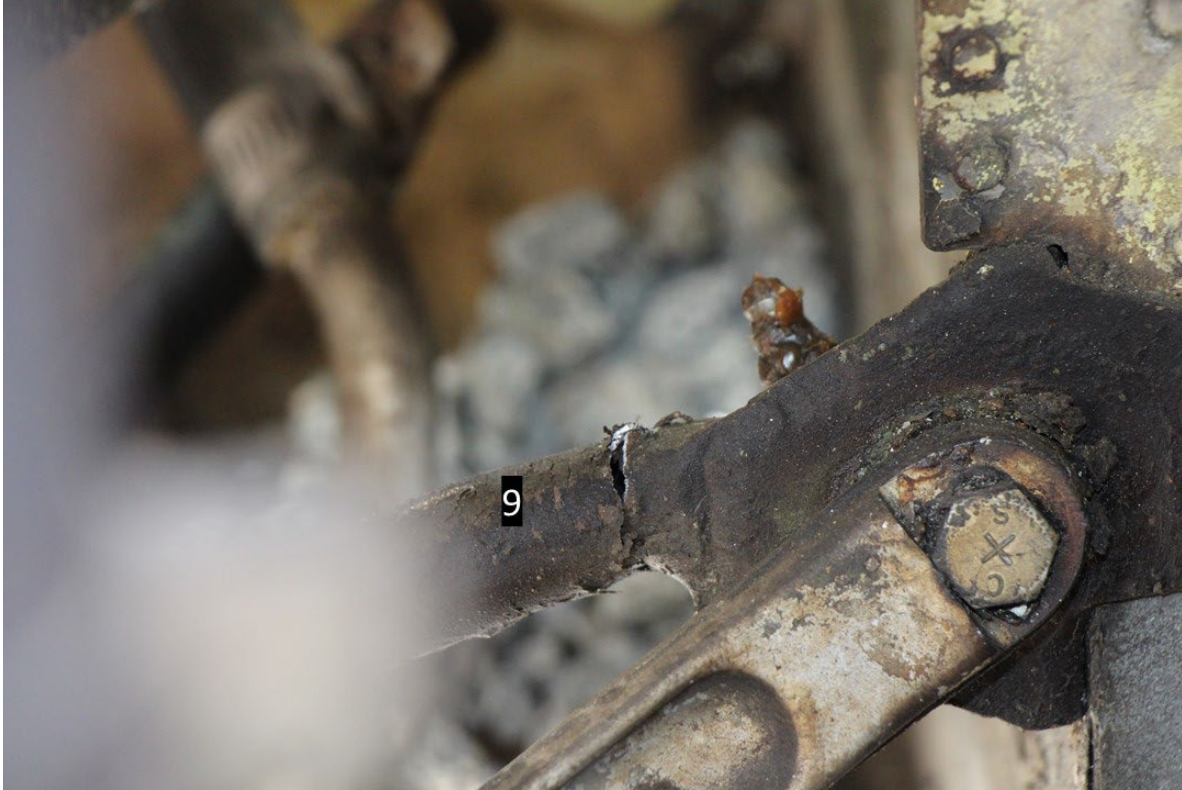
Photograph 7: RH Engine Mount Tube at Engine Firewall; No. 6 (NTSB)

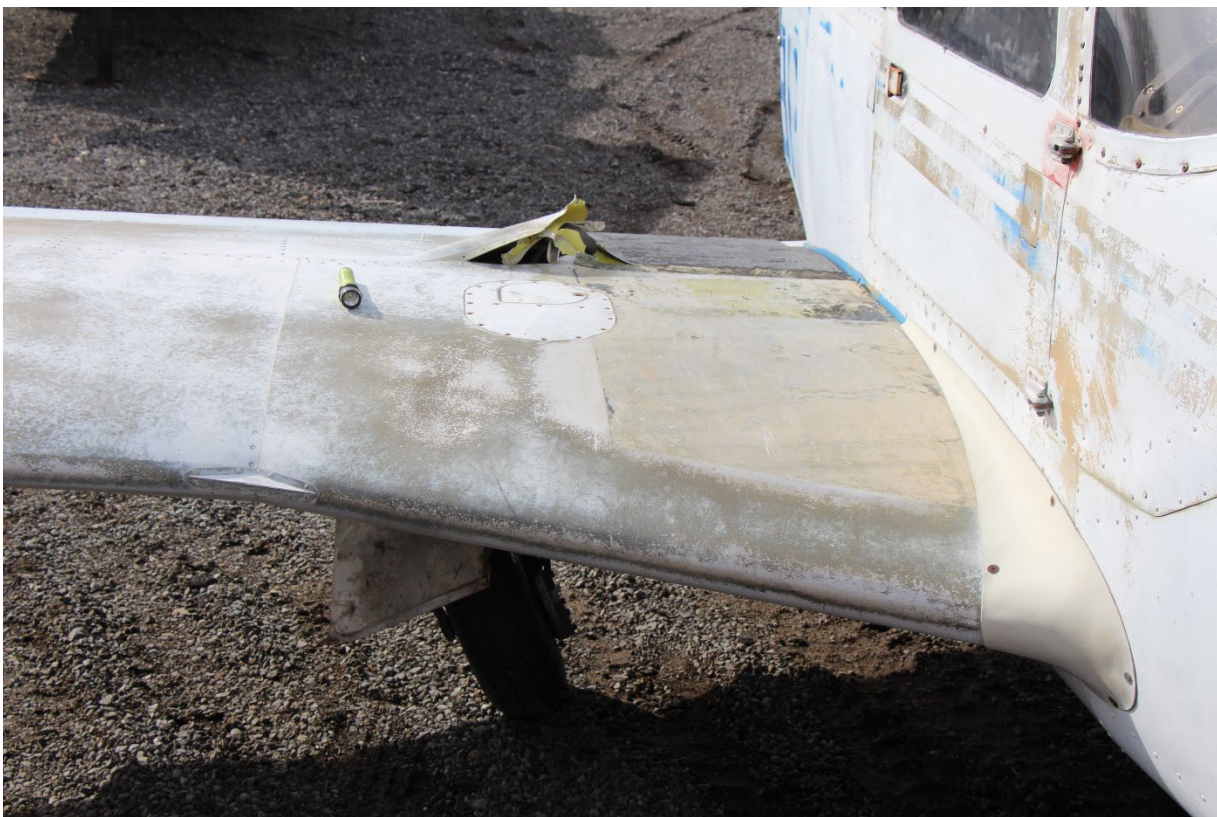
The inboard right wing exhibited a large vertical protrusion originating at the landing gear well and terminating at the right wing top skin (photograph 8). Examination of the right main landing gear revealed that the landing gear strut was secured to its respective connections. Part of the RMLG assembly had separated from its mount and moved freely within the gear well (photograph 9).

Photograph 8: Right Wing with Protrusion Through Top Skin (NTSB)

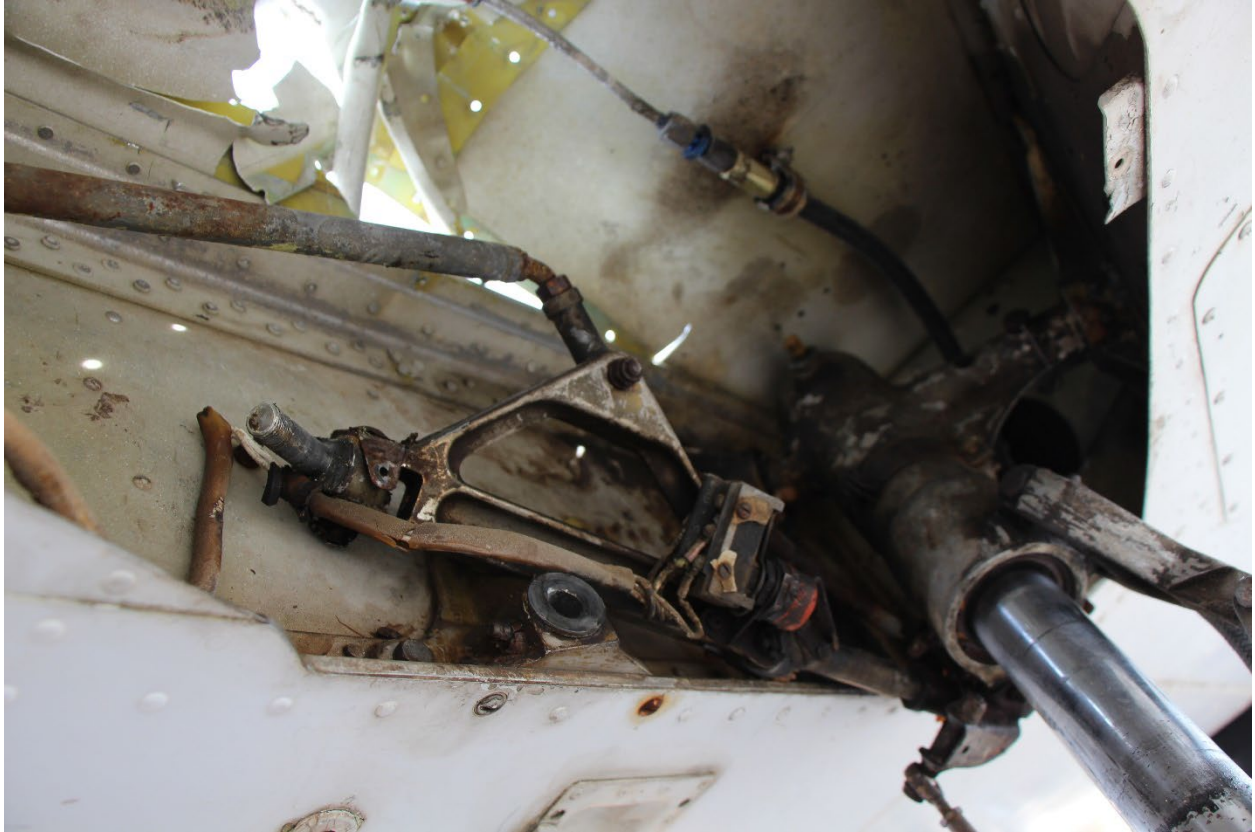
Photograph 9: Right Main Landing Gear Strut and Assembly (NTSB)
