# NATIONAL TRANSPORTATION SAFETY BOARD

## MATERIALS LABORATORY STUDY REPORT

Report No. 20-018

Place : Reno, NV  
Date : March 17, 2019  
Vehicle : Piper PA 24, N5028P  
NTSB No. : WPR19LA098  
Investigator : Stephen Stein (AS-WPR)

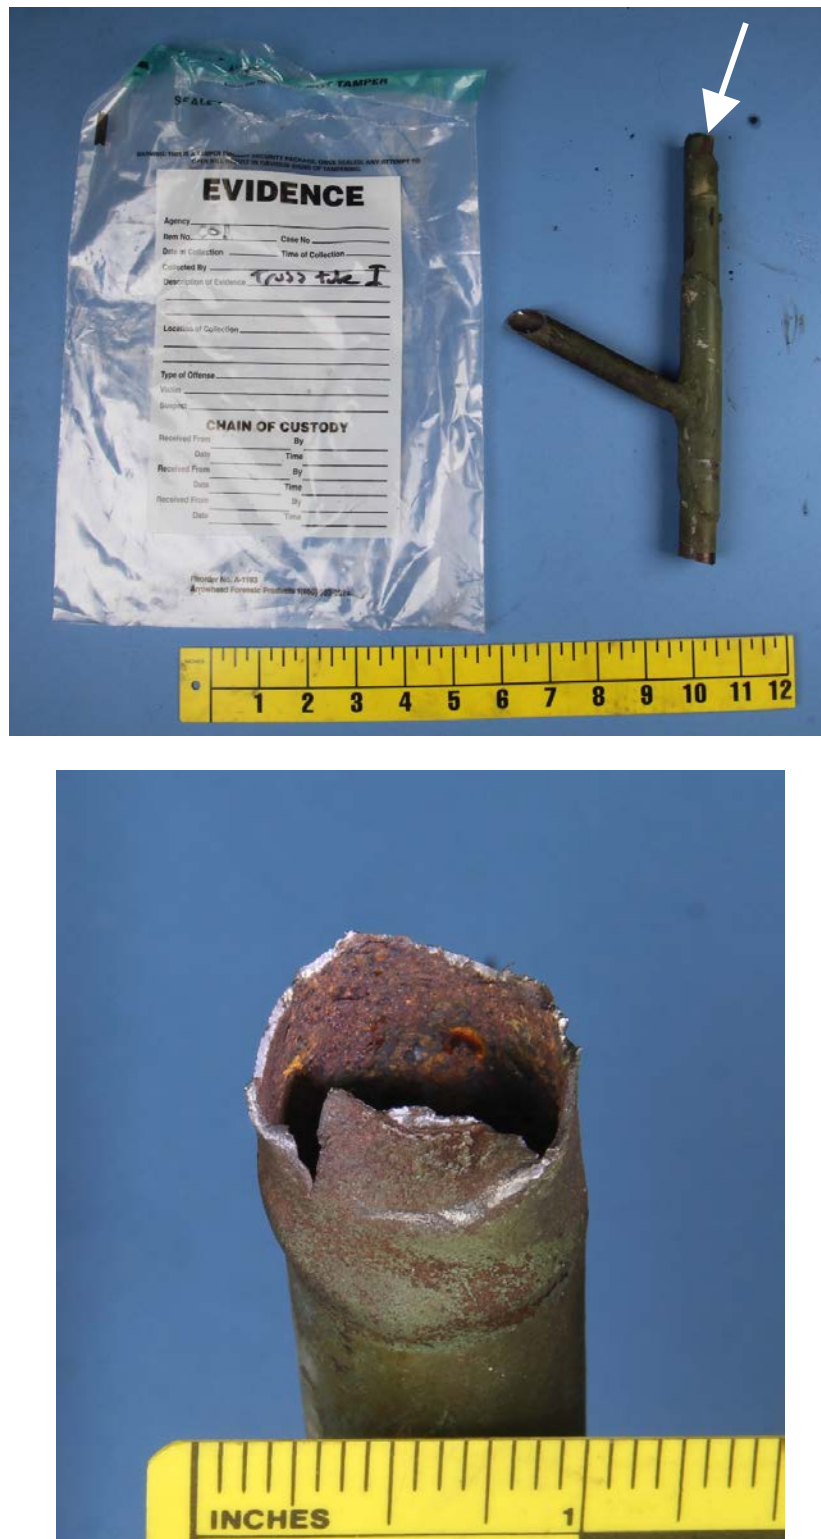
All the pieces had at least one fracture surface on the truss tubes. The fracture surfaces on each truss tube are shown in Figures 1-9. The fracture surfaces were non-planar and rough, which is consistent with overstress. The remaining truss tube surfaces were flat with evidence of cutting, which is consistent with sectioning to facilitate removal from the wreckage.

| Truss Tube | Internal Corrosion Deposits | Tearing Adjacent to Fracture Surface | Wall Thinning | Figure |
|---|---|---|---|---|
| I | Heavy | No | Yes | 1 |

Figure 1: The top photo shows an overall view of truss tube I. The white arrow points to the viewing perspective in the close-up shown in the bottom photo.

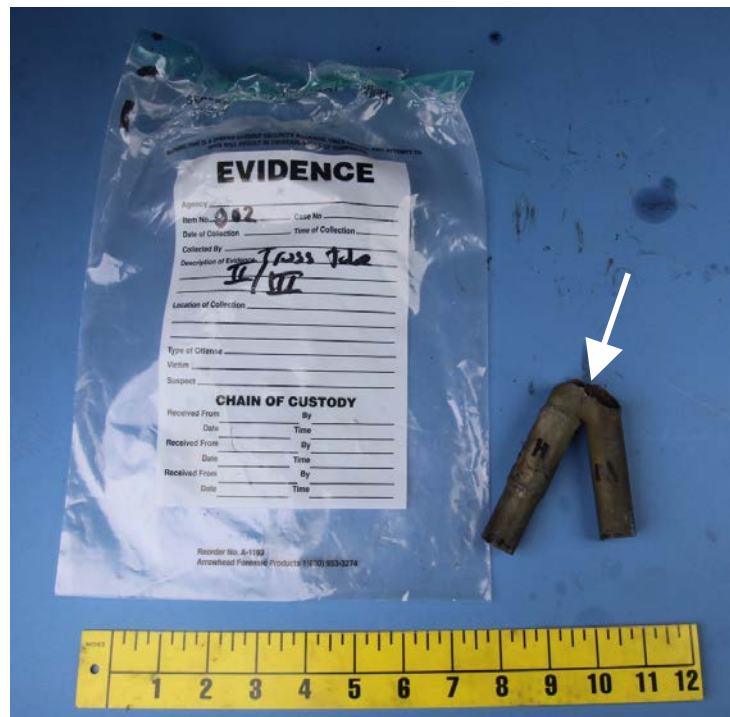
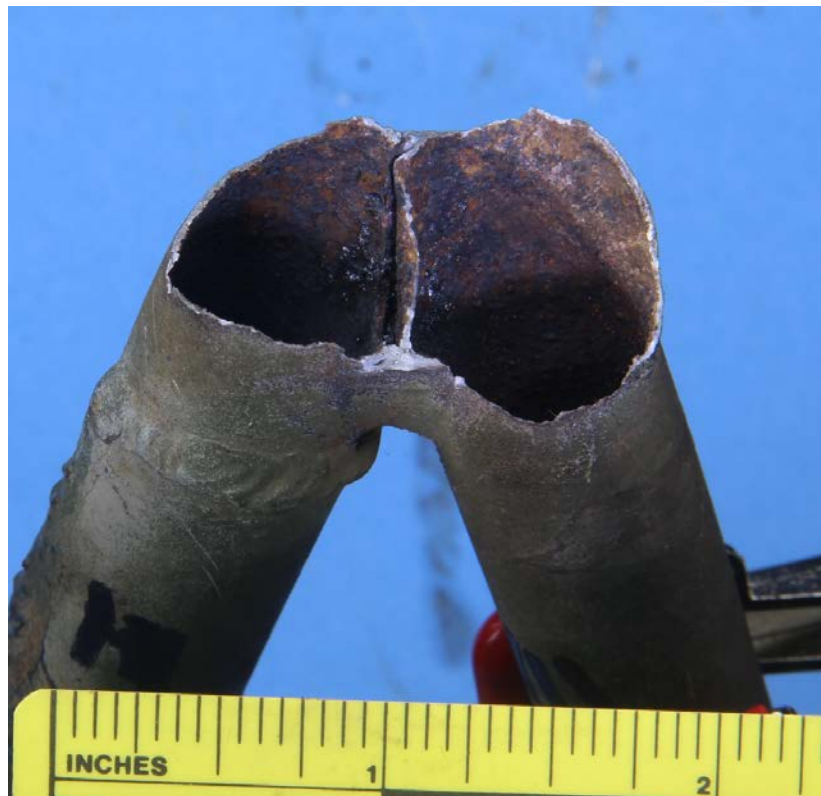
| Truss Tube | Internal Corrosion Deposits | Tearing Adjacent to Fracture Surface | Wall Thinning | Figure |
|---|---|---|---|---|
| II | Moderate | No | Yes | 2,10 |
| III | Moderate | No | Yes | 2,10 |

Figure 2: The top photo shows an overall view of truss tubes II and III. The white arrow points to the viewing perspective in the close-up shown in the bottom photo.

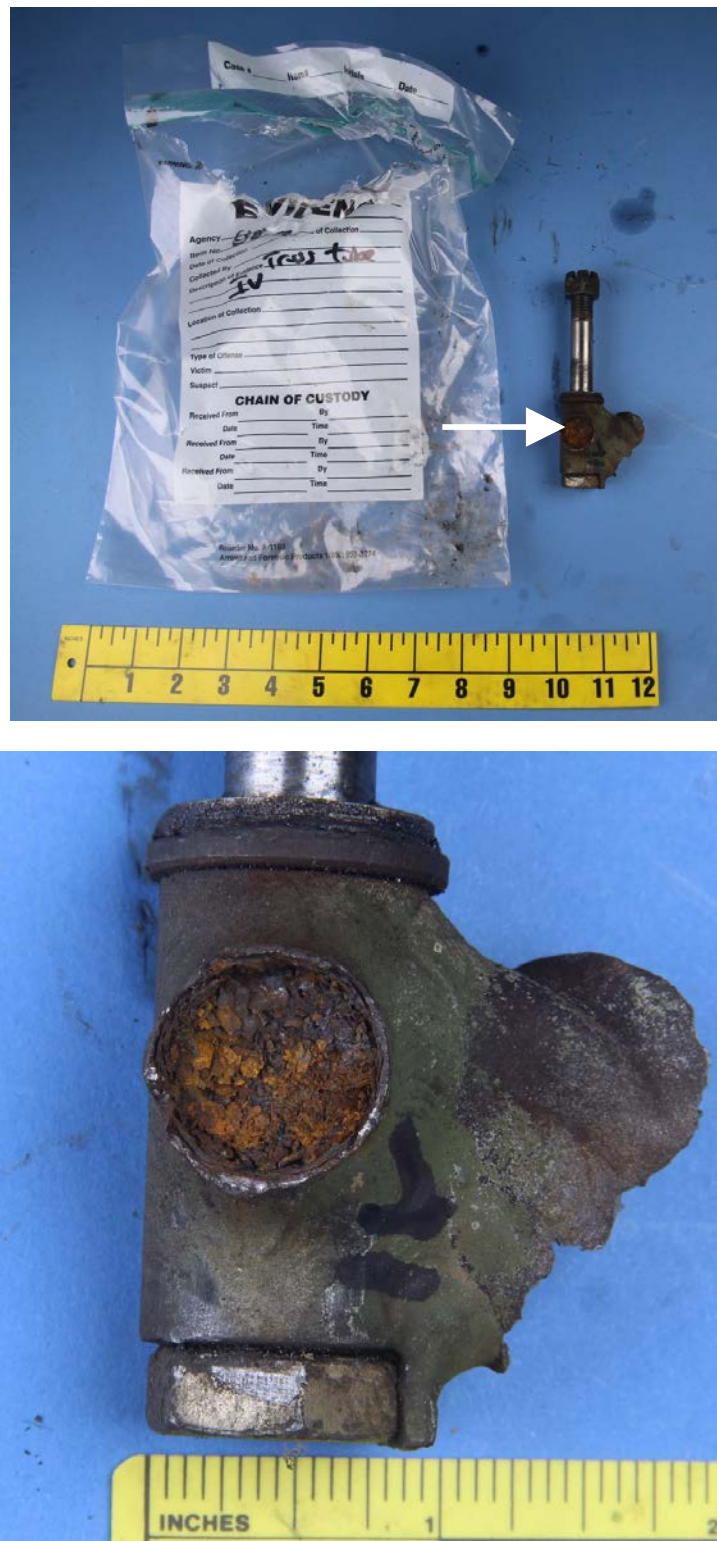
| Truss Tube | Internal Corrosion Deposits | Tearing Adjacent to Fracture Surface | Wall Thinning | Figure |
|---|---|---|---|---|
| IV | Heavy | No | Yes | 3,4,11,12 |

Figure 3: The top photo shows an overall view of truss tube IV. The white arrow points to the viewing perspective in the close-up shown in the bottom photo.

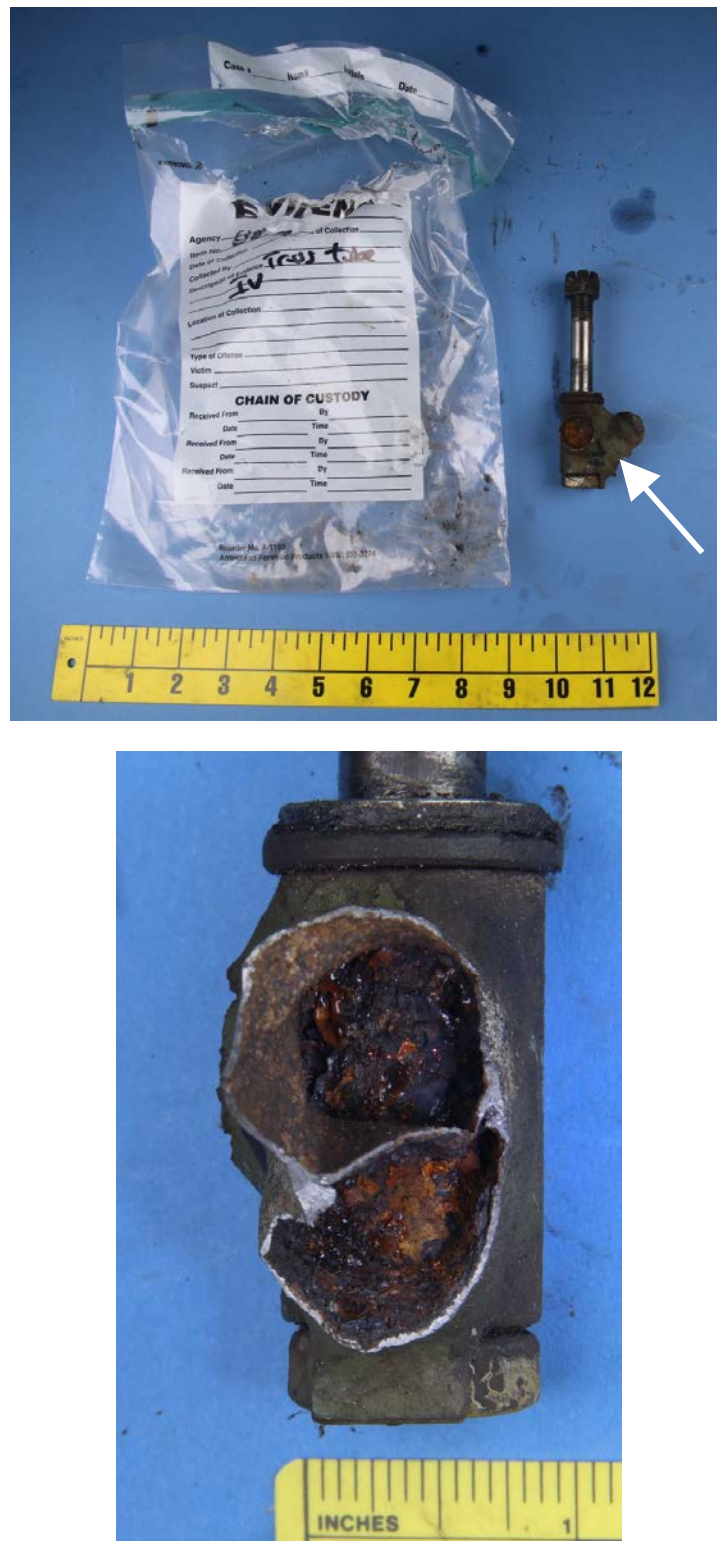
Figure 4: The top photo shows an overall view of truss tube IV. The white arrow points to the viewing perspective in the close-up shown in the bottom photo.

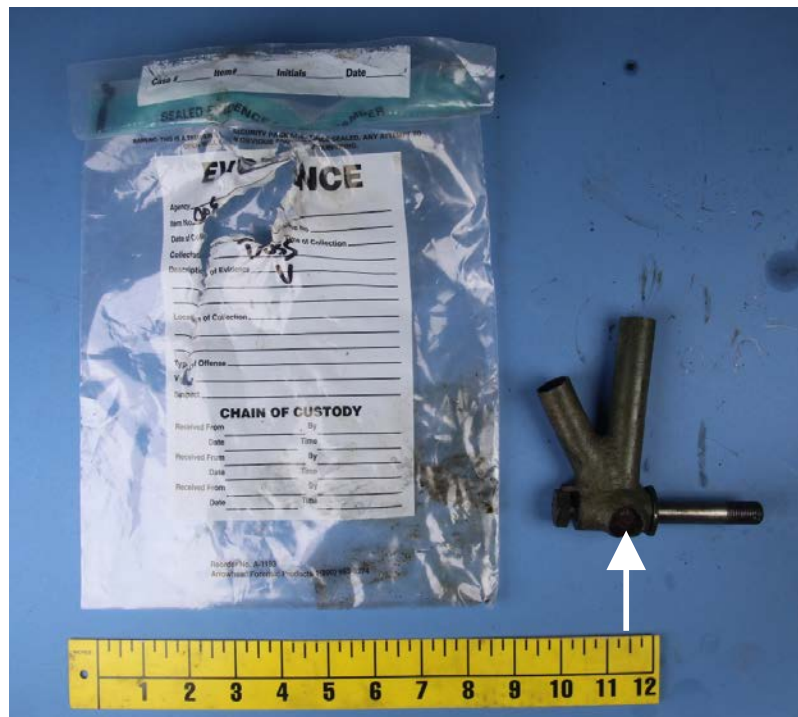
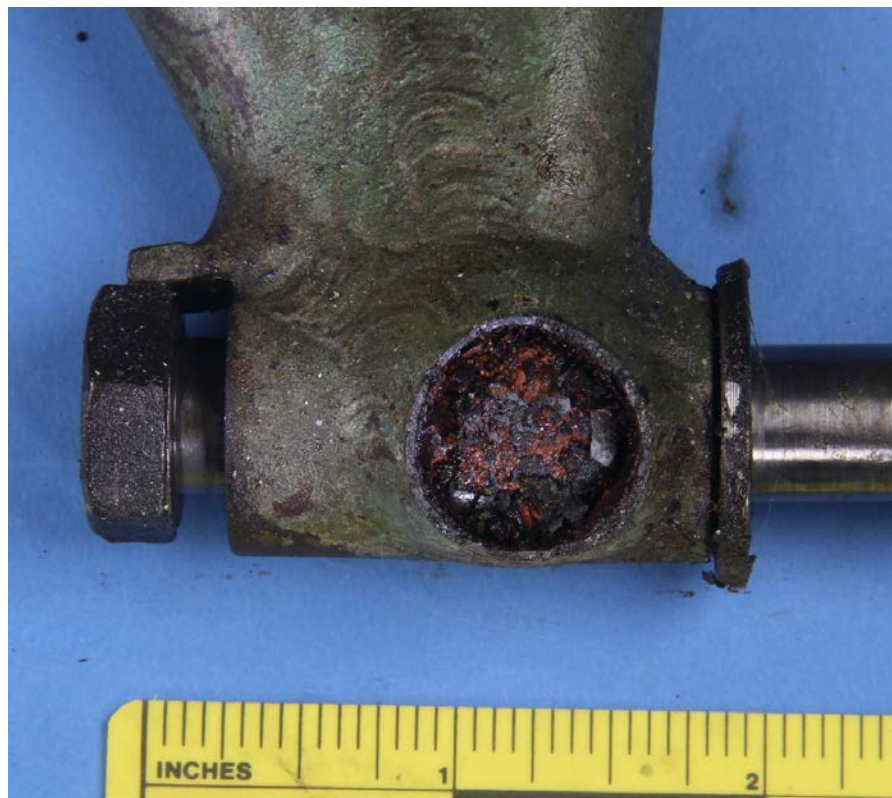
| Truss Tube | Internal Corrosion Deposits | Tearing Adjacent to Fracture Surface | Wall Thinning | Figure |
|---|---|---|---|---|
| V | Heavy | No | Yes | 5 |

Figure 5: The top photo shows an overall view of truss tube V. The white arrow points to the viewing perspective in the close-up shown in the bottom photo.

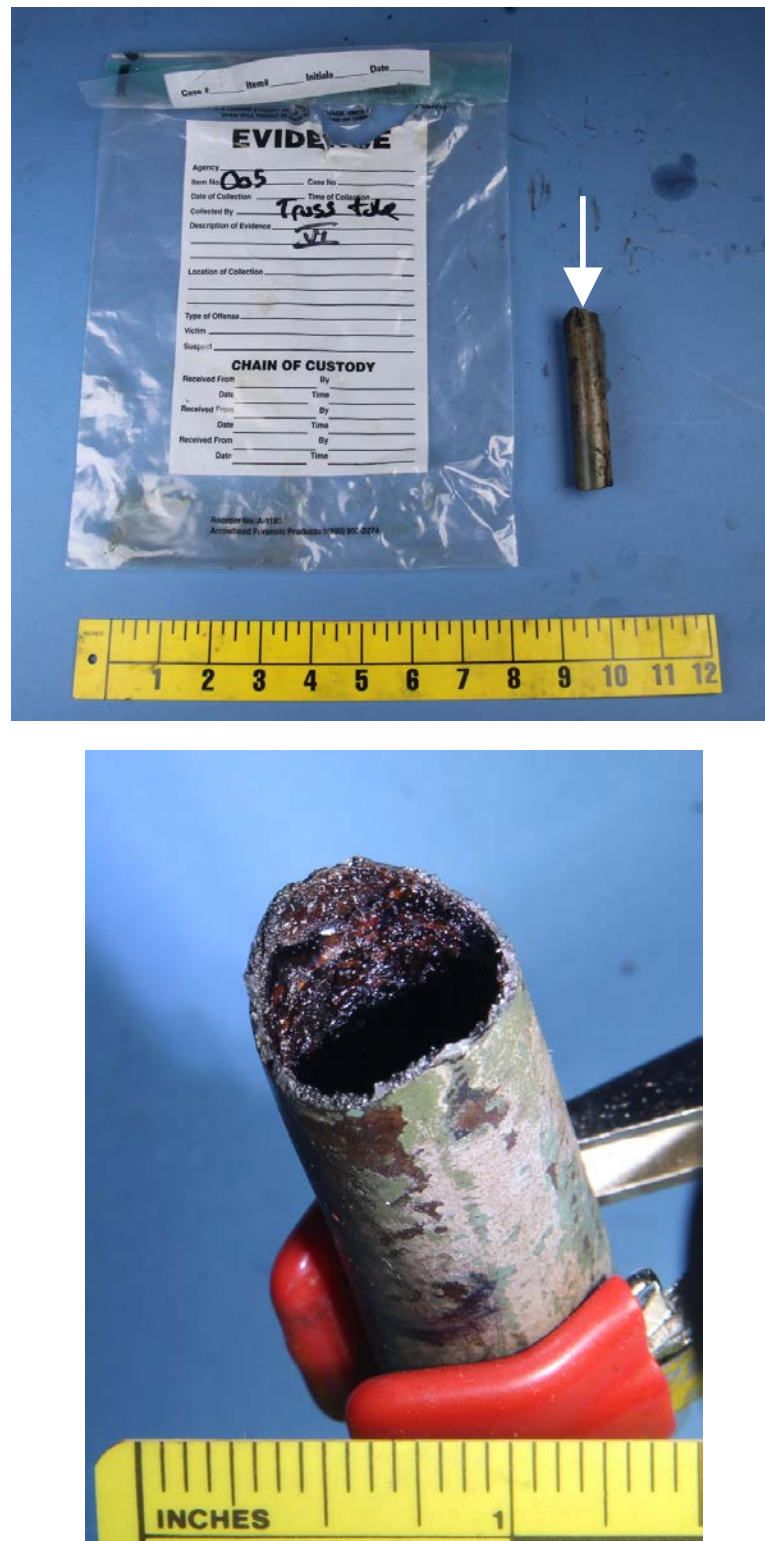
| Truss Tube | Internal Corrosion Deposits | Tearing Adjacent to Fracture Surface | Wall Thinning | Figure |
|---|---|---|---|---|
| VI | Heavy | No | No | 6 |

Figure 6: The top photo shows an overall view of truss tube VI. The white arrow points to the viewing perspective in the close-up shown in the bottom photo.

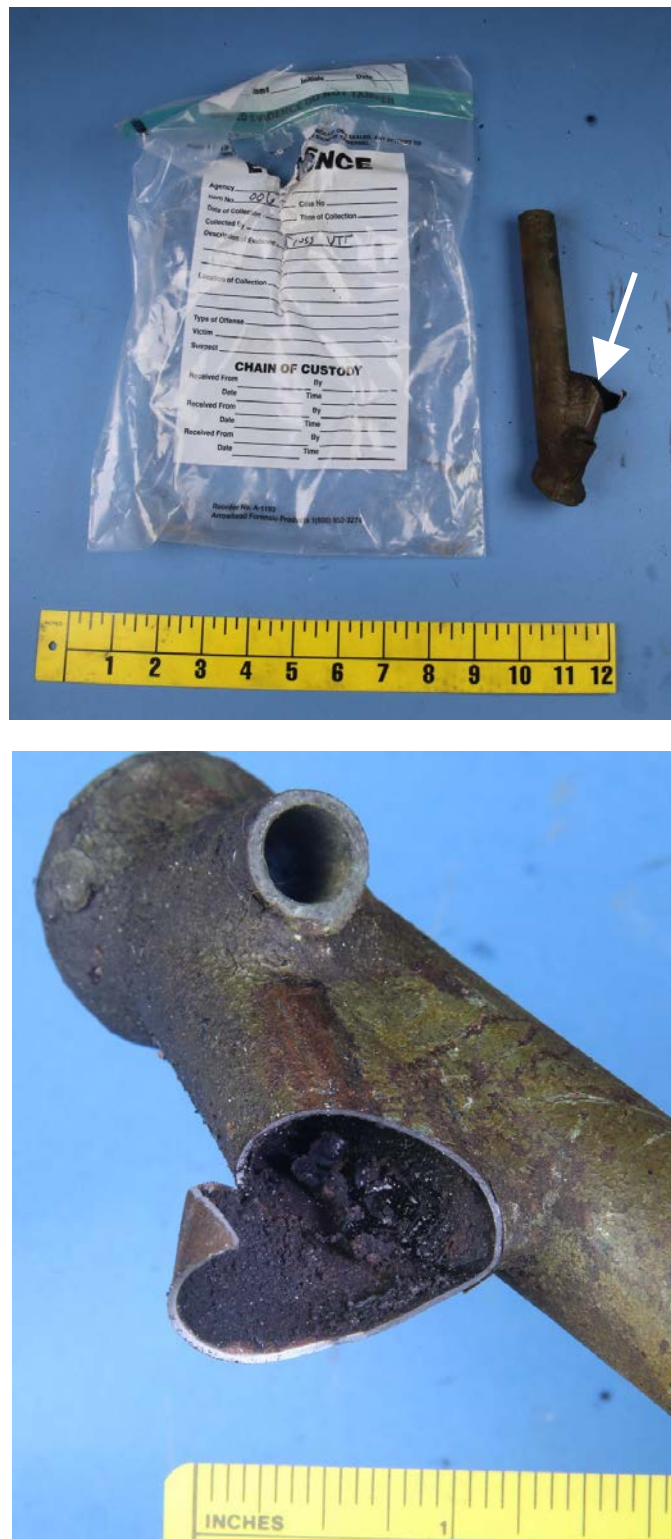
A few truss tubes had tearing adjacent to their fracture surfaces. The tearing was likely due to deformation prior to final separation. In general, the truss tubes with tearing had less internal corrosion products.

| Truss Tube | Internal Corrosion Deposits | Tearing Adjacent to Fracture Surface | Wall Thinning | Figure |
|---|---|---|---|---|
| VII | Moderate | Yes | No | 7 |

Figure 7: The top photo shows an overall view of truss tube VII. The white arrow points to the viewing perspective in the close-up shown in the bottom photo.

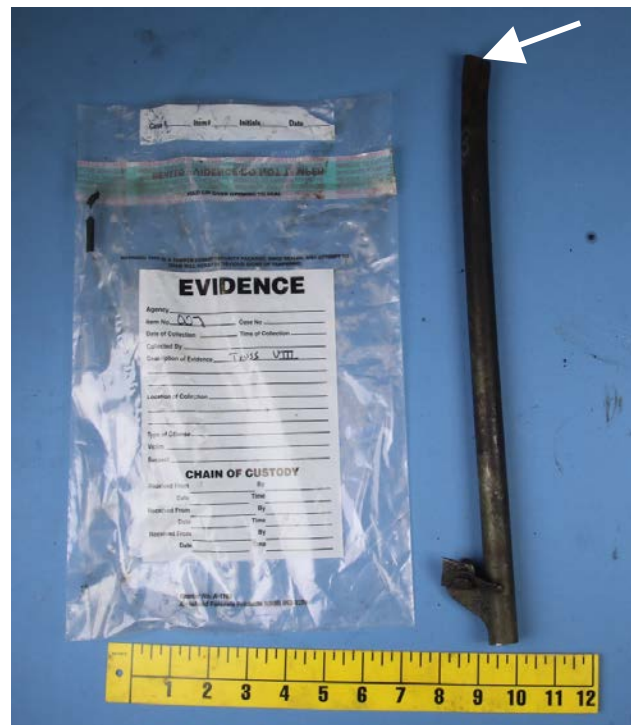
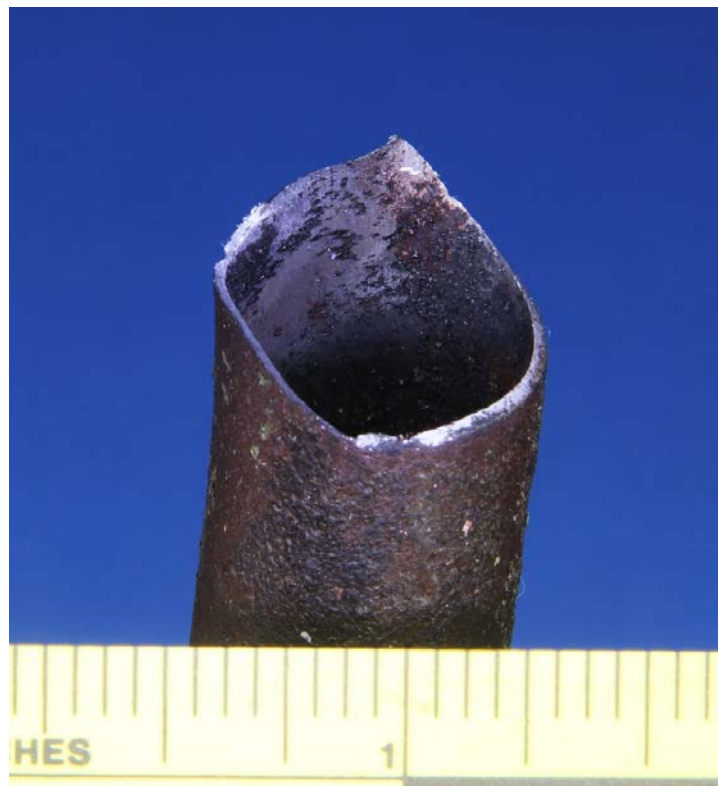
| Truss Tube | Internal Corrosion Deposits | Tearing Adjacent to Fracture Surface | Wall Thinning | Figure |
|---|---|---|---|---|
| VIII | Light | Yes | No | 8 |

Figure 8: The top photo shows an overall view of truss tube VIII. The white arrow points to the viewing perspective in the close-up shown in the bottom photo.

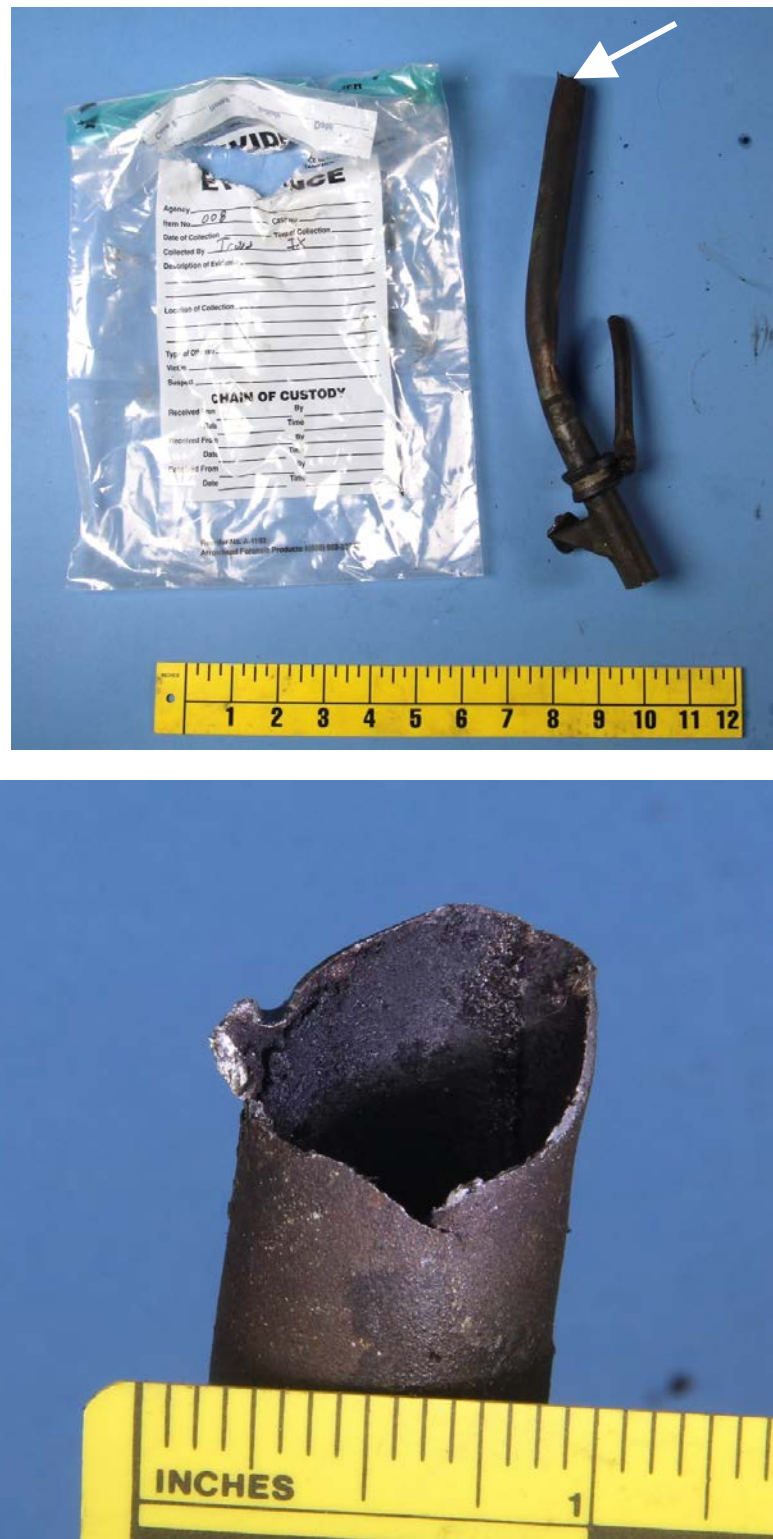
| Truss Tube | Internal Corrosion Deposits | Tearing Adjacent to Fracture Surface | Wall Thinning | Figure |
|---|---|---|---|---|
| IX | Light | Yes | No | 9 |

Figure 9: The top photo shows an overall view of truss tube IX. The white arrow points to the viewing perspective in the close-up shown in the bottom photo.

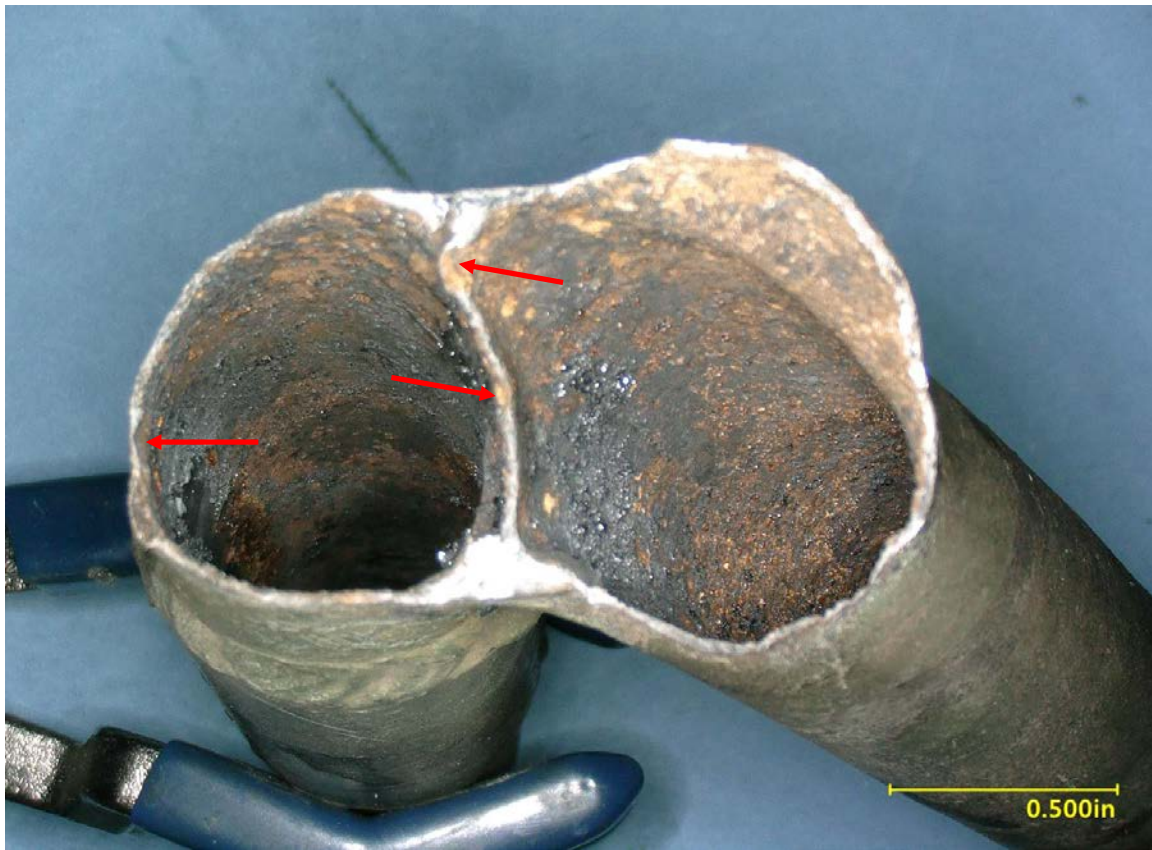
Corrosion products were observed on the inner surfaces of all the truss tubes. Several of the truss tubes had evidence of wall thinning resulting from the internal corrosion. Close-up images of exemplar truss tubes with wall thinning are shown in Figures 10-12.

Figure 10: Digital microscope image showing corrosion deposits on the internal surfaces of truss tubes II and III. The red arrows indicate wall thinning due to corrosion.

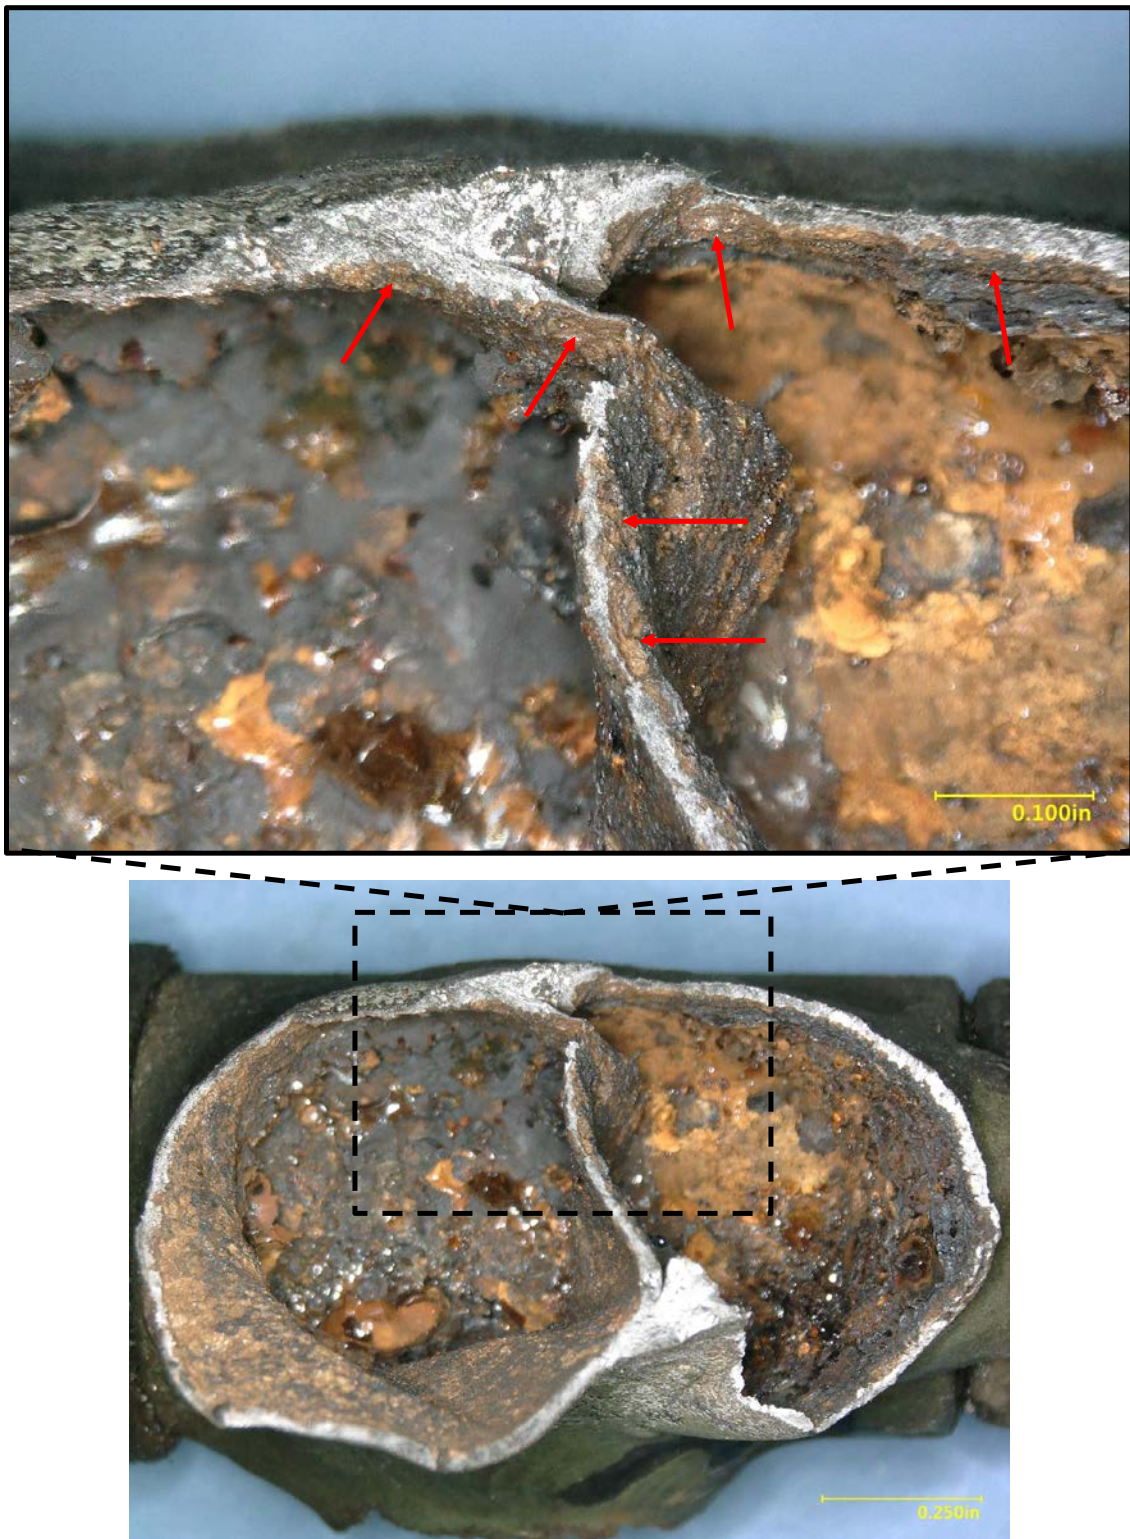
Figure 11: Digital microscope images showing corrosion deposits on the internal surfaces of truss tube IV. The red arrows indicate wall thinning due to corrosion.

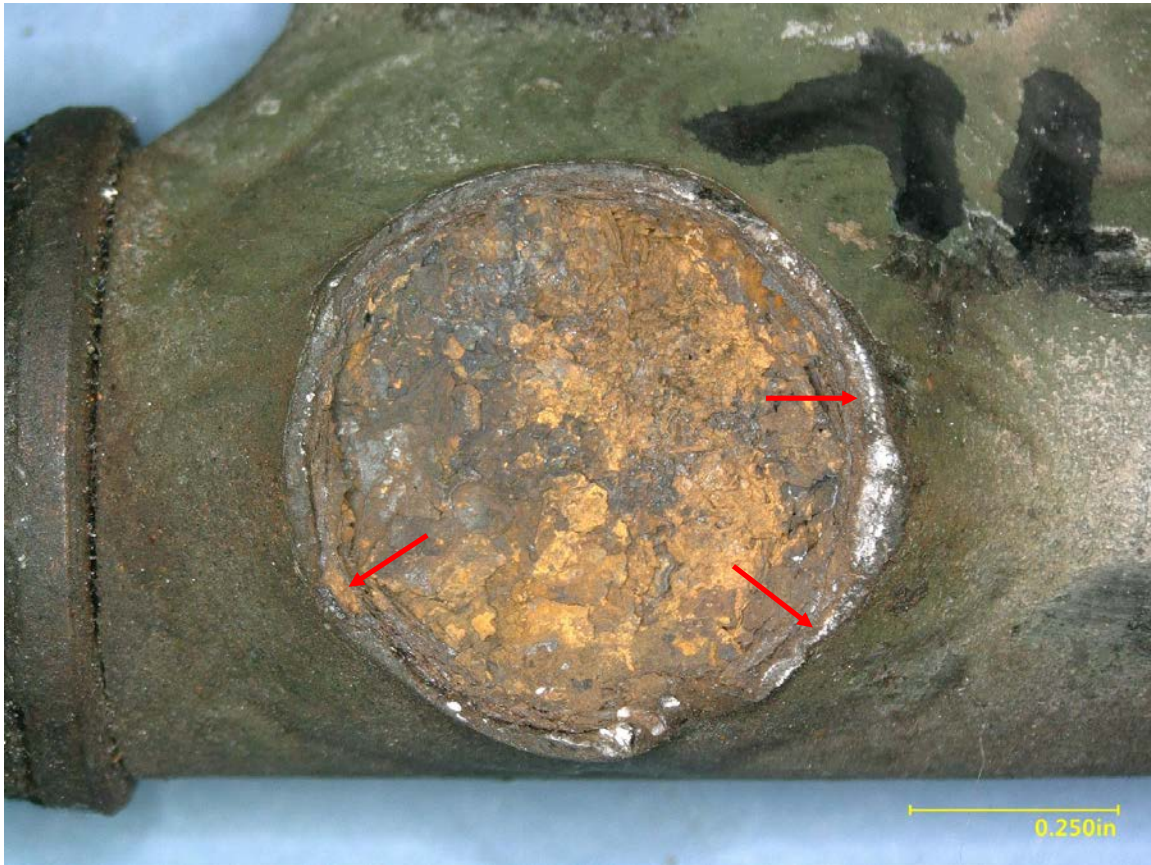
Figure 12: Digital microscope images showing corrosion deposits on the internal surfaces of truss tube IV. The red arrows indicate wall thinning due to corrosion.
