## **NATIONAL TRANSPORTATION SAFETY BOARD**

# **AIRFRAME AND ENGINE EXAMINATION**

**WPR19LA100**

Location: Watsonville, CA  
Date: February 9, 2019  
Aircraft: Bellanca 7GCAA Registration Number: N11666,  
NTSB IIC: Albert Nixon

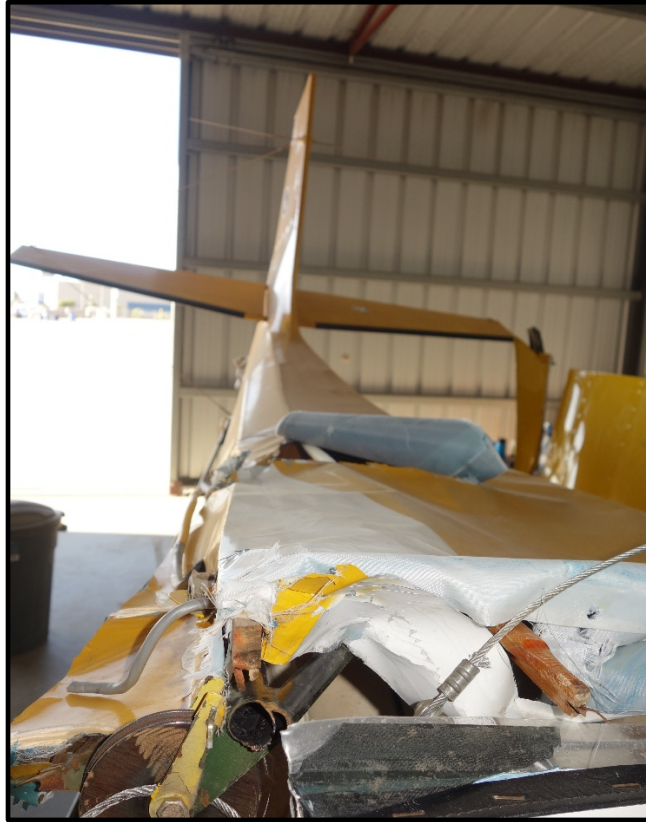
Examination of the airplane revealed that the wings, elevators, and rudder, were removed for recovery. The engine was attached.

Figure 1: The airplane wreckage in hanger before examination.

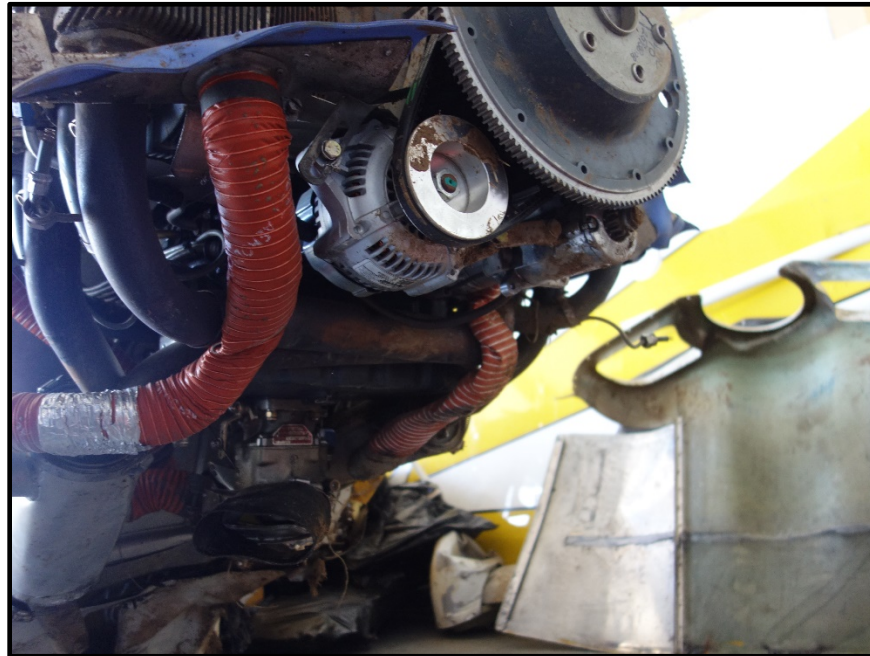
Examination of the Lycoming O-320-A2B engine, serial number L12089-27A, revealed that the engine sustained impact damage on the exhaust system and the carburetor heat box. No engine mounts were observed fractured. The crankcase was intact. The propeller and spinner had separated from the crankshaft. All rocker covers were removed, and examination revealed that all intake and exhaust rocker arms, shafts, and valve springs, were intact with no anomalies observed. The crankshaft was able to be rotated by hand and rotational continuity was established throughout the engine and valve train in all cylinders. All cylinders displayed appropriate compression and suction in the proper firing order. The left magneto was secured in its mount and when crankshaft was rotated, spark was observed at all ignition leads. The right magneto was removed and during manual rotation, spark was observed on all the ignition leads.

**Figure 2: Engine as viewed from the right bottom side.**

The engine exhaust system remained attached but was bent upward and aft. The exhaust system mufflers were removed, and internal examination revealed no anomalies were noted.
