## **NATIONAL TRANSPORTATION SAFETY BOARD**

### **SUMMARY OF AIRCRAFT EXAMINATION**

**(WPR19LA101)**

| Aircraft: | Dennis L. Zumwalt Sky Bolt |

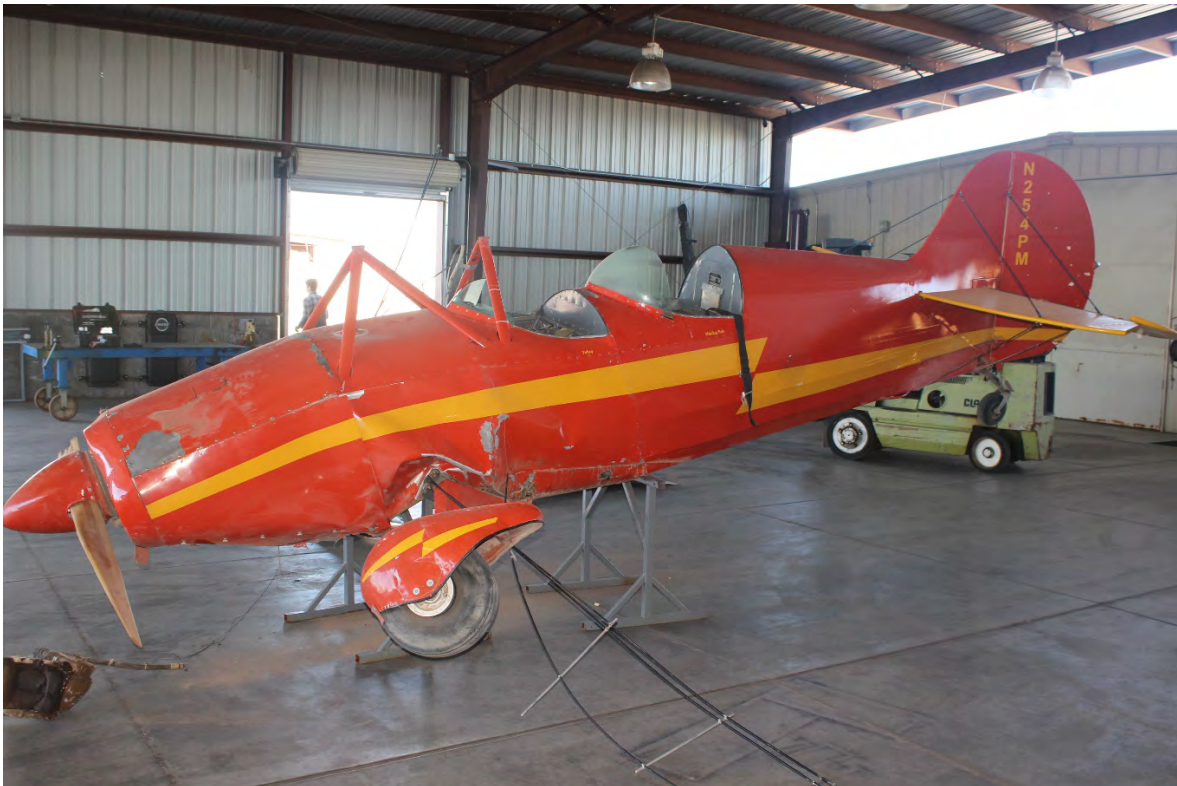
The forward section of the airframe, from the aft cockpit to the front of the airplane was substantially damaged. Both lower wing panels and support struts were impact damaged, with the right lower wing panel being destroyed during the accident sequence. Only minor damage was observed from the back of the rear cockpit to the rudder; the empennage was not damaged. The pilot reported no issues with controllability during the emergency descent and off-field landing. All components necessary for flight were accounted for at the accident site.

Figure 1 - photo of damage to airplane as received

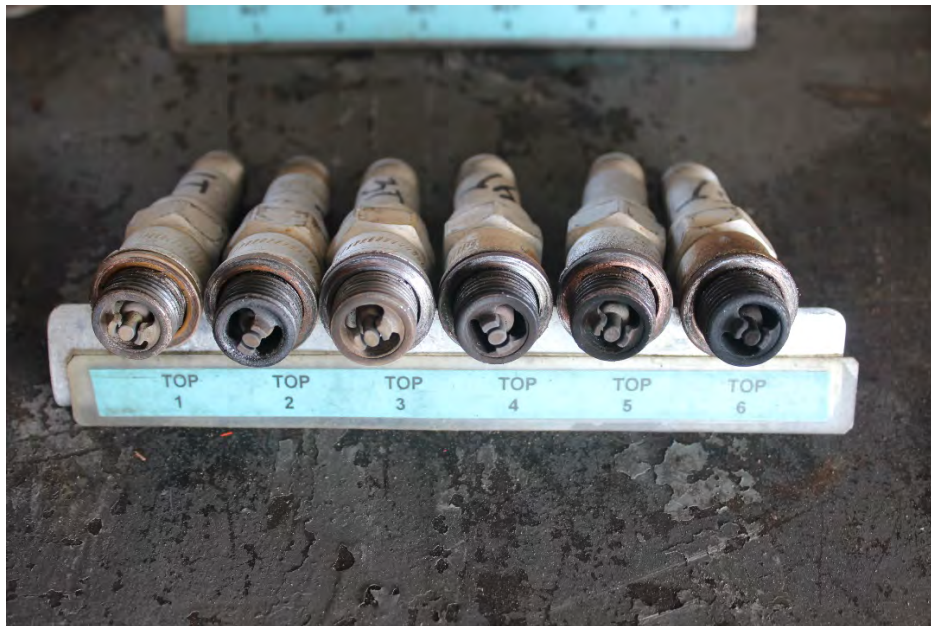
The spark plugs were secure at each position with their respective spark plug lead attached. The spark plugs were removed, examined and photographed. The spark plugs electrodes remained mechanically undamaged, and according to the Champion Spark Plugs "Check-A-Plug" chart AV-27, the spark plug electrodes displayed coloration consistent with normal operation. The static oil soaking of the spark plugs (as noted) was attributed to the engine positioning at the mishap site and post recovery.

Figure 2 - top spark plugs

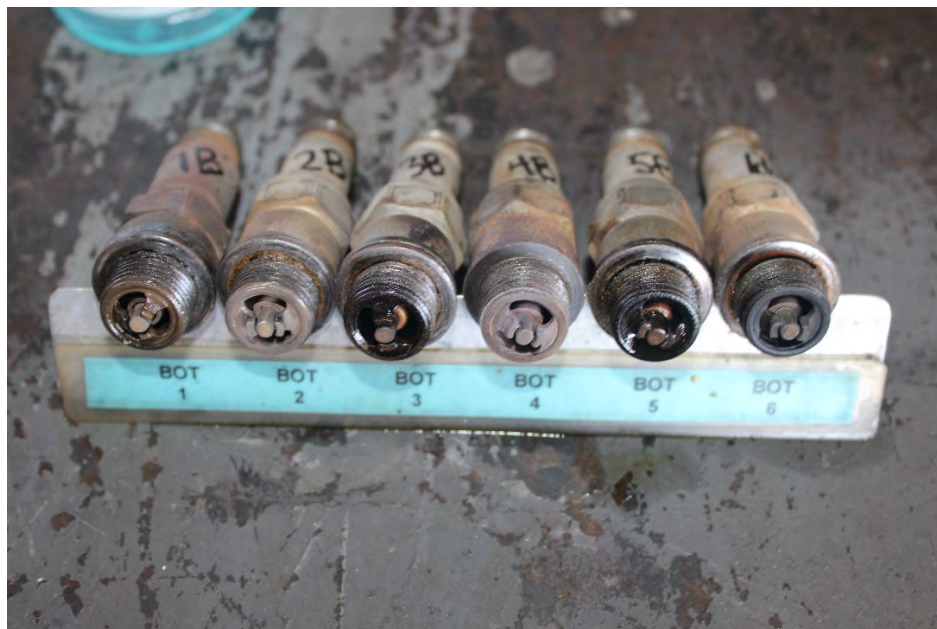
Figure 3 - bottom spark plugs

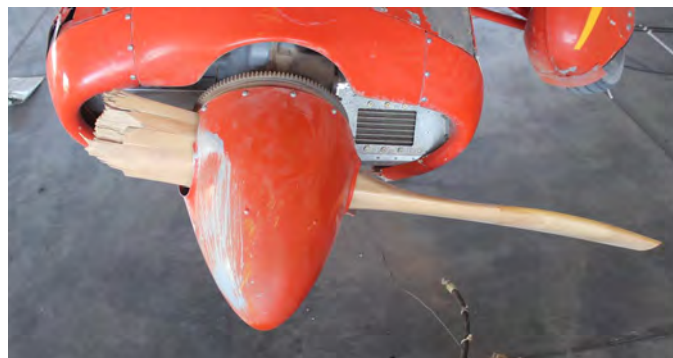
The wooden two bladed fixed pitch propeller remained attached at the crankshaft flange. The spinner was attached to the propeller. One of the propeller blades was splintered and liberated near the hub. The opposing blade remained intact.

Figure 4 - photo of propeller and spinner as received
