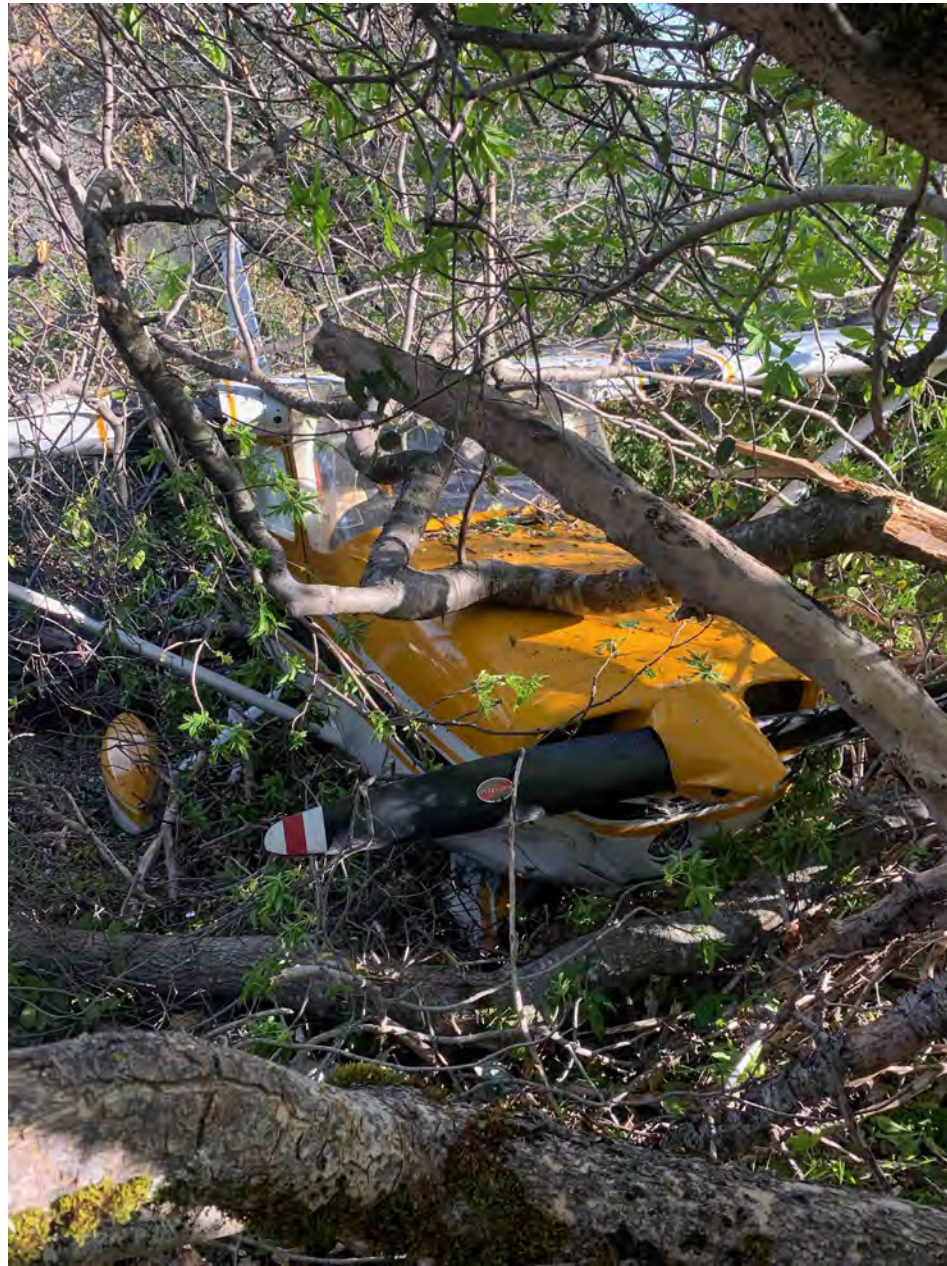
**Photo 1 – Airplane at Accident Site (photo courtesy of Placerville Airport Operations)**

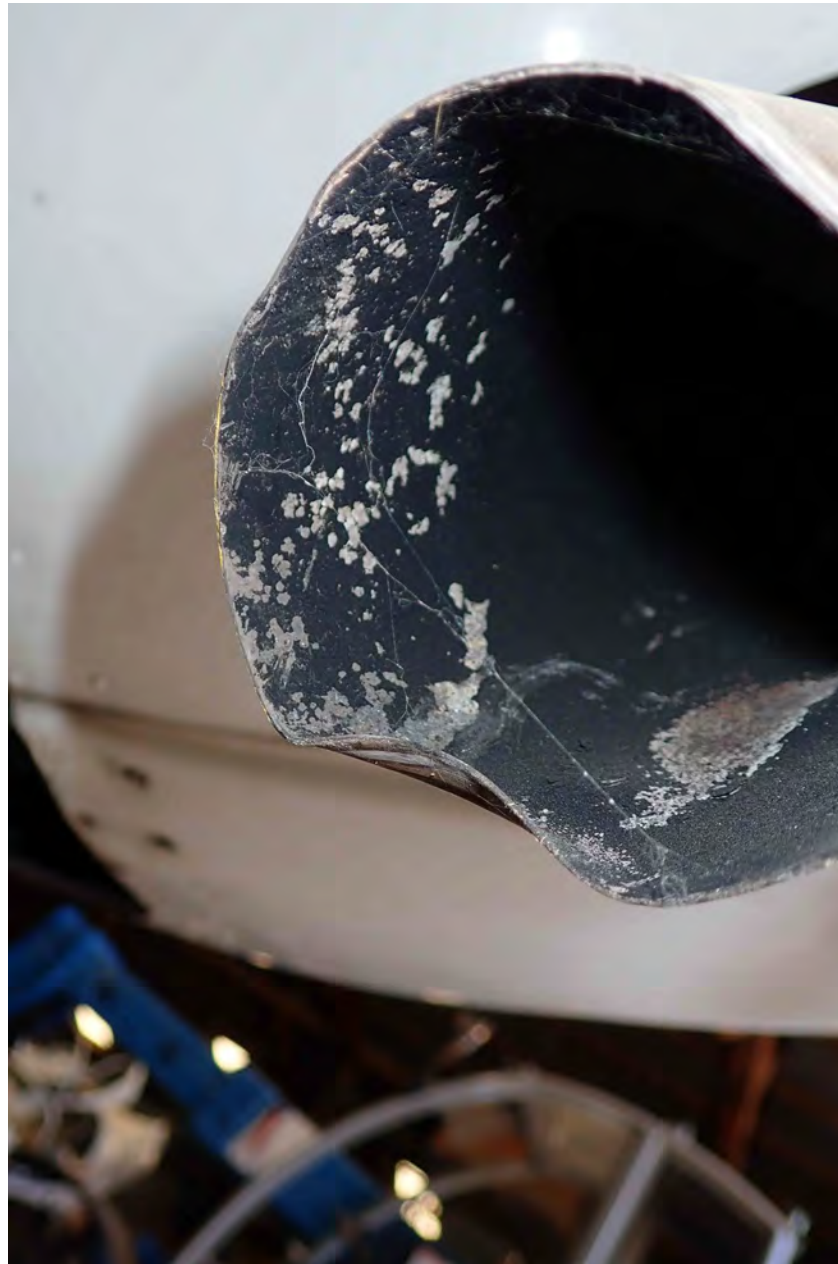
**Photo 2 – Inner Surface of Exhaust Pipe**

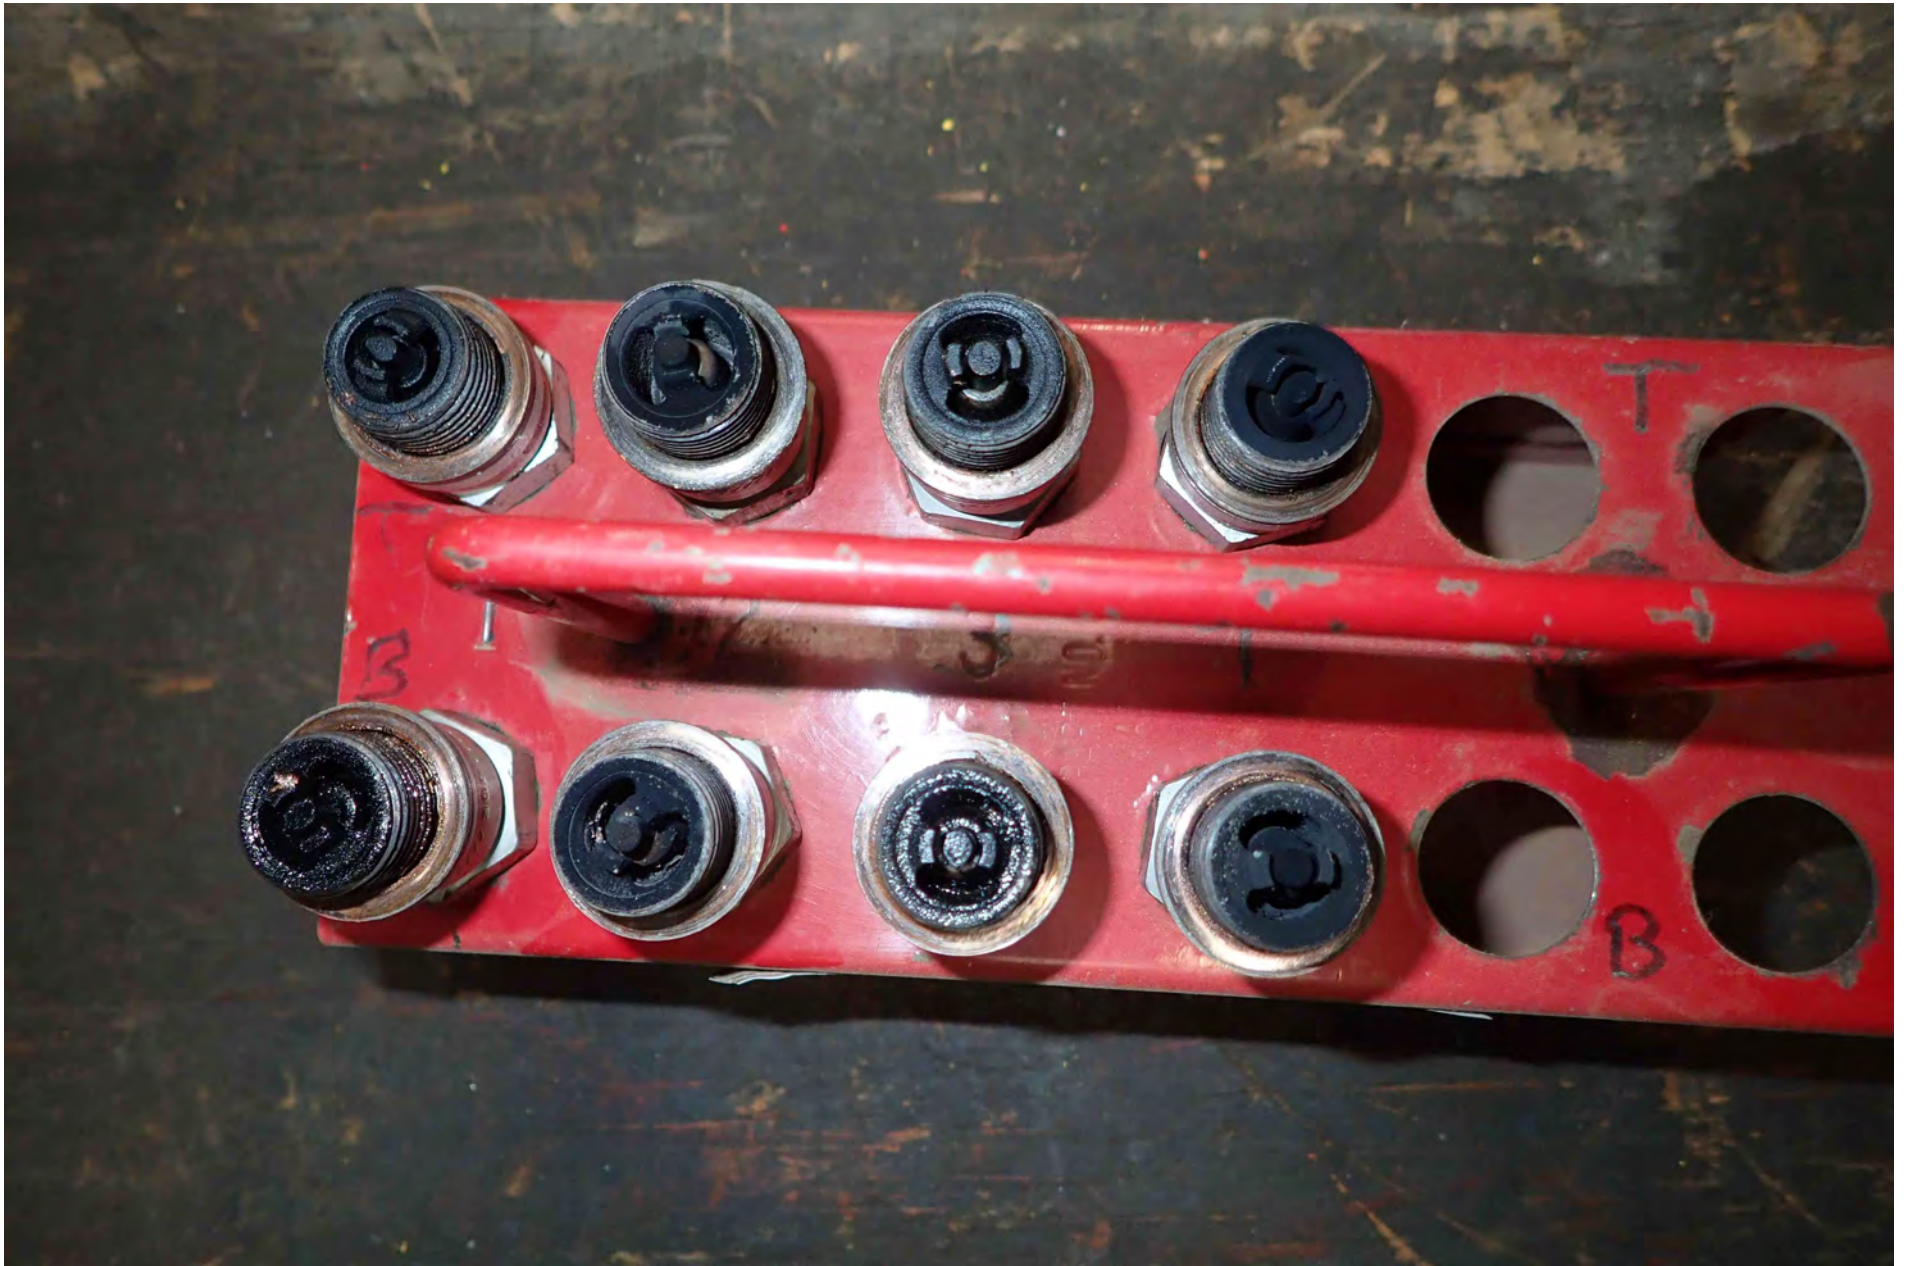
**Photo 3 – Spark Plugs**

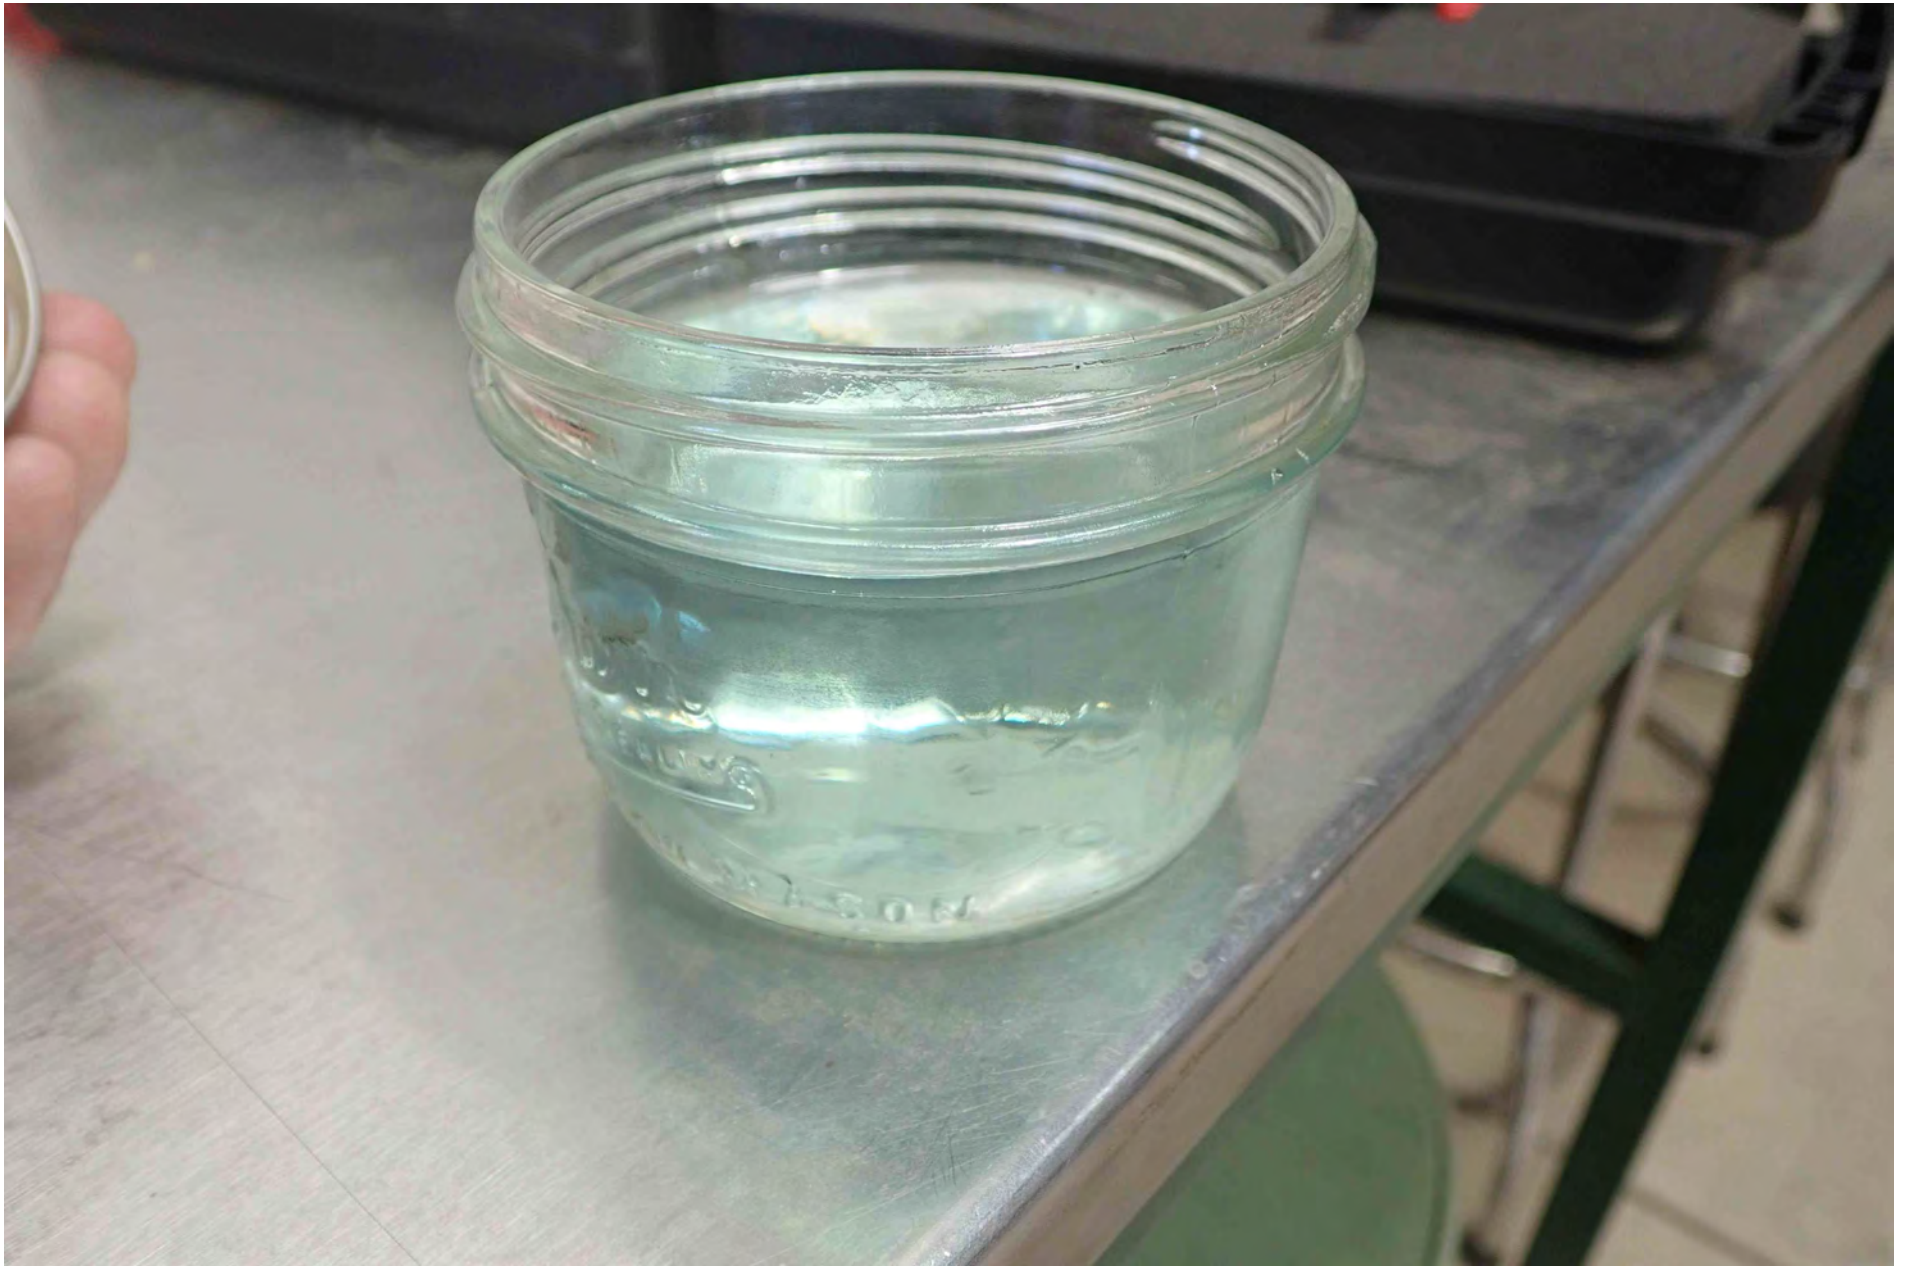
**Photo 4 – Fuel Drained from Gascolator**

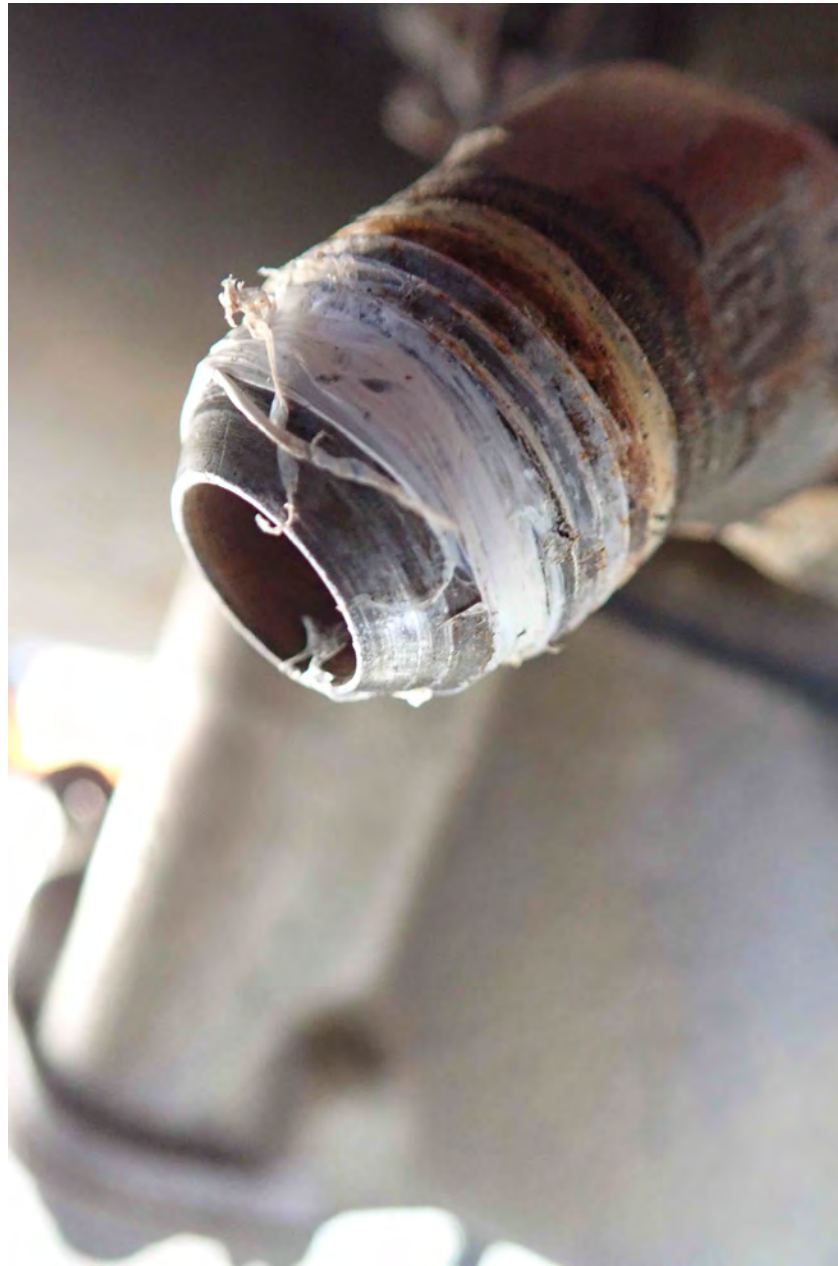
**Photo 5 – Teflon Tape on Carburetor Fuel Inlet Fitting**

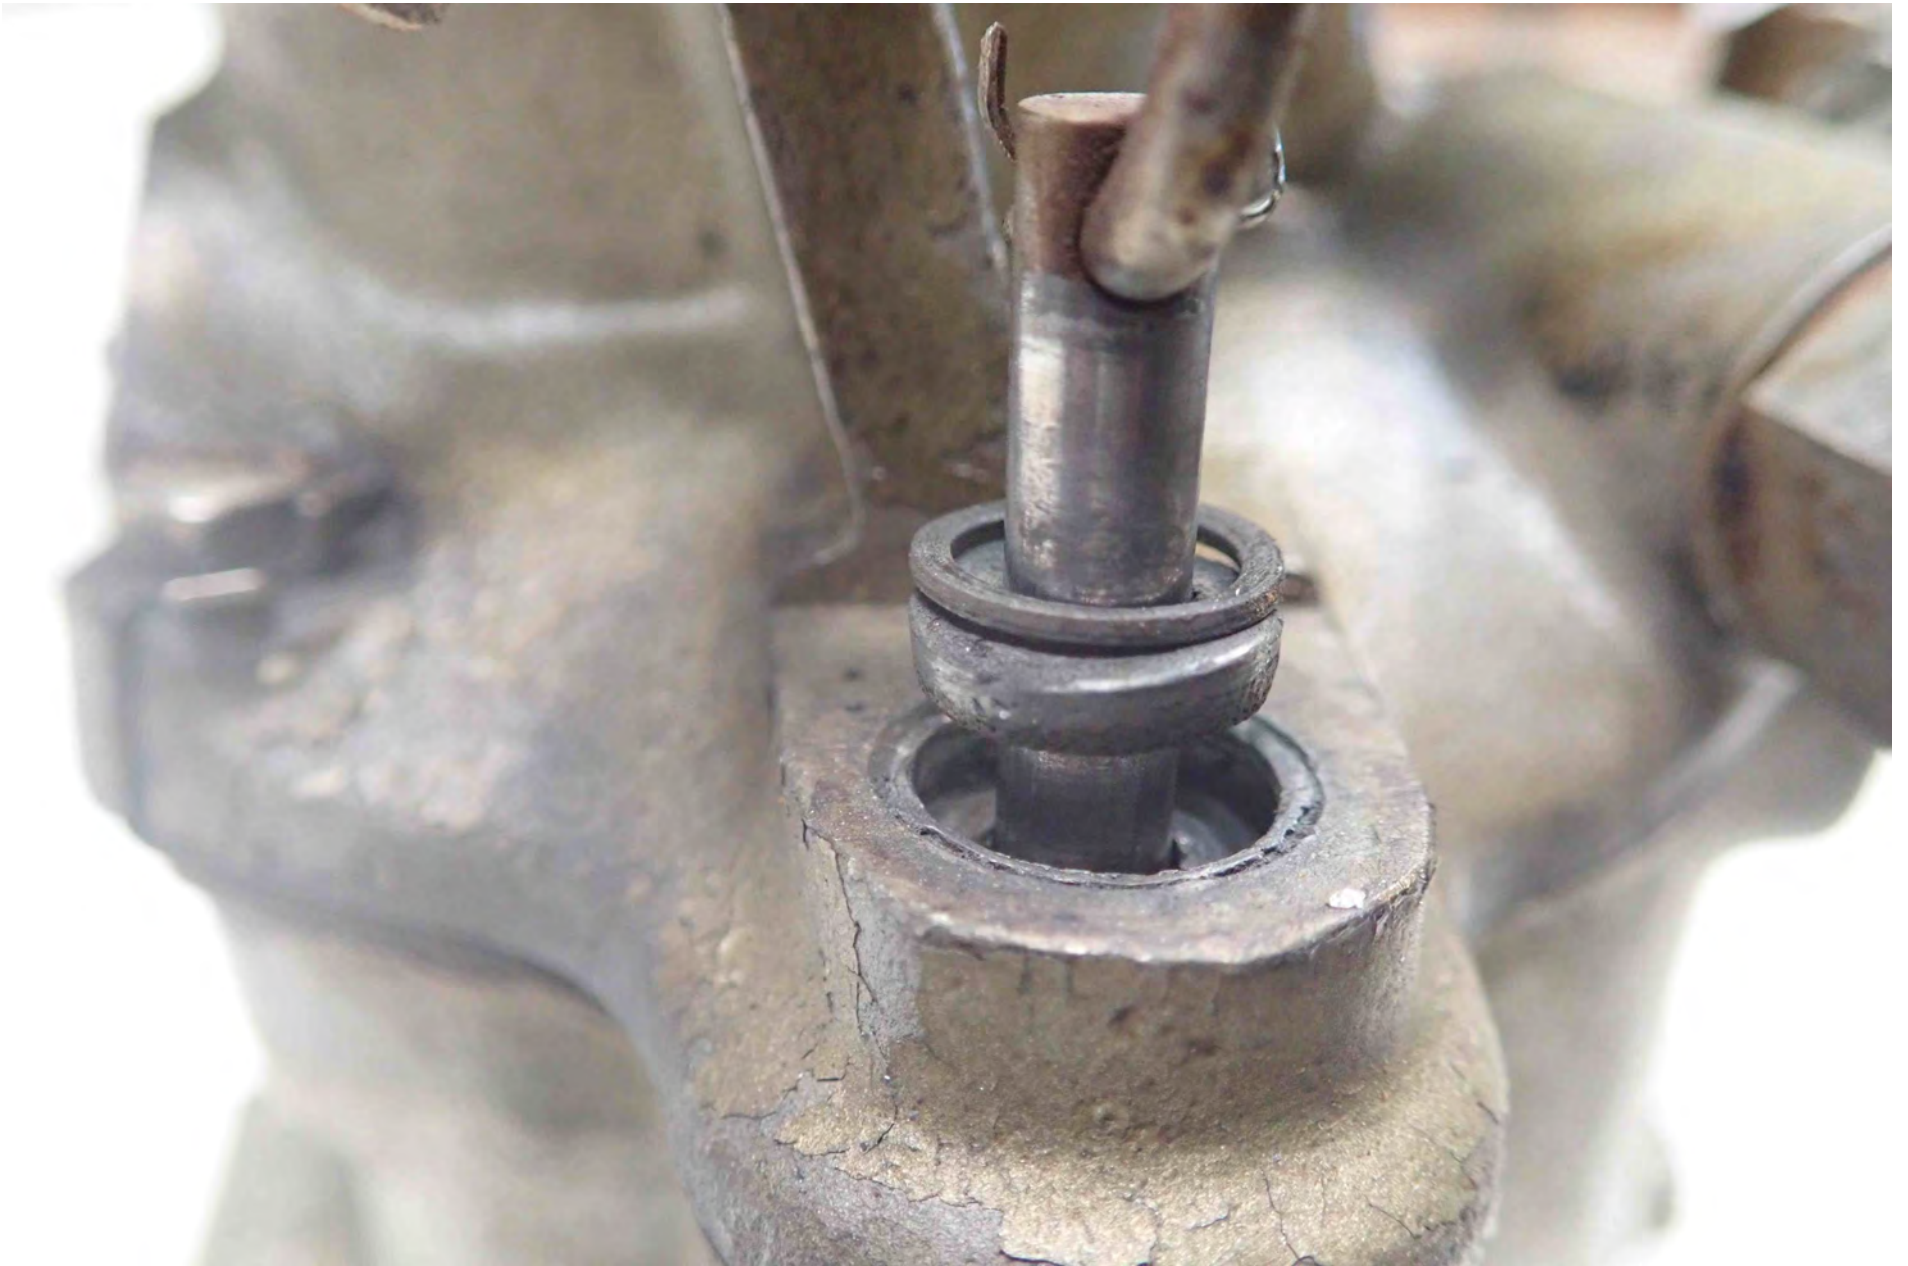
**Photo 6 – Loose Accelerator Pump Packing**

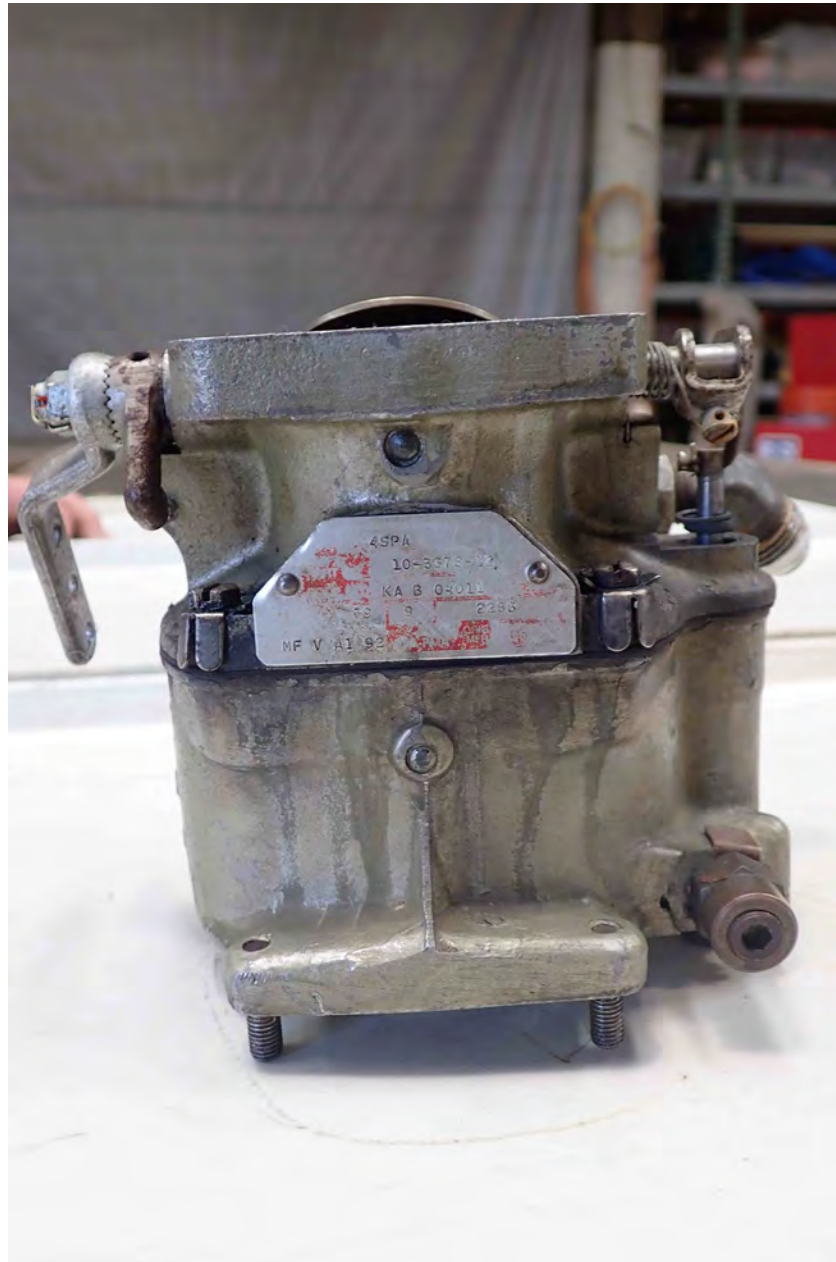
**Photo 7 – Fuel Leak at Body-to-Bowl Join**

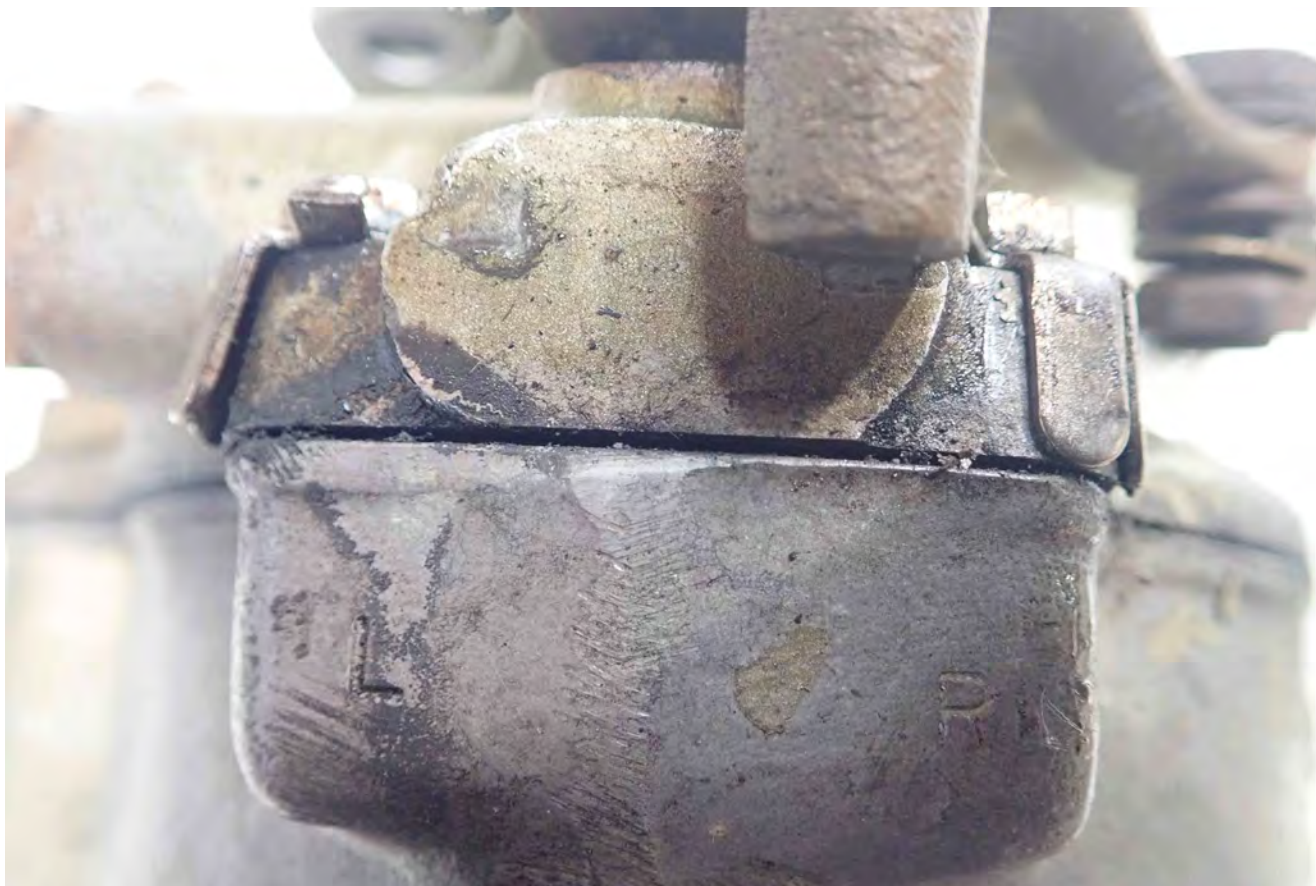
**Photo 8 – Body-to-Bowl Join Gap**

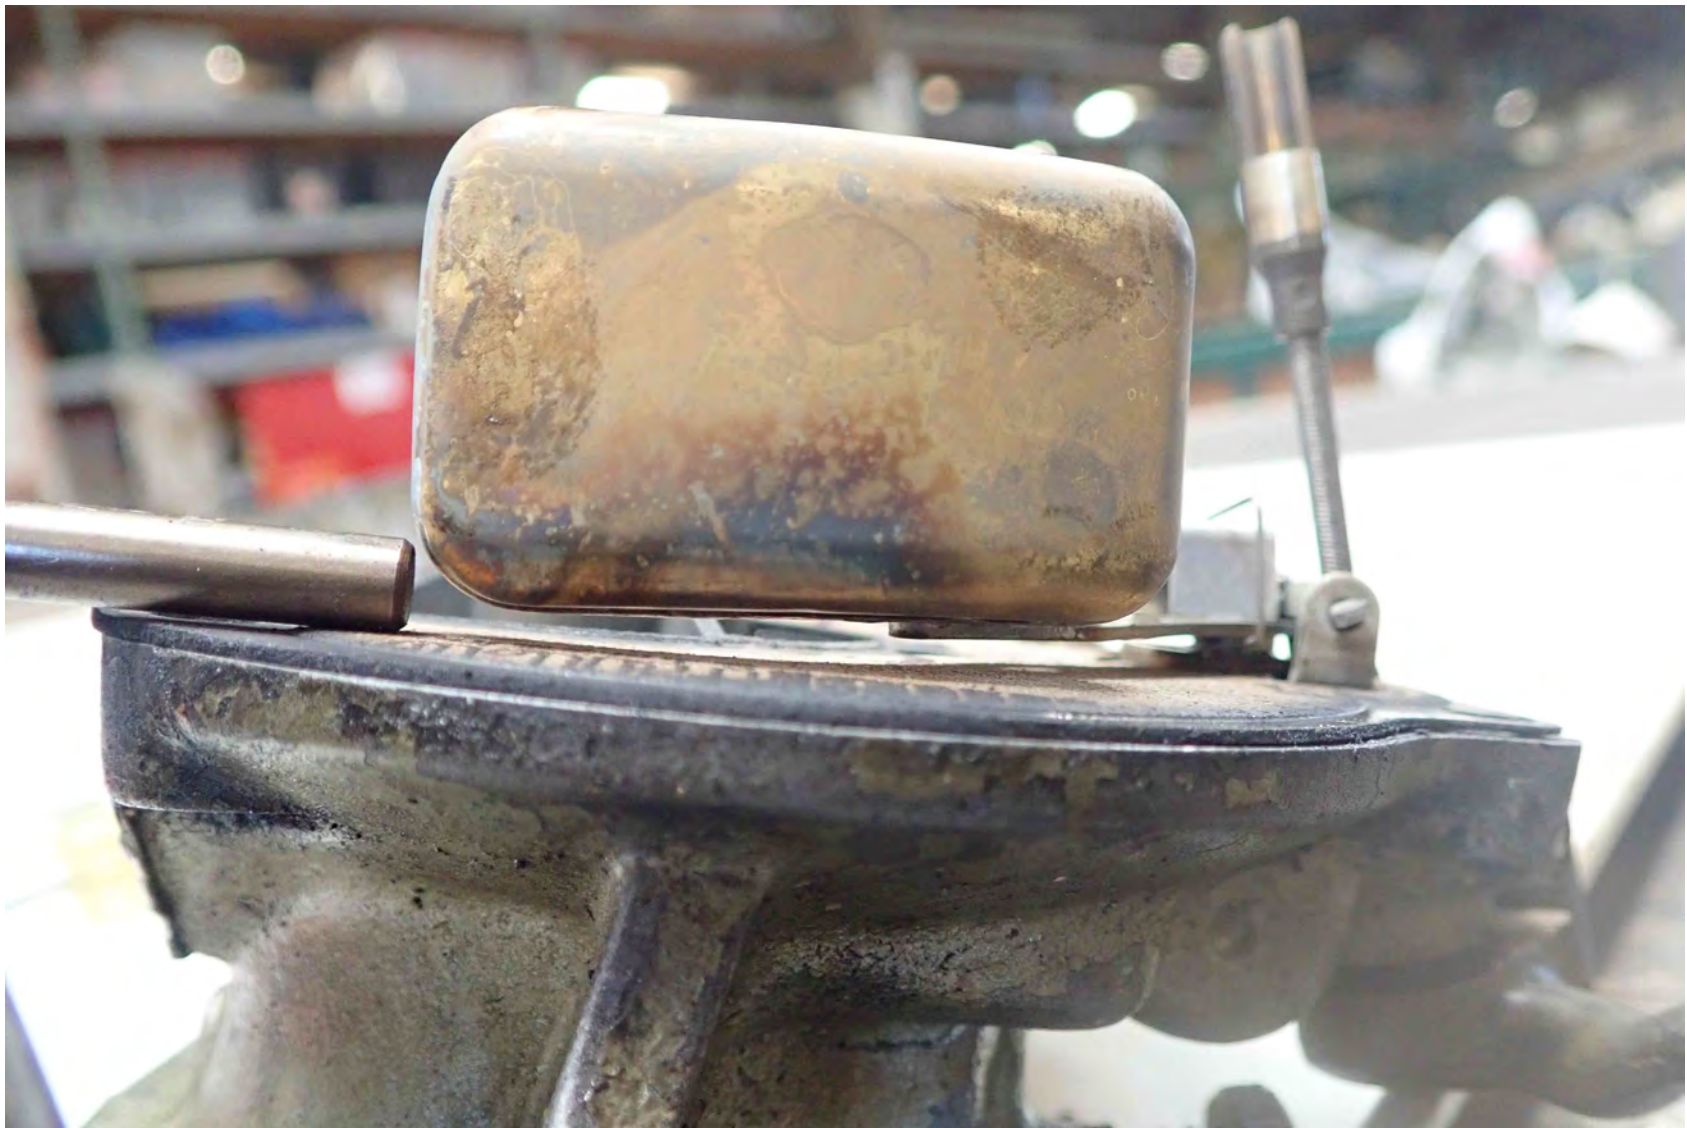
**Photo 9 – Float Clearance compared to 7/32 inch Drill Bit**

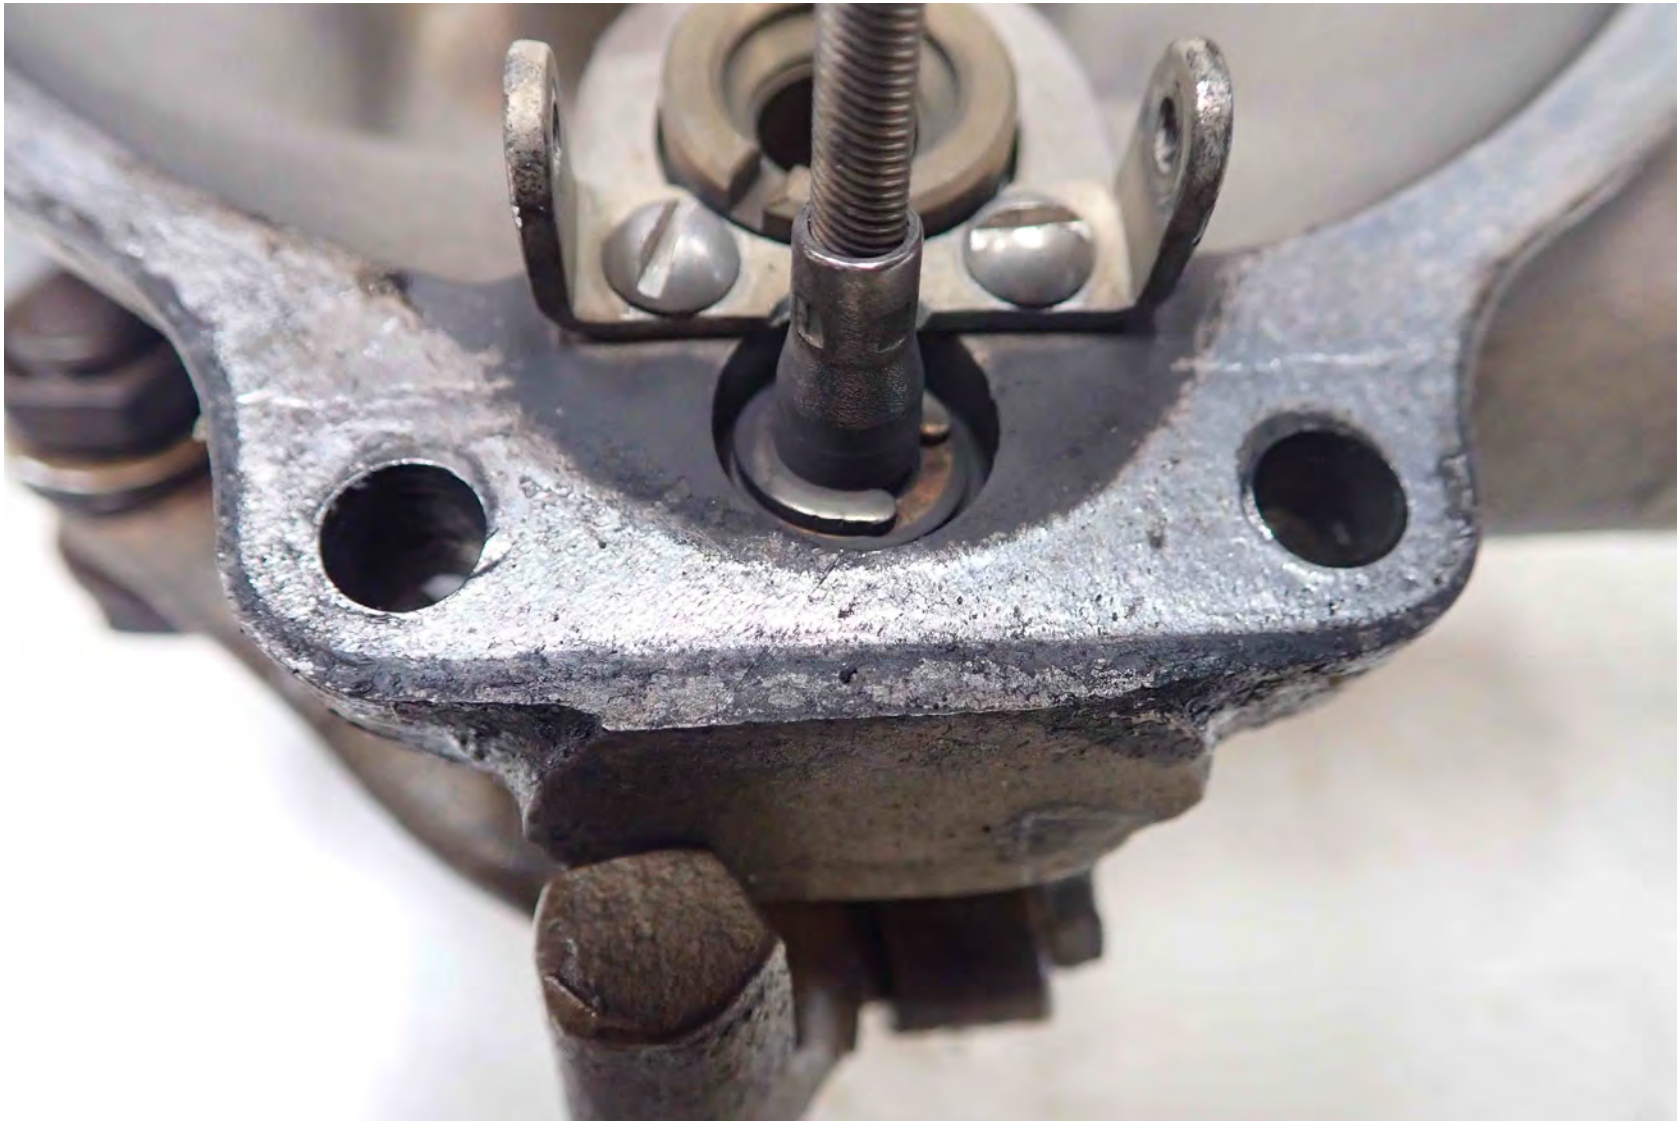
**Photo 10 – Polishing and Fretting at Body-to-Bowl Join**

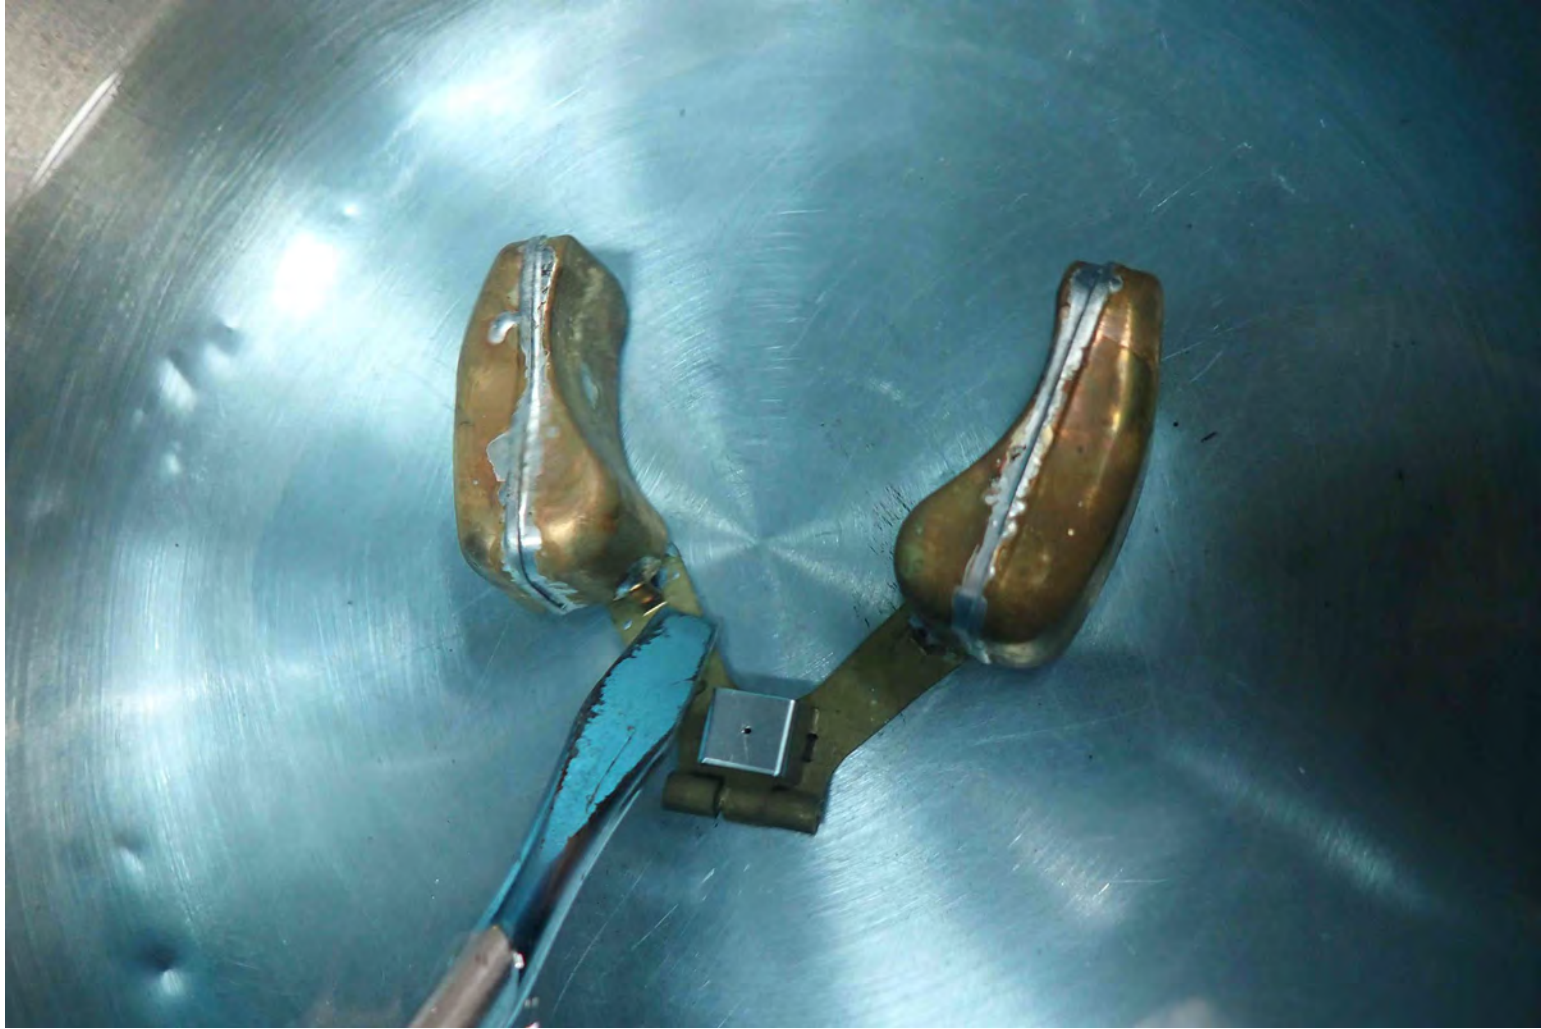
**Photo 11 – Float in Fuel**
