# Service Bulletin Fuel Systems

**SUBJECT: OVERHAUL PERIODS FOR FLOAT CARBURETORS.**

**Service Bulletin: SB-17**

**SUBJECT – BODY TO BOWL FUEL LEAKS**

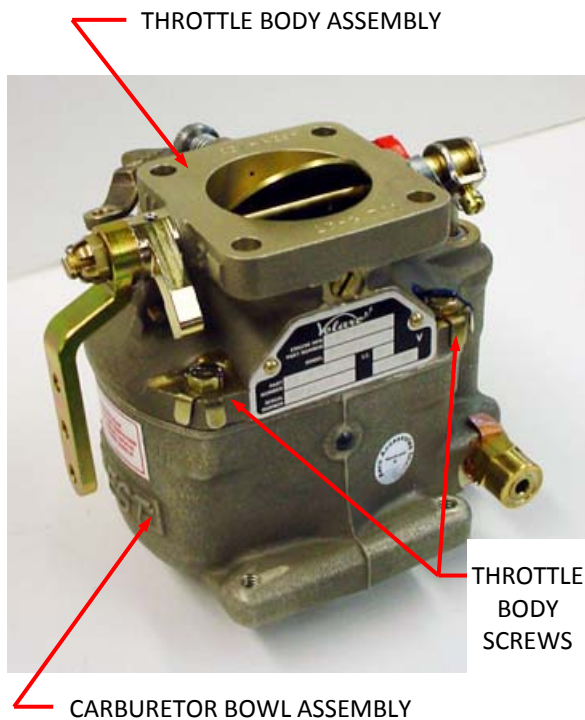
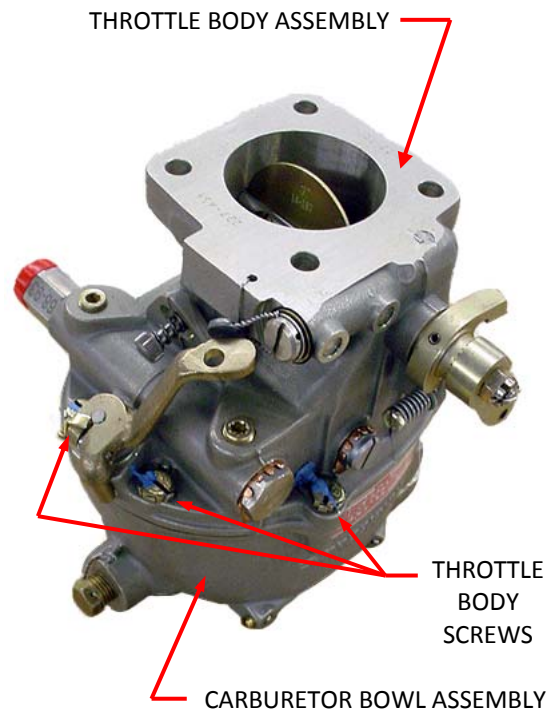
3. **Background:** Instances have been reported of leakage past the gasket between the bowl and throttle body of the carburetor evidenced by fuel stains in the area of the leak. Leakage of this type may be accompanied by loose bowl to throttle body screws.

- Models MA-3™, MA-3A™, MA-3PA™, MA-3SPA™, MA-4™, and MA-4SPA™ have four (4) screws.
- Models MA-4-5™, MA-5™, MA-4-5AA™, MA-6™, and MA-6AA™ have six (6) screws.

- d) If there is evidence of fuel stains, looseness of the bowl relative to the throttle body, or loose throttle body to bowl screws, an appropriately rated mechanic, engineer, or repair station must: Remove the carburetor from the engine. In accordance with the appropriate carburetor service manual; remove the bowl from the throttle body. Inspect the threaded holes in the bowl and screws to be sure the threads are serviceable. Install a new body to bowl gasket. Install new lock tab washers. Install and torque the screws in accordance with appropriate specifications. Test the carburetor in accordance with instructions in the appropriate service manual. Secure the lock tab washers by bending the tabs.
- e) Reinstall the carburetor on the engine and rig it in accordance with the applicable engine and airframe service manual instructions.

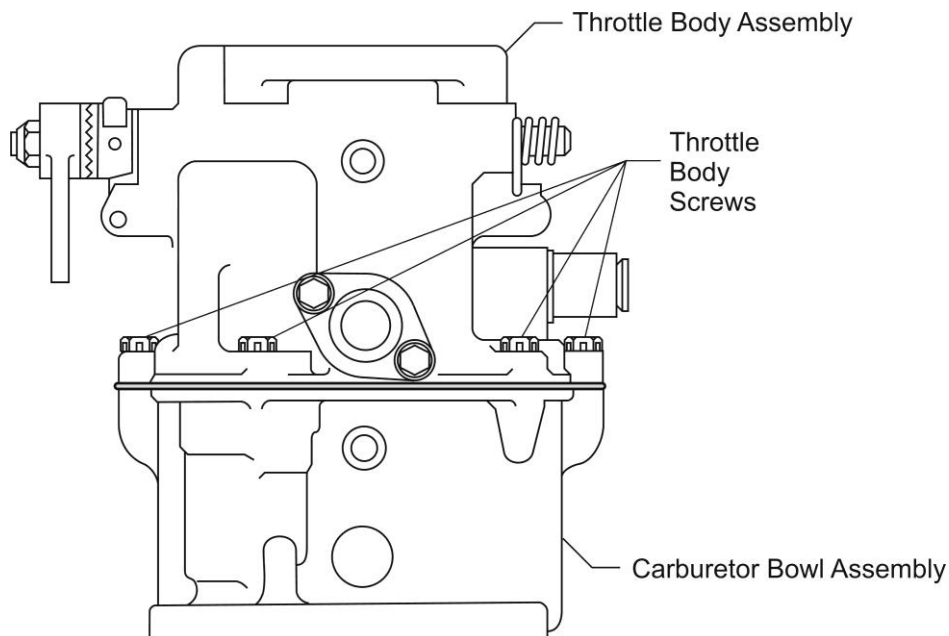
**Figure 1**  
**Illustrative Example of Throttle Body Attaching Screws**

Instances have been reported of leakage through the gasket between the bowl assembly and throttle body of the carburetor, evident by fuel stains in the area of the leak. Leakage of this type can be accompanied by loose screws that attach the bowl and throttle body.

See Figure 1 for illustrative example of the throttle body attaching screws.

Models MA-3A, MA-3PA, MA-3SPA, and MA-4SPA have four screws. Models MA-4-5, MA-4-5AA, and MA-6AA have six screws.

1. Examine the carburetor for evidence of fuel stains on the outside of the bowl along the parting line.
2. Complete a check for movement between the throttle body and bowl.
3. Make sure each throttle body-to-bowl attaching screw is secure and not loose by attempting to move the screw and/or locktab washers with your fingers.

4. If there is evidence of fuel stains, movement between the throttle body and bowl, or the throttle body-to-bowl attaching screws are loose then remove the carburetor in accordance with the applicable engine and airframe service manuals. Send the carburetor to a qualified repair station for troubleshooting and repair. Reinstall the carburetor in accordance with the applicable engine and airframe service manuals.
5. Make an appropriate logbook entry showing compliance with this Service Bulletin.
