**N215T Photographs – WPR19LA105**  
(courtesy Grays Harbor County Sheriff and AvTek)

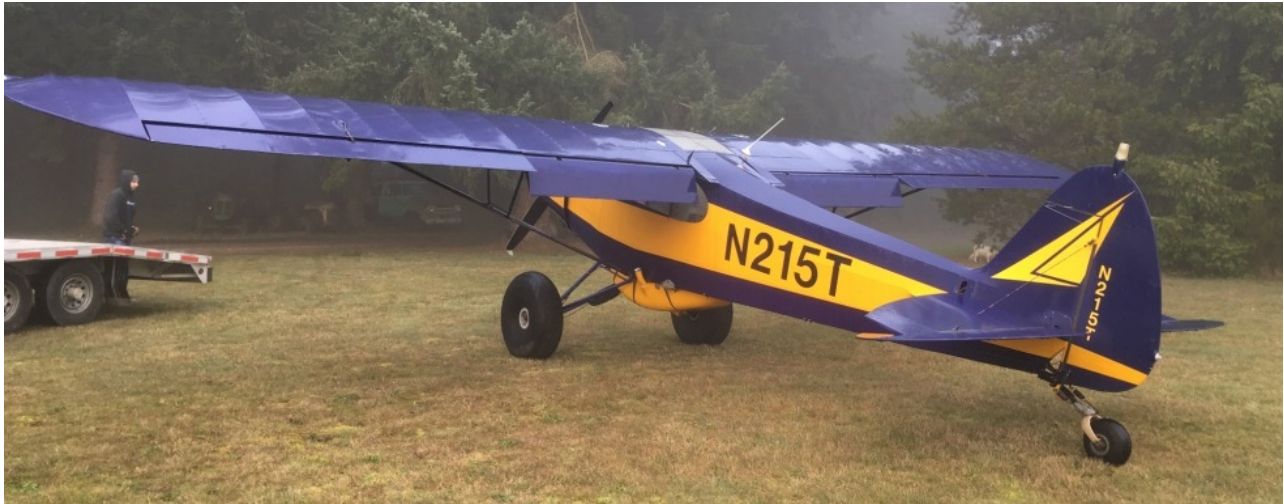
**Figure 1 - PreAccident Airplane**

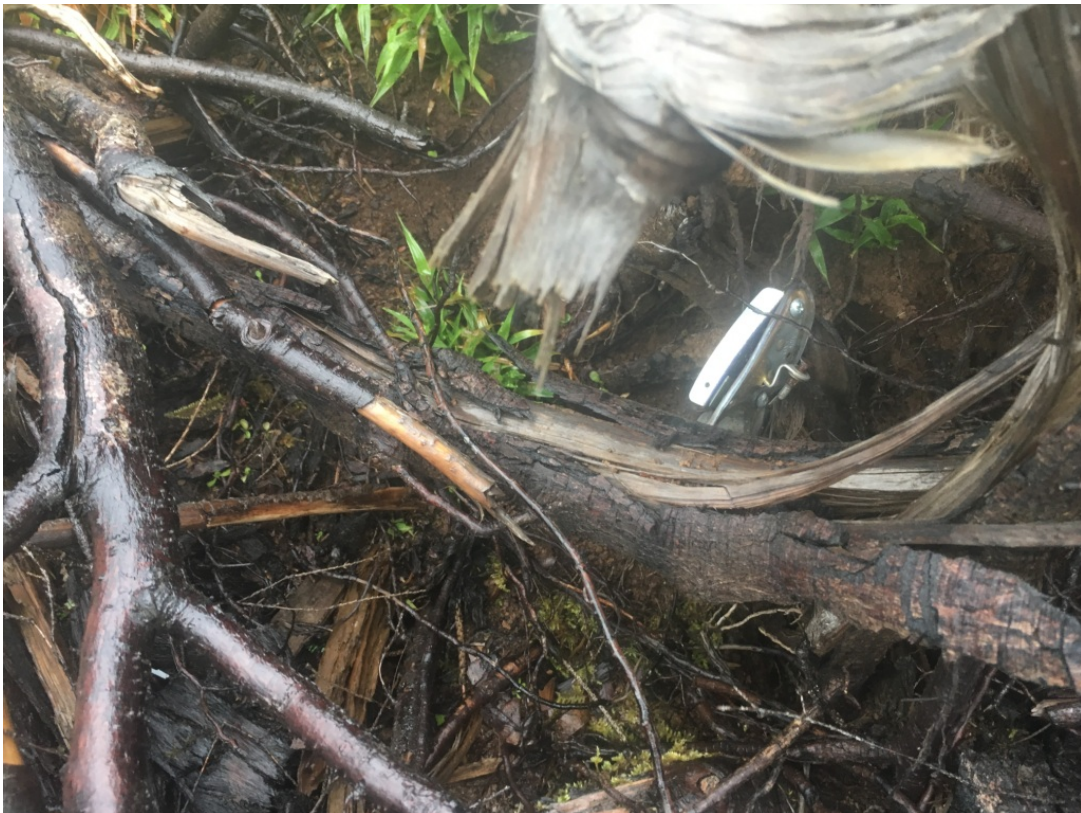
**Figure 2 - First Stump Struck**

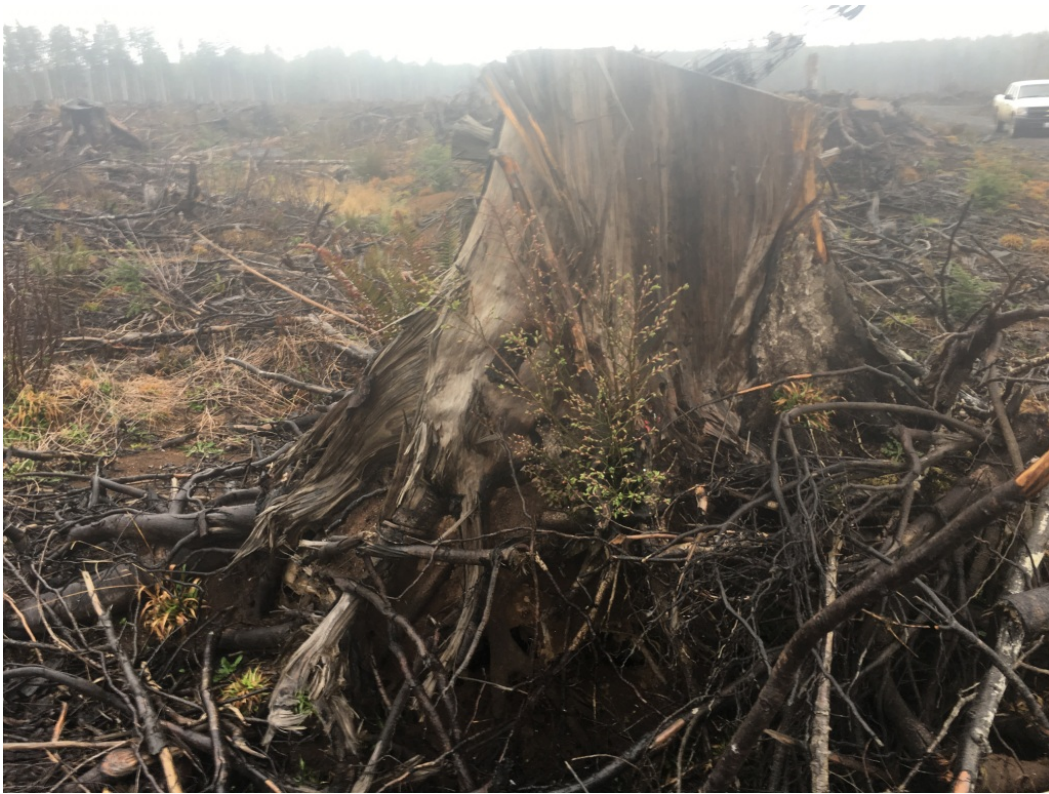
**Figure 3 - First Stump**

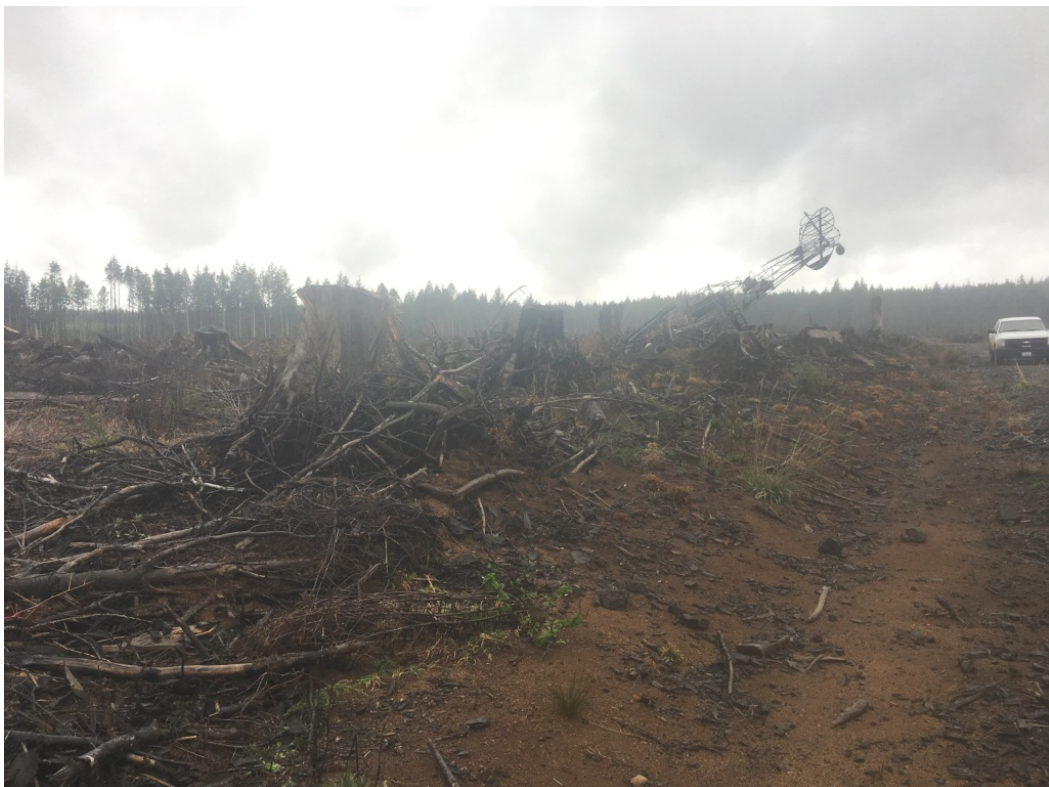
**Figure 4 - First Stump and Airplane**

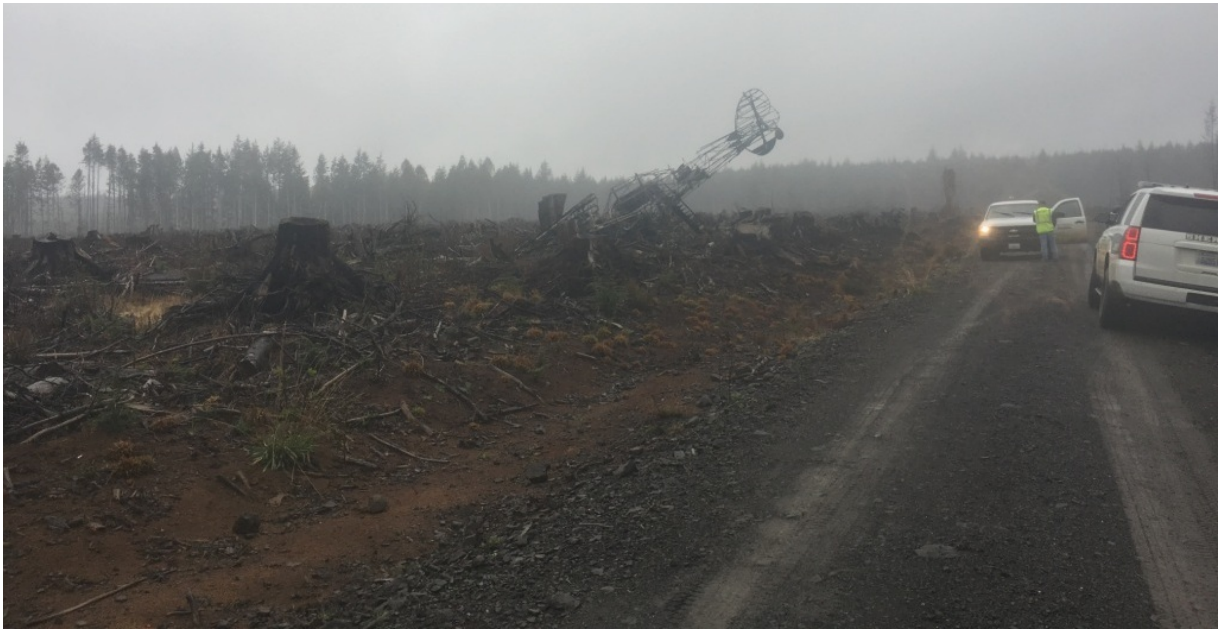
**Figure 5 - Airplane in Relation to Road**

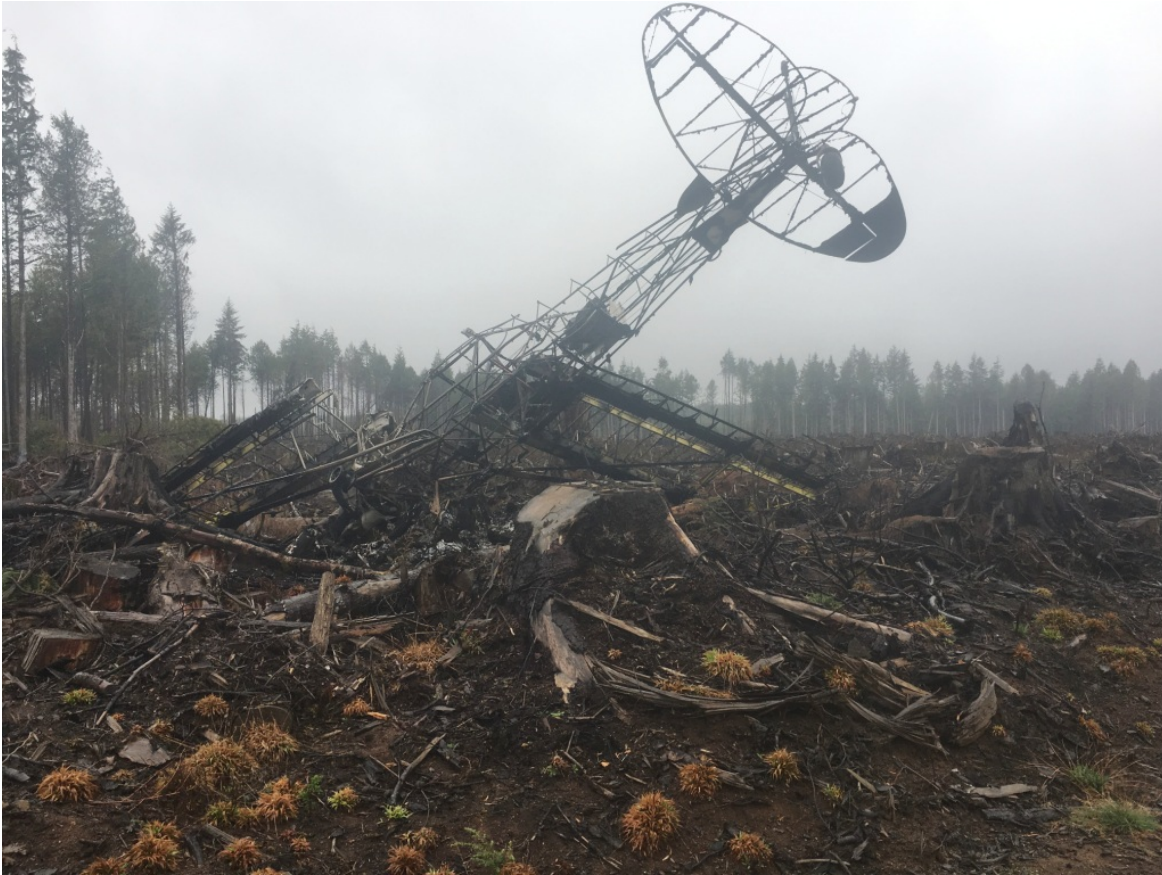
**Figure 6 - Main Wreckage**

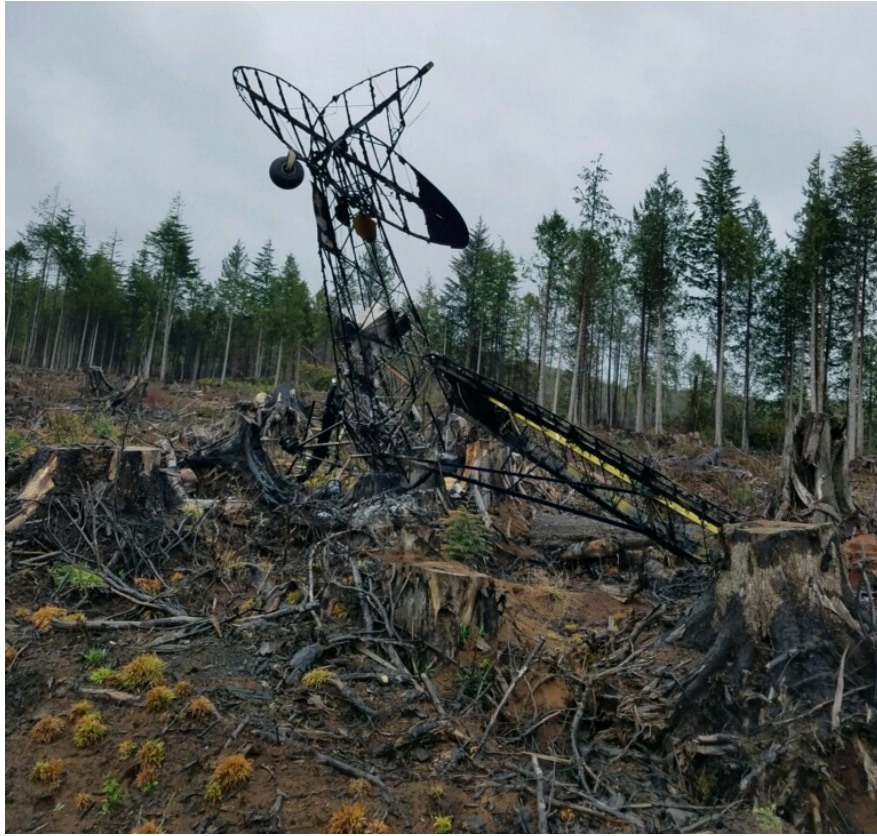
**Figure 7 - Main Wreckage**

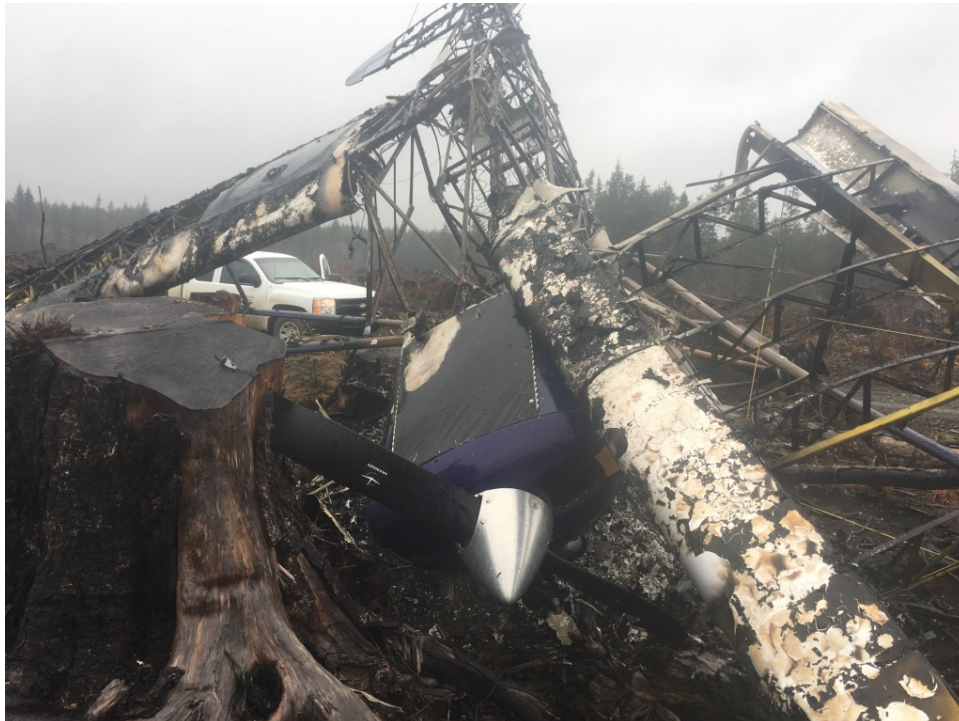
**Figure 8 - Front View**

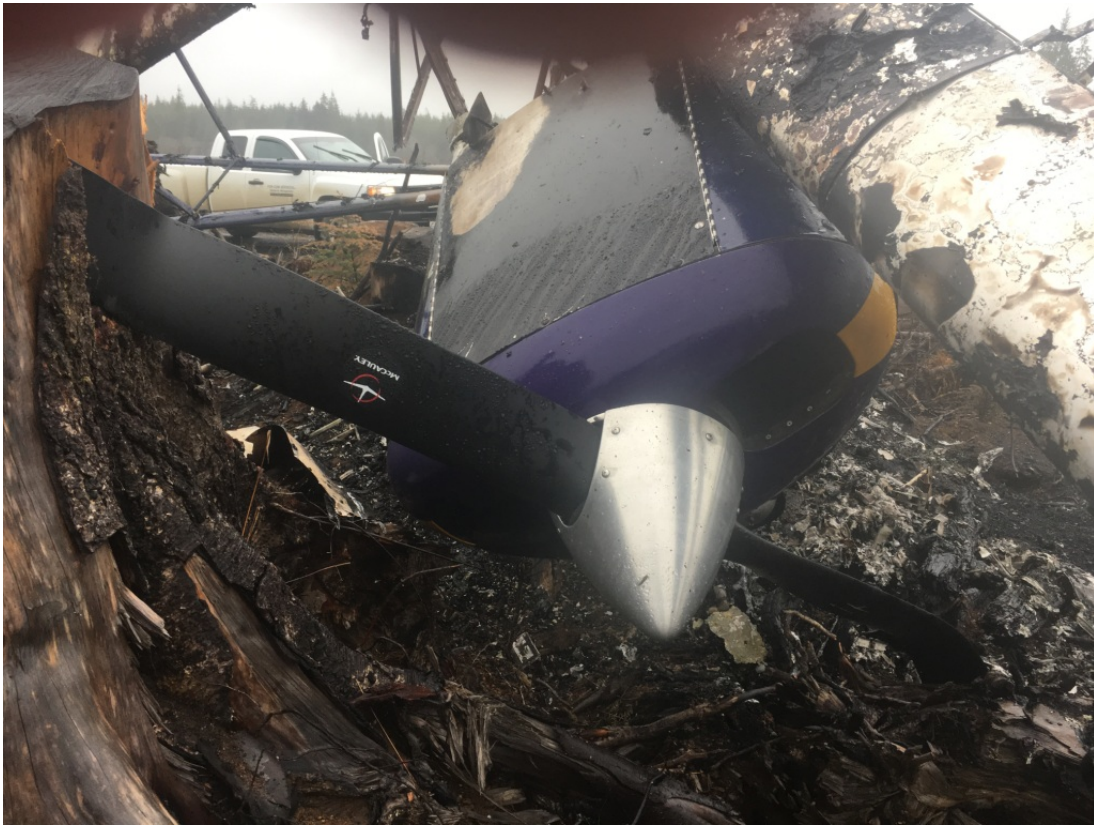
**Figure 9 - Spinner and Propeller**

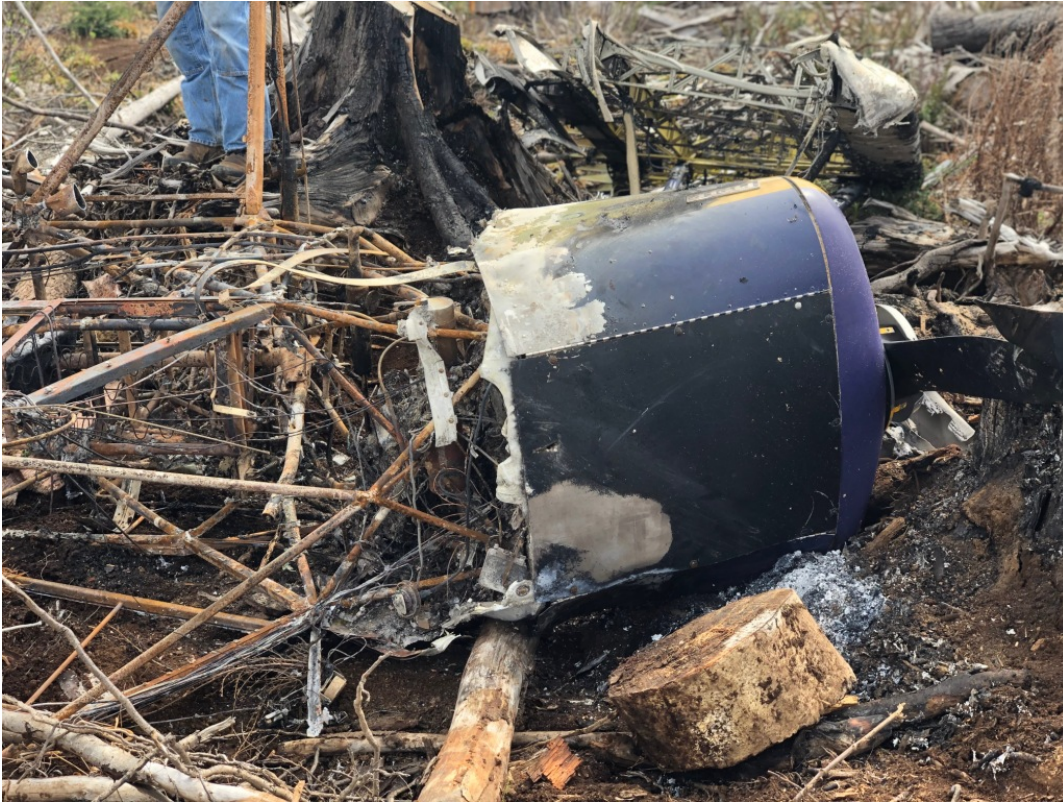
**Figure 10 - Cowl and Forward Fuselage**

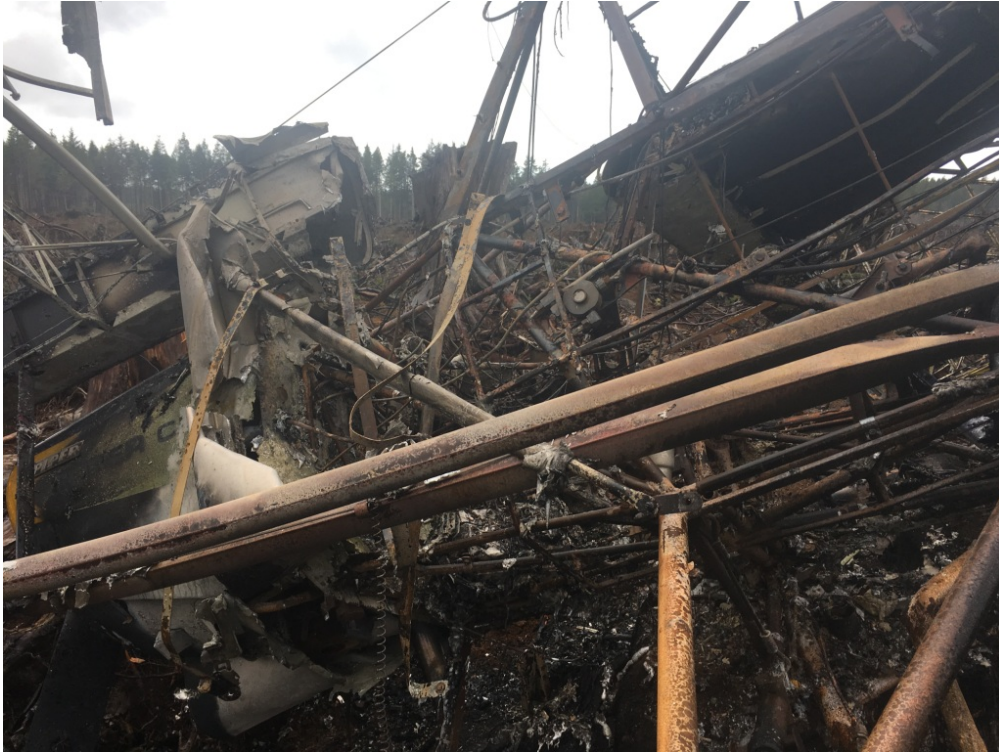
**Figure 11 - Cockpit Area**

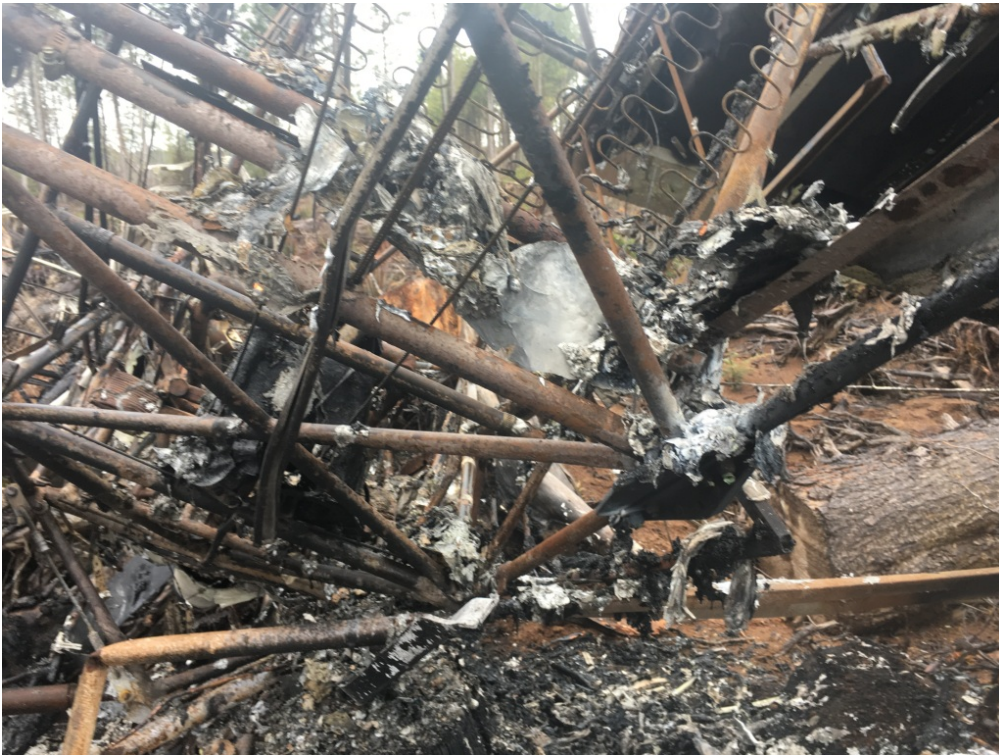
**Figure 12 - Cockpit Area**

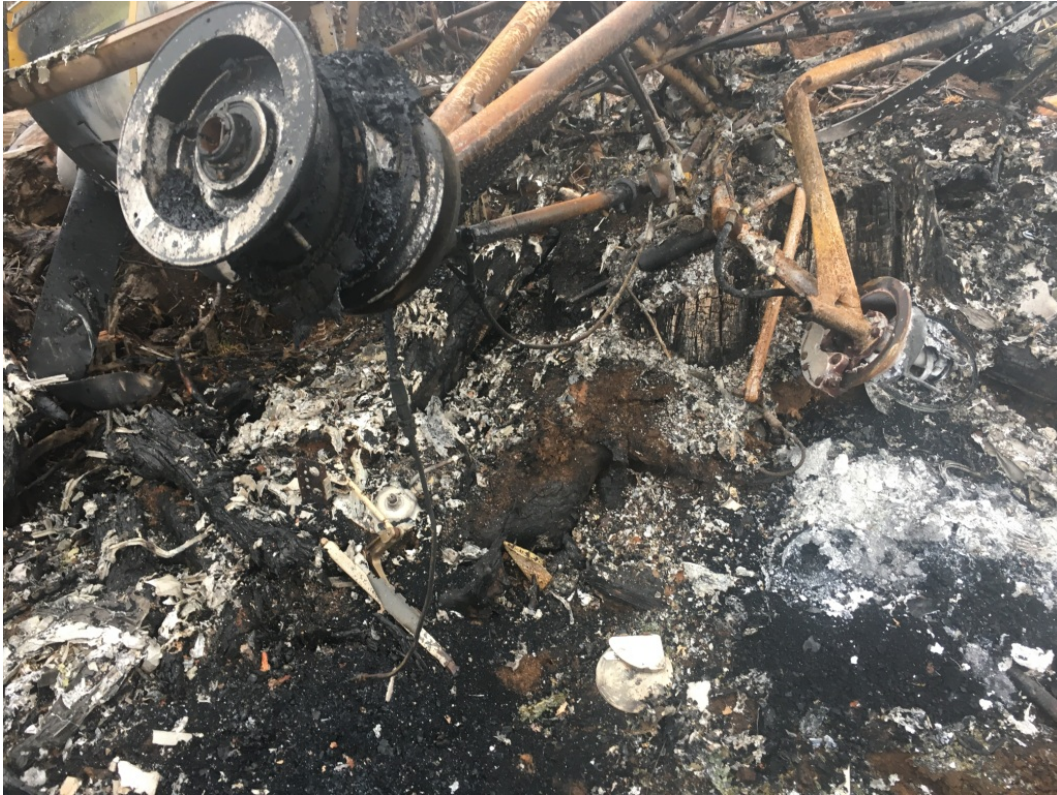
**Figure 13 - Main Wheel**

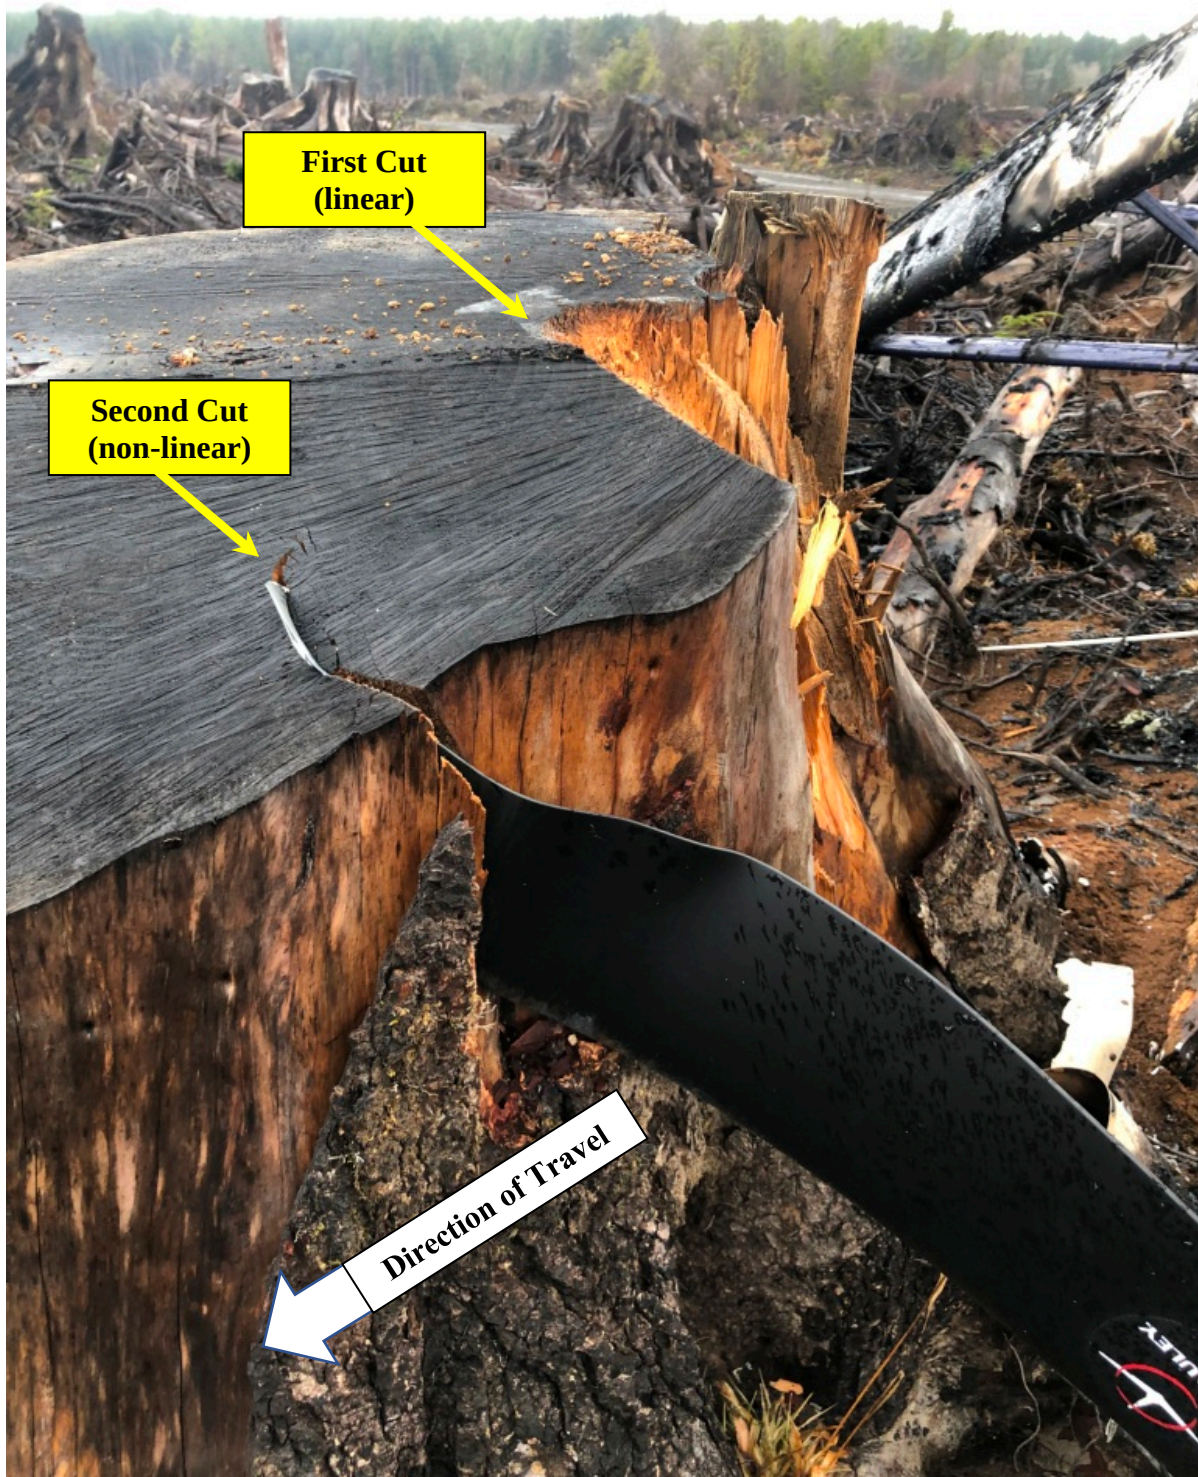
**Figure 14 - Propeller Blade Cut in Stump**

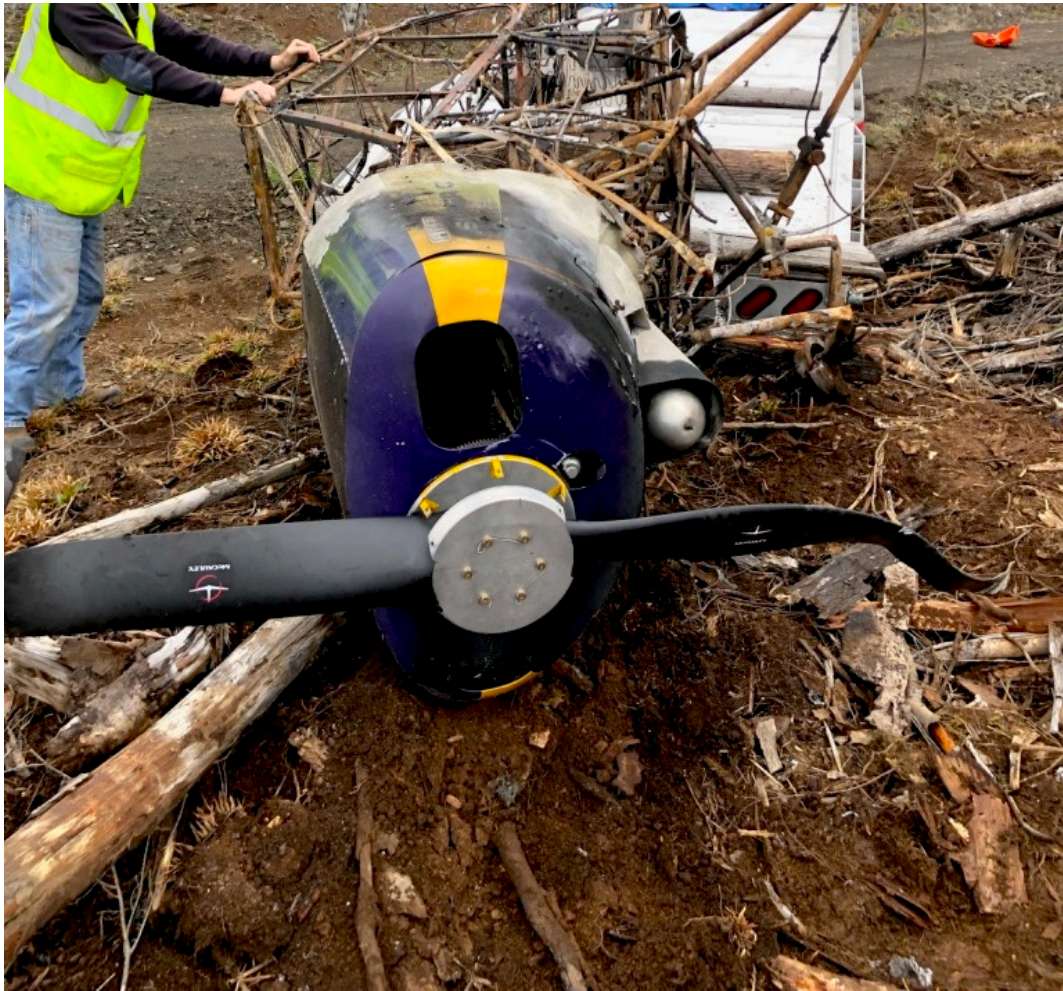
**Figure 15 - Propeller**
