## **NATIONAL TRANSPORTATION SAFETY BOARD**

### **ENGINE EXAMINATION**

**WPR19LA108**

**WPR19LA108**  
**Winters, California**  
**April 13, 2019**  
**1145 PST**  
**Europa XS – N120EJ**

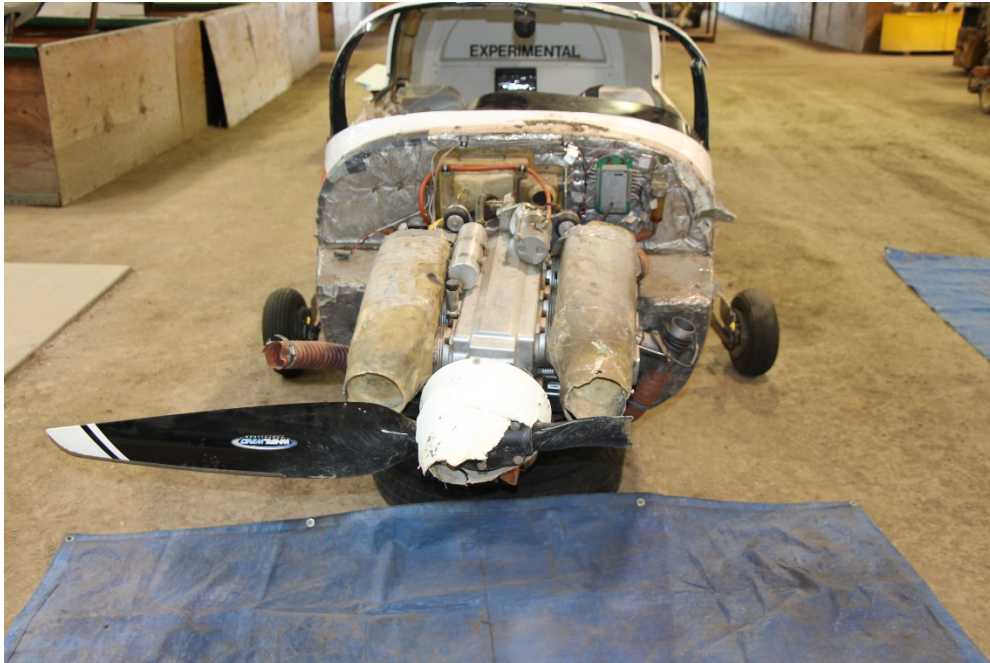
Photograph 1: Engine Firewall and Engine after Recovery

The engine was contaminated with dirt and debris from the airplane's impact with the ground; however, the engine case and accessories were not damaged. The vacuum pump had been removed by the owner; however, the pump gasket remained and the accessory gear was exposed. One propeller blade from the two-bladed whirlwind propeller was separated at the blade root and the other propeller blade remained attached to the propeller hub. The propeller spinner was fractured.

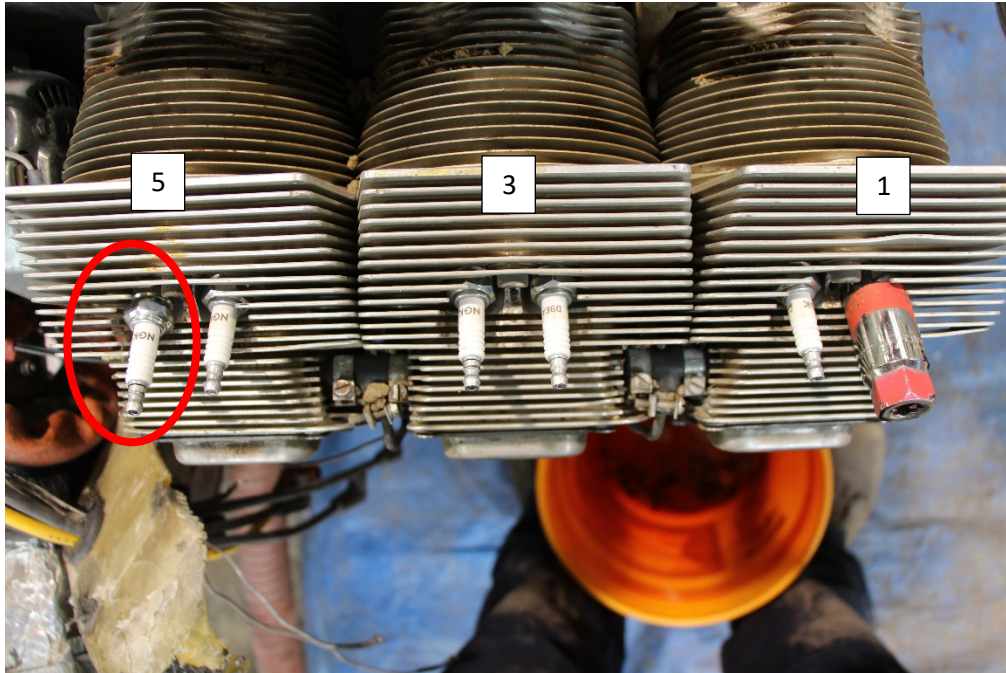
Each of the engine's 12 NGK spark plugs were removed and examined for their condition. Most of the spark plugs were gray in appearance, consistent with normal wear; however, both spark plugs from the no. 5 cylinder and the forward spark plug from the no. 2 cylinder displayed trace amounts of oil residue, but were not fouled. Additionally, the cylinder no. 5 aft spark plug was partially expelled from the spark plug porthole (photograph 2), and displayed some evidence of cross-threading near the plug core. The propeller was seized and could not be rotated by hand. The magnetos remained attached to their stator mounts.

Photograph 2: Spark Plugs to Cylinder Nos. 1, 3, 5

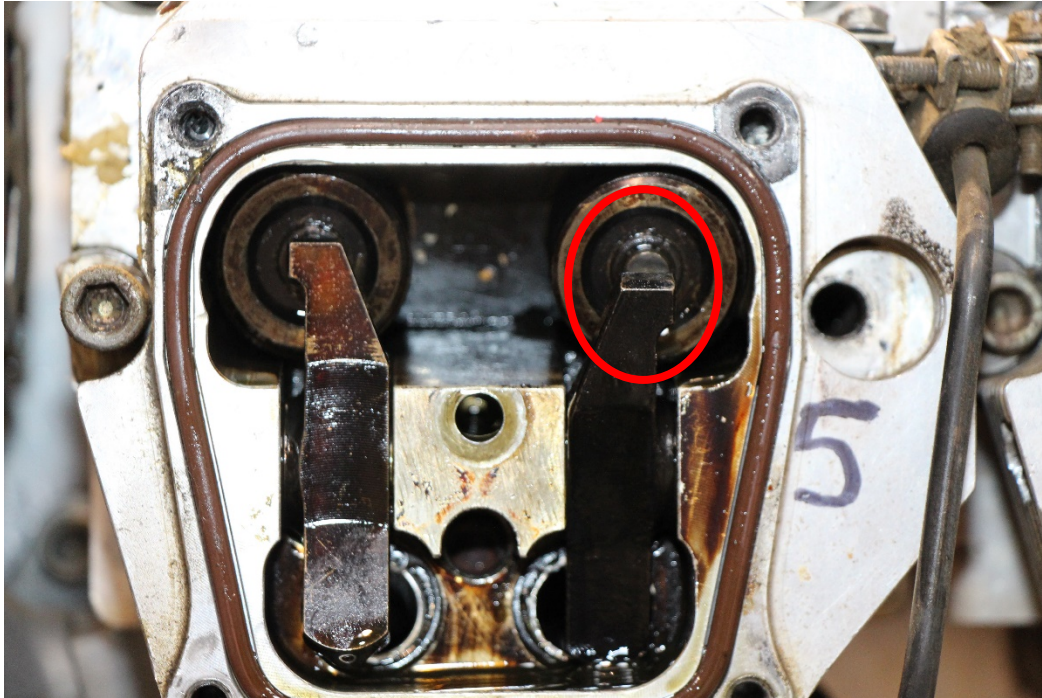
The rocker box covers were removed and most of the rocker arms were normal in appearance and displayed resistance when force was applied, with the exception of the no. 5 exhaust valve rocker arm, which moved freely (photograph 3). Further examination revealed that the cylinder no. 5 exhaust valve push rod was partially inside the engine case and the exhaust valve lifter was missing. The cylinder heads were removed. Most of the piston heads were unremarkable with the exception of the cylinder no. 5, which exhibited multiple gouges along the circumference, striations, galling and some polishing (photograph 4). The cylinder walls to cylinder no. 5 also displayed gouges, scraping, and galling (photograph 5). A journal that houses the wrist pin (or gudgeon) on the backside of the piston had separated and was accompanied by a large gouge (photograph 6). The other wrist pin journal was damaged, but otherwise intact. The cylinder no. 5 wrist pin was found above the crankshaft inside the engine case (photograph 7). Both wrist pin snap rings were found inside the engine; one snap ring was intact and retrieved from the oil sump

Photograph 3: Cylinder no. 5 with Rocker Box Cover Removed

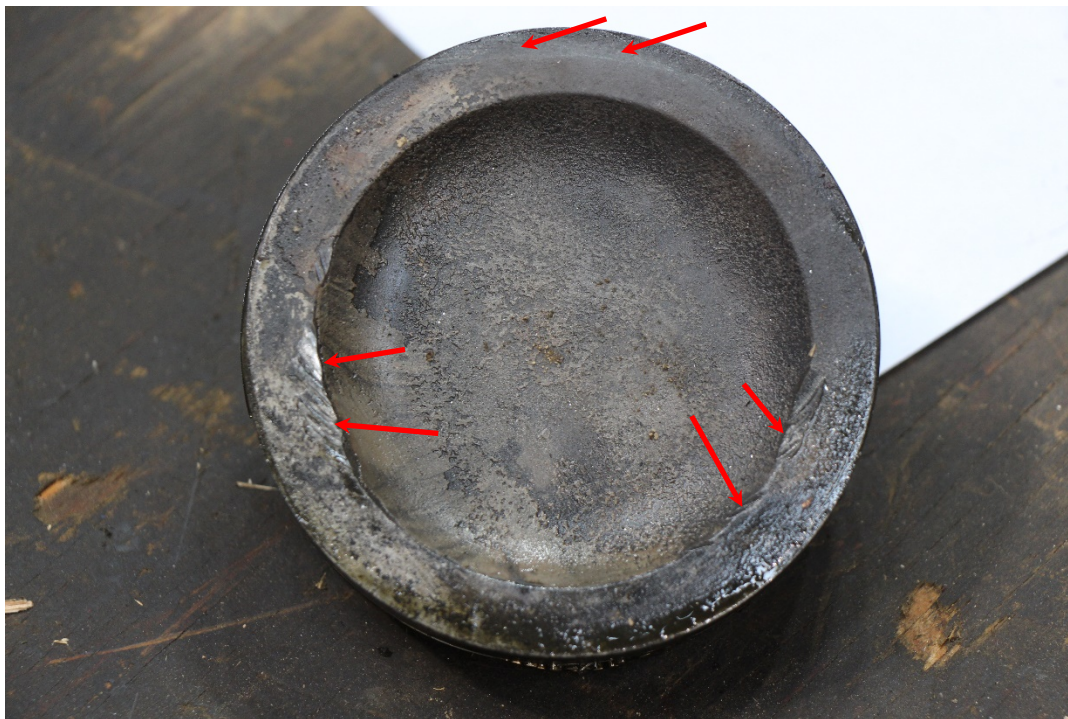
Photograph 4: Cylinder No. 5 Piston Face

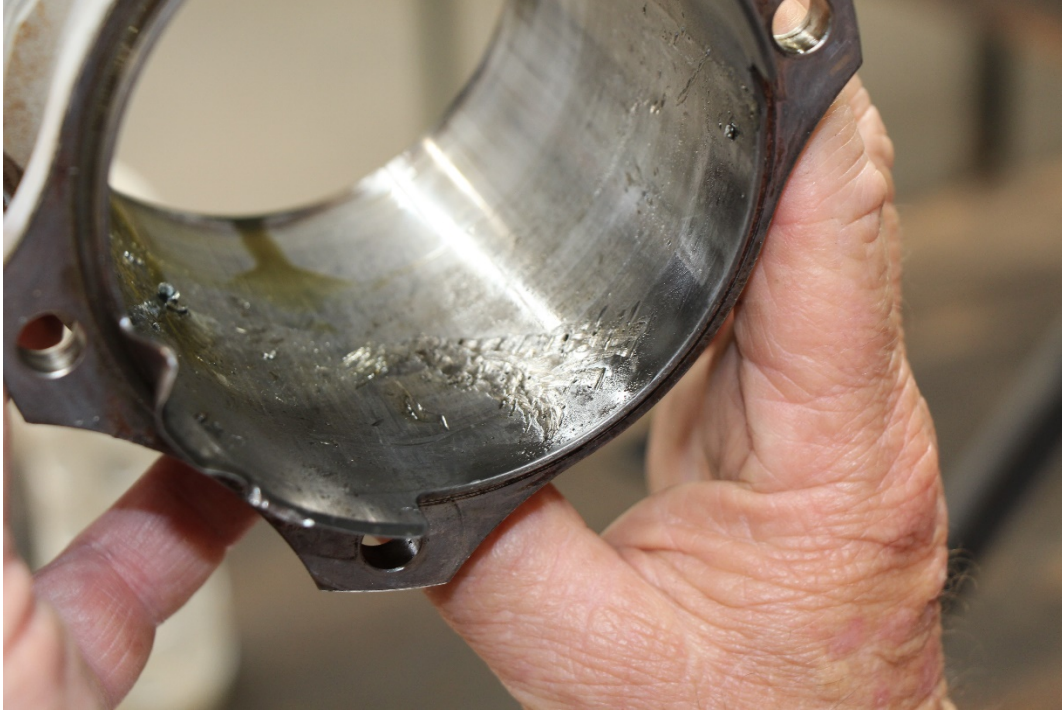
Photograph 5: Cylinder No. 5, Cylinder Wall

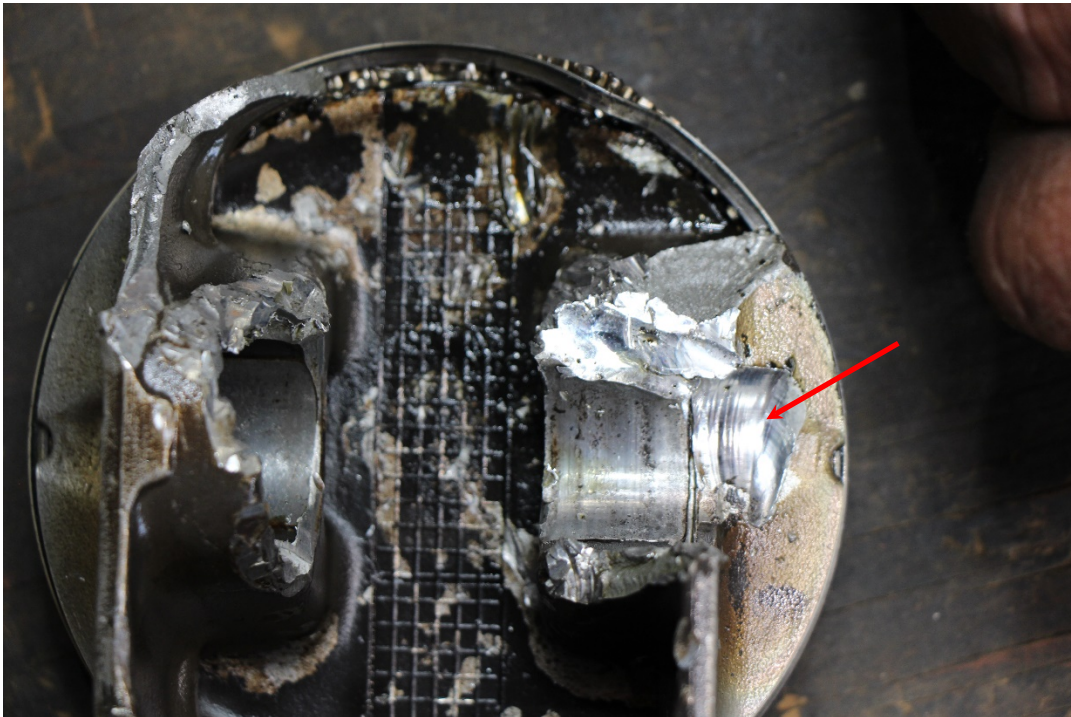
Photograph 6: Cylinder No. 5 Piston Backside

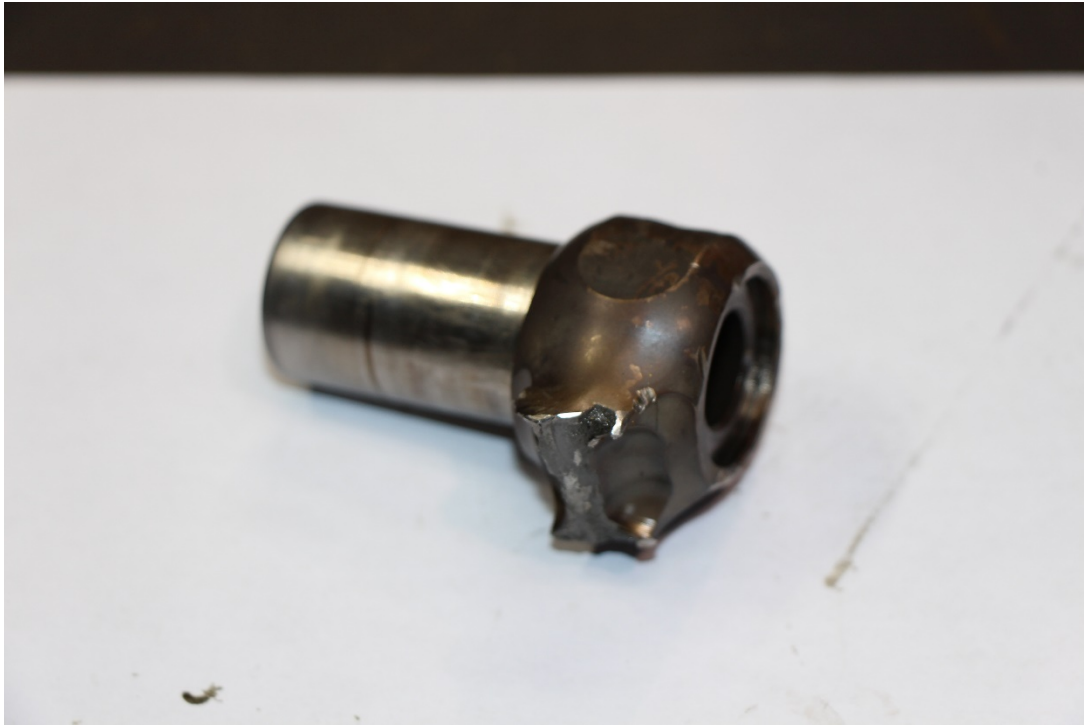
Photograph 7: Cylinder No. 5 Piston Wrist Pin

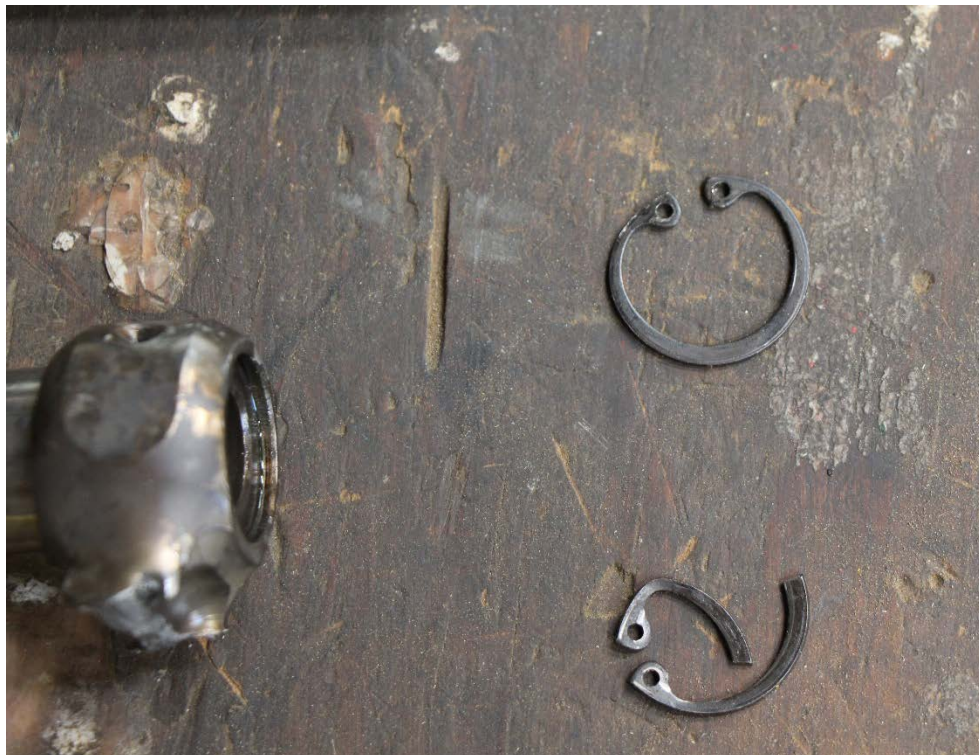
Approximately 3 quarts of oil were drained from the oil sump, before the reservoir was removed and inspected. Numerous metallic fragments and a snap ring were recovered from the oil sump.

and the other snap ring was found in two pieces within the engine case (photograph 8). The other cylinder walls, pistons, and wrist pins were undamaged and unremarkable. Most of the intake and exhaust valves were normal in appearance; however, the valves to cylinder no. 5 were both canted.

Photograph 8: Piston Wrist Pin Snap Rings

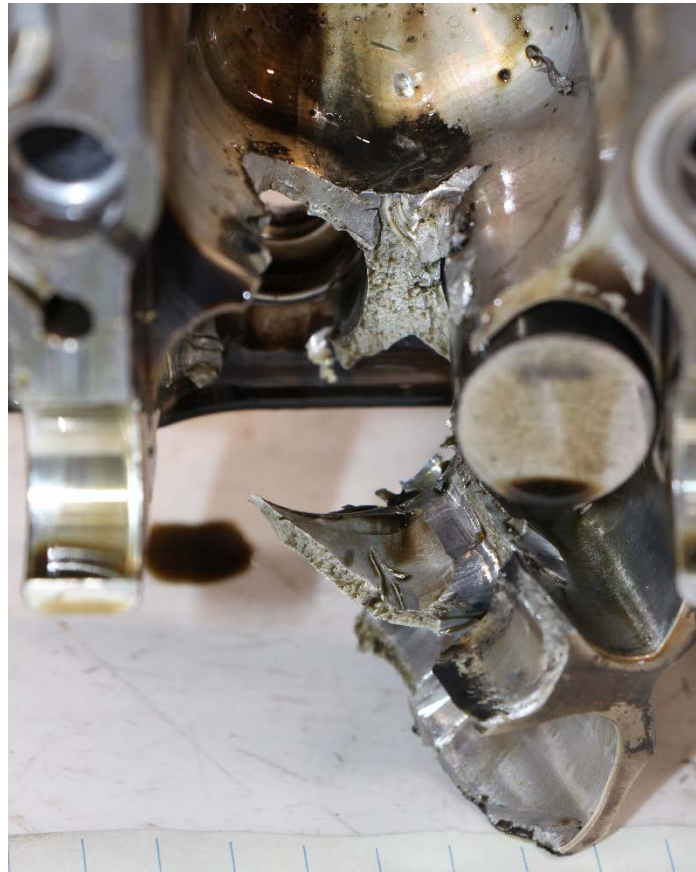
The engine accessories were removed and the crankcase was separated to examine the internal condition of the engine. The cylinder no. 5 valve journal bank was separated from the engine case (photograph 9). A large indentation was observed in the crankcase opposite the no. 5 cylinder that appeared after the cylinder no. 5 connecting rod was removed (photograph 10). A small section of the cylinder no. 5 connecting rod remained attached to the crankshaft (photograph 11).

Photograph 9: Cylinder No. 5 Lifter Journals

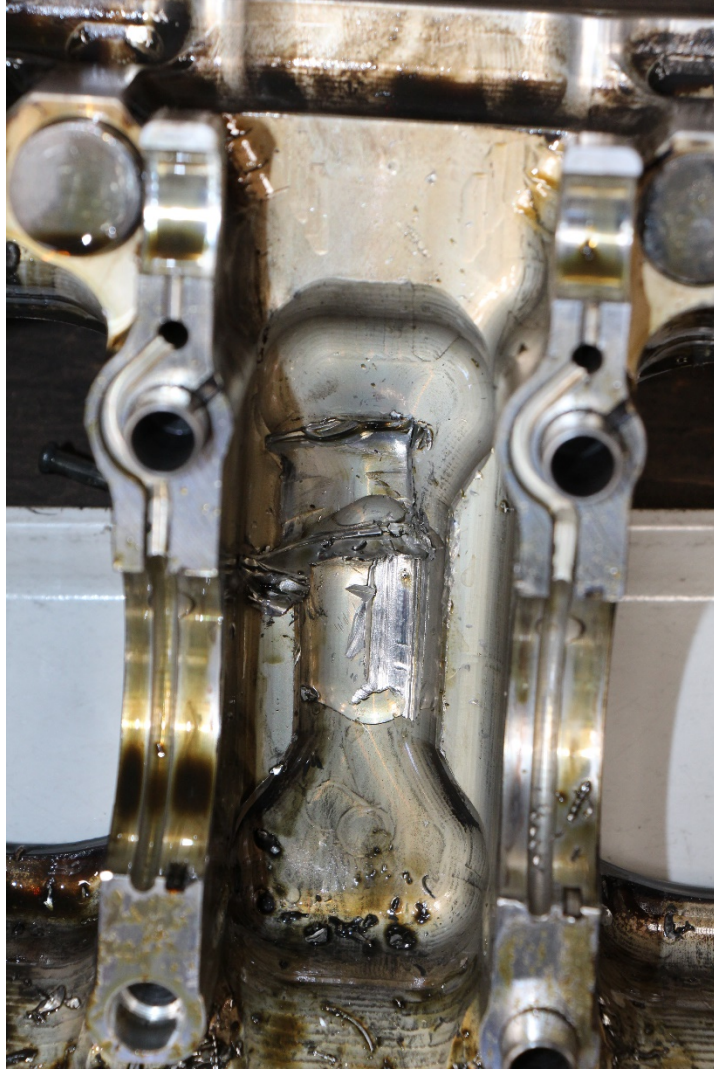
Photograph 10: Engine Crankcase Opposite No. 5 Cylinder

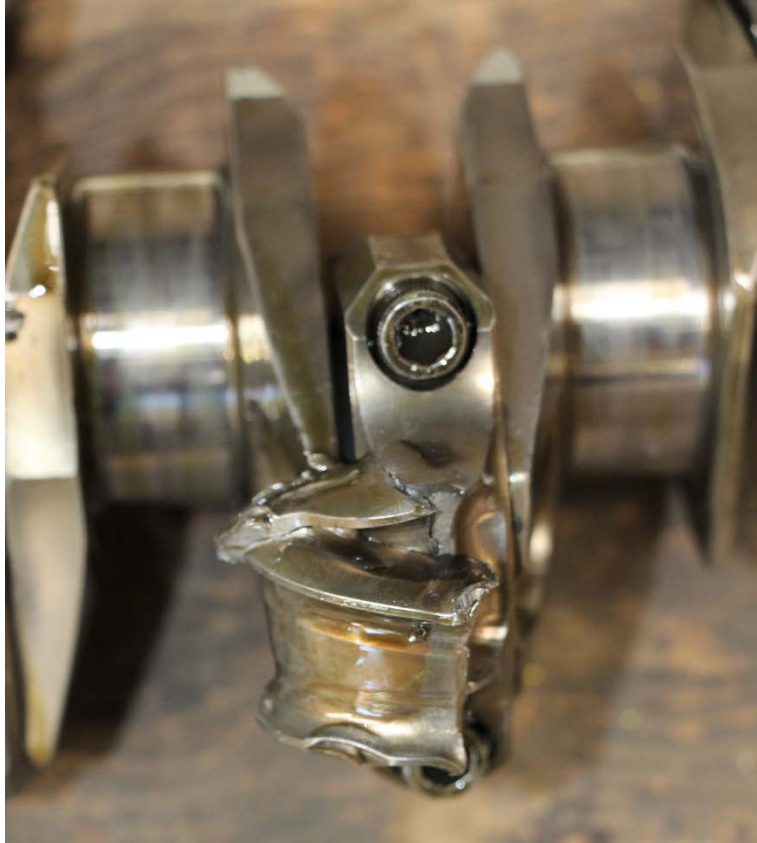
Photograph 11: Portion of Cylinder No. 5 Connecting Rod
