## **NATIONAL TRANSPORTATION SAFETY BOARD**

# **AIRFRAME EXAMINATION REPORT**

**WPR19LA112**

Location: Morganza, Louisiana  
Date: April 16, 2019  
Aircraft: Airplane Air Tractor AT-502B, Registration Number: N599LA,  
Serial #: 502-0599  
NTSB IIC: Tealeye Cornejo

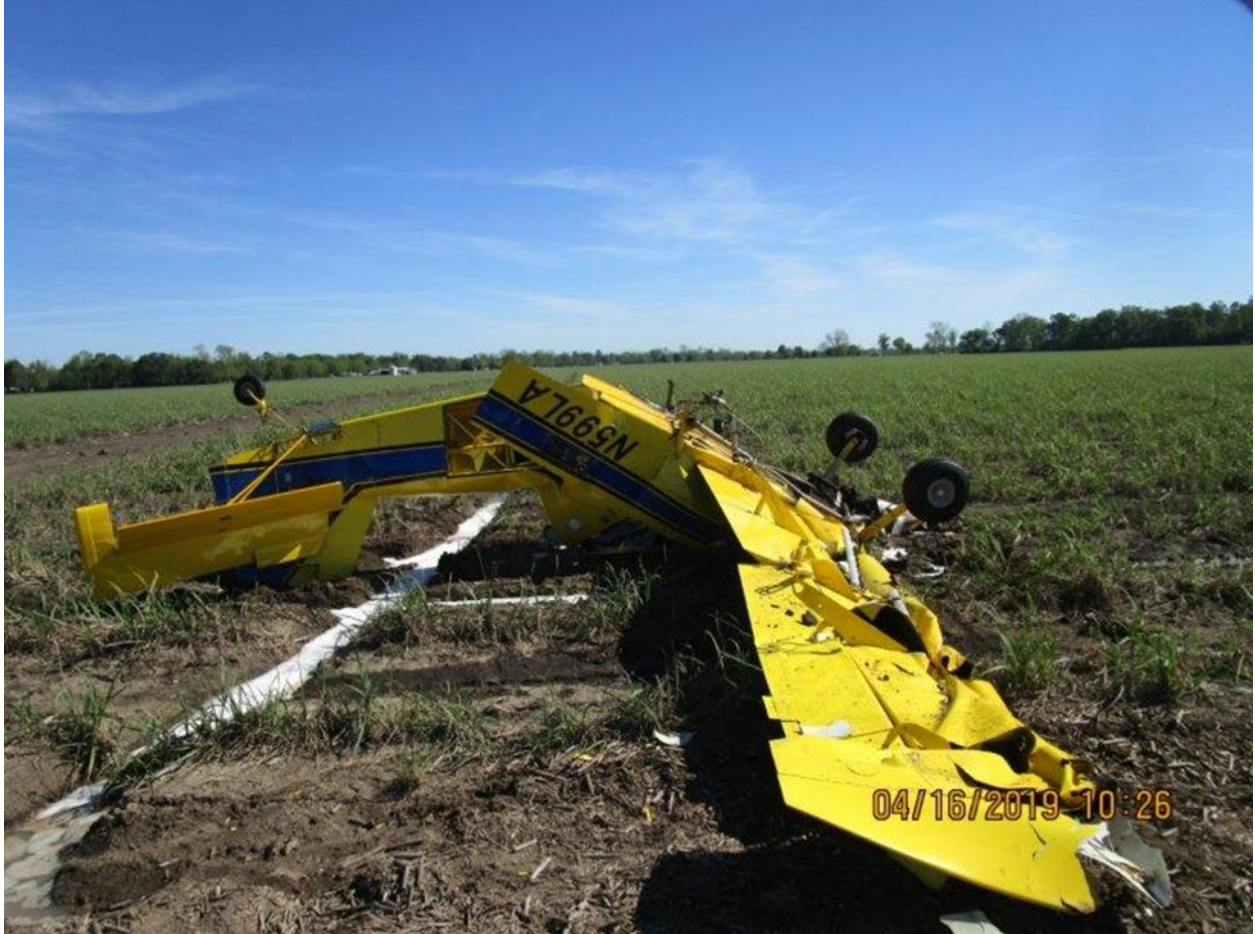
Photo 1 - Main Wreckage (Courtesy of FAA)

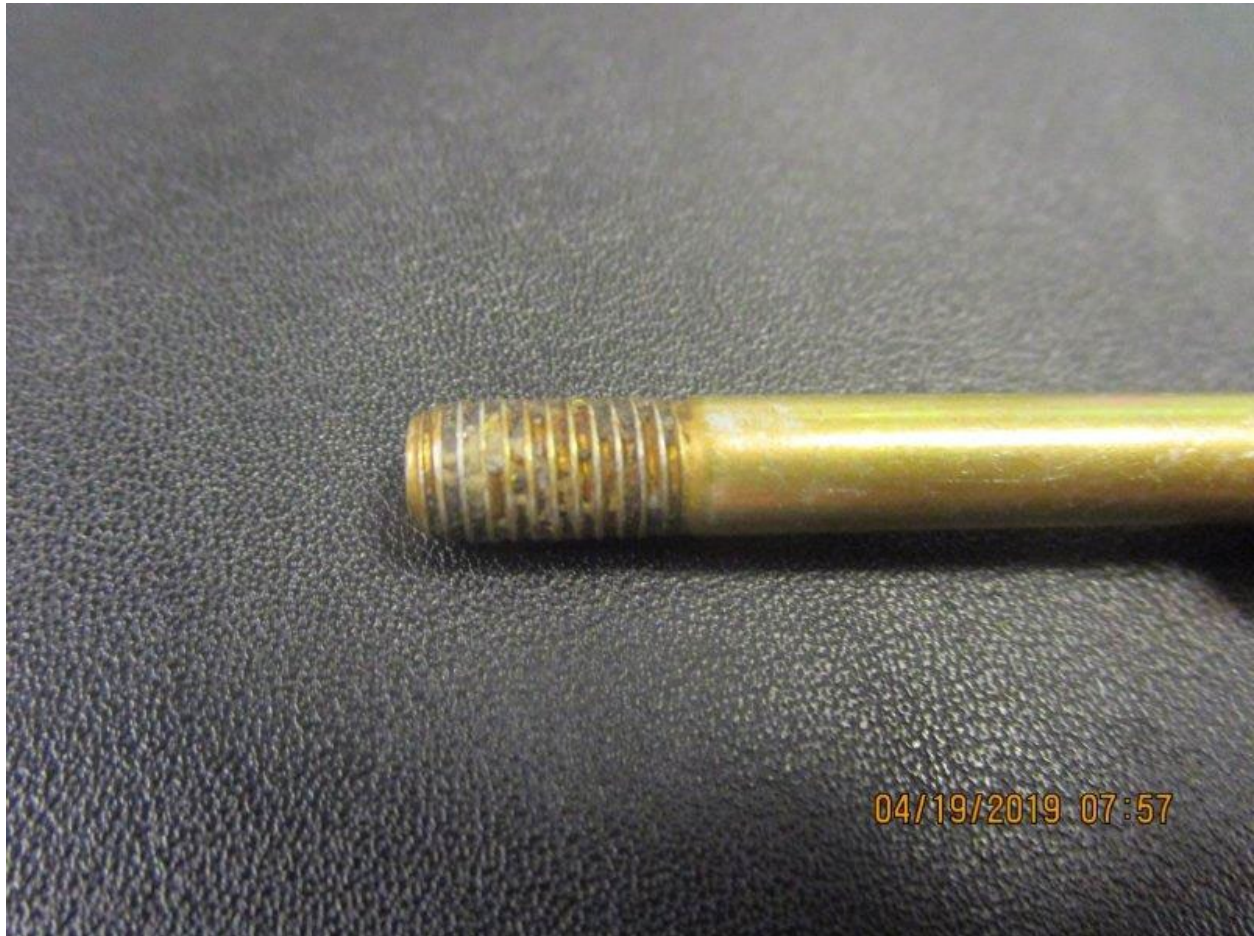
The FAA responded to the accident site and noted that the aluminum elevator pushrod was disconnected from the forward idler and that the attachment bolt was missing. It was later found loose, in the wreckage.

Photo 2 - Bolt - Up close view of Threads (Courtesy of FAA)

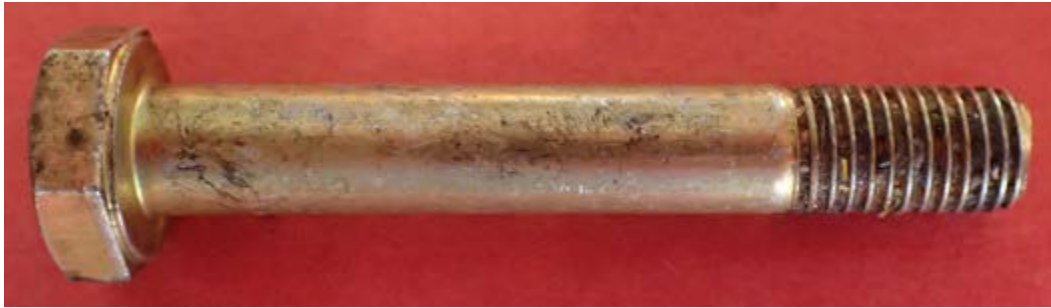
Photo 3 - View of undamaged bolt (Courtesy of FAA)

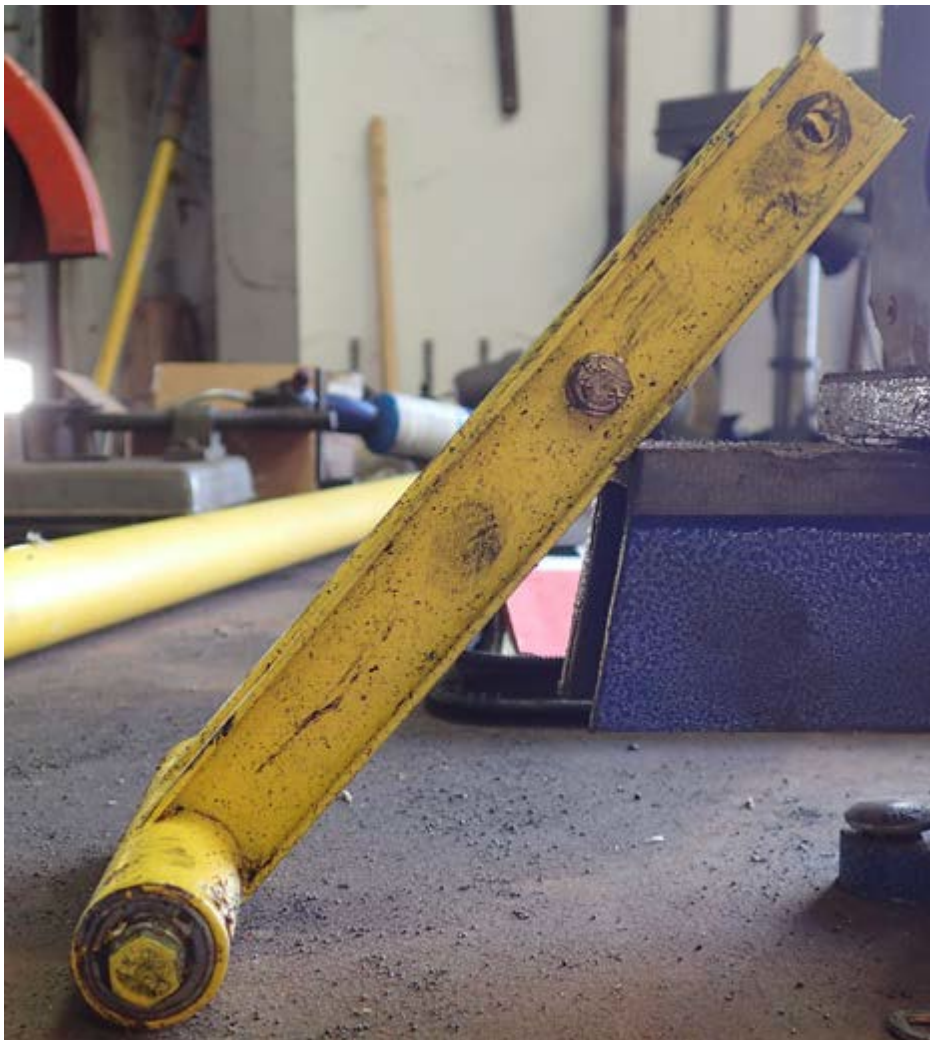
Examination of the airframe revealed that the bolt connecting the forward idler to the main pushrod was missing. There was no sign of damage to the forward idle or to the rod end bearing.

Photo 4 - Forward Elevator Idler (Courtesy of Air Tractor)

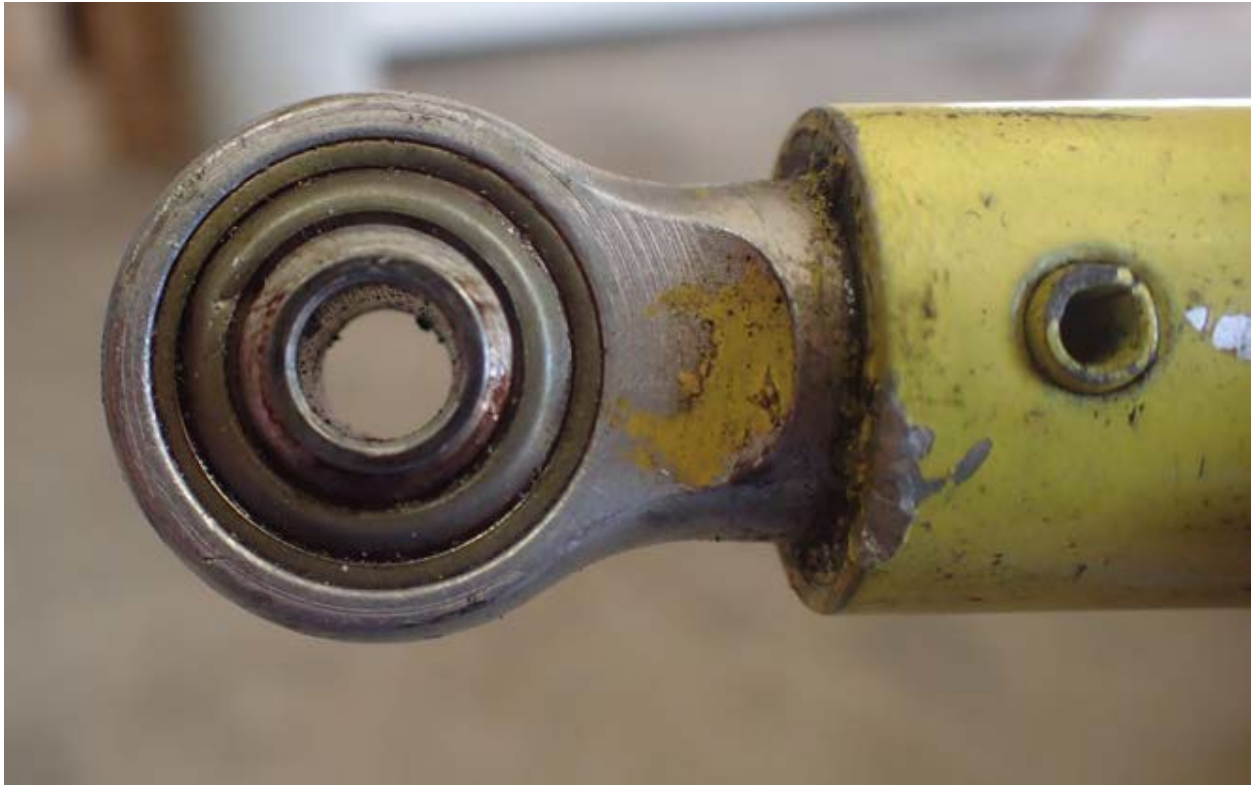
Photo 5 - Forward Rod End Bearing of Elevator Pushrod (Courtesy of Air Tractor)

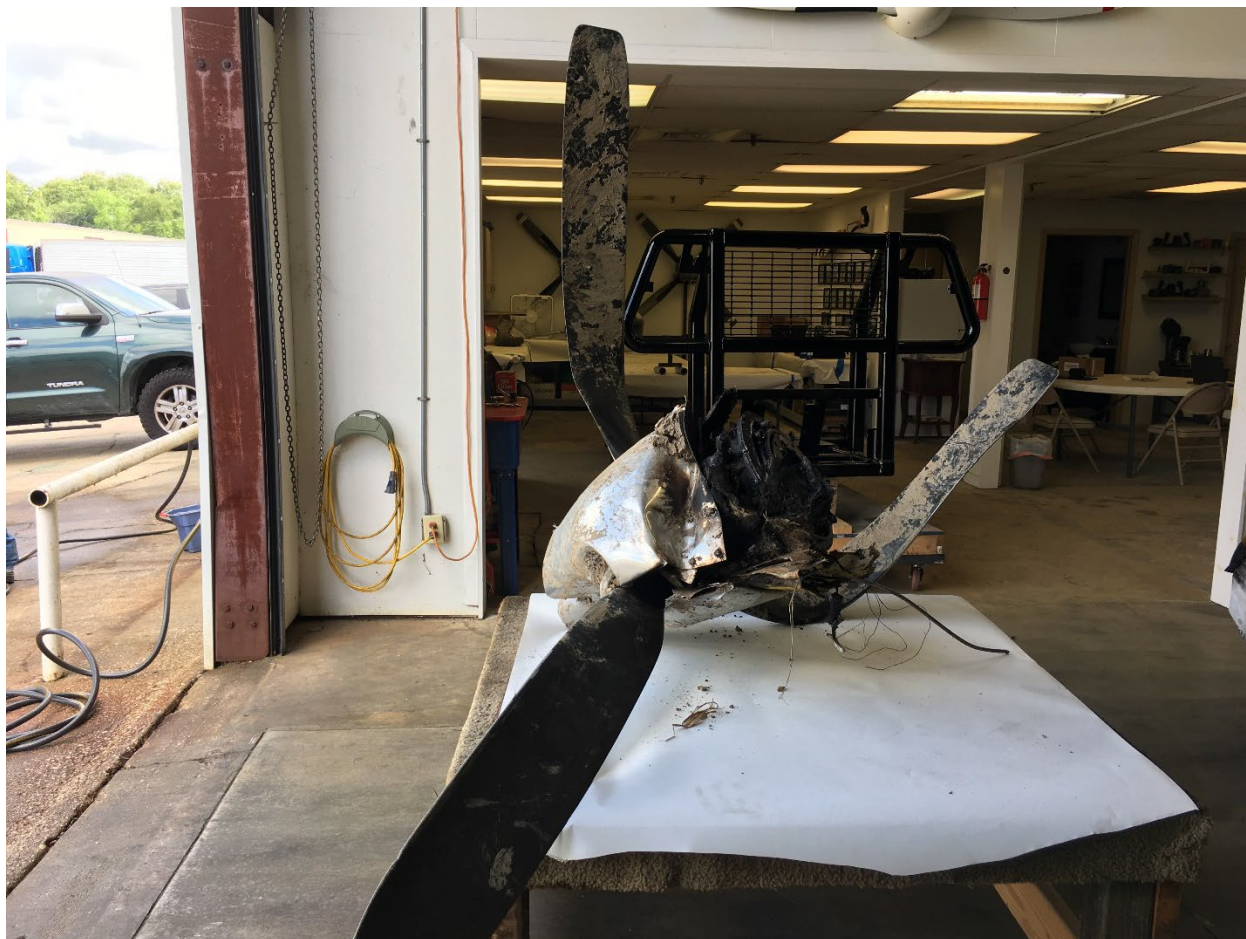
The engine and engine mount was separated from the airplane and sustained crush and impact damage. The mid-fuselage area between the cockpit and firewall sustained impact damage as well as heat and fire damage to the forward right side of the firewall. All three propeller blades remained attached to the hub.

Photo 6 - View of propeller Blades (Courtesy of NTSB)

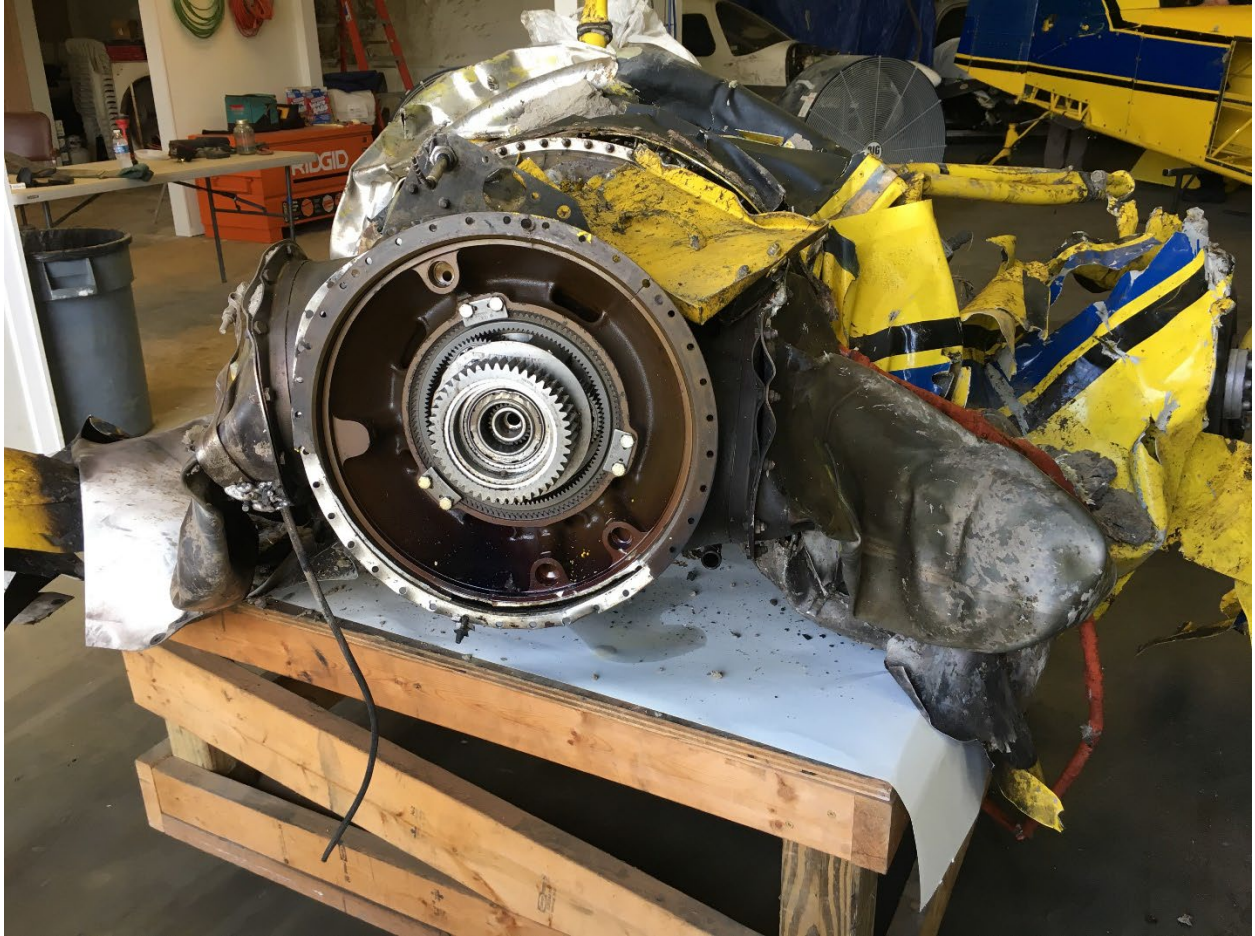
Photo 7 - View of the engine (Courtesy of NTSB)
