**Air Tractor, Inc.**  
Accident Investigation

**EXAMINATION REPORT**

**WPR19LA112**

**4/16/19**  
**Morganza, LA**

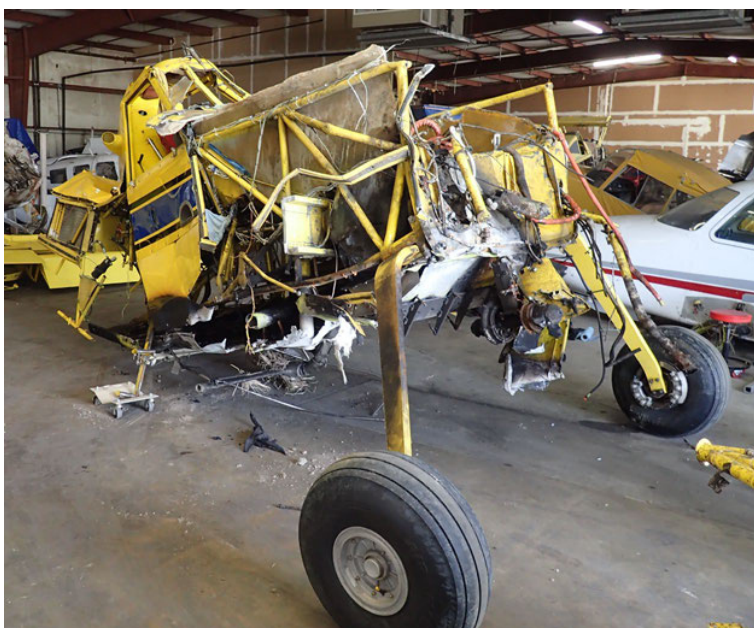
**Forward Fuselage Wreckage**

Upon initial arrival at the salvage company's facilities, the fuselage and wings were found laying upright. The wings had been separated from the fuselage along with the horizontal stabilizers and elevators. The aft fuselage was found separated from the cockpit just aft of the air conditioner plenum. The engine and engine mount were separated from the fuselage. The propeller was separated from the engine.

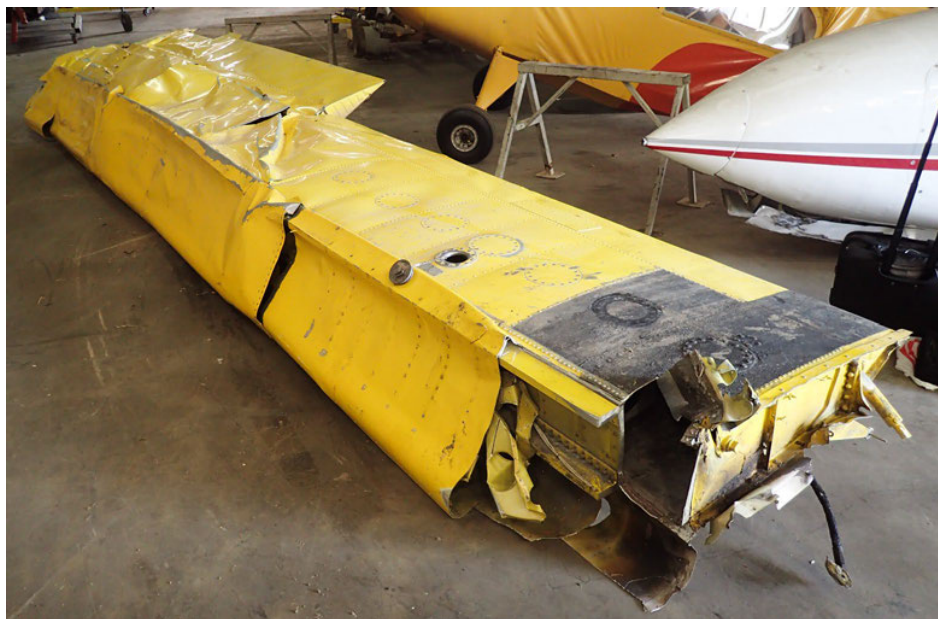
**Right Wing Wreckage**

The wing center splice connection was found intact, separated from the right fuselage attach point and attached to the left fuselage attach point. Both wing main spars appeared to have been cut during the aircraft recovery. The right rear spar attach plate was found separated from the fuselage, consistent with shear tearout. The bolt remained installed in the fuselage fitting.

Both wing leading edges were crushed aft and downward to the main spar. Both fuel tank top skins exhibited bulging between the wing ribs.

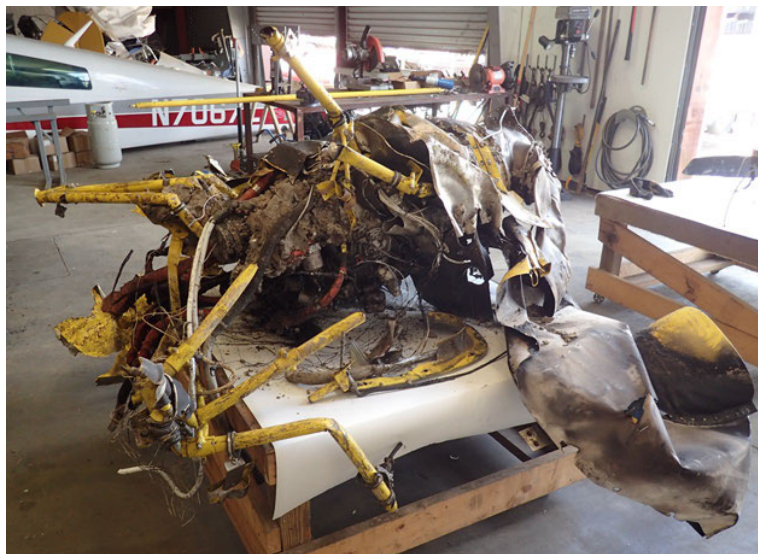
**Engine Mount Wreckage (Right Side)**

The fuselage was found with impact and isolated heat/fire damage. The engine and engine mount were separated from the firewall and were examined separately. The engine remained attached to the mount and the mount showed significant crumpling and impact damage.

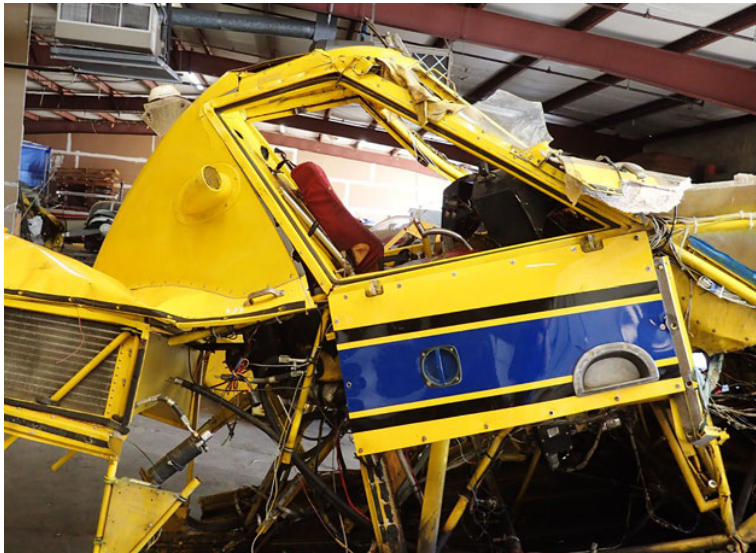
**Cockpit Wreckage**

The mid-fuselage section between the firewall and cockpit was found with impact damage and

heat/fire damage on the forward, right side of the firewall.

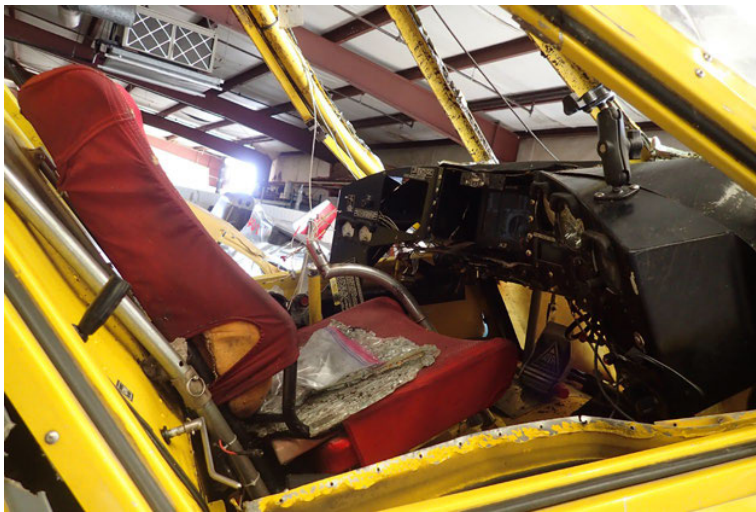
**Pilot Seat and Instrument Panel**

The occupiable space in the cockpit was reduced due to deformation of the upper overturn structure aft and the movement of the upper instrument panel toward the pilot's seat. The aircraft was found to be equipped with four-point restraints that remained buckled. The webbing on three of the four restraints was reported to have been cut during pilot extrication. The left lap belt remained attached to the seat anchor point.

The powerplant control levers (power, propeller, and condition levers) were found in the following positions: The power lever was in a low power position, the propeller lever was in a full forward position and the condition lever was in the ground idle position. These would have been typical control positions during final approach, but due to damage of the aircraft, extrication efforts of first responders and recovery of the airplane, it is possible that these do not represent the pre-impact positions.

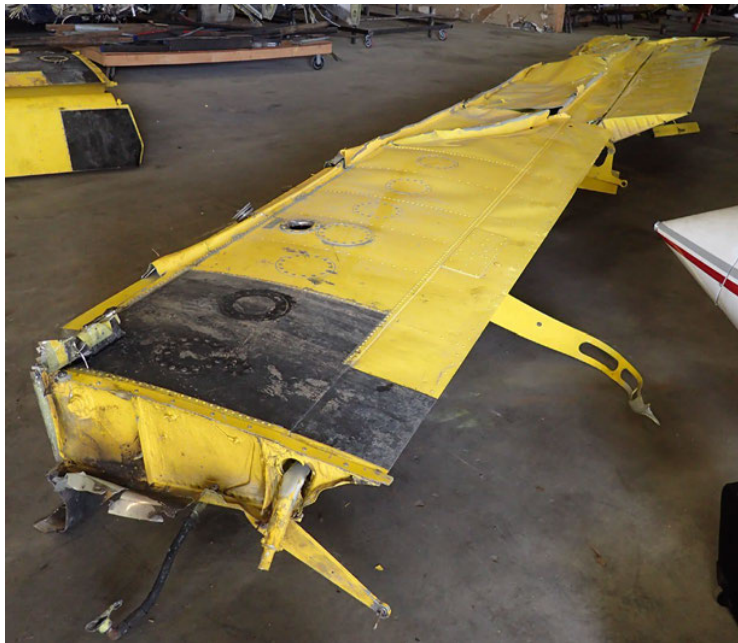
**Right Wing with Aileron**

Both ailerons remained attached to the wings. The left flap remained attached to the left wing. The right flap was found separated from the wing. Both aileron counterweights were found in place.

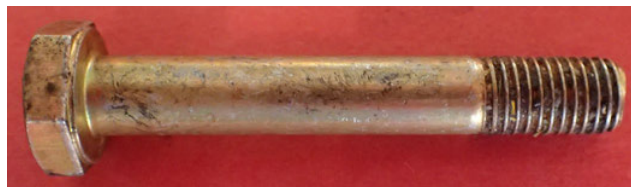
**Bolt Found by FAA**

During the initial on scene investigation FAA Inspector Keenon Wood reported that the aluminum elevator pushrod was found disconnected from the forward idler. The bolt intended to connect the idler to the pushrod was reported missing. A bolt suspected of being the missing bolt was reportedly found, loose, in the wreckage.

installed hardware prior to the accident. A bolt suspected of being the missing bolt was located, loose, in the wreckage during the on scene investigation performed by FAA Inspector Keenon Wood. A nut was not located in the wreckage. During the on scene investigation the aluminum pushrod was removed from the airplane and taken possession of by FAA Inspector Keenon Wood. The elevator controls were found to be continuous from the aft idler to the elevator control arms, which were torn from the elevator torque tubes.

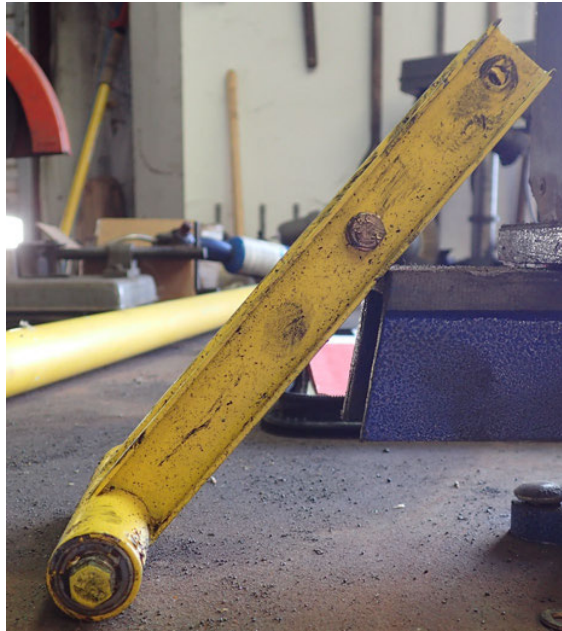
**Forward Elevator Idler**

The elevator controls are manually operated by steel and aluminum pushrods connecting the control stick to the elevator control horns through two control idlers. The controls were found to be continuous from the control stick to the forward idler. The bolt connecting the forward idler to the main pushrod (see red circle in Figure 1) was not found in its proper location. No sign of damage to the forward idler or to the rod end bearing was found to indicate properly

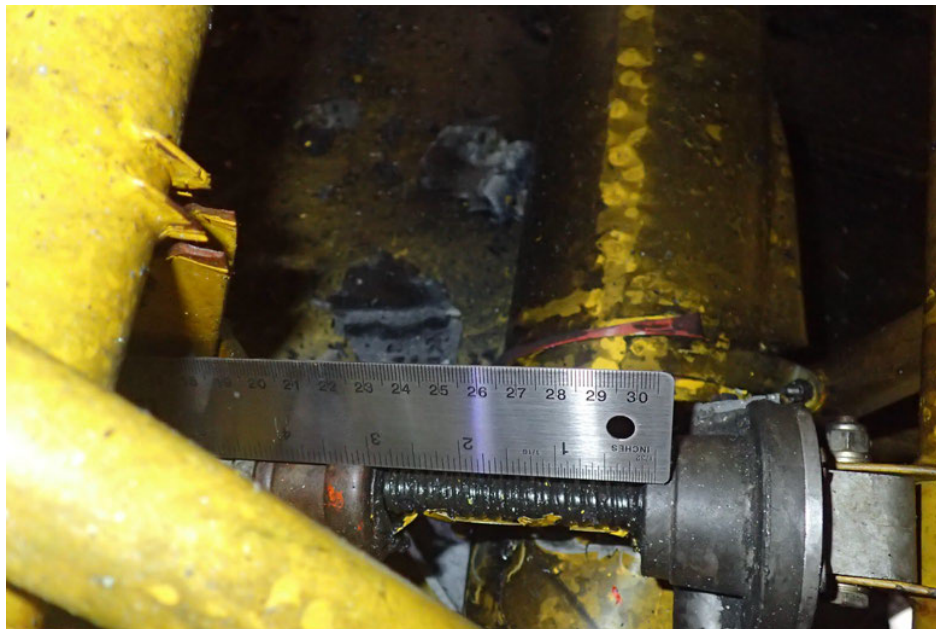
**Flap Actuator Extension**

There was minimal damage to the flap control system. The flap control system was found to be continuous from the flap actuator to the flap pushrods. The flaps were detached from the pushrods during the recovery of the airplane (as reported by the recovery crew). The flap actuator was found to have an extension of 3", which corresponds to a flap extension of approximately 23°.

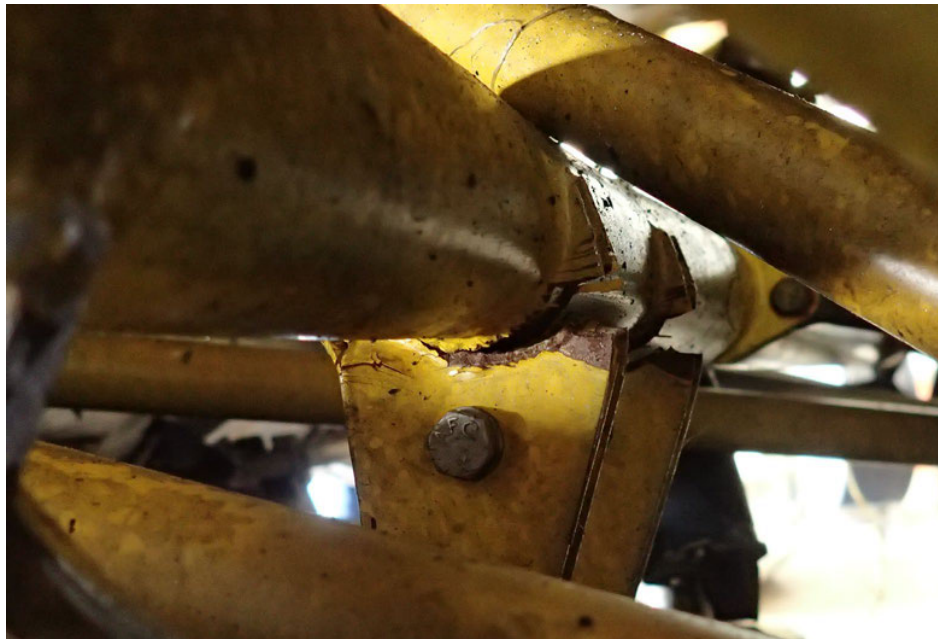
**Partial Separation of Flap Torque Tube Plates**

The flap torque tube plates were found partially separated from the torque tube. Service Letter #347 was issued on 6/10/16 to notify operators of the potential for cracks to form in this location. The service letter includes a procedure for inspection of the welds. It is unknown if the partial separation occurred prior to the accident, or during the accident sequence.

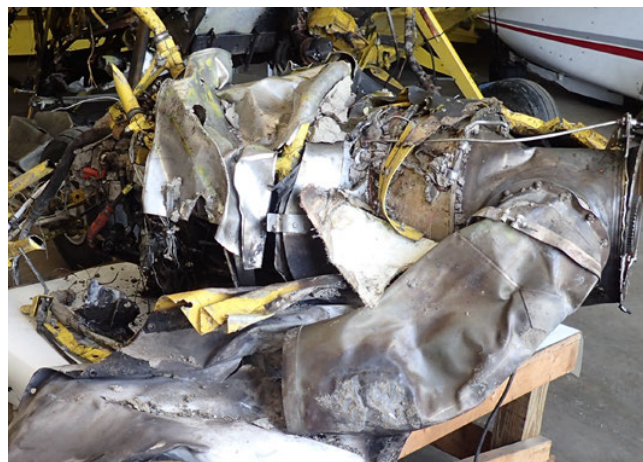
**Engine Wreckage**

The powerplant was found attached to the engine mount. Through documentation the engine was determined to be a PT6A-42, serial number PCE-PJ1125. The engine exhibited impact damage and was found with a separation at "A" Flange.

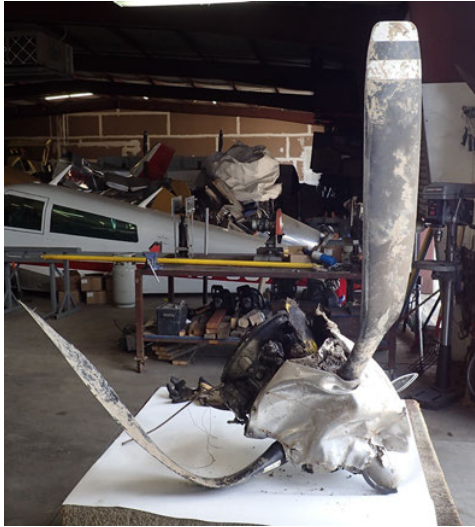
**Propeller Wreckage**

The engine was equipped with a three bladed reversible Avia propeller. All three blades remained attached to the hub.
