# NATIONAL TRANSPORTATION SAFETY BOARD

## MATERIALS LABORATORY FACTUAL REPORT

Report No. 19-066

Place : Grass Valley, California  
Date : April 19, 2019  
Vehicle : Nanchang CJ6, N621JM  
NTSB No. : WPR19LA117  
Investigator : Joshua Cawthra, AS-WPR

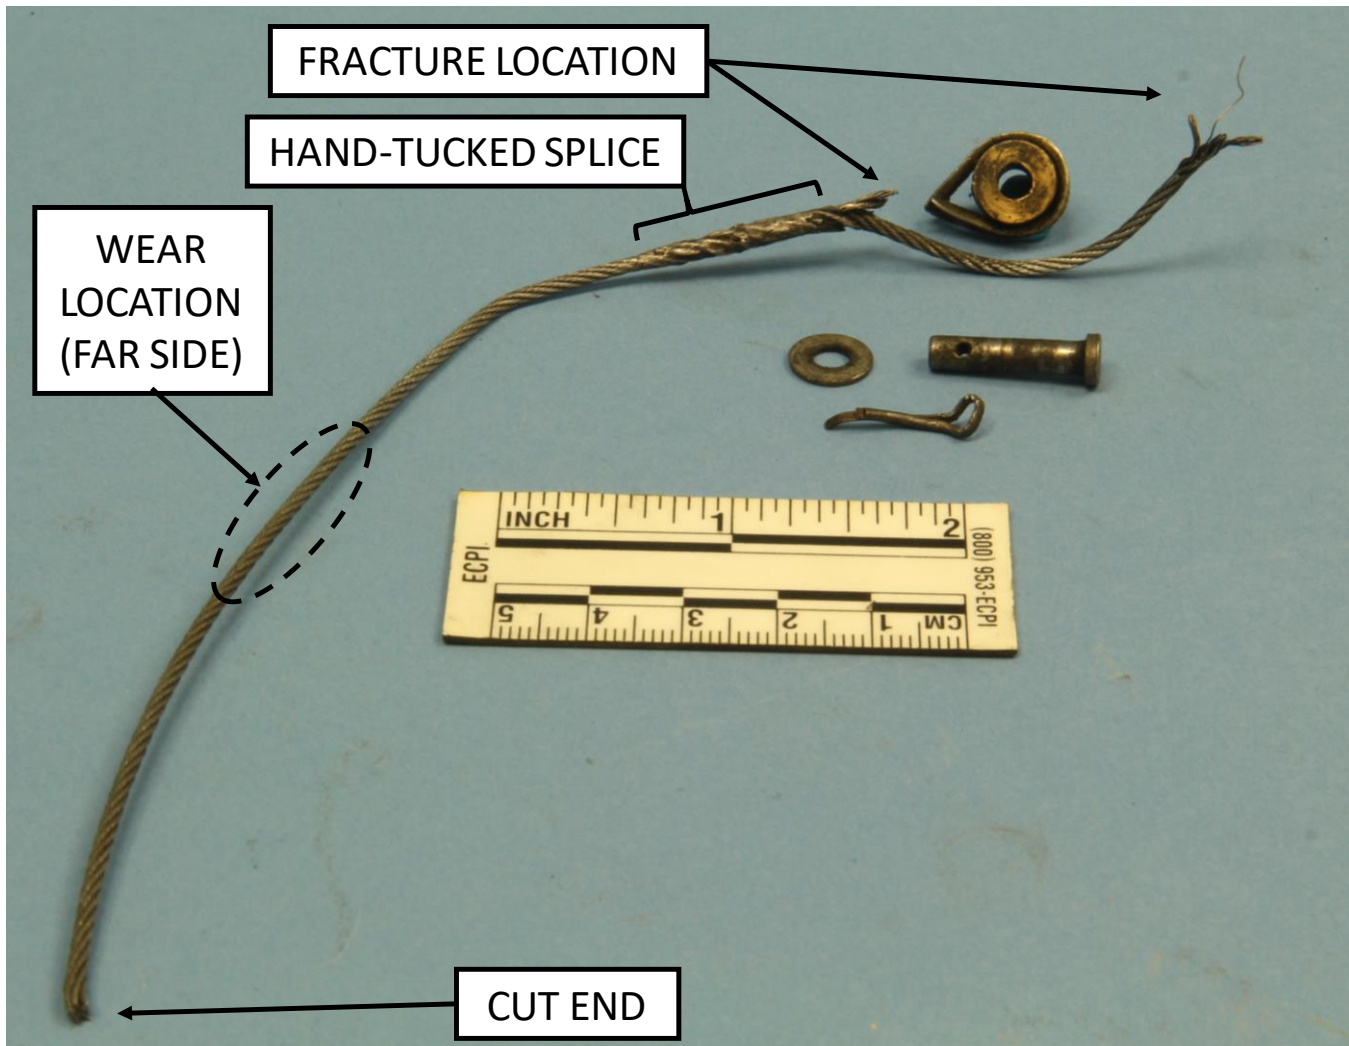
The portion of brake cable measured approximately 8  $\frac{3}{4}$  inches in length and was constructed of seven strands of seven metal wires (7x7) with a right regular lay. The nominal outside diameters of the cable and strands were measured using a digital caliper to be approximately 0.07 inches and 0.024 inches, respectively. One free end of the cable was fractured through all the strands. The fractured strands and wires were raveled approximately  $\frac{3}{8}$  inches away from the fracture location with a single wire approximately  $\frac{3}{8}$  inches longer than the other fractured strands and wires. A second fracture location was observed approximately 2  $\frac{1}{8}$  inches further along the cable at a feature consistent with a tapered and concealed hand-tucked splice joint for an eye termination. When comparing the thimble with the cable contour between these fracture locations, the fit was consistent with a thimble-eye termination created by a hand-tucked splice joint. This indicated that the two fracture locations observed were mating fracture surfaces.

Figure 1: As-received components with cable fracture location identified with arrows. Location of the thimble with retained bushing intended to show a pseudo-reconstructed view of the eye termination. Mating fracture surfaces were within the eye and adjacent to the start of the hand-tucked splice joint when the cable was wrapped around the thimble.

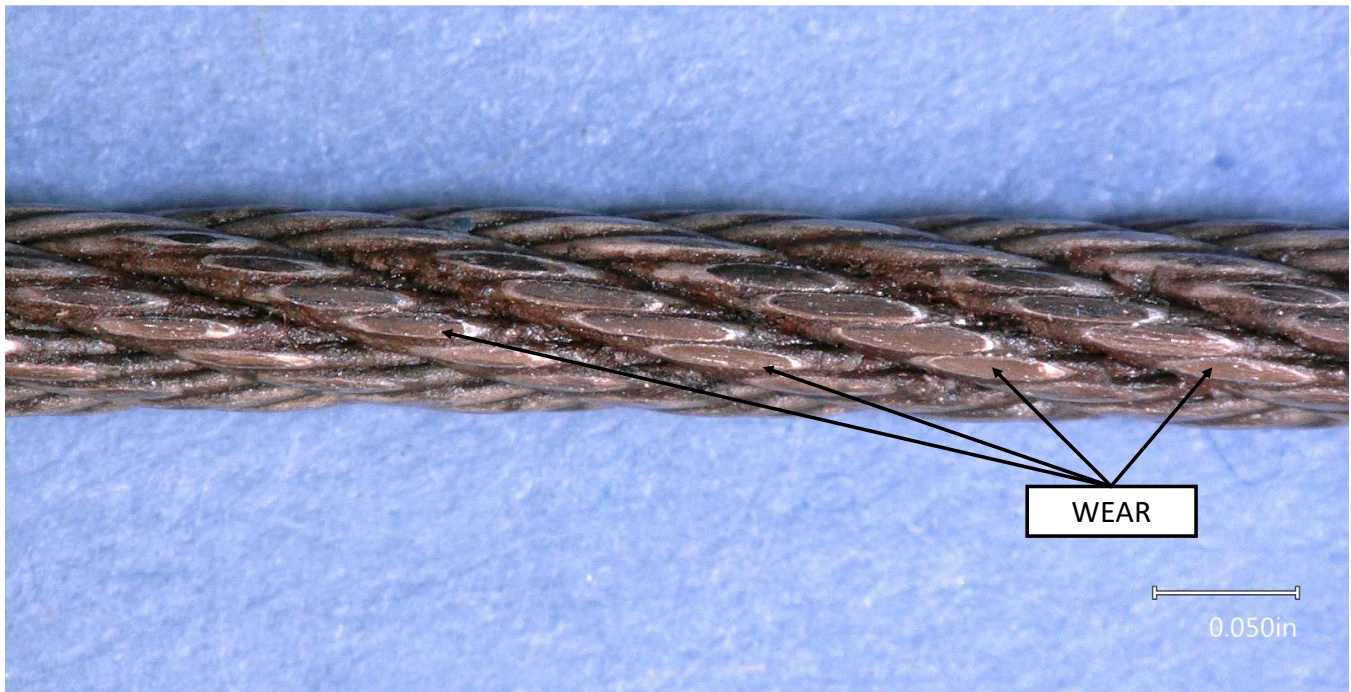
The other free end of the brake cable exhibited wire and strand terminations at approximately the same location and same knife-edge orientation with no evidence of raveling, consistent with having been mechanically cut. A permanent bend in the cable, approximately 120° with approximately a 0.3 – 0.4 inch radius of curvature was observed approximately  $\frac{1}{2}$  inch from the end of the hand-tucked splice joint towards the cut end of the cable. A localized area of external cable wear approximately one inch long and up to 40% of the individual wire diameter was observed on one side of the cable approximately 2  $\frac{1}{2}$  inches from the cut end as shown in figures 1 and 2.

Figure 2: Magnified view showing external wear to the individual wires from the section of cable identified in figure 1. Arrows indicating several locations of features consistent with wear.

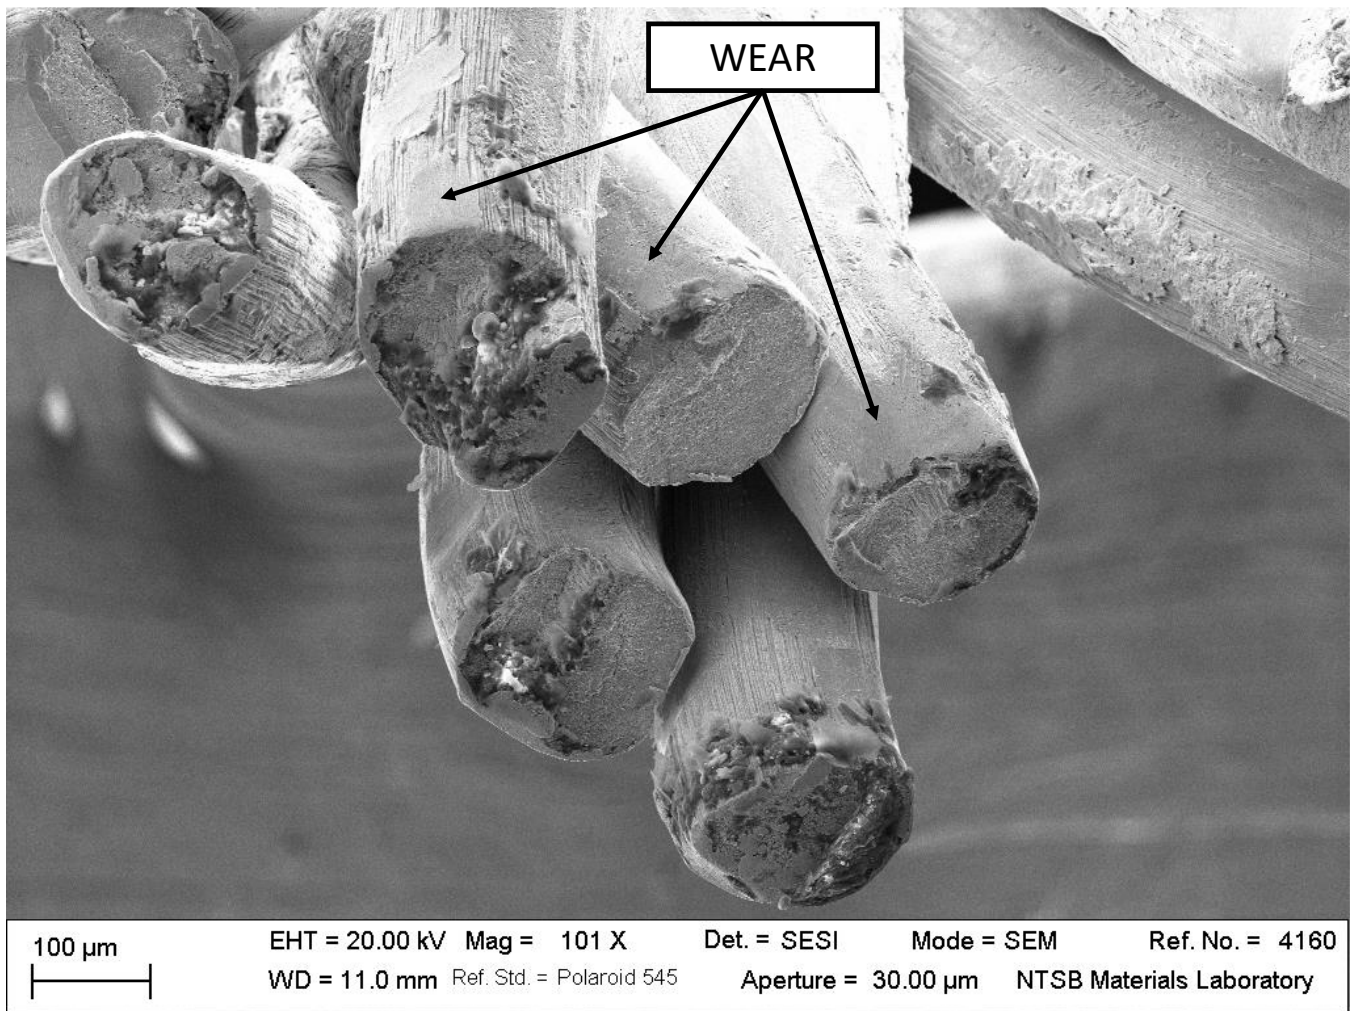
The fracture surface of the cleaned cable was examined using a scanning electron microscope (SEM). To facilitate examination, the cable was cut within the eye adjacent to the hand-tucked splice approximately 0.25 inches from the start of the splice. Six of the seven strands of wires exhibited evidence of relatively flat fracture surfaces oriented normal to the wire axis as shown in figures 3 and 4, consistent with a progressive fracture mechanism, such as fatigue fracture. Only one strand and a few of the remaining individual wires showed evidence of minor elongation at the fracture location. Energy dispersive spectroscopy (EDS) examination of the fatigue fracture location returned peaks of iron, nickel, and zinc consistent with galvanized steel. In addition, EDS found lead and tin, consistent with typical solder alloys. Strands and wires at the fracture location and within the hand-tucked eye splice were surrounded with solidified metal consistent with a lead-tin solder alloy. This material was visible on the external surfaces of wires, as shown in figures 3 and 4. Figure 5 presents a photograph of the hand-tucked eye splice with solder present. There were visible cracks in the solder network oriented along the general direction of the cable strands and wires.

Figure 3: SEM micrograph of fractured wires exhibiting relatively flat fracture surfaces consistent with fatigue cracking and evidence of wear on the outer surface of individual wires.

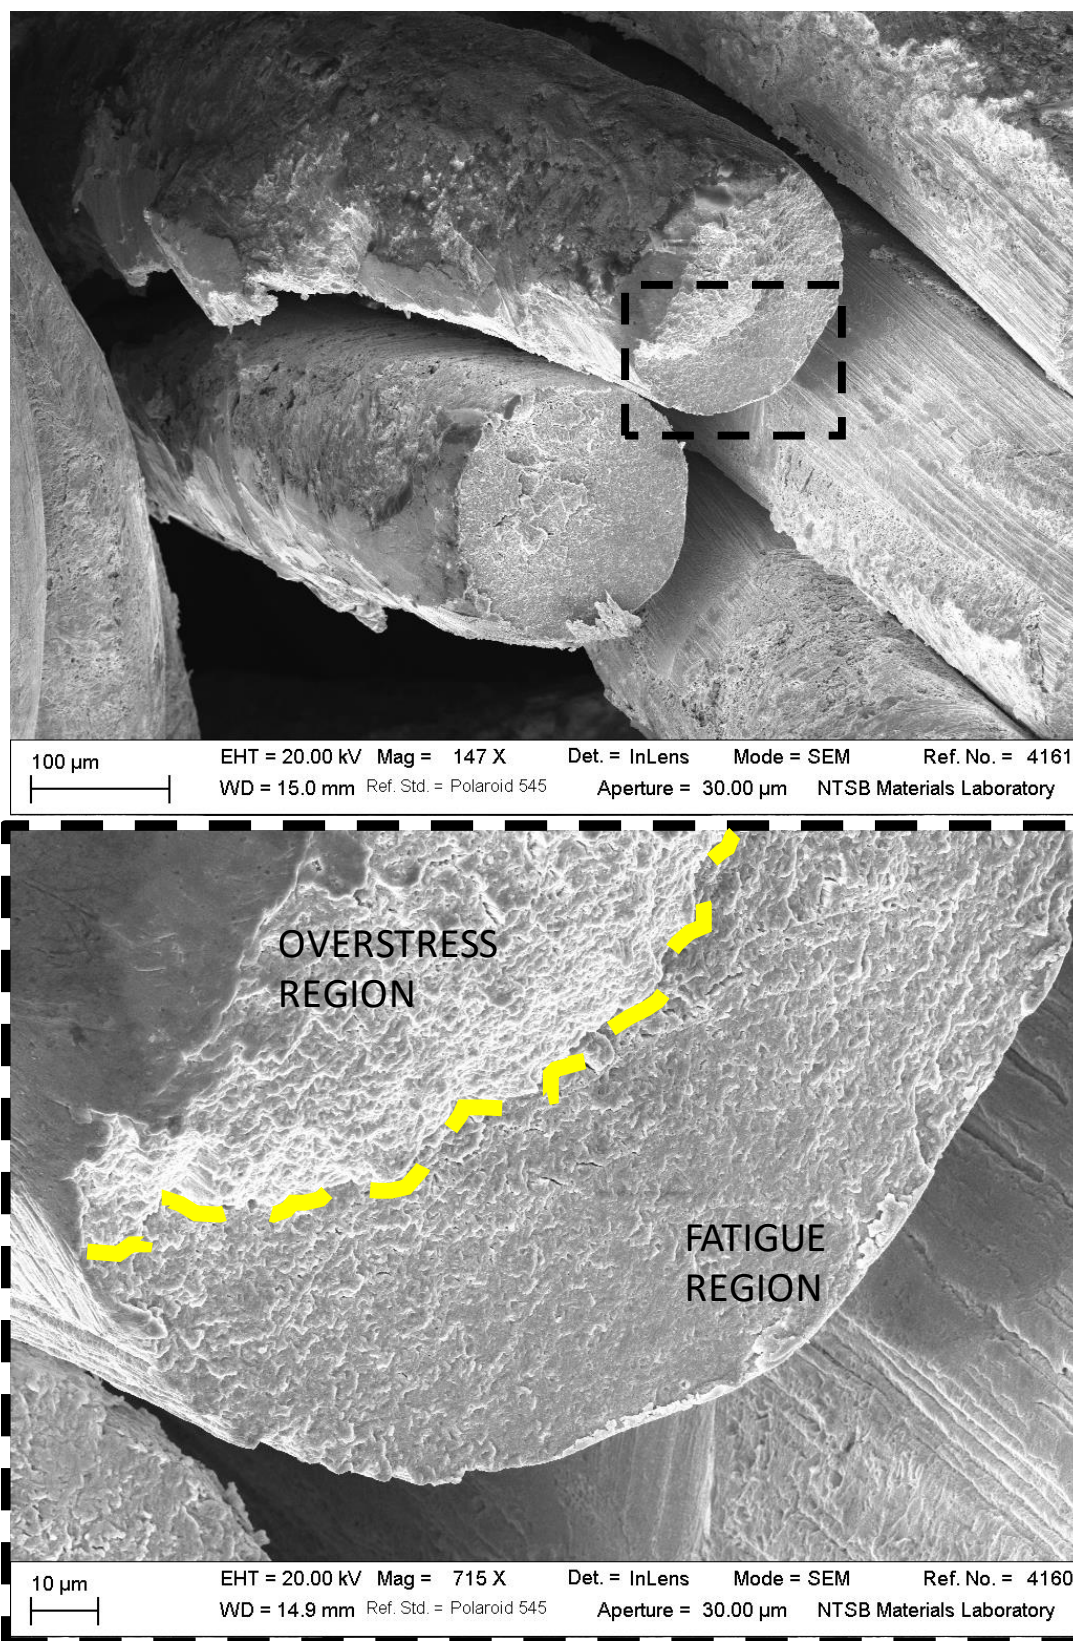
Figure 4: SEM micrographs of fractured wires showing features consistent with fatigue fracture. The right image shows higher magnification of the area indicated on the left image.

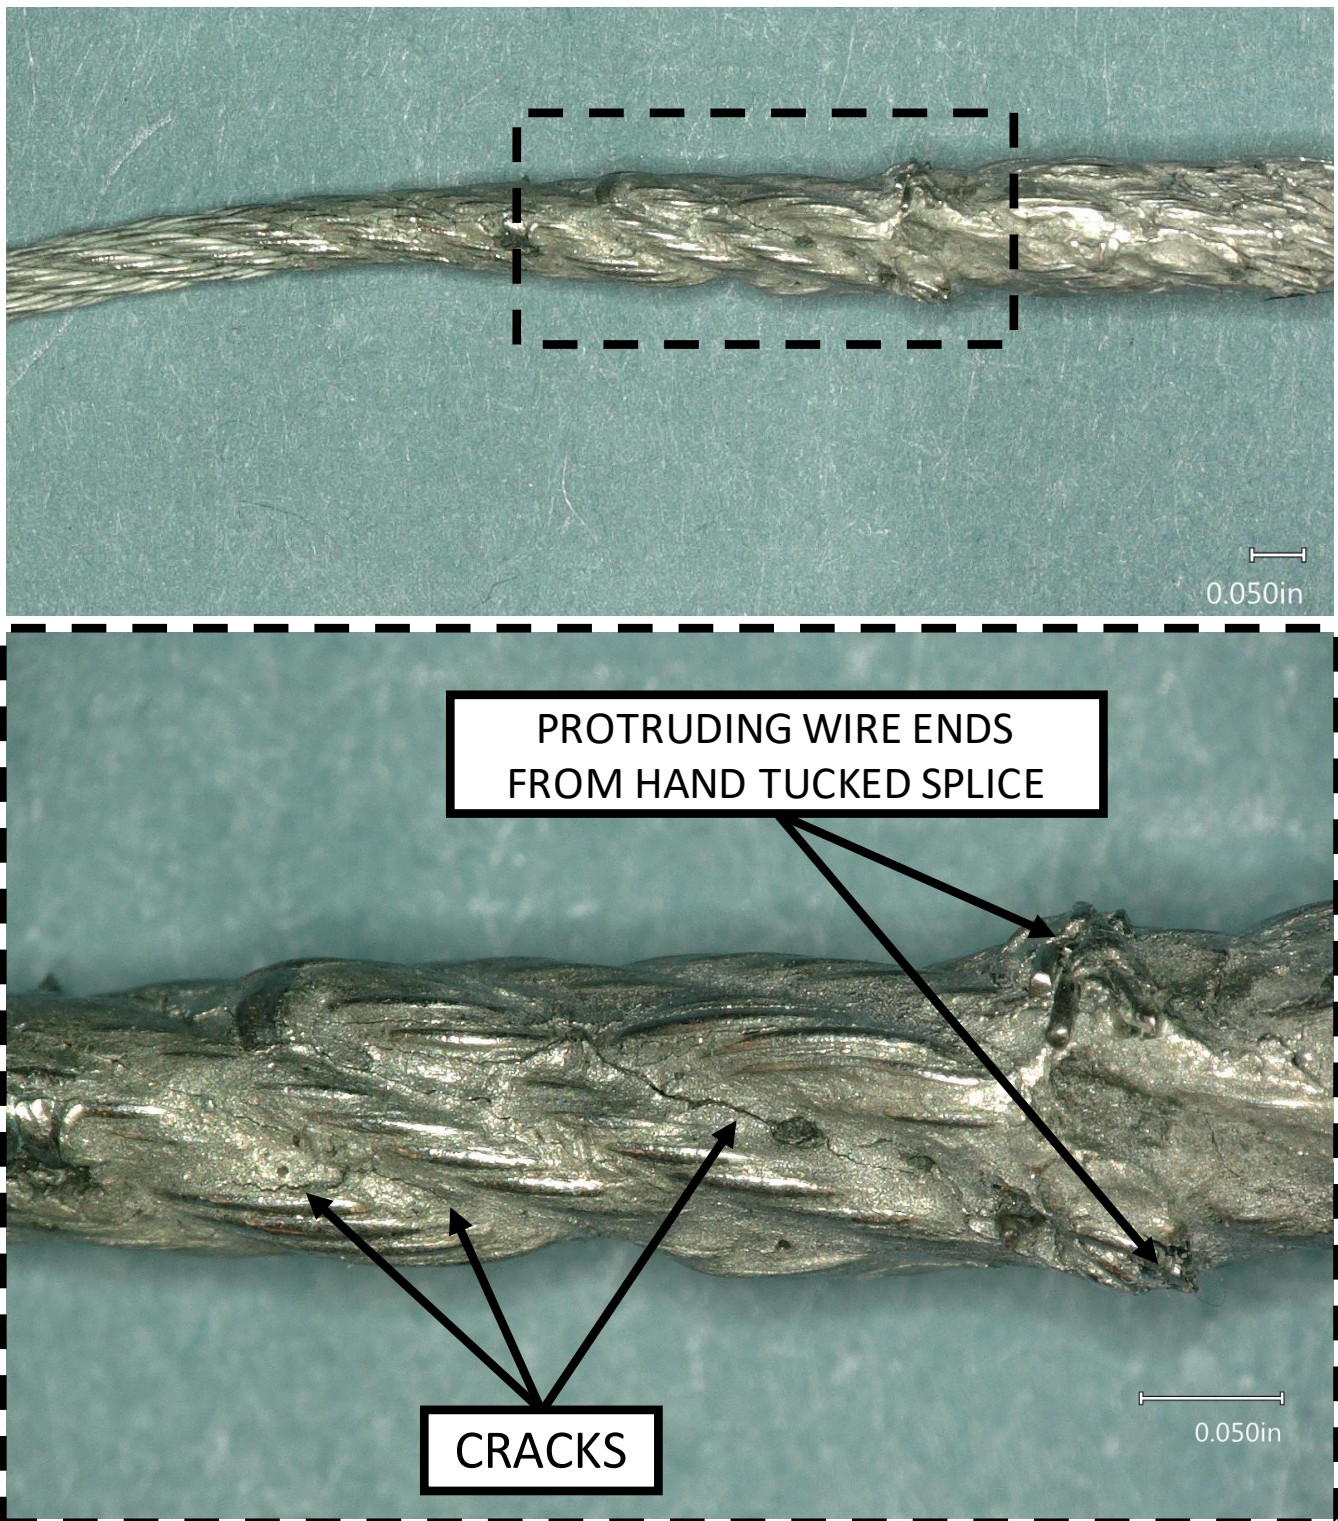
Figure 5: Cleaned cable at terminating end of hand-tucked splice joint showing a smooth metallic material surrounding cable strands and wires. The left image shows the termination of the hand-tucked splice joint transitioning to un-spliced cable as viewed from right-to-left. The right image shows a magnified view of the indicated region of the left image to highlight several cracks observed in this surrounding material.
