**NATIONAL TRANSPORTATION SAFETY BOARD**  
**Office of Aviation Safety**  
**Washington, D.C. 20594**

**POWERPLANT GROUP CHAIRMAN'S FACTUAL REPORT**

**NTSB No: WPR19LA122**

Aircraft: Bell 206 Helicopter, Registration Number N206JH

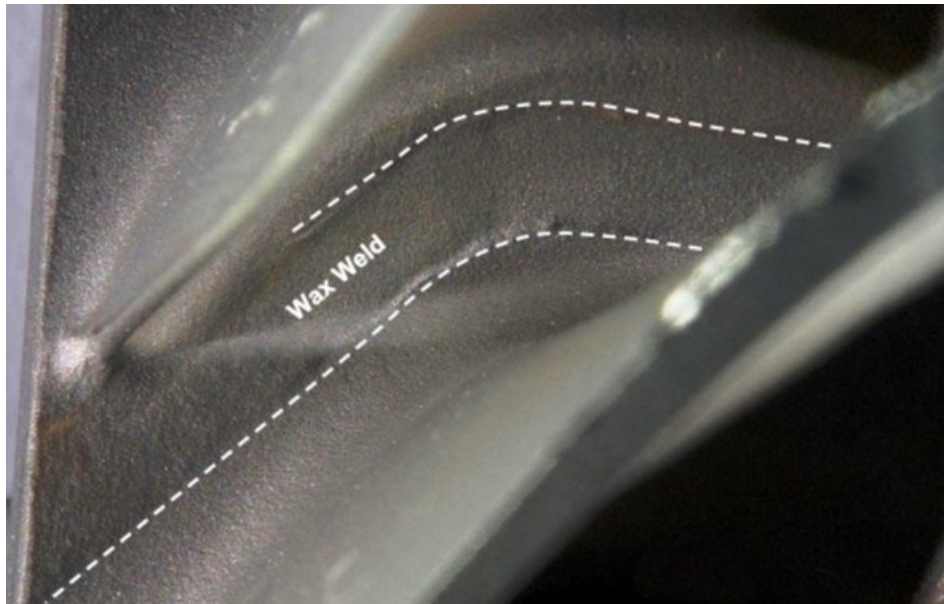
- 3) The pressure side wax weld adjacent to every airfoil intersected the airfoil root radius (Figure 2)
- 4) The hardness, chemistry, and microstructure of the 3<sup>rd</sup> stage turbine wheel were consistent with the material required by the component definition.

Figure 2 – Example of the wax weld intersected the airfoil root radius of both airfoils.

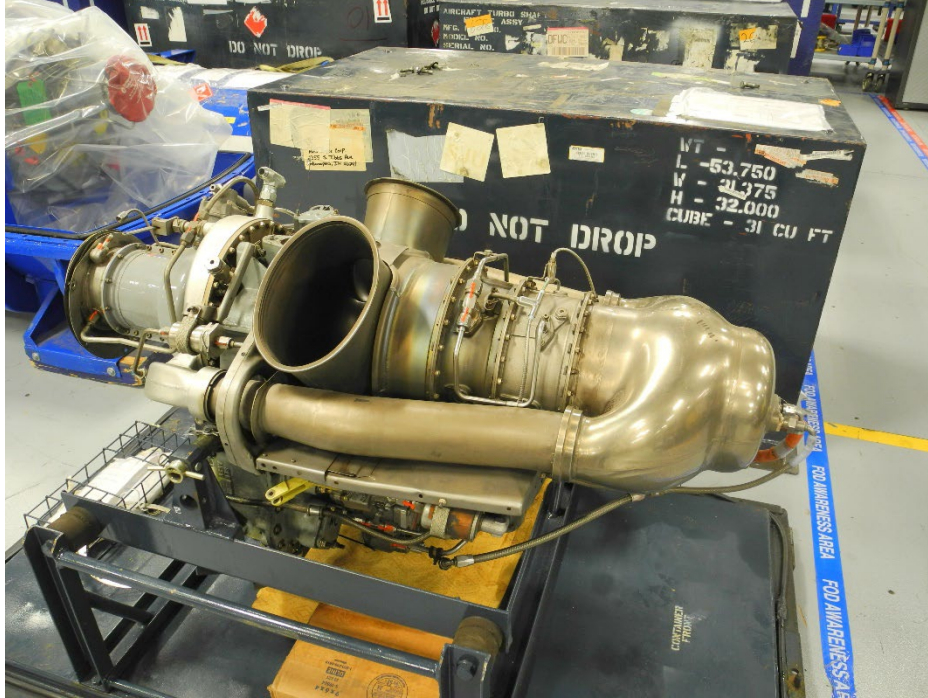
The engine was in a metal engine container which was opened in the presence of the NTSB ([Photo 1](#)). It was externally generally clean and intact. There was no evidence of an un-containment. The starter-generator was not returned.

**Photo 1** - Rolls-Royce M250-C20B S/N CAE-832565 - As Received

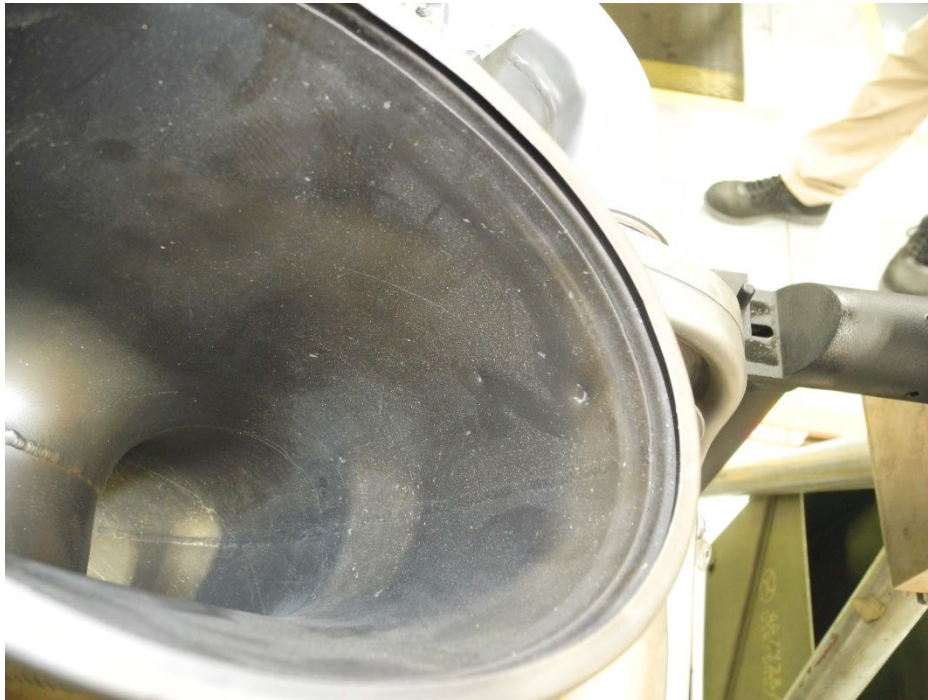
The internal surface of the exhaust collector duct exhibited numerous small indents, consistent with impact from high-speed particles ([Photo 2](#)). Additionally, the duct was fractured at the 12 o'clock<sup>1</sup> location near the upper mount strut ([Photo 3](#)).

**Photo 2** – Exhaust Duct – Small Dents

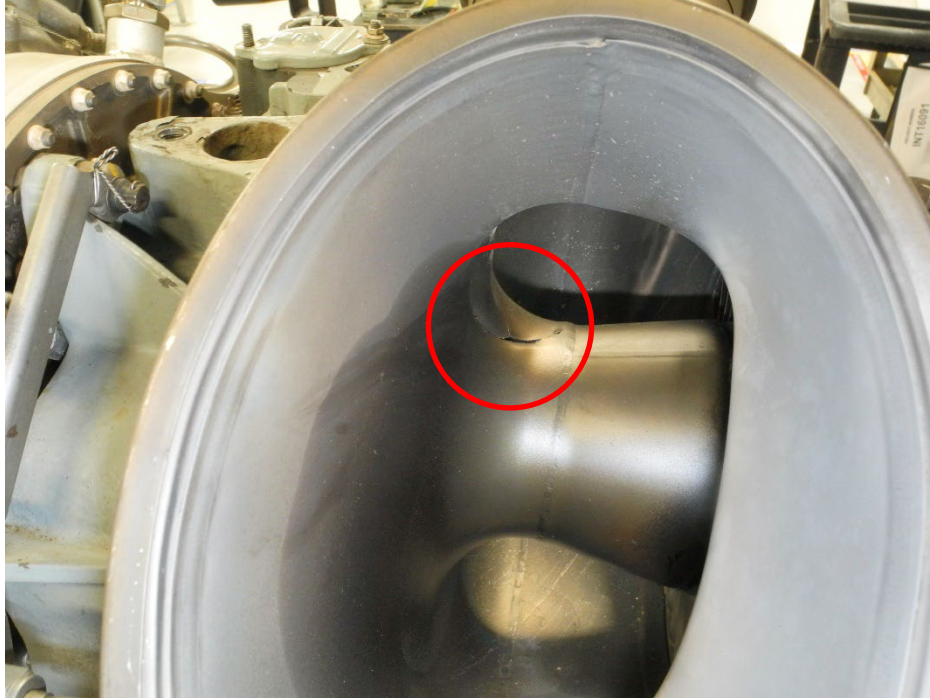
Photo 3 – Fracture at 12 O'clock Location in Exhaust Duct

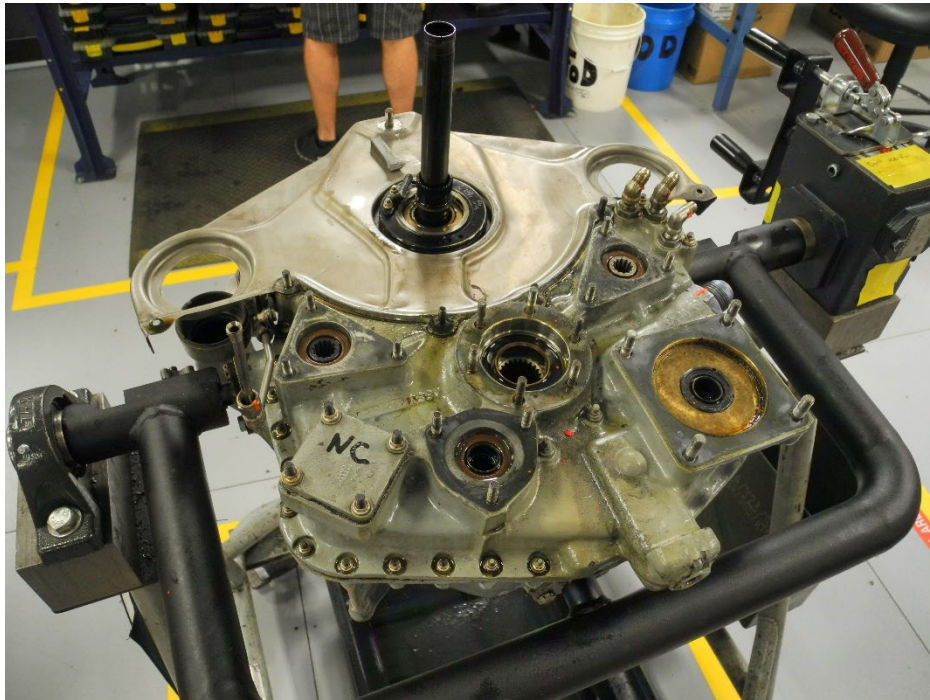
The gearbox module, S/N CAG-36471, and was intact and appeared to be undamaged ([Photo 4](#)). An examination of the two chip detectors revealed fine particles on the upper chip detector and a small shiny flake in the lower chip detector ([Photo 5](#)). A rattling noise emanated from the No. 6 and No. 7 bearing oil sump can as it had been drained of approximately a ½ cup of oil, and upon further investigation revealed that it contained a damper from one of the No. 6 or No. 7 bearings ([Photo 6](#)). The oil supply nozzles for the Nos. 6, 7 and 8 nozzles were removed and found to be oil wetted and undamaged. The last-chance oil screen was clean ([Photo 7](#)). Alcohol was introduced into the feed tube and seen to exit the nozzles, indicating a clear flow path.

Photo 4 – Gearbox Module - Undamaged

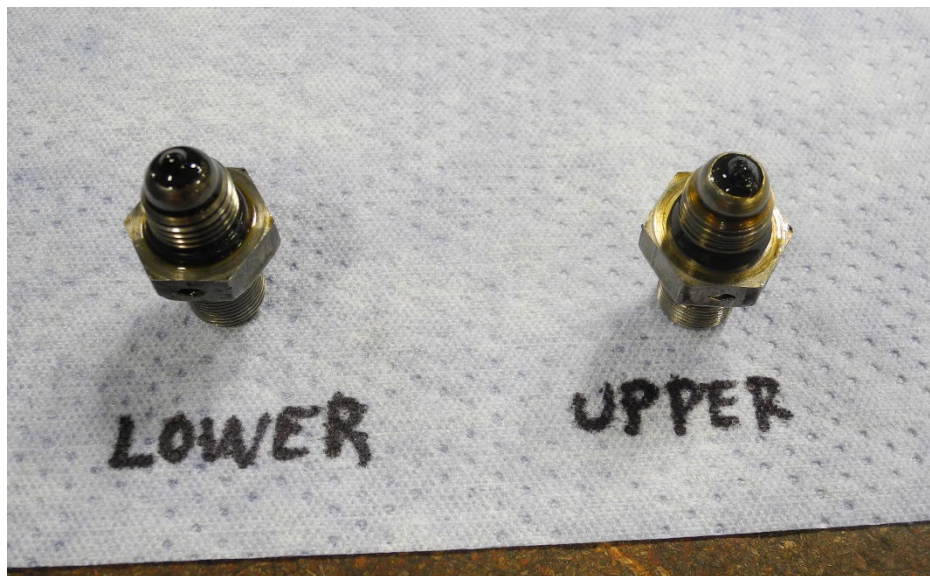
Photo 5 – Chip Detectors - Clean

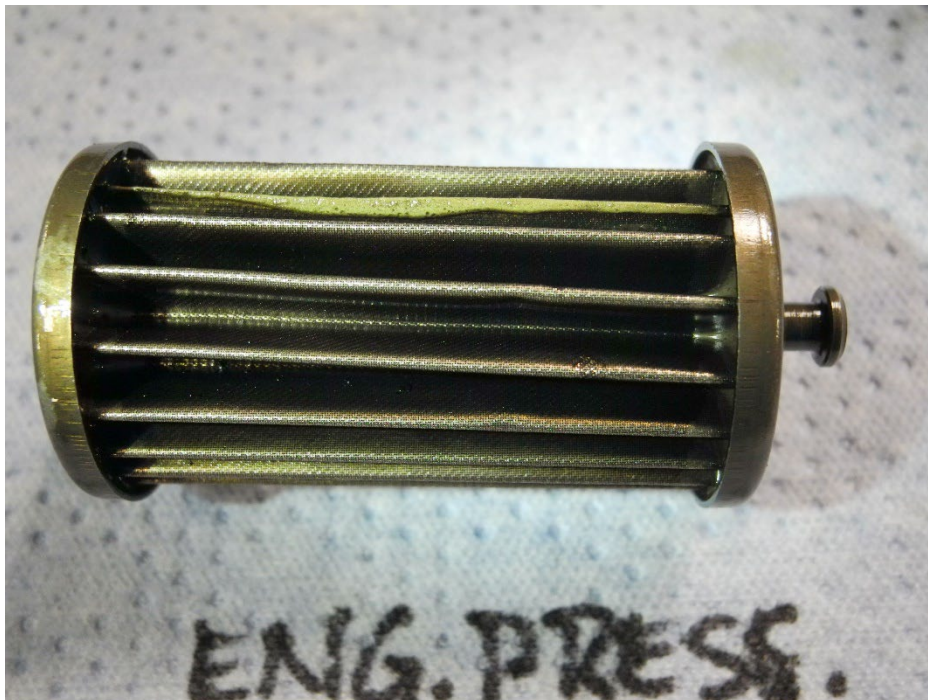
The oil filter was examined and found to be clean ([Photo 8](#)).

Photo 8 – Oil Filter - Clean

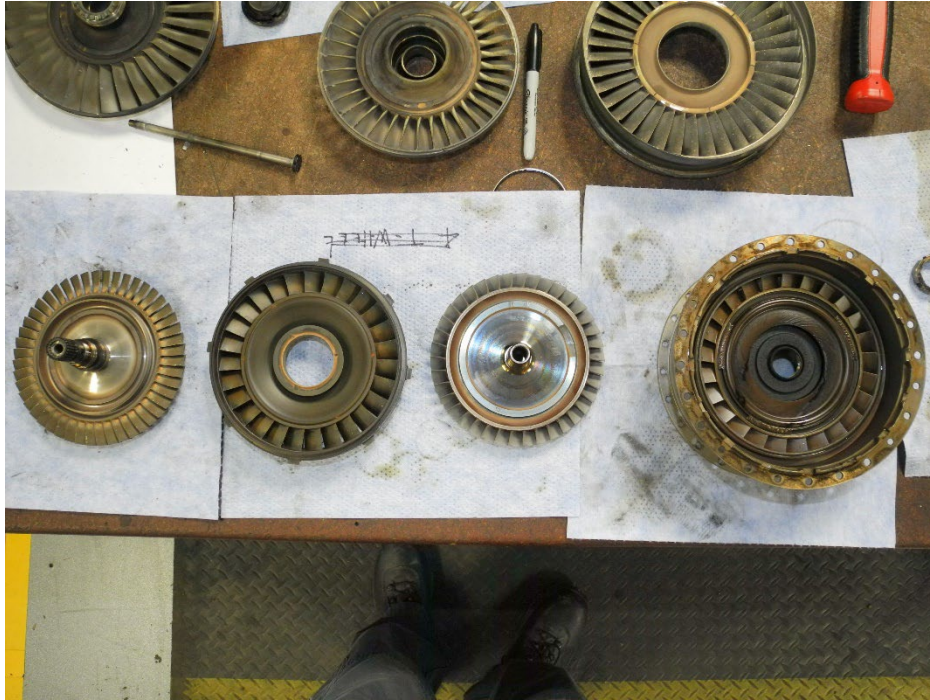
The 1<sup>st</sup> stage turbine nozzle and the 1<sup>st</sup> stage turbine wheel and it's curvic coupling were intact and undamaged ([Photo 11](#)).

Photo 11 – Compressor Turbine Components

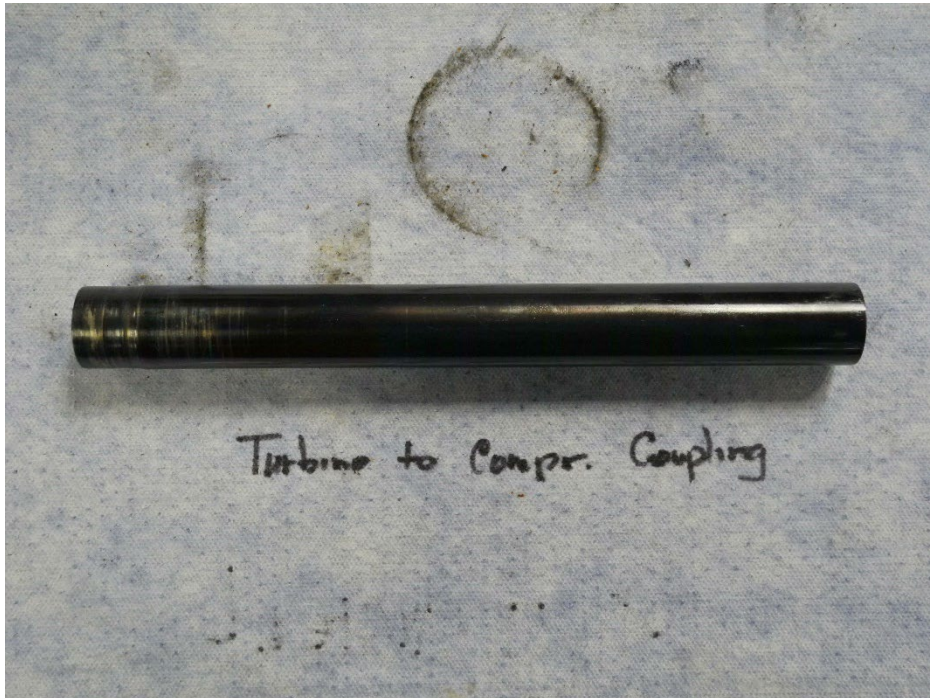
The turbine-to-compressor coupling ([Photo 12](#)) was intact; however, the aft 1-½ inch of the tube was deformed and the outer surface was rotationally scored.

Photo 12 – Turbine-to-Compressor Coupling

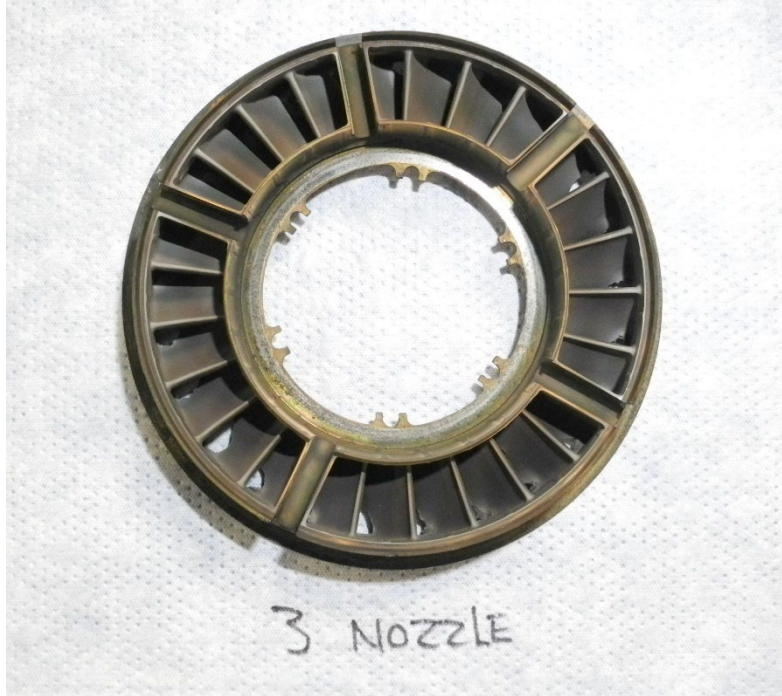
The 3<sup>rd</sup> stage turbine nozzle was generally intact. The leading edges of the vanes were undamaged (Photo 13). The trailing edges of all the vanes were dented and missing material, with most of the damage occurring on the outer  $\frac{1}{3}$  of the vane chord (Photo 14). Each vane had approximately a fingernail sized portion missing. Five vanes exhibited heavy gold-colored metal spray on their downstream faces (Photo 15).

Photo 13 - 3<sup>rd</sup> Stage Turbine Nozzle – Upstream Face

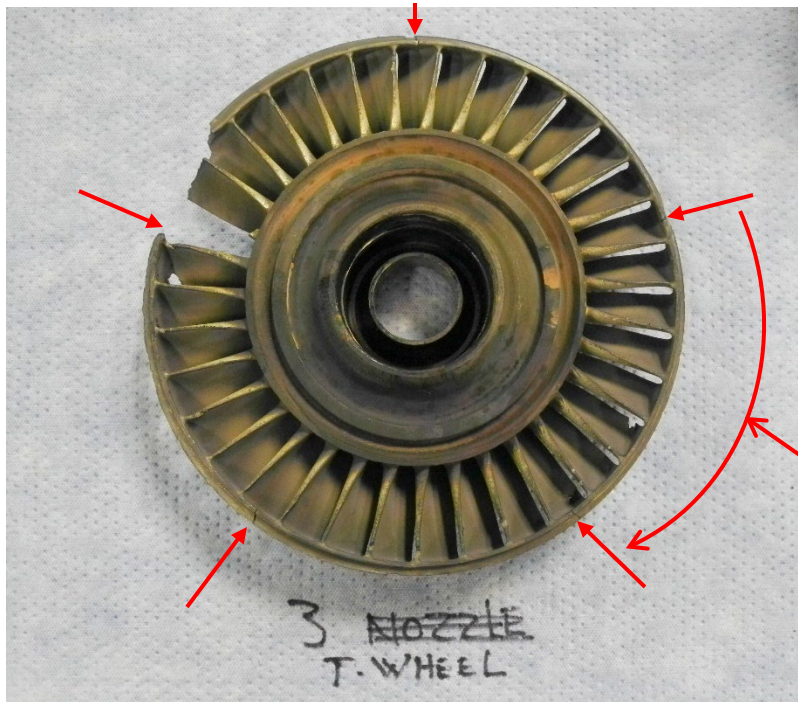
Photo 16 - 3<sup>rd</sup> Stage Turbine Wheel – Upstream Side

The 3<sup>rd</sup> stage turbine wheel was missing one blade with the corresponding 1.5 inch-long, 2-blade span of outer shroud segment (Photo 16). The 3<sup>rd</sup> stage turbine wheel, as cast, features 35 blades that are supported along the outer edge with a continuous shroud. During manufacturing, 5 wire electrical discharge machining (EDM) slots are cut into the shroud, forming 5 'packets' of 7 blades each. The blade fractured at the root near the inner platform was the last in its 'packet'. The missing segment was not found. A visual examination of the blade root fracture surface revealed a fatigue zone from the trailing edge to approximately  $\frac{2}{3}$  along the chord, at which point the fracture surface abruptly changed texture, becoming rough, consistent with overload failure (Photo 17). The leading adjacent blade was present; however, the shroud segment had fractured from the tip (Photo 18). The labyrinth air seals were heavily rotationally scored, consistent with contact against the blade track. The leading-edge convex surfaces all had a  $\frac{1}{4}$  inch wide gold-colored metal spray deposit along the chord. The curvic coupling was undamaged. The wheel was identified as a component of a post-SB CEB -1365 or 'enhanced' turbine assembly design.

The Rolls Royce mitigation plan was to redesign the 3<sup>rd</sup> stage turbine wheel, featuring a modified fillet radius at the platform and improved manufacturing processes to reduce fillet variations, with production that began in December 2020. An in-service replacement program was begun on July 30, 2021, via SB CEB A-1428, requiring removal of the SB CEB-1365 3<sup>rd</sup> stage turbine wheel and installation of the new SB CEB A-1428 3<sup>rd</sup> stage turbine wheel at the next replacement time. The new design is expected to increase low and high cycle fatigue resistance.

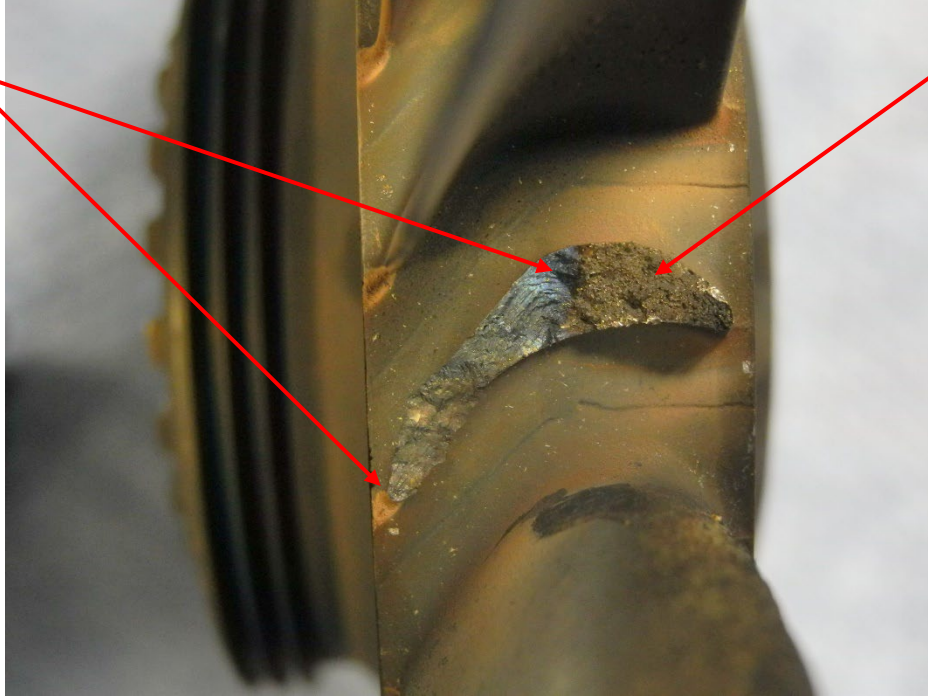
Photo 17 – Fracture Surface of 3<sup>rd</sup> Stage Turbine Wheel Blade

- 1) A single packet trailing 3<sup>rd</sup> stage turbine airfoil was fractured and liberated. The fracture initiated at the trailing edge tip approximately 0.025-inch outboard of the rim in low cycle fatigue (LCF) and propagated at least 0.012 inch toward the leading edge before transitioning to high cycle fatigue (HCF). The fracture grew to a total length of 0.546 inch before the airfoil was liberated in overload.

Disassembly and examination of the engine revealed no un-containment. One blade of the 3<sup>rd</sup> stage turbine wheel was fractured near the inner platform at the blade root. Visual examination of the blade platform fracture surface of the blade root revealed a high cycle fatigue zone from the trailing edge to approximately  $\frac{2}{3}$  along the chord, at which point the fracture surface changed texture, becoming rough, consistent with overload failure. The Rolls Royce materials laboratory report stated that the fracture initiated in low-cycle fatigue near the trailing edge radius of the blade to the inner platform which progressed to a high cycle fatigue process along the blade chord and final

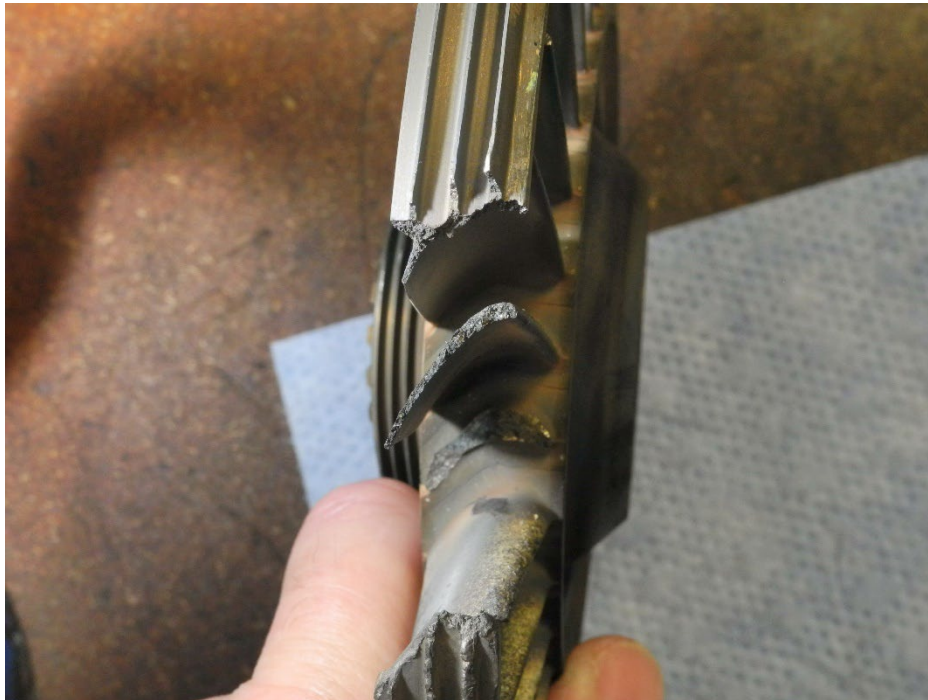
- 2) All of the other packet trailing airfoils on the 3<sup>rd</sup> stage turbine wheel as well as the airfoil immediately preceding the fractured and liberated airfoil exhibited crack-like FPI<sup>2</sup> indications.

Photo 18 - Adjacent Blade Fracture Detail

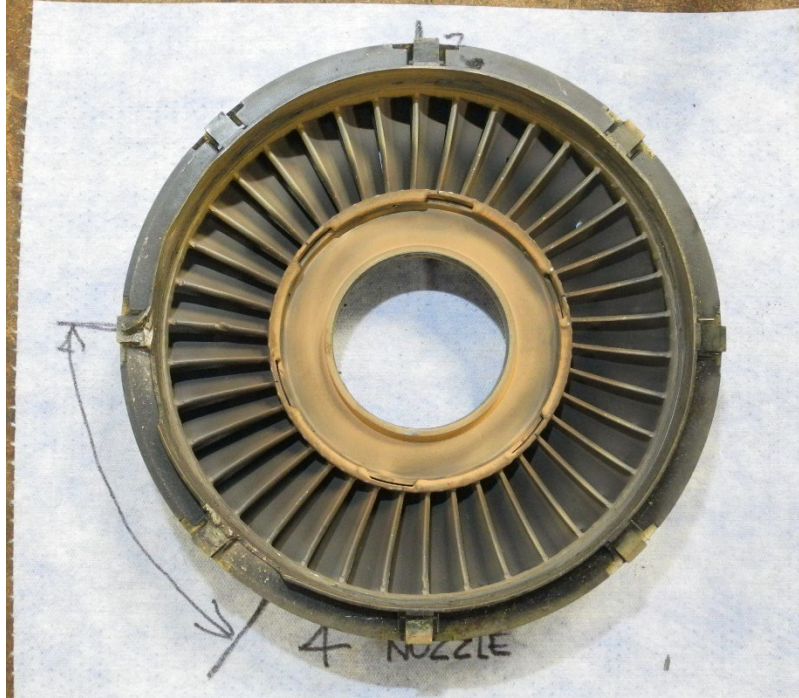
Photo 19 - 4<sup>th</sup> Stage Turbine Nozzle – Upstream Side

The 4<sup>th</sup> stage turbine nozzle was generally intact (Photo 19), however a 60-degree segment of the 3<sup>rd</sup> stage turbine blade track was heavily scored, consistent with contact against the 3<sup>rd</sup> stage turbine wheel labyrinth seals and fractured at two locations. All the nozzle vanes were present; however, one vane leading edge was dented at the mid span. Several vane trailing edges exhibited minor impact damage at the mid span (Photo 20). The 4<sup>th</sup> stage blade track was rotationally scored. The convex side of the trailing edges exhibited a gold-colored metal spray.

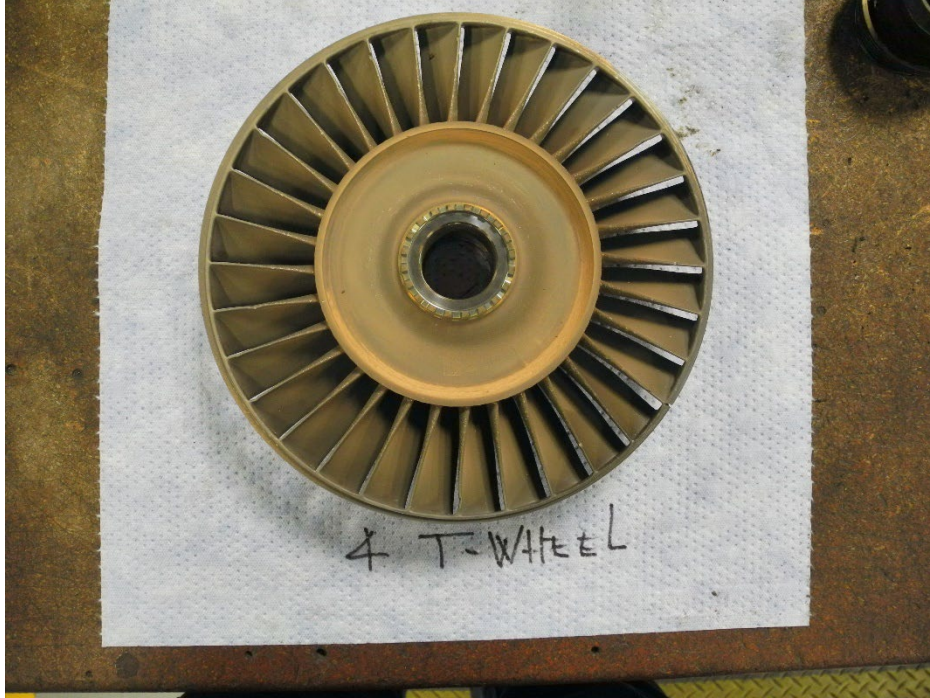
Photo 21 - 4<sup>th</sup> Stage Turbine Wheel – Upstream Side

The 4<sup>th</sup> stage turbine wheel (Photo 21) was intact; however, the shroud was fractured at one location (Photo 22) with no loss of material. The shroud labyrinth seal was heavily scored, and heat discolored along a 90-degree segment with the fracture occurring at approximately the middle of the scoring. The trailing edges were undamaged; however, a minor amount of gold-colored metal spray was observed on the convex side of the blades. Both curvic couplings were undamaged.

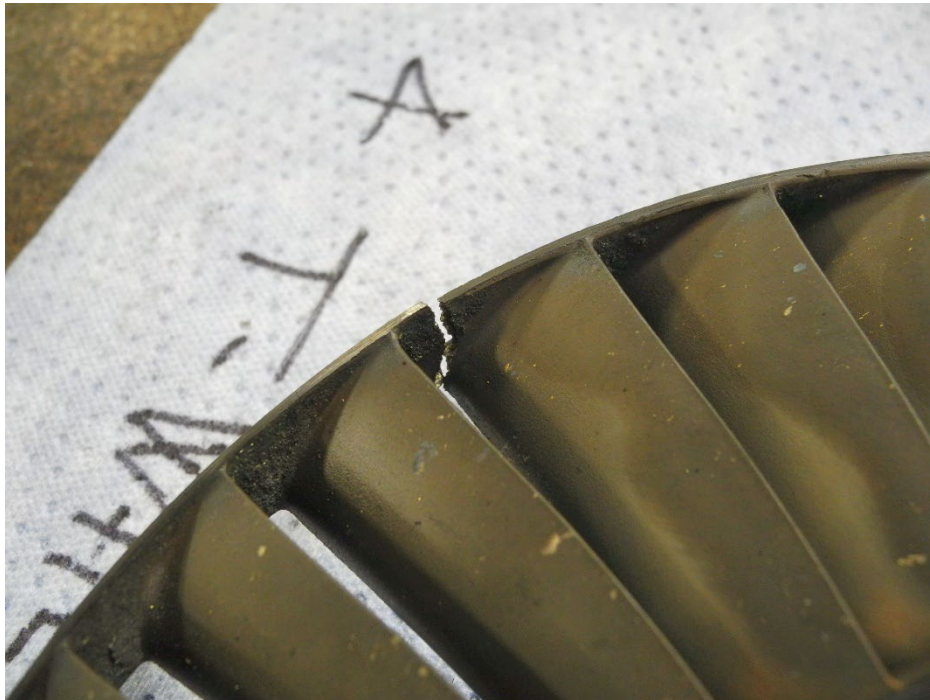
Photo 22 - 4<sup>th</sup> Stage Turbine Wheel – Shroud Fracture

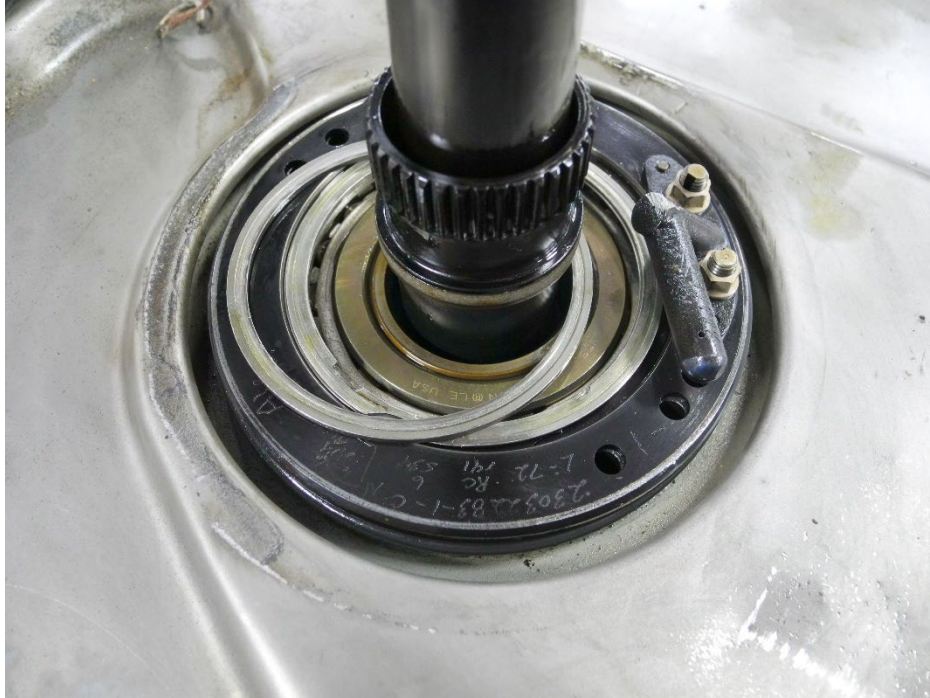
Photo 23 - #5 Bearing & Snap Ring with Spacer

The N2 (power turbine) bearing set consists of the No. 3, No. 4, No. 5, and No. 6 bearings. The No. 5 bearing snap ring was found dislodged from its groove ([Photo 23](#)), and the shim was loose.

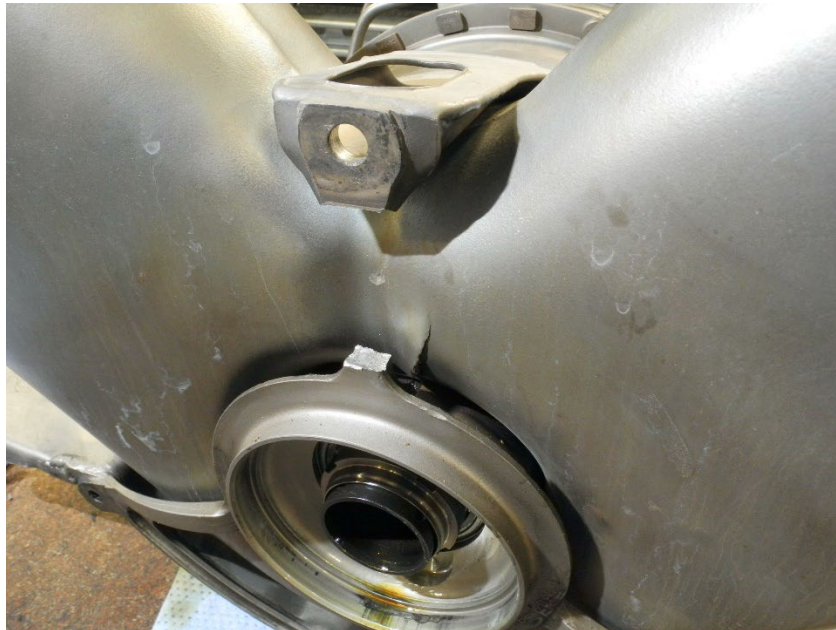
The exhaust collector was intact; however, the internal surface of the exhaust collector duct exhibited numerous small dents, consistent with impact from high-speed particles. Additionally, the duct was fractured at the 12 o'clock location near the upper mount strut and the upper mount strut was fractured at two locations ([Photo 24](#)), liberating the strut. It was still retained in the cavity between the exhaust collector and the gearbox.

Photo 24 - Exhaust Collector Support Strut and Duct Fracture
