| <b>Rolls-Royce</b> | Rolls-Royce Corporation<br>450 S. Meridian Street<br>Indianapolis, Indiana<br>46225-1103, USA | <b>REPORT NO.</b><br>19FAE-061-PR | <b>REV.</b><br>Initial | <b>PAGES</b><br>1 of 64 |
| <b>TITLE</b><br><br><b>METALLURGICAL INVESTIGATION OF A THIRD STAGE TURBINE WHEEL, P/N 23065818, REMOVED FROM AN M250 C20B ENGINE, S/N CAE832565 OPERATED BY WILBUR ELLIS CO.</b> | | <b>PREPARED</b><br><br>Signatures on File | | |

| Part Name: | Third Stage Turbine Wheel |
| Engine Serial Number: | CAE832565 |

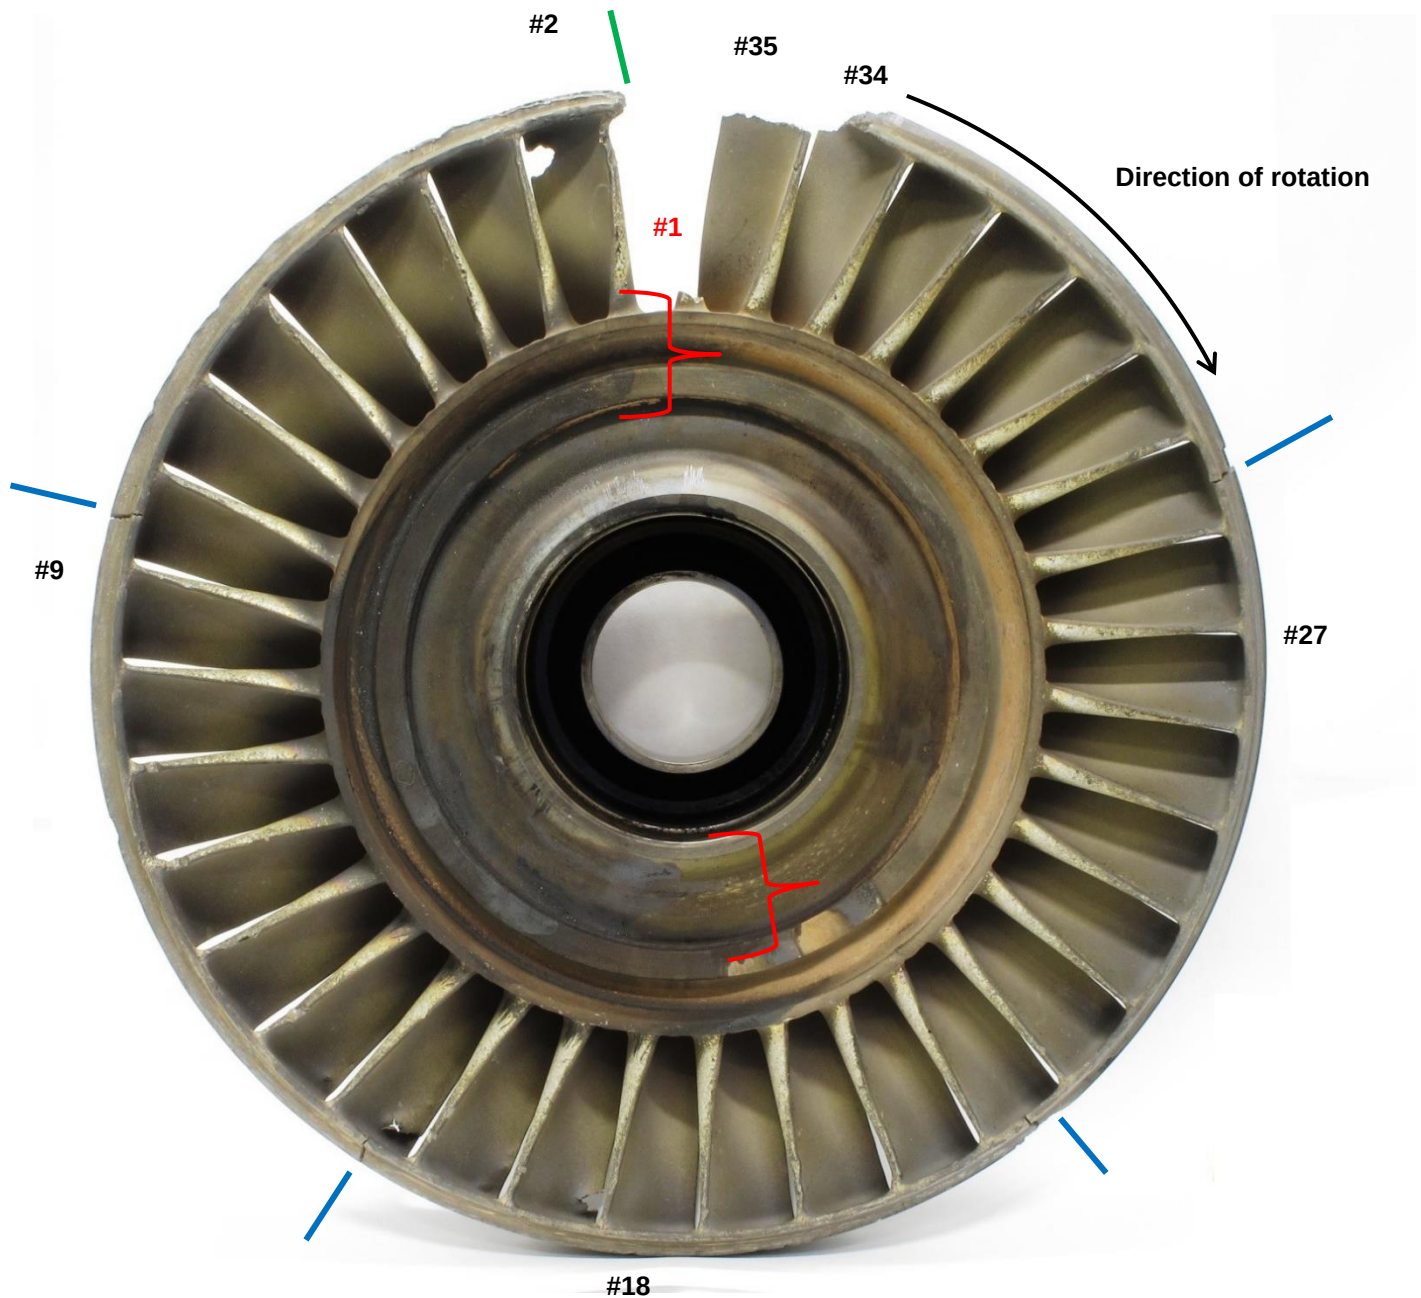
The as-received condition of the third stage turbine wheel is shown in Figure 2 and Figure 3, and the part markings are shown in Figure 4. The part markings read: PNR 23065818 REV G AREA 11.32, MFR 63005, SER X637545. A single airfoil was liberated from the wheel. The leading edge side hub of the wheel exhibited dark discoloration. The airfoils on the wheel were numbered sequentially for the purposes of this report, starting with #1 for the liberated airfoil and increasing opposite the direction of engine rotation. The shroud slots were found adjacent to the pressure side of the airfoils numbered #1, #8, #15, #22, and #29, indicating the liberated airfoil (#1) was the last airfoil in its packet. The shroud slots appeared to be centered between the adjacent airfoils. Airfoil #1 was liberated just outboard of the rim as shown axially in Figure 5 and radially in Figure 6. Additionally, the shroud outboard of airfoils #34, #35, and #2 was fractured and liberated. Detailed views of the shroud fractures are shown in Figure 7 and Figure 8; The liberated material from airfoil #1 and the fractured shroud were not recovered.

**Figure 2.** Leading edge side view of the third stage turbine wheel showing the fractured airfoils and shroud. The liberated airfoil was numbered #1 and the rest of the airfoils were numbered sequentially opposite the direction of engine rotation for the purposes of this report. The blue lines indicate the locations of the shroud slots; the nominal location of the fifth slot was immediately following the liberated airfoil and is indicated by the green line. The hub of the wheel was stained dark gray around approximately 180° (between red braces).

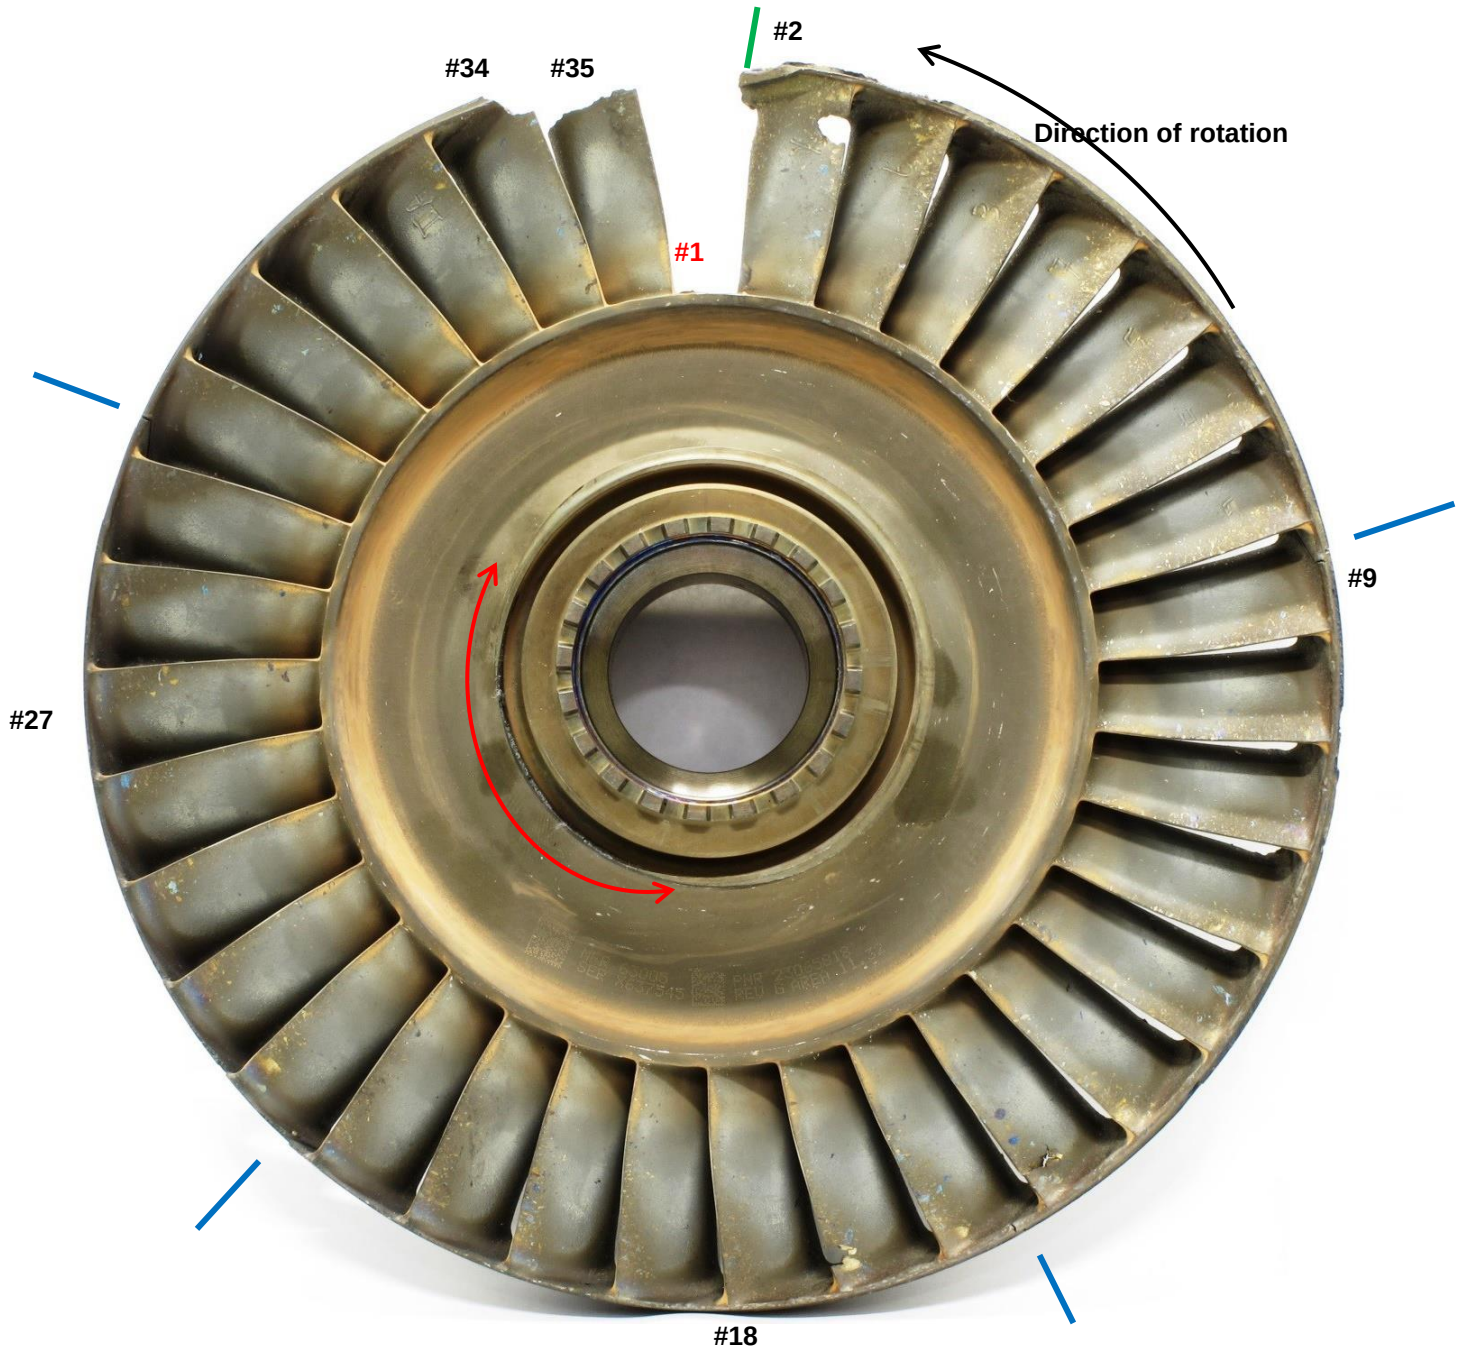
**Figure 3.** Trailing edge side view of the third stage turbine wheel showing the fractured airfoils and shroud. The liberated airfoil was numbered #1 and the rest of the airfoils were numbered sequentially opposite the direction of engine rotation for the purposes of this report. The blue lines indicate the locations of the shroud slots; the nominal location of the fifth slot was immediately following the liberated airfoil and is indicated by the green line. The red arrow indicates the fractured span of the inter-stage knife seal arm (see Figure 9).

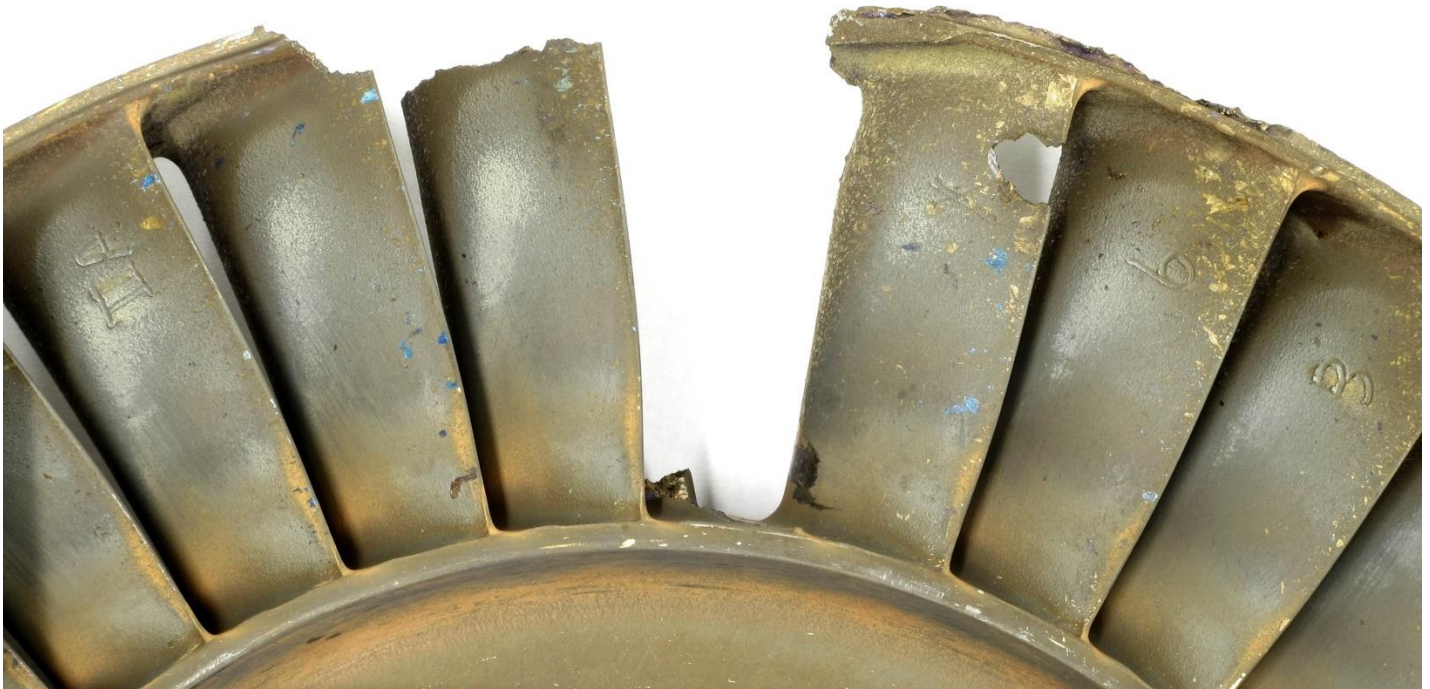
**Figure 5.** Detailed trailing edge view showing the fractured airfoils and shroud adjacent to the liberated airfoil on the third stage turbine wheel.

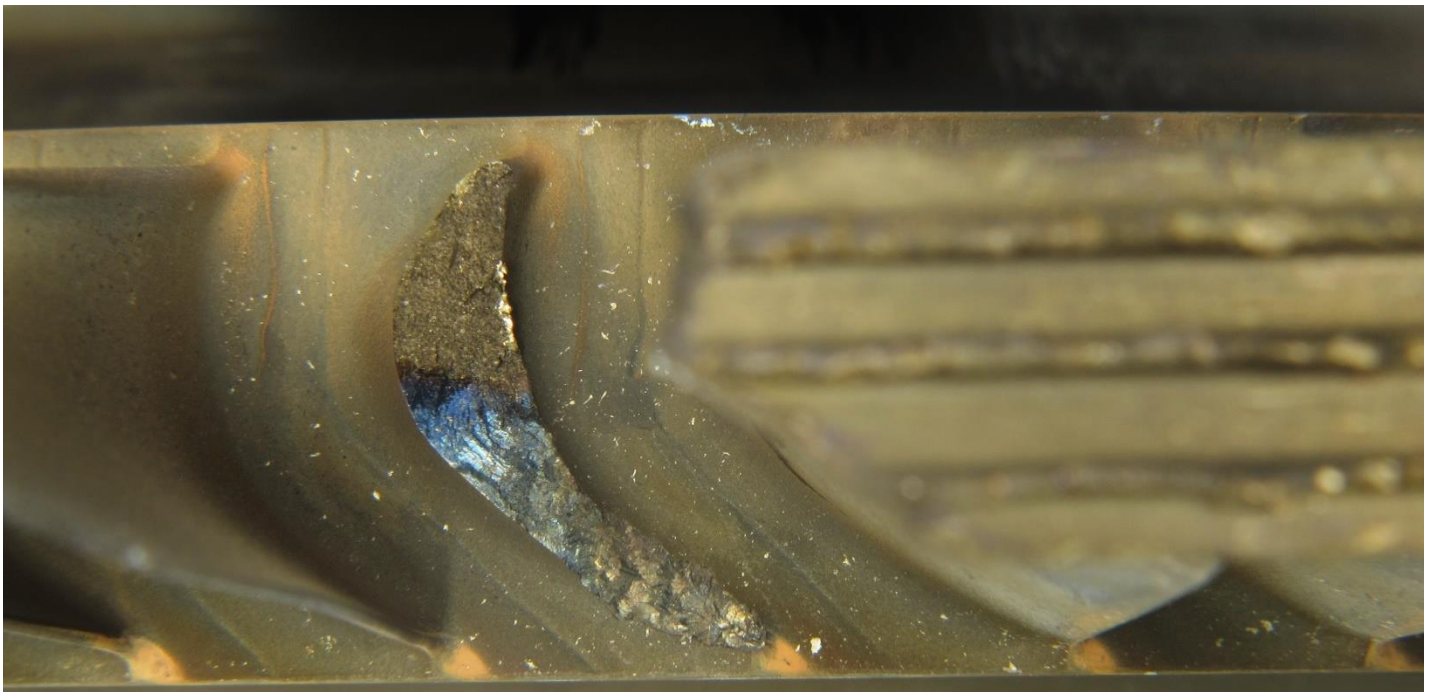
**Figure 6.** Fracture surface on airfoil #1 near the root.

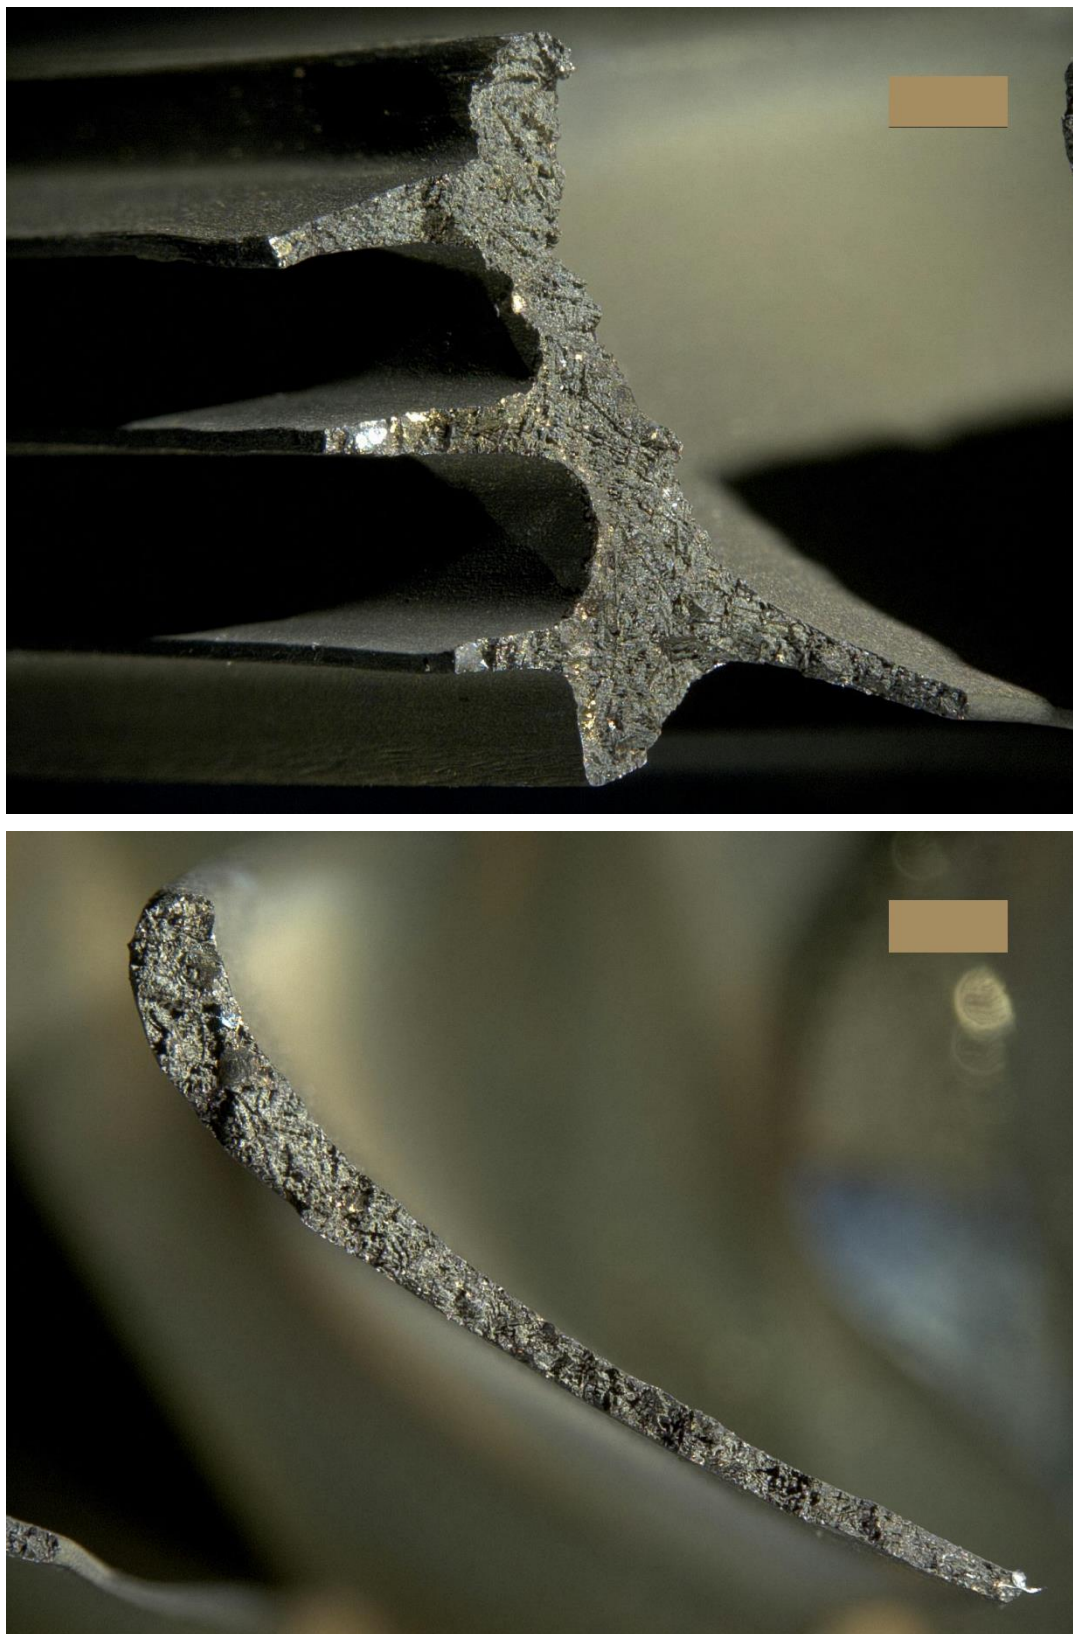
**Figure 7.** Detailed views of the fracture surfaces on airfoils #34 (top) and #35 (bottom).

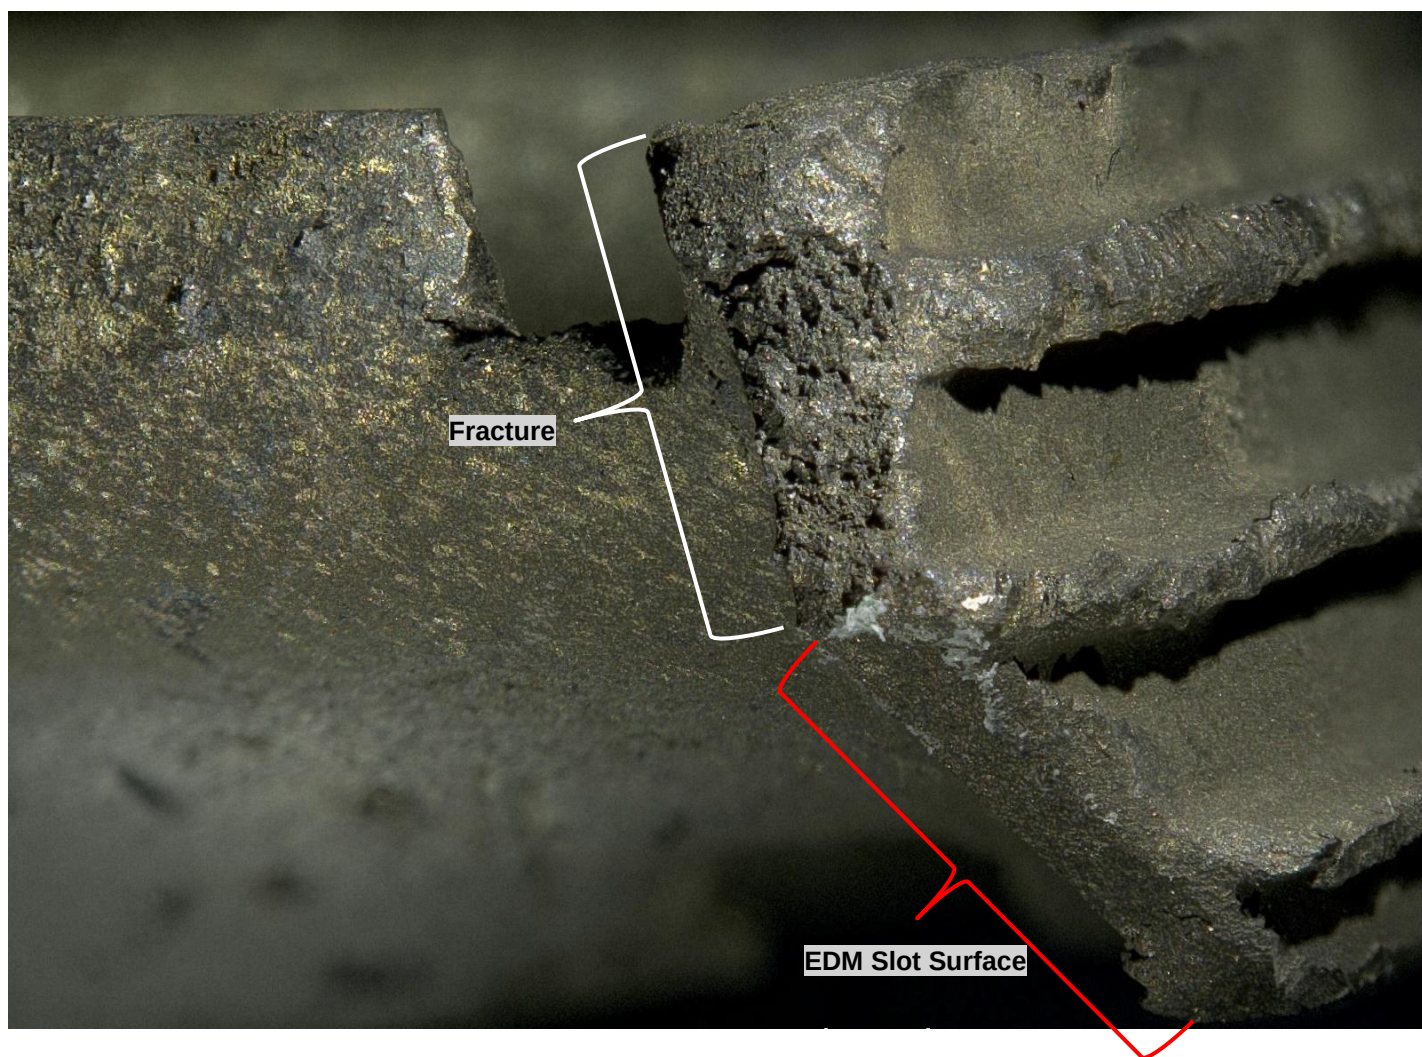
**Figure 8.** Detailed view showing the fracture through the shroud adjacent to the EDM slot outboard of airfoil #2.

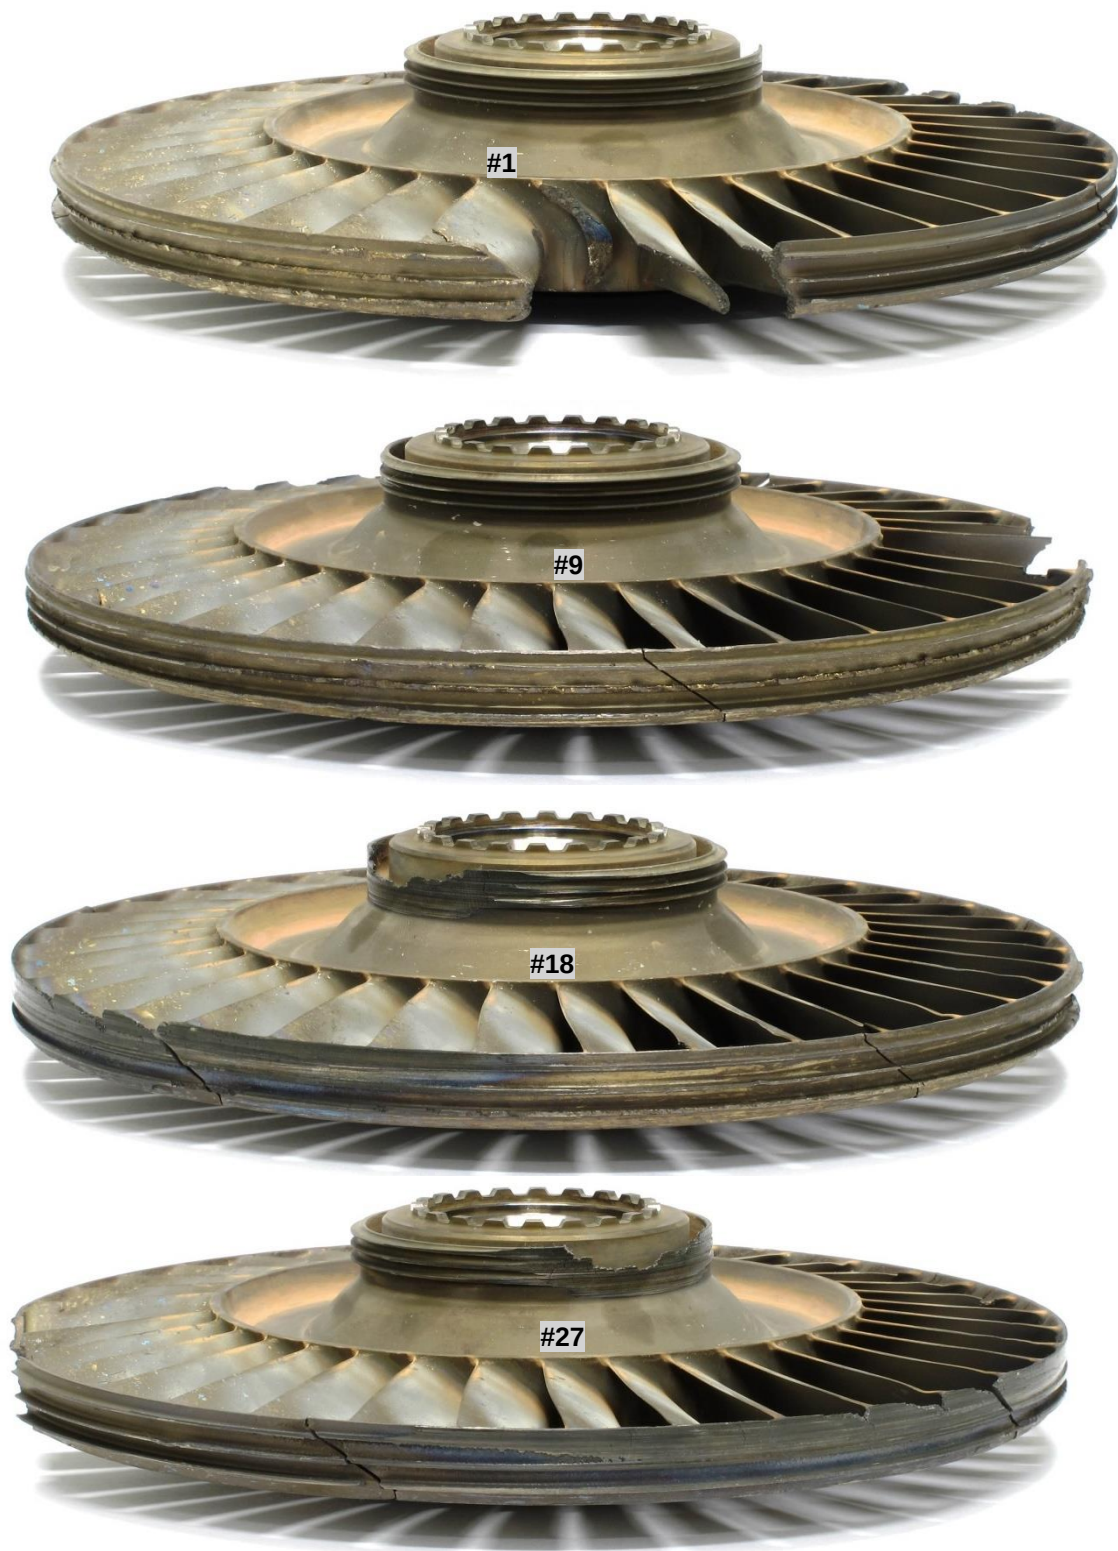
Figure 9 shows 90° radial views of the third stage turbine wheel. The outboard surface of the shroud and knife seals, as well as the trailing edge side interstage knife seals, exhibited asymmetric rub damage. The thickness

**Figure 9.** Four views of the third stage turbine wheel showing the extent of the rub damage to the knife seals and shroud. Each image is rotated ~90° from previous in the direction of turbine rotation.

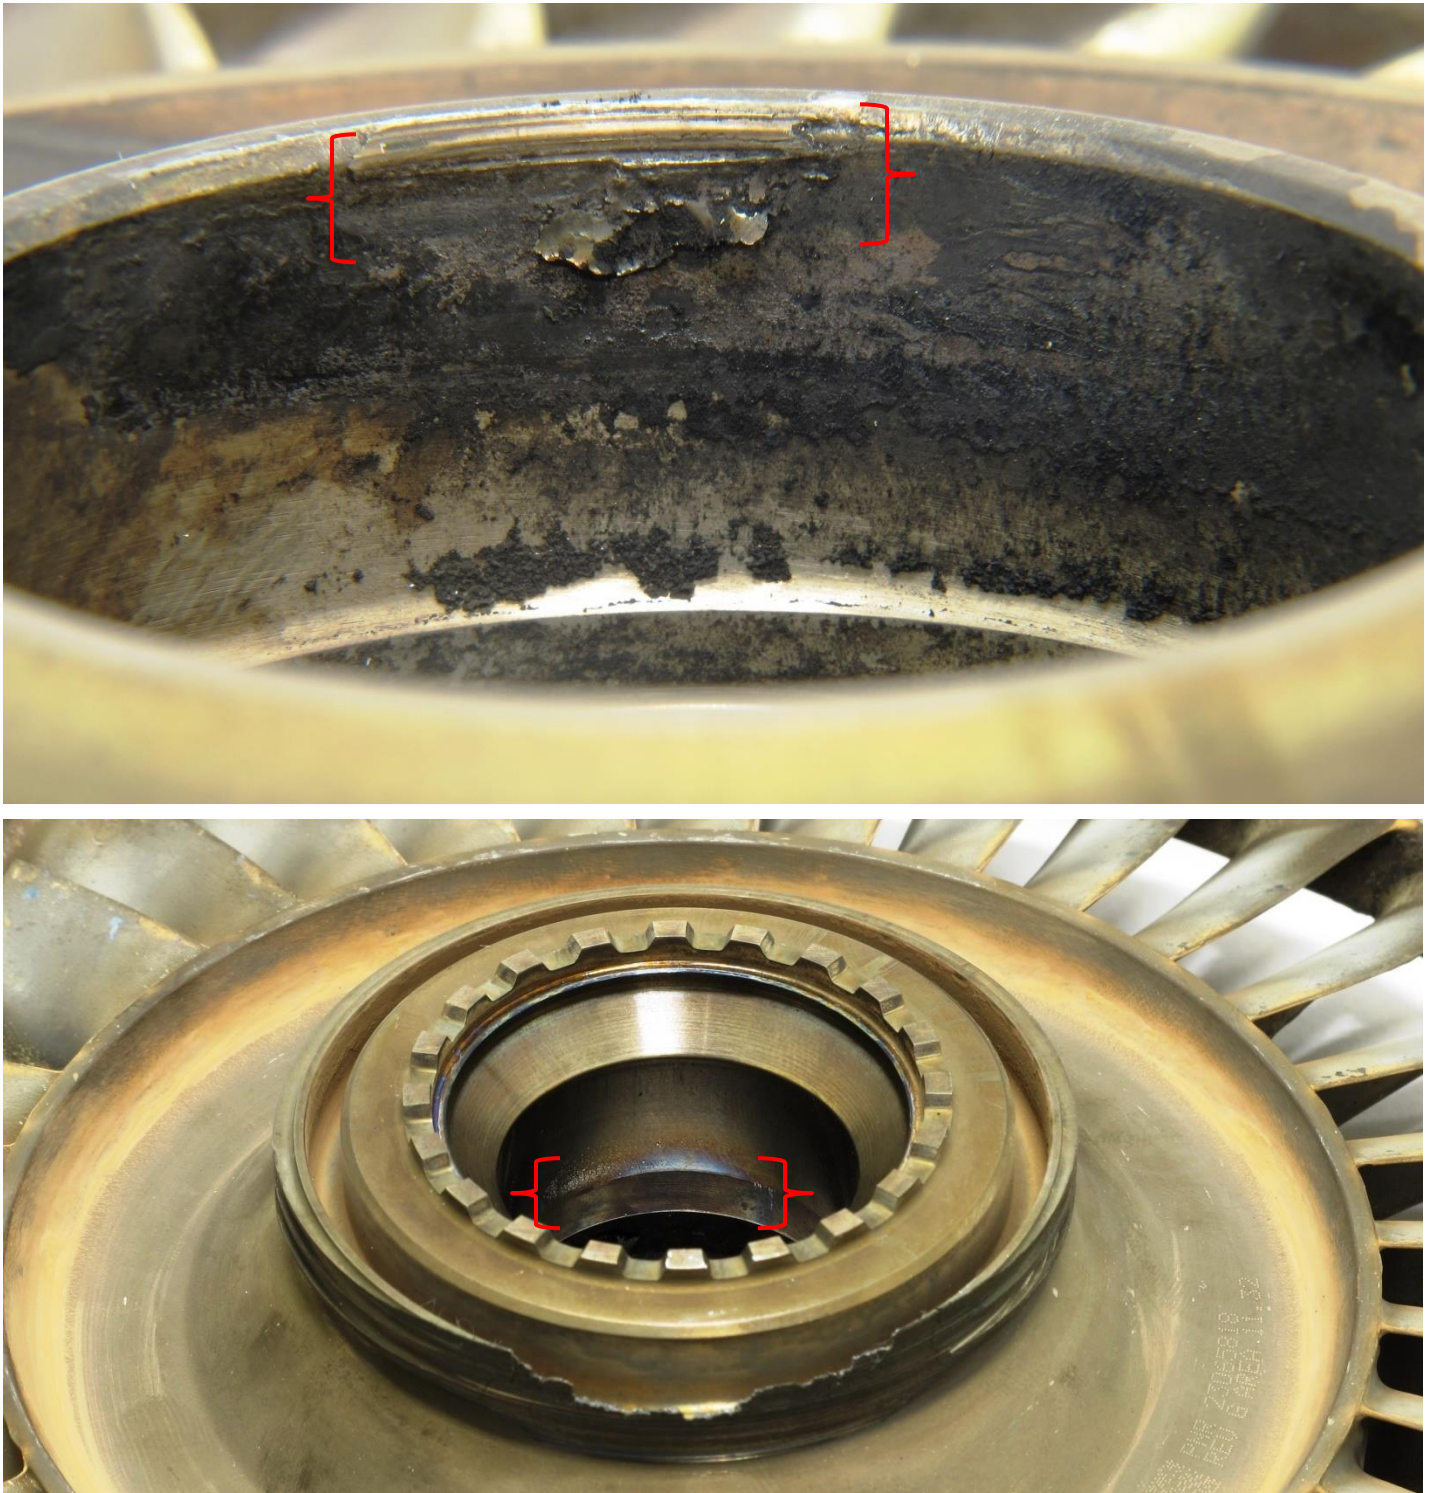
of the shroud band on both the leading and trailing edge sides was measured adjacent to airfoils #2, #9, #18, and #27 and the results are shown in Table 2. The bore also exhibited rub damage, Figure 10, on a span from airfoil #2 to #7. The leading edge side of the bore also exhibited coked oil. Figure 11 shows the interstage curvic teeth on the third stage turbine wheel, which exhibited wear on both the drive and coast side flanks.

**Figure 10.** Detailed views showing rub damage (red braces) on the leading edge (top) and trailing edge (bottom) sides of the bore. The leading edge side of the bore also exhibited coked oil.

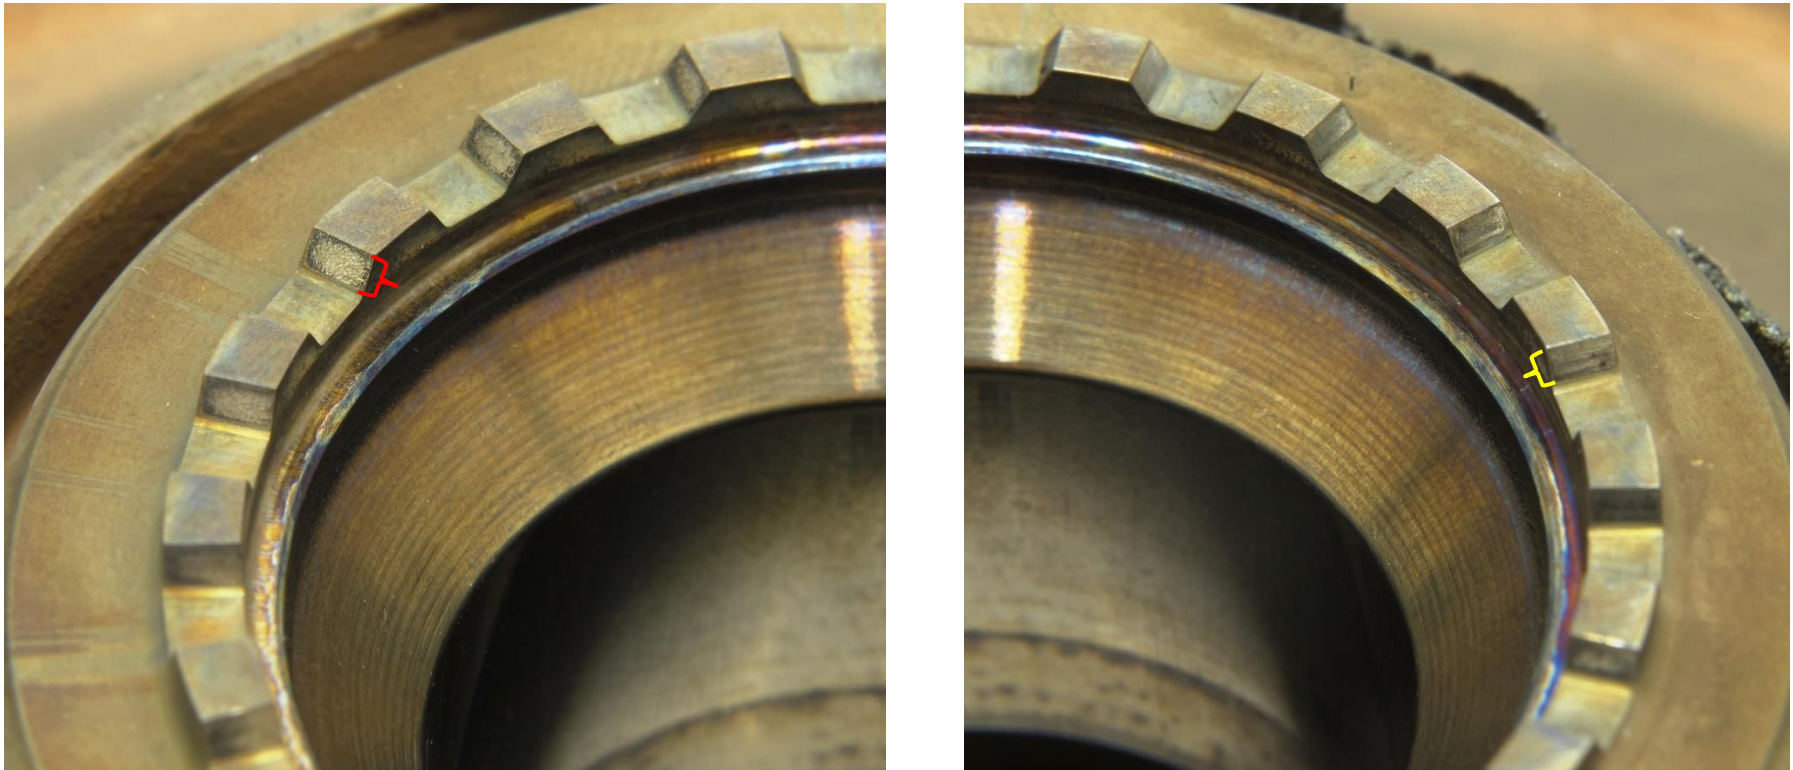
Figure 11. Representative condition of the drive (left, red brace) and coast (right, yellow brace) side flanks of the interstage curvic teeth.

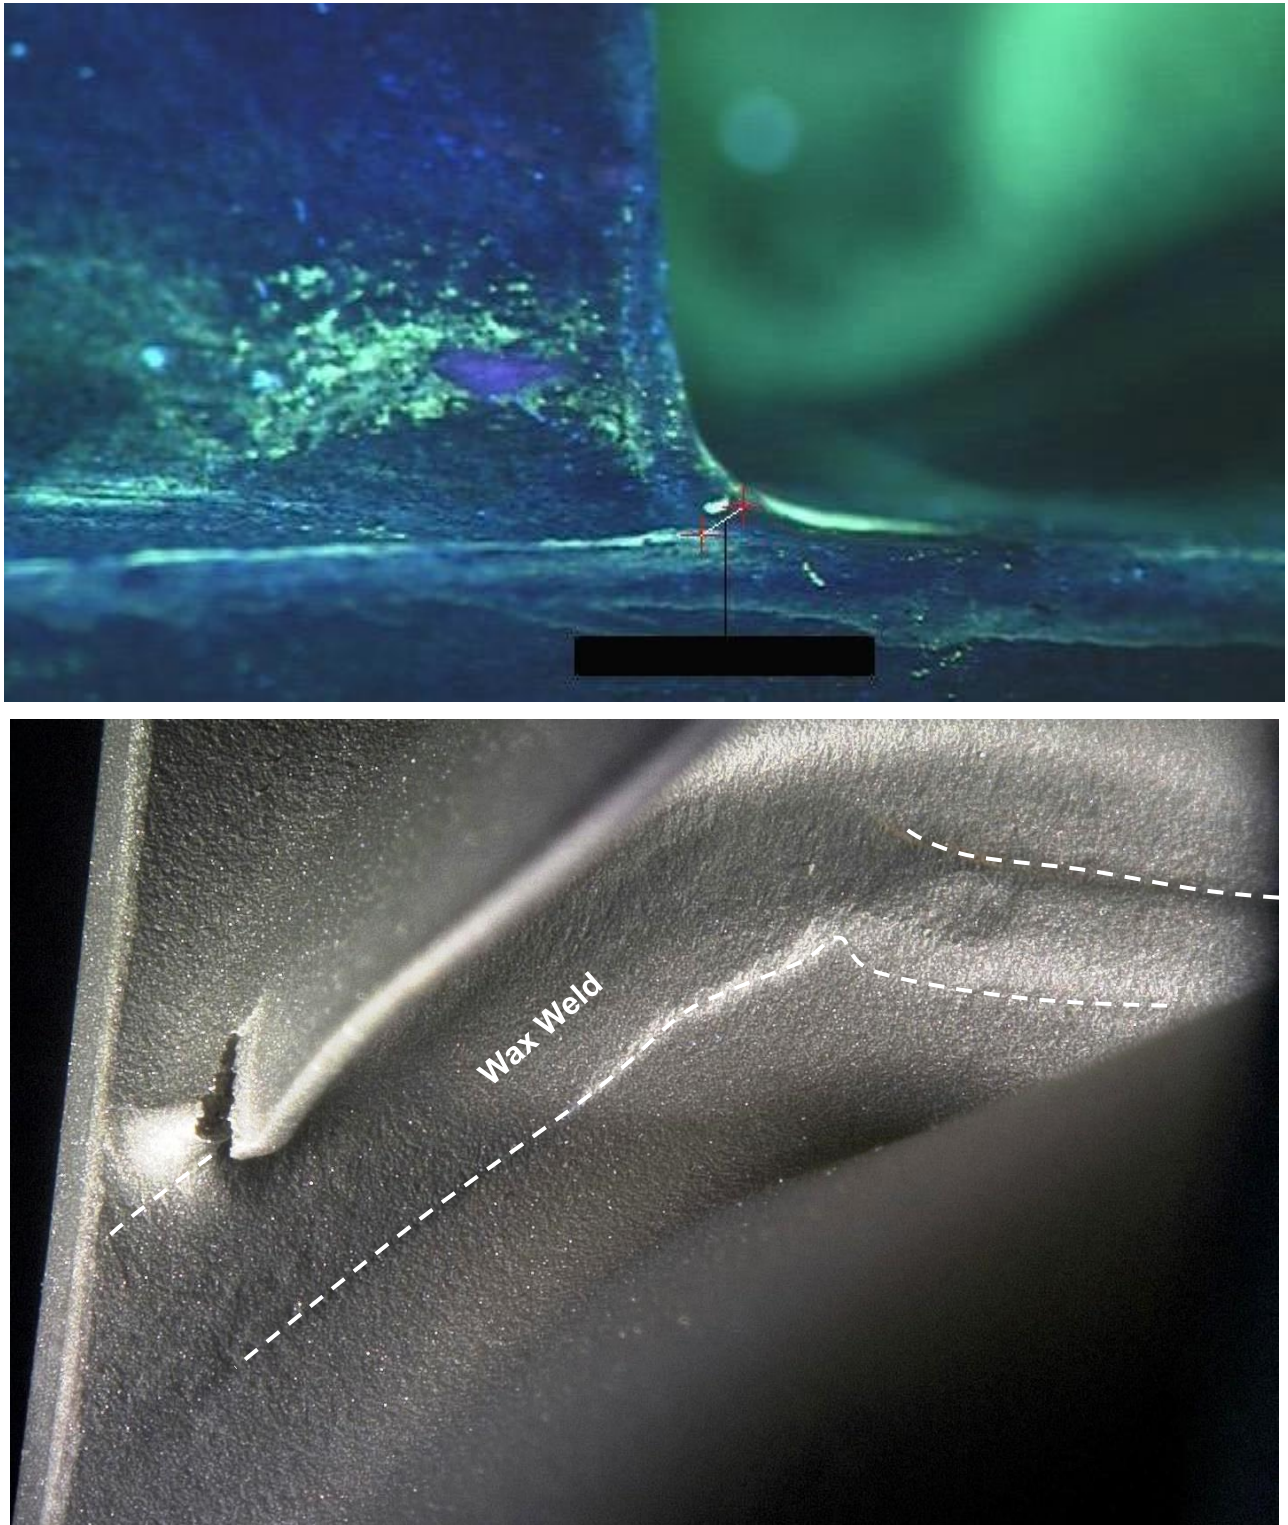
The third stage turbine wheel was subjected to fluorescent penetrant inspection (FPI) by the Rolls-Royce Corporation Test Department. Crack-like FPI indications were found in the trailing edge root radius of each of the packet trailing airfoils #8, #15, #22, and #29, as well as in airfoil #35, which immediately preceded the fractured and liberated airfoil #1. The indications in each packet trailing airfoil and in airfoil #35 are shown in Figure 12 through Figure 16, along with radial views showing the pressure side wax weld adjacent to each airfoil with an FPI indication in the trailing edge. The pressure side wax weld intersected the airfoil root radius of each airfoil. Figure 17 and Figure 18 show representative pressure side wax weld intersections on airfoils that did not exhibit crack-like FPI indications.

**Figure 12. Top: Black light image showing the crack-like FPI indication in the trailing edge root radius of airfoil #8.**  
**Bottom: White light image showing the wax weld on the pressure side of airfoil #8. The wax weld intersected the airfoil root radius.**

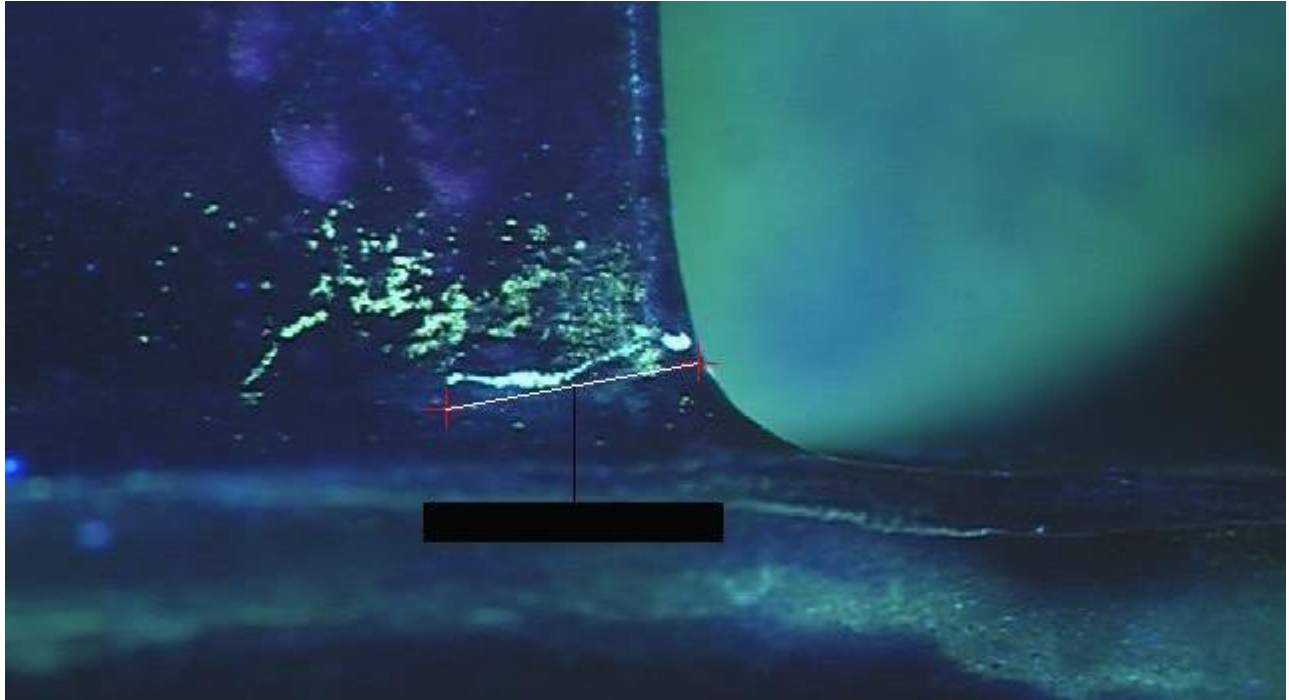
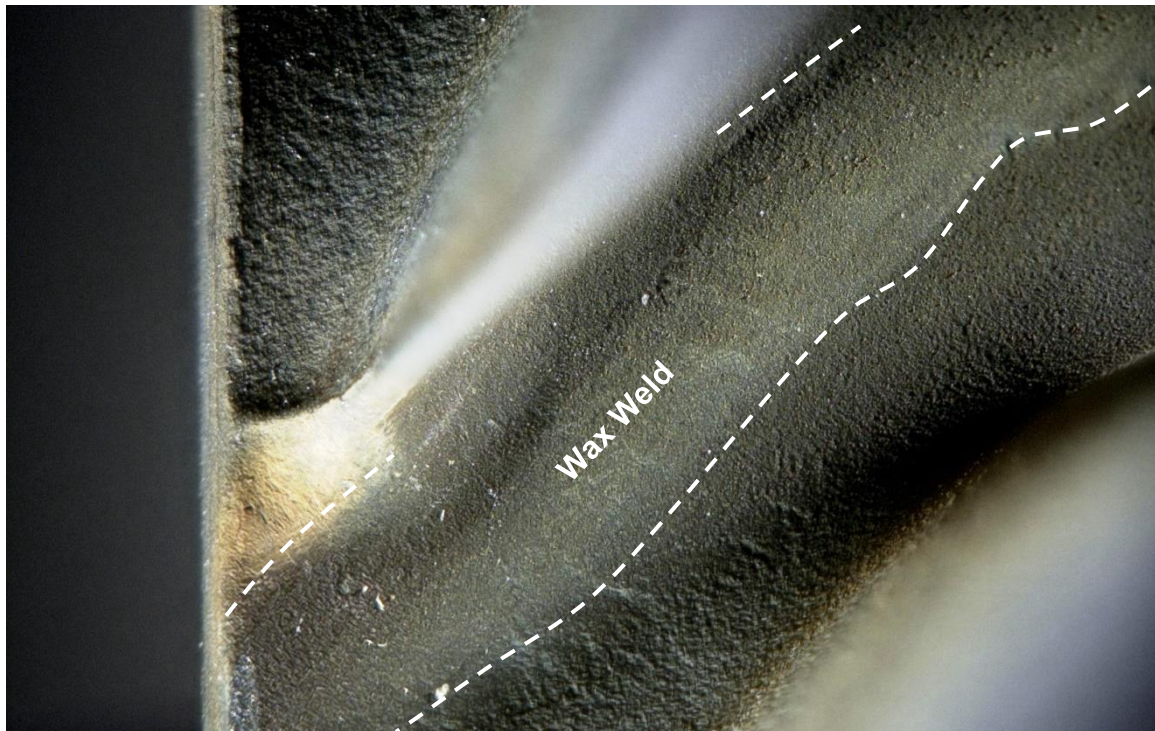
An attempt at lab fracturing the crack-like FPI indication in airfoil #15 was unsuccessful, but the indication was undamaged from the lab fracture process. The airfoil was cut, mounted, and polished, which revealed a crack measuring approximately 0.051 inch long extending from the trailing edge root radius, shown in Figure 36.

**Figure 13. Top: Black light image showing the crack-like FPI indication in the trailing edge root radius of airfoil #15.**  
**Bottom: White light image showing the wax weld on the pressure side of airfoil #15. The wax weld intersected the airfoil root radius.**

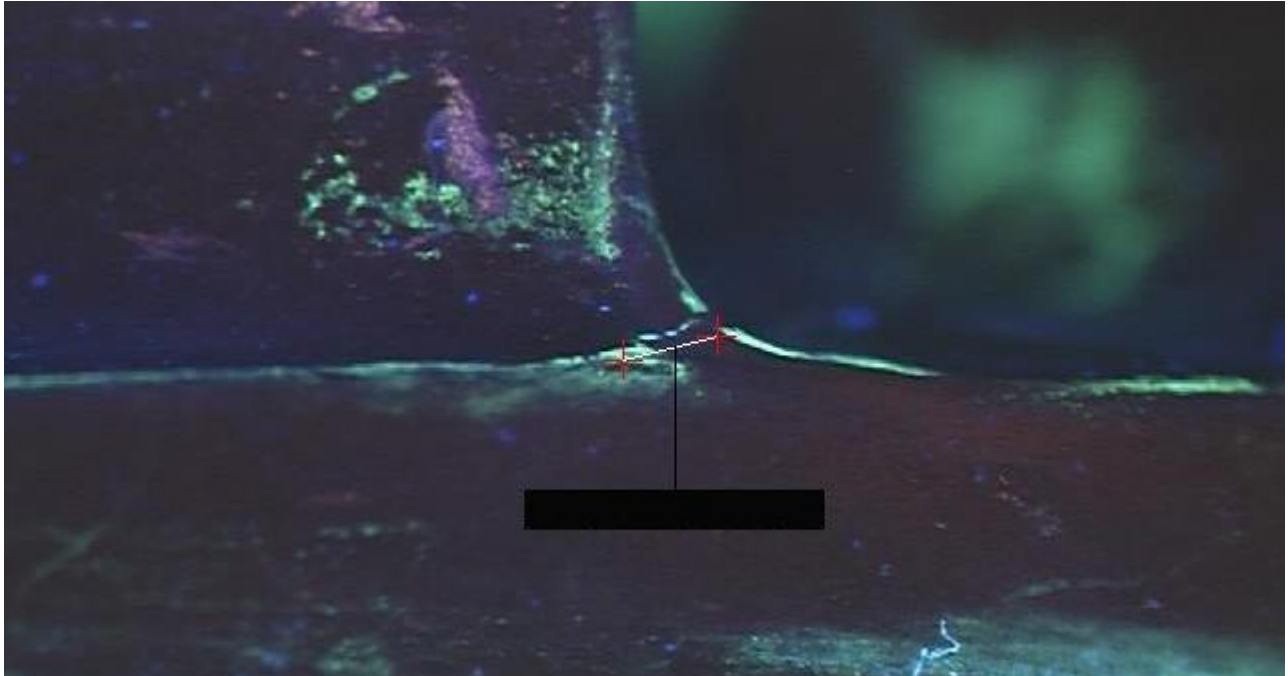
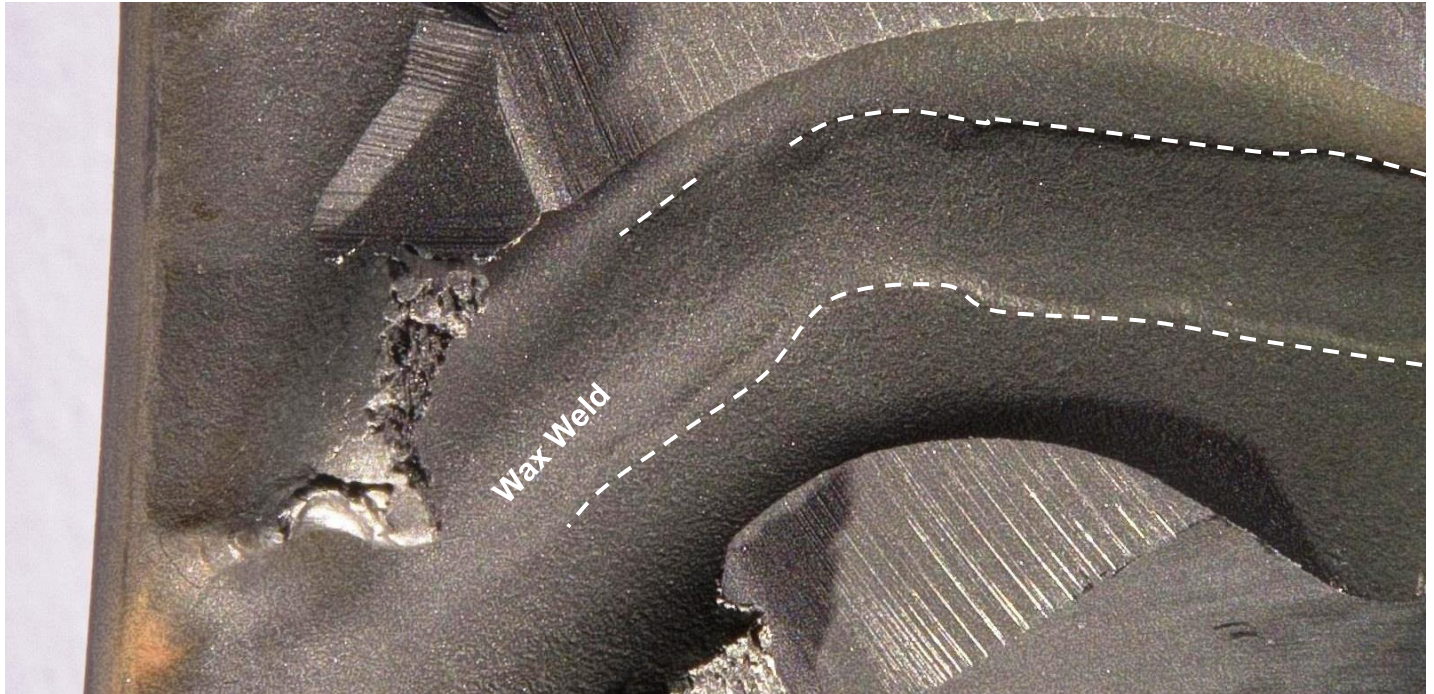
**Figure 14. Top: Black light image showing the crack-like FPI indication in the trailing edge root radius of airfoil #22.**  
**Bottom: White light image showing the wax weld on the pressure side of airfoil #22. The wax weld intersected the airfoil root radius.**
