| <b>Rolls-Royce</b> | Rolls-Royce Corporation<br>450 S. Meridian Street<br>Indianapolis, Indiana<br>46225-1103, USA | <b>REPORT NO.</b><br>19FAE-061-PR | <b>REV.</b><br>Initial | <b>PAGES</b><br>1 of 64 |
| <b>TITLE</b><br><br><b>METALLURGICAL INVESTIGATION OF A THIRD STAGE TURBINE WHEEL, P/N 23065818, REMOVED FROM AN M250 C20B ENGINE, S/N CAE832565 OPERATED BY WILBUR ELLIS CO.</b> | | <b>PREPARED</b><br><br>Signatures on File | | |

| Part Name: | Third Stage Turbine Wheel |
| Engine Serial Number: | CAE832565 |

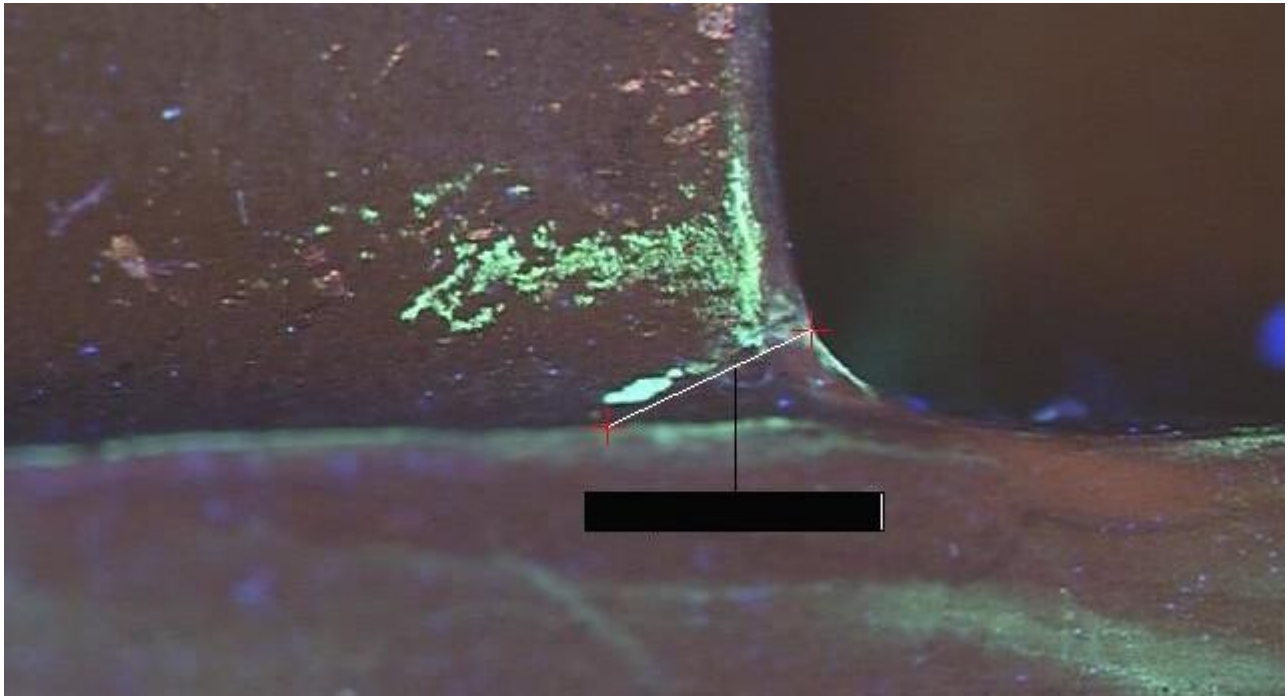
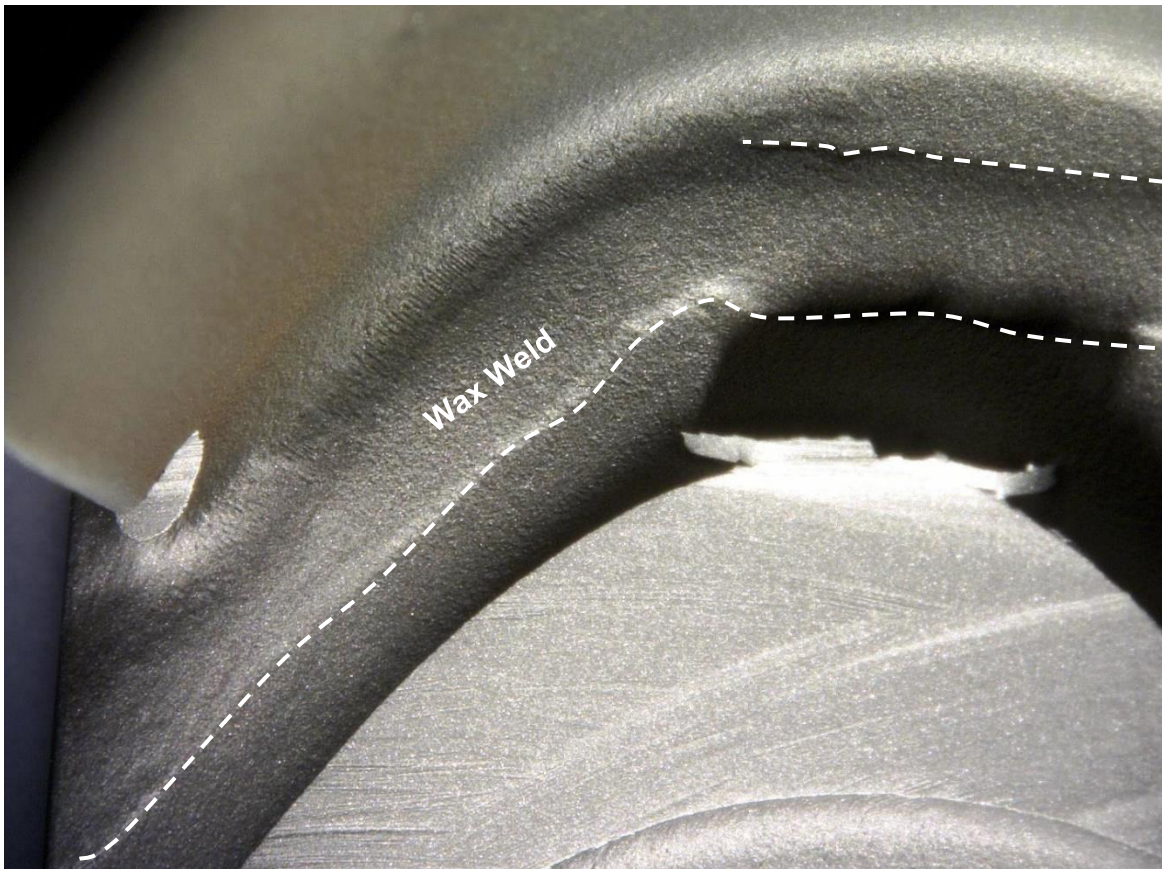
**Figure 15. Top: Black light image showing the crack-like FPI indication in the trailing edge root radius of airfoil #29.**  
**Bottom: White light image showing the wax weld on the pressure side of airfoil #29. The wax weld intersected the airfoil root radius.**

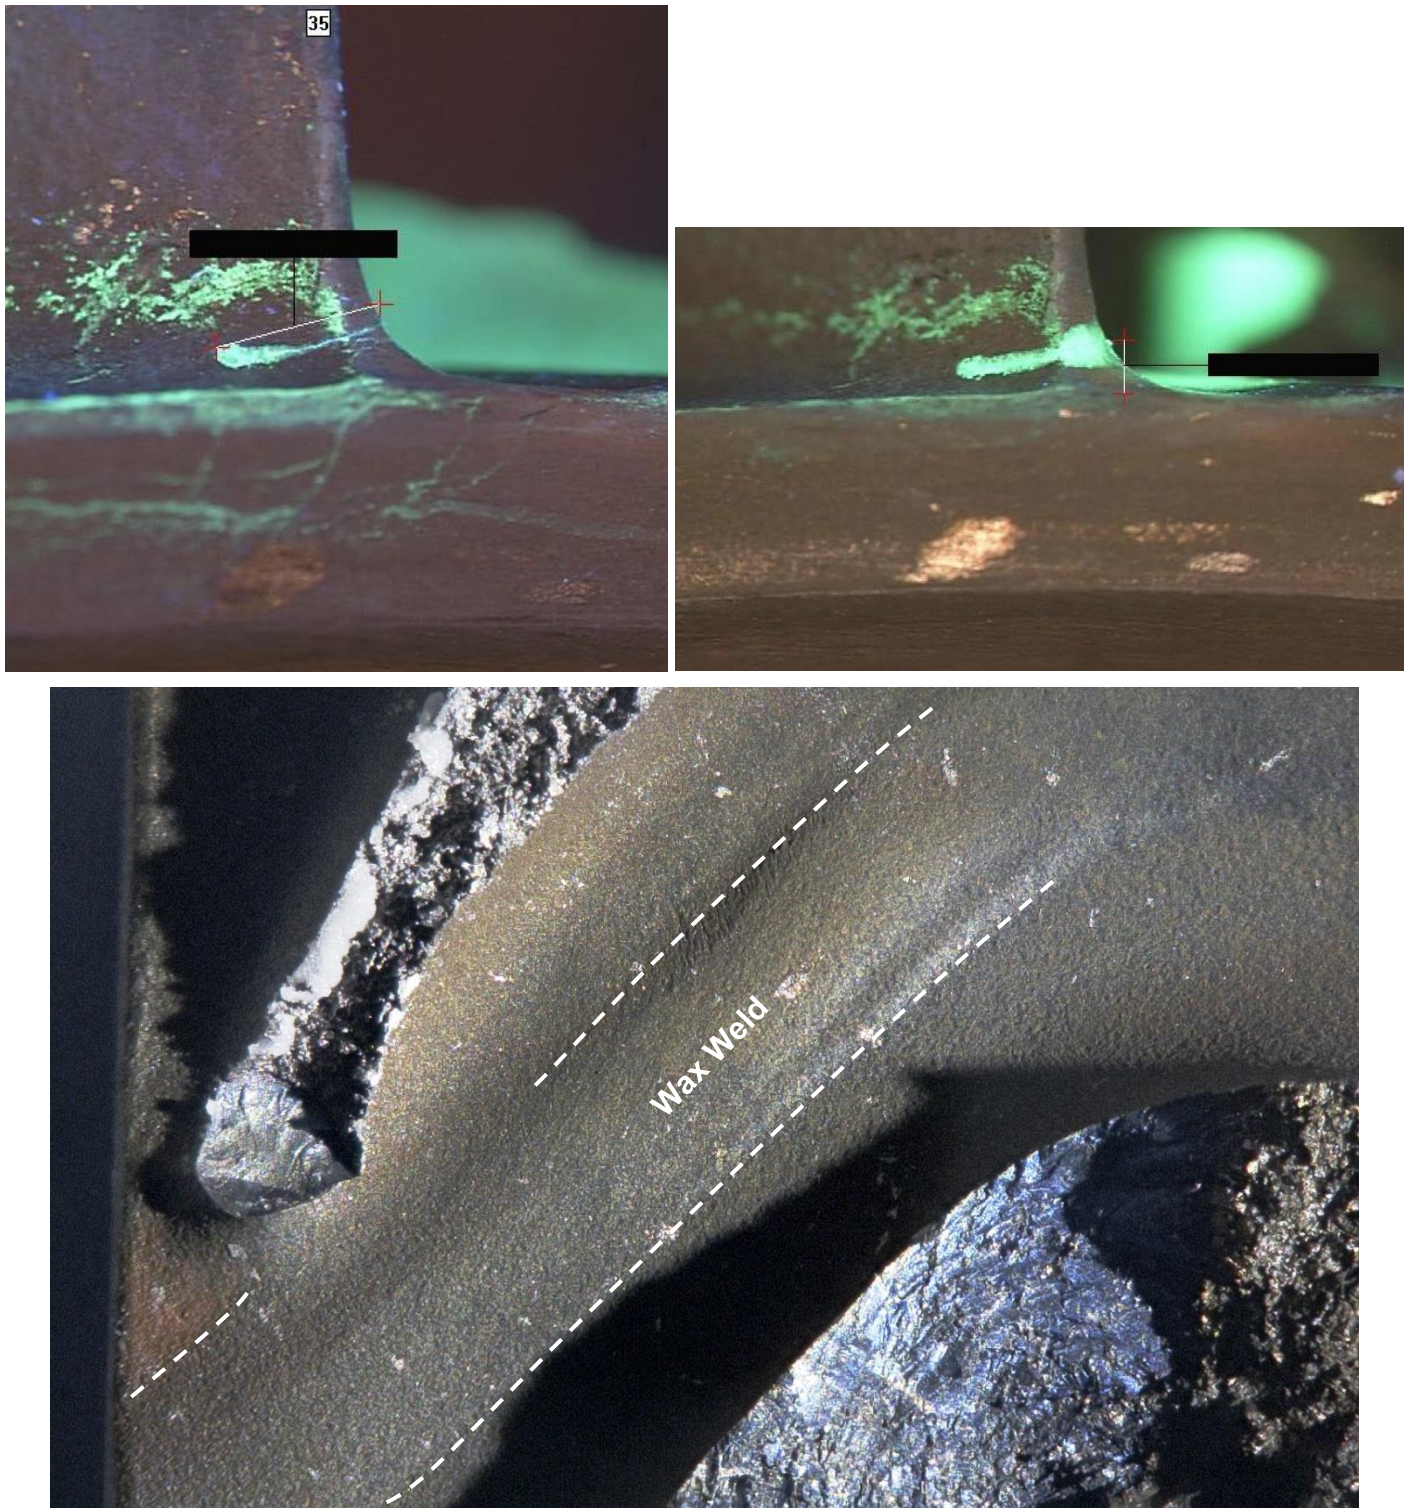
The crack-like FPI indication in the trailing edge root radius of airfoil #35 (Figure 16) was fractured in the laboratory; the revealed fracture surface, located approximately 0.020 inch outboard of the rim, is shown in Figure 31. The fracture surface exhibited beach marks radiating away from the trailing edge tip. Figure 32 shows a suction side view of the fracture, which propagated inboard and toward the leading edge for approximately

**Figure 16.** Top: Black light images showing the crack-like FPI indication in the trailing edge root radius of airfoil #35.  
Bottom: White light image showing the wax weld on the pressure side of airfoil #35. The wax weld intersected the airfoil root radius.

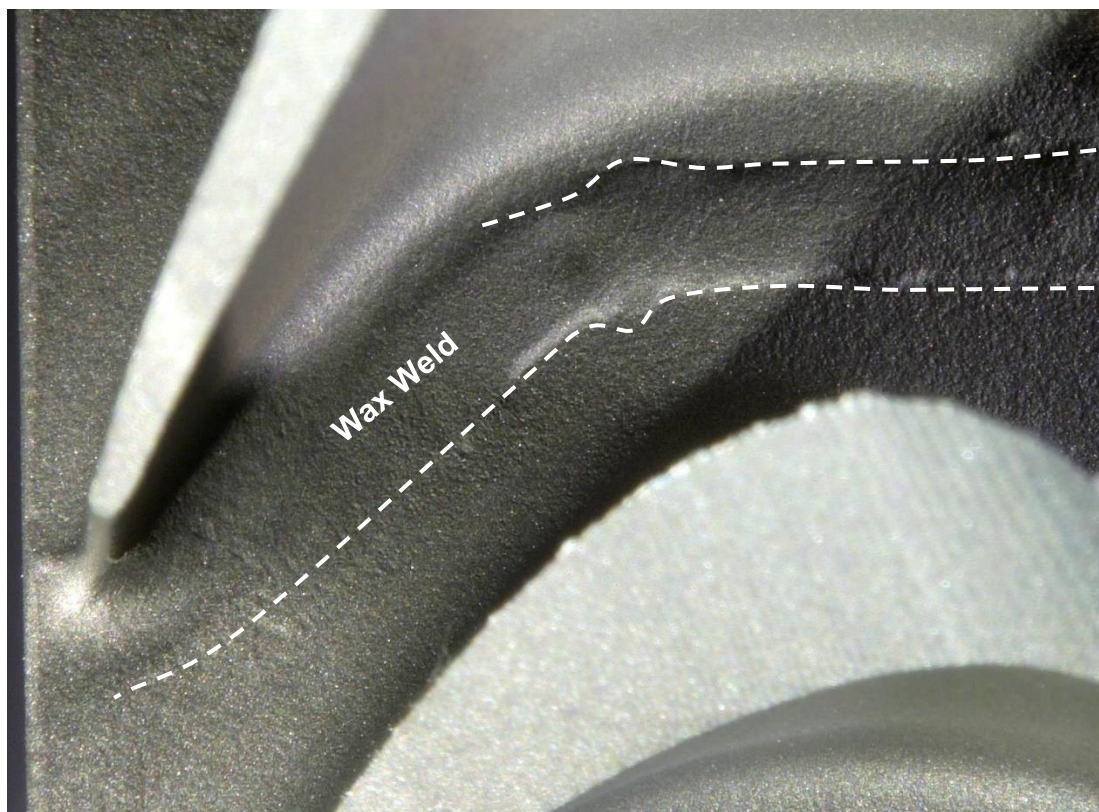
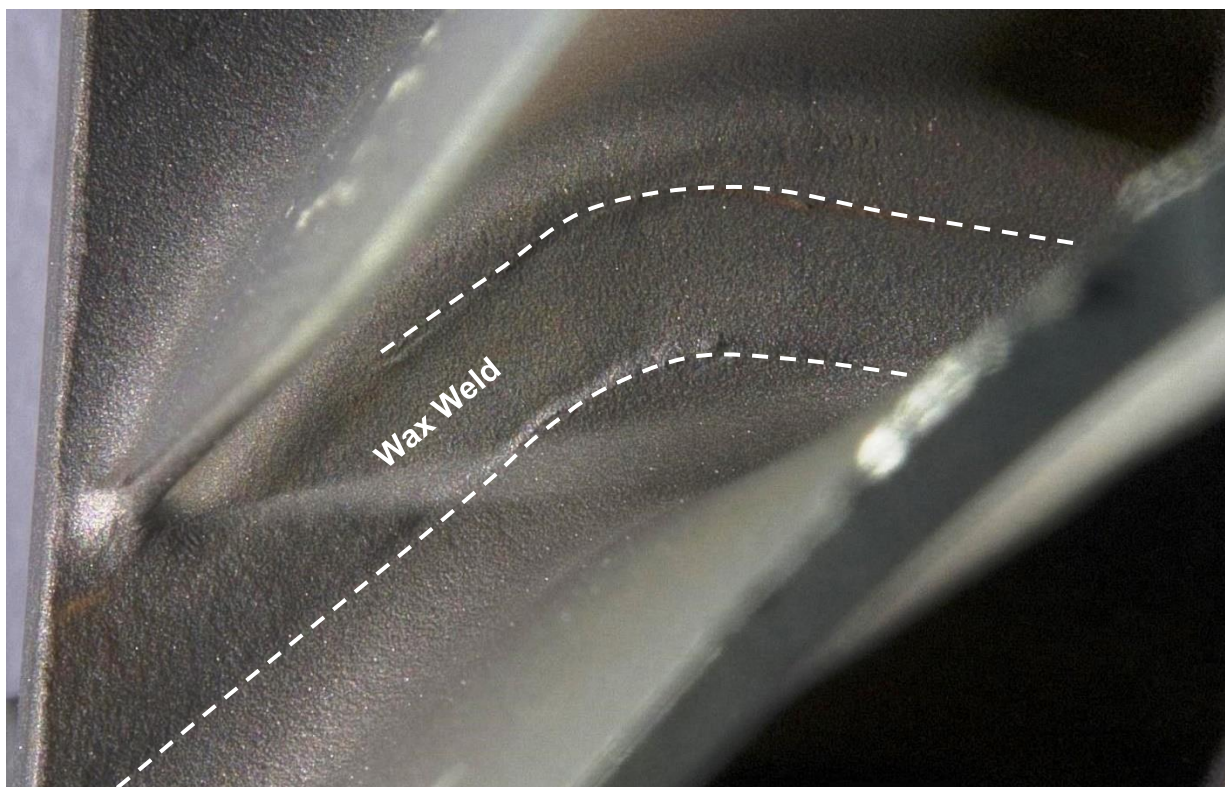
**Figure 17. Detailed views showing the wax weld on the pressure side of airfoils #11 (top) and #24 (bottom). The wax weld intersected the airfoil root radius of both airfoils.**

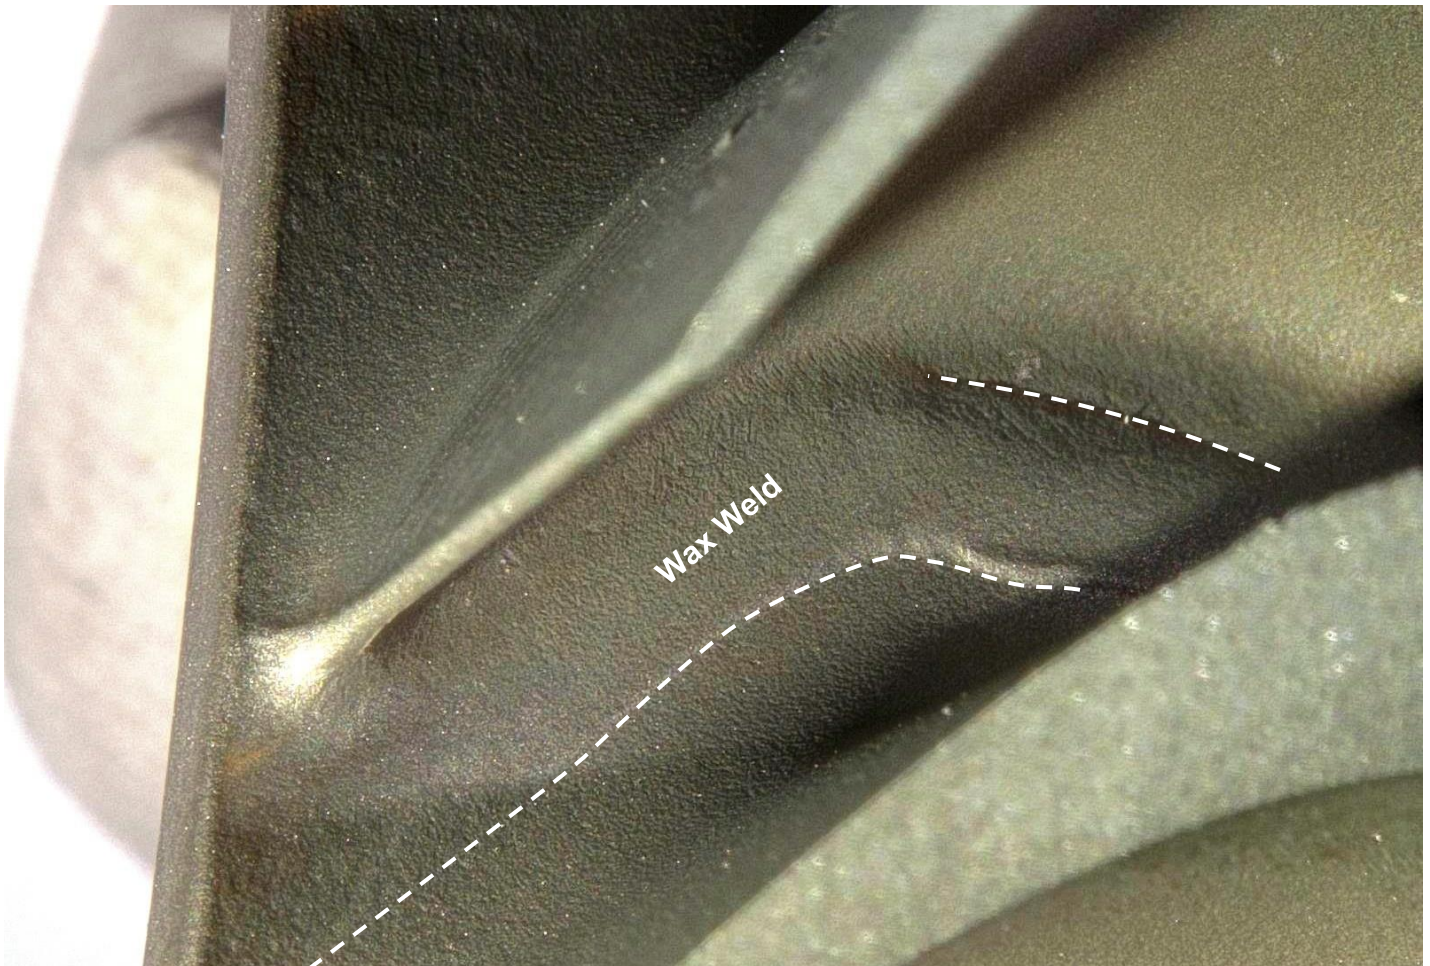
**Figure 18.** Detailed view showing the wax weld on the pressure side of airfoil #25. The wax weld intersected the airfoil root radius.

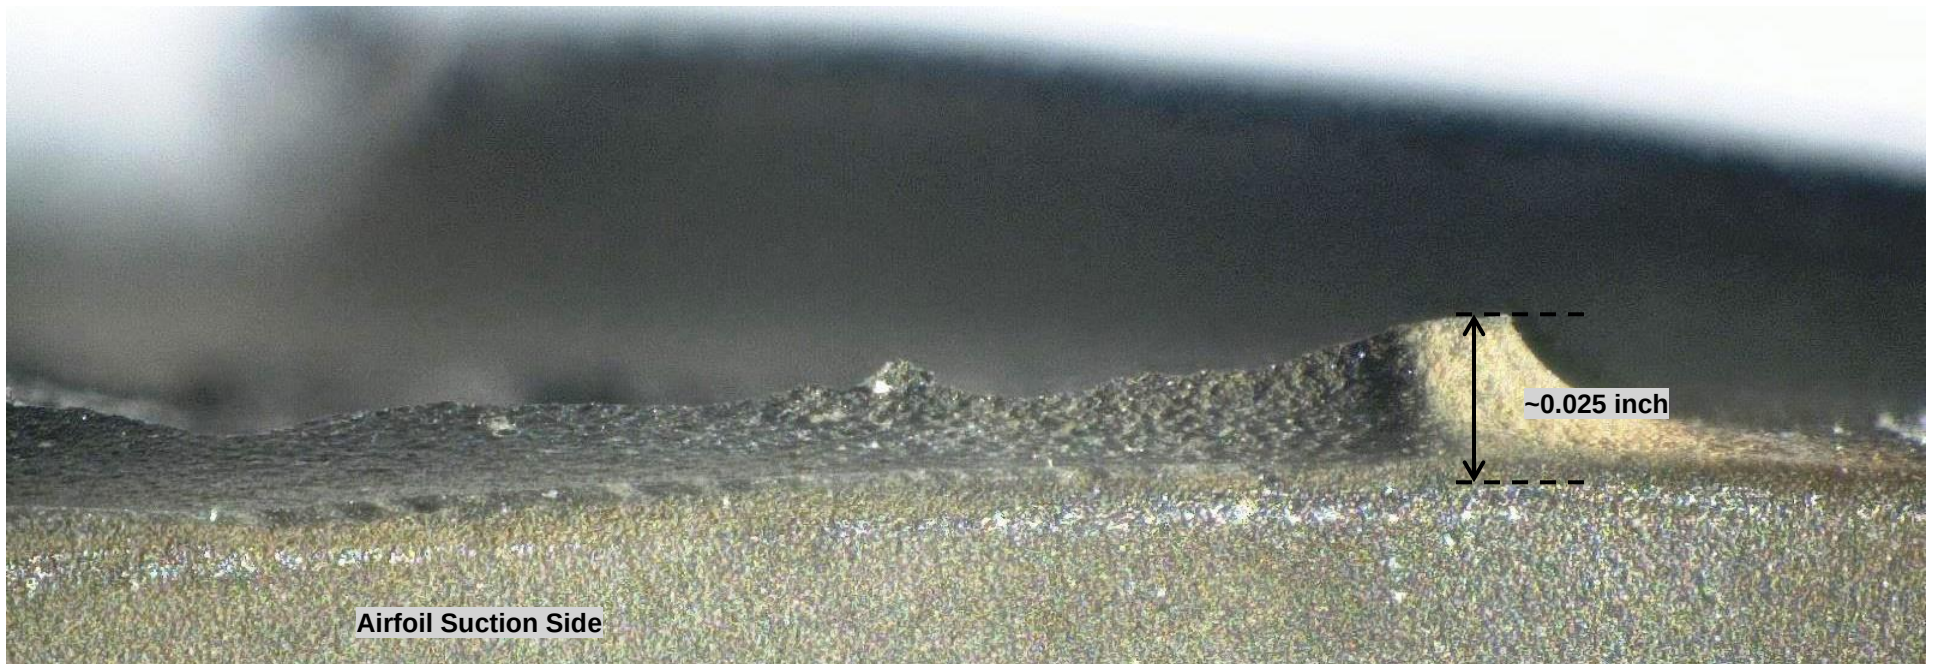
Detailed visual inspection of the inboard portion of airfoil #1 showed that the airfoil fractured approximately 0.025 inch outboard of the rim at the trailing edge root radius as shown in Figure 19. From the trailing edge, the fracture progressed along the length of the airfoil and slightly inboard toward the rim for approximately 0.044 inch as measured on the pressure side and 0.069 inch as measured on the suction side. The fracture surface profile at the trailing edge is shown in Figure 20 and Figure 21. The fracture propagated toward the leading edge approximately parallel to the rim surface before turning outboard approximately halfway along the length of the fatigue fracture, shown in the confocal laser scanning microscope (CLSM) image in Figure 22. Detailed inspection of the remnant of airfoil #1 also revealed that the pressure side airfoil wax weld intersected the airfoil fillet on the pressure side of the airfoil. The wax weld also extended out of the fillet radius at the trailing edge tip of the airfoil as shown in Figure 23.

**Figure 19. Detailed trailing edge view of airfoil #1 showing the geometry of the fillet and the profile of the fracture surface. The fracture initiated approximately 0.025 inch outboard of the rim.**

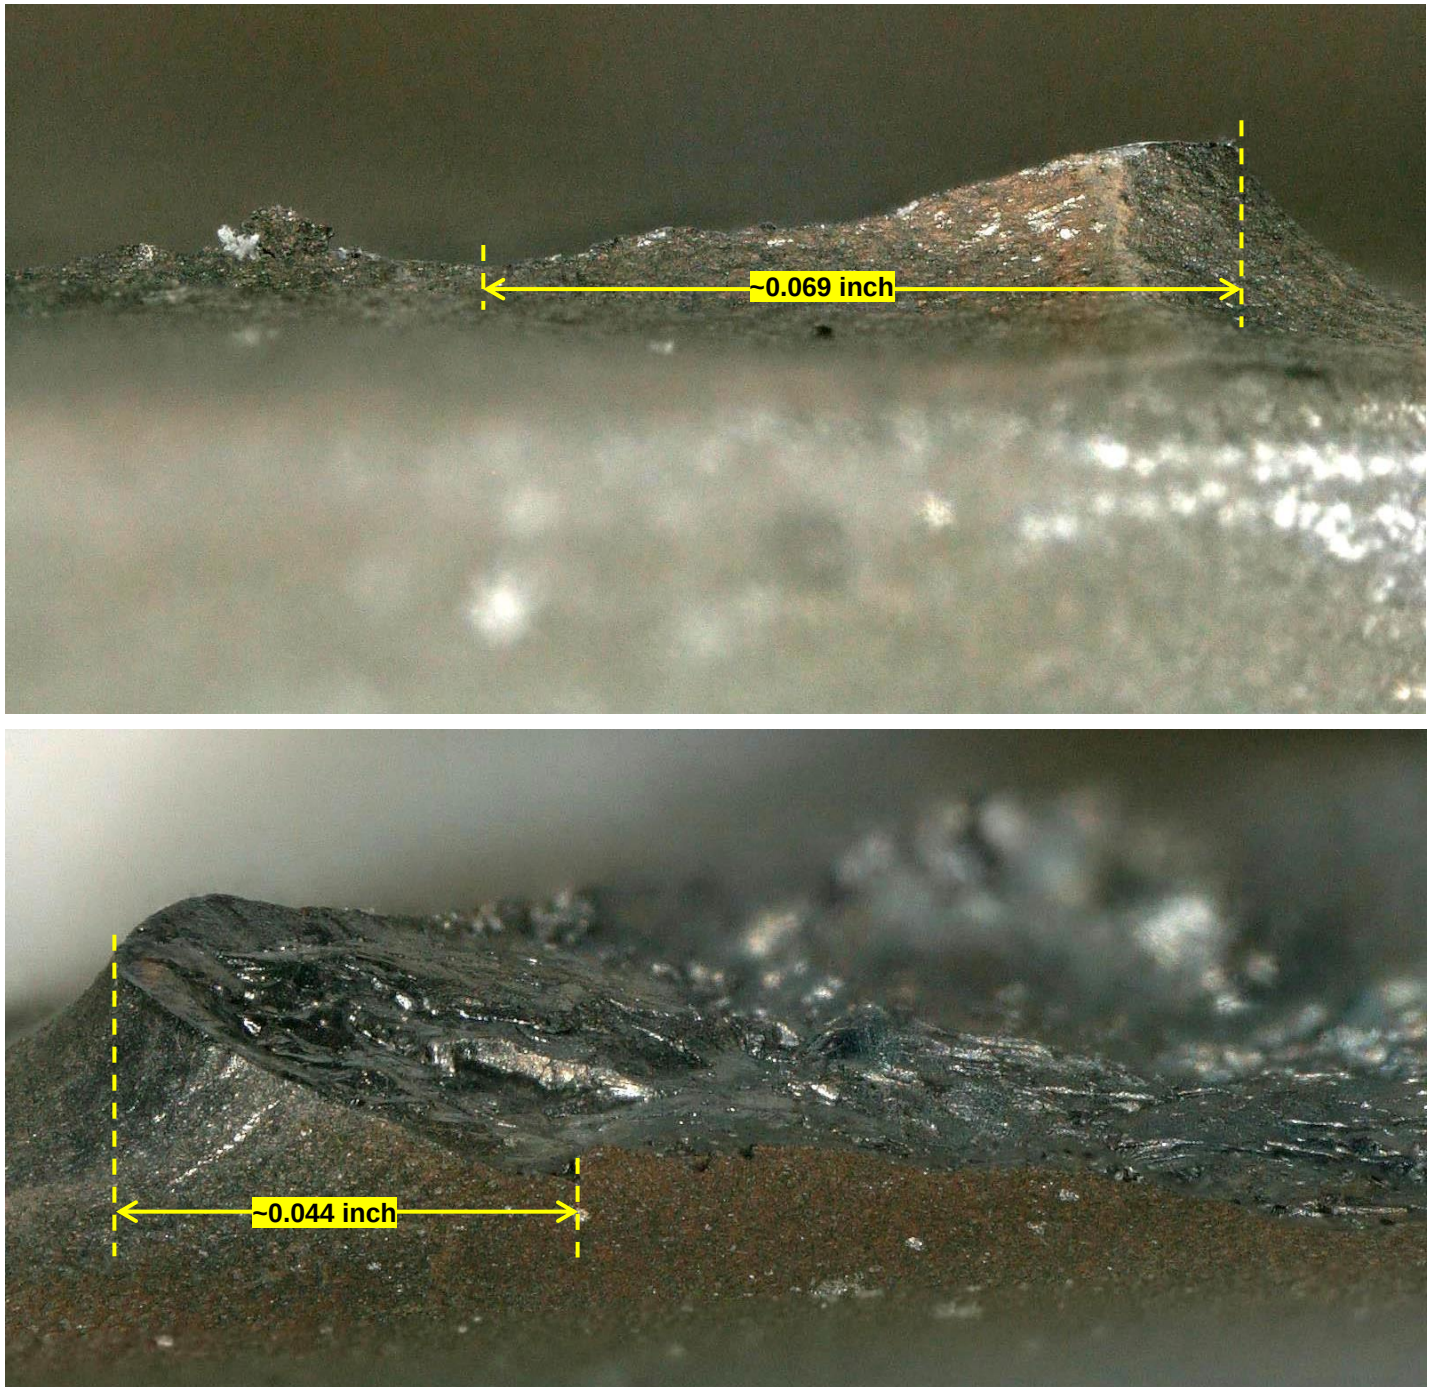
**Figure 20. Suction (top) and pressure (bottom) side views of the trailing edge area of the fracture. The fracture progressed inboard from the trailing edge before turning to propagate approximately parallel to the rim surface.**

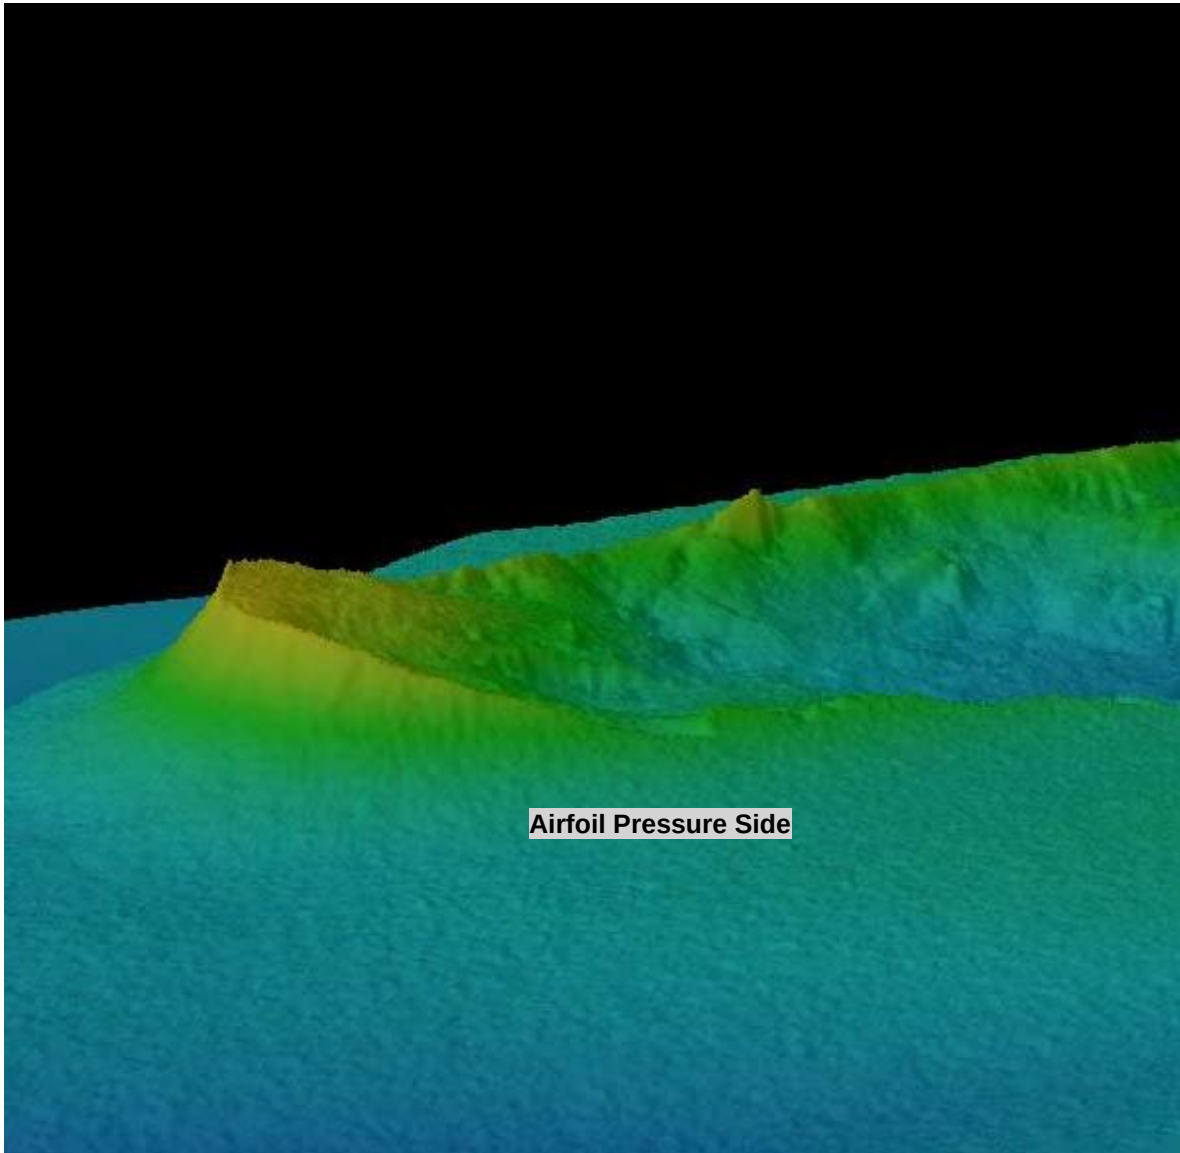
**Figure 21. Confocal laser scanning microscope (CLSM) scan of the trailing edge of airfoil #1 showing the profile of the fracture surface.**

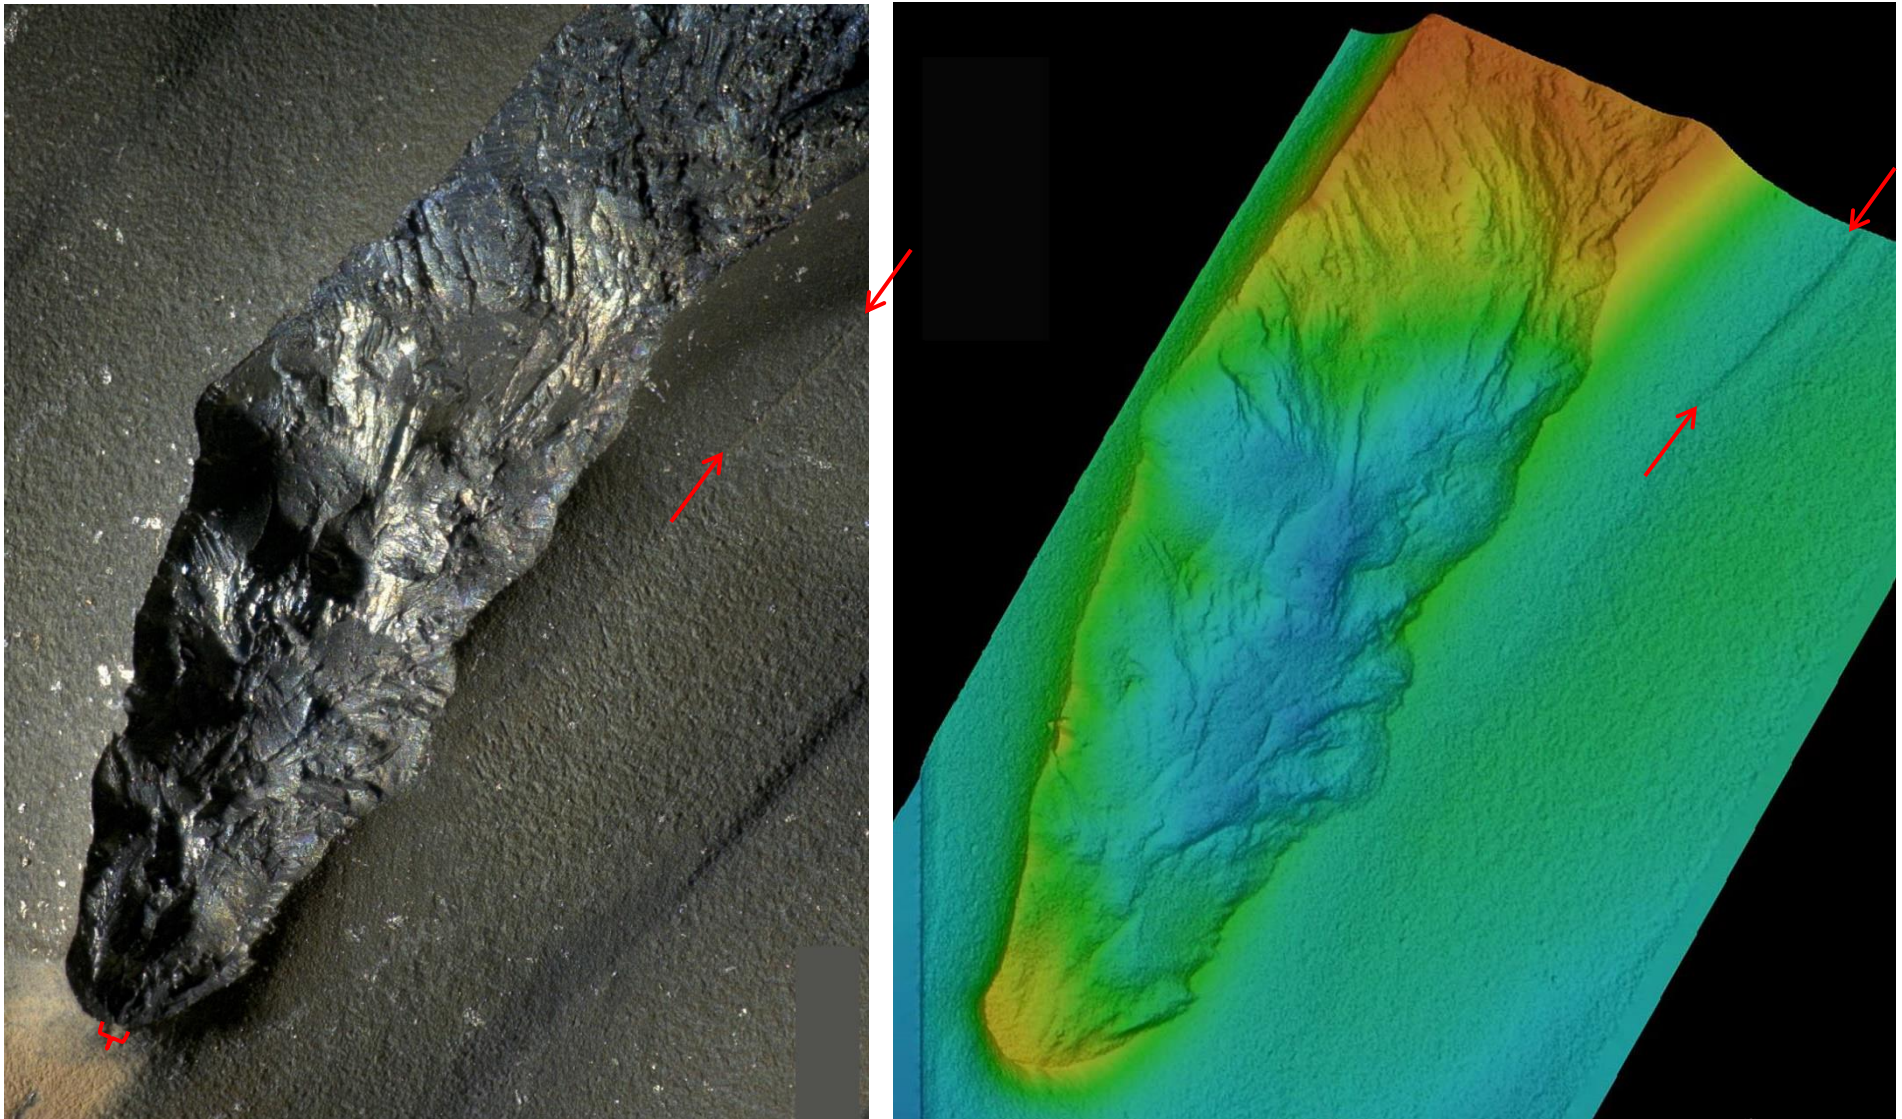
Figure 22. Optical image (left) and confocal laser scanning microscope (CLSM) topographical scan (right) of the trailing edge of airfoil #1 showing the location of the pressure side airfoil wax weld (between red arrows) adjacent to airfoil #1. The red brace shows the approximate location of the fatigue origin area shown in Figure 27.

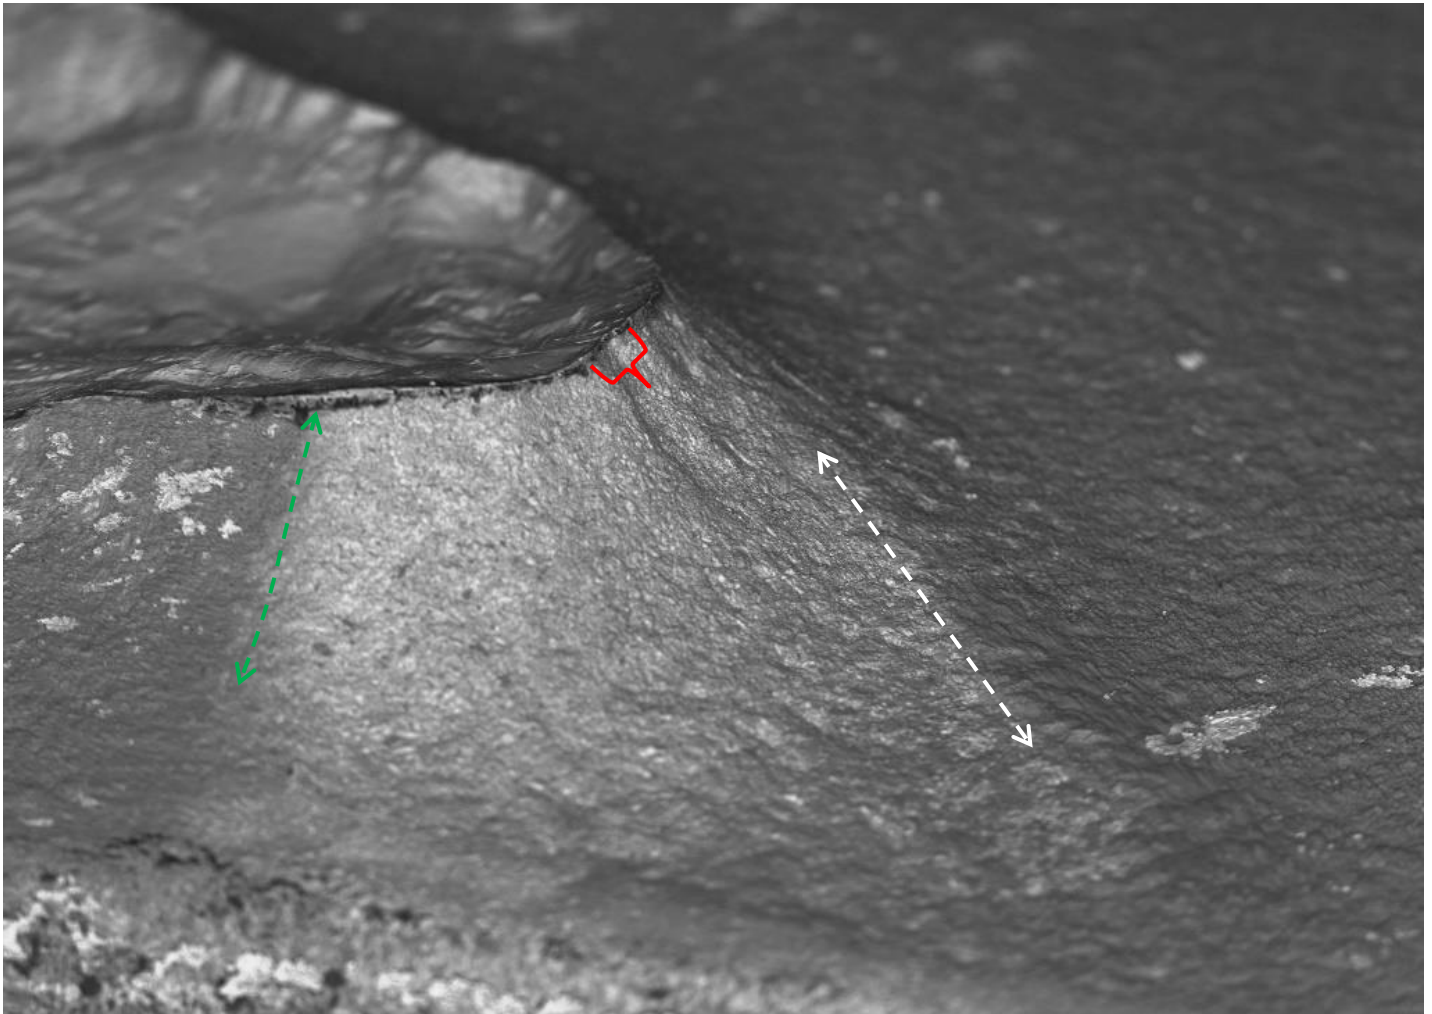
**Figure 23. Backscattered electron SEM image showing the airfoil parting line (green dashed line) and the pressure side wax weld (white dashed line) extending out of the fillet radius at the trailing edge tip of the airfoil. The fatigue origin (red brace) was located between the wax weld and parting line.**

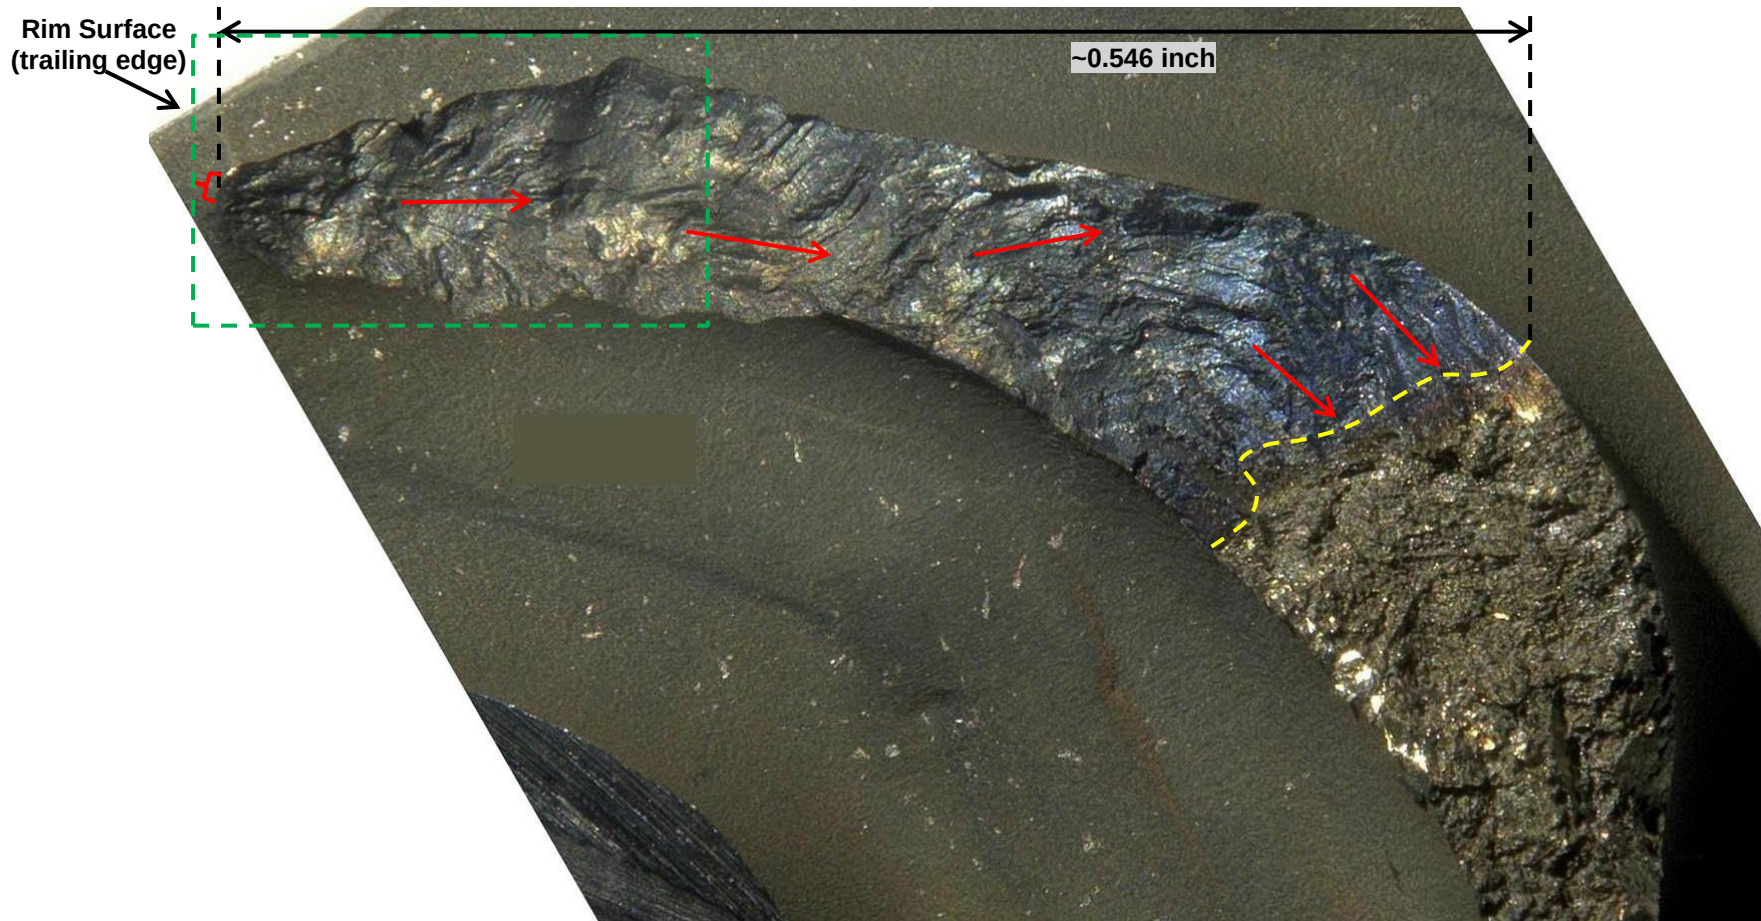
Detailed examination of the fracture surface on airfoil #1 revealed macroscopic fracture features consistent with fatigue progression from the trailing edge to approximately 0.546 inch from the trailing edge as shown in Figure 24. After this point, the fracture surface exhibited macroscopic fracture features with a dendritic appearance consistent with overload. The fracture surface also exhibited a change in reflectivity on an arc located approximately 0.072 inch from the trailing edge, shown in Figure 25. The fracture surface was examined using a scanning electron microscope (SEM), which revealed fracture features, Figure 26, consistent with a single fatigue origin at the trailing edge tip of the airfoil between where the wax weld extended out of the fillet radius and the airfoil parting line. The fatigue origin area is shown in Figure 27. Approximately 0.012 inch from the trailing edge, the fracture surface exhibited a transition in fracture features from cohesive crack fronts to multiple crack fronts on several planes as shown in Figure 28 and Figure 29. There was no obvious change in the degree of oxidation on the fracture surface. Representative fatigue fracture features are shown in Figure 30.

**Figure 24.** Detailed view of the fracture surface on airfoil #1 showing macroscopic fracture features consistent with fatigue progression (red arrows). The red brace indicates the origin area, shown in more detail in Figure 27. The crack progressed approximately 0.546 inch toward the leading edge before transitioning to overload (yellow dashed line). The green dashed boxed area is shown in more detail in the following figure.

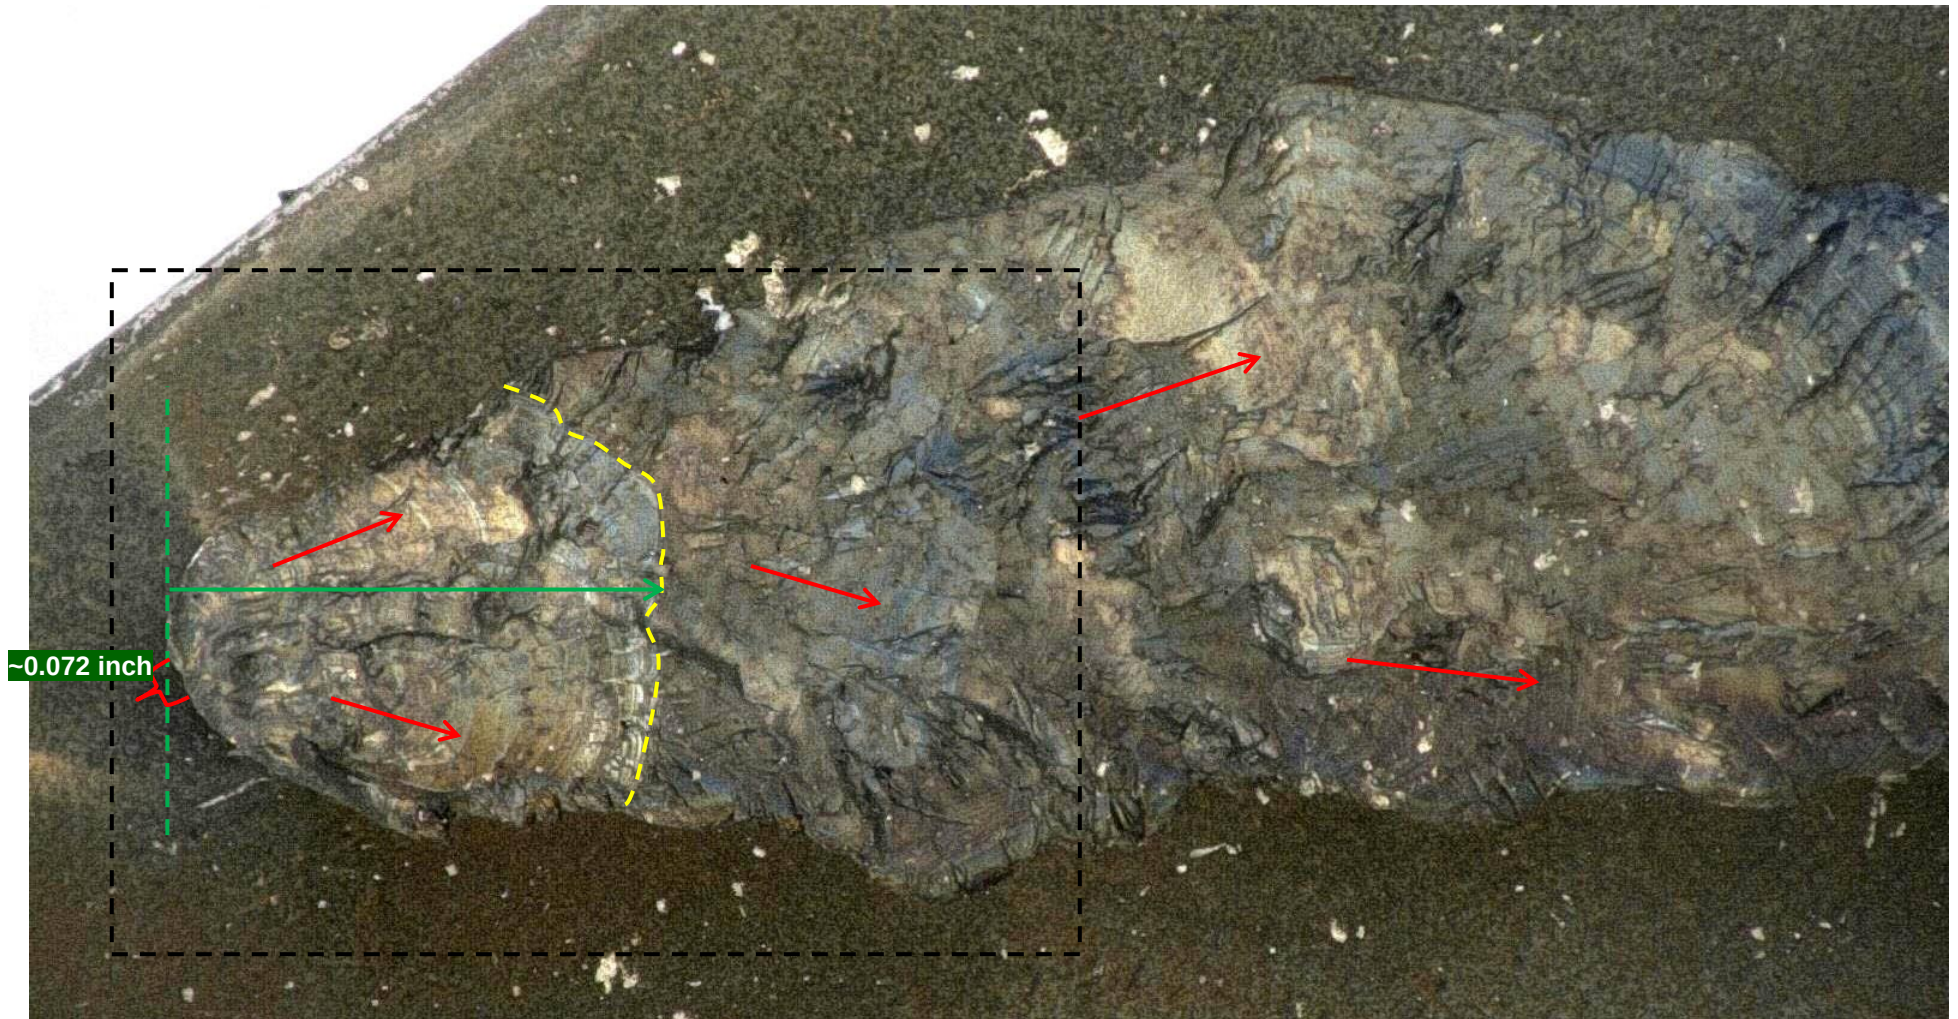
Figure 25. Detailed view showing macroscopic fracture features consistent with fatigue progression (red arrows). The red brace indicates the origin area at the trailing edge. The fracture surface exhibited a change in reflectivity from shiny (left of yellow dashed line) to dull (right of dashed line). The black dashed boxed area is shown in more detail in the following figure.

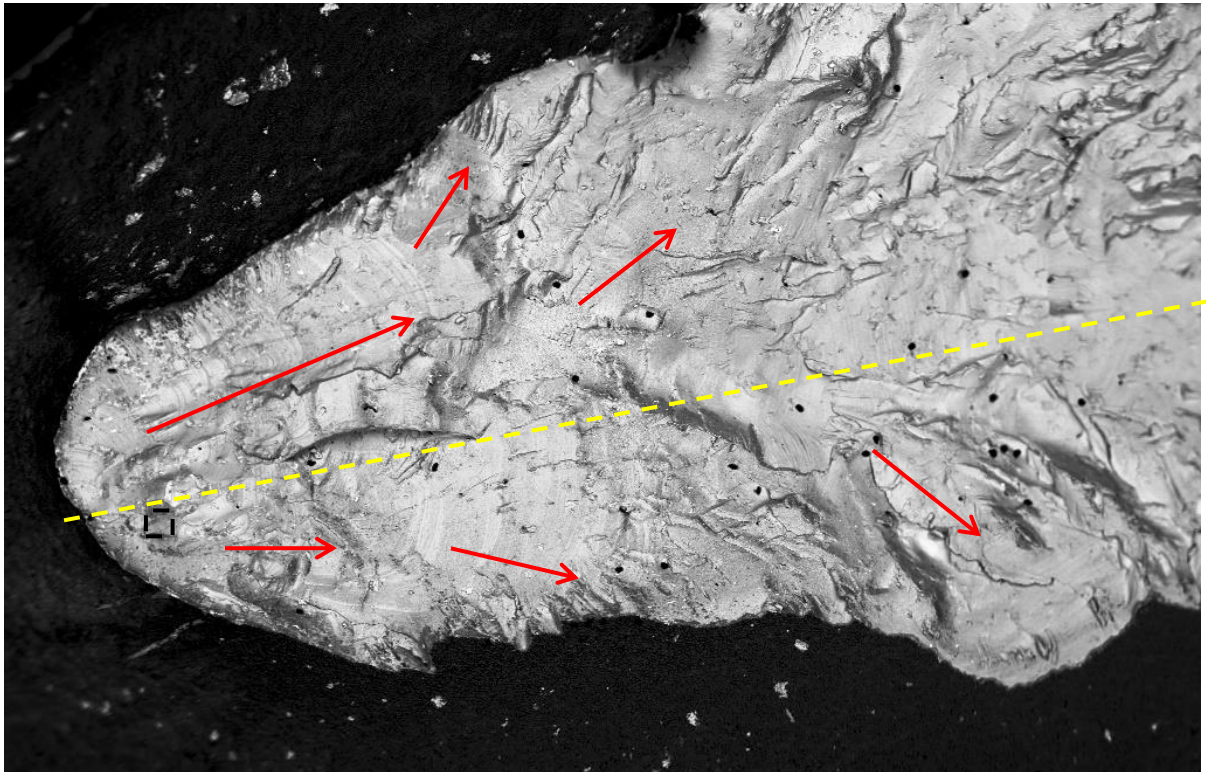
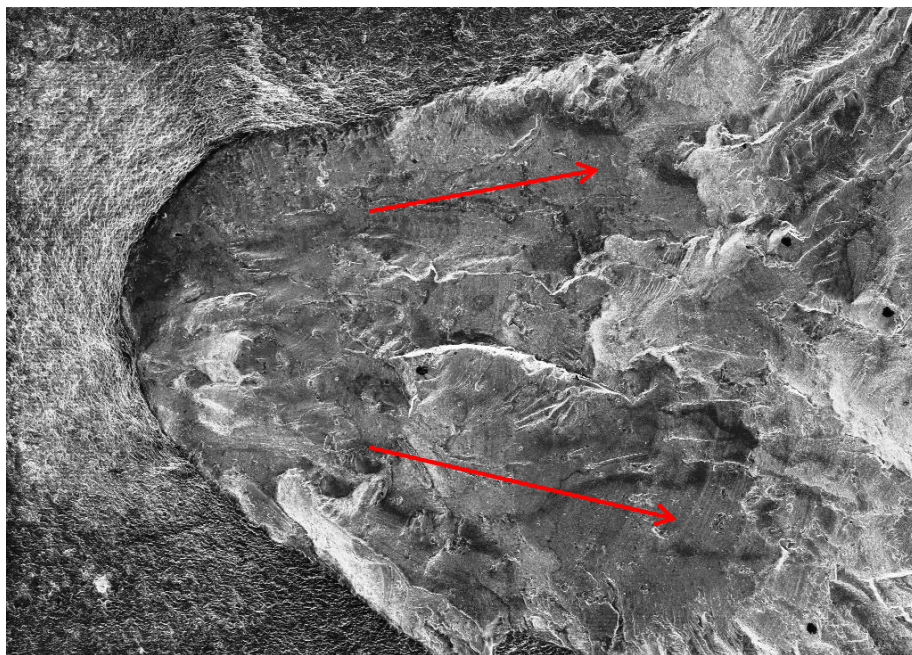
**Figure 26.** Backscattered (top) and secondary (bottom) electron SEM images of the fracture surface at the trailing edge of airfoil #1 showing fracture features consistent with fatigue progression (red arrows). The yellow dashed line indicates the plane of metallographic examination. The black dashed boxed area is shown in more detail in Figure 29.
