| <b>Rolls-Royce</b> | Rolls-Royce Corporation<br>450 S. Meridian Street<br>Indianapolis, Indiana<br>46225-1103, USA | <b>REPORT NO.</b><br>19FAE-061-PR | <b>REV.</b><br>Initial | <b>PAGES</b><br>1 of 64 |
| <b>TITLE</b><br><br><b>METALLURGICAL INVESTIGATION OF A THIRD STAGE TURBINE WHEEL, P/N 23065818, REMOVED FROM AN M250 C20B ENGINE, S/N CAE832565 OPERATED BY WILBUR ELLIS CO.</b> | | <b>PREPARED</b><br><br>Signatures on File | | |

| Part Name: | Third Stage Turbine Wheel |
| Engine Serial Number: | CAE832565 |

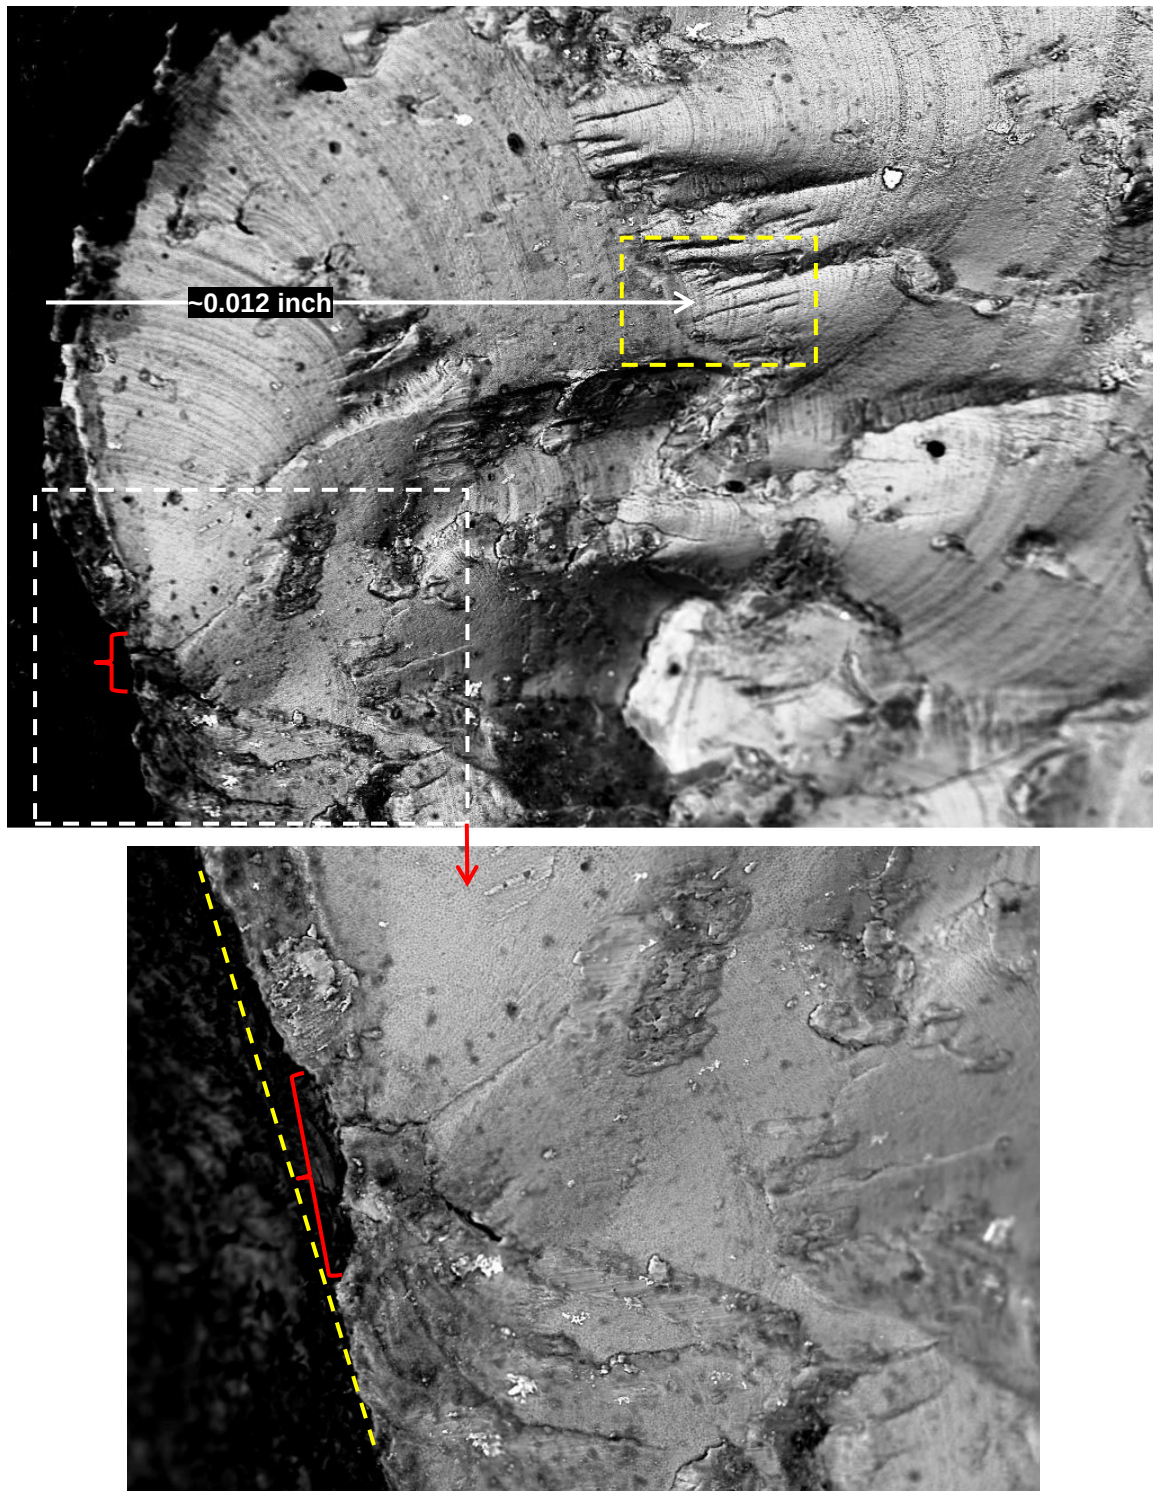
**Figure 27.** Detailed backscattered electron SEM images of the fracture surface at the trailing edge (top) and the fatigue origin area (bottom, red brace). The trailing edge surface was puckered inward at the origin (yellow dashed line on trailing edge profile for emphasis). The yellow dashed boxed area is shown in more detail in Figure 28.

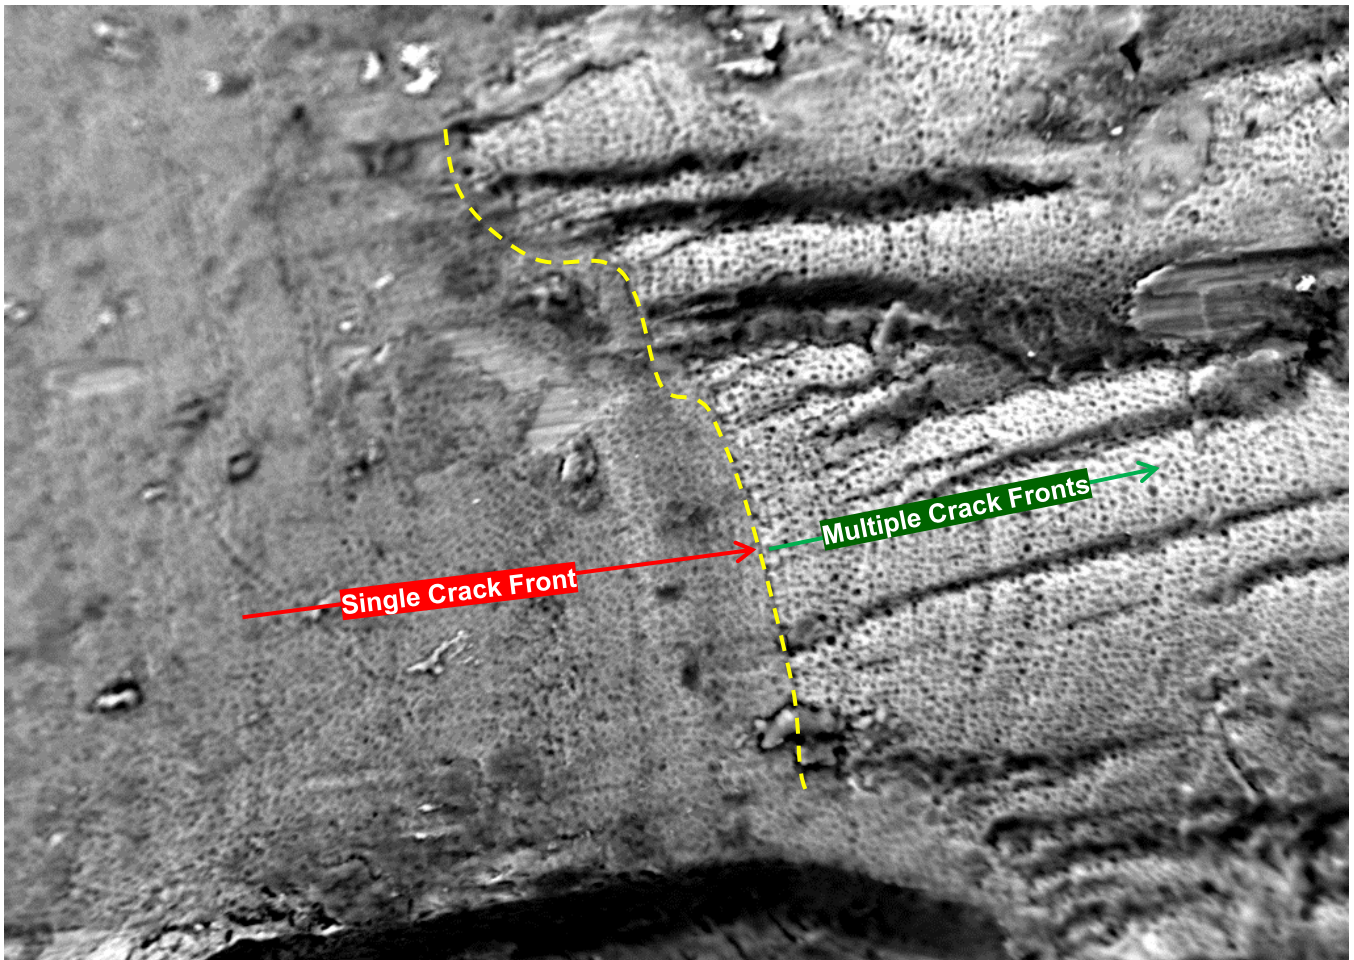
**Figure 28.** Detailed view showing one location where the fracture transitioned from a single crack front (left of yellow dashed line) to multiple crack fronts (right of line).

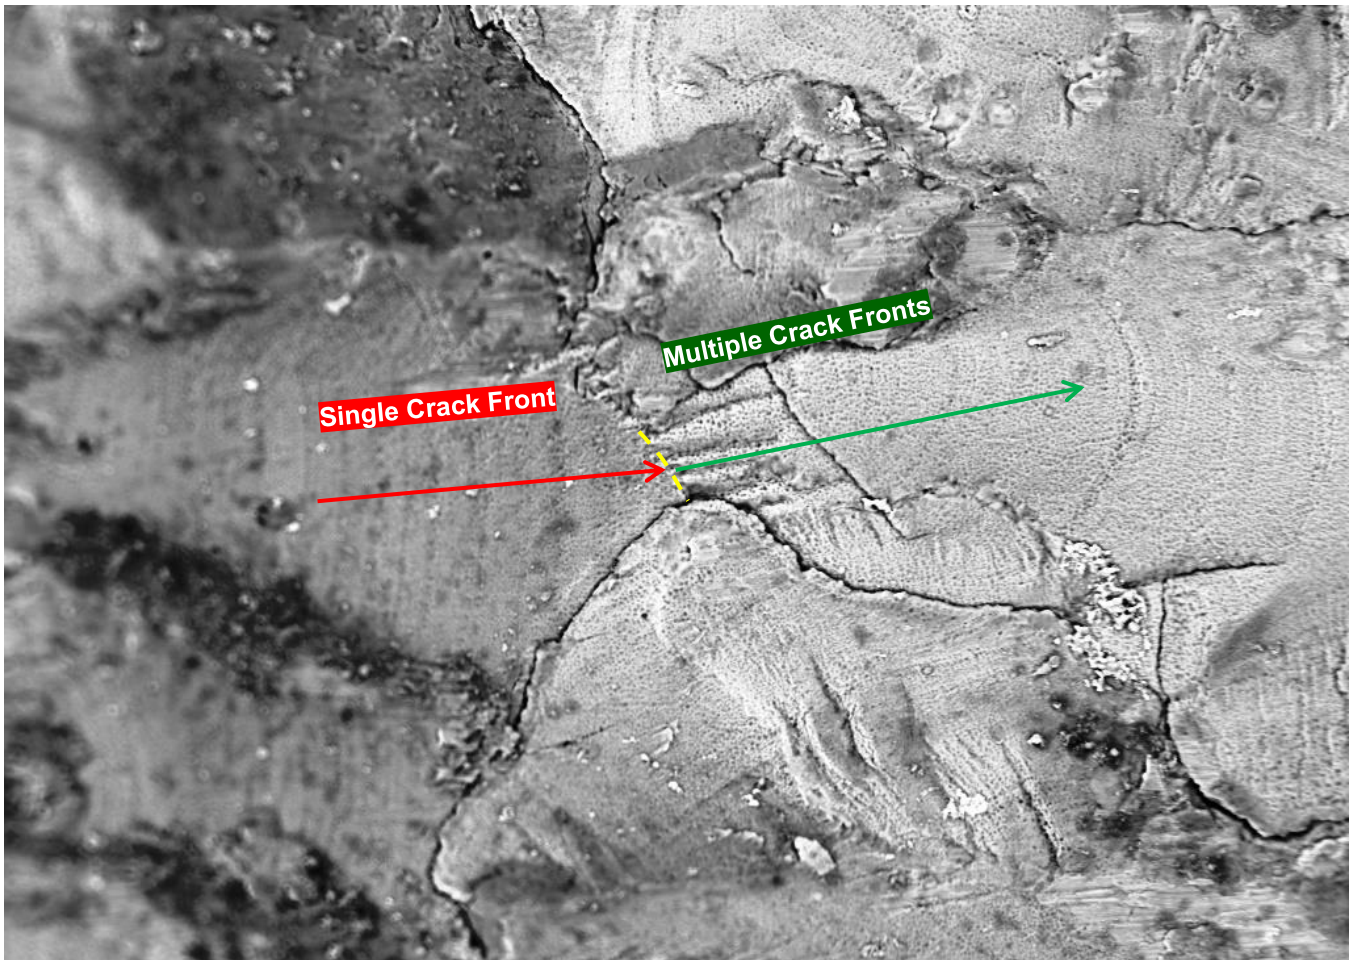
**Figure 29.** Detailed view showing another location where the fracture transitioned (yellow dashed lines) from a single crack front (red arrow) to multiple crack fronts (green arrow).

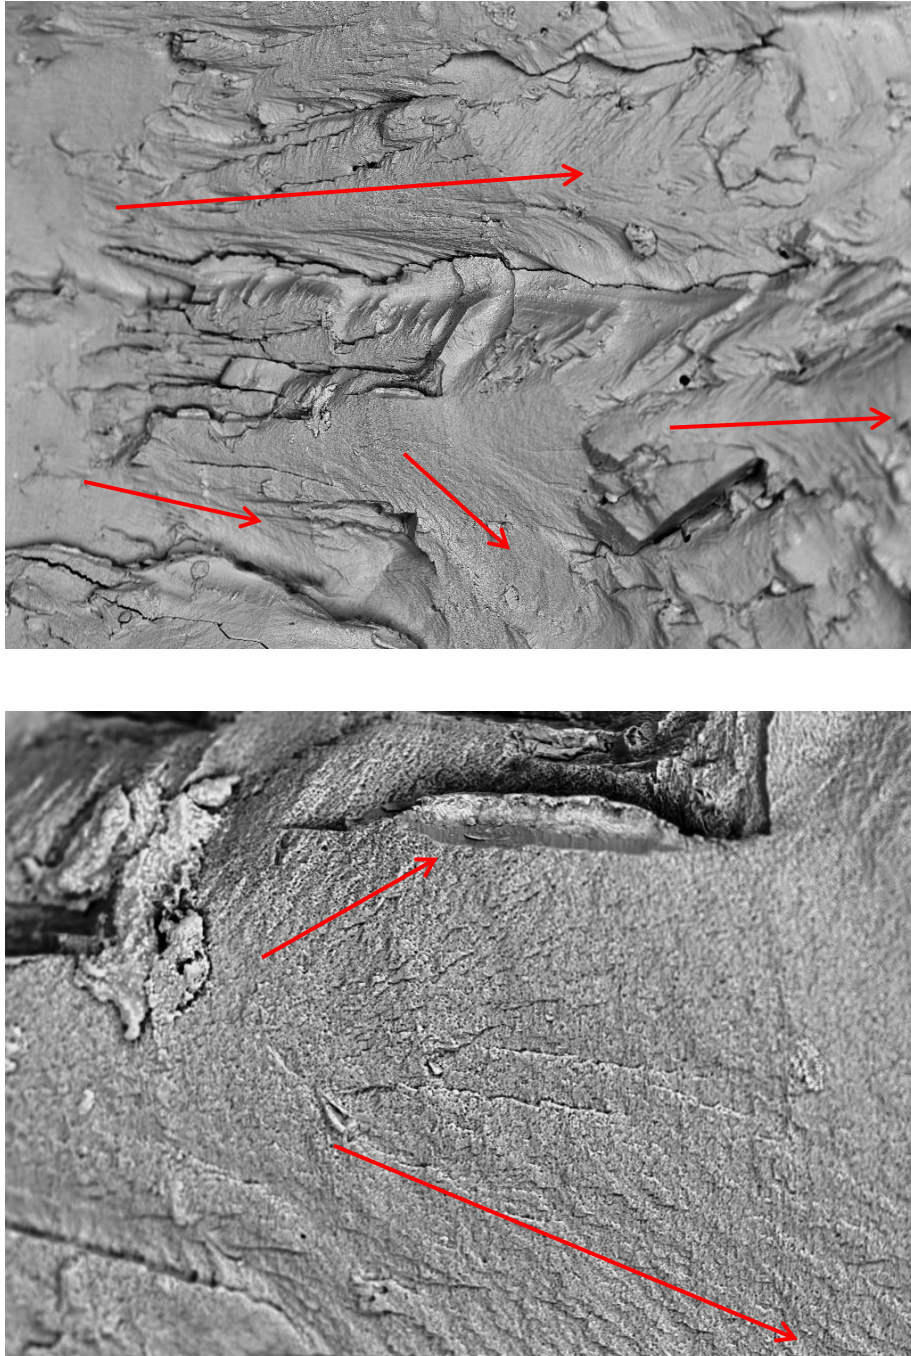
**Figure 30. Backscattered electron SEM images showing representative fatigue fracture features (red arrows) remote from the trailing edge area.**

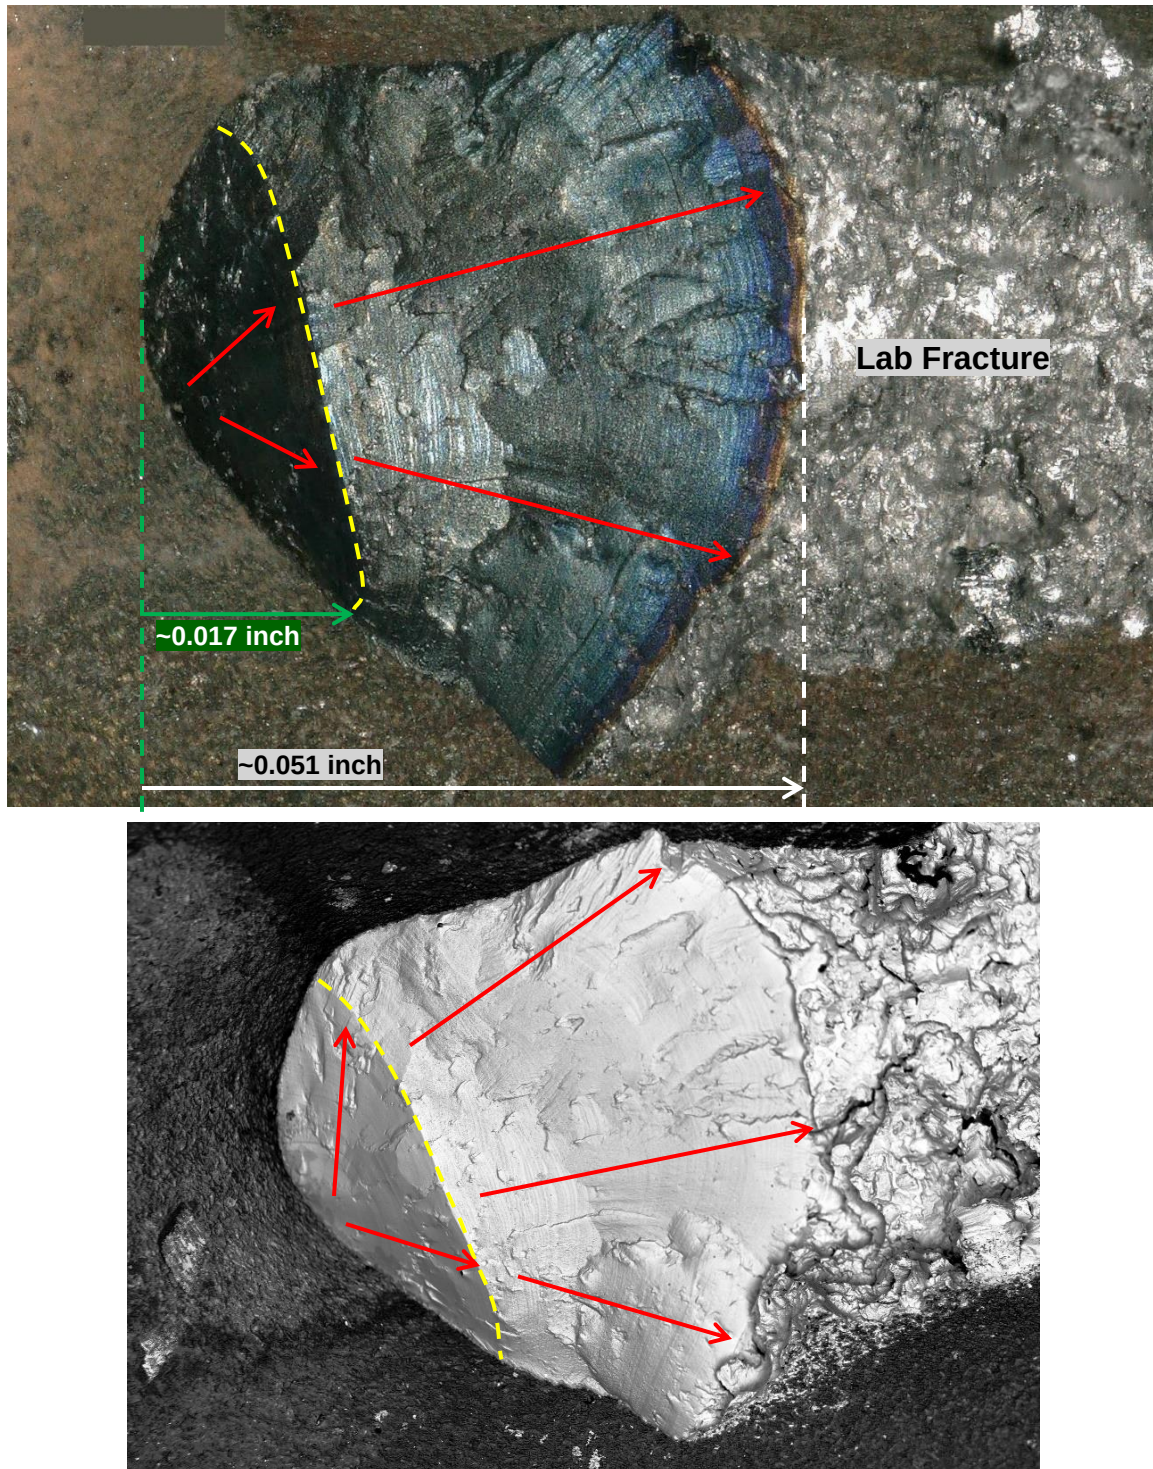
0.020 inch before turning to propagate towards the leading edge approximately parallel to the rim to a total length of approximately 0.051 inch. There was no obvious transition in fracture features or degree of oxidation of the fracture surface at the change in propagation direction. Figure 33 shows the origin area at the trailing edge tip of the airfoil, which was oxidized. Figure 34 shows representative fracture features near the trailing edge on the inboard plane of propagation and near the end of the fatigue fracture.

**Figure 31.** Optical (top) and backscattered electron SEM (bottom) images showing fracture features consistent with fatigue progression (red arrows) at the trailing edge of airfoil #35. The fracture progressed inboard from the trailing edge tip before turning to propagate approximately parallel to the rim surface. The darker appearance of the fracture surface (left of yellow dashed line) on the inboard plane of propagation was a geometric effect and did not indicate any gradient in oxidation on the fracture surface.

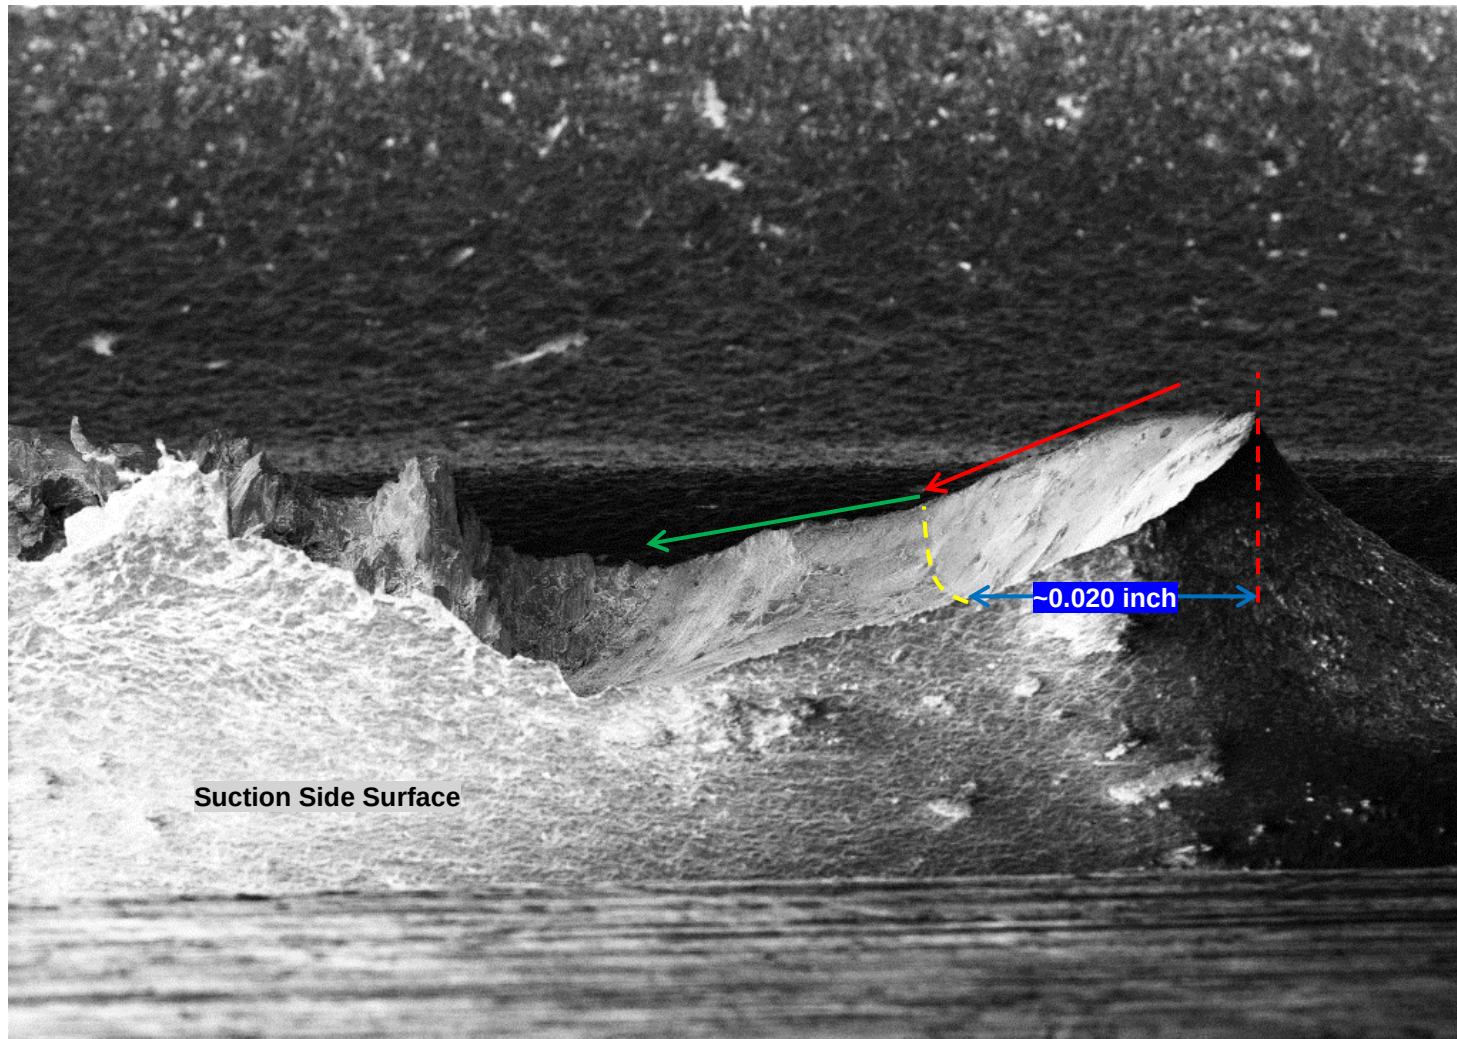
**Figure 32.** SEM image showing a suction side view of the fracture surface in airfoil #35. The yellow dashed line indicates where the fracture turned from propagating inboard and toward the leading edge (right of dashed line, red arrow) to propagate toward the leading edge approximately parallel to the rim (left of dashed line, green arrow). The change in propagation direction was coincident with the change in fracture surface appearance denoted by the yellow dashed line in Figure 31.

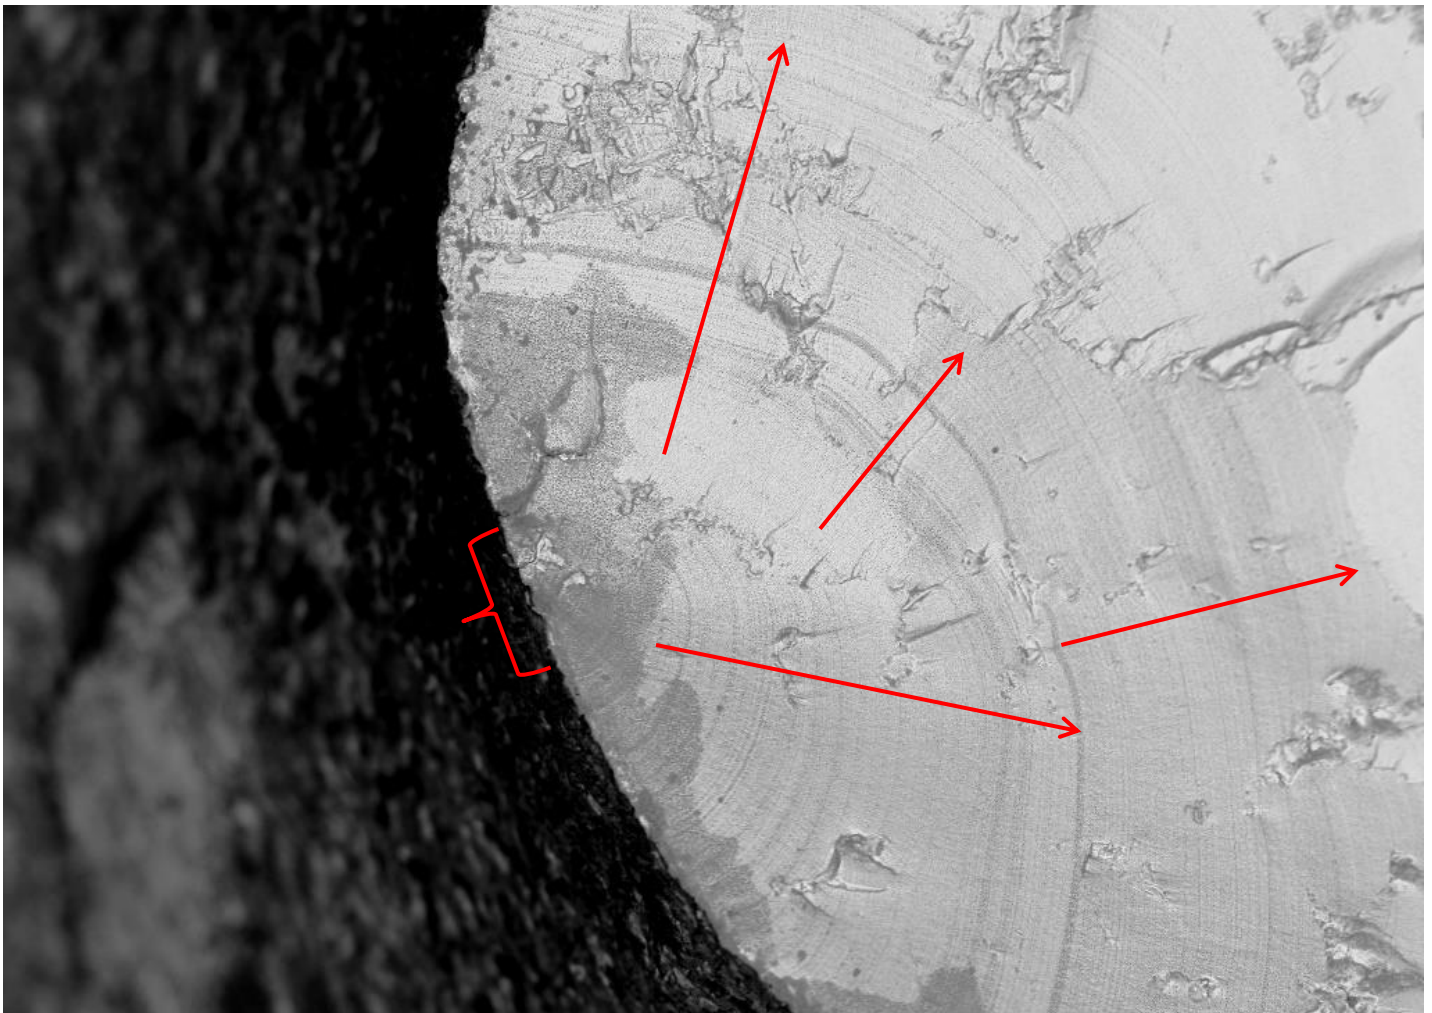
**Figure 33. Backscattered electron SEM image showing the origin area (red brace) of the fatigue fracture on airfoil #35.**

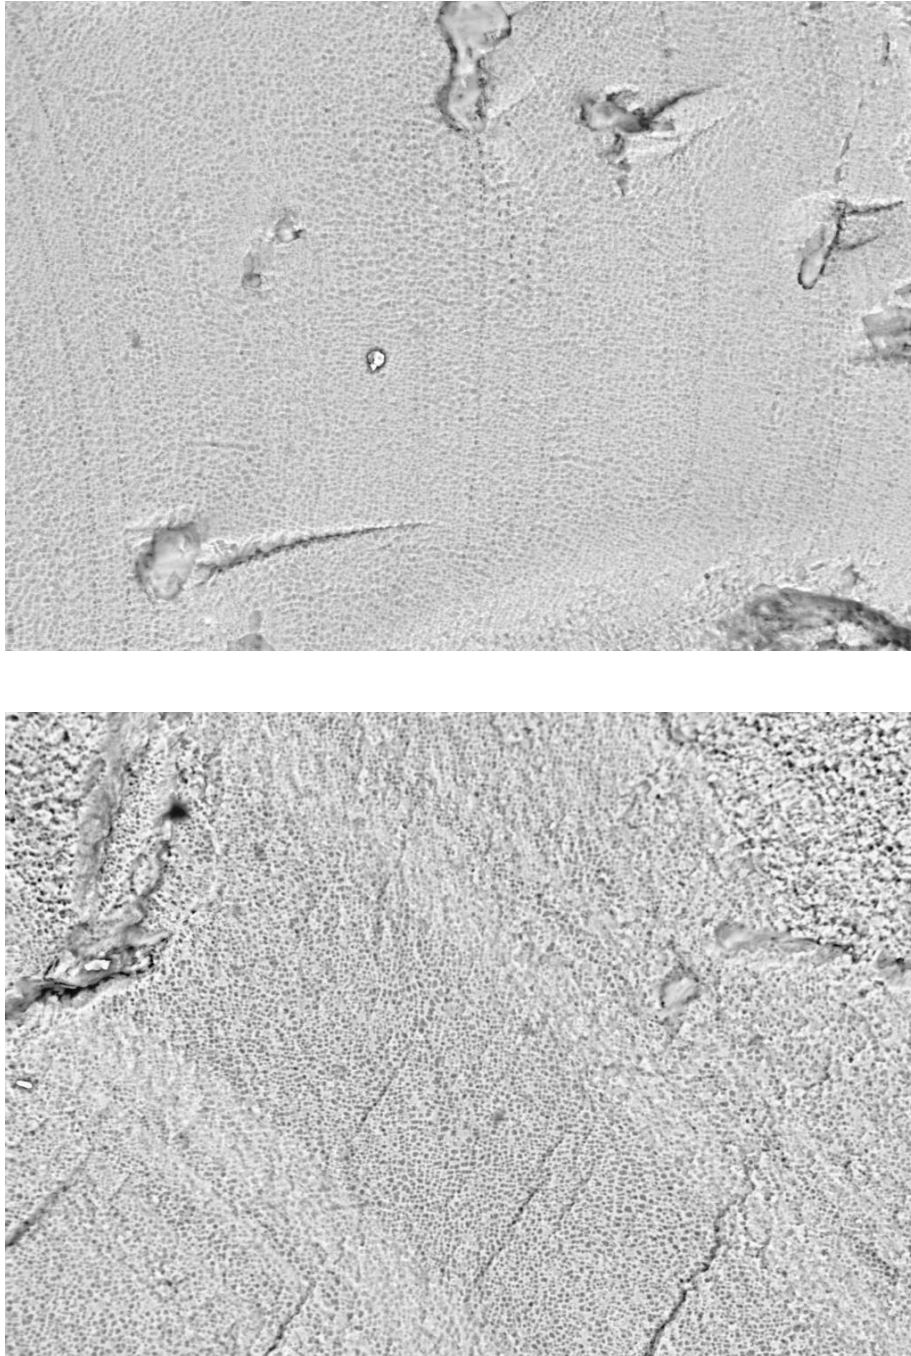
**Figure 34. Backscattered electron SEM images showing representative fracture features near the trailing edge on the inboard plane of propagation (top) and near the end of the fatigue fracture (bottom). The fracture surface was equally oxidized in both areas.**

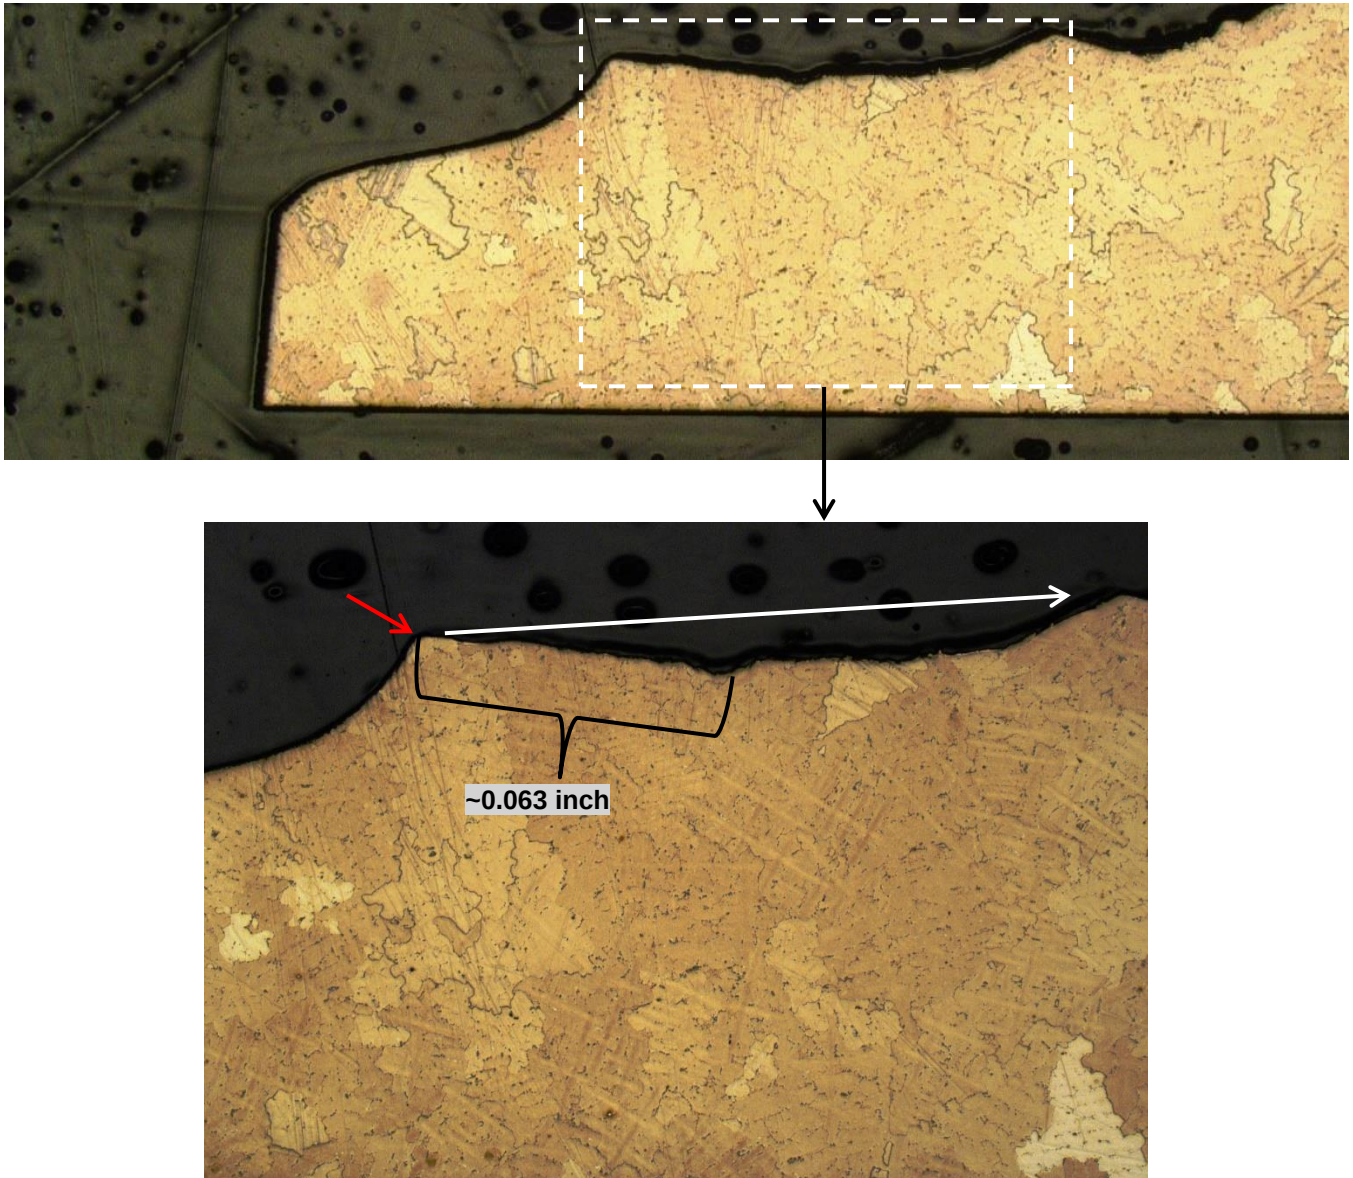
A metallographic cross-section (Figure 26) was prepared through the origin of the fatigue fracture on airfoil #1 and is shown in Figure 35. In this plane of examination, the fracture propagated inboard for approximately 0.063 inch before turning to progress parallel to the rim surface.

**Figure 35.** Cross-section through the fatigue origin (red arrow) on airfoil #35. There were no metallurgical anomalies at the origin. The white arrow shows the direction of fatigue propagation. In this plane of examination, the fracture propagated inboard for approximately 0.063 inch before turning outboard. Etchant: MT

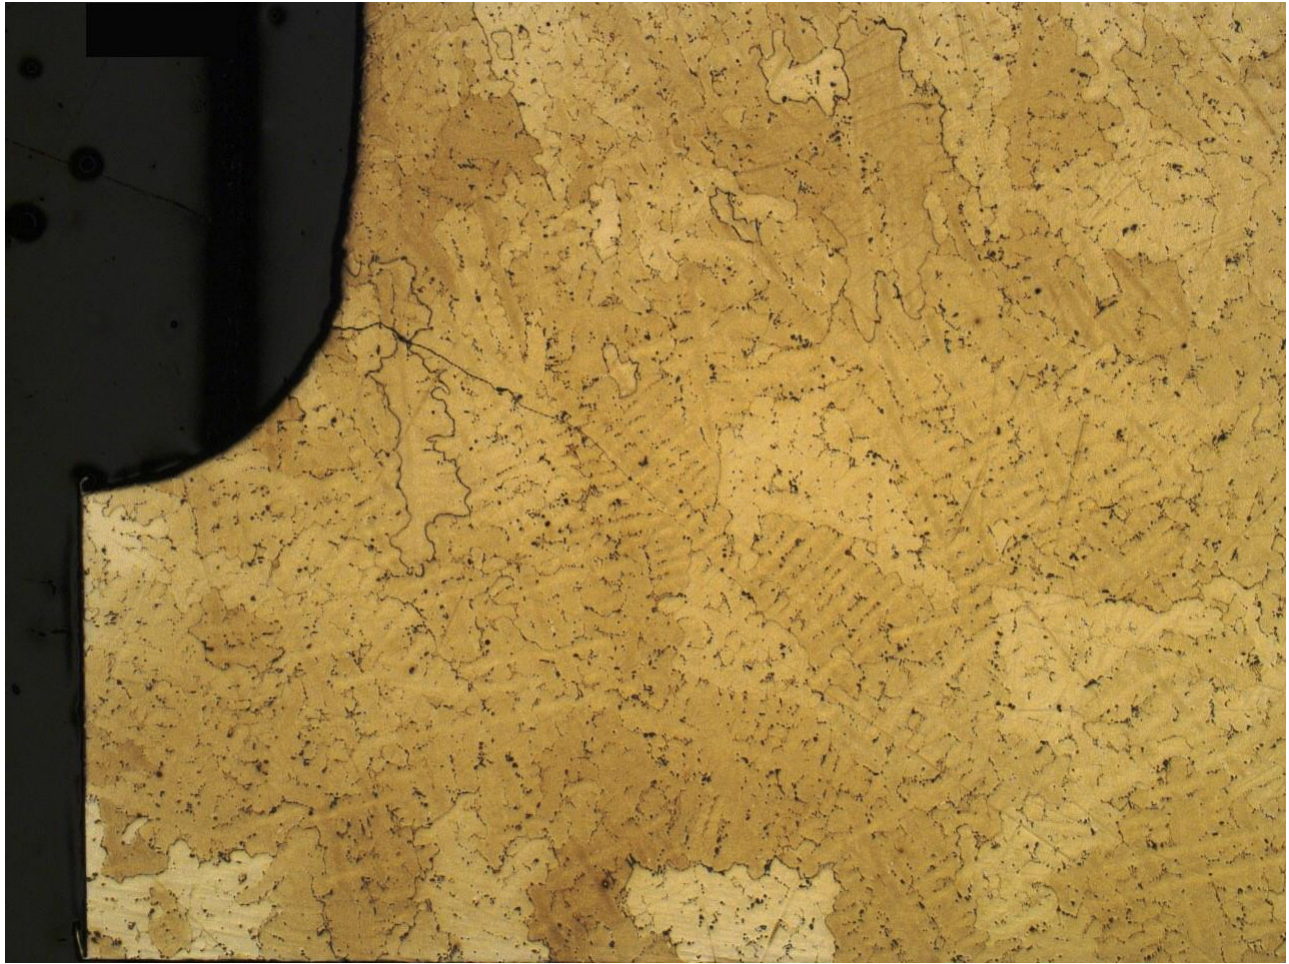
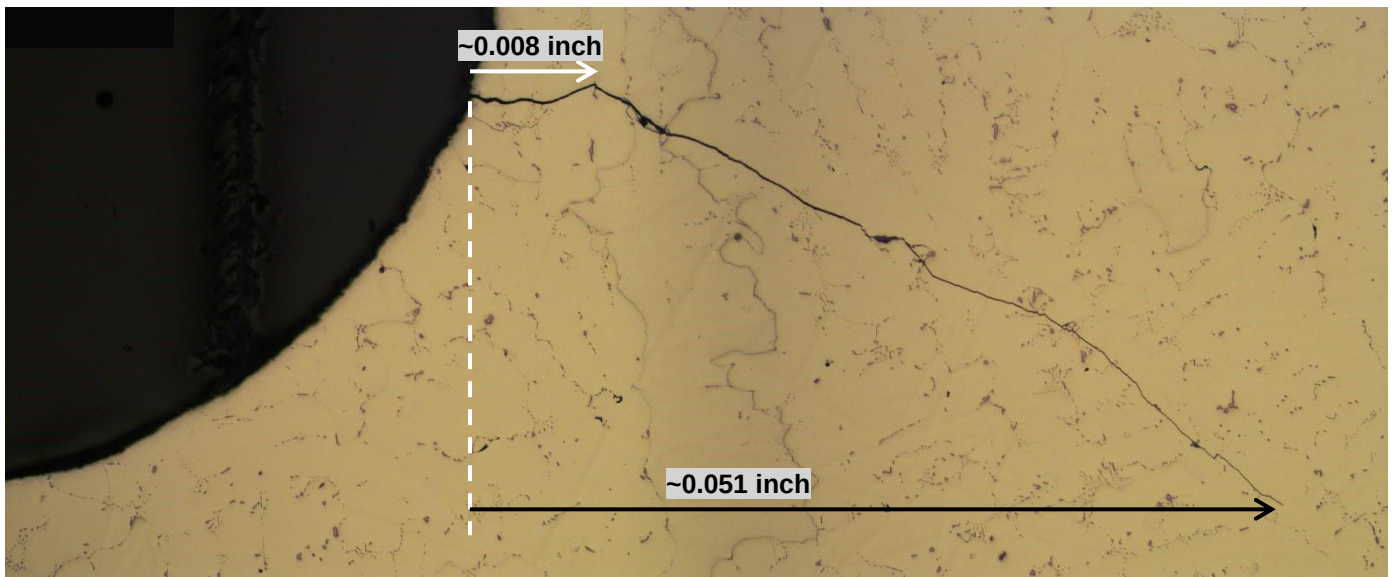
An attempt at lab fracturing the crack-like FPI indication in airfoil #15 was unsuccessful, but the indication was undamaged from the lab fracture process. The airfoil was cut, mounted, and polished, which revealed a crack measuring approximately 0.051 inch long extending from the trailing edge root radius, shown in Figure 36.

**Figure 36.** Cross-section through the crack in the trailing edge of airfoil #15. The crack propagated approximately parallel to the rim surface and slightly outboard for approximately 0.008 inch before turning inboard to propagate to a total length of approximately 0.051 inch. Top etchant: MT; Bottom: Unetched

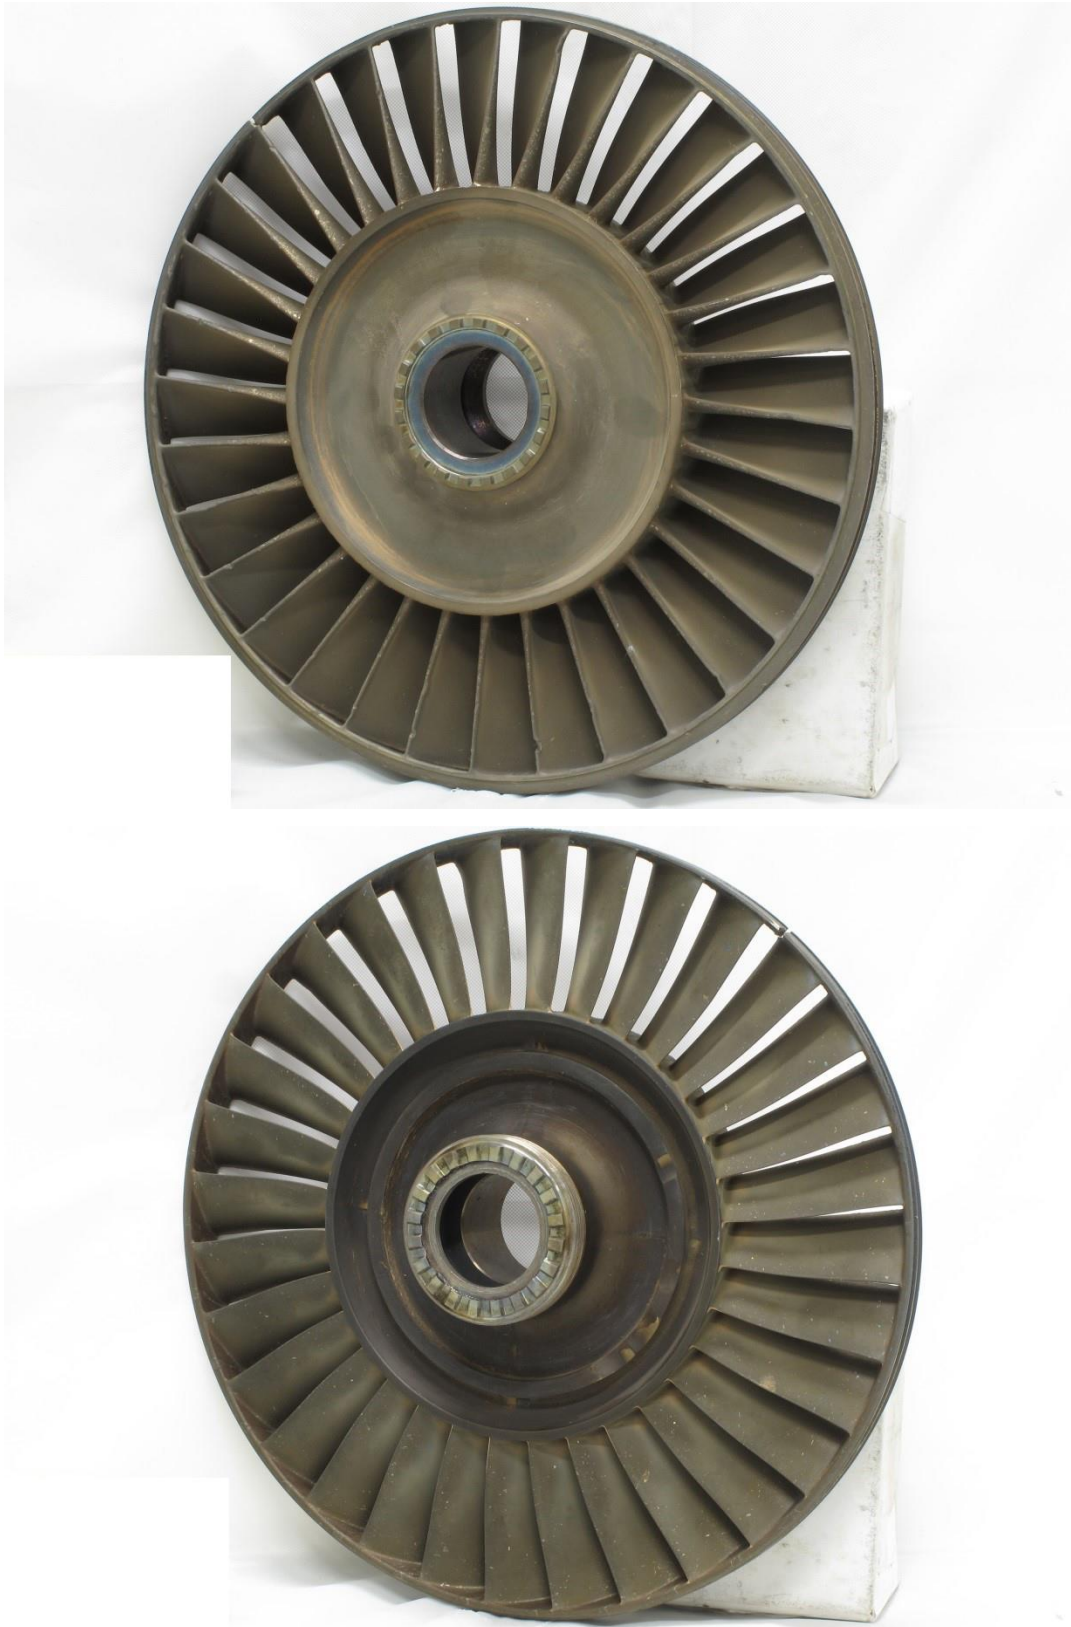
The as-received condition of the fourth stage turbine wheel is shown in Figure 37. The airfoil leading edges exhibited impact damage. Figure 38 shows two diametrically opposed views of the shroud and knife seals on the wheel, which exhibited asymmetric rub damage with a fracture through the shroud band in one location. The fourth stage turbine wheel to stub shaft curvic teeth are shown in Figure 39; both the drive and coast side flanks exhibited patches of wear. Coked oil was found in the troughs between curvic teeth and on the inner diameter surfaces of the teeth. The interstage curvic teeth on the fourth stage wheel are shown in Figure 40 and exhibited wear patches on the drive side flanks of the teeth. The fourth stage wheel was subjected to FPI by the Rolls-Royce Corporation Test Department, which did not reveal any crack-like FPI indications.

**Figure 37. Leading (top) and trailing (bottom) edge side views showing the as-received condition of the fourth stage turbine wheel.**

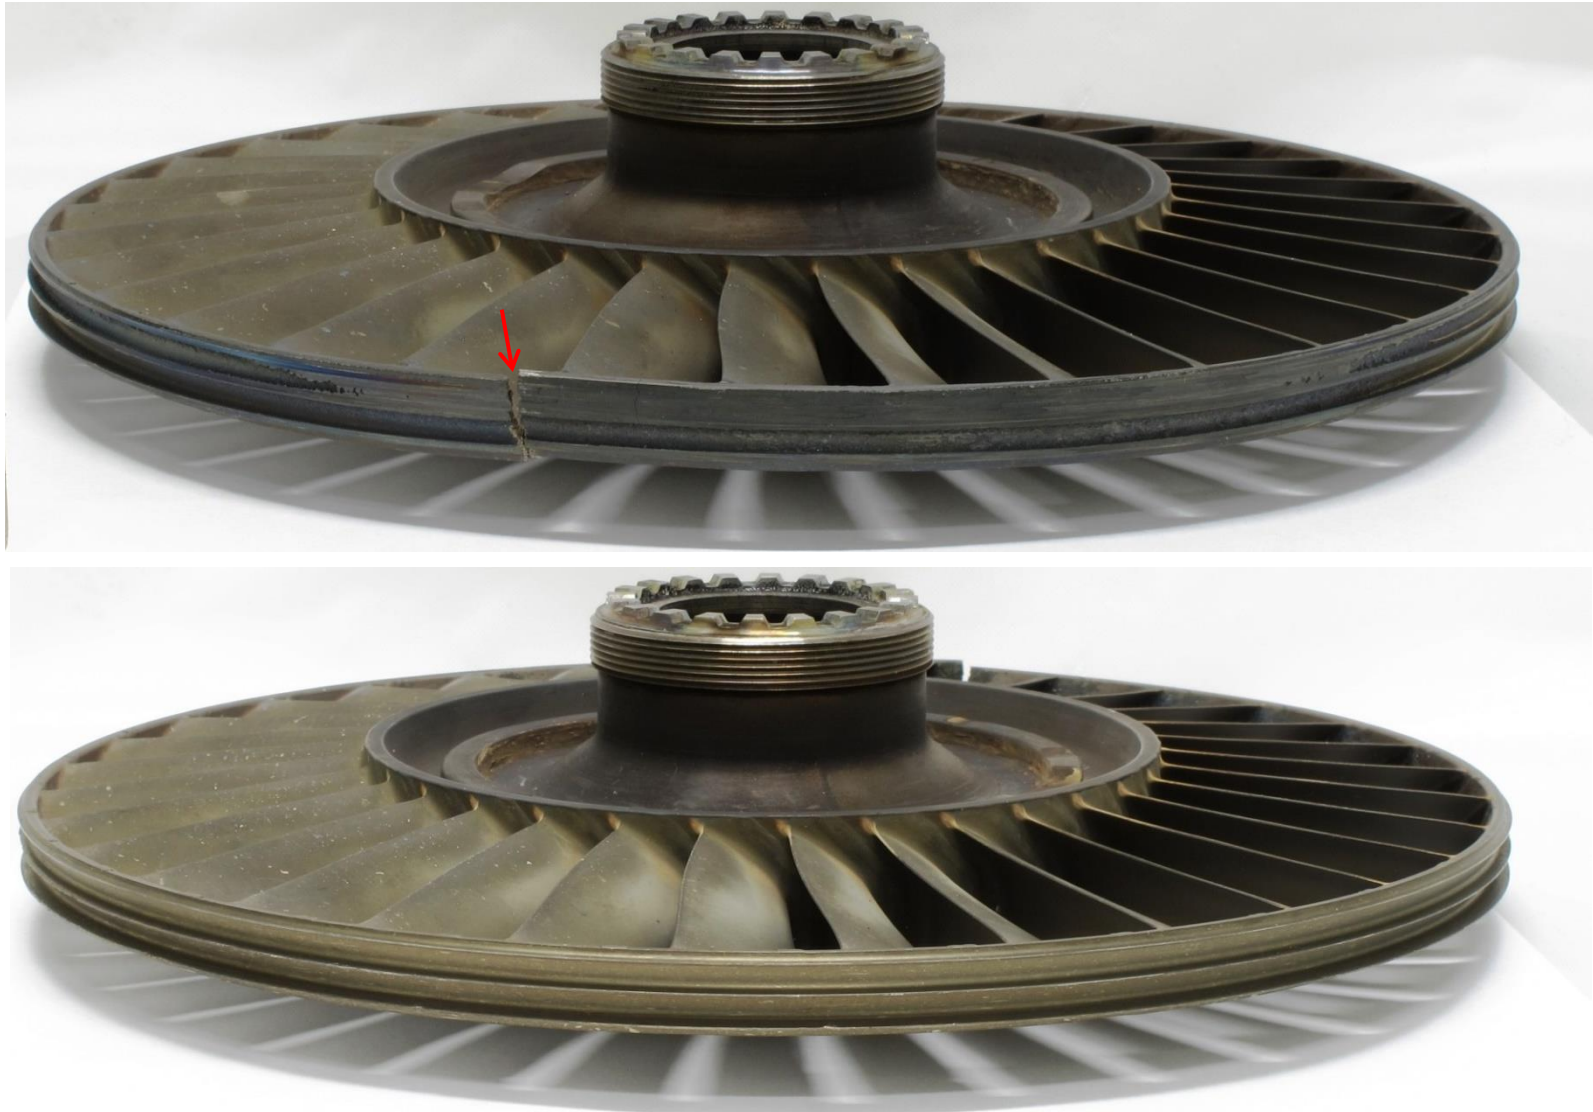
**Figure 38. Radial views showing the rub damage to the shroud and knife seals. The shroud band was cracked (red arrow).**

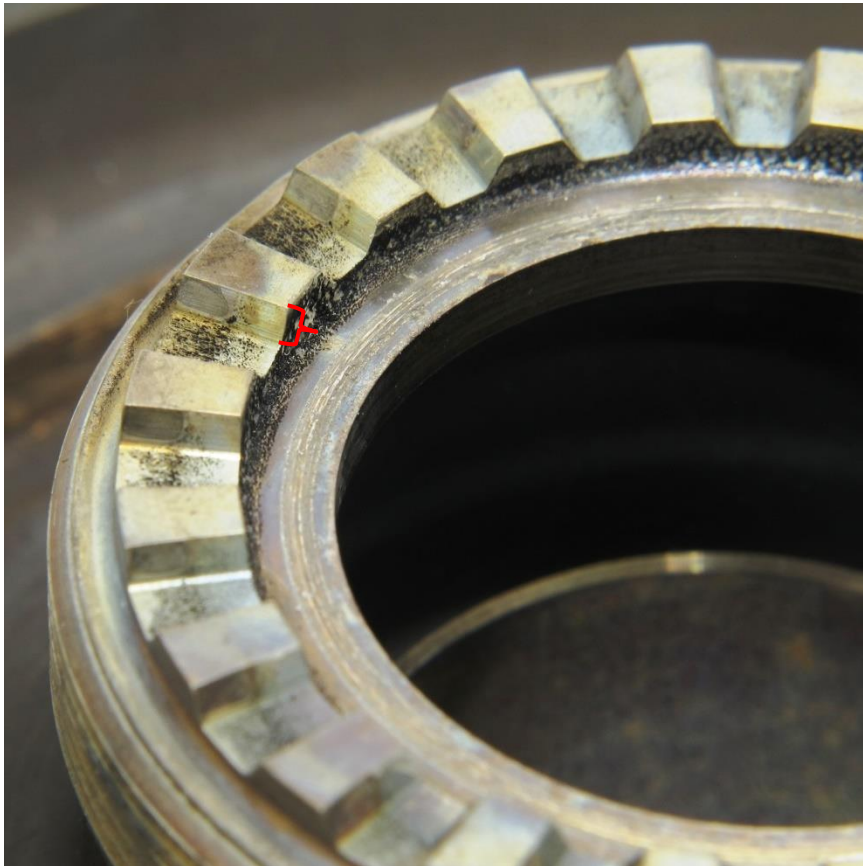
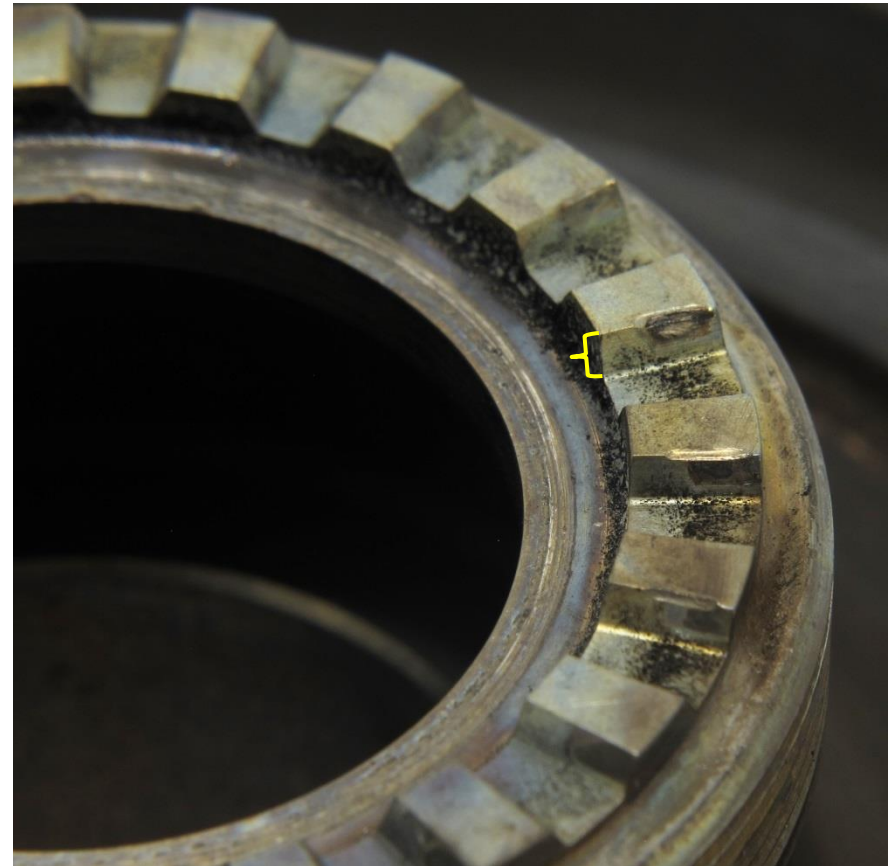
**Figure 39.** Detailed views showing the representative condition of the drive (left, red brace) and coast (right, yellow brace) side flanks of the turbine wheel to stub shaft curvic teeth of the fourth stage turbine wheel. The teeth exhibited patches of wear on both flanks. Coked oil was present on the curvic teeth and adjacent surfaces.

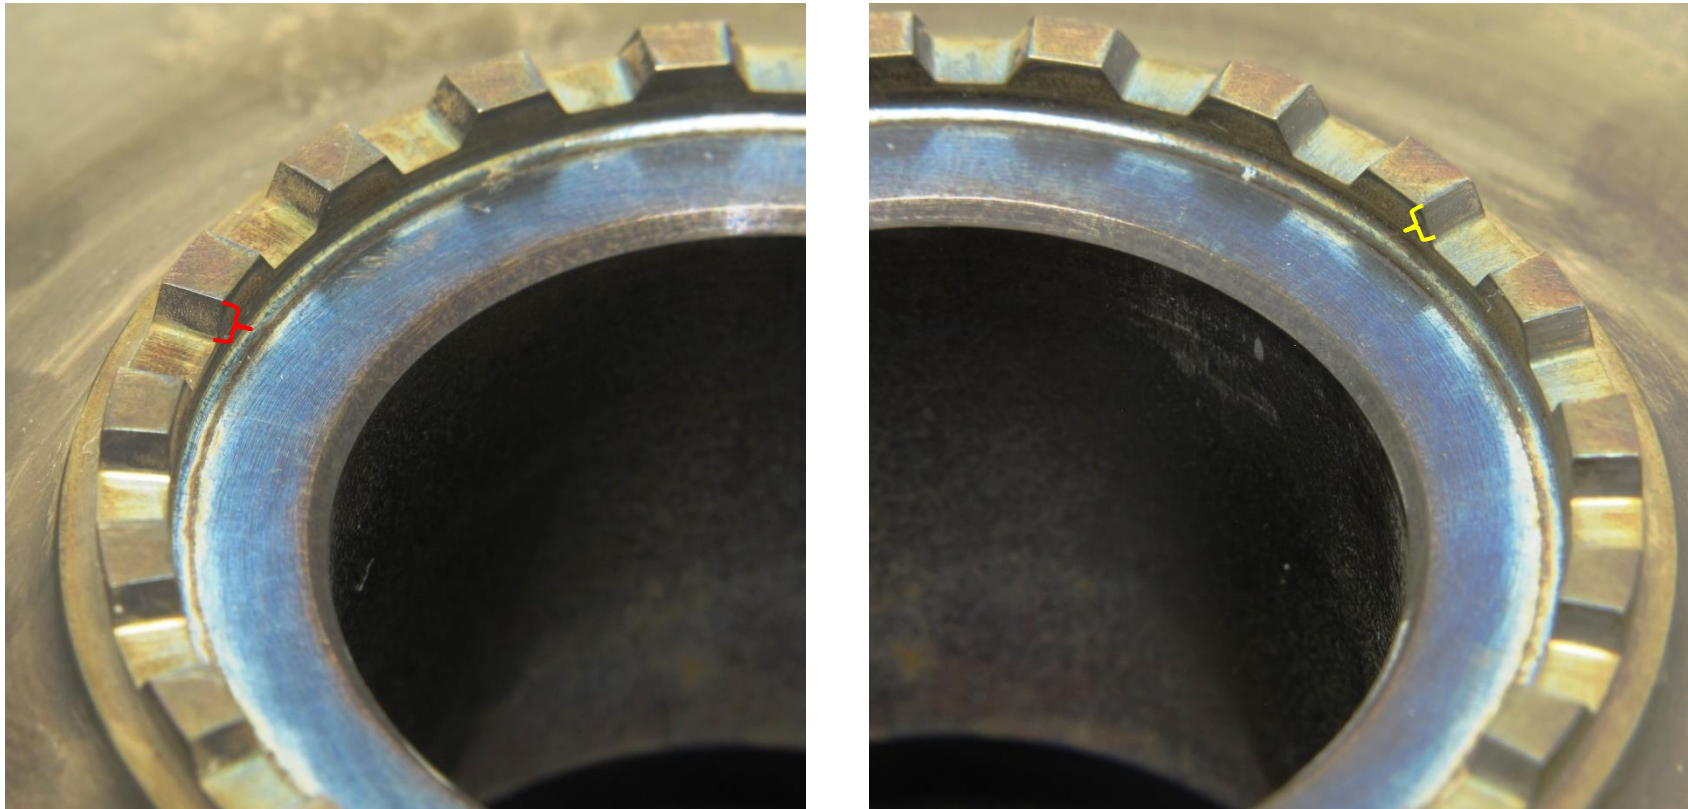
**Figure 40. Representative condition of the drive (left, red brace) and coast (right, yellow brace) side flanks of the interstage curvic teeth on the fourth stage turbine wheel. The drive side flanks exhibited wear patches.**
