| <b>Rolls-Royce</b> | Rolls-Royce Corporation<br>450 S. Meridian Street<br>Indianapolis, Indiana<br>46225-1103, USA | <b>REPORT NO.</b><br>19FAE-061-PR | <b>REV.</b><br>Initial | <b>PAGES</b><br>1 of 64 |
| <b>TITLE</b><br><br><b>METALLURGICAL INVESTIGATION OF A THIRD STAGE TURBINE WHEEL, P/N 23065818, REMOVED FROM AN M250 C20B ENGINE, S/N CAE832565 OPERATED BY WILBUR ELLIS CO.</b> | | <b>PREPARED</b><br><br>Signatures on File | | |

| Part Name: | Third Stage Turbine Wheel |
| Engine Serial Number: | CAE832565 |

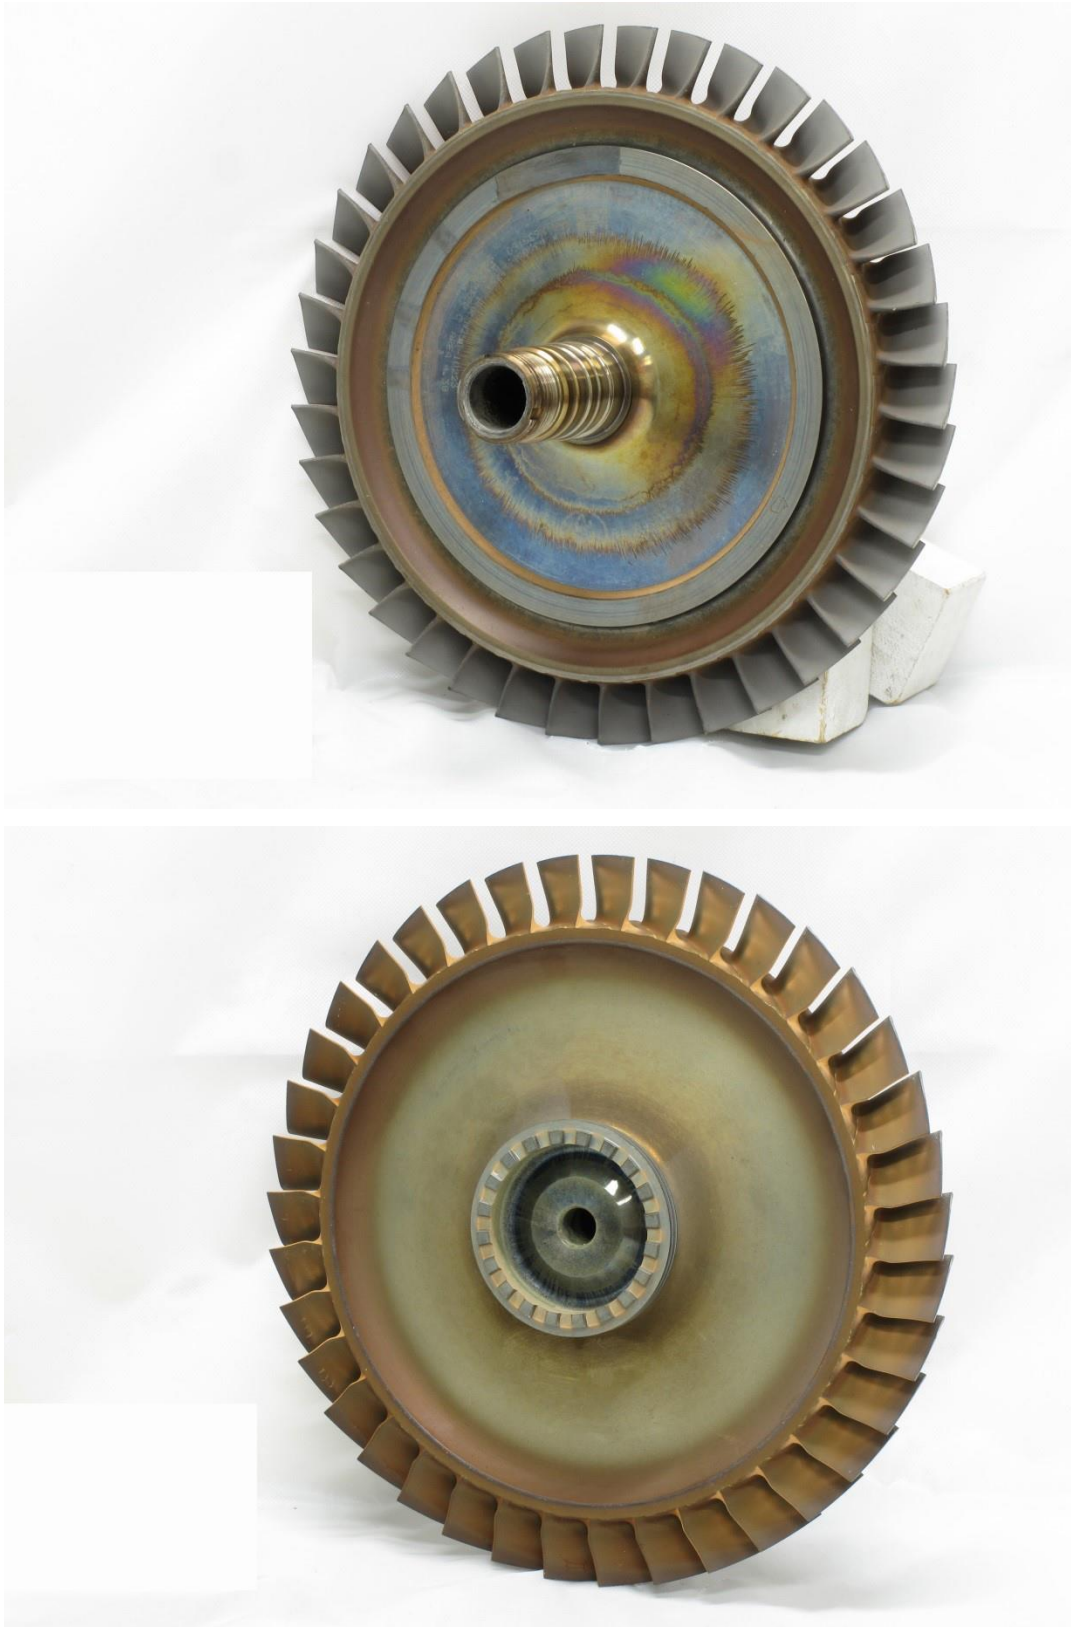
The as-received condition of the first stage turbine wheel is shown in Figure 41. The web of the wheel was heat tinted on the leading edge side and exhibited brownish discoloration on the trailing edge side. The suction side surfaces of the airfoils also exhibited brownish discoloration. The first stage turbine wheel was subjected to FPI, which did not reveal any crack-like FPI indications. The second stage turbine wheel is shown in Figure 42 and exhibited impact damage to the leading and trailing edges. The suction side surfaces near the root exhibited a reddish-brown coloration.

**Figure 41. Leading (top) and trailing (bottom) edge side views showing the as-received condition of the first stage turbine wheel.**

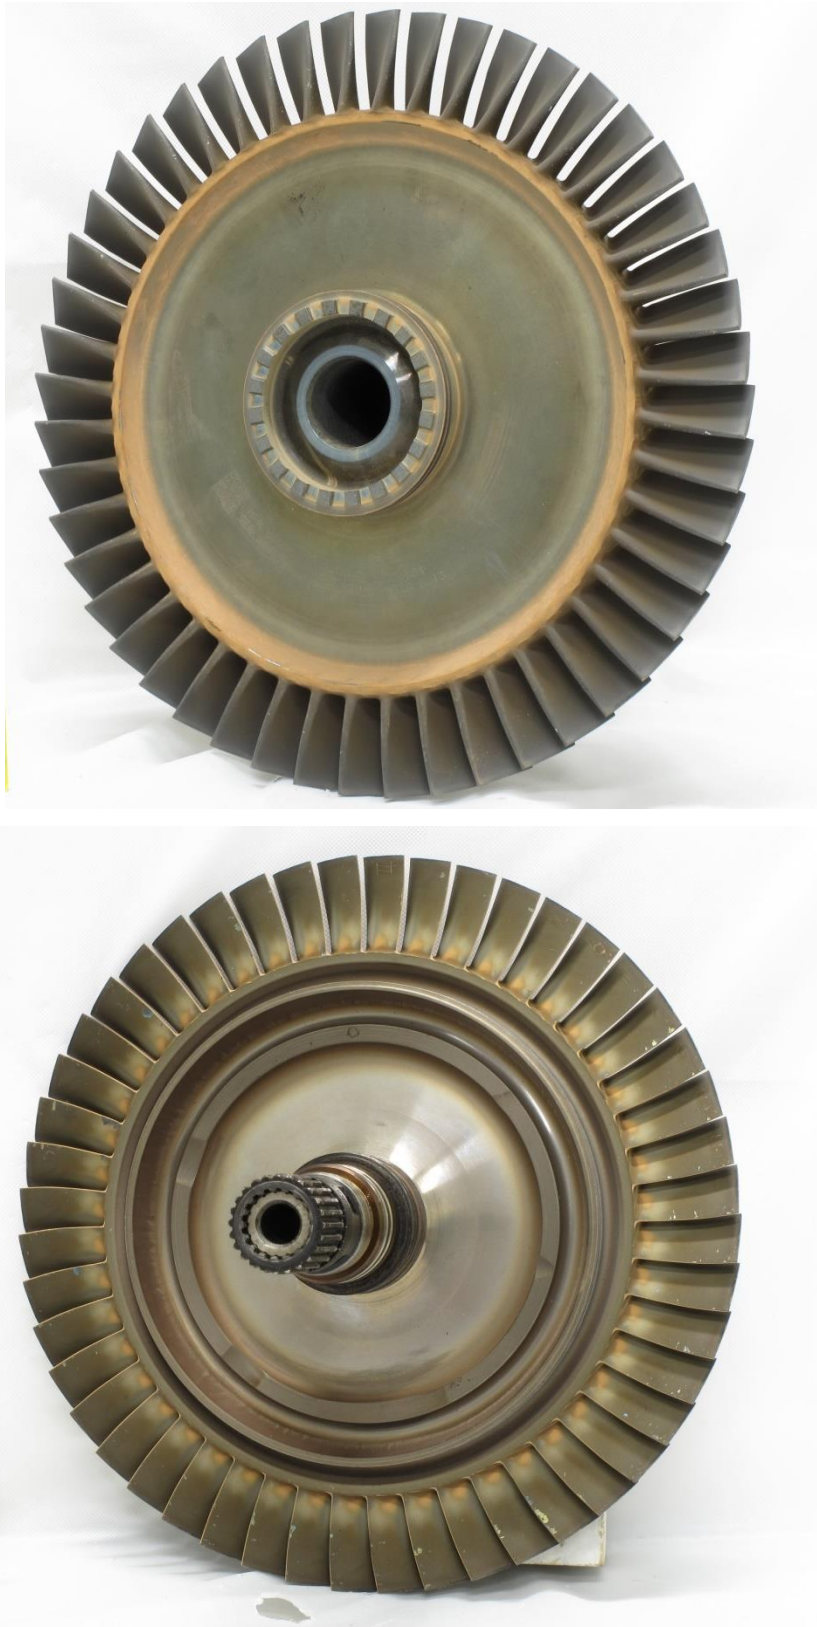
**Figure 42. Leading (top) and trailing (bottom) edge side views showing the as-received condition of the second stage turbine wheel. The airfoil trailing edges exhibited impact damage.**

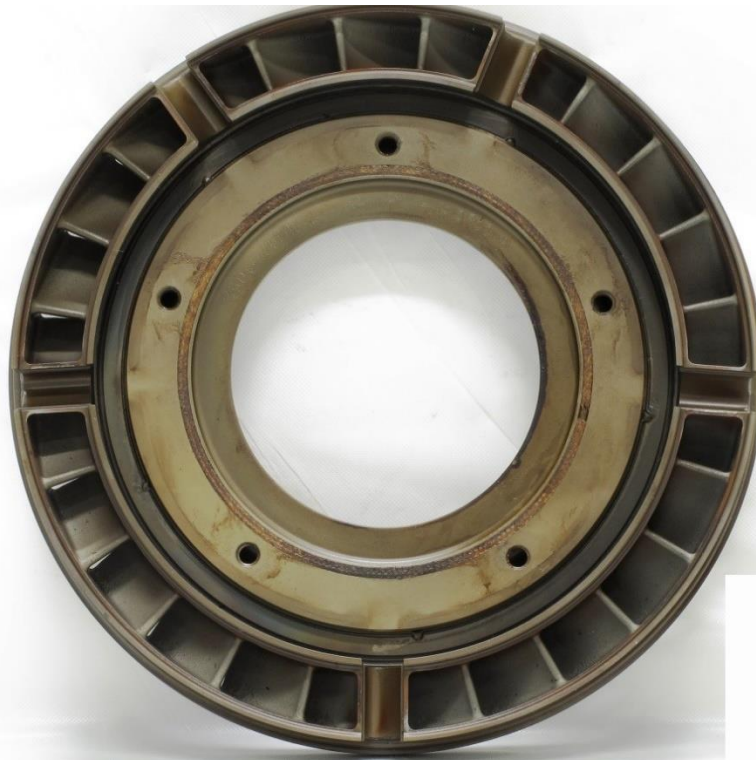
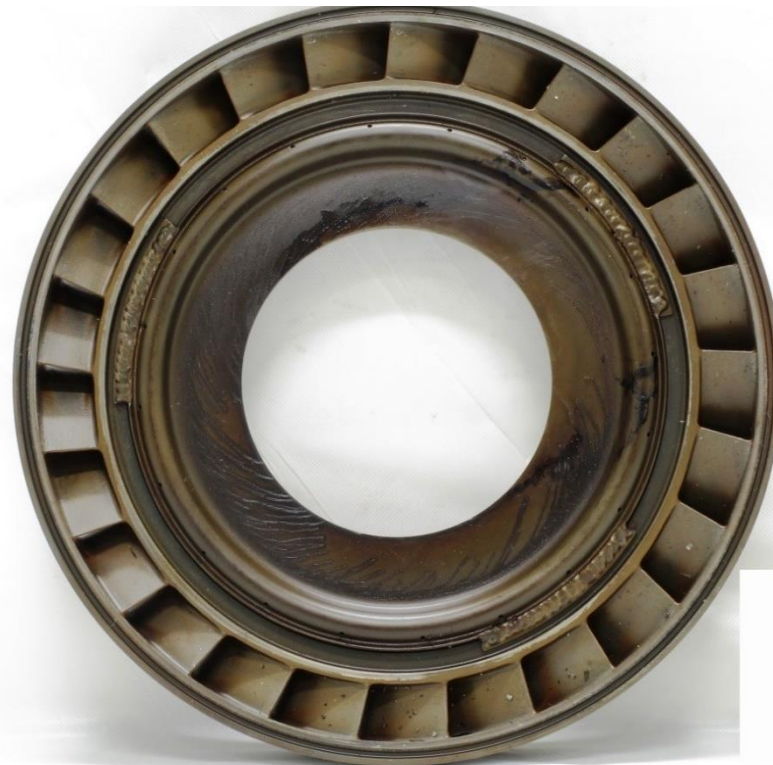
The first stage turbine nozzle is shown in Figure 43. The trailing edge side web exhibited oil deposits and there was debris on the airfoils. The second stage turbine nozzle is shown in Figure 44. The suction side surfaces of the vane airfoils exhibited impact damage. The third stage turbine nozzle is shown in Figure 45 and exhibited impact damage to the trailing edges and vane airfoil suction side surfaces. The fourth stage turbine nozzle is shown in Figure 46 and exhibited impact damage to the airfoil surfaces. Part of the third stage blade track was liberated from the nozzle.

**Figure 43. Leading edge (top) and trailing edge (bottom) side views of the first stage turbine nozzle. The trailing edge side web exhibited oil deposits and there was debris on the airfoils.**

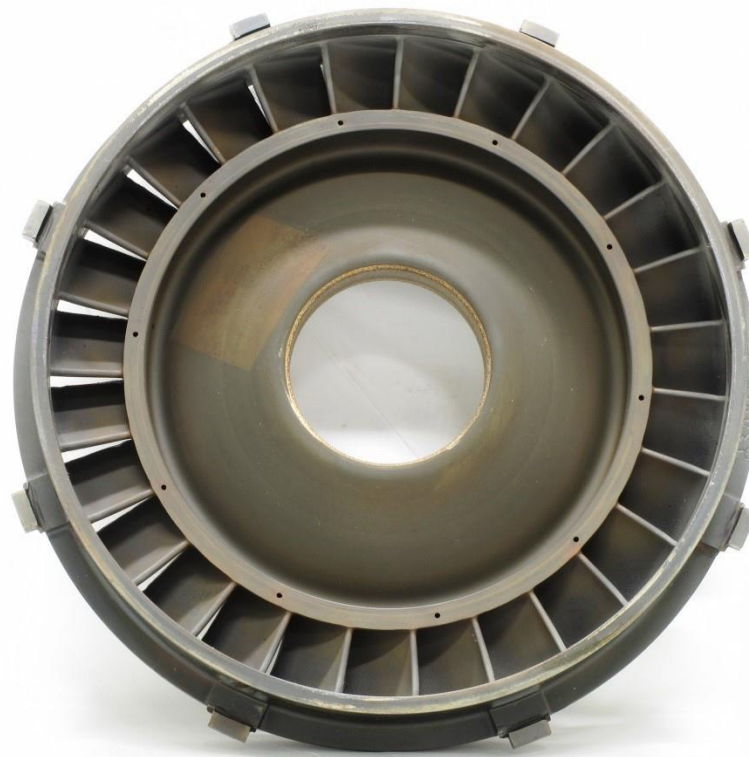
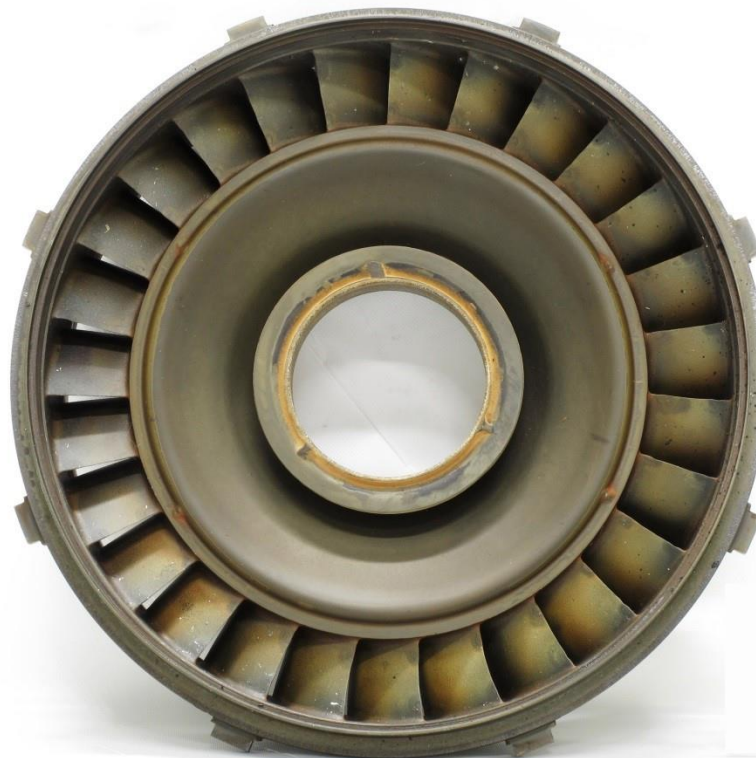
**Figure 44. Leading edge (top) and trailing edge (bottom) side views of the first stage turbine nozzle. The vane airfoil suction side surfaces exhibited impact damage.**

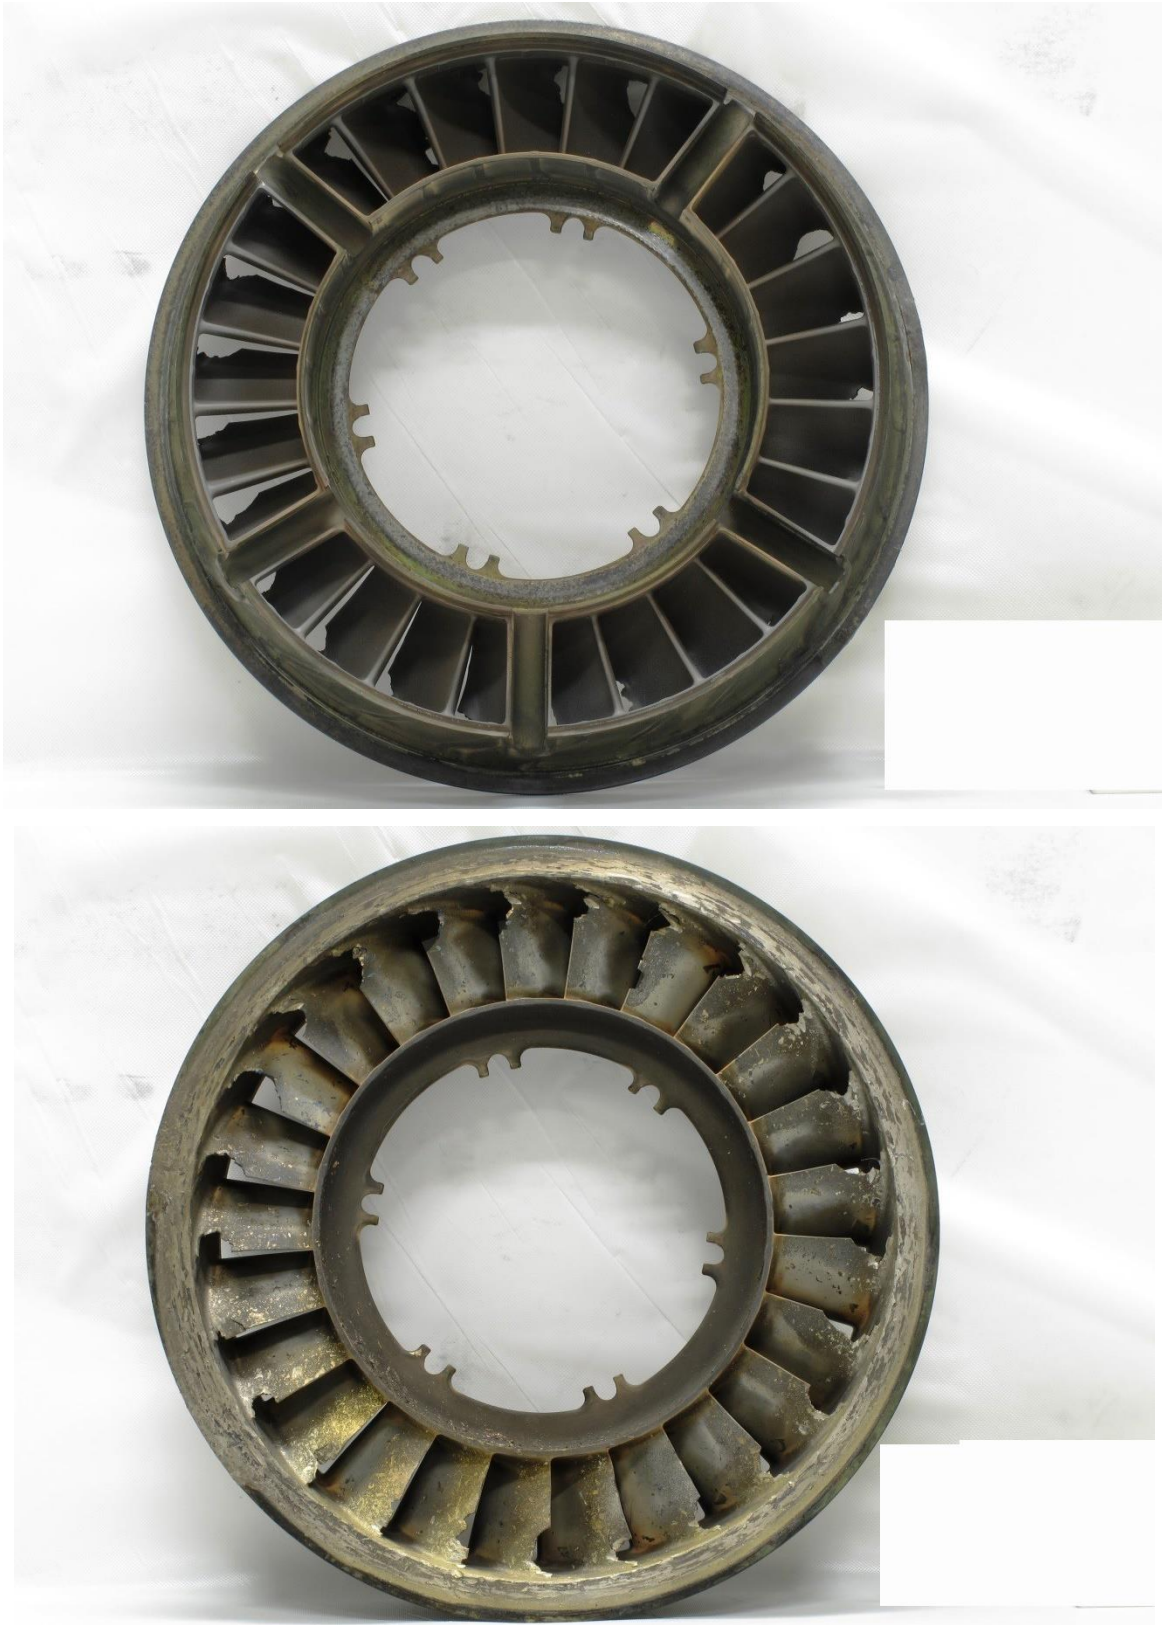
**Figure 45. Leading (top) and trailing (bottom) edge side views of the third stage turbine nozzle. The suction side surfaces and trailing edges of the vane airfoils exhibited impact damage.**

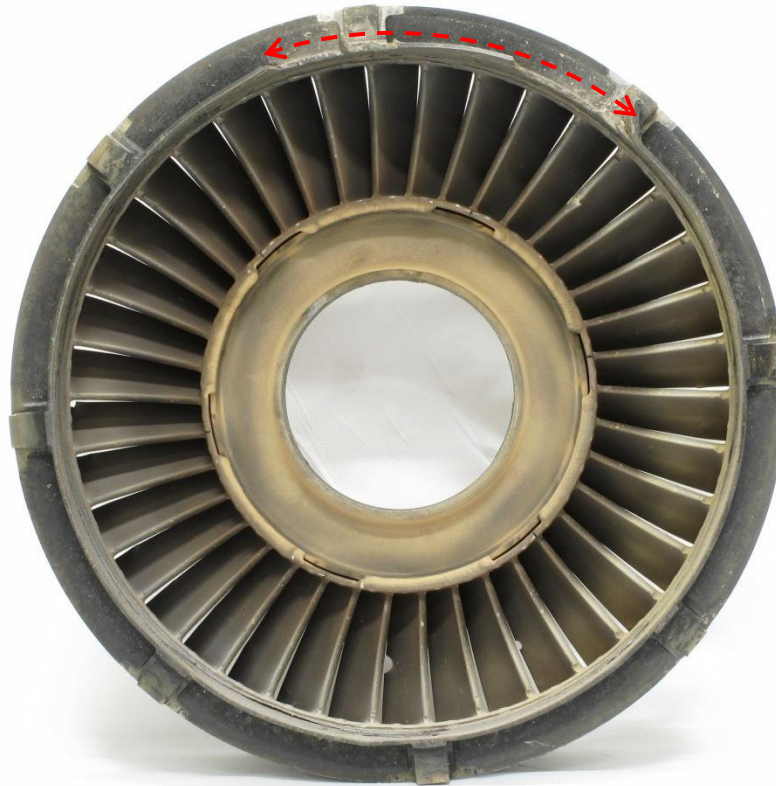
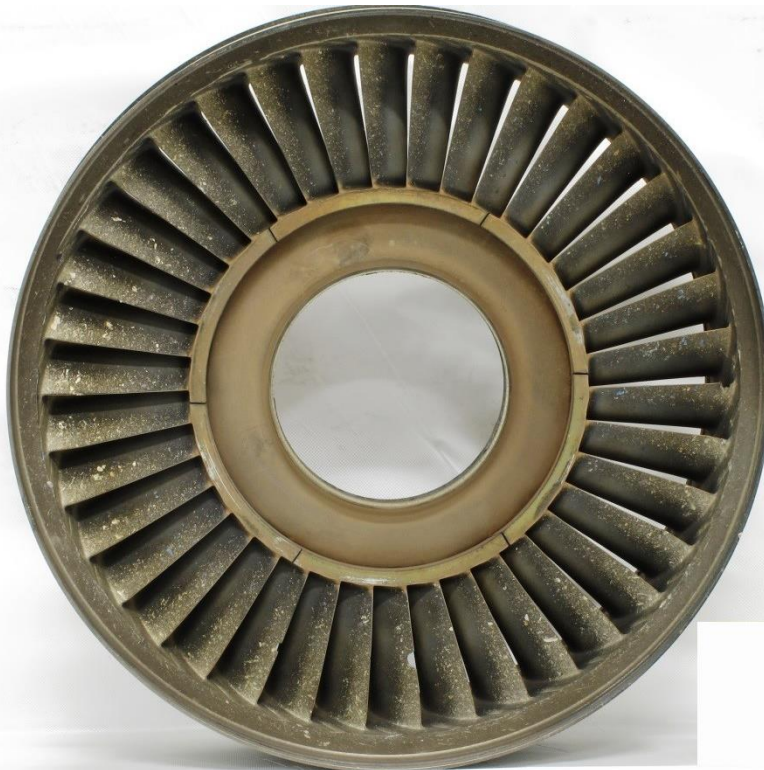
**Figure 46. Leading (top) and trailing (bottom) edge side views of the fourth stage turbine nozzle. Part of the third stage blade track was liberated (red arrow), and the airfoils exhibited impact damage.**

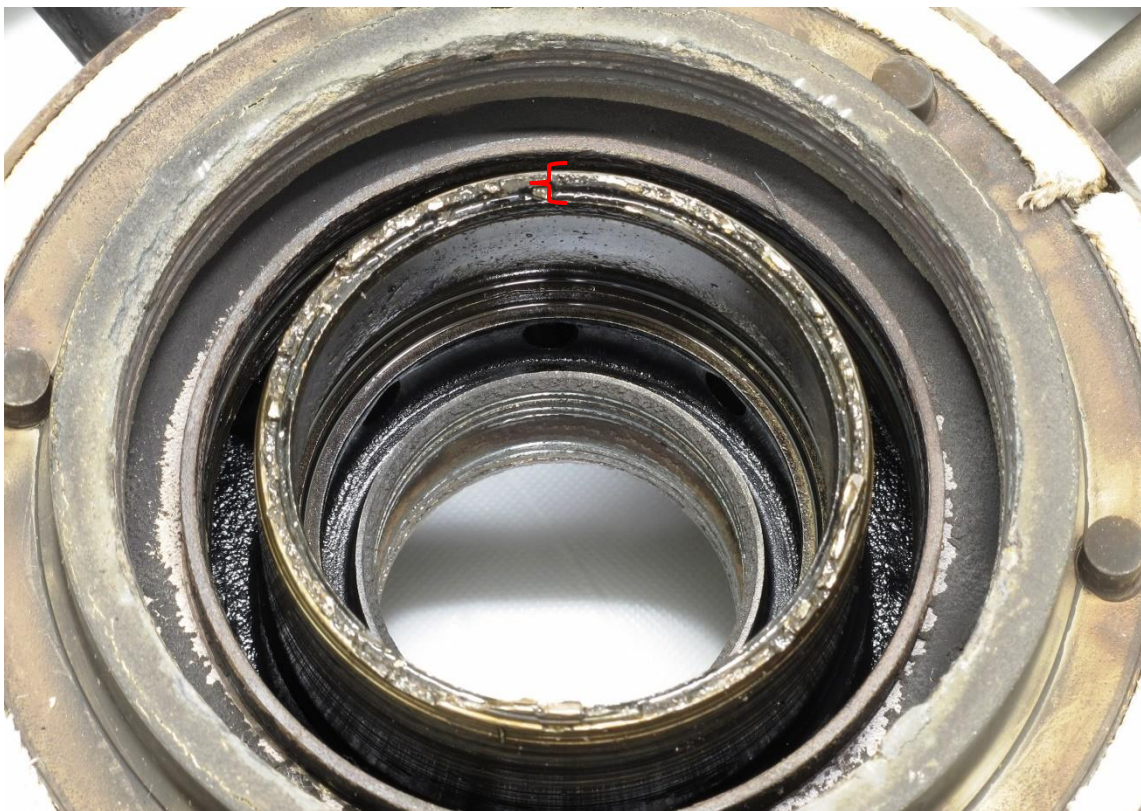
Figure 47 through Figure 49 show the power turbine support assembly, the Nos. 6 and 7 bearing sump stationary labyrinth seal, and the Nos. 6 and 7 bearing sump. The bore was fractured at the forward end. Figure 50 shows the gas producer turbine support. The forward face of the bore exhibited coked oil on the surface.

**Figure 49.** Forward looking aft view of the Nos. 6 and 7 bearing sump in the power turbine support. The bore of the sump was fractured circumferentially at the forward end (red brace).

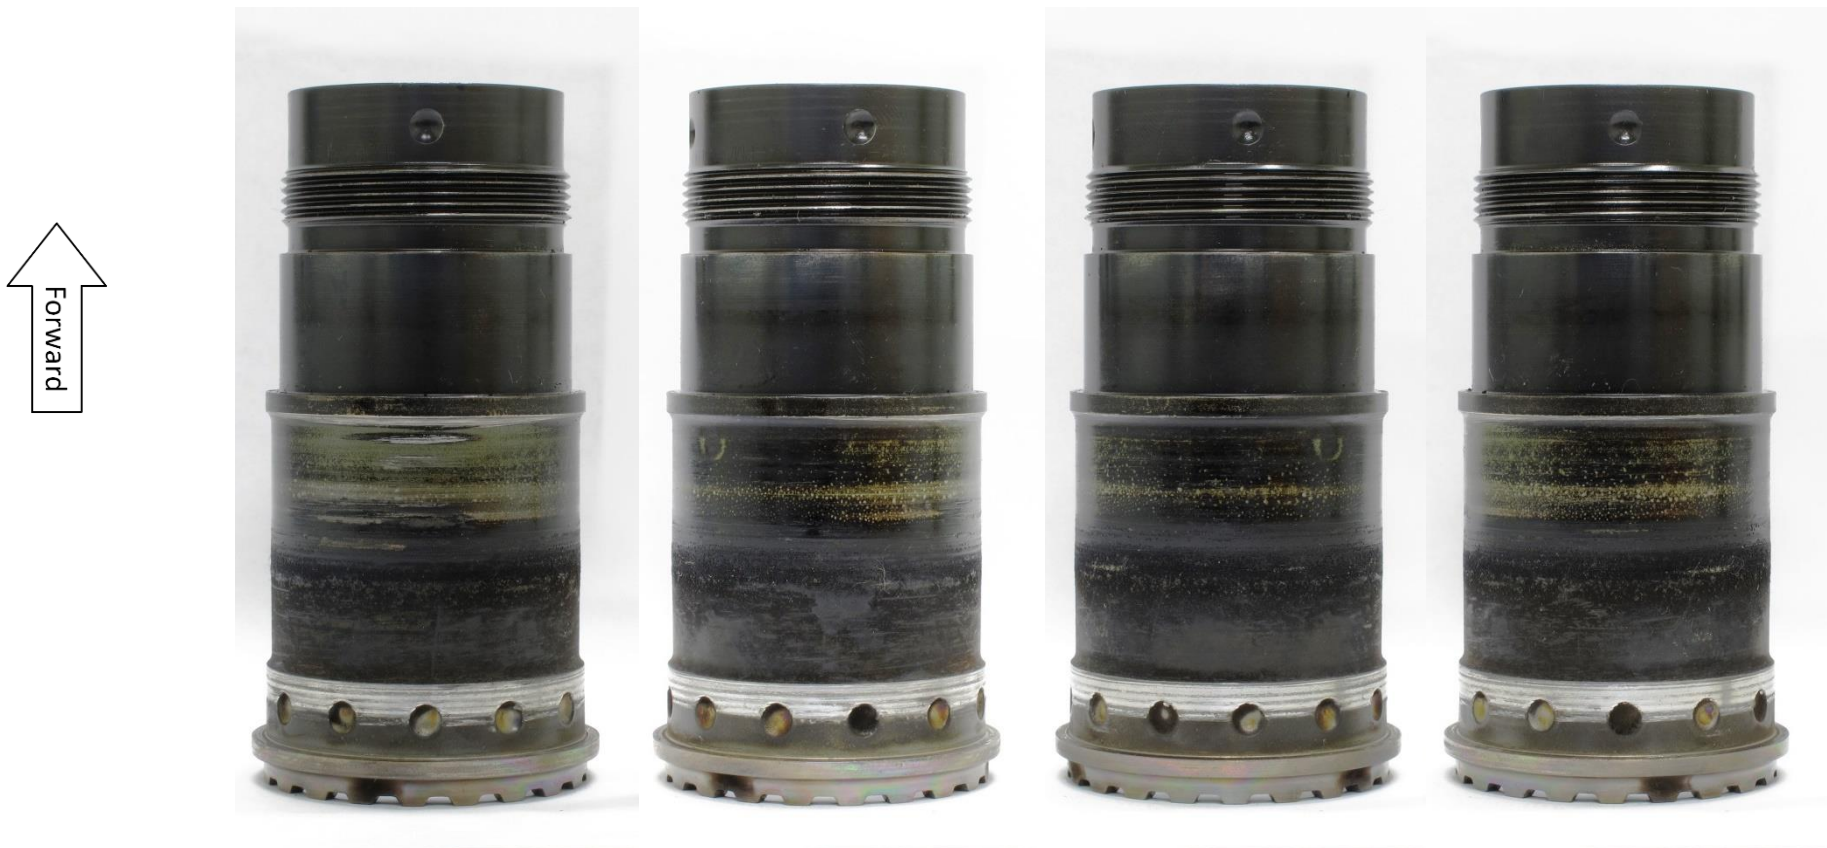
Figure 51 shows the power turbine outer shaft (PTOS). The PTOS exhibited rub and coked oil deposits on the outer diameter surface. Figure 52 shows the power turbine inner shaft (PTIS) with the fractured-off portion of the PT support bore and the No. 6 bearing, Figure 53, retained on the aft end of the shaft. Figure 54 shows the PT

**Figure 51. 90° rotated views of the power turbine outer shaft. The shaft exhibited asymmetric rub, with the most severe rub shown at far left. The shaft also had coked oil deposits on the surface.**

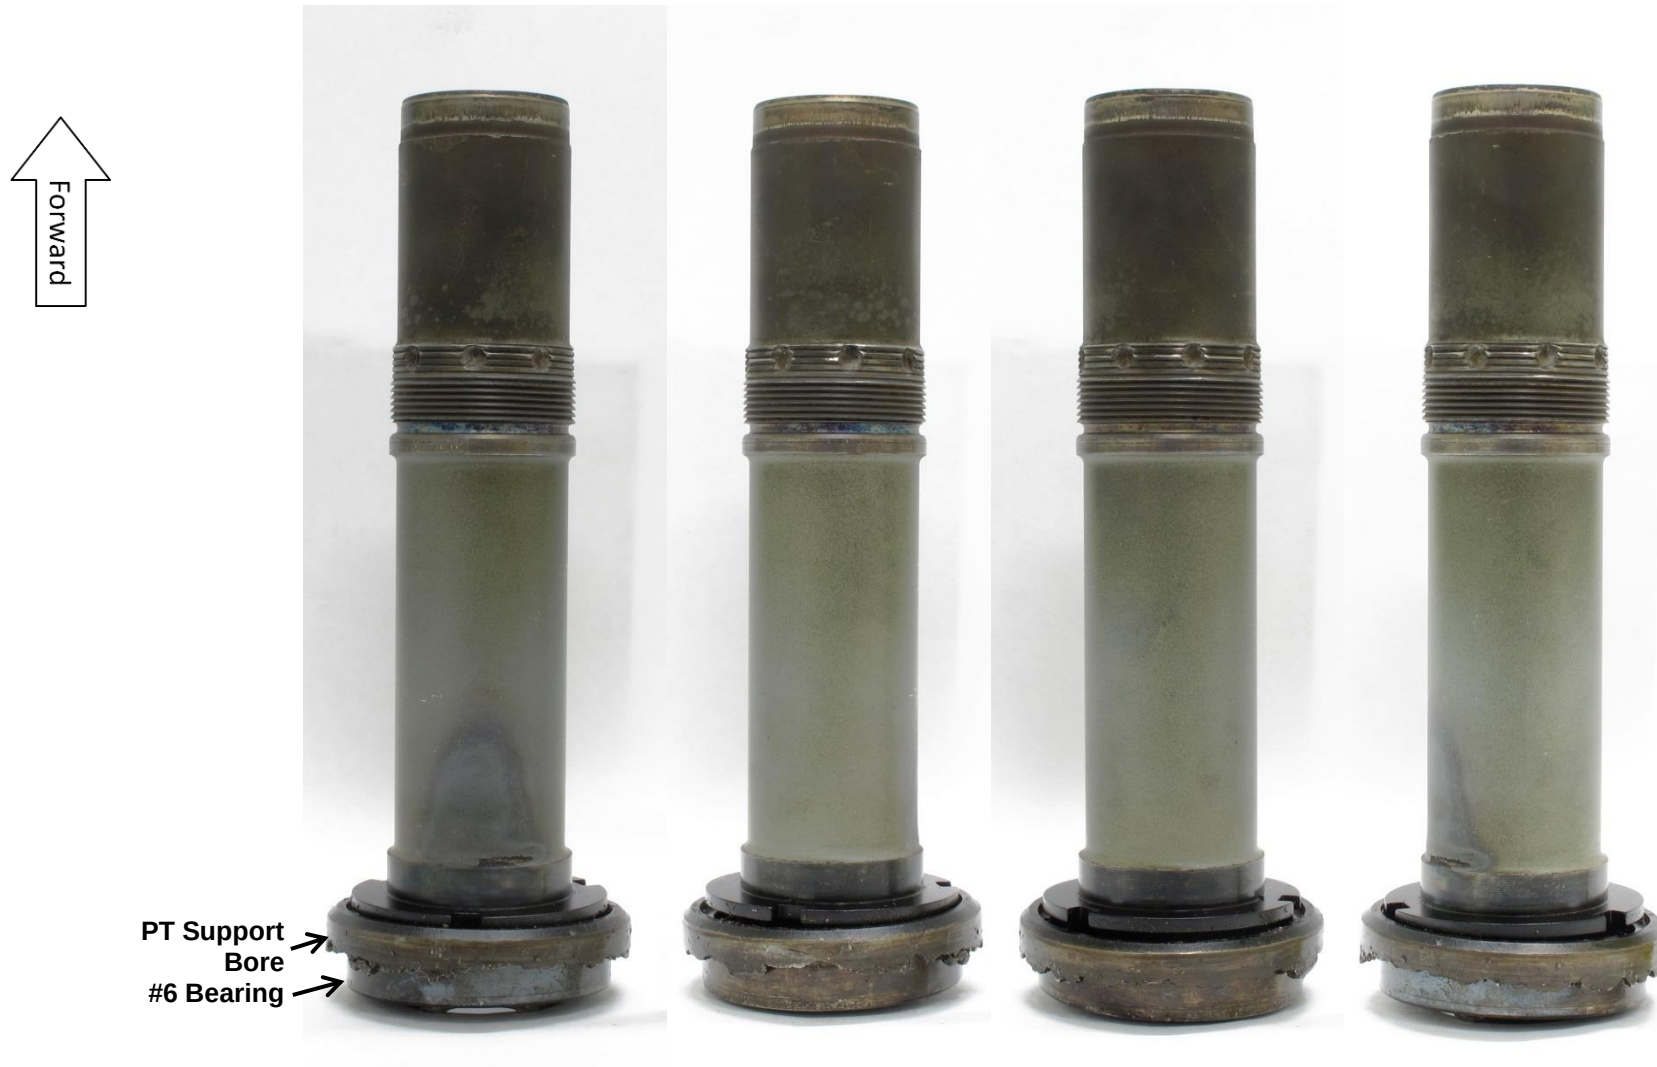
**Figure 52. 90° rotated views of the power turbine inner shaft with the No. 6 bearing stuck on the integral inner race. The fractured portion of the PT support bore was retained on the shaft.**

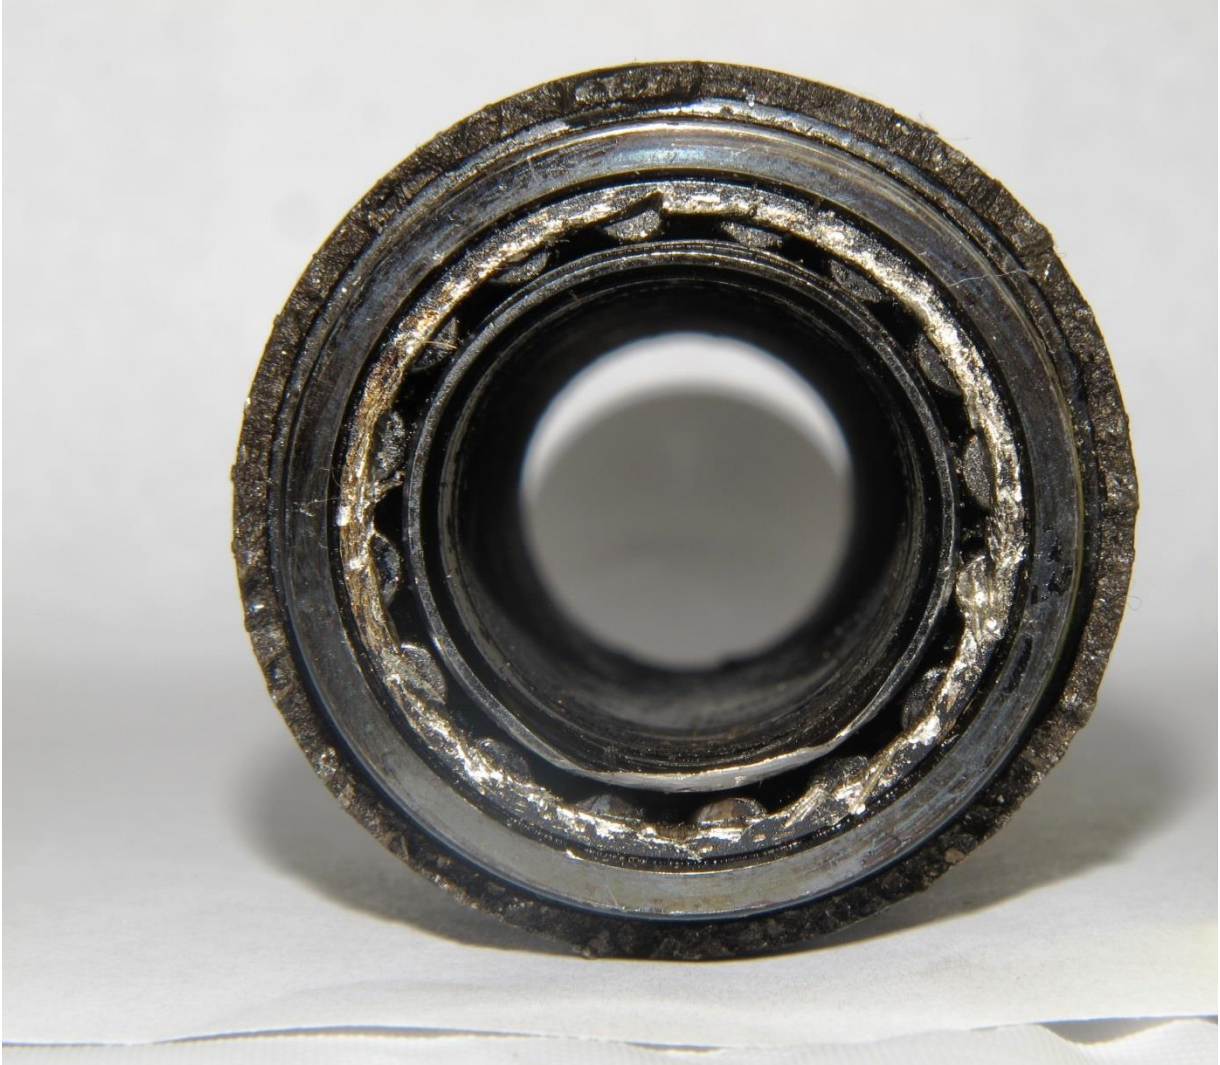
**Figure 53. Aft looking forward view showing the No. 6 bearing stuck on the inner race, which is integral to the power turbine inner shaft.**

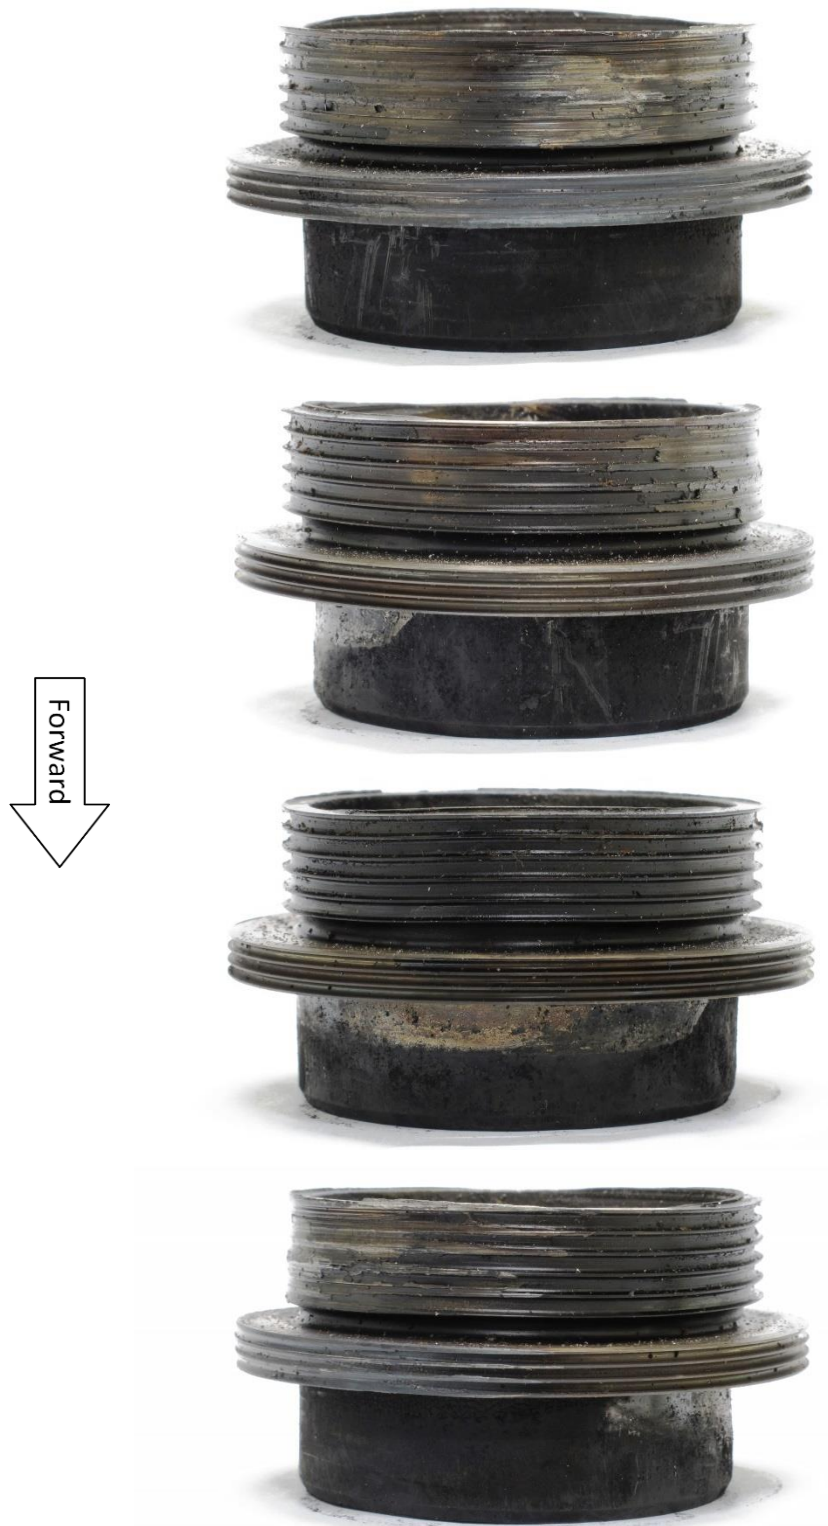
outer and inner shaft nuts. Figure 55 and Figure 56 show the third stage power turbine labyrinth seal, which exhibited rub that rubbed through the seal forward of the knives. Figure 57 shows the turbine to pinion gear coupling, which was a PMA component and was not examined in detail. Figure 58 shows the turbine to compressor coupling, which exhibited rub damage on the outer diameter at one end. Figure 59 shows the turbine tie bolt, which was not fractured. Figure 60 shows the No. 7 bearing. Figure 61 shows the No. 8 bearing, which was a PMA component and not examined in detail. Figure 62 shows the No. 5 bearing, which was a PMA component and not examined in detail.

**Figure 55. 90° rotated views of the third stage power turbine labyrinth seal. The seal exhibited asymmetric rub, with the most severe rub damage shown at top.**

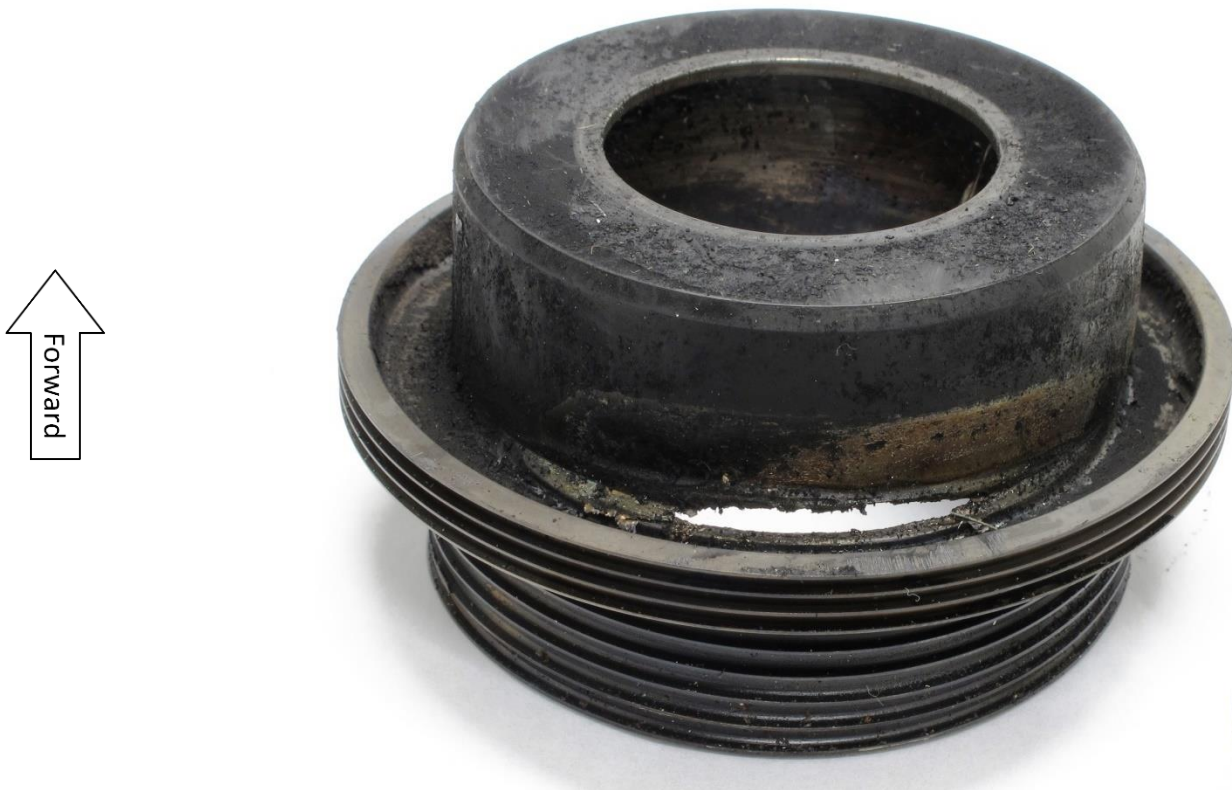
Figure 56. Detailed view showing the rubbed-through area on the third stage power turbine labyrinth seal.
