**NATIONAL TRANSPORTATION SAFETY BOARD**

**ENGINE EXAMINATION FIELD INSPECTION REPORT - WPR19LA125**

**Accident:** WPR19LA125  
**Location:** Sequim, WA  
**Date:** April 28, 2019  
**Aircraft:** Boeing A75N1, N68825  
**NTSB IIC:** Jack Vanover

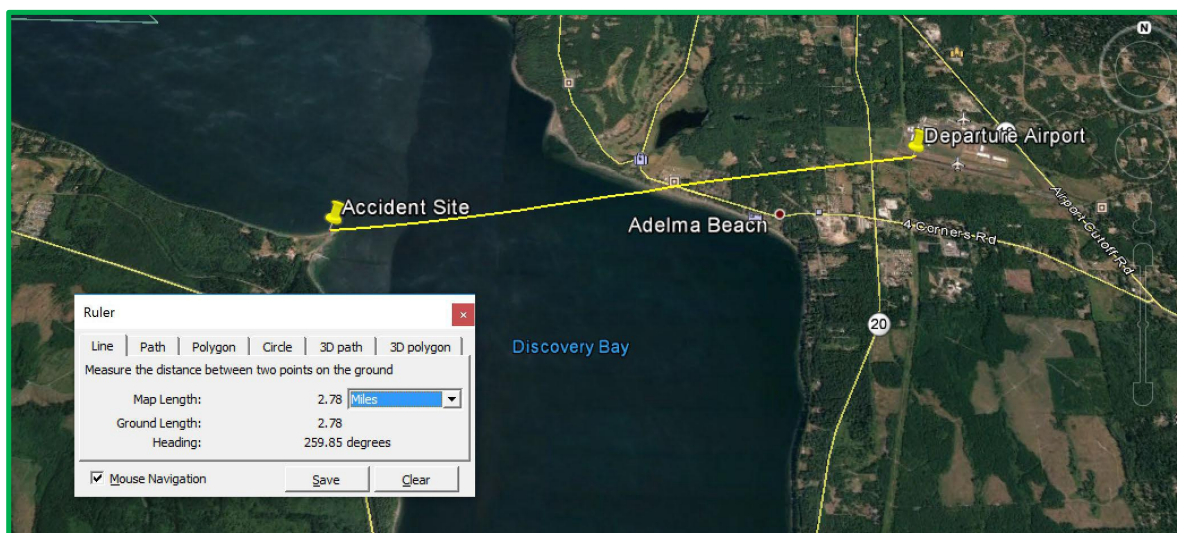
Figure 1: view of accident location

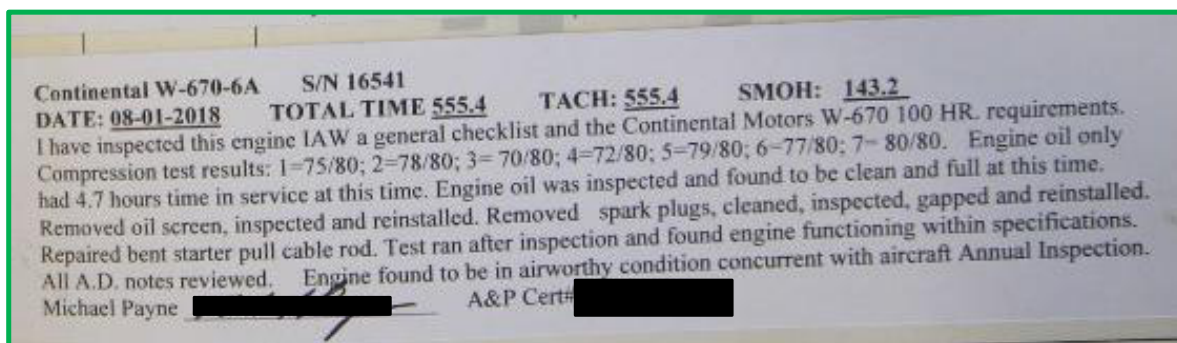
Figure 2: last annual inspection record

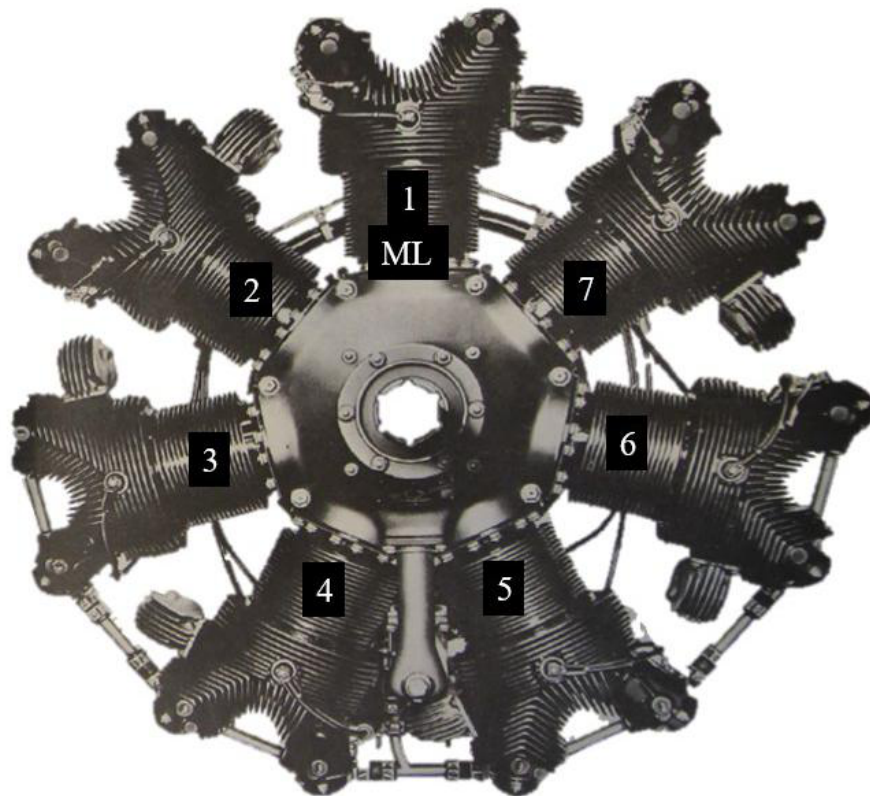
*Figure 4: cylinder and master link (ML) location*

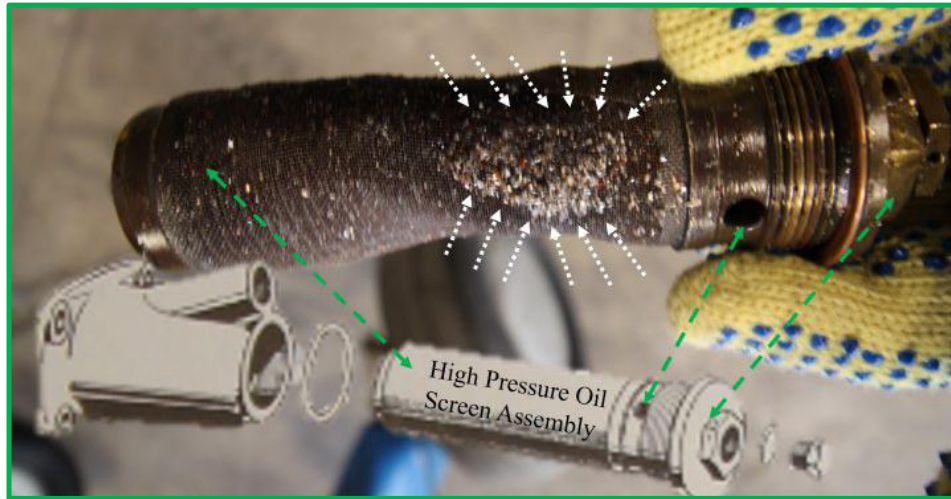
Prior to the examination the owner of the airplane removed the high-pressure oil screen assembly. Metal flakes were observed on the outside of the screen.

*Figure 5: high pressure oil screen assembly*

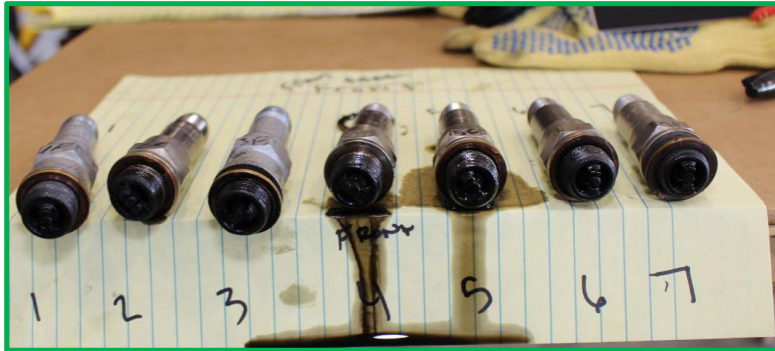
The primary ignition leads were removed from the front and back spark plugs. The spark plugs were removed from all cylinders. No. 2 cylinder from and back spark plugs were observed to have been carbon fouled. No. 4 and 5 front and back spark plugs were covered in oil.

Figure 6: view of front spark plugs

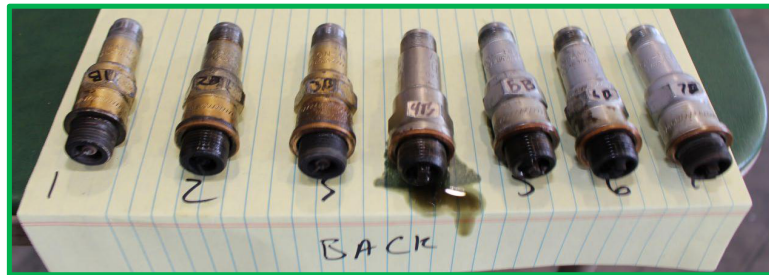
Figure 7: view of rear spark plugs

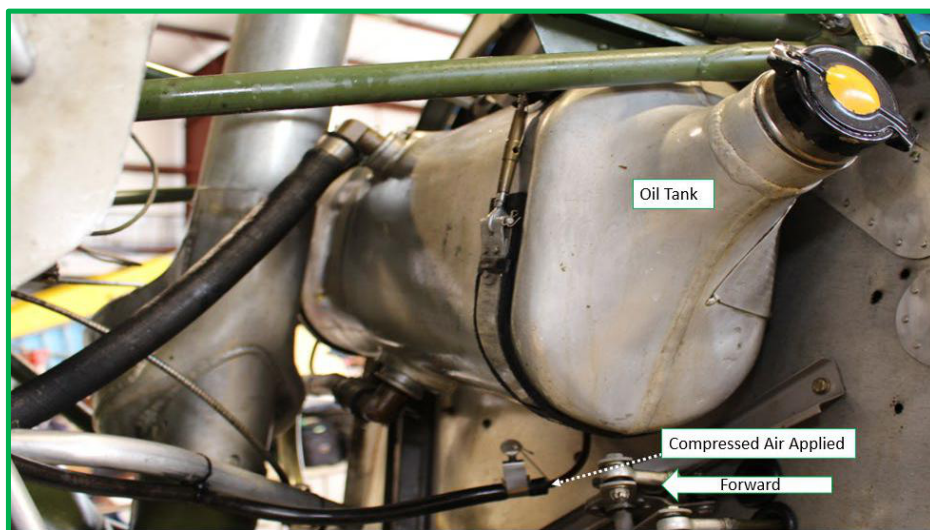
Compressed air ( $\approx 30$  LBS) was applied to the oil system and found to bleed from the base of the crankshaft and forward engine case area.

Figure 8: compressed air was applied to the oil system

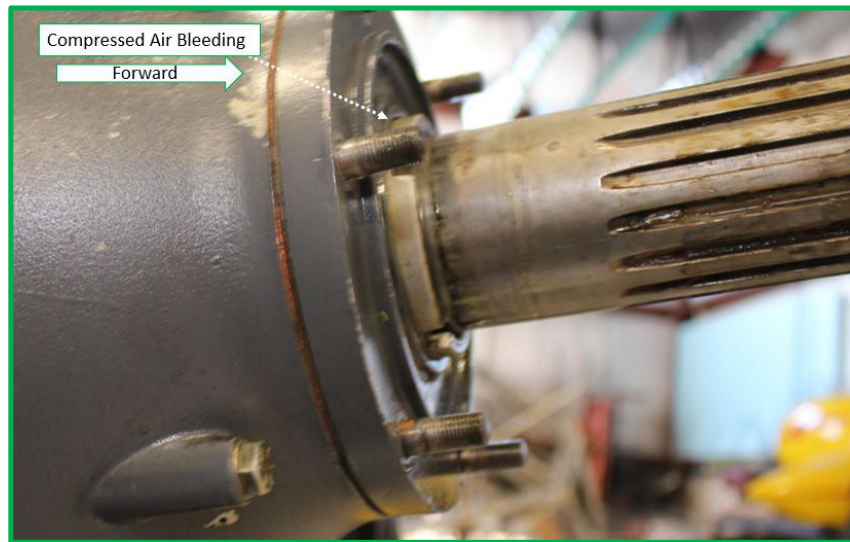
Figure 9: compressed air bleed point

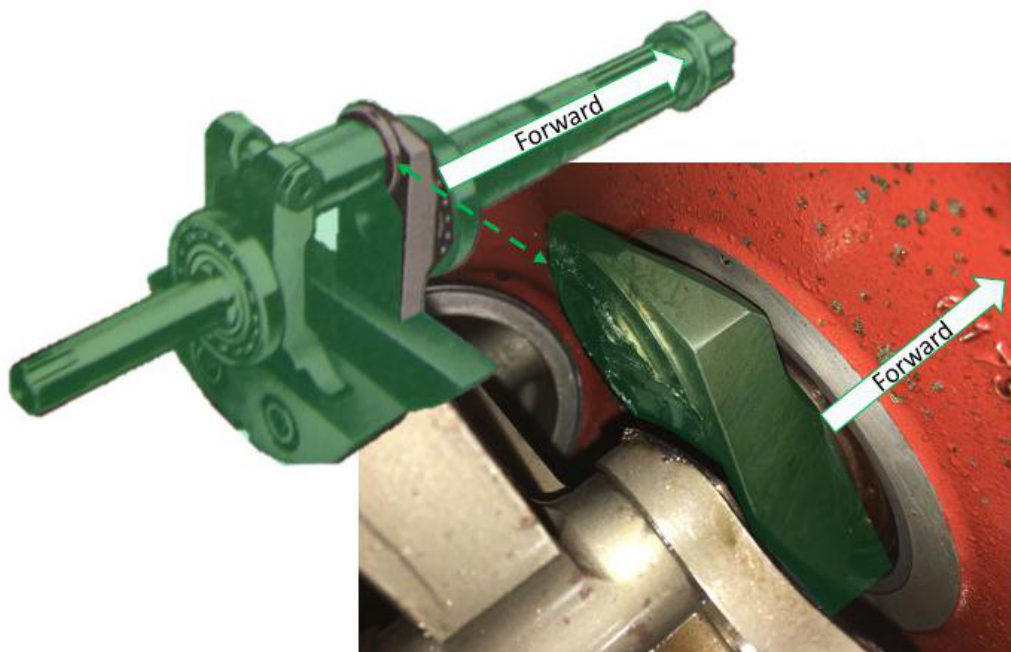
The No. 3 cylinder was removed, which revealed a failure of the crankshaft

Figure 10: view of crankshaft failure

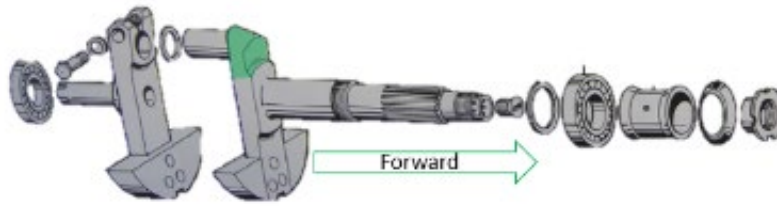
Figure 11: view of failure in relation to crankshaft

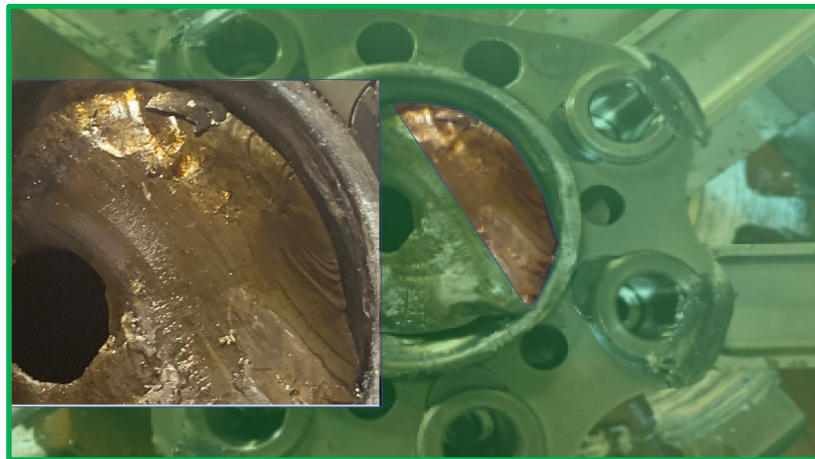
Figure 12: view of failure area

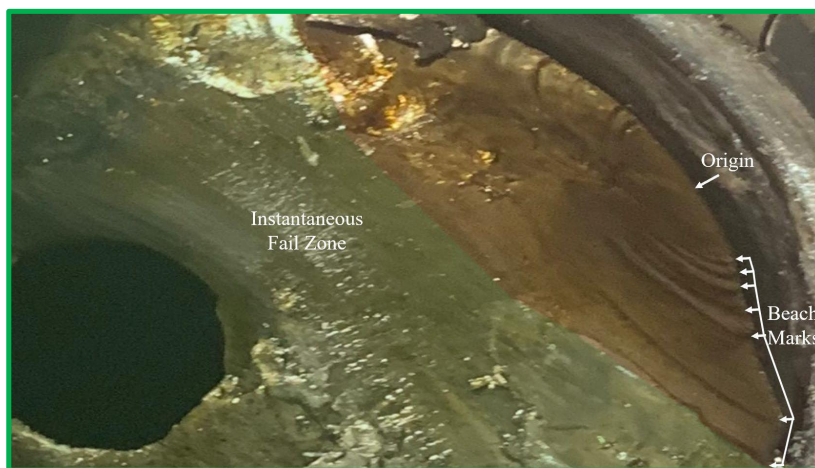
Figure 13: view of beach marks and origin of failure
