## **NATIONAL TRANSPORTATION SAFETY BOARD**

# **AIRFRAME AND ENGINE EXAMINATION**

**WPR19LA128**

Location: Sedona AZ  
Date: May 1, 2013  
Aircraft: Beech S-35, N6864Q, Serial # D-7479  
NTSB IIC: Michael Huhn

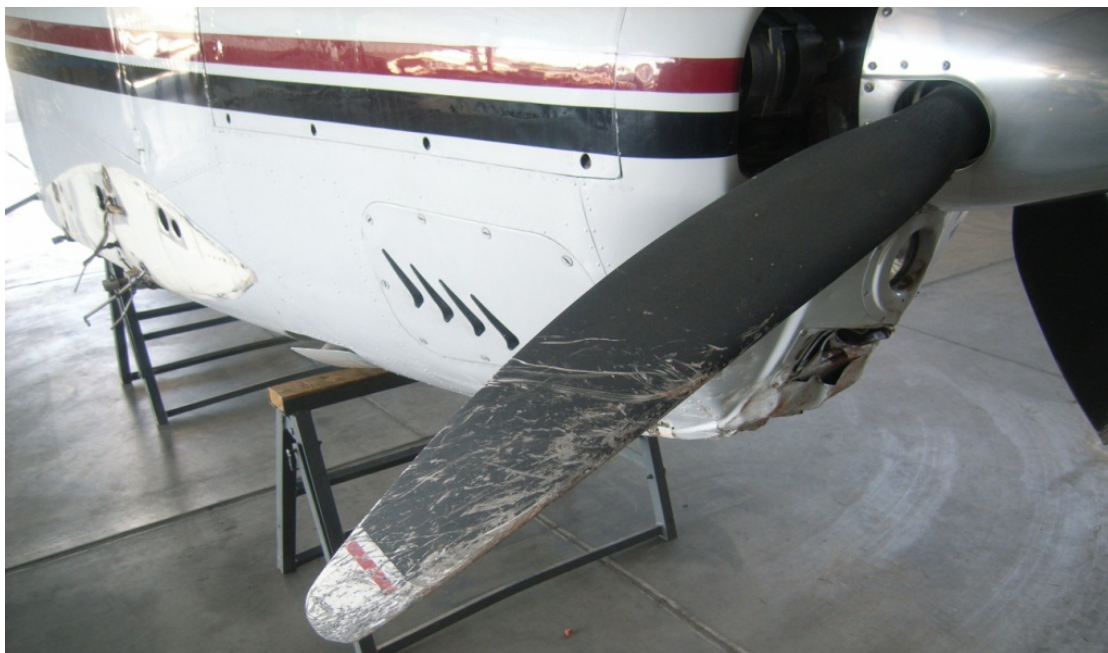
- Engine Dataplate (new engine): TCM IO-520-BA (23) Serno 822910-R
- Two of the three blades of the propeller were damaged from impact and some rotation

- One of those was loose in the hub
  - The third blade was intact and secure in the hub
- The forward lower cowl displayed minor impact damage
- The air intake and filter were partially damaged

**Figure 4 - Damaged Blade**

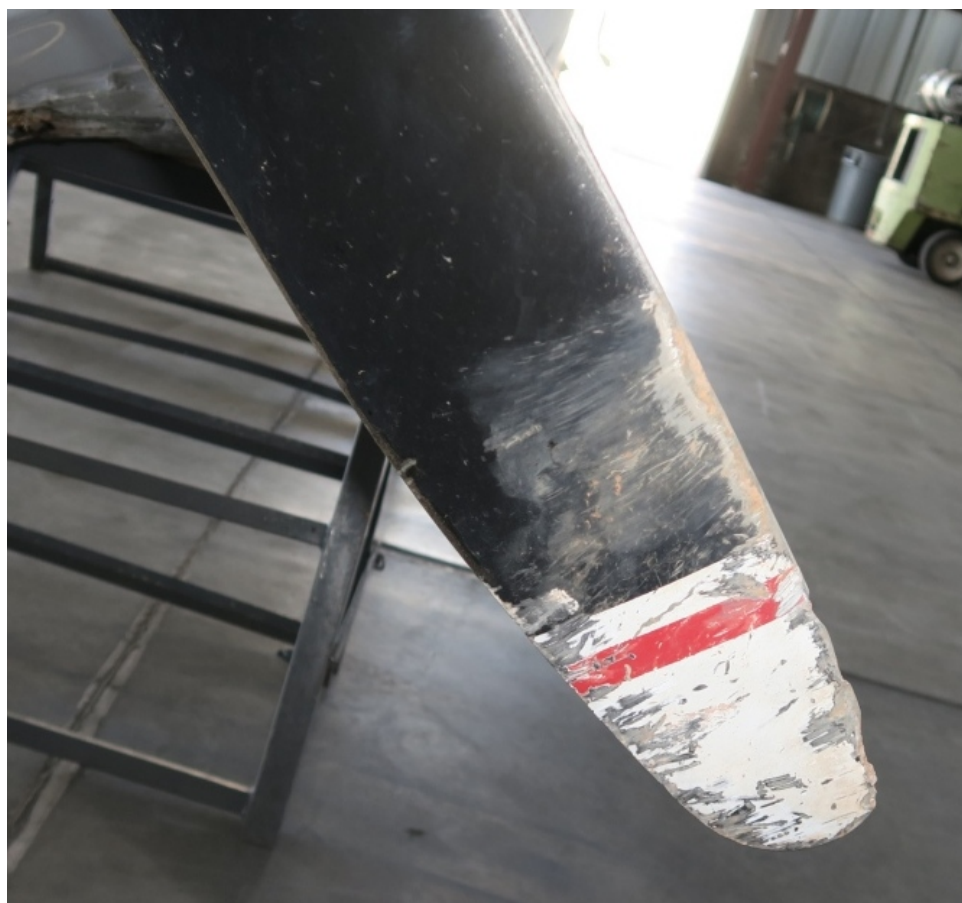
**Figure 5 - Damaged Blade**

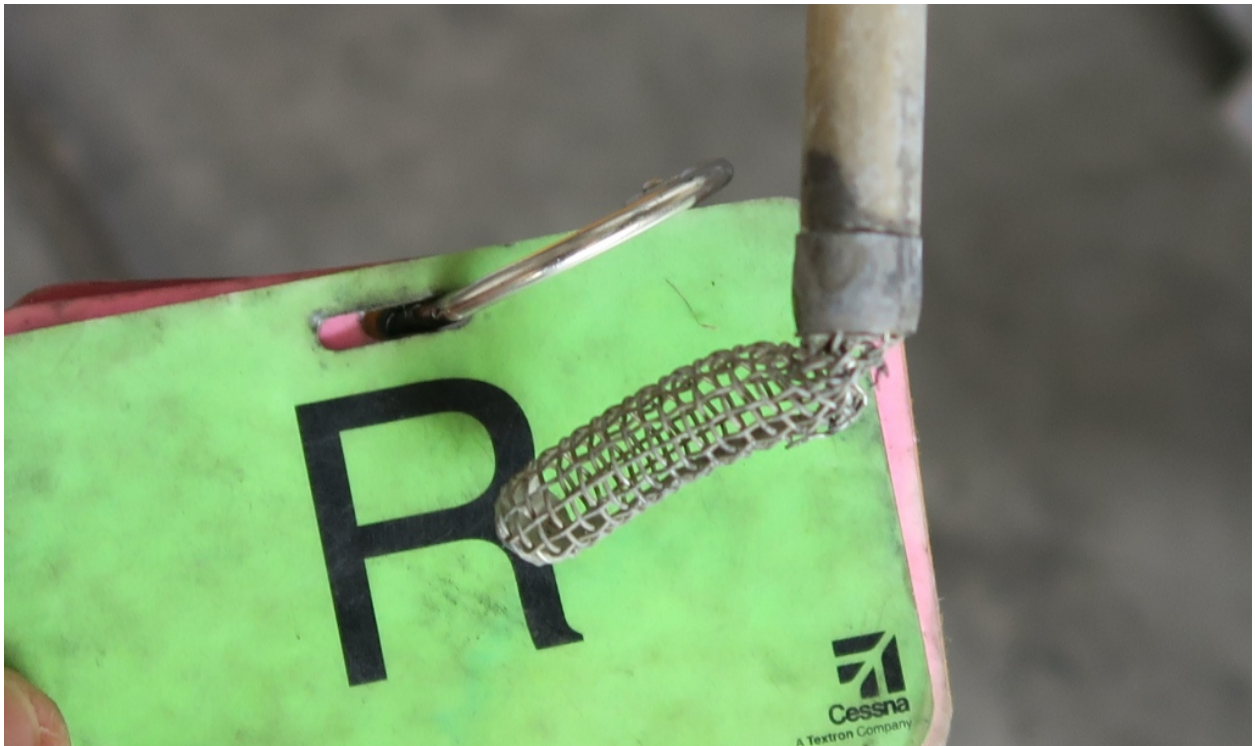
- Both wings had been unbolted and separated from the fuselage for recovery
- The fuselage was on stands and the front seats had been removed for recovery
- The fuel lines from each tank, with their respective finger screens, remained intact and attached to the cockpit fuel selector valve
- The cockpit appeared intact
- The engine appeared nearly intact

**Figure 7 - Right Tank Fuel Pickup Finger Screen**

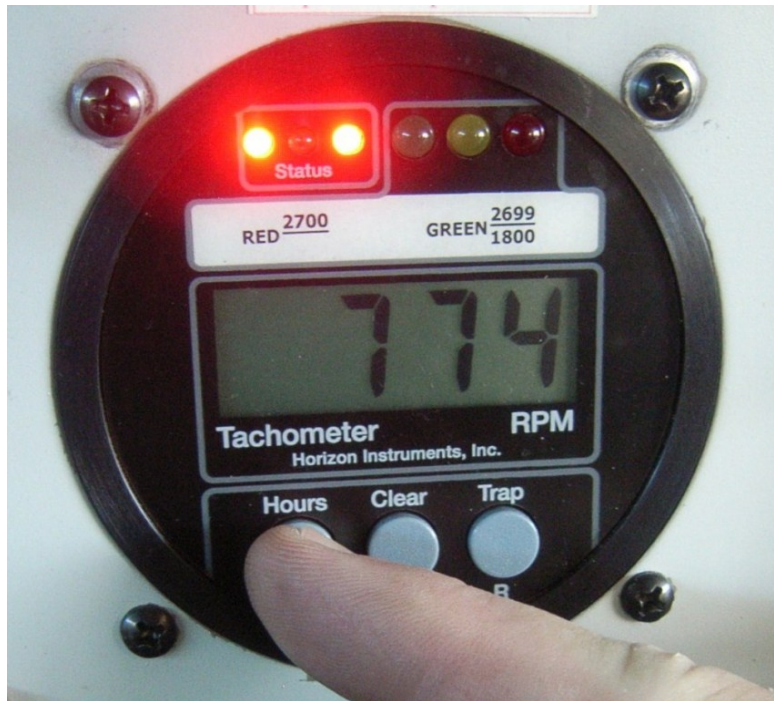
- The battery was intact and remained connected
- The electronic tachometer (with power applied) indicated 774.24 hrs
- The fuel totalizer (with power applied) indicated 63.3 gallons of fuel remaining

Figure 8 - Tachometer

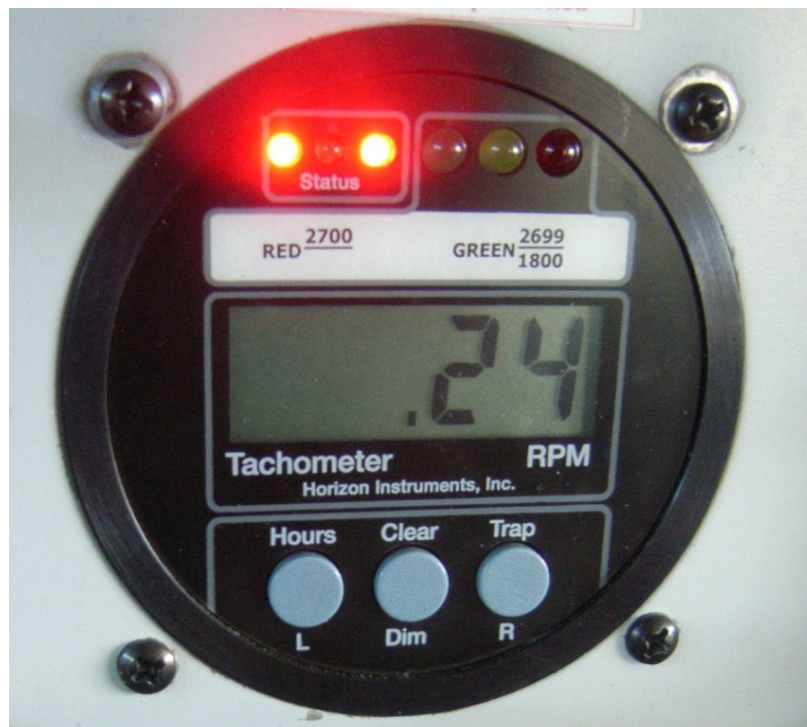
Figure 9 - Tachometer (decimal display)

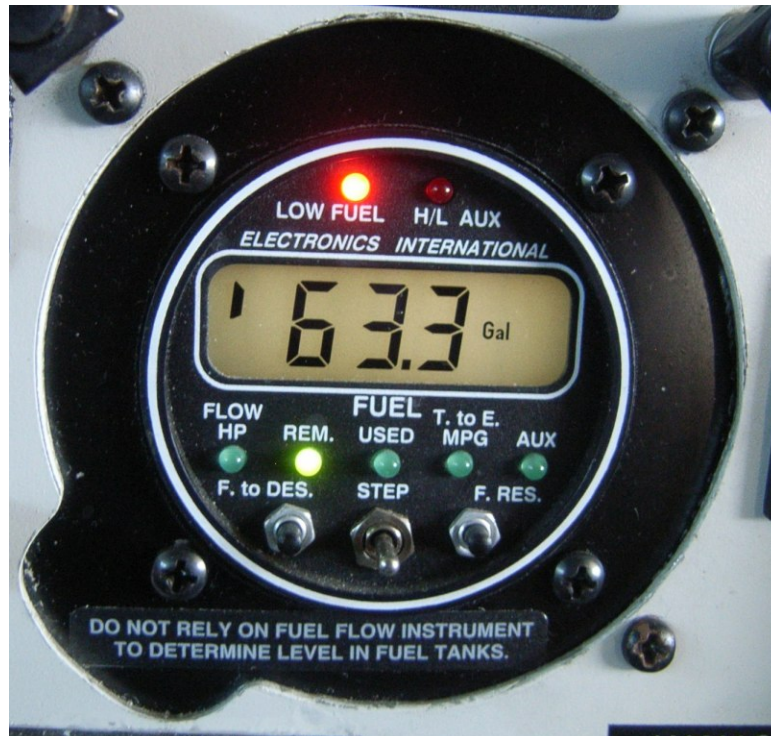
Figure 10 - Fuel Flowmeter

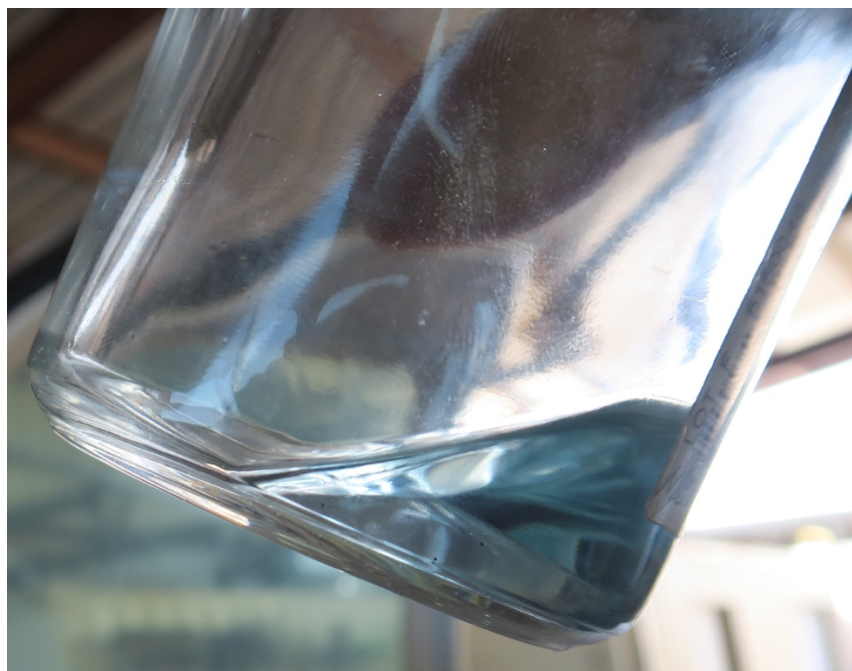
- Clear blue fuel was obtained from the fuel strainer that was attached to the bottom of the fuel selector valve

Figure 11 - Fuel Sample from Fuel Strainer

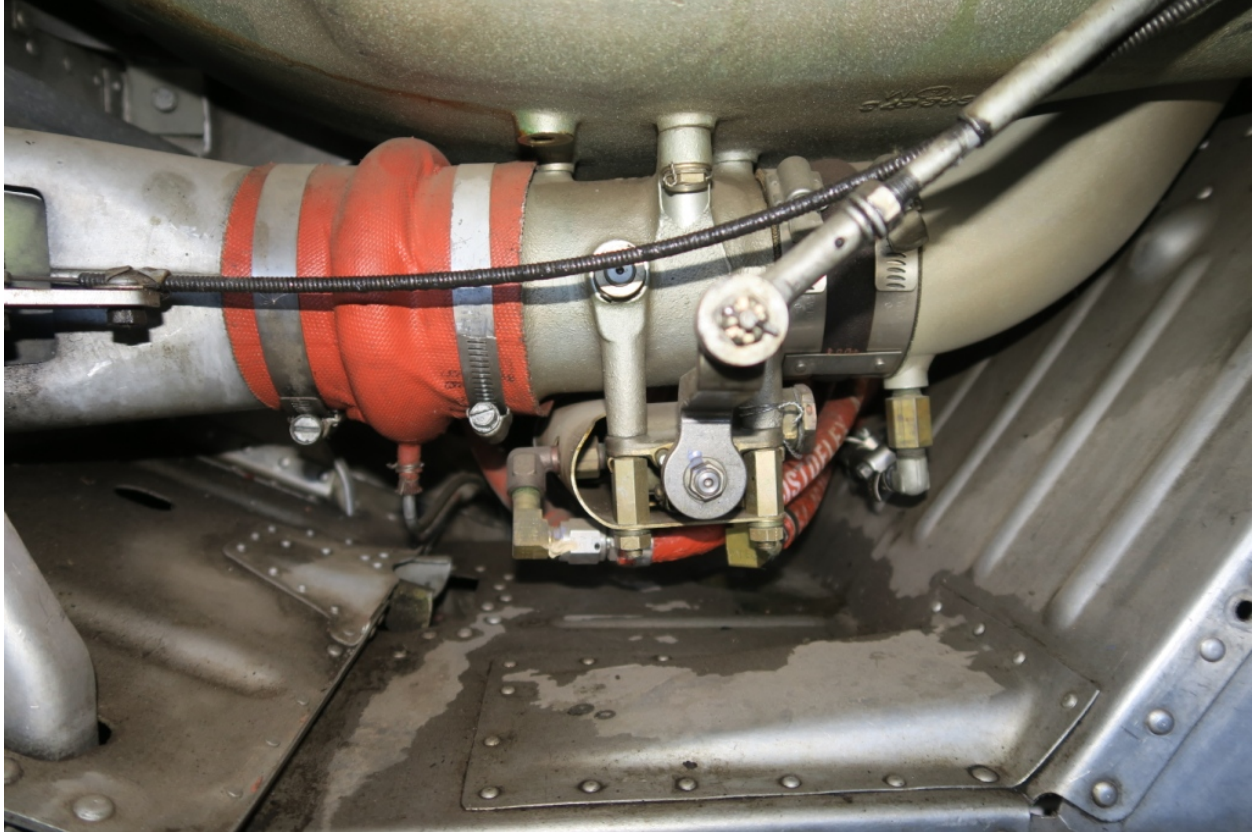
- The inner cowl and the exterior of the underside were examined for indications of fuel staining; none was observed
- Review of inner cowl photos taken before any engine priming or runs were conducted indicated some type of liquid staining/residue and grime on the upper surface of the NLG well (where the fuel was observed to drip and pool after priming and during engine runs).
- The memory unit for the EI engine monitor was removed and retained for data download by NTSB personnel
  - EI Monitor model UBG-16
  - Memory module MUX-8A SN 079395

**Figure 12 - Pre-prime/run Staining/leak indications**

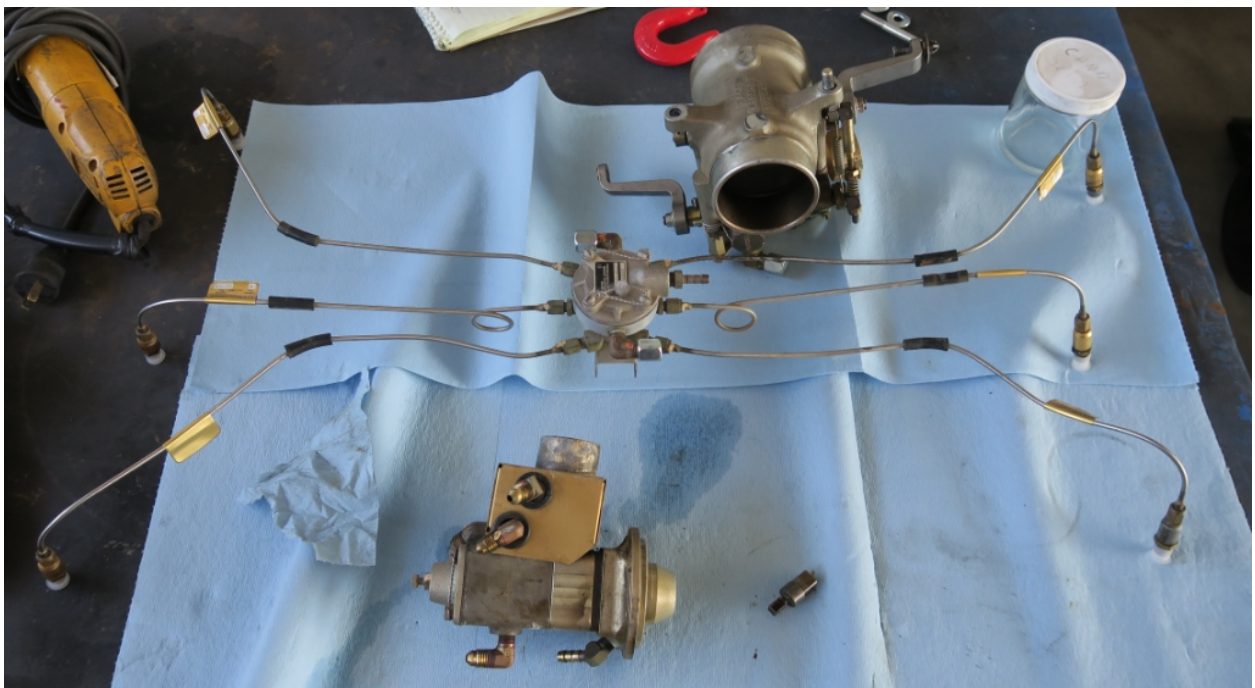
- These were:
  - Flow divider assy w/ lines and injectors
  - Throttle body w/ FCU
  - Engine-driven fuel pump (EDP)
- The components were removed; all were securely attached and except as listed below, no mechanical anomalies were noted

**Figure 13 - Removed Components**

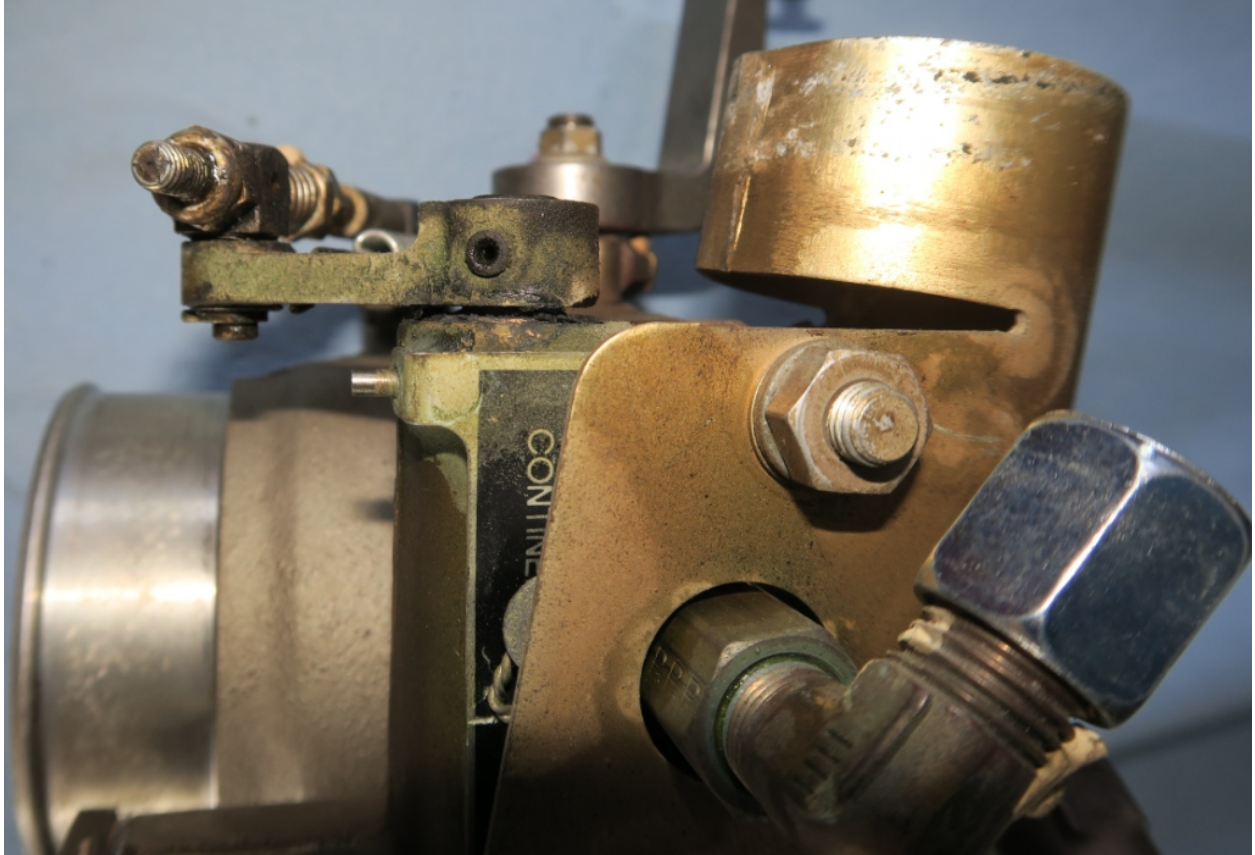
- Unlike the throttle body and the remainder of the FCU, the FCU body did have some accumulated 'grime' surrounding the exit locations of the throttle & mixture shafts (the leak sources).

- The grime suggested that these locations had been leaking for some time
  - Manual rotation of the mixture shaft in the FCU revealed a variation in resistance, akin to a partial 'dead band' (very little resistance)

Figure 14 - Grime on FCU Shaft Exit
