## **NATIONAL TRANSPORTATION SAFETY BOARD**

### **FUEL SYSTEM COMPONENTS**

**WPR19LA128**

Location: Sedona, Arizona  
Date: May 1, 2019  
Aircraft: Beech S35, N6864Q, Serial # D-7479  
NTSB IIC: Michael Huhn

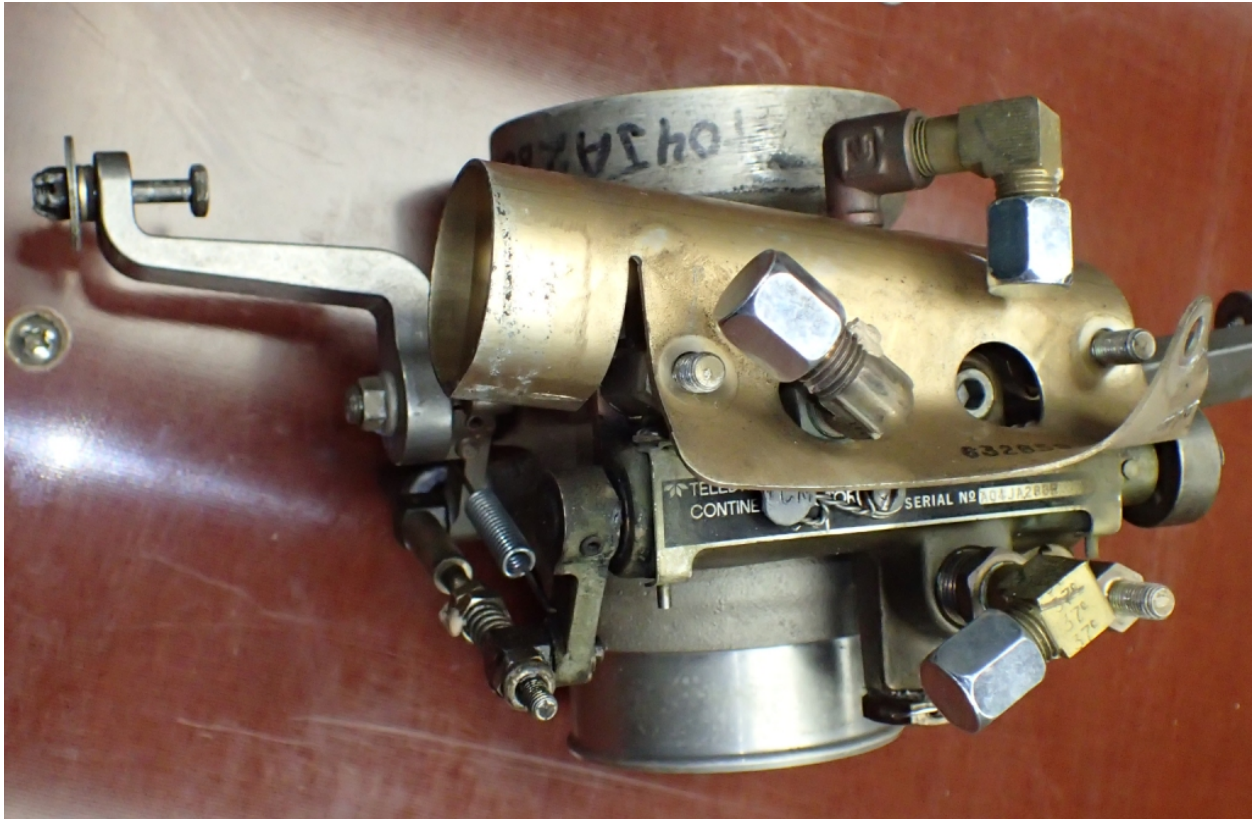
- PN 631515A8, SN A04JA280R
- No evidence of impact or any other damage or deficiencies
- Safety wire/lead seal from original manufacture was present/undisturbed
- A Continental records check indicated the following
  - Engine manufactured 2004
  - Component delivered on engine
- Therefore unit not overhauled since manufacture in 2004 (14 years prior to accident)
- Manufacturer's recommended overhaul interval every 12 calendar years or 1,700 hours in service, whichever comes first

- Date of engine installation in airplane was not able to be determined (insufficient documentation)
- All linkages were properly installed and safetied
- The body bore was clean and undamaged

Figure 1 - Throttle and Metering Assembly

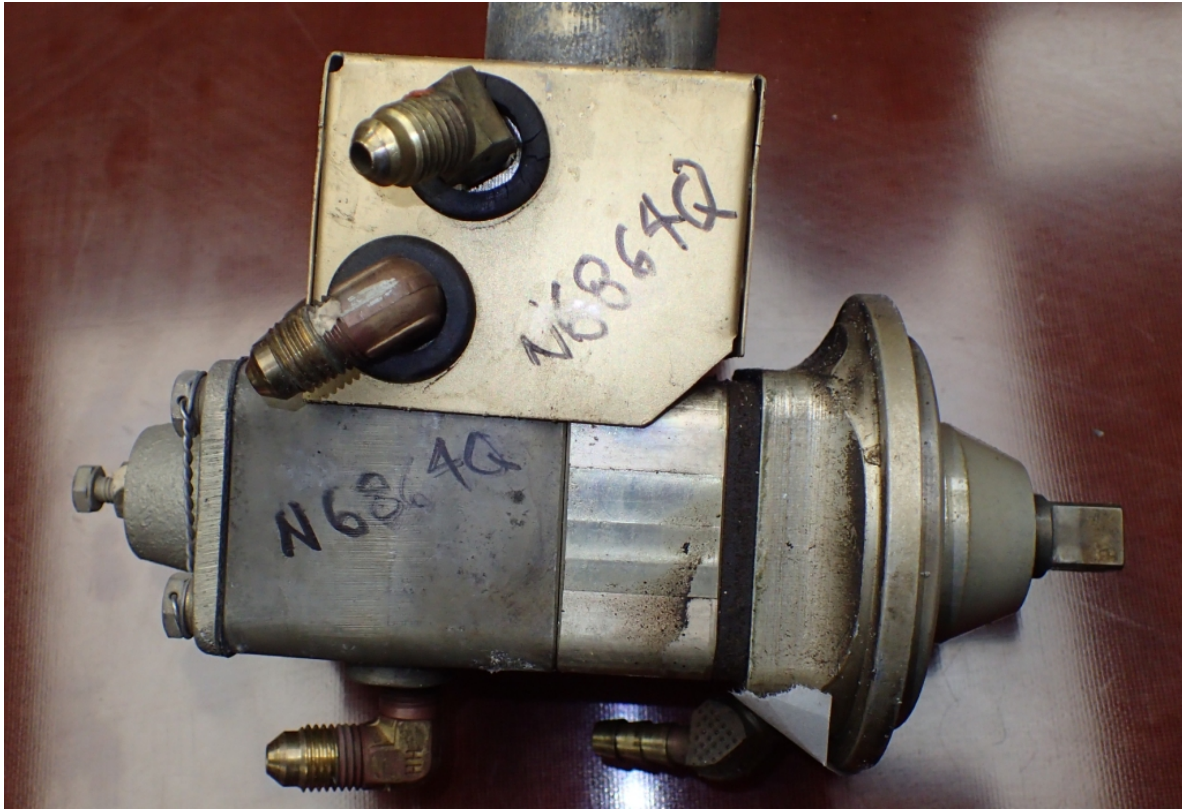
- PN 646212-24A1, SN B04JA328R
- No evidence of impact, or any other damage or deficiencies
- Drive shear shaft installed & intact
- Adjustment bolt retained intact torque/motion stripe

**Figure 2 - Engine-Driven Fuel Pump**

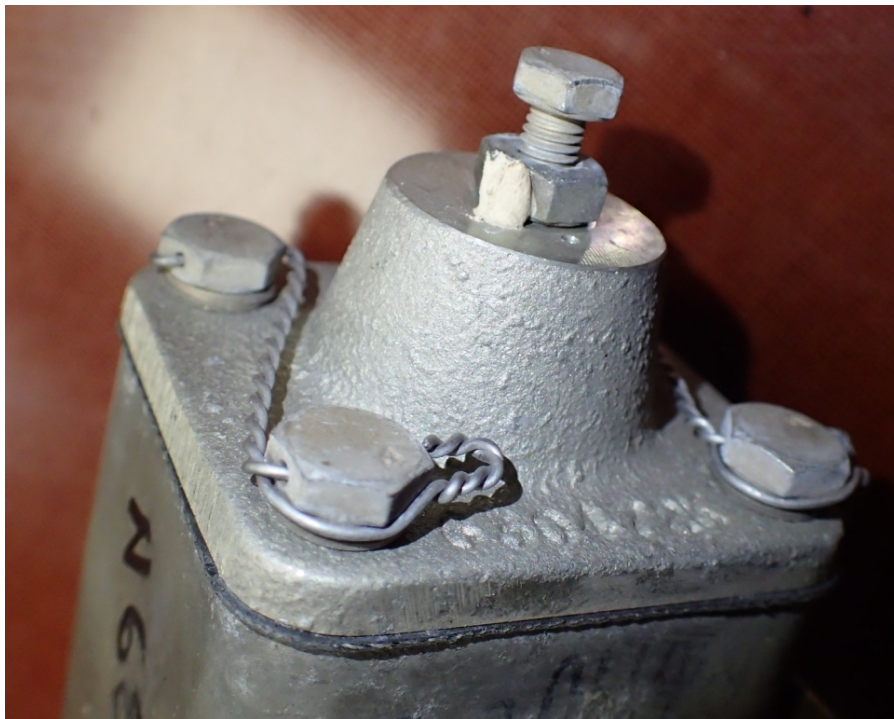
**Figure 3 - EDP Adjustment Bolt (undisturbed)**

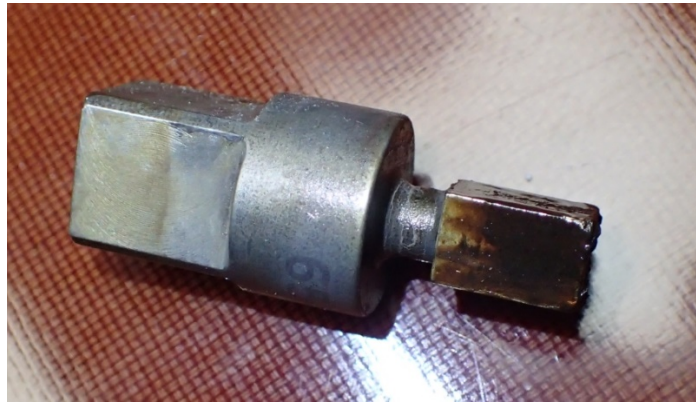
**Figure 4 - EDP Drive Shaft**

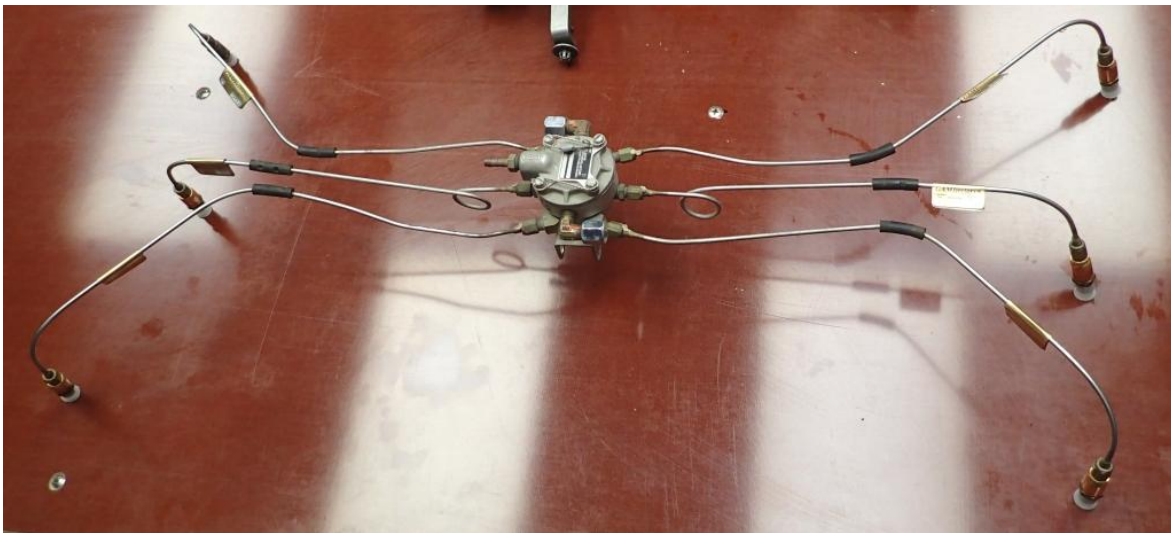
- Manifold Valve PN 631427-2A21, SN A04JA280R
- GAMI-brand Injectors GA173 (qty 2, cyls 1 & 2), GM156 (qty 2, cyls 3 & 4), GA147 (qty 2, cyls 5 & 6)
- Manifold valve, lines, and injectors removed from engine as a unit
- No evidence of impact, or any other damage or deficiencies

**Figure 5 - Distribution Manifold and Lines**

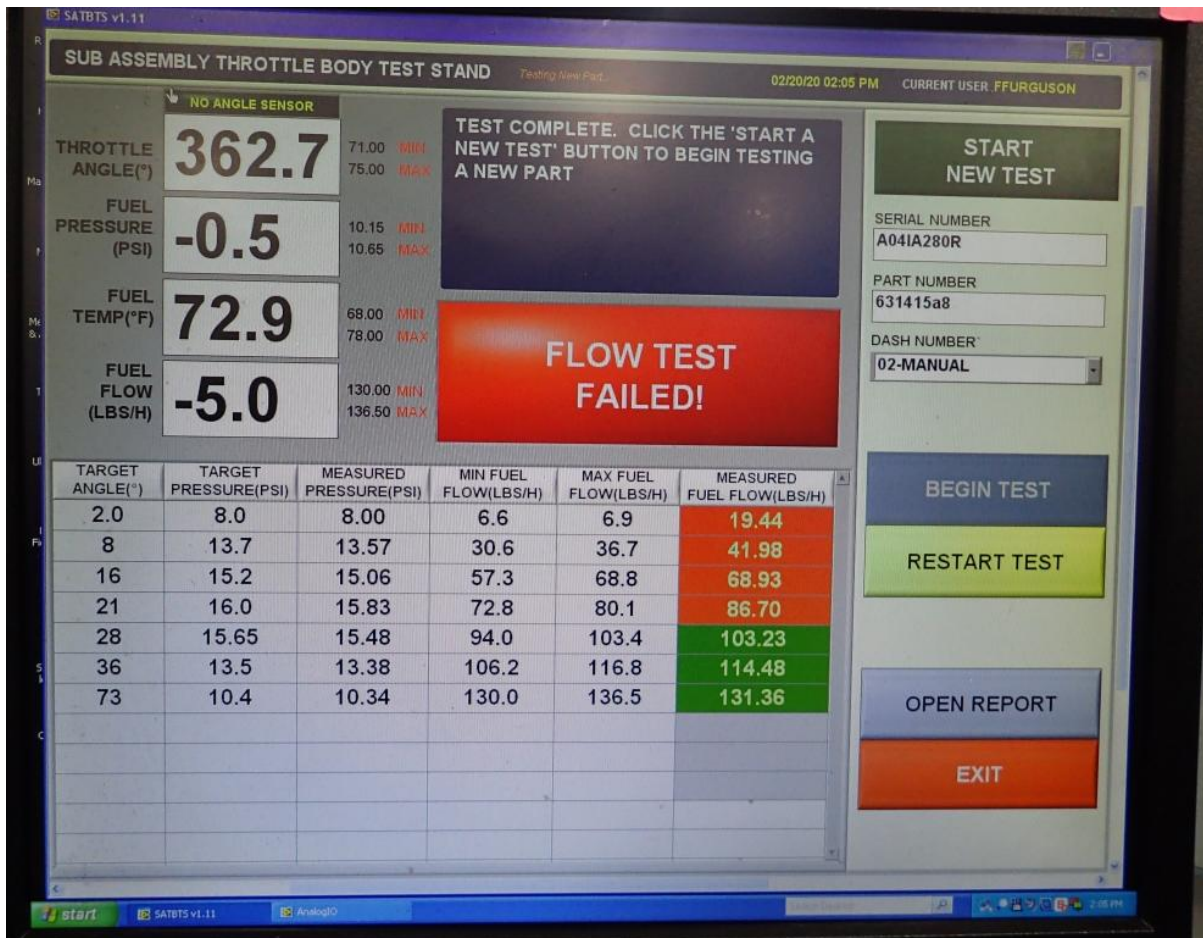
- All test points were completed, but the T/MA did not pass the ATP
  - The first 4 flow rates were outside their respective acceptable ranges
  - The last 3 flow rates were within their respective acceptable ranges

Figure 6 - T/MA Test Results

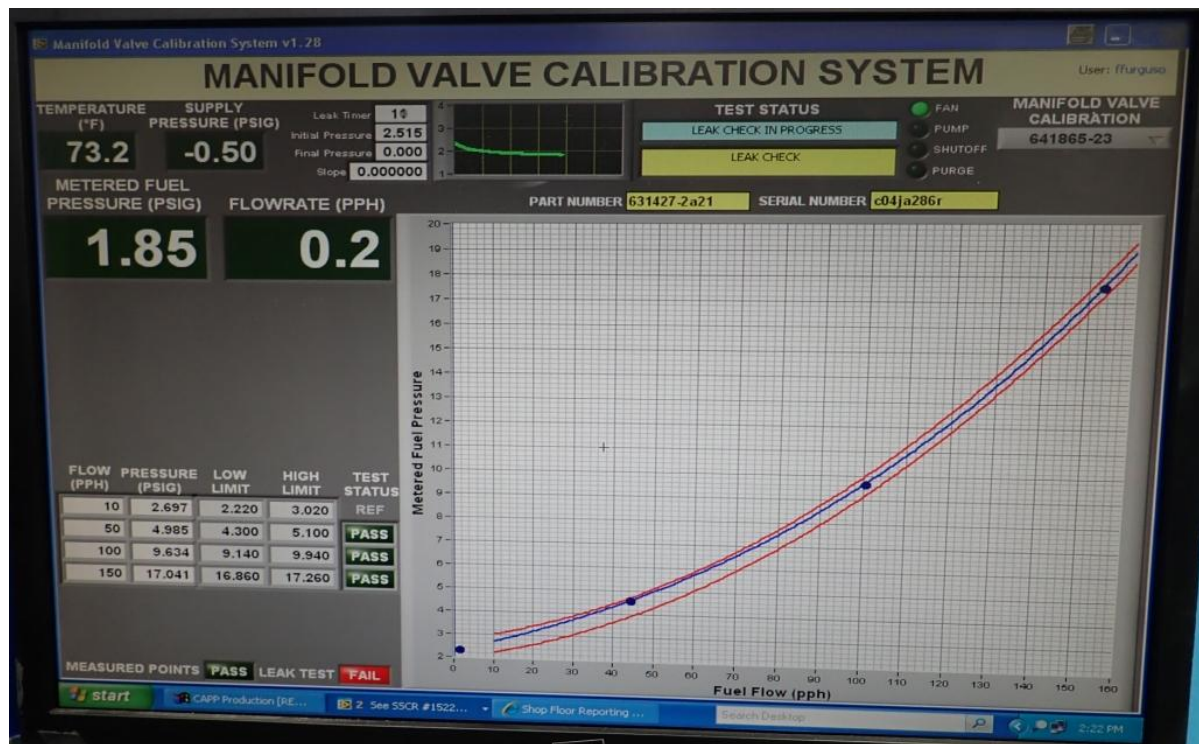
- The test assembly/procedure provided fuel at 1 set test reference pressure, and then 3 set test pressures, and then measured flow at those 3 test pressures
- All 3 test points fell within the prescribed flow rate range boundaries

Figure 8 - Manifold/Injector Test Results

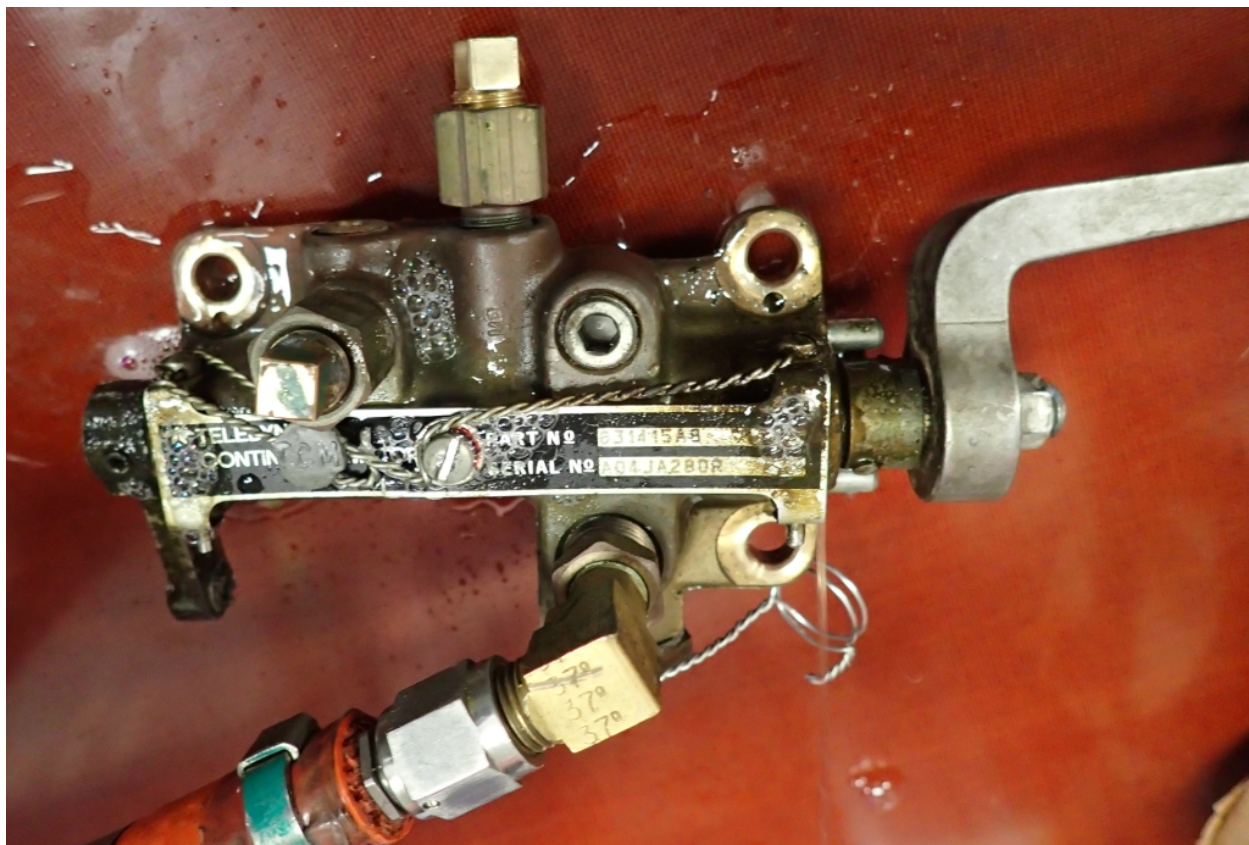
- Metering assembly on the T/MA was identified as the source of the fuel leak(s).
- The metering unit was detached from the throttle body and tested for leak locations using compressed air and soapy water.
- Leaks were observed at both ends (throttle and mixture) of the metering unit
- The metering unit was disassembled and its O-rings examined
  - o The O-rings lacked normal flexibility and were non-resilient

Figure 9 - Leaking Metering Unit

- The only way to safely test how the observed leaks would affect engine operation is by testing the fuel system as a whole, but CAT does not have such capability
- During the engine runs at the recovery facility and the follow-up individual fuel system component examinations and tests, the metering assembly fuel leaks were the only anomalies detected that could have resulted in a loss of engine power

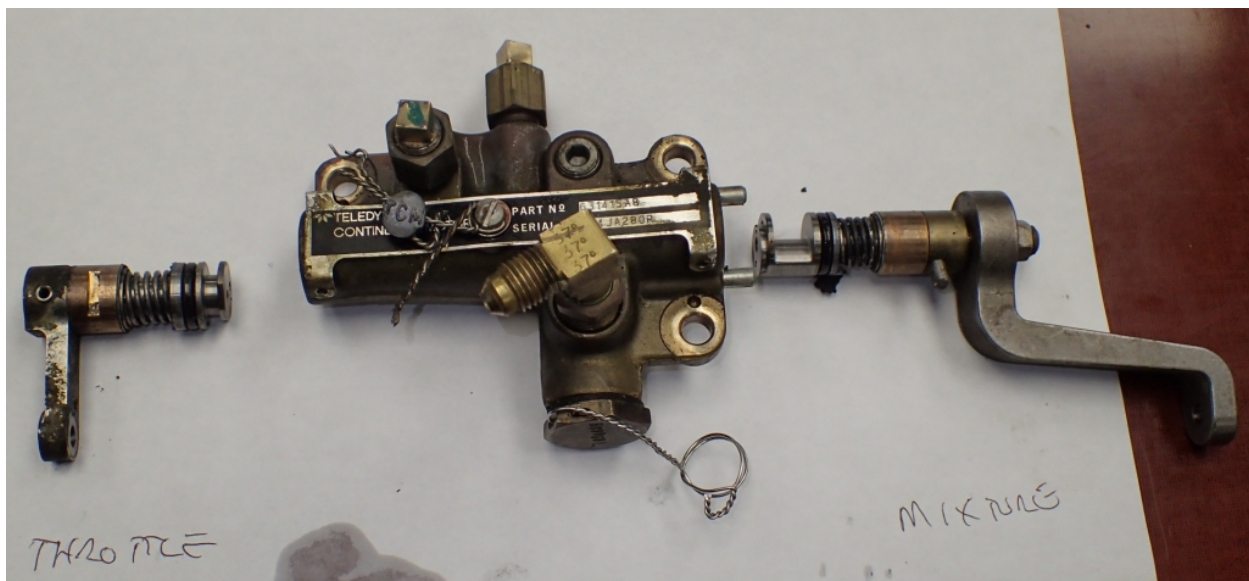
Figure 10 - Disassembled Metering Unit

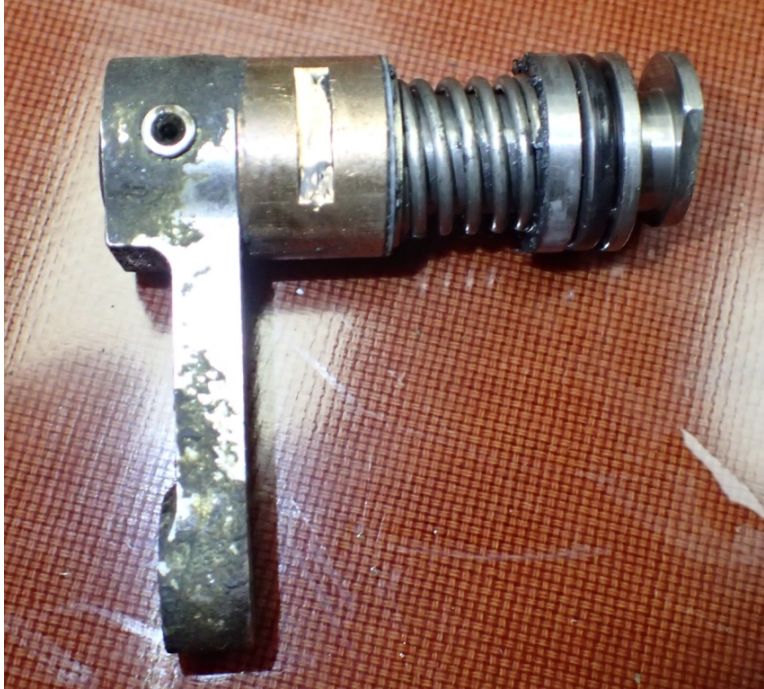
**Figure 11 - Throttle Metering Cam and O-Ring**

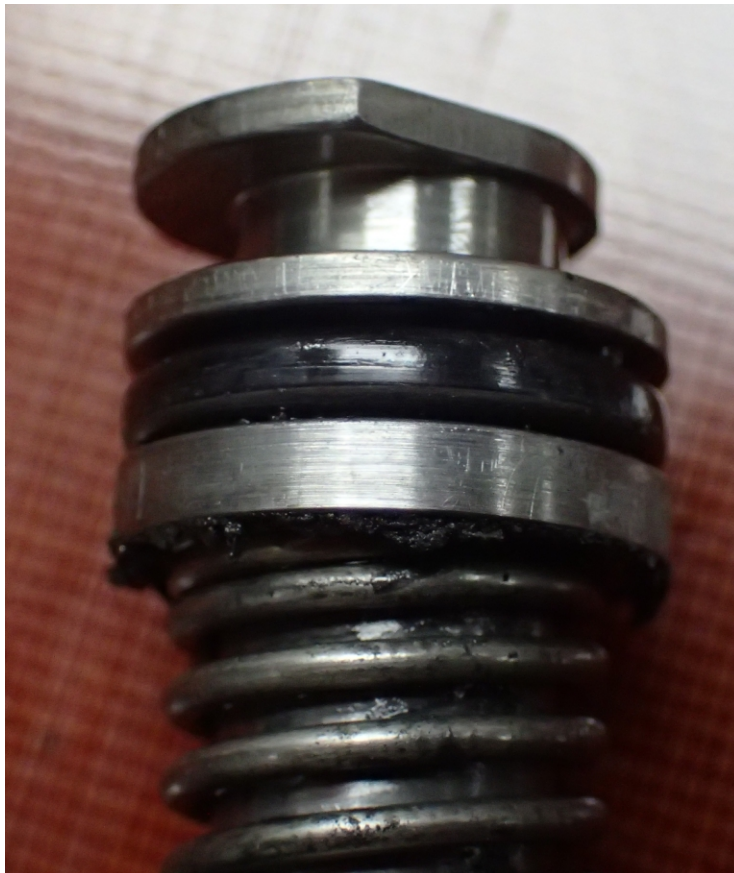
**Figure 12 - Throttle Cam O-Ring**

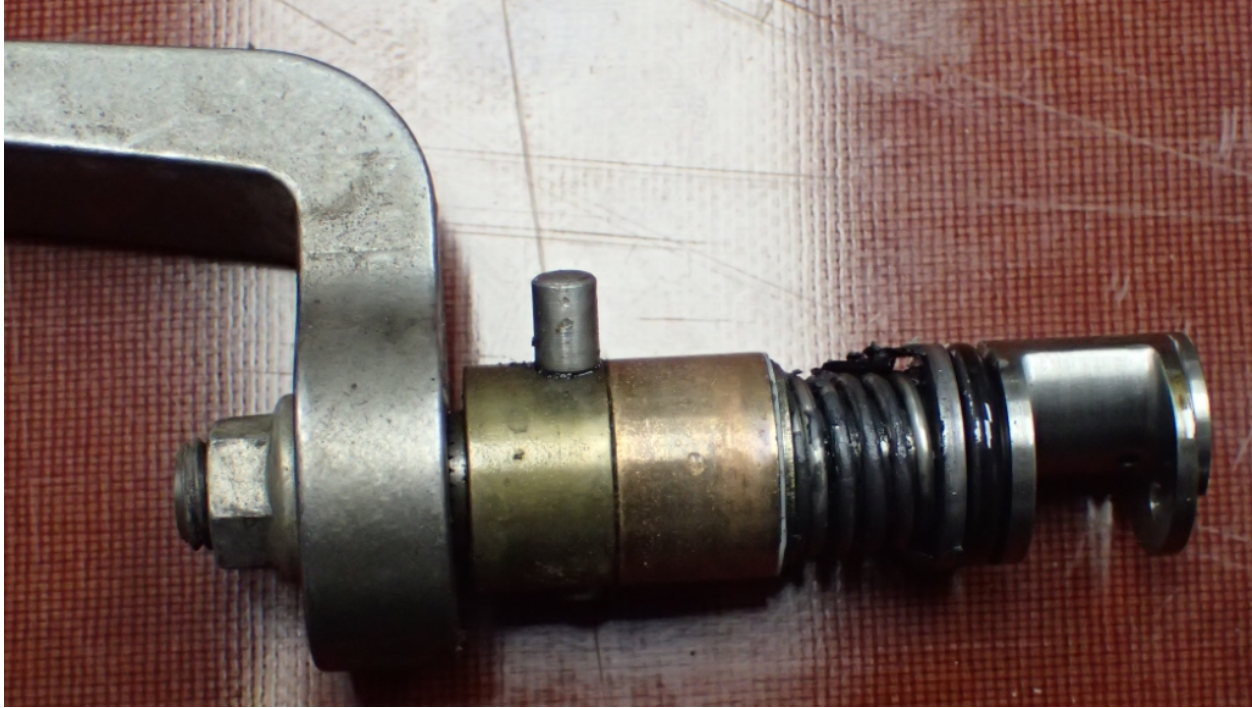
**Figure 13 - Mixture Metering Cam**
