## MEMORANDUM FOR RECORD

**NTSB Accident Number: WPR19LA137**  
**Aircraft Registration & Make/Model: N3630D; Schweizer G-164B**  
**Accident Location: Sutter, California**  
**Accident Date: May 5, 2019**

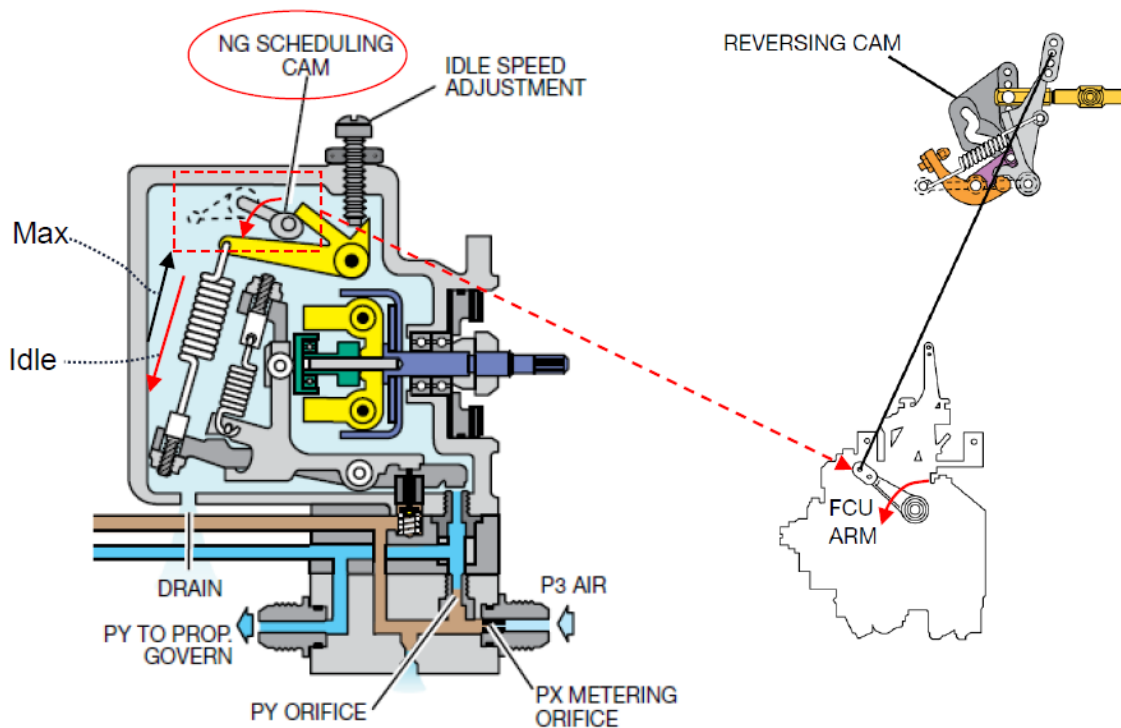
During engine operation, a reversing cam and FCU actuating lever coordinate inputs from the three cockpit controls with the FCU and propeller governor. The FCU interconnect rod joins the FCU to the propeller governor through the actuating lever and reversing cam. According to the engine manufacturer, if the interconnect is disconnected during flight, the FCU arm, which moves the spring-loaded compressor speed scheduling cam within the FCU, will rotate counter-clockwise under spring tension and bring the operating condition of the FCU back to idle power automatically. The FCU arm will remain at idle as long as the interconnect rod is separated.
