# NATIONAL TRANSPORTATION SAFETY BOARD

MATERIALS LABORATORY FACTUAL REPORT

Report No. 20-012

Place : Sutter, California  
Date : May 5, 2019  
Vehicle : Schweizer G-164B  
NTSB No. : WPR19LA137  
Investigator : Stephen Stein

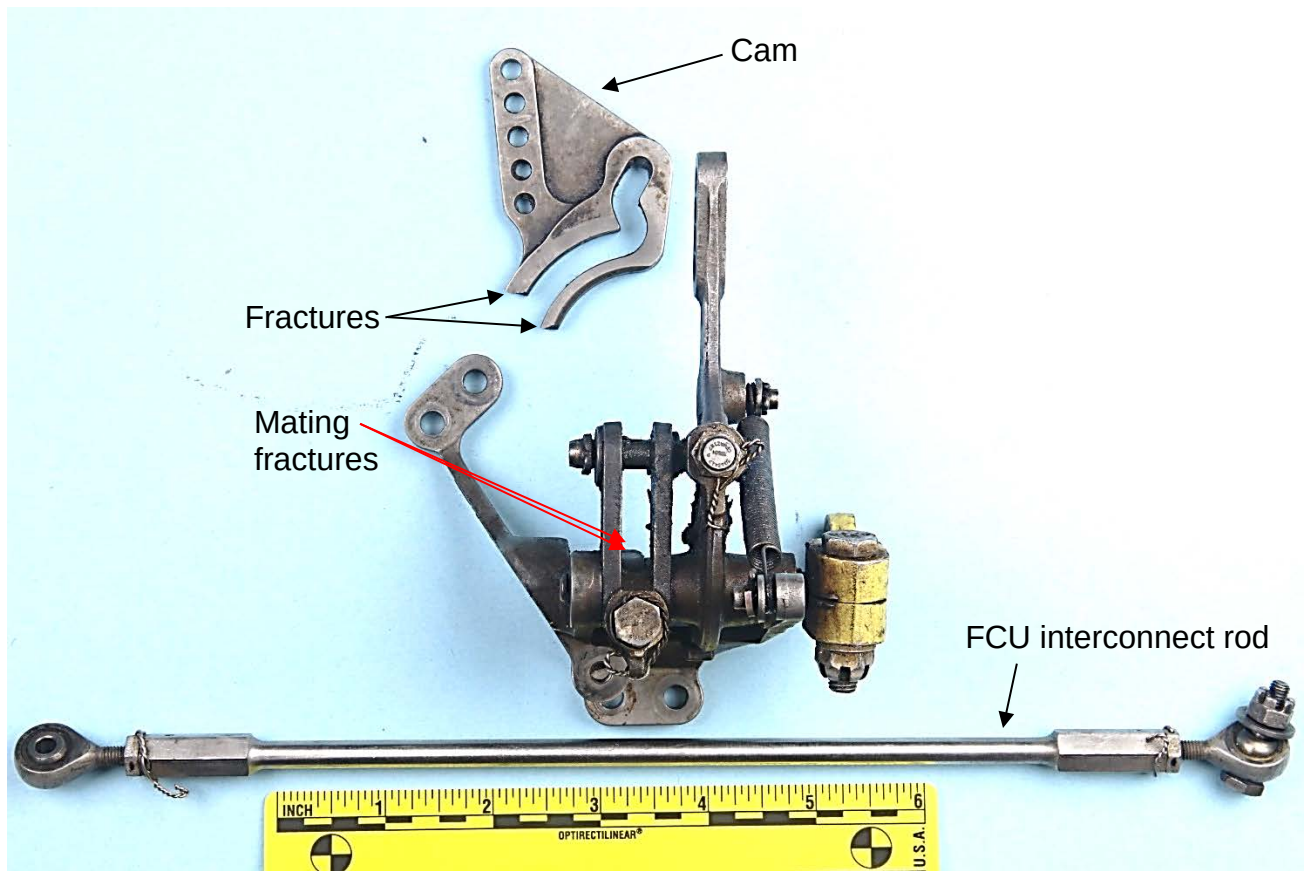
Figure 1 shows a photograph of the as-received FCU interconnect rod, propeller governor cam boss, and cam. The cam fractured at the arm portion in the areas indicated in figure 1. The as-received pieces were ultrasonic cleaned in Alconox, a commercial detergent that removes oxides and lubricants from ferrous metal. Detailed bench binocular microscope examination of the cam revealed the fracture faces exhibited a coarse texture consistent with an overstress separation and no evidence of fatigue cracking. The FCU interconnect rod at one end contained a rod bearing assembly with a bolt. The bolt was inserted through the hole portion of the ball. A castellated nut and washer were attached to the threaded end of the bolt. A cotter pin was not attached to the nut. In the laboratory, the nut was disassembled from the bolt and the exposed threads showed no evidence of mechanical damage. The rod bearing assembly at the other end of the FCU interconnect rod contained no evidence of a bolt, castellated nut and washer, and the through-hole at the ball portion of the rod end bearing assembly showed no evidence of corrosion or mechanical damage.

Figure 1. As-received FCU interconnect rod, propeller governor cam boss, and cam.
