**NATIONAL TRANSPORTATION SAFETY BOARD**

**ENGINE EXAMINATION**

**WPR19LA137**

**Schweizer Aircraft Corporation G-164B – N3630D**

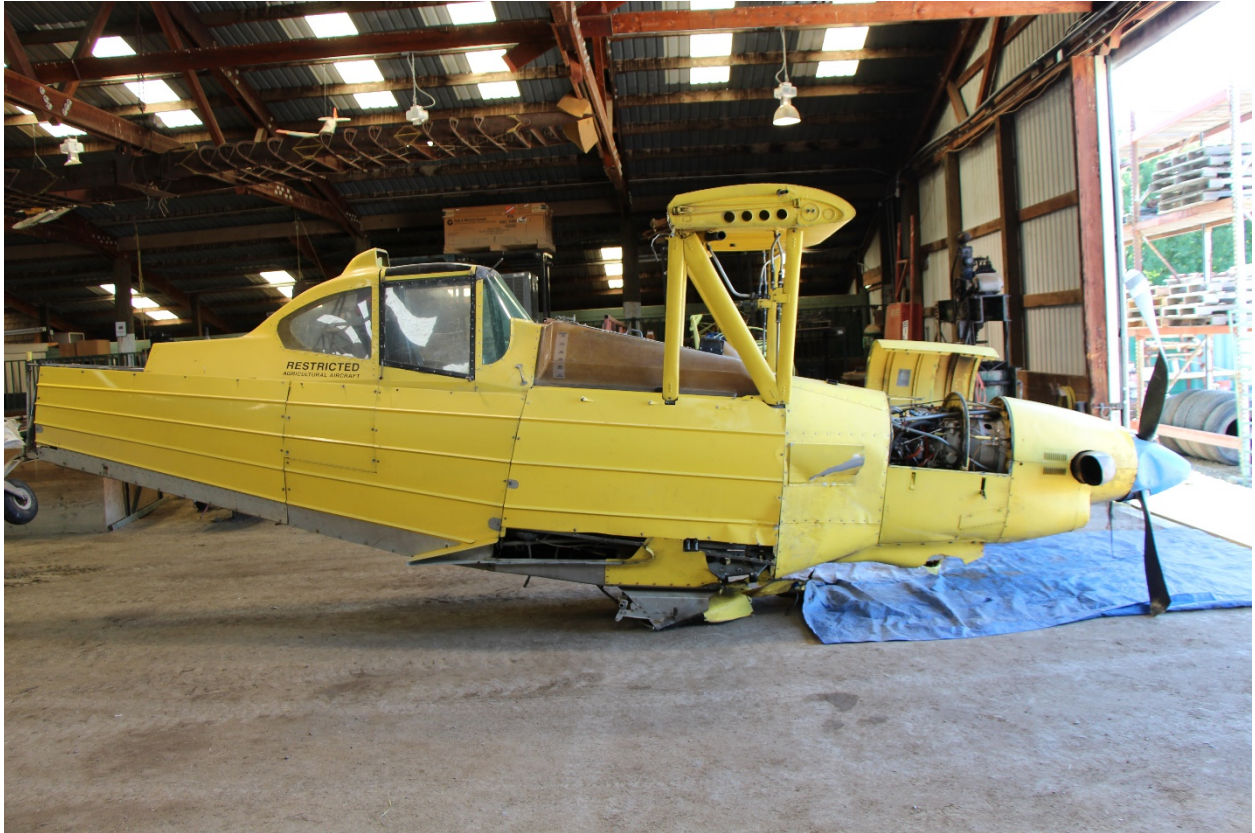
Photograph 1: Accident Airplane

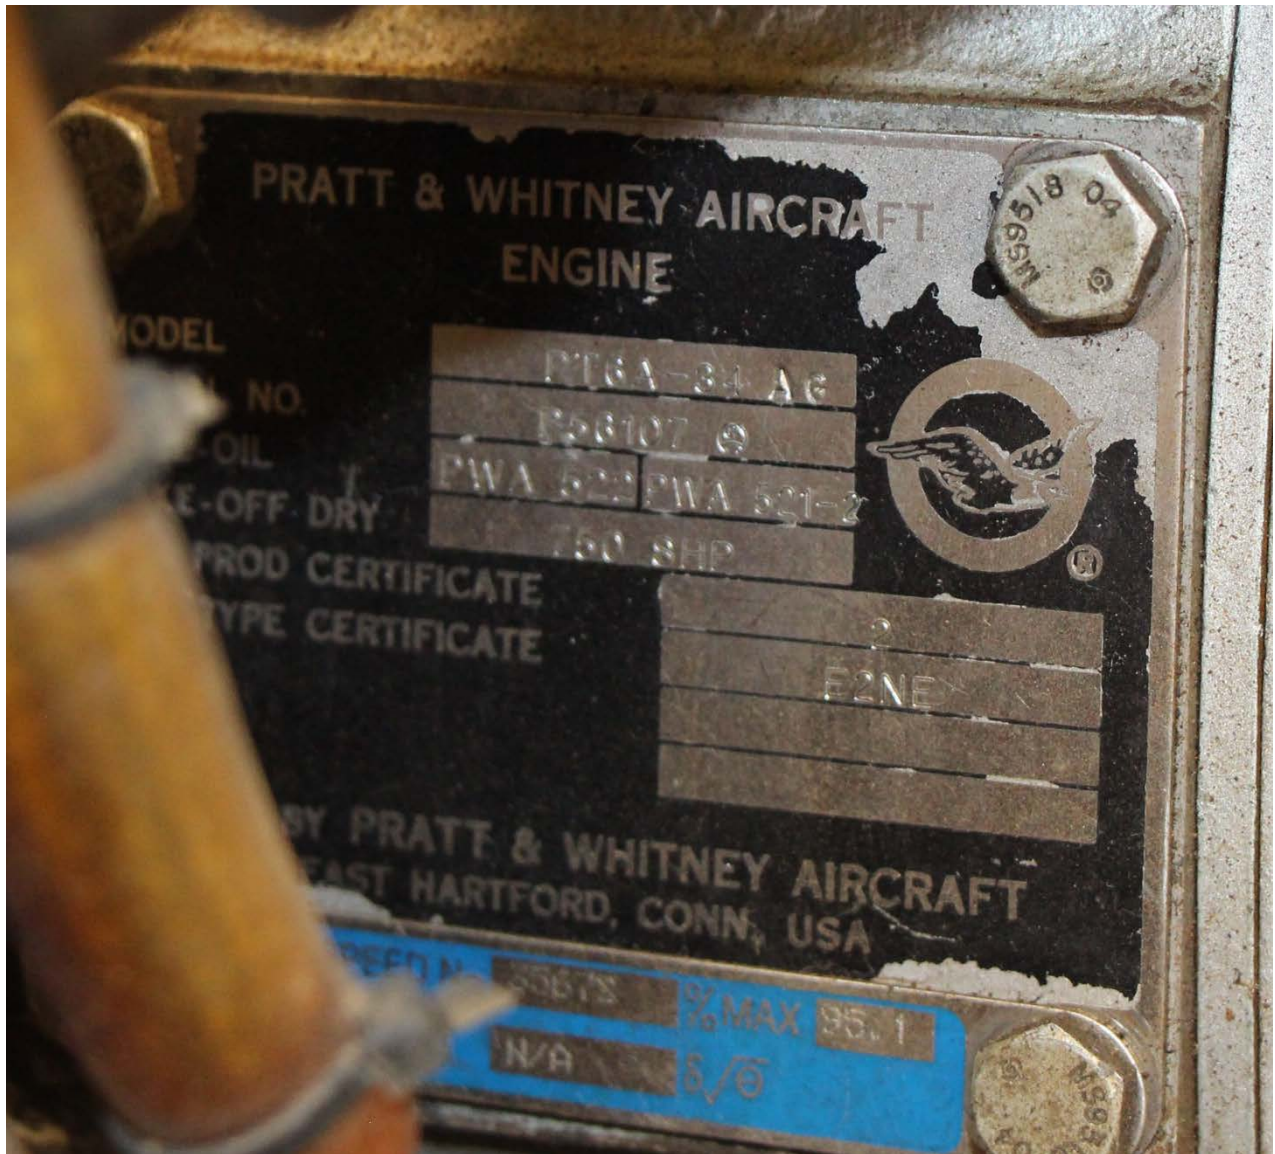
Photograph 2: Engine Data Plate

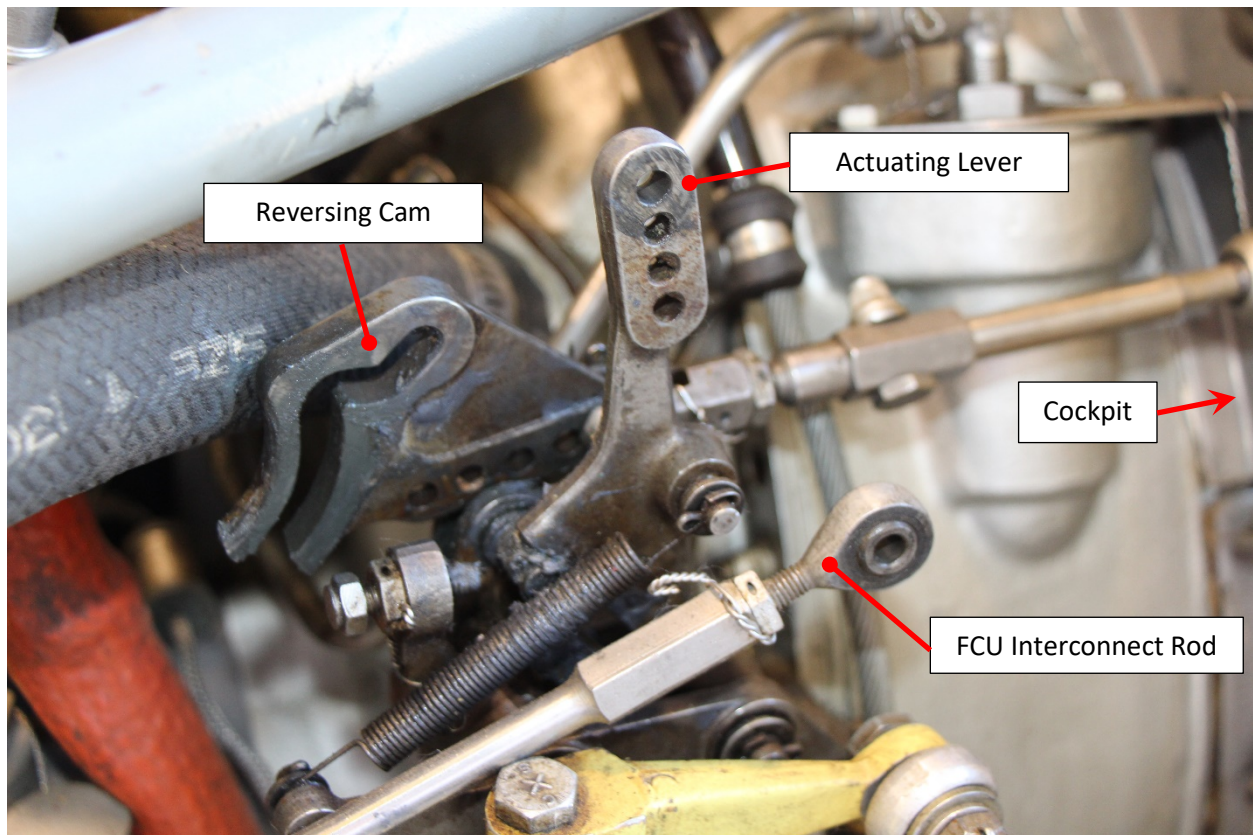
The propeller control cam manages propeller movement when the engine is in beta, or ground operation. Examination of the assembly showed that the propeller control cam had fractured at the root.

Photograph 3: Cam Box Assembly and Throttle to FCU Interconnect Rod

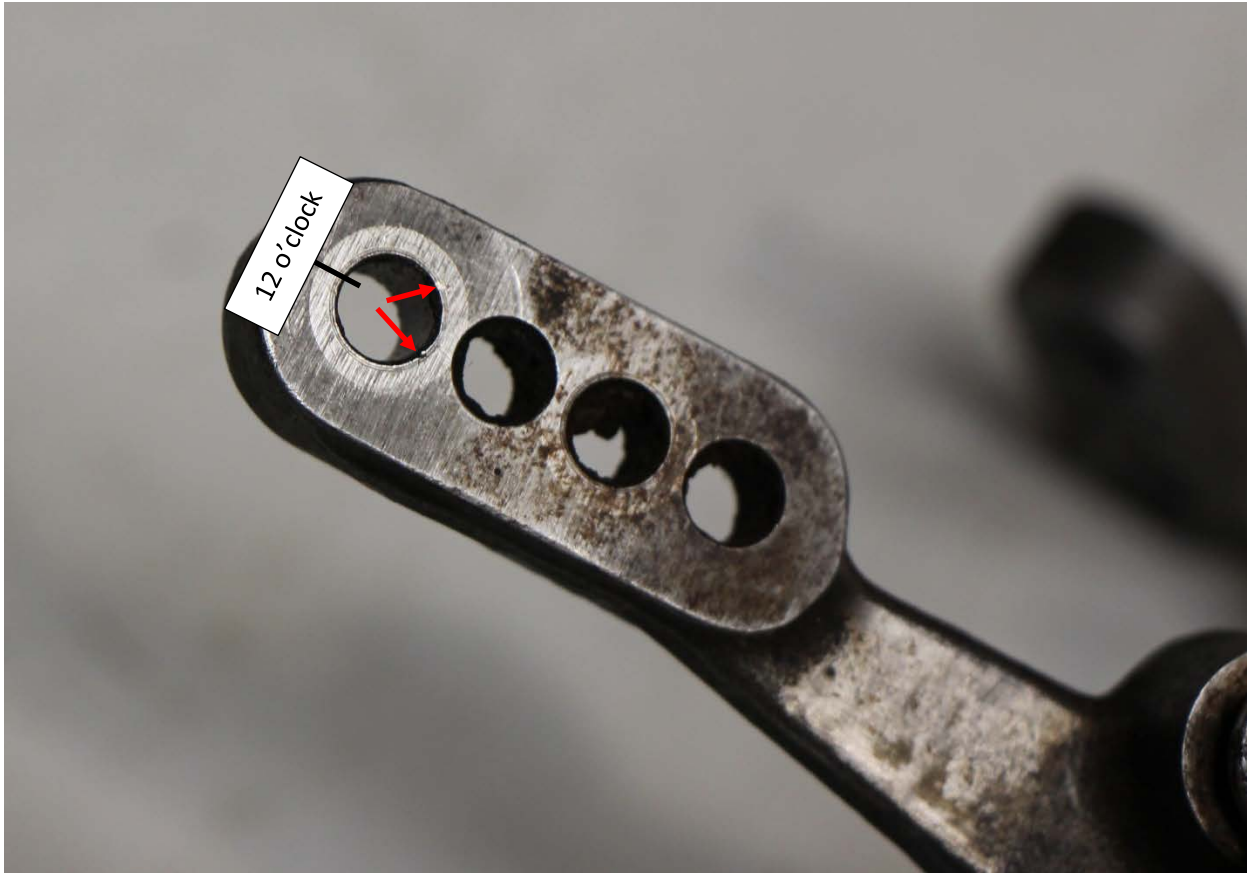
Most of the FCU linkages were unremarkable with the exception of the interconnect rod, which joins intermediate FCU linkage to the FCU through a flange and is secured with a bolt, spacer, castellated nut and cotter pin. In this application, the interconnect rod was undamaged, but had separated at the rod end attach point. The interconnect rod attachment flange top bolt hole was consistently faded around its circumference and nicks were observed at the edge of the bolt hole at the 4 o'clock and 7 o'clock positions (see photograph 4).

Photograph 4: Interconnect Rod End Attachment Point
