## **NATIONAL TRANSPORTATION SAFETY BOARD**

### **SUMMARY OF ENGINE EXAMINATION**

**(WPR19LA140)**

| Aircraft: | Cessna 172 / N8887U |

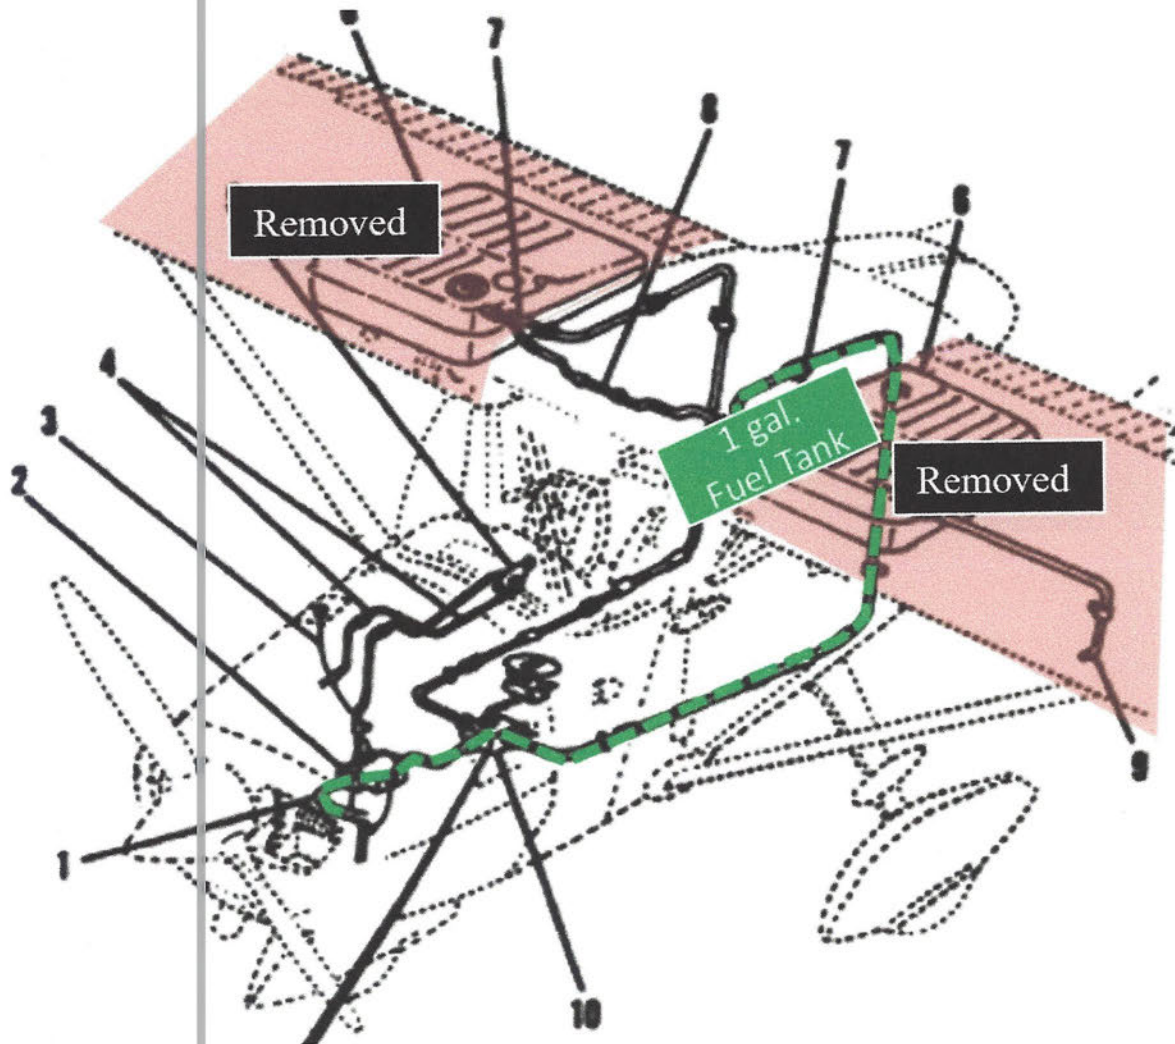
The fuel selector was set to *LEFT*, the master was turned on, the mixture was advanced full forward, and the engine started successfully. During the engine run, about 2230 RPM, the mixture was leaned with no anomalies noted—then advanced full forward. The carburetor heat was opened, the RPM dropped about 50 RPM and then returned once the carburetor heat was closed. The fuel selector was moved to right and then off, both times the engine stopped. The engine was successfully ran on the *LEFT* and *BOTH* fuel selector positions with the left fuel line plumbed in.

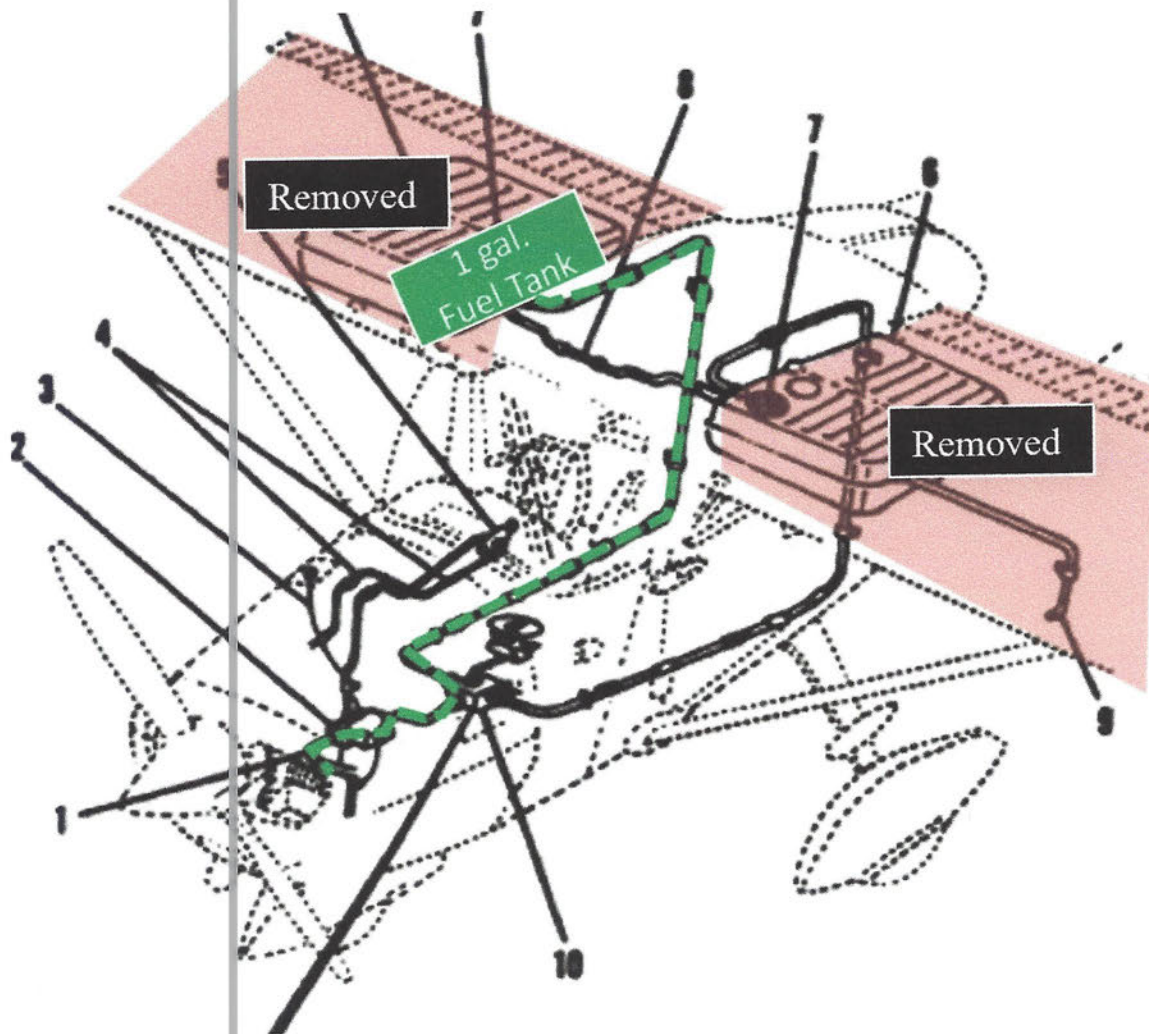
The fuel selector was set to *RIGHT*, the master was turned on, the mixture was advanced full forward, and the engine started successfully. The engine was advanced forward to about 2,280 RPM. The engine was successfully ran on the *RIGHT* and *BOTH* fuel selector positions with the right fuel line plumbed in. (Note: The first time the engine run was attempted, the engine lost power due to a lack of fuel in the 1 gal. external fuel tank. The fuel tank was refueled, and the engine run was completed without further incident).

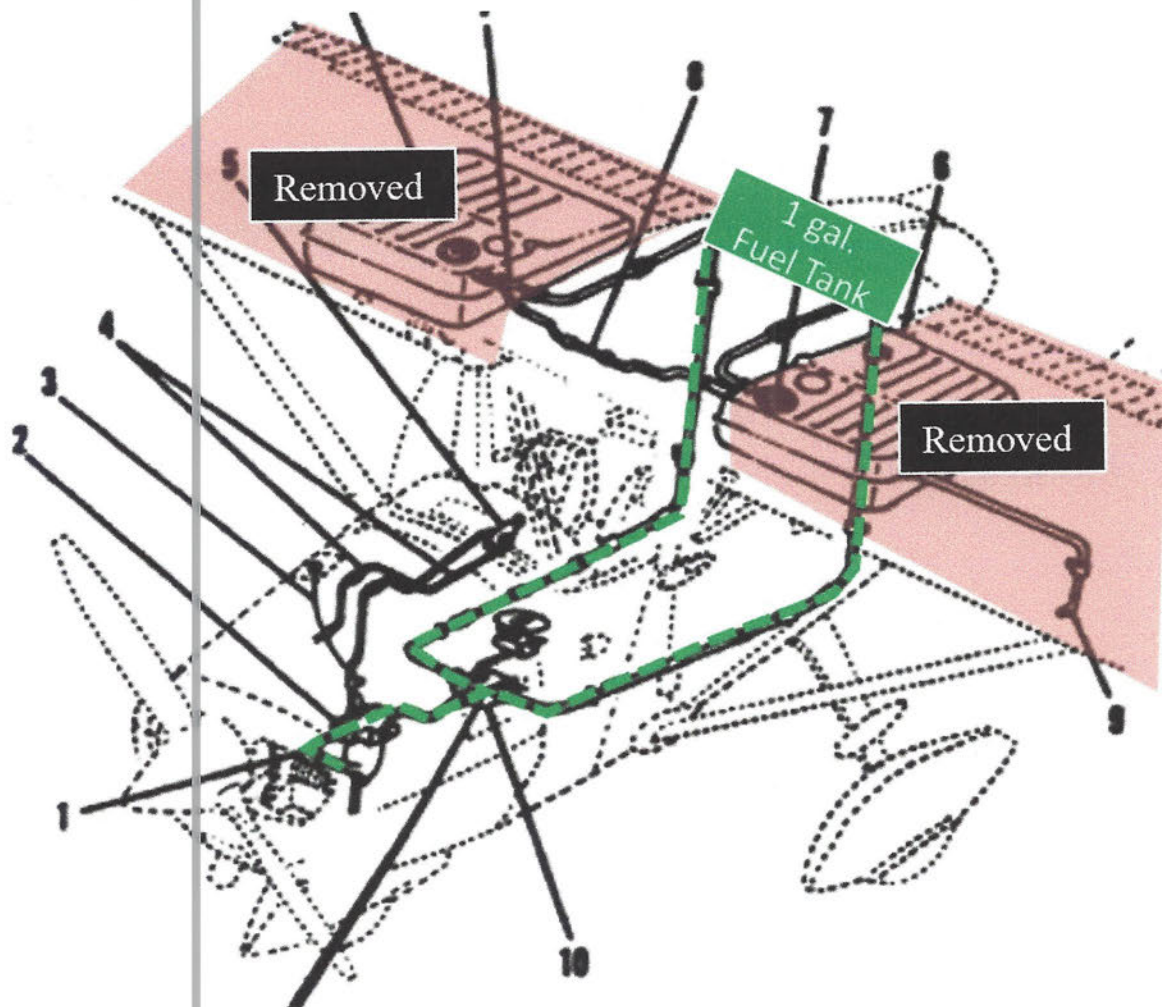
The fuel selector was set to *BOTH*, the master was turned on, the mixture was advanced full forward, and the engine started successfully. The engine was advanced forward to about 2,280 RPM. The engine was successfully ran on the *RIGHT*, *LEFT* and *BOTH* fuel selector positions with the right and left fuel line plumbed in.
