**Federal Ministry**  
**Republic of Austria**  
Climate Action, Environment,  
Energy, Mobility,  
Innovation and Technology

Ref.No.: Accredited representative for N423EB

On June 16<sup>th</sup> 2020, the Federal Safety Investigation Authority of Austria offered assistance to perform functional test of following items out of N423EB:

## 1.1 Fuel Pumps, Check Valves, Fuel Lines, ECU

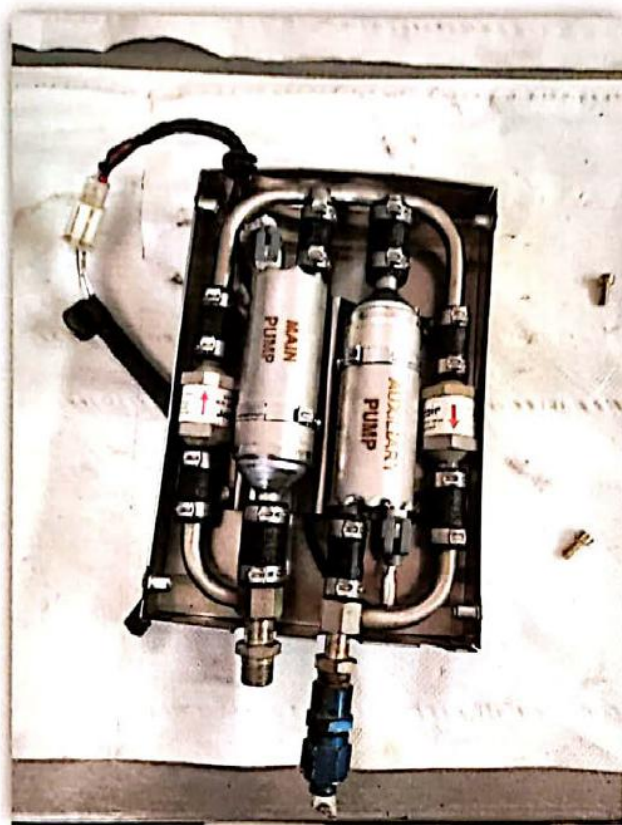
Both fuel pumps found within the nominal operational ranges. There were no fuel leaks observed – neither internal nor external. The electrical load of both pumps found within the specification of the engine manufacturer BRP Rotax.

The check valves found working properly, without any leak or damage.

The fuel lines were found tight, sealed and without any anomalies.

The electrical wiring found satisfactory and undamaged.

Picture #1: Fuel pump assembly with main and auxiliary fuel pumps, check valves, fuel lines, and electrical wiring

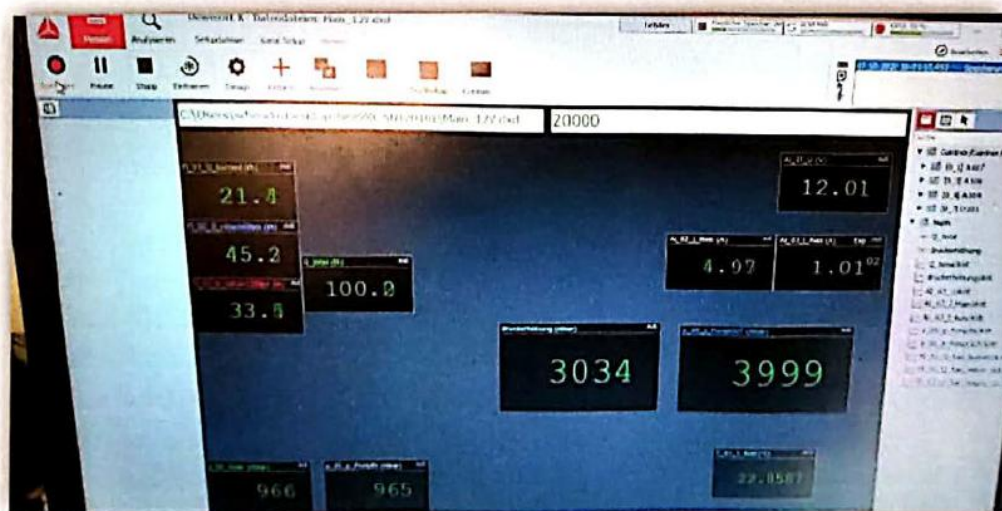
Picture #2: Fuel pump operational testing at BRP Rotax facility

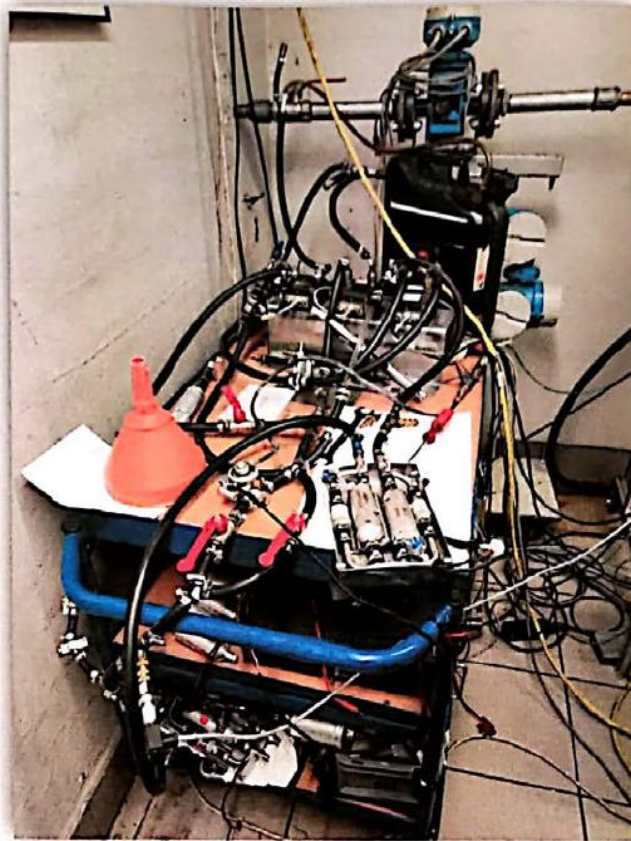
Picture #3: Fuel pump test bench at BRP Rotax facility

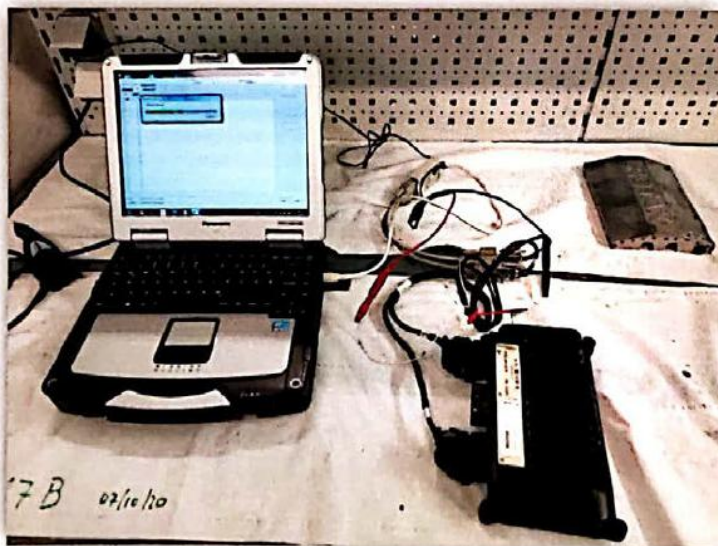
The Electronic Control Unit has been tested and downloaded. There were no anomalies or damages found.

Picture #4: ECU testing at BRP Rotax facility

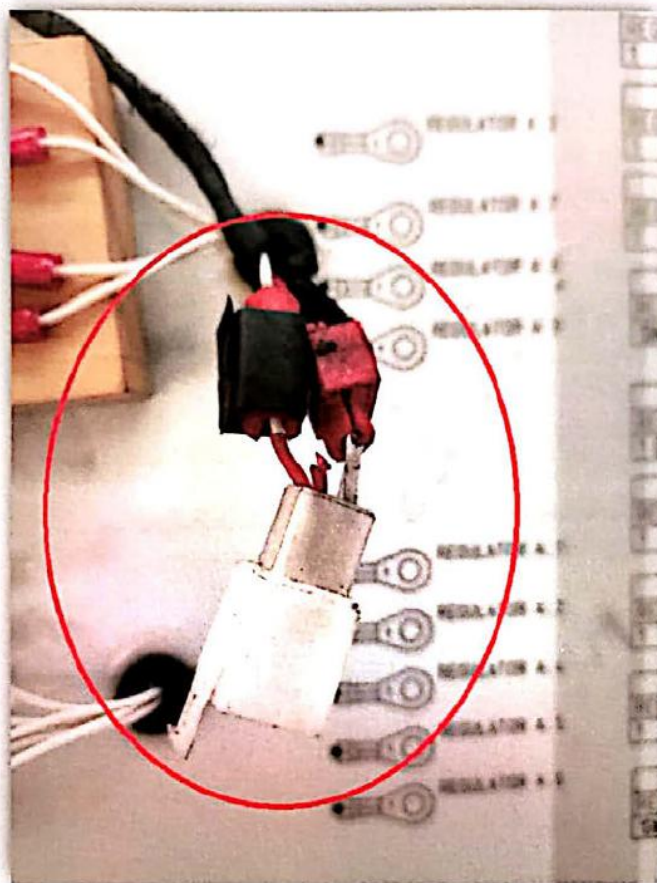
The test of the main harness has been conducted on the manufacturer test bench for this type of harness. The cables for the electrical fuel pumps found modified by someone, most likely to ensure that the length of the cables to the fuel pumps are sufficient. BRP Rotax offers extension kits for the aircraft manufacturers in order to create the correct length of the fuel pump cables. As the fuel pumps are mounted in different locations of the many different aircraft types, it is necessary to give the aircraft manufacturers the possibility to adjust their fuel pump wiring accordingly. However, the cable extension of this particular main wiring is not in common with the requirements of BRP Rotax. The red connector is not aviation standard, the cables were cutted and not sealed. It is the responsibility of the aircraft manufacturer to ensure that the requirements of the engine manufacturer complied with.

Picture #5: Engine main harness cable for Fuel Pump. This connector is not the required connector as per BRP Rotax requirement.

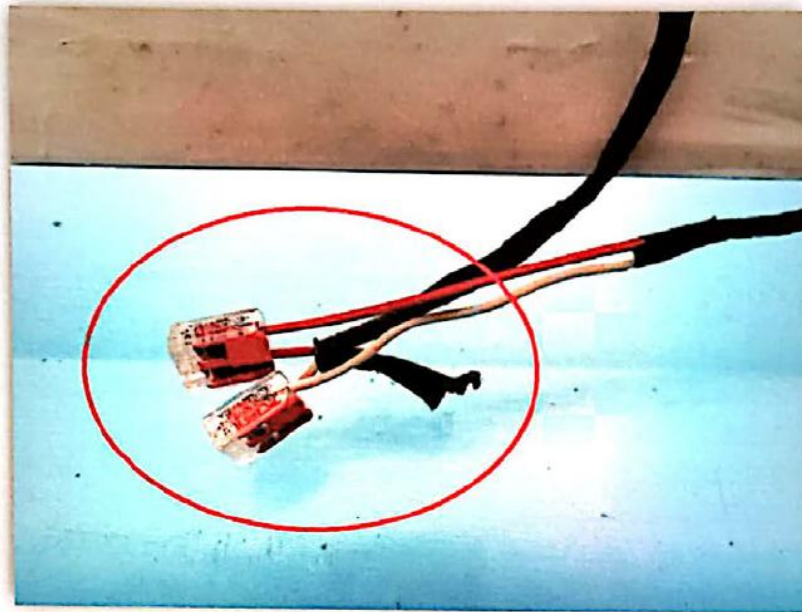
Picture #6: For test purposes, it was necessary to remove the red cable connector (picture #5) and extended the cable length

The main harness manufacturer GPV mounted the harness on the test bench, repaired the fuel cables of the fuel pumps and performed a system and resistance check three times. Each of the three tests were carried out without any problems. There were, except the cables for the fuel pumps, had no signs of e.g. anomalies, a broken/damaged cable; defective connector, etc.

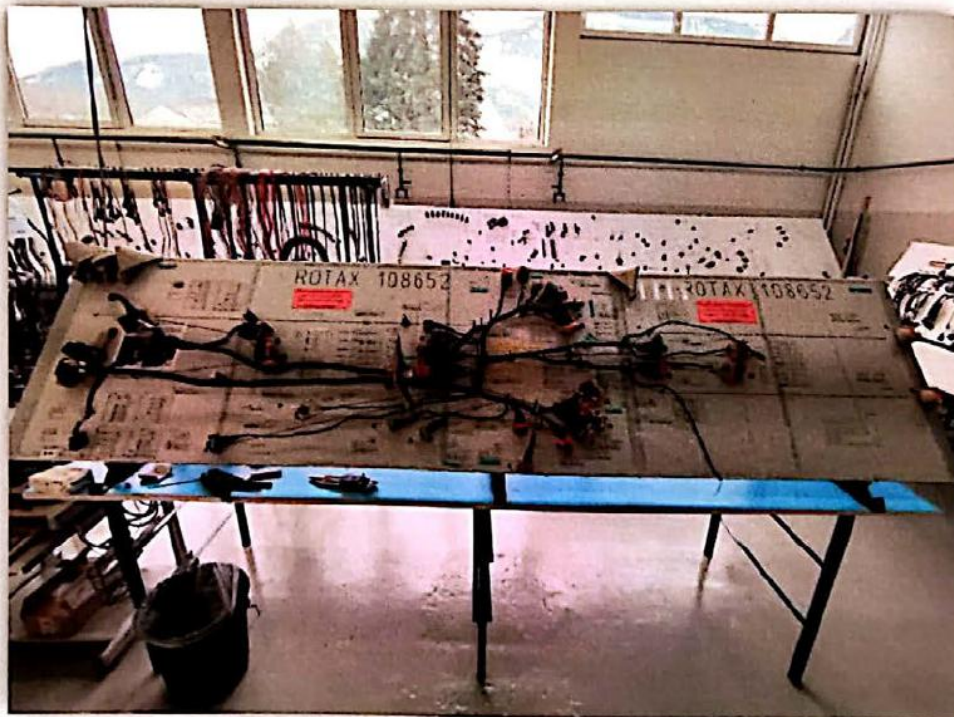
Picture #7: Bench test at GPV facility

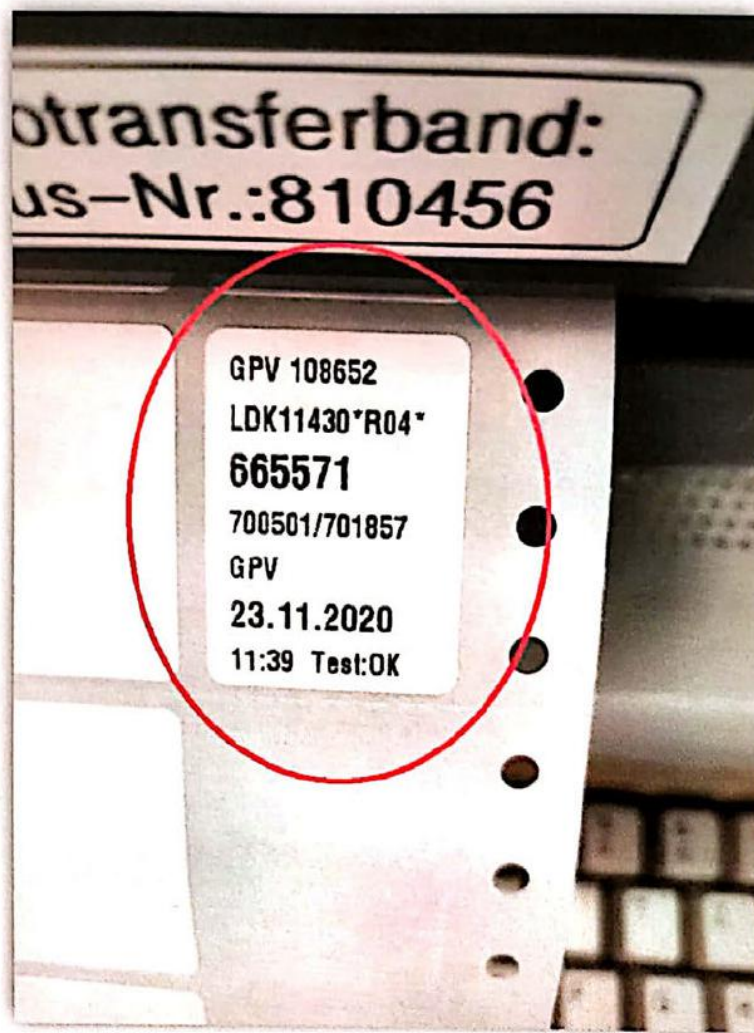
Picture #8: Bench test result for the engine main harness
