## MEMORANDUM FOR RECORD

**NTSB Accident Number: WPR19LA141**  
**Aircraft Registration & Make/Model: N423EB; Flight Design CTLS**  
**Accident Location: Boulder City, Nevada**  
**Accident Date: May 7, 2019**

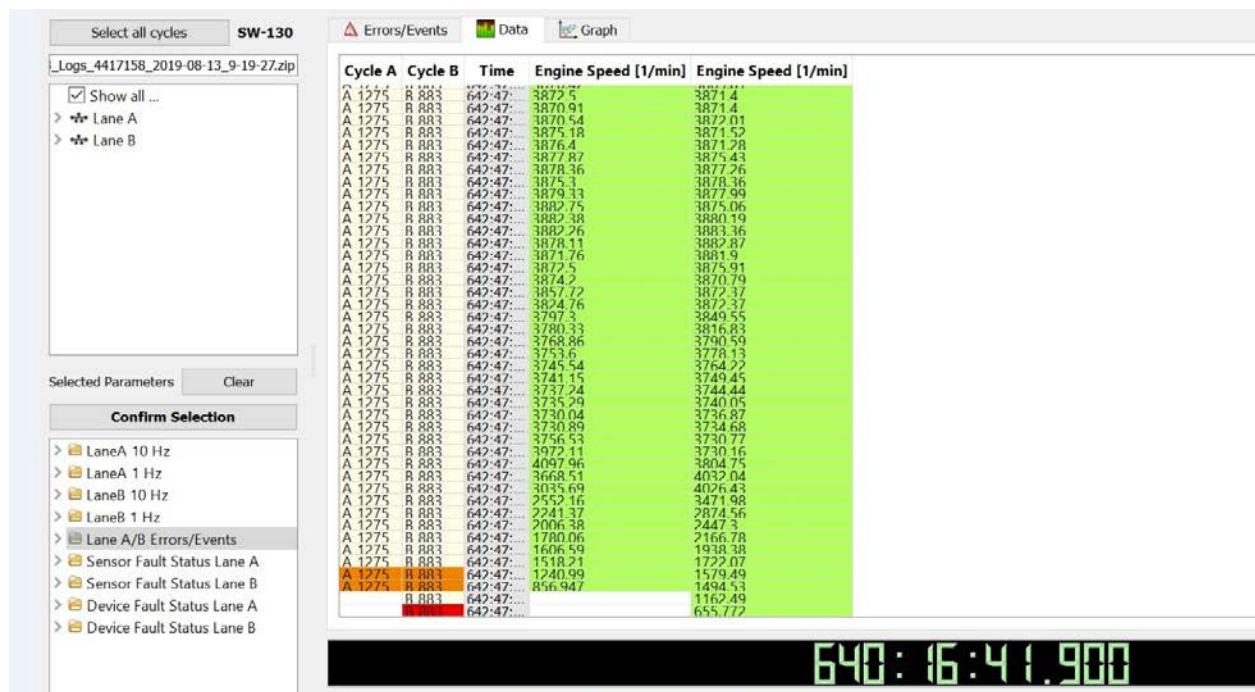
| Cycle | Time | Category | FC_Class | FC_Type | FC_Test | FC_Error | Fault Reading |
|---|---|---|---|---|---|---|---|
| R 372 | 301:42:19 | Failure | 3: Component | 5: ETPU | 0: ETPU Test | 1: Synchronization Lost | 2 |
| A 621 | 374:28:28 | Failure | 3: Component | 5: ETPU | 0: ETPU Test | 1: Synchronization Lost | 2 |
| R 581 | 411:51:22 | Failure | 1: Sensor | 11: Crank Bias Negative Voltage | 2: Failure Test | 1: Below Range | 1.19741 |
| R 672 | 462:15:37 | Failure | 3: Component | 5: ETPU | 0: ETPU Test | 1: Synchronization Lost | 2 |
| R 796 | 582:57:36 | Failure | 3: Component | 5: ETPU | 0: ETPU Test | 1: Synchronization Lost | 2 |
| B 883 | 642:40:11 | Failure | 2: Actuator | 5: Ignition 1 (Cyl 1 and 2) | 1: TPU Test | 1: Nominal Current Not Reached | 30 |
| B 883 | 642:47:43 | Failure | 2: Actuator | 7: Generator Select | 3: Test While Not Commanding Gen | 5: Generator Select In Failsafe | 6.91866 |

*Only one fault appears as the “second one” shows up right at the time of engine shut down and this would be considered normal due to circumstances - The failure “Nominal current not reached” Code has a solid lane light. The ECU systems monitors the current level when changing an ignition coil. If the current does not meet a nominal level (6A), the system reports and records the event with a status flag. If the status flag is set in separate engine revolutions this fault is recorded for the ignition coil of Cylinder 1 or 2.*
