# NATIONAL TRANSPORTATION SAFETY BOARD

## POWERPLANTS GROUP FIELD NOTES

NTSB ID No.: WPR19LA157

Aircraft: Vought F4U-7, N965CV

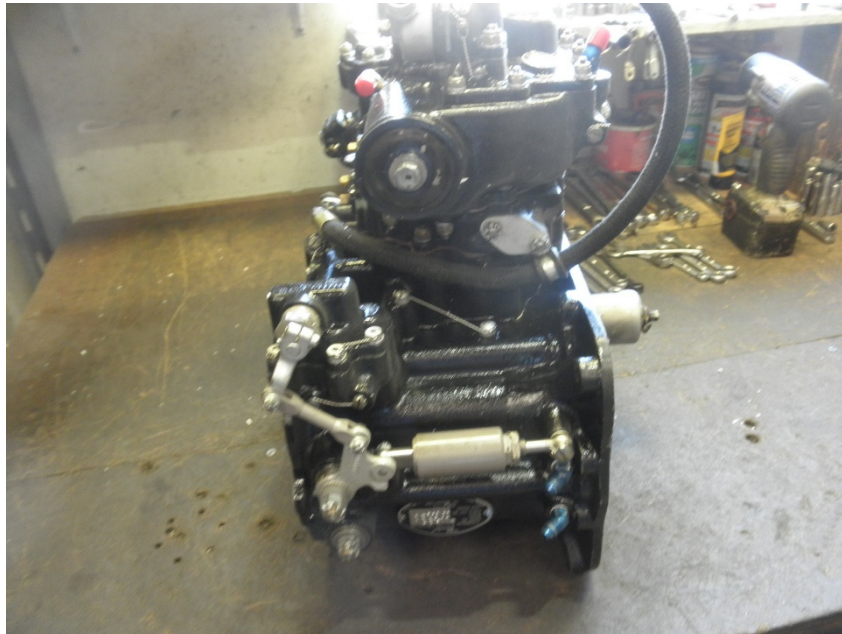
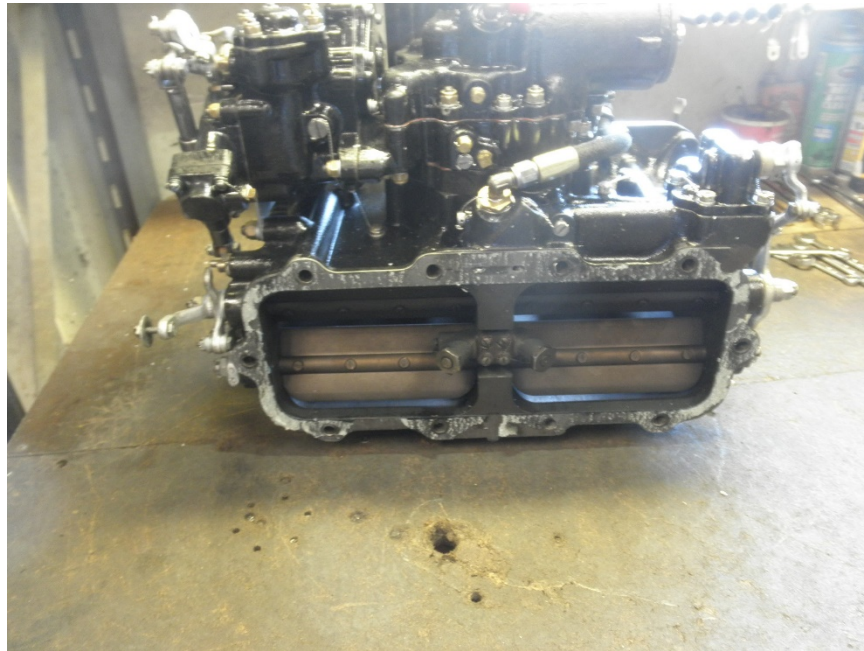
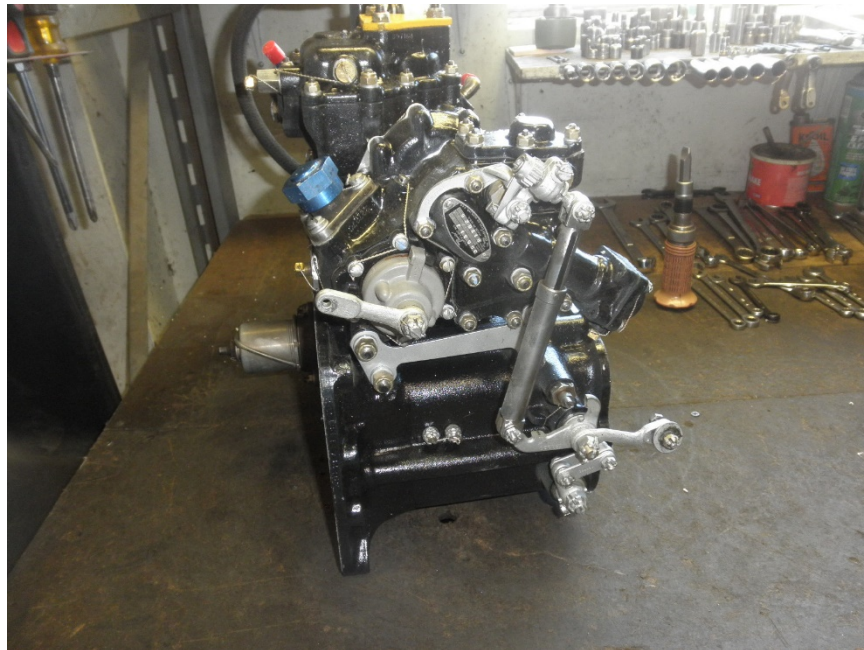
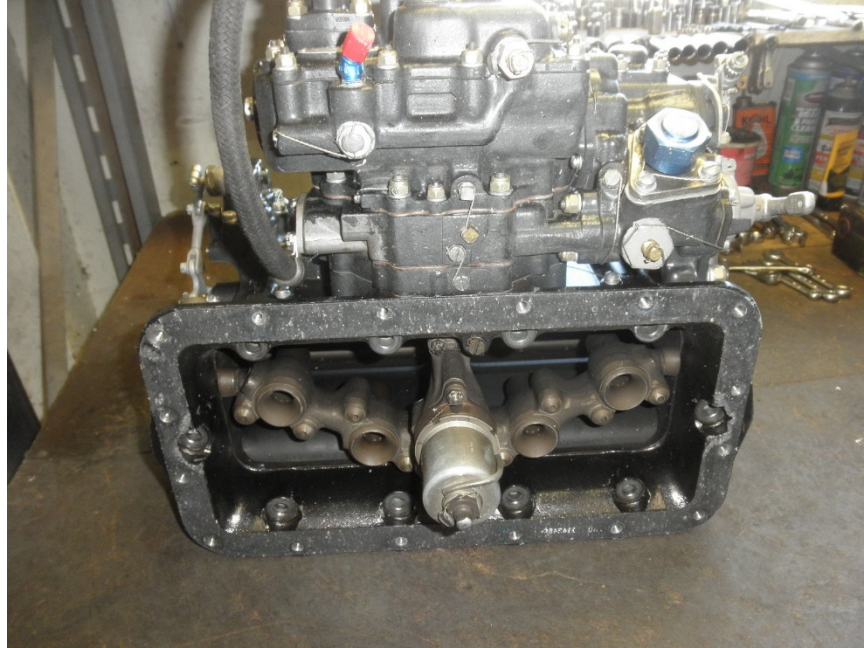
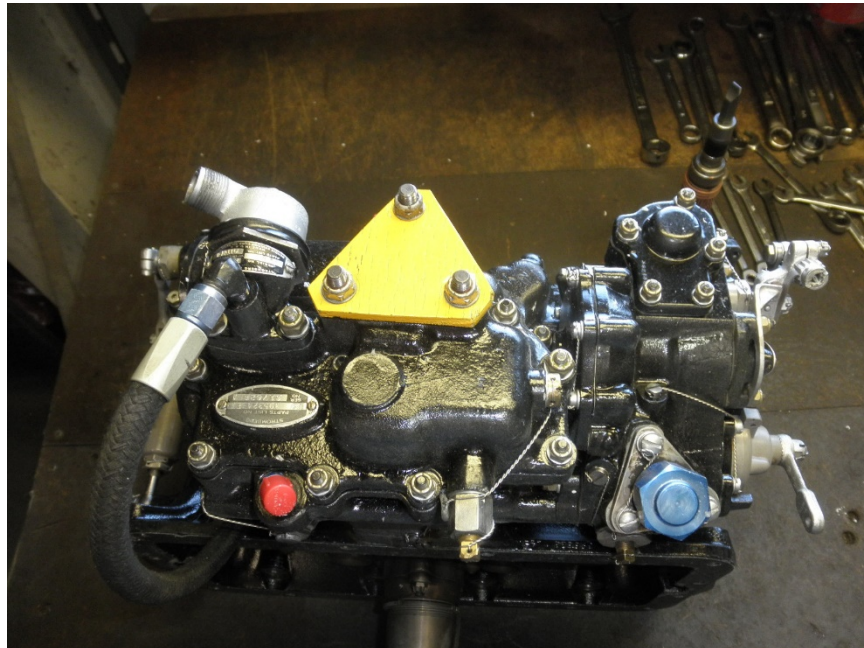
The visual examination of the carburetor showed that it did not have any physical damage to the exterior. (Photos Nos. 4, 5, 6, 7, and 8)

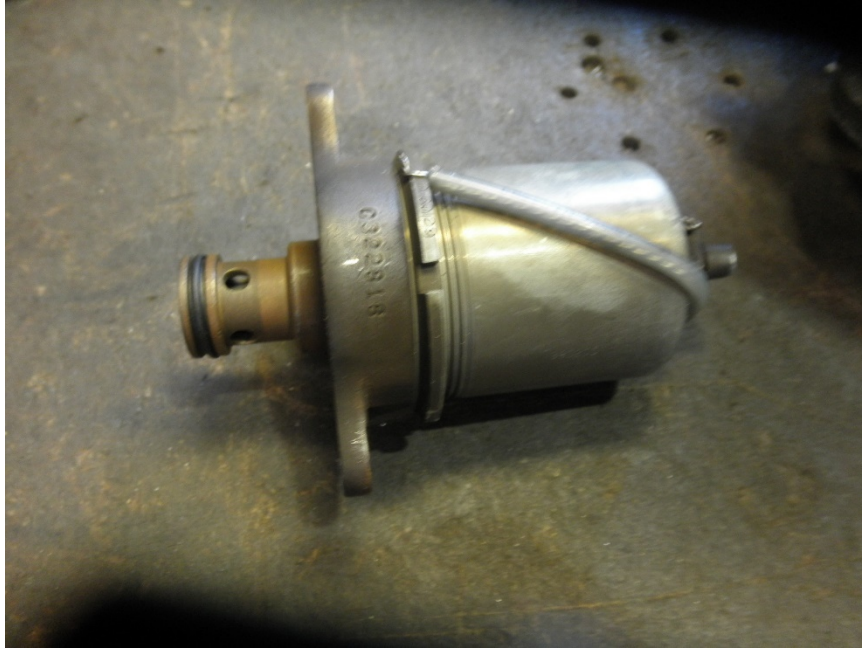
The throttle linkage moved freely and without restriction. The automixture control was in place on the carburetor. When it was removed, it was noted that the O-ring was in place and intact. However, the O-ring was dry and was cut. (Photo No. 9)

Photo No. 9: Automixture control showing O-ring that was dry was in place.

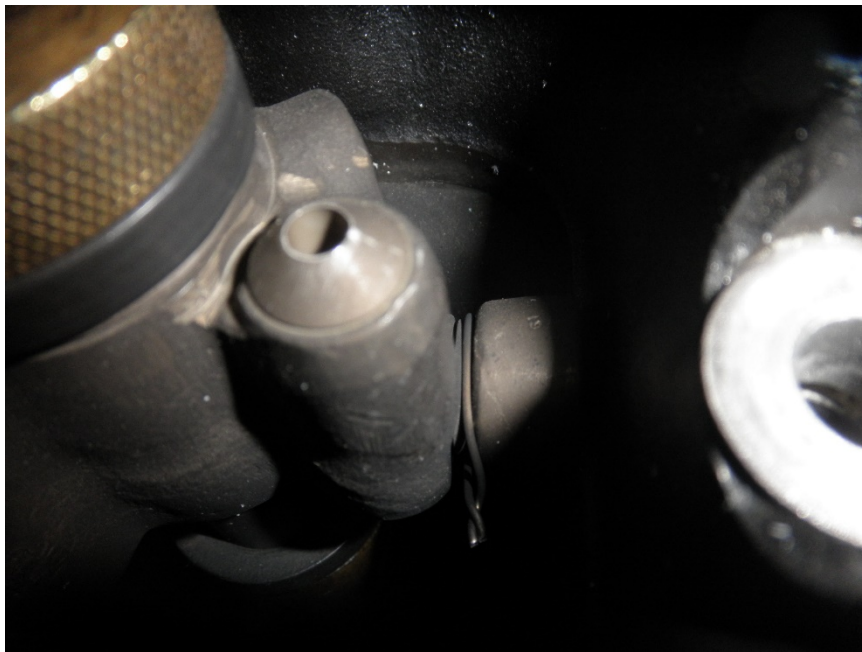
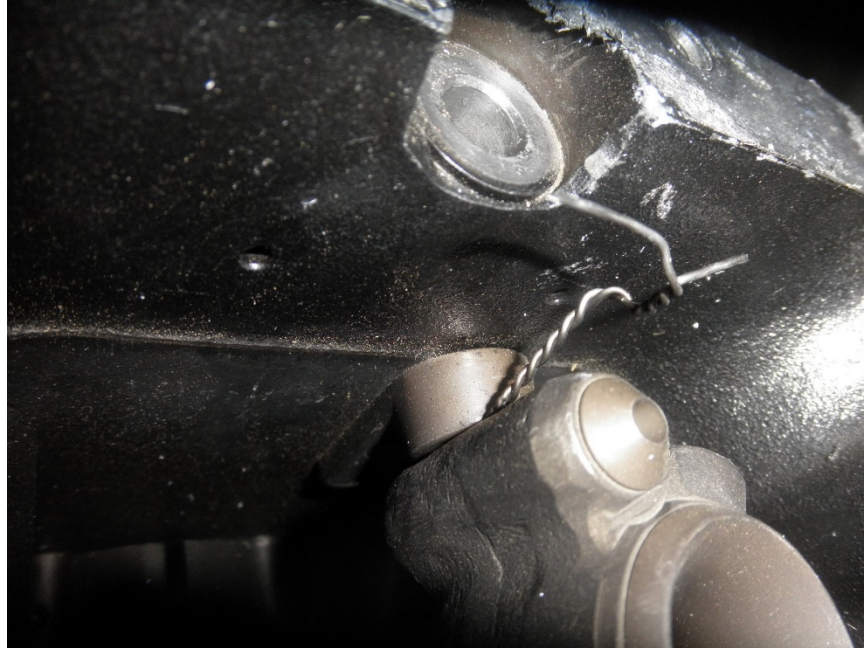
The carburetor was installed on a Stromberg Carburetor Flow Bench. All of the gages had stickers indicating their calibration was still valid. The test fluid was naphtha. It was noted that there was a loop of safety wire on each end of the boost rack. (Photos Nos. 10 and 11) According to Vintage Carburetor, the safety wire on the boost rack was not normal. The throttle plates idle gap was greater than the required 0.015 inches.

Photo No. 10: Close up view of loop of safety wire around end of boost rack.

Photo No. 11: Close up view of loop of safety wire around end of boost rack.

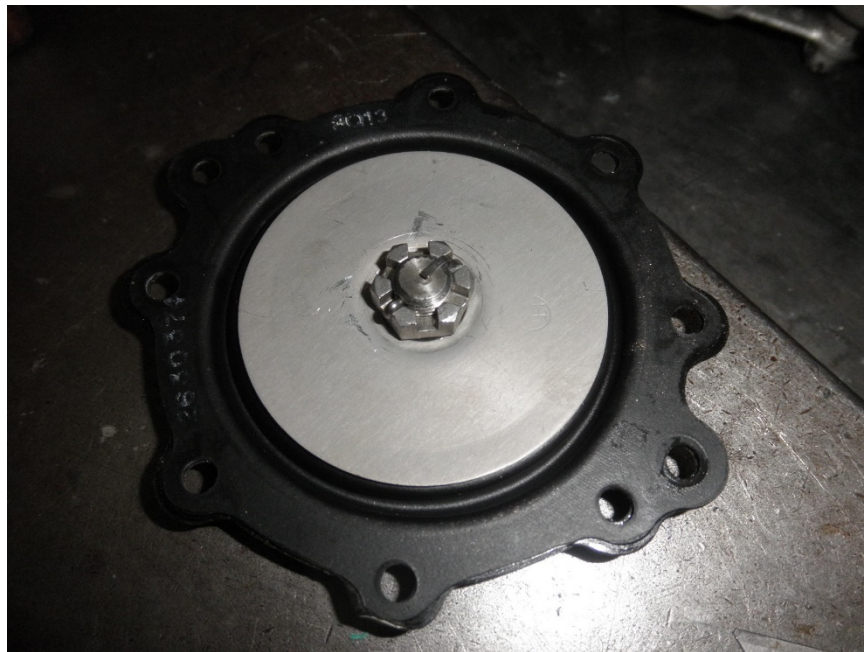
Following the completion of the tests, the carburetor was removed from the flow bench and transferred to a work bench and disassembled. The enrichment valve diaphragm was intact, but it was noted to be stiff. (Photo No. 12) According to Vintage Carburetor, the stiff enrichment valve diaphragm would cause the fuel flow at the higher settings to be lower than required. The main fuel diaphragm, air diaphragm, and the center balance diaphragm were all in place and intact. Photos Nos. 13, 14, and 15)

Photo No. 12: The enrichment valve showing that it was intact.

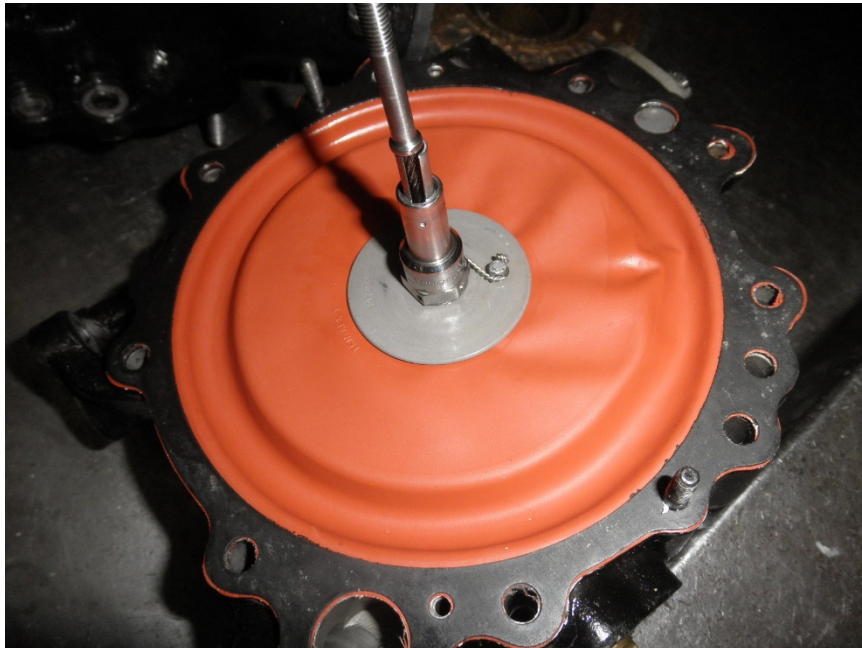
Photo No. 14: Air diaphragm showing that it was intact.

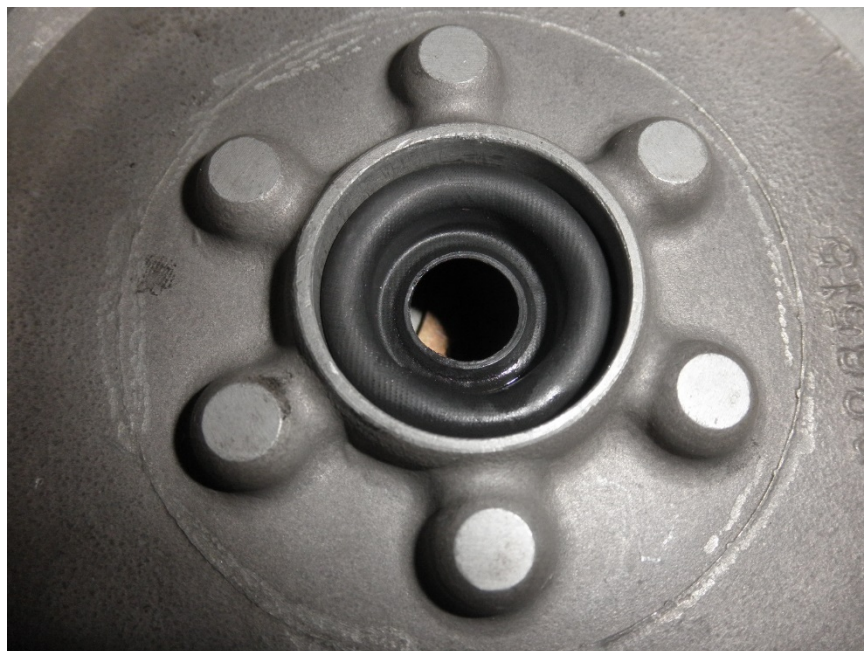
Photo No. 15: Center balance diaphragm showing that it was intact.
