**NATIONAL TRANSPORTATION SAFETY BOARD**

**AIRPLANE & ENGINE EXAMINATION**

**WPR19LA160**

Aircraft: Cessna 150

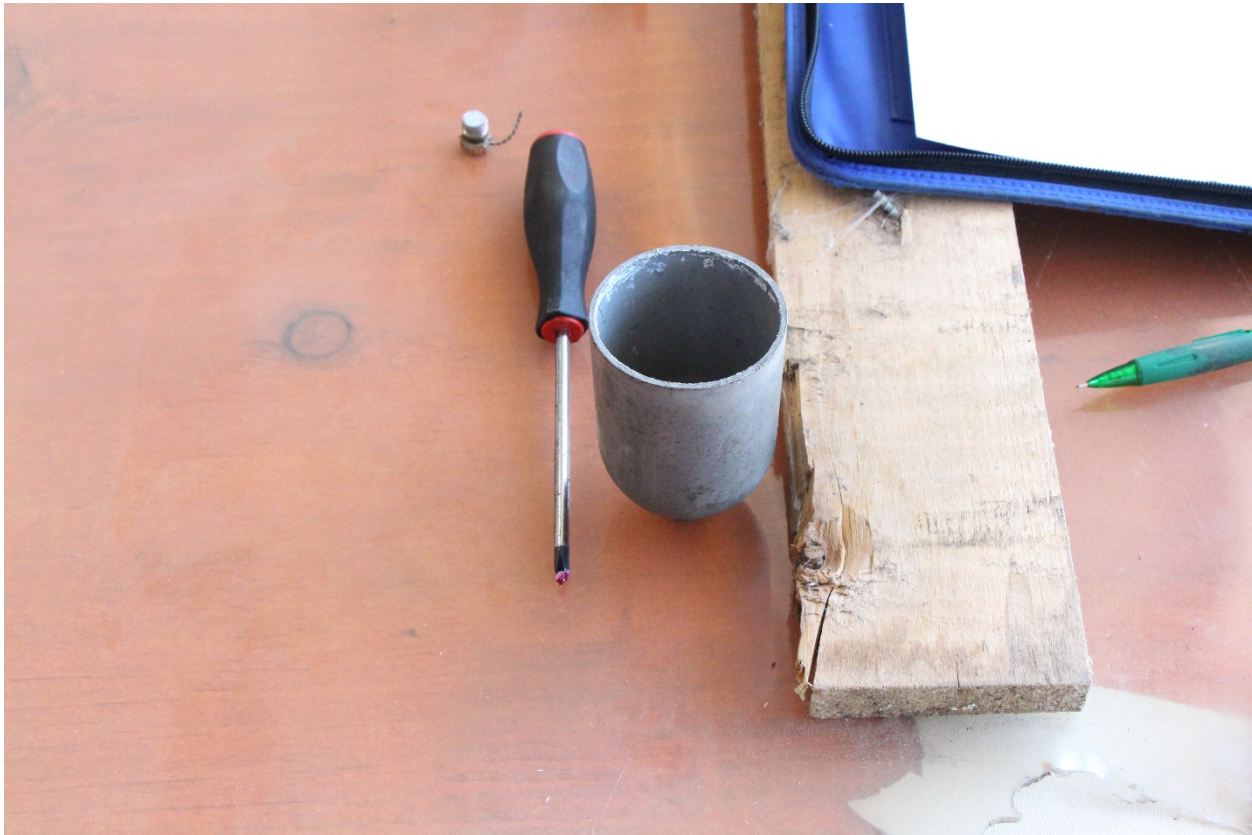
The gravity fed fuel system directed fuel to the engine through a single point fuel shut-off valve, which had two positions; ON and OFF. Examination of the fuel valve showed that the unit was not obstructed. The gascolator fuel bowl was removed and showed a white powdery residue consistent with water contamination along the rim of the bowl. The bowl was mostly void of fuel with the exception of a trace amount of liquid at the bottom of the bowl, which tested positive for water contamination using SARGEL water finding paste (*photograph 1*). The upper gascolator mount displayed white powdery residue (*photograph 2*). The fuel tanks were not breached and the fuel lines were not compromised.

Photograph 1: Gascolator Bowl and SARGEL Water Finding Paste

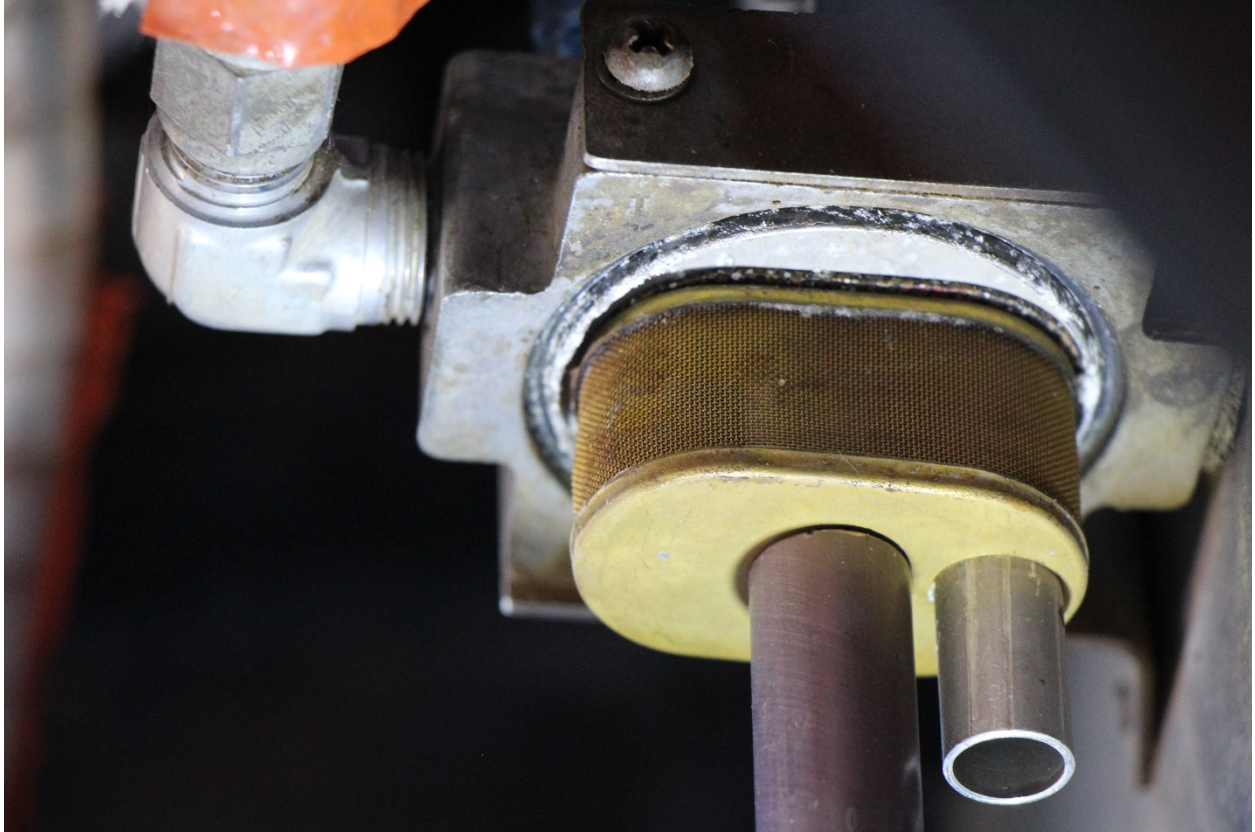
Photograph 2: Gascolator Upper Mount

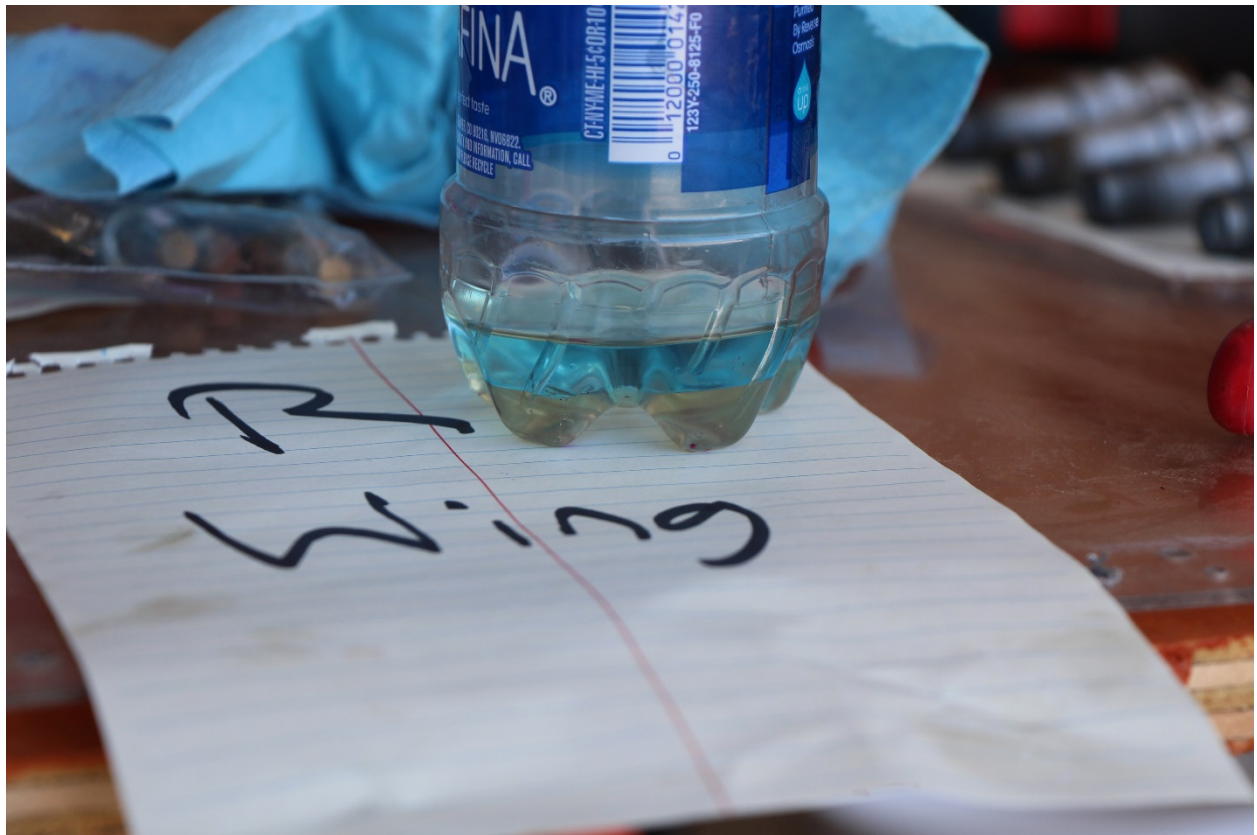
Both wings had been removed prior to the examination and had been stored in a hangar until the date of the examination. The residual fuel in each wing was drained; the fuel from the left wing was consistent with 100 low lead aviation grade gasoline and did not show evidence of water contamination. A few ounces of fuel obtained from the right wing was comprised of water, which was confirmed using SARGEL water finding paste (*photograph 3*). (*photograph 4*). The left wing fuel tank flange was also rusted and rotated with the fuel tank cap, but the fuel tank gasket appeared to have been recently replaced.

Photograph 3: Right Wing Fuel Sample

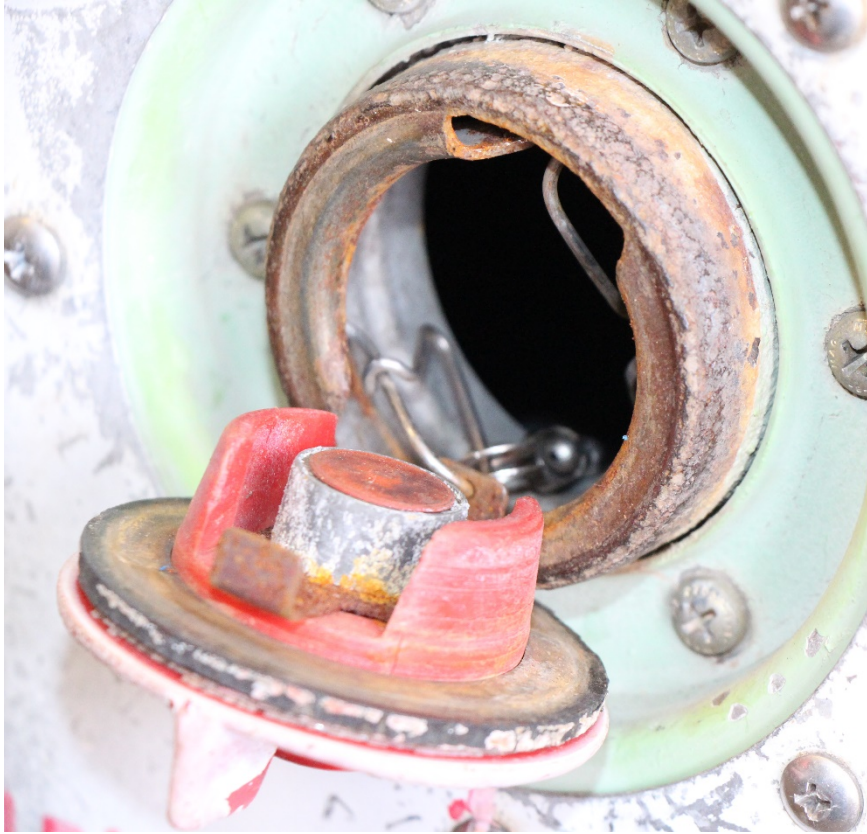
Photograph 4: Right Fuel Tank Cap and Flange

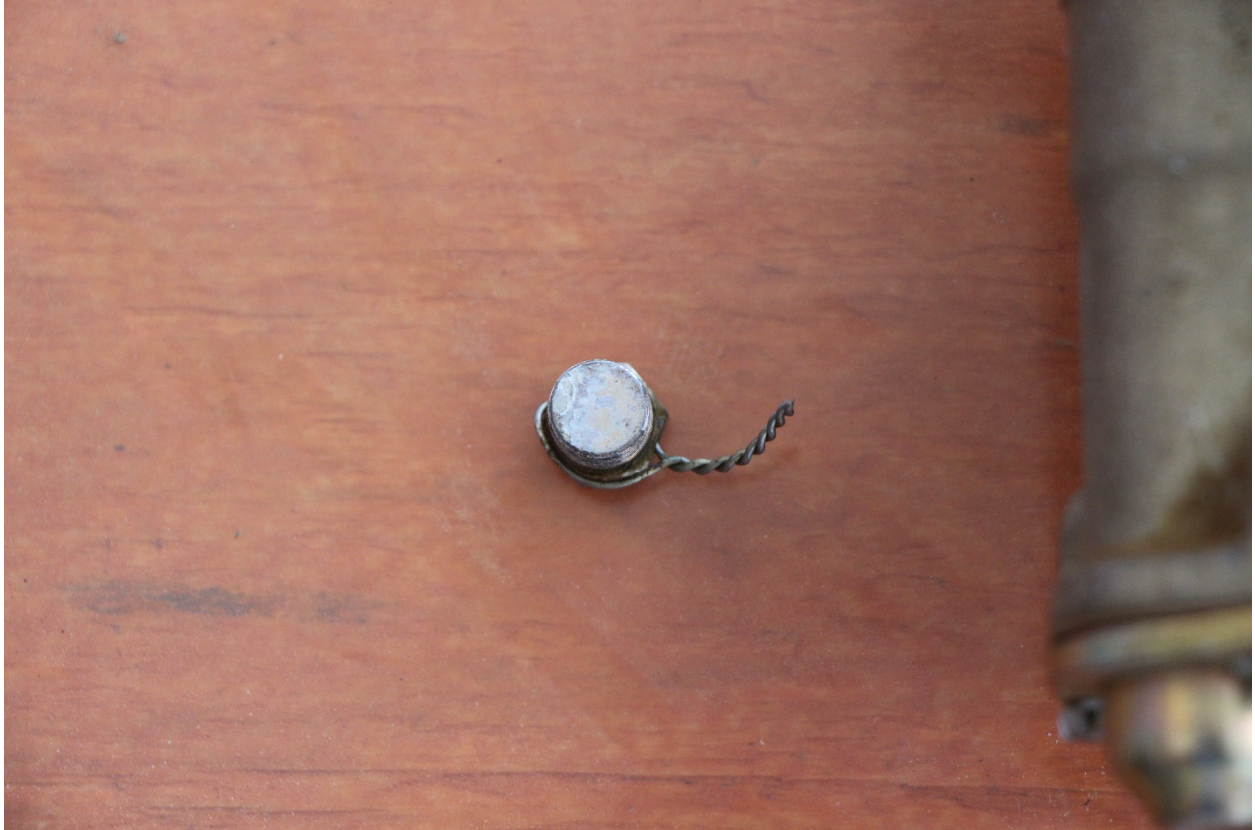
The carburetor was manufactured by Marvel Schebler and was a model MSA-3SPA. The fuel drain plug was caked in white powdery residue as was the bottom of the fuel bowl cavity (*photograph 5*). Both floats operated normally when tested. The carburetor fuel screen was free of debris.

Photograph 5: Carburetor Fuel Drain Plug
