## INVESTIGATION SUPPORT SUMMARY

On June 10, 2019, about 1245 Pacific daylight time, a Cessna 210D, N3997Y, experienced a total loss of power and collided with terrain short of the runway during an emergency landing to Ramona Airport, Ramona, California. The certified flight instructor (CFI), the registered owner, was operating the airplane under the provisions of 14 *Code of Federal Regulations* (CFR) Part 91. The CFI and pilot-rated passenger were not injured; the airplane sustained substantial damage to the right wing. The personal local flight departed from Gillespie Field, San Diego, California, about 1200 and was diverting to Ramona, California. Visual meteorological conditions prevailed and no flight plan had been filed.

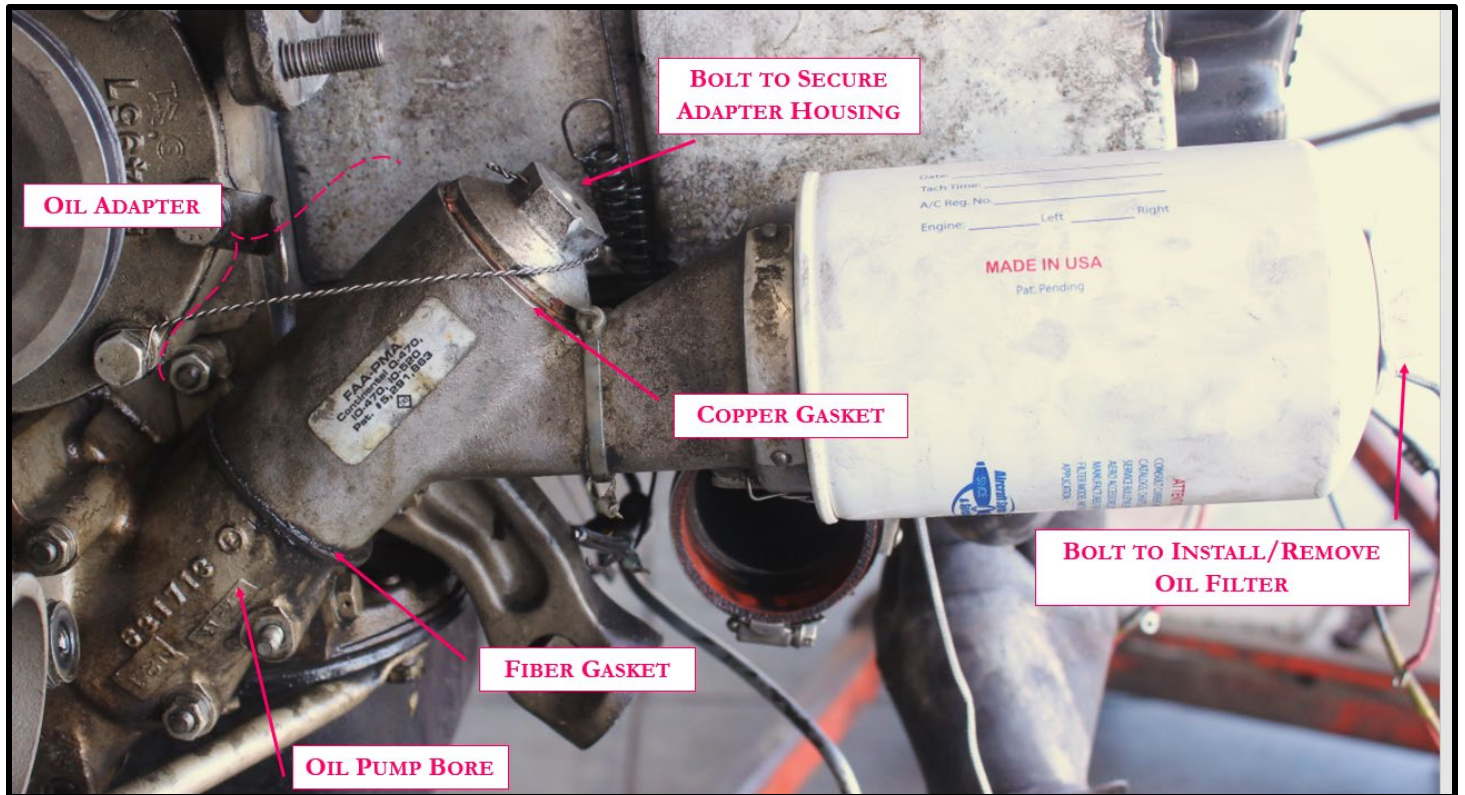
An external examination revealed that the filter adapter was loose, and the adapter housing could be rotated about the shaft.<sup>1</sup> The crown head of the shaft and the oil filter screen bolt head both remained saftied. There was a

concentration of oil in the area of the adapter and adjacent firewall. The nut on the hub had several wear marks, consistent with a tool slipping on the nut. There was an older zip tie around the adapter arm that held two wires. The plastic and wear was consistent with the tie wrap being installed several years prior, and the location of the wrap end was in position near the nut, where the installation/removal of the nut was prohibited by its position.<sup>2</sup>

*Picture 05: Oil Filter Adapter as Installed on Oil Pump Bore*

A closer examination revealed that the fiber gasket, located between the oil pump casting and the adapter was protruding with the outside edge extending beyond the castings. Additionally, a tear could be seen in the gasket where the adapter housing abutted the engine case. Investigators removed the safety wire and attempted to assess the breakaway torque of the adapter. A torque wrench was used to determine that the breakaway torque was 9 foot-pounds

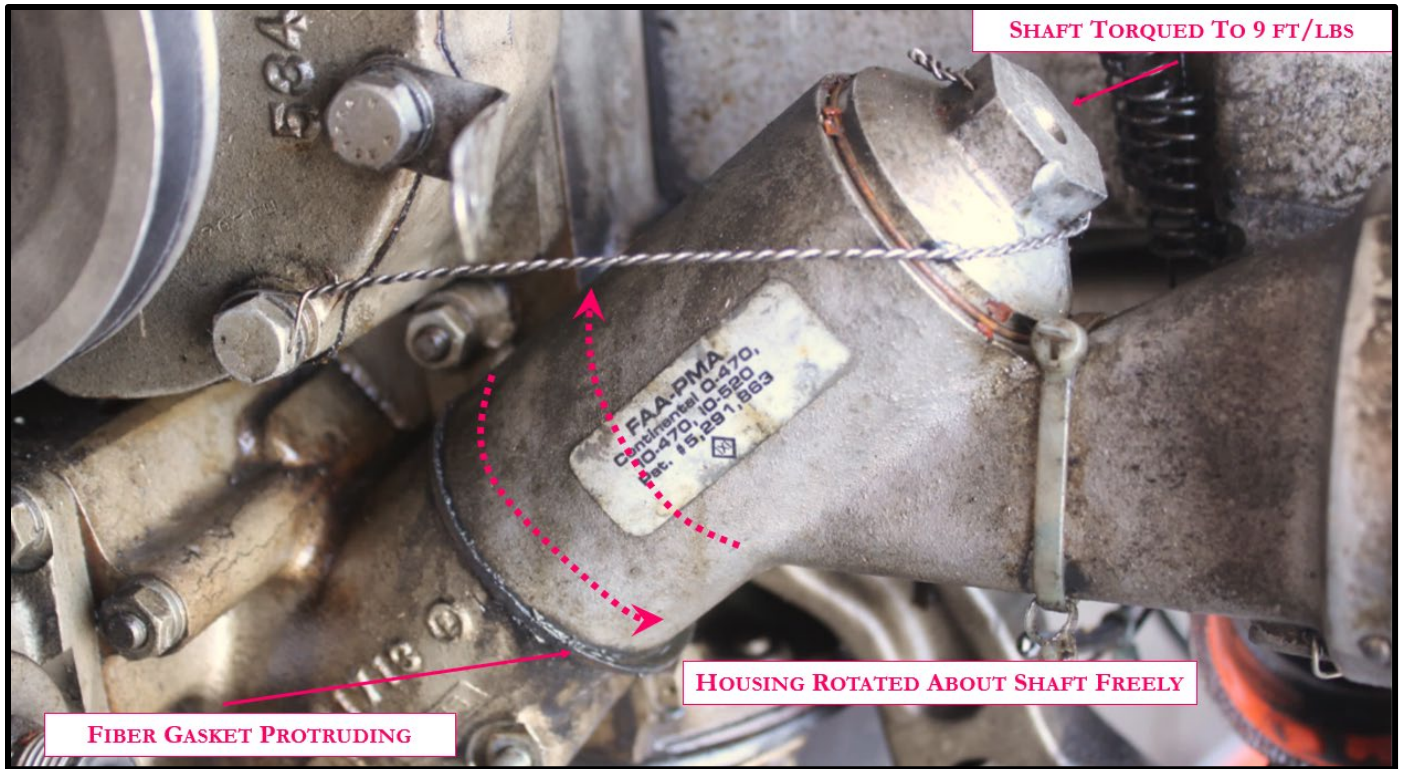
*Picture 06: Oil Filter Adapter Could be Rotated Freely*

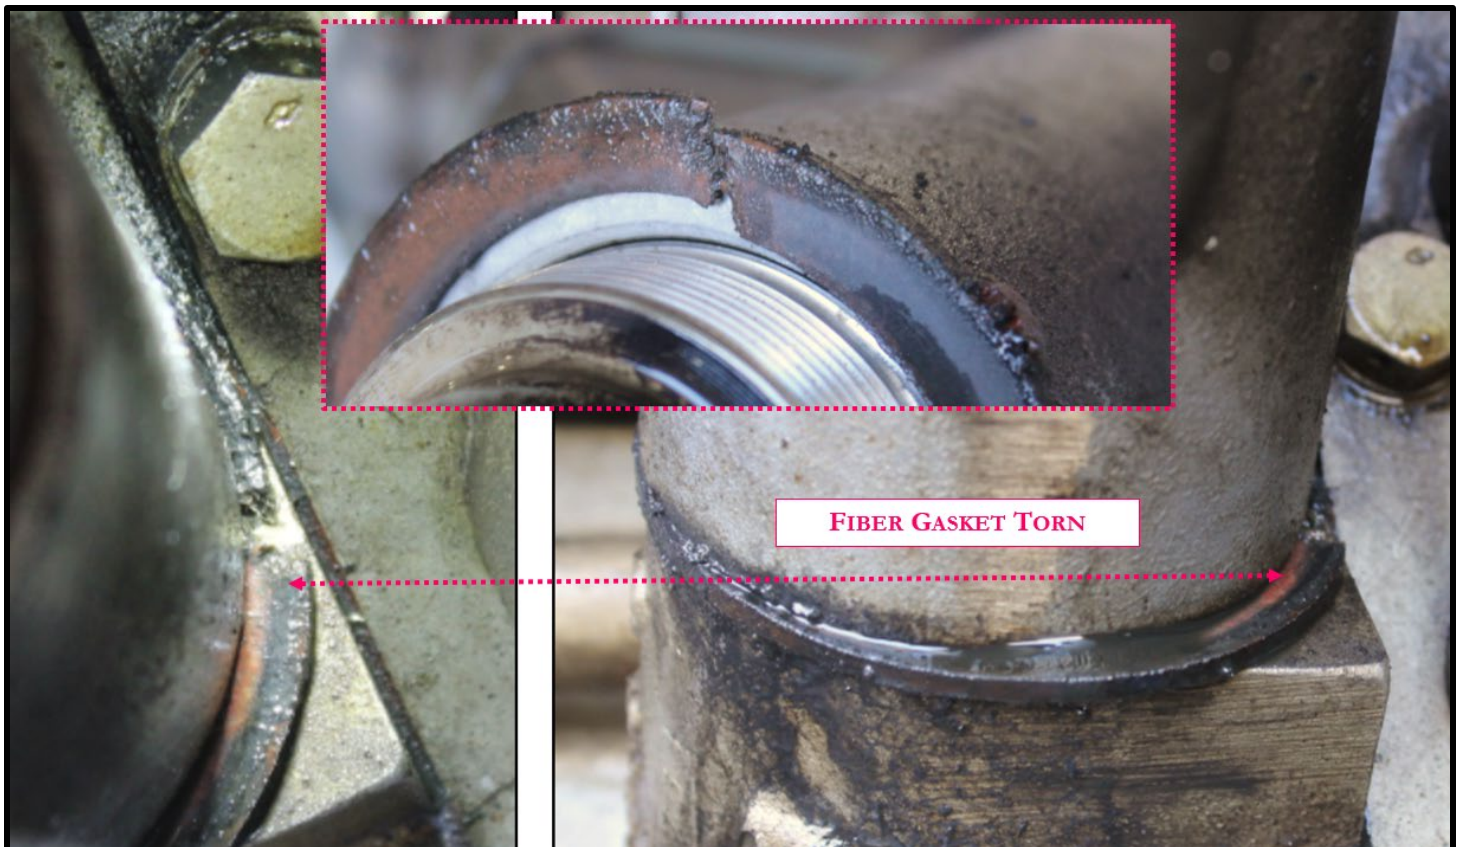
Removal of the adapter revealed that the fiber gasket was completely split and contained several lips where it appeared the gasket had been pinched between the engine case and the adapter housing. The copper crush gasket was intact.

*Picture 07: Fiber Gasket*

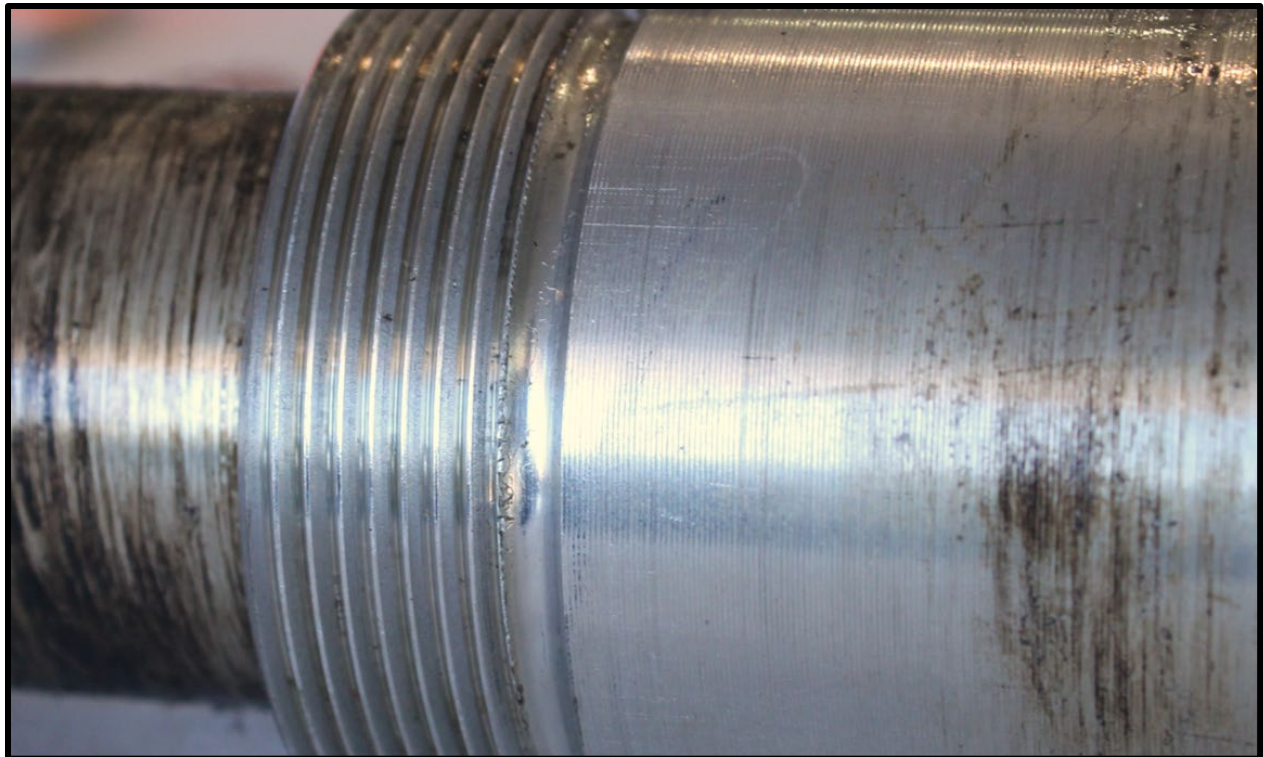
Picture 09: Threads on Hub

The threads on the upper area of the hub, adjacent to the annular groove were rough.

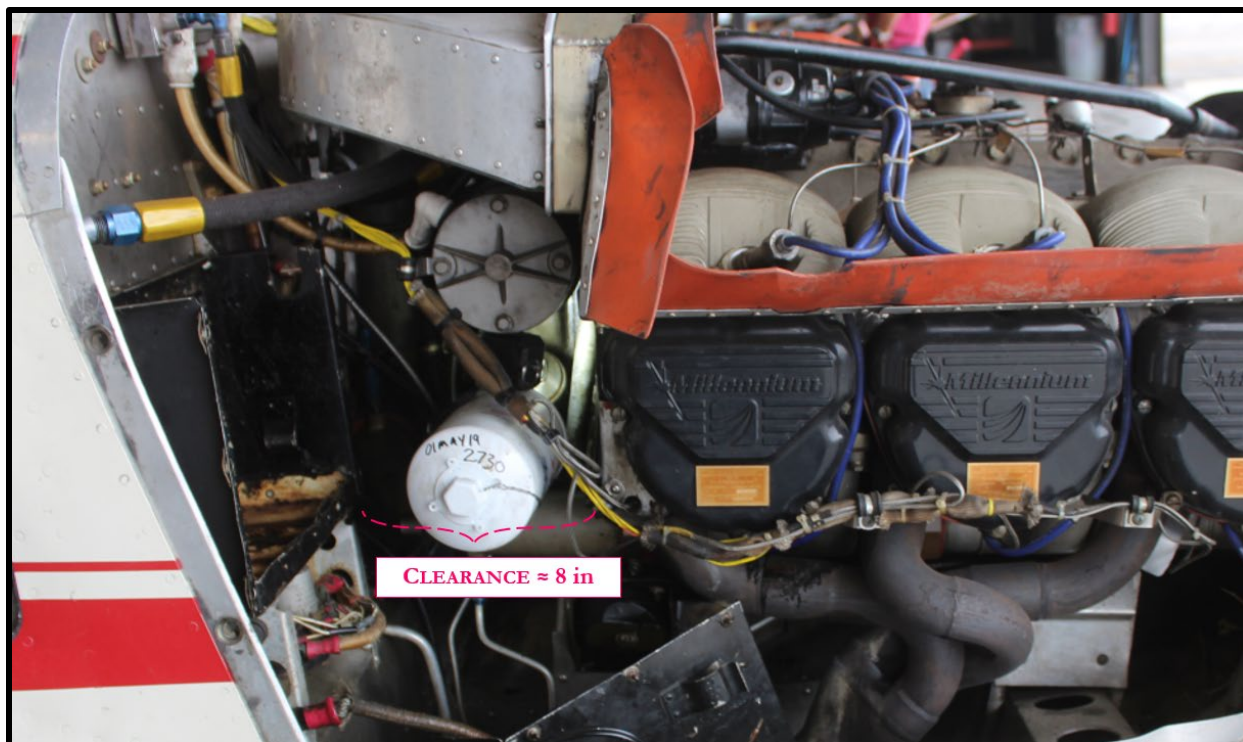
After measuring and photo documenting the oil filter adapter assembly, a new fiber and copper gasket were used to install the oil filter adapter on the engine, using a calibrated torque wrench. A mechanic installed the adapter while investigators captured the installation on video.<sup>3</sup> When sliding the fiber gasket over the hub threads, there was light scraping due to the tight fit of about 0.022 inches as measured with a feeler gauge. Despite numerous components being removed (e.g., the starter), the mechanic had only about 8 inches of space to torque the adapter. The limited space prohibited the mechanic from being able to visually discern the alignment of the fiber gasket.<sup>4</sup>

Picture 11: Area to Install Adapter with All Components Installed

<sup>4</sup> The clearance between the hub and the fiber gasket was about 0.031 inch clearance.
