## OIL FILTER ADAPTER RESEARCH

On May 01, 2019 a fatal accident occurred in Mill Creek, California (WPR19FA126). The oil had egressed the engine at a high velocity from the F&M the oil filter adapter. Just over a month later, on June 10, 2019 another accident that occurred in Romana, California (WPR20LA166). The same teams responded to both accidents: Zoë Keliher (NTSB investigator-in-charge IIC), Michael Council (Continental Aerospace Technologies), and Henry Soderlund (Textron Aviation – Cessna).

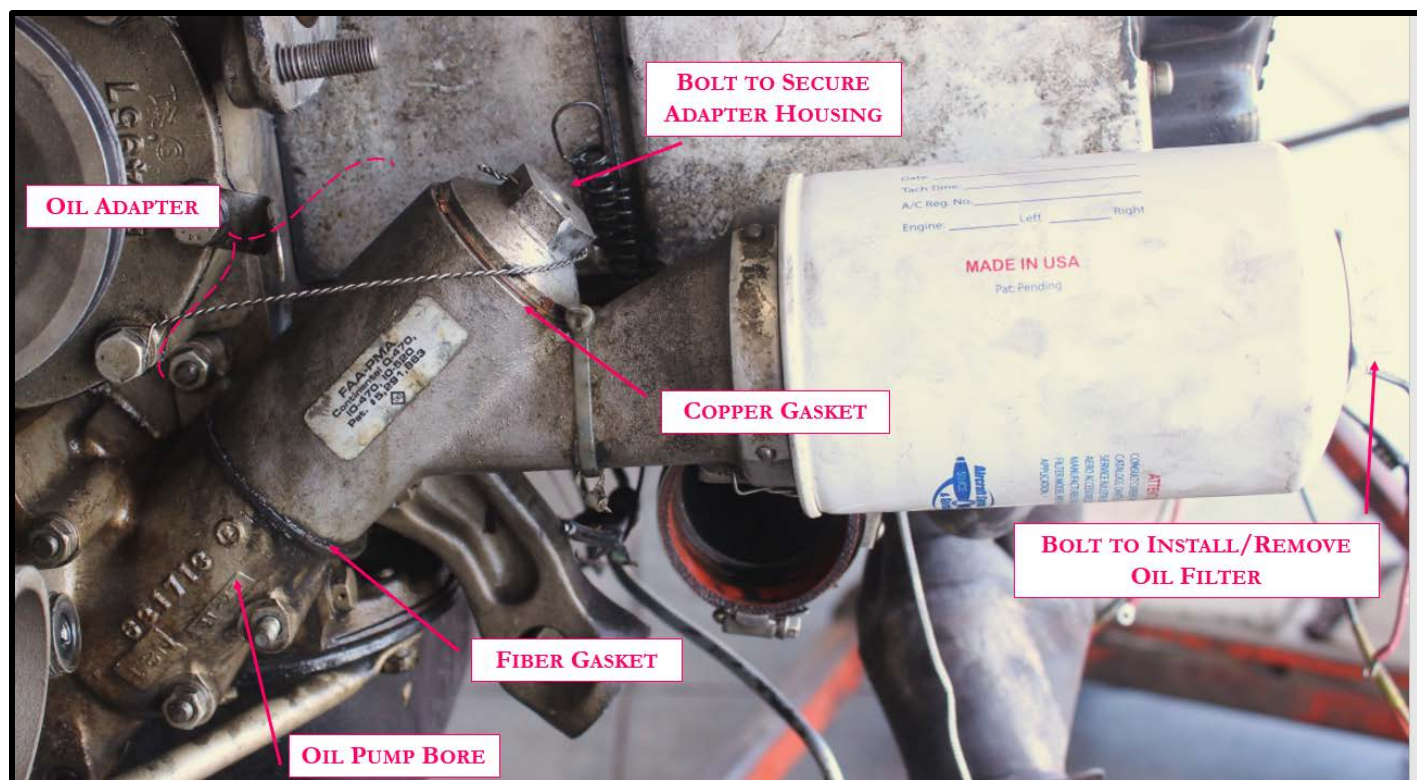
An external examination revealed that the filter adapter was loose, and the adapter housing could be rotated about the shaft.<sup>14</sup> The crown head of the shaft and the oil filter screen bolt head both remained saftied. There was a concentration of oil in the area of the adapter and adjacent firewall. The nut on the hub had several wear marks, consistent with a tool slipping on the nut. There was an older zip tie around the adapter arm that held two wires. The plastic and wear was consistent with the tie wrap being installed several years prior, and the location of the wrap end was position near the nut, where the installation/removal of the nut was prohibited by its position.<sup>15</sup>

Figure 12: Oil Filter Adapter as Installed on Oil Pump Bore

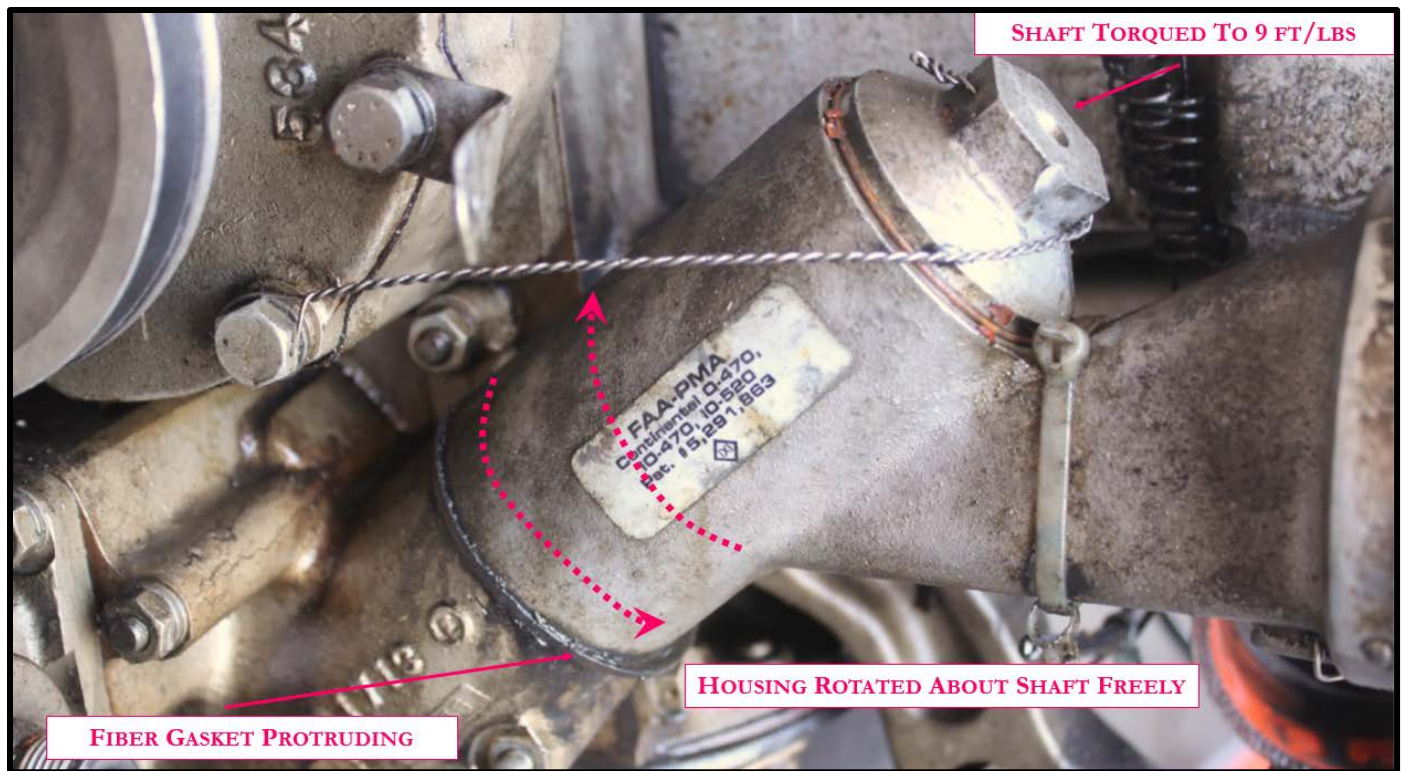
A closer examination revealed that the fiber gasket, located between the oil pump casting and the adapter was protruding with the outside edge extending beyond the castings. Additionally, a tear could be seen in the gasket where the adapter housing abutted the engine case. Investigators removed the safety wire and attempted to assess the breakaway torque of the adapter. A torque wrench was used to determine that the breakaway torque was 9 foot-pounds

*Figure 13: Oil Filter Adapter Could be Rotated Freely*

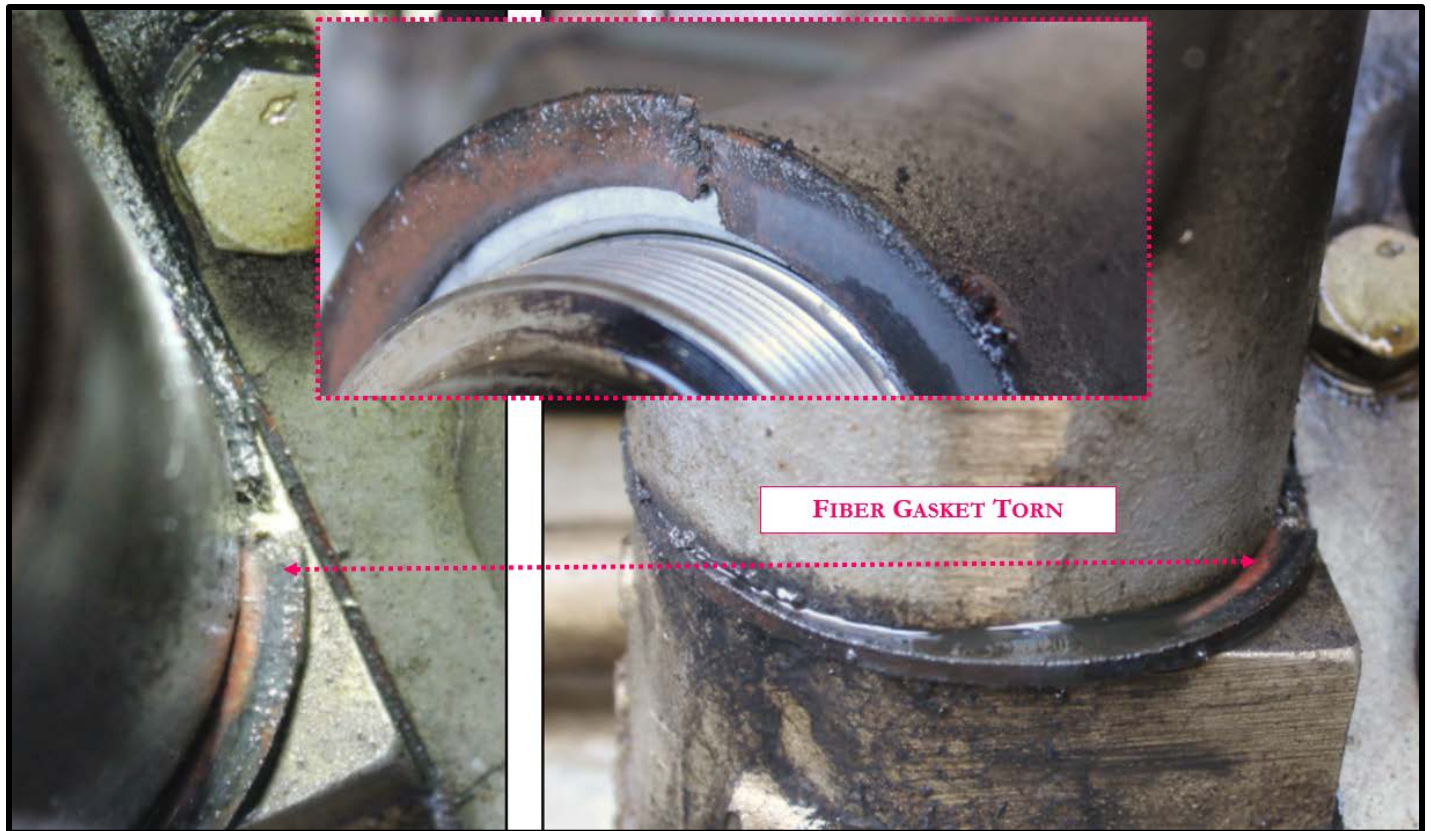
Removal of the adapter revealed that the fiber gasket was completely split and contained several lips where it appeared the gasket had been pinched between the engine case and the adapter housing. The copper crush gasket was intact.

Figure 14: Fiber Gasket

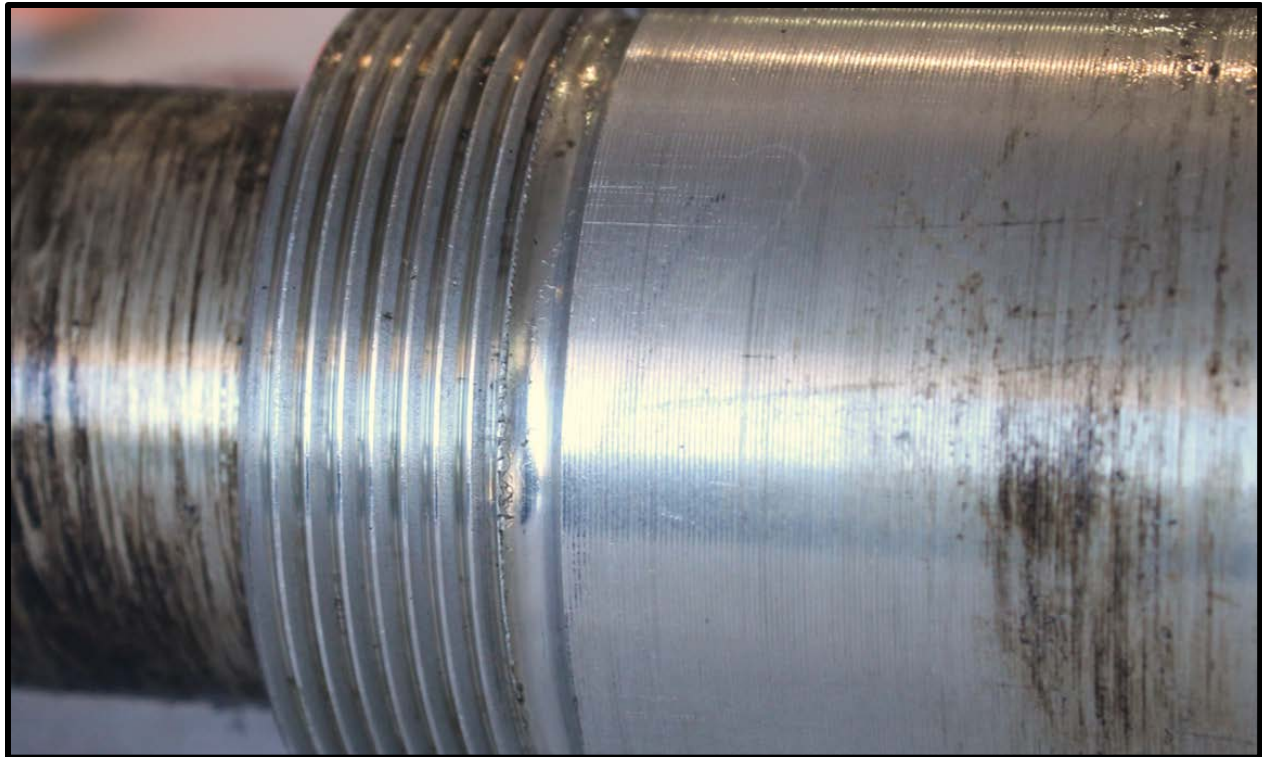
The threads on the upper area of the hub, adjacent to the annular groove were rough.

Figure 16: Threads on Hub

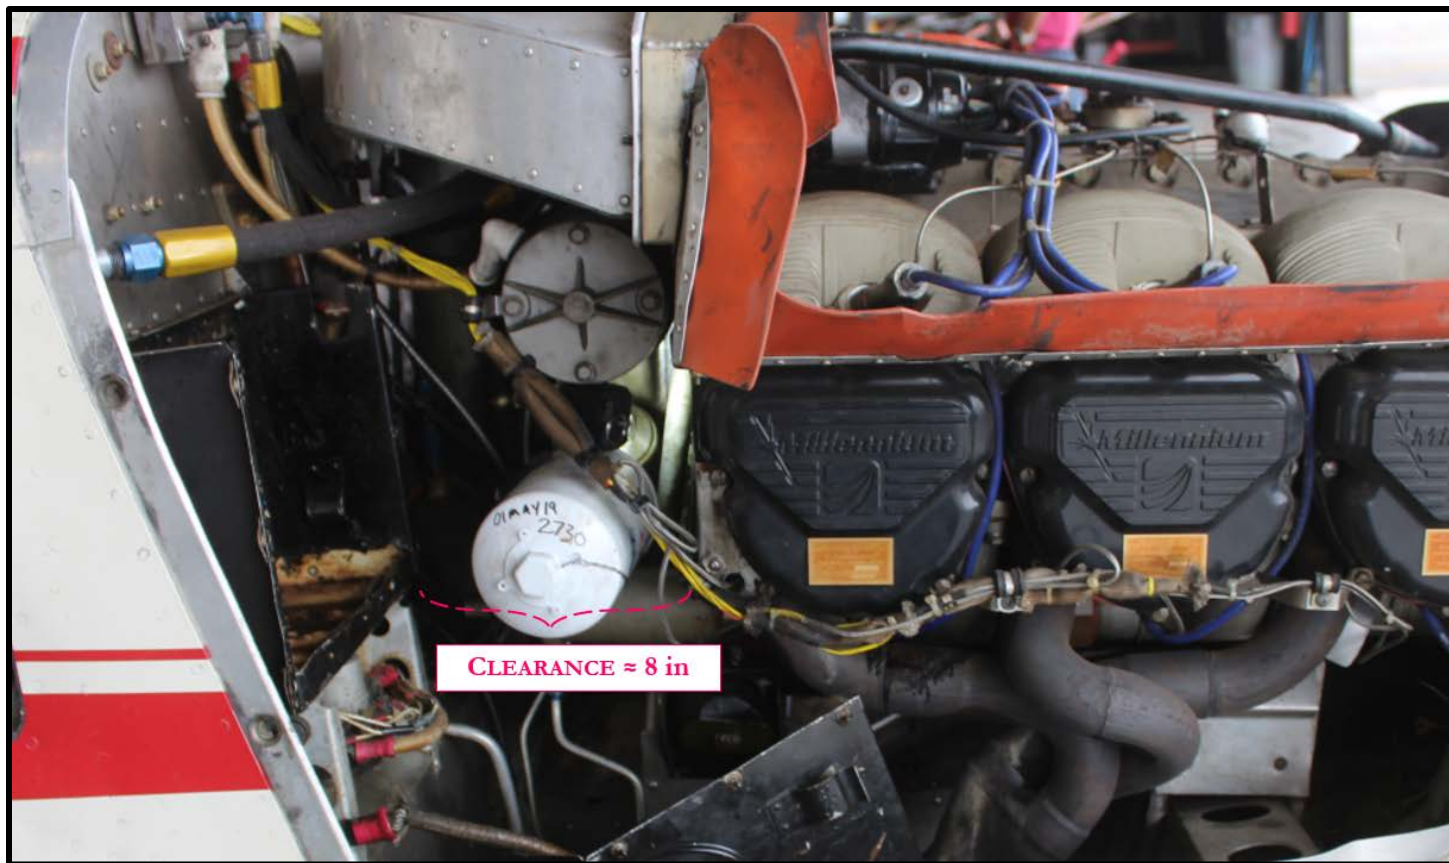
being removed (e.g., the starter), the mechanic had only about 8 inches of space to torque the adapter. The limited space prohibited the mechanic from being able to visually discern the alignment of the fiber gasket.<sup>17</sup>

*Figure 18: Clearance to Install Adapter with All Components Installed*

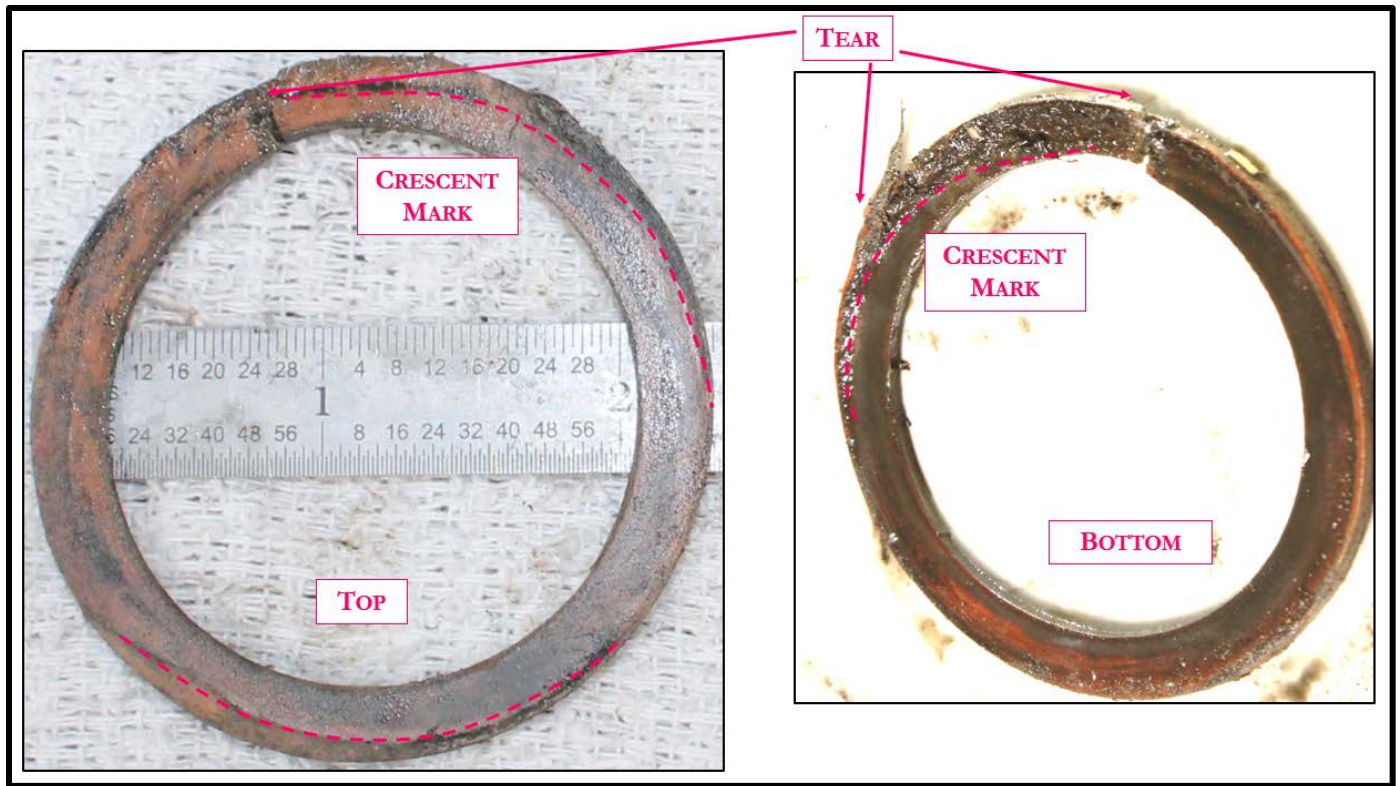
The gasket had numerous impressions and markings consistent with the crescent shape of the flanges.

Figure 31: Gasket Showing Impressions/Marks

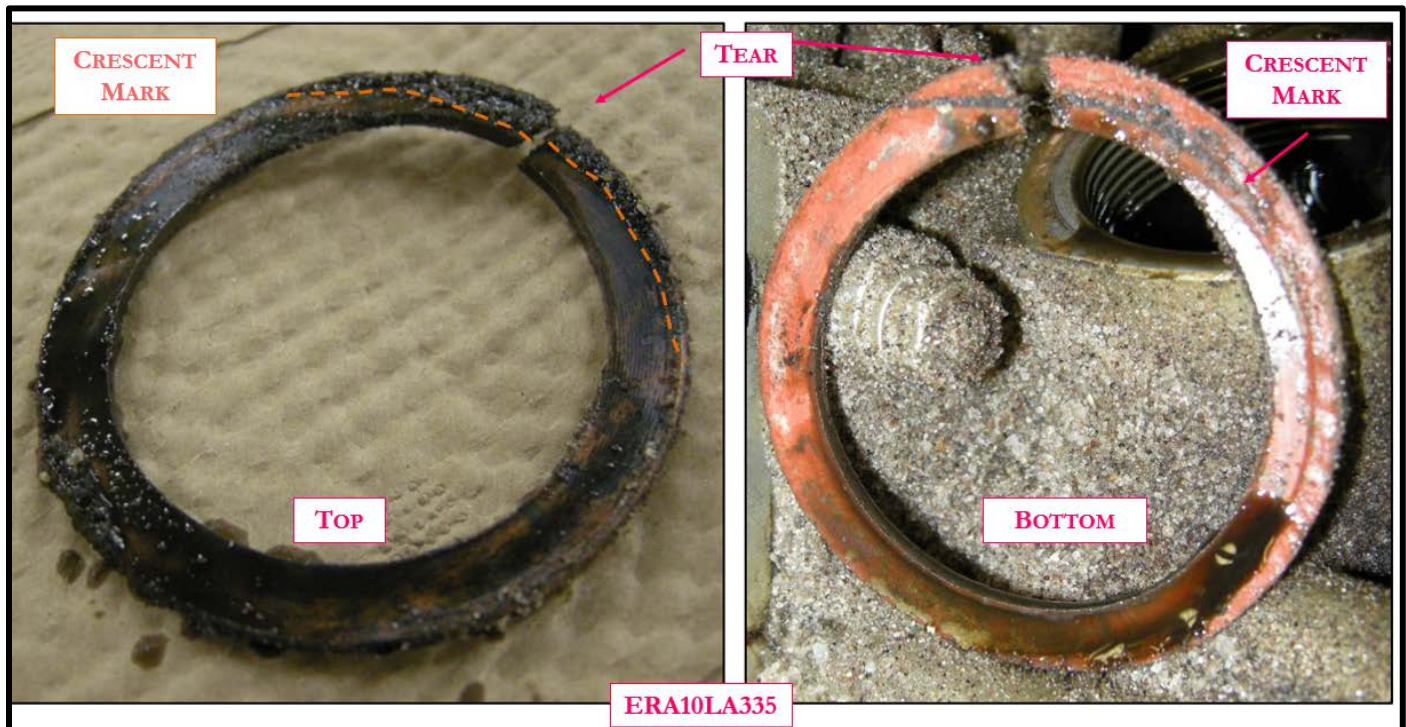
A review of pictures of prior accidents revealed that there were crescent marks similar to the accident mark. Better quality photographs are currently be searched for.

Figure 32: Prior Accident Gasket Showing Impressions/Marks ERA10LA335

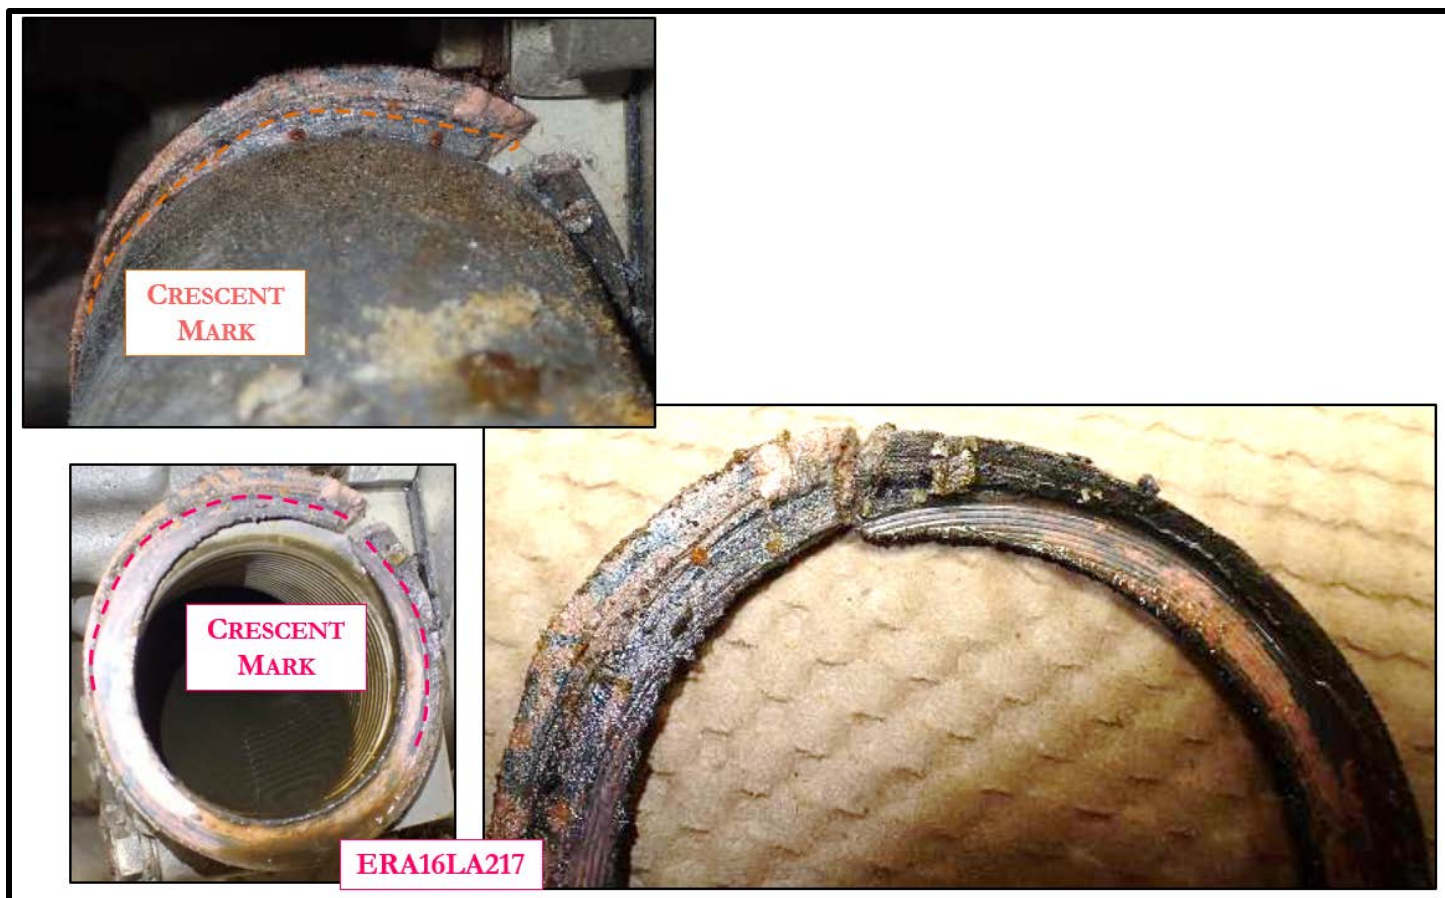
Figure 33: Prior Accident Gasket Showing Impressions/Marks ERA16LA217

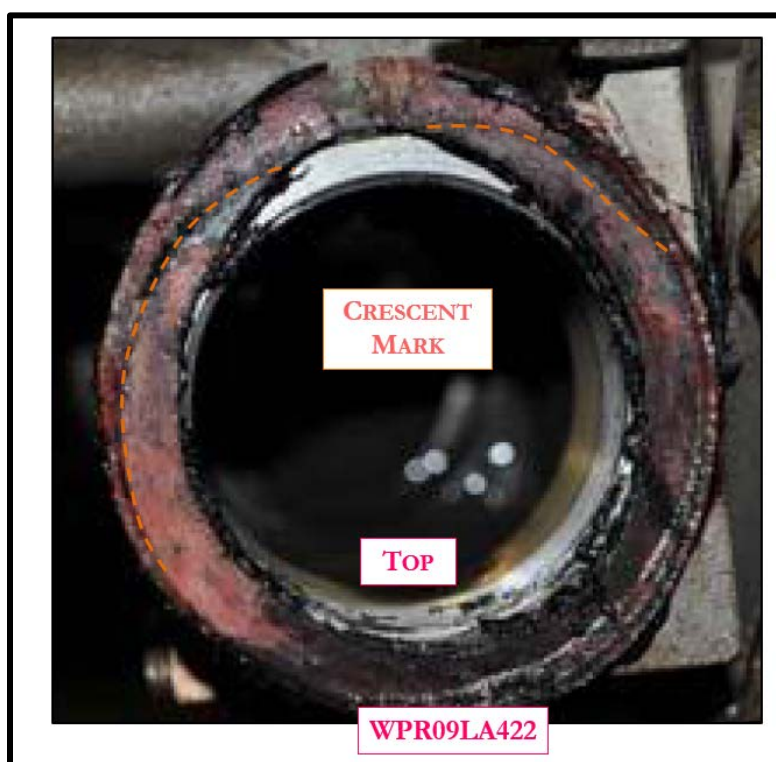
Figure 34: Prior Accident Gasket Showing Impressions/Marks WPR09LA422

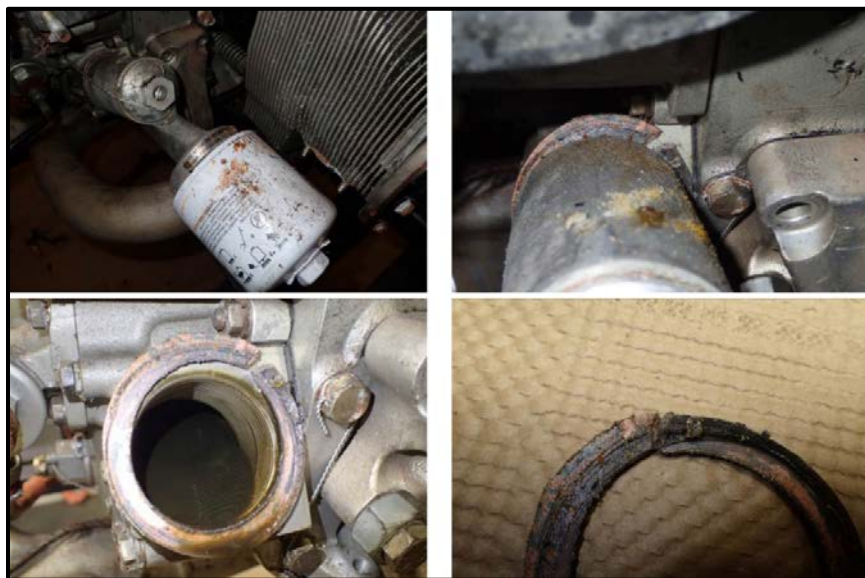
*Figure 35: Prior Accident ERA16LA217*

ERA16LA217 (Beech P35) – Nearly the same accident-

A total loss of engine power due to inadequate maintenance of the oil filter adapter, which resulted in an oil leak and subsequent oil starvation to the engine.

For ERA16LA217, the IIC did not see the problem as systemic because the “mechanic did not replace the gasket at the regular interval per the maintenance instructions, which ultimately lead to the oil coming out of the engine.” The maintenance required the gasket to be replaced every 300 hours or 3 years, whichever occurred first; the maintenance records indicated that the oil filter adapter was installed about 4.5 years before the accident.

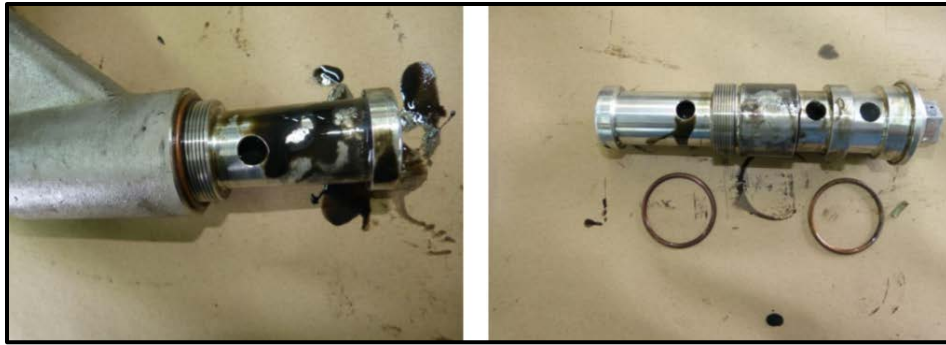
Figure 36: Prior Accident ERA14LA436

ERA14LA436 (Bellanca) -used 2 copper gaskets

The improper installation of the oil filter adapter at an unknown time, which resulted in an oil leak and subsequent oil starvation to the engine.

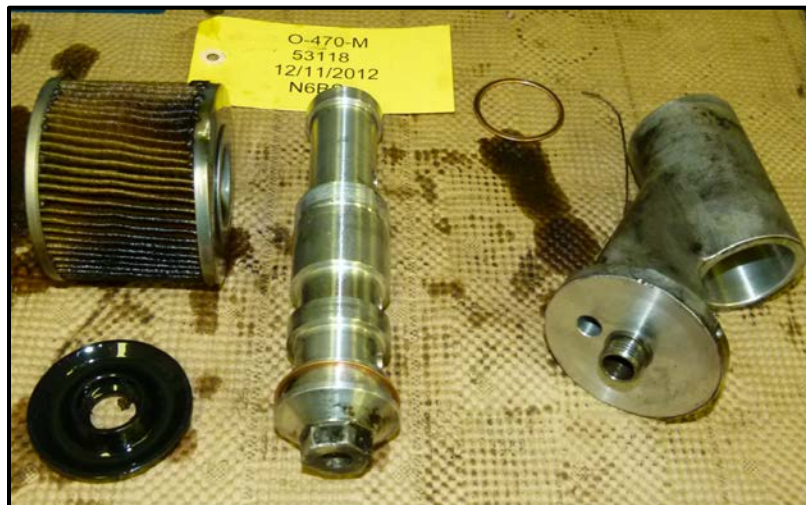
Figure 37: Prior Accident CEN13FA044

CEN13FA044 (Cessna 310) -used 2 copper gaskets

The pilot's failure to maintain airplane control after he shut down the right engine in flight due a loss of oil pressure... the mechanic's improper assembly and installation of the right engine's oil filter adapter, which resulted in a loss of oil to that engine.

For CEN13FA044, the IIC the adapter was not properly safety-wired to the engine as per the installation instructions in the STC and was loose. There were two copper crush rings (gaskets) were found on the oil transfer cylinder. According to the STC, only one copper crush ring was to be used and a fiber leak-guard gasket was to be used at the base of the adapter. Additionally, the IIC determined that the copper crush ring did not exhibit the signatures or dimensions that would be created if it had been installed at the proper torque value. The mechanic admitted to not torqueing the filter in accordance with the STC.

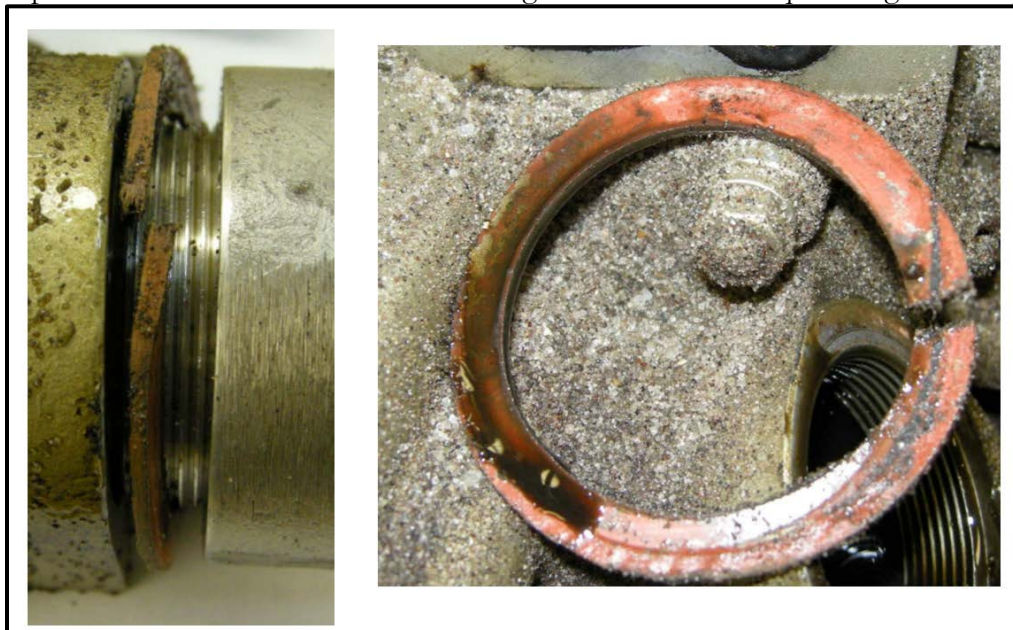
*Figure 38: Prior Accident ERA10LA335*

ERA10LA335 (Cessna 210)

The loss of engine power due to the failure of the oil filter gasket and the subsequent engine oil depletion.

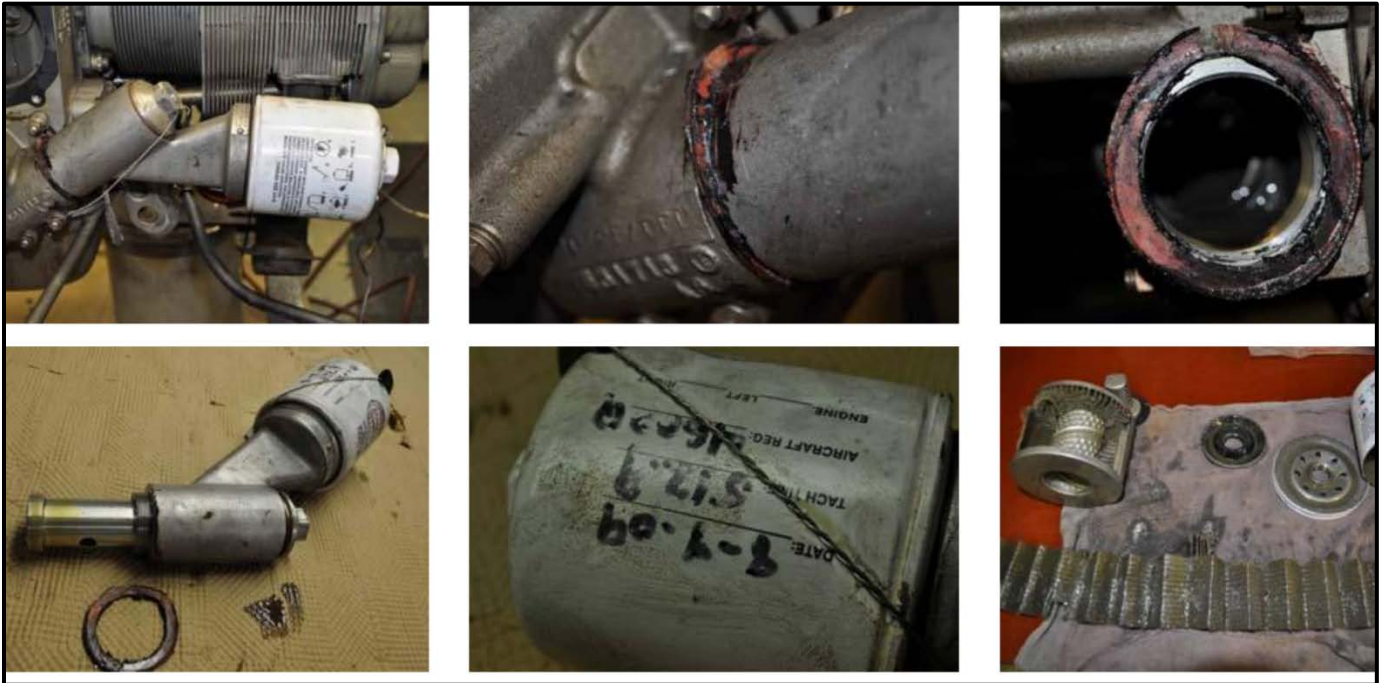
*Figure 39: Prior Accident WPR09LA422*

WPR09LA422 (Cessna 210)- Nearly the same accident findings

A total loss of engine power due to the displaced oil filter adapter gasket, which resulted in an oil leak and oil exhaustion. Contributing to the accident was the unsuitable terrain for a forced landing.

For WPR09LA422, the IIC stated that there was a displacement of the oil filter gasket, but he could not definitively determined what precipitated the displacement. He thought it was most likely due to improper maintenance when the adapter wasn’t torqued correctly during install.

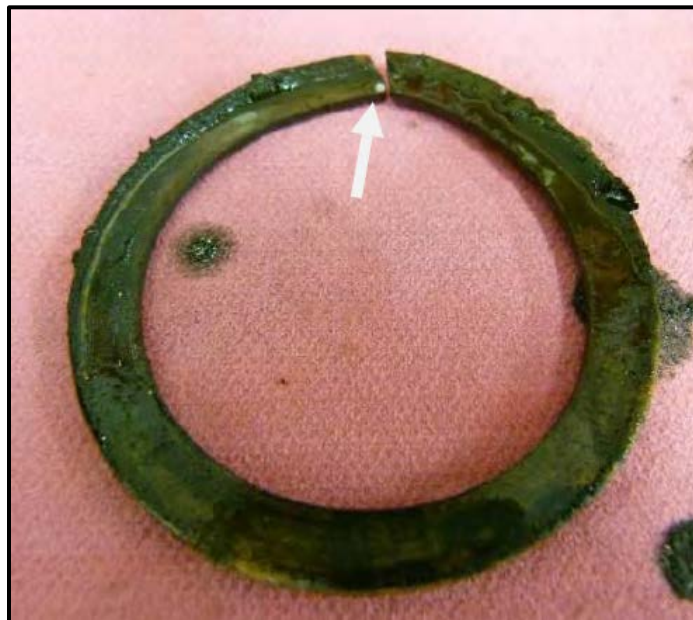
*Figure 40: Picture 18: Prior Accident CEN13LA056*

CEN13LA056 (Cessna 210):

The total loss of engine power due to the loss of oil to the engine. Contributing to the accident was maintenance personnel's improper installation of the engine oil filter adaptor, which resulted in the loss of oil to the engine.
