## **NATIONAL TRANSPORTATION SAFETY BOARD**

### **ENGINE EXAM / RUN (Rev A)**

**WPR19FA167**

Activity Dates: February 19-20, 2020

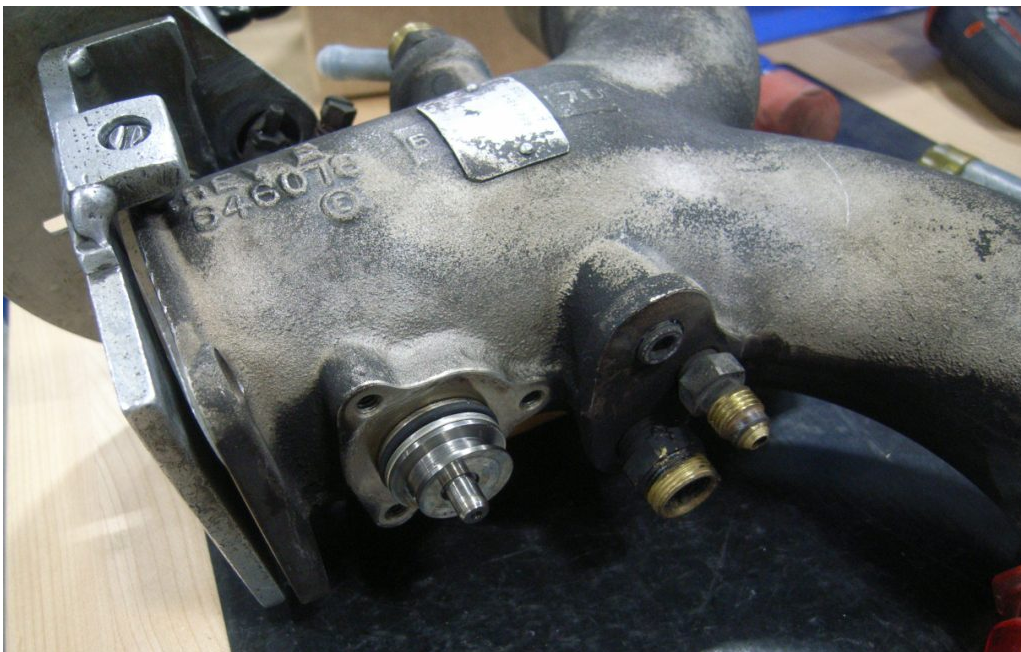
- The metering assembly (MA) is normally affixed to the throttle body (Fig 1)
- The internal spring and its associated Teflon washer in the metering plug (Fig 2) were replaced

Figure 1 - Metering Assembly on Throttle Body

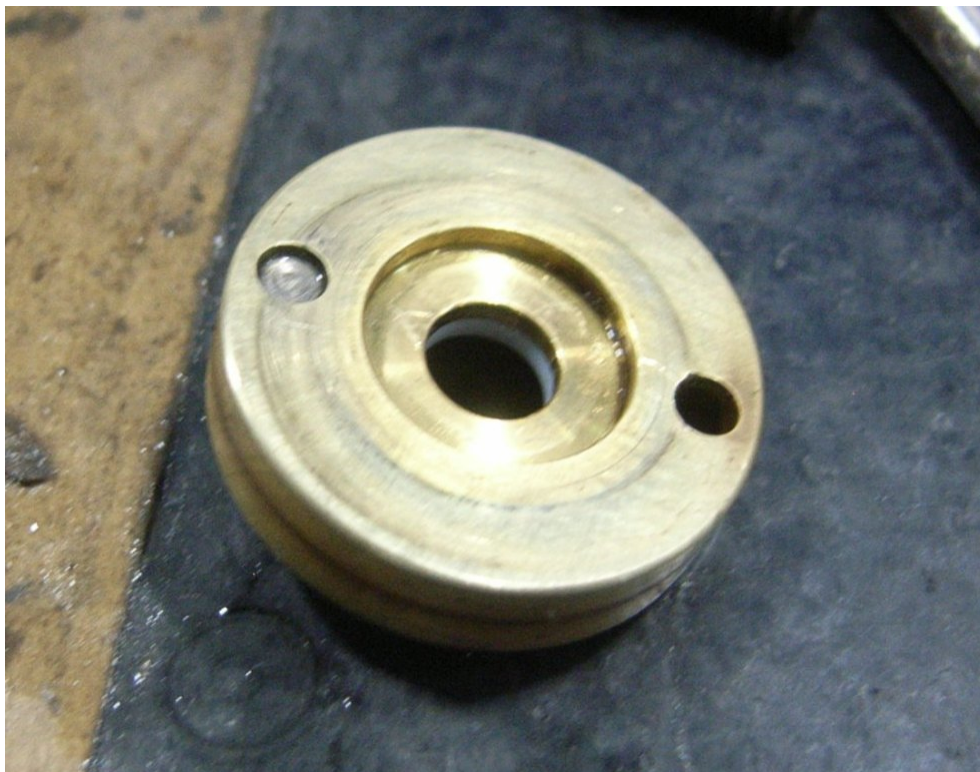
**Figure 2 - Metering Plug (mating surface, prior to lapping)**

- The MA was removed and disassembled
  - The mating surfaces of the metering plug and metering cam were lapped to polish their interface
  - Hard deposits of what appeared to be melted plastic that re-solidified on the throttle body bore walls in the vicinity of where the throttle plate sealed against the bore wall were removed by scraping and polishing (Fig 6)

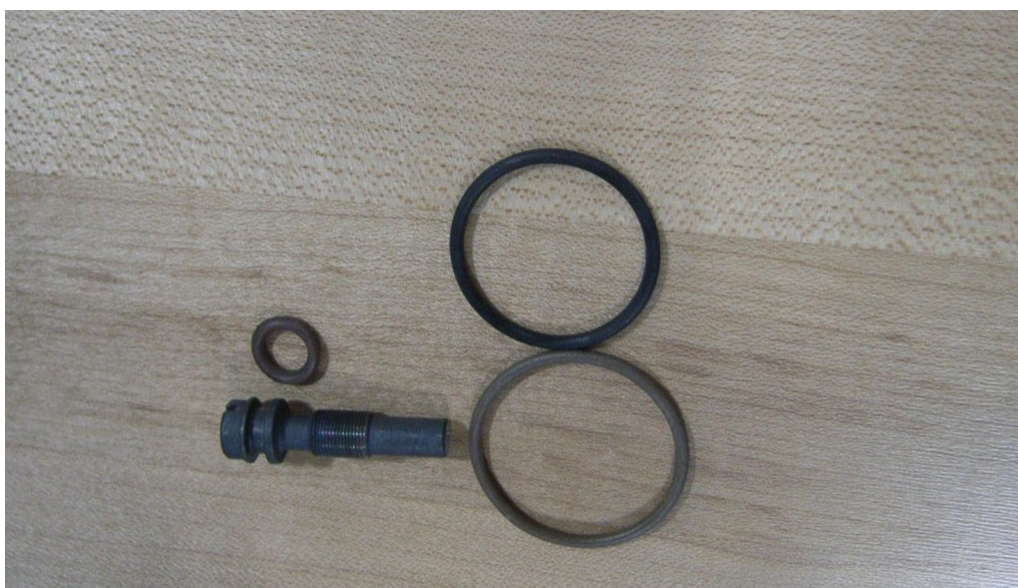
- Idle mixture adjust screw (dirty/contaminated washer & shaft)
  - MA Housing O-ring (brown, ~1.25" ID)
  - Throttle body O-ring (black, ~1.25" ID)
- The MA was reassembled, reinstalled on the throttle body and re-tested

**Figure 3 – Removed Idle Mixture Screw (cleaned) and MA O-Rings**

- Actual ~37 pph vs target range of 12.9 – 13.5 pph
- The test series was discontinued, and the MA was disassembled
- The following components were changed out for new: (Fig 3)

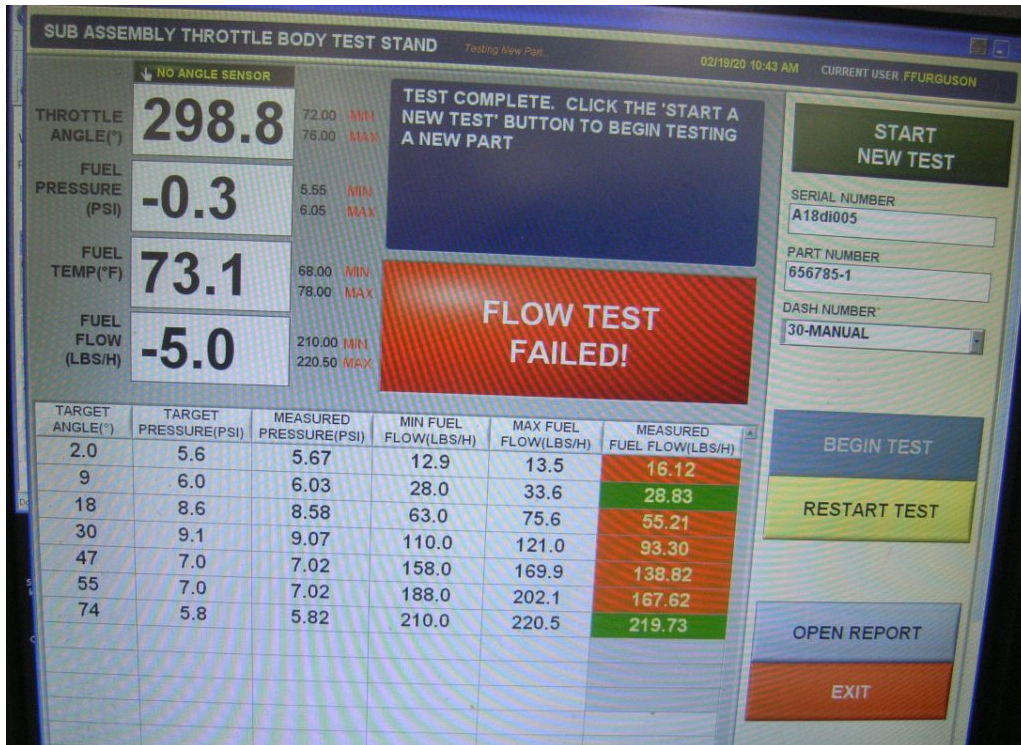
- The full test series was completed anyway (Fig 4), but in a discontinuous fashion, when the idle mix screw was re-adjusted when at the 47° setting
  - All test points failed (high flow)

Figure 2 - Test Results (First full run)

- The idle mix screw was adjusted when at the 74° setting to reduce the flow to within the target value range (Actual of 219.82 vs target of 210.0 220.5)

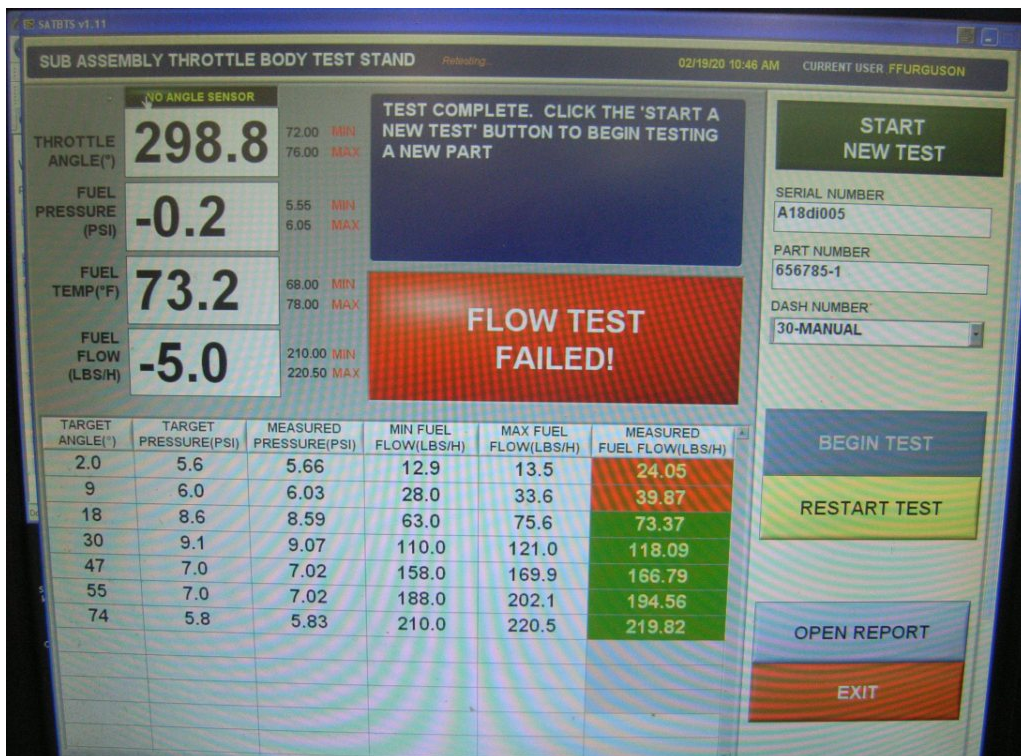
- A second flow test series, the first in this configuration, was run (Fig 5)
  - The 2° and 9 settings failed (high flow)
  - The other 5 settings passed

Figure 3 - Test Results (Second full run)

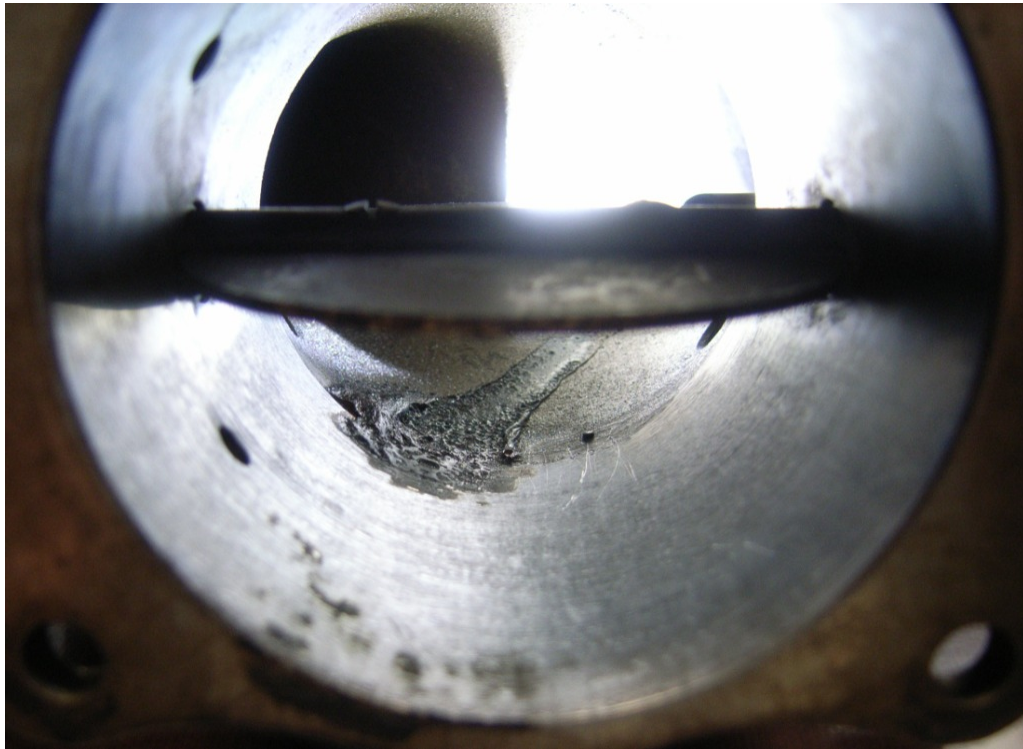
- The plastic was presumed to be a result of the post accident fire
- The throttle body with the MA was re-assembled and retested
- This third full test series was successful for all 7 throttle plate angles (Fig 7)

Figure 4 - Throttle Bore Deposits (Downstream of cleaned area)

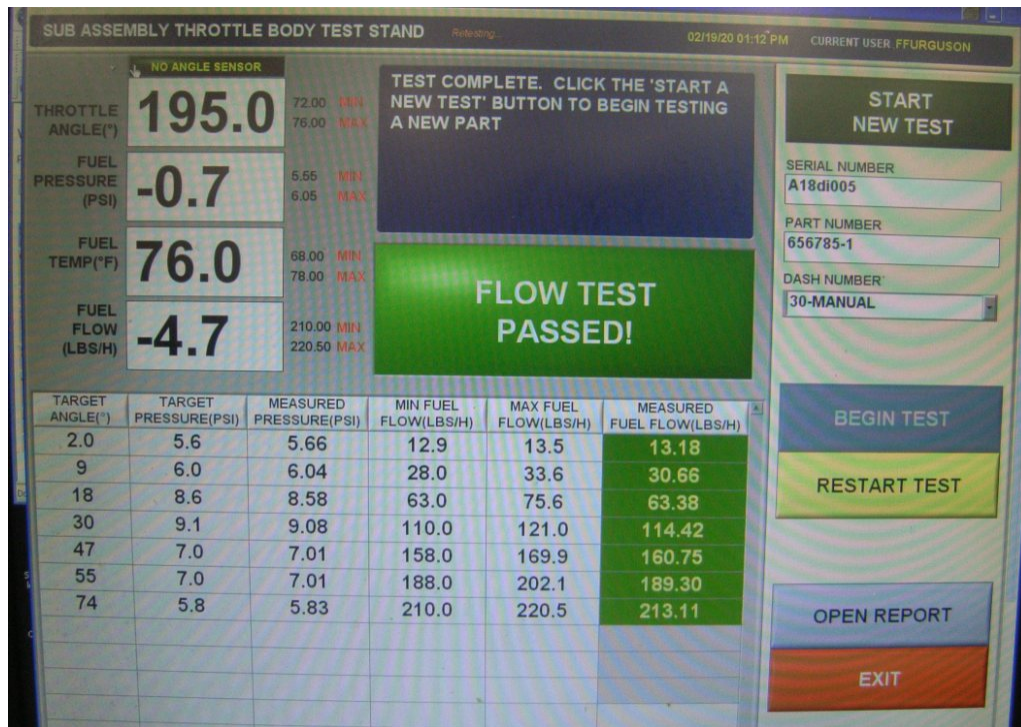
Figure 5 - Test Results (third/final full run)
