## **NATIONAL TRANSPORTATION SAFETY BOARD**

### **Accident Site and Wreckage Examination Summary**

**WPR19LA167**

Location: Deer Valley, Arizona  
Date: June 11, 2019  
Aircraft: N576CM; Mooney M20V  
NTSB Investigator-in-Charge: Andrew Swick

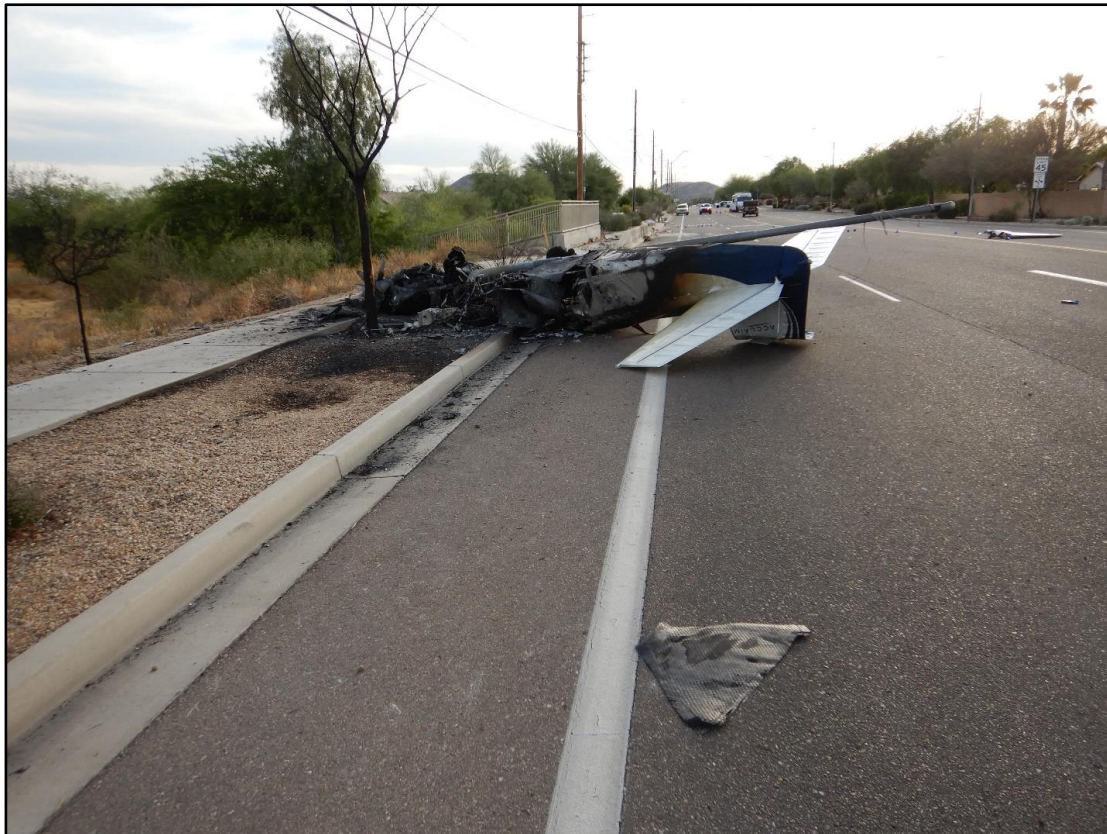
Figure 1-Accident Site, Main Wreckage (West View)

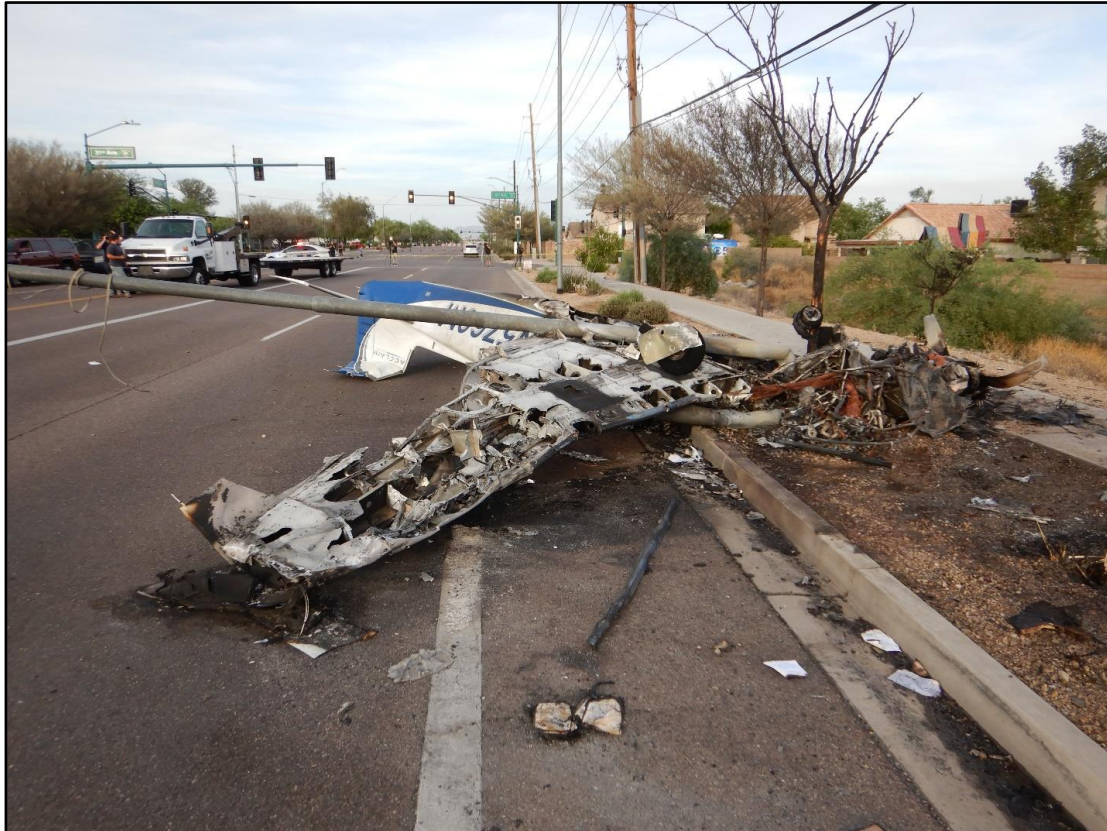
**Figure 2-Accident Site, Main Wreckage (East View)**

The first identified point of contact (FIPC) was a 30 ft tall street light pole on the south side of the eastbound street. The right wing separated from the airplane and was found in the westbound lane about halfway down (eastbound) the debris field. A second light pole about 125 ft from the FIPC, on the south side of the street, was separated from the ground and entangled with the main wreckage. The main wreckage came to rest inverted and was on the south side of the street curb, about 275 ft from the FIPC. The main wreckage had with post-crash fire damage to the cabin and left wing. The vertical stabilizer and rudder were crushed to one side. All flight controls were accounted for and flight control continuity was attained. The propeller assembly remained attached to the engine and showed some rotational signatures during impact. The engine had thermal damage to the induction tubes, fuel pump aneroid housing, oil sump, hydraulic lines and magnetos. Engine control continuity was established from the cabin controls to the engine components.

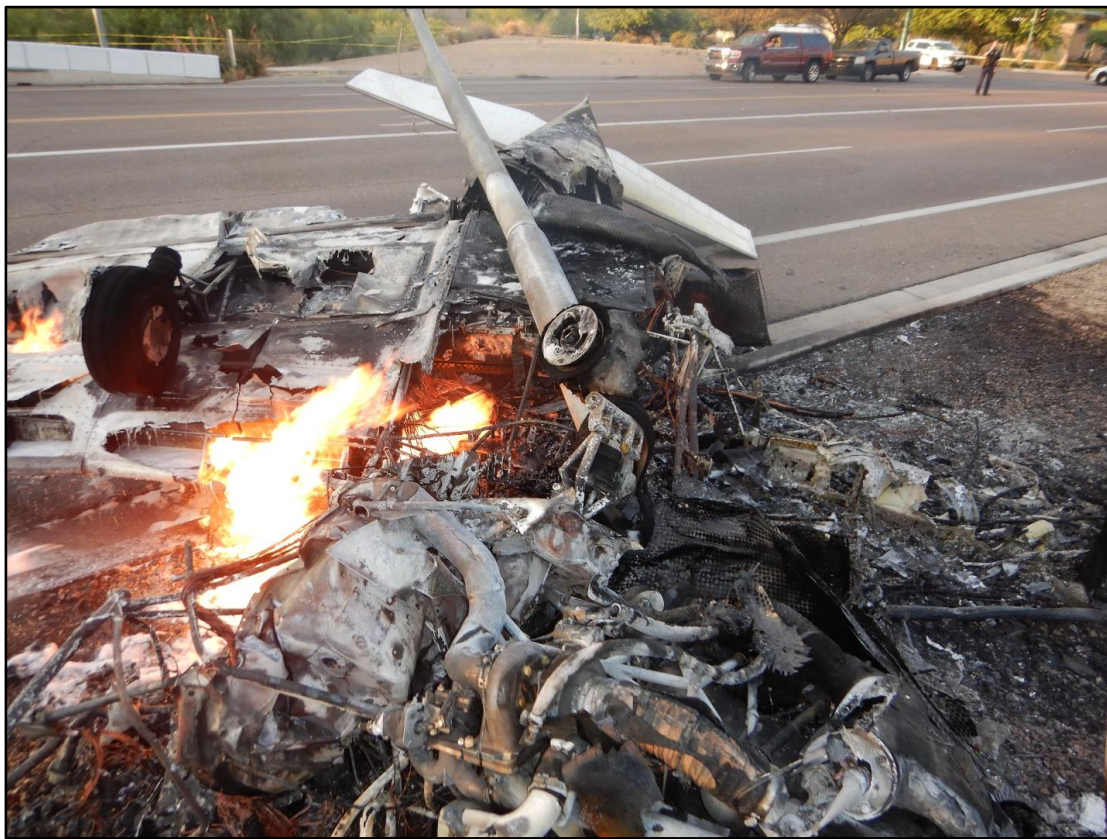
During the recovery efforts, the left wing was cut without the IIC knowing. The wing fuel tank exploded with 5 people surrounding the airplane. The saw operator had 2<sup>nd</sup> degree burns to his left arm. The fire department was called and distinguished the fire. The wing ignited two more times during the recovery process.

**Figure 3-Accident Site, Recovery Efforts**

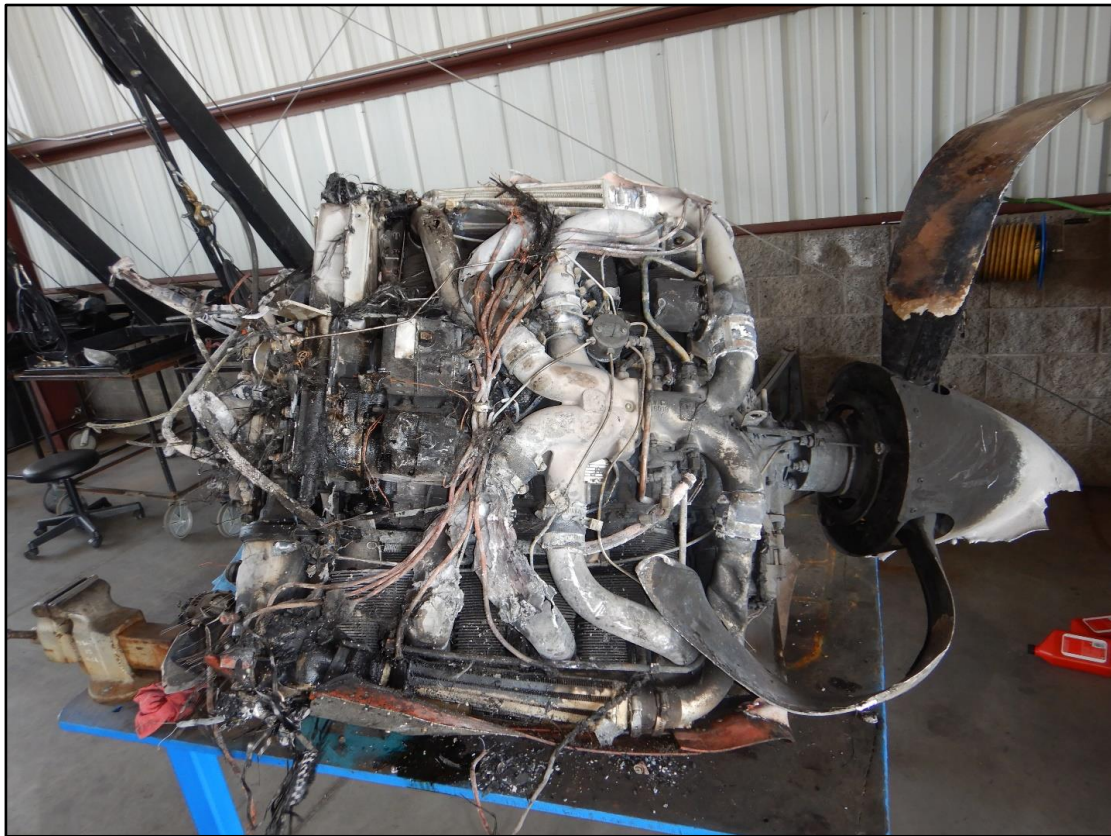
The engine was separated from the main wreckage. The left exhaust pipe was cut in preparation of shipment to the manufacturer. The controller and rear engine driven alternator were found in the main wreckage.

Figure 4-Engine Examination

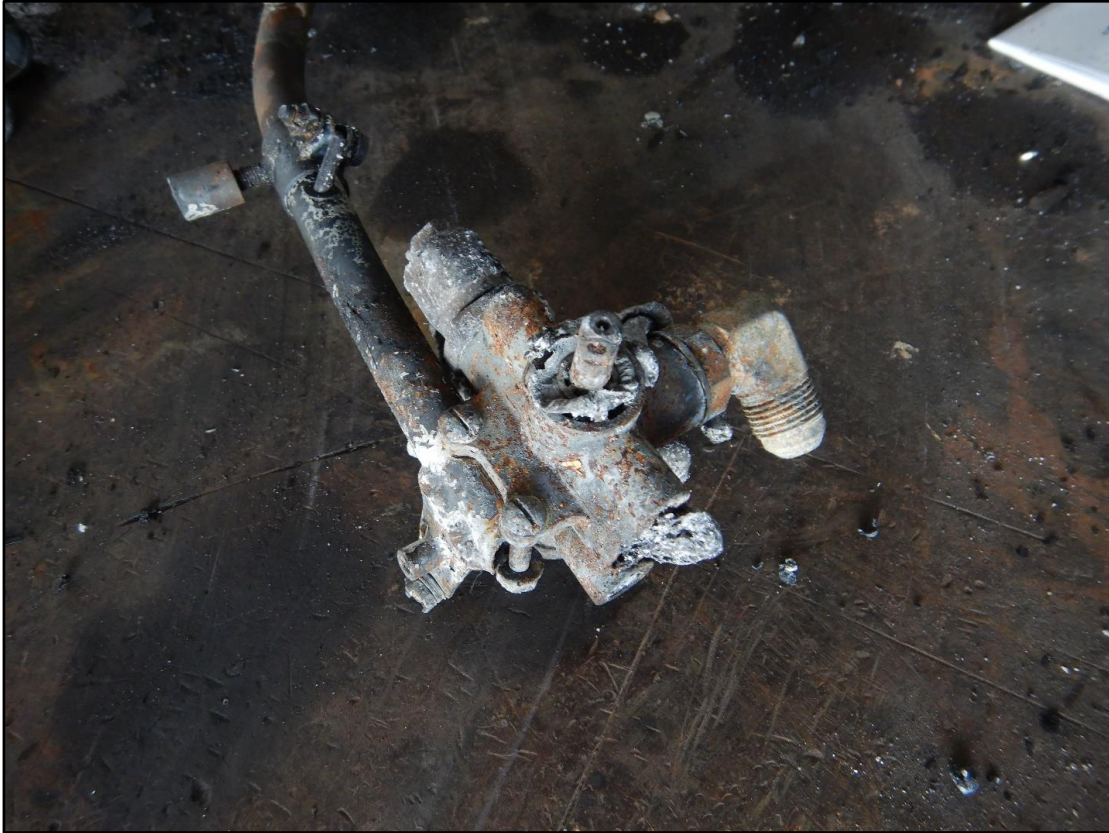
The fuel selector valve was found in the main wreckage. The fuel selector was found in an open position.

**Figure 5-Followup Examination-Fuel Selector Valve**

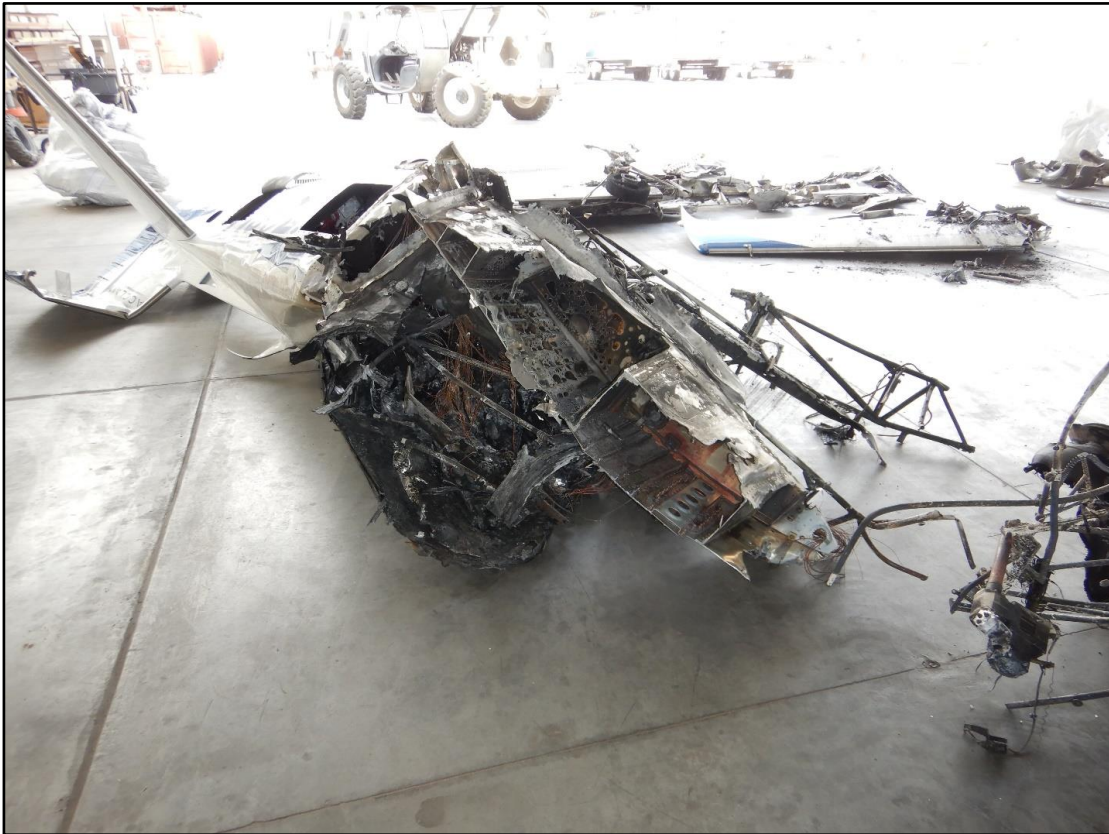
The flaps appeared to be in the up position and the landing gear was in the down and locked position. The elevator trim jack screw was photographed and it is unknown to its position. The cabin area was mostly consumed by postimpact fire. The instrument panel was not identified and the PFD and MFD were not found.

Figure 6-Followup Examination-Main Wreckage
