## **NATIONAL TRANSPORTATION SAFETY BOARD**

### **ENGINE EXAMINATION SUMMARY**

**WPR19LA167**

Location: Deer Valley, Arizona  
Date: June 11, 2019  
Aircraft: N576CM; Mooney M20V  
NTSB Investigator-in-Charge: Andrew Swick

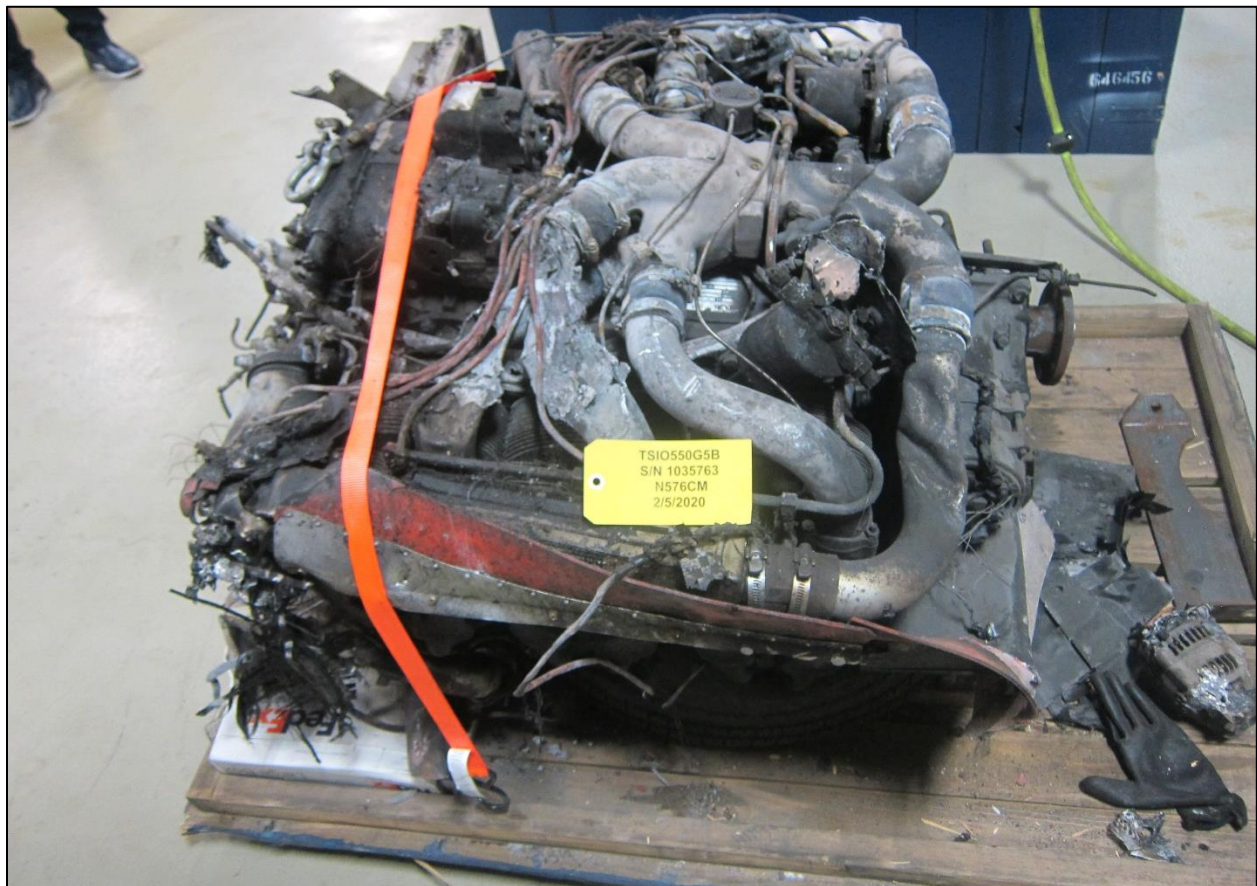
The sealed engine crate was opened on February 5, 2020, at the Analytical Department at Continental Aerospace Technologies, Mobile, Alabama. The engine support structure had impact damage and was removed from the engine.

**Figure 1-Engine assembly after crate was opened.**

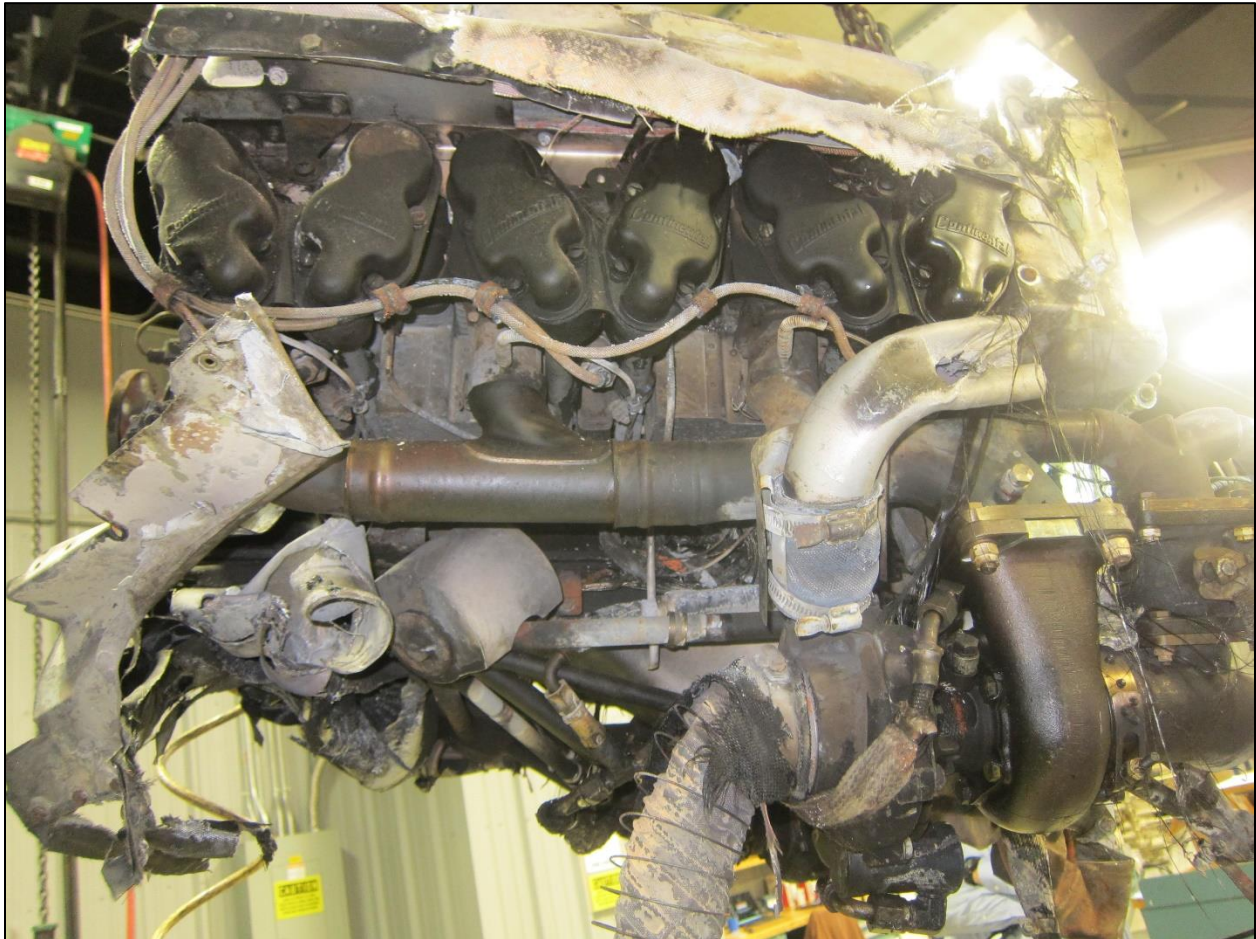
The exhaust assembly was crushed in areas near the turbochargers. The turbocharger driveshaft rotated freely by hand. The induction assembly had thermal damage to several induction tubes. The standby alternator separated from the accessory section and had thermal damage.

Figure 2-Engine assembly, left lower view.

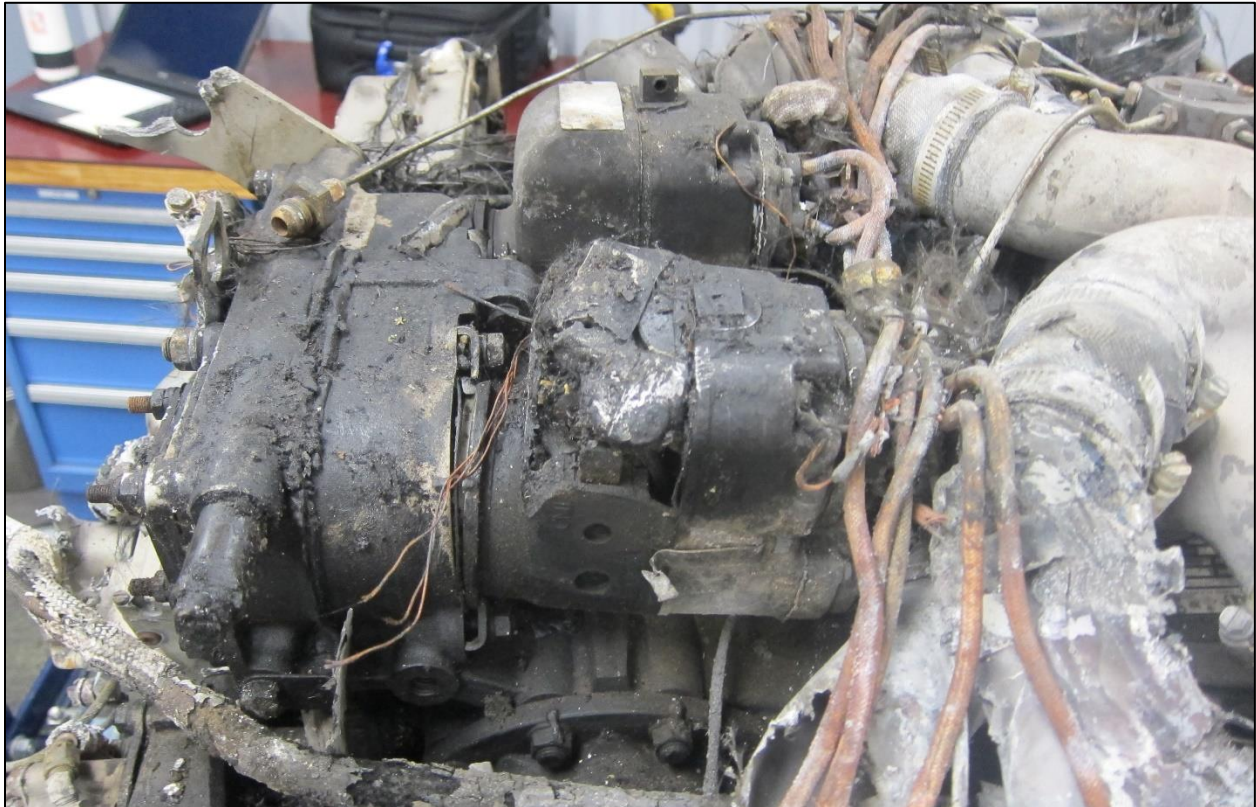
The magnetos remained attached to the engine and had thermal damage to the ignition leads. The right magneto housing had thermal damage, revealing internal surfaces. The left magneto housing had thermal discoloration and was setup on a test bench. The distributor and ignition leads were replaced, and no spark was attained. The left magneto was disassembled, revealed thermal damage to the internal components.

Figure 3-Magneto assemblies installed on the engine.

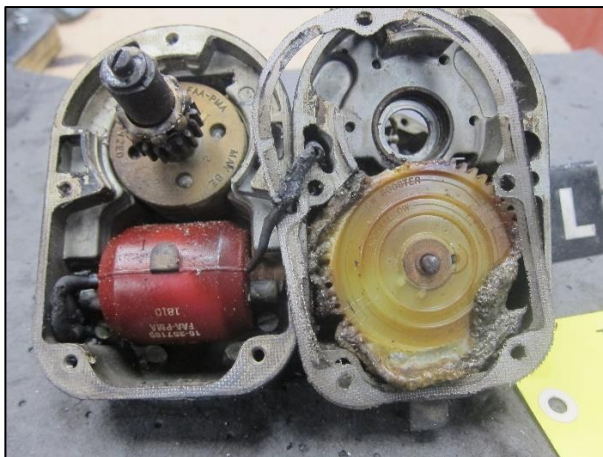
Figure 4-Left magneto disassembled.

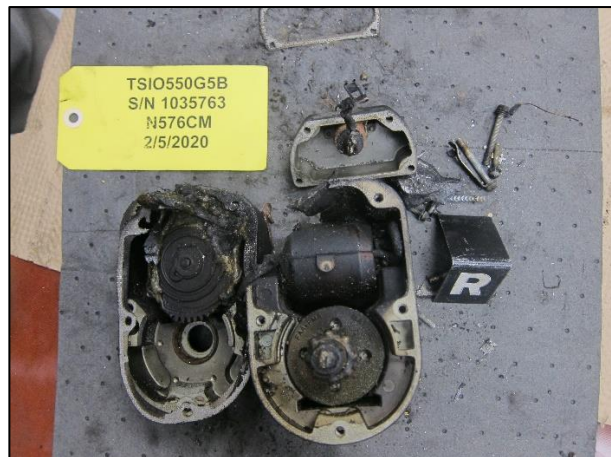
Figure 5-Right magneto disassembled.

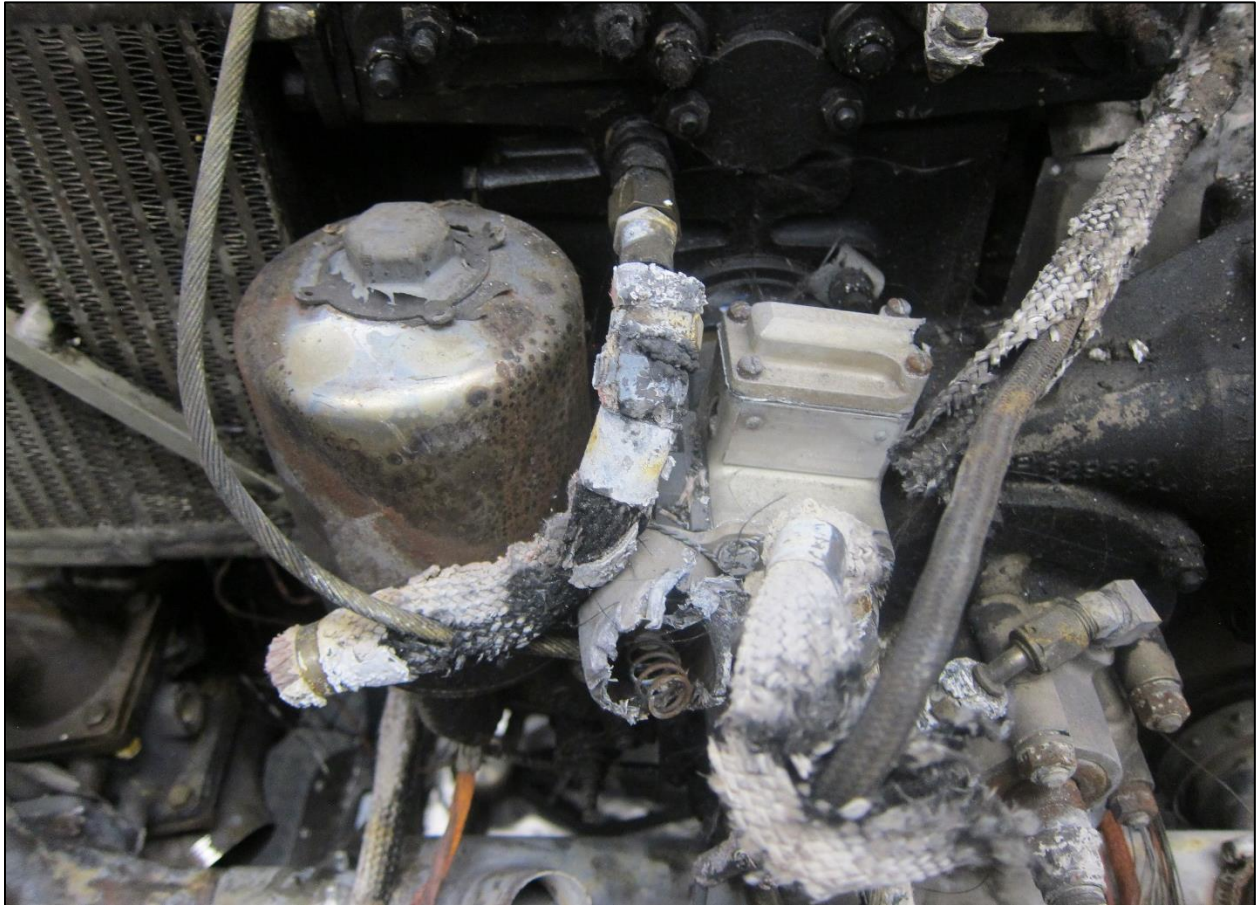
The fuel pump had thermal damage and was removed from the accessory section and disassembled. The fuel pump drive coupling was intact.

Figure 6-Engine driven fuel pump installed on the engine.

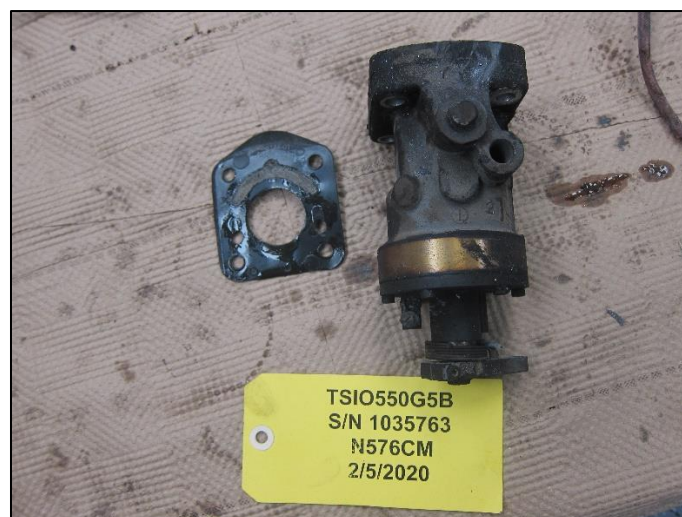
The propeller governor had thermal discoloration and was undamaged. The propeller governor was removed for the test run.

Figure 7-Propeller governor.

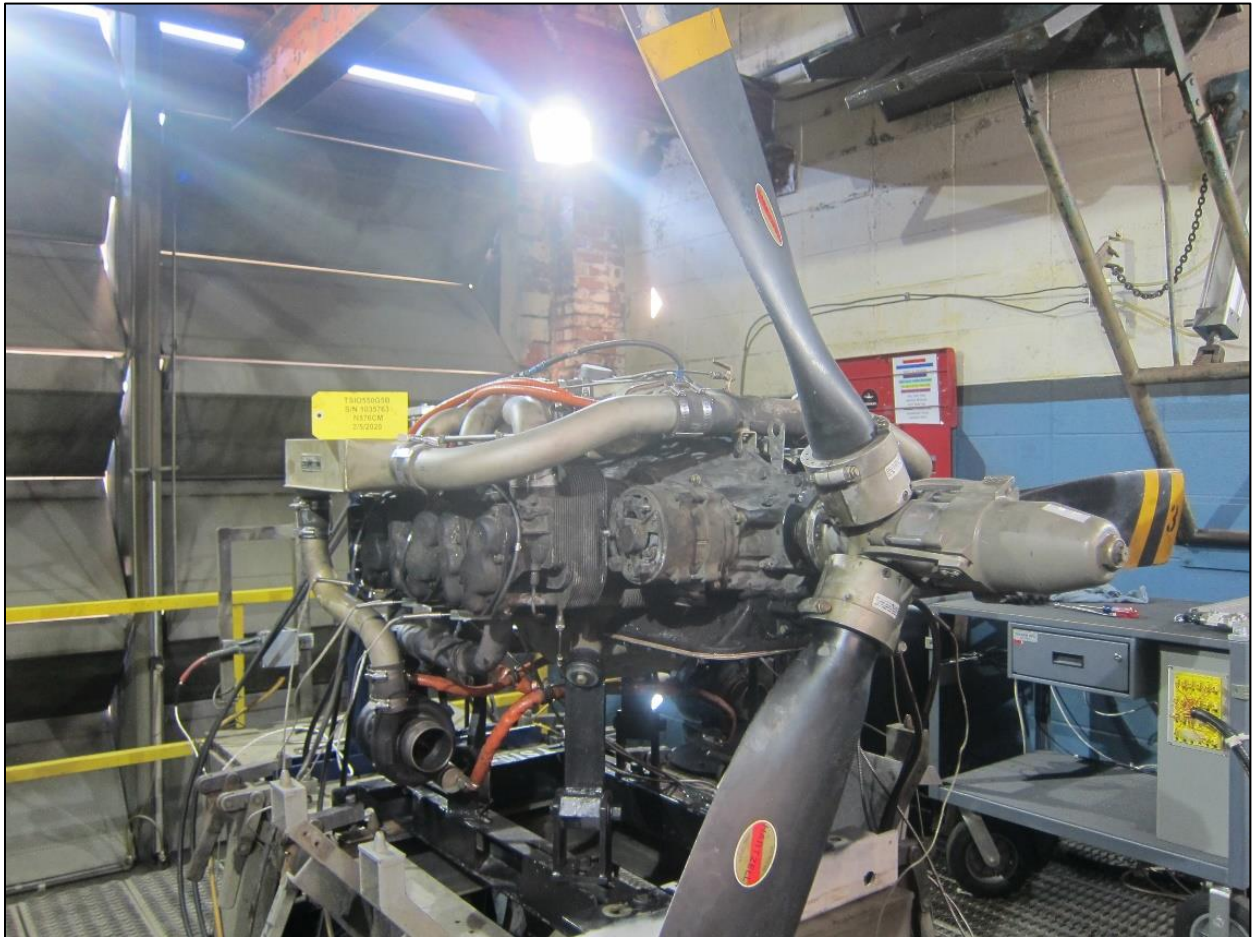
The oil sump had thermal damage and the oil sump valve separated from the sump and found in the sump area. Damaged parts were installed on the engine in preparation for the test run: exhaust assembly, induction plenum, inner coolers, oil sump, fuel pump, magnetos, ignition leads and various hydraulic lines. The engine test run resulted in a mostly successful run program, except at idle.

Due to time restraints the engine was further tested for the idle problem at a future date.

**Figure 8-Engine installed on a test stand.**
