# NATIONAL TRANSPORTATION SAFETY BOARD

## MATERIALS LABORATORY FACTUAL REPORT

Report No. 19-086

Place : Independence, Oregon  
Date : June 12, 2019  
Vehicle : Cessna 140  
NTSB No. : WPR19LA169  
Investigator : Tealeye Cornejo

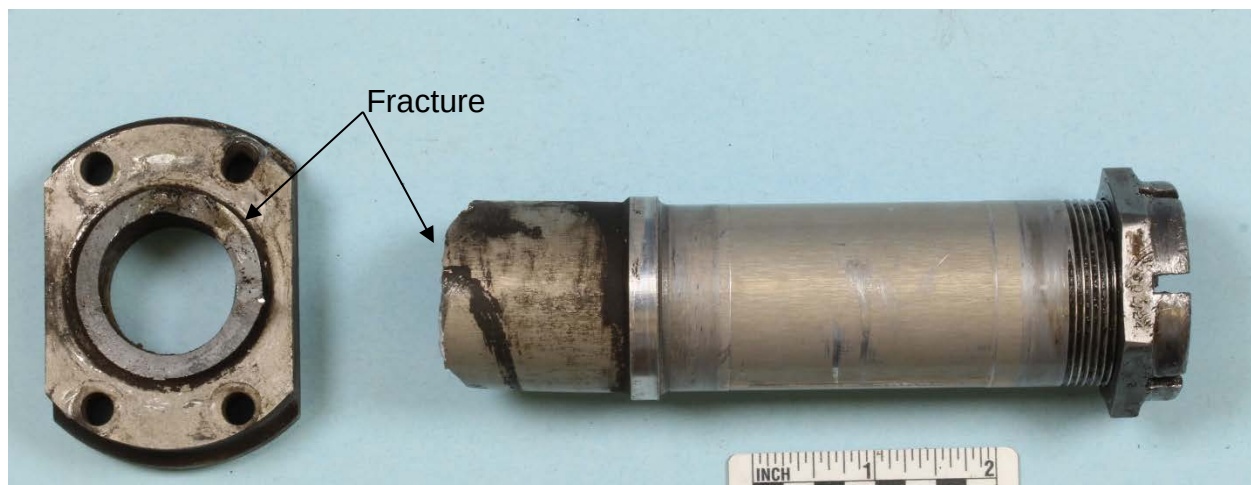
Figure 1 shows a photograph of the fractured landing gear axle assembly. The landing gear axle fractured at the transition radius between the longitudinal barrel (tube) portion and the plate portion. The plate portion was ultrasonic cleaned with Alconox, a detergent that removes iron oxide from ferrous metal. Scanning electron microscope (SEM) examination of the fractured plate portion revealed a fatigue crack emanating from multiple origins at the outer surface of the transition radius, in the area indicated by brackets "O" in figure 2 and bracket "O" in figure 3. The multiple origin fatigue crack extended approximately 0.7 inch circumferentially around the outer surface of the transition radius, and approximately 0.02 inch below the outer surface. Figure 4 shows typical fatigue striations within the fatigue crack region. The fatigue crack terminated in the general area indicated by a dashed line in figures 2 and 3. The fracture features outside of the fatigue region showed micro-void coalescence fracture features typical of overstress separation.

Figure 1. Fractured landing gear axle assembly.

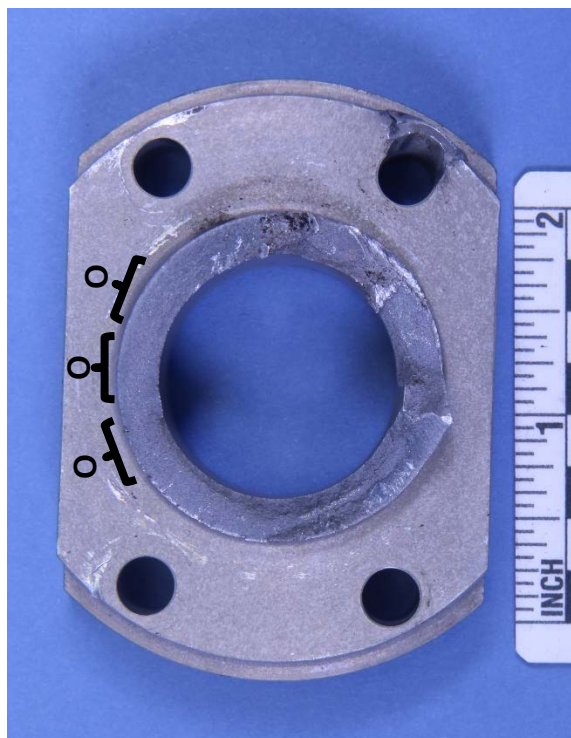
Figure 2. Overall view of one half of the fracture face (plate portion side) showing a fatigue crack that emanated from multiple origins at the outer surface of the transition radius between the flat plate portion and the longitudinal barrel portion, in the area indicated by brackets "O".

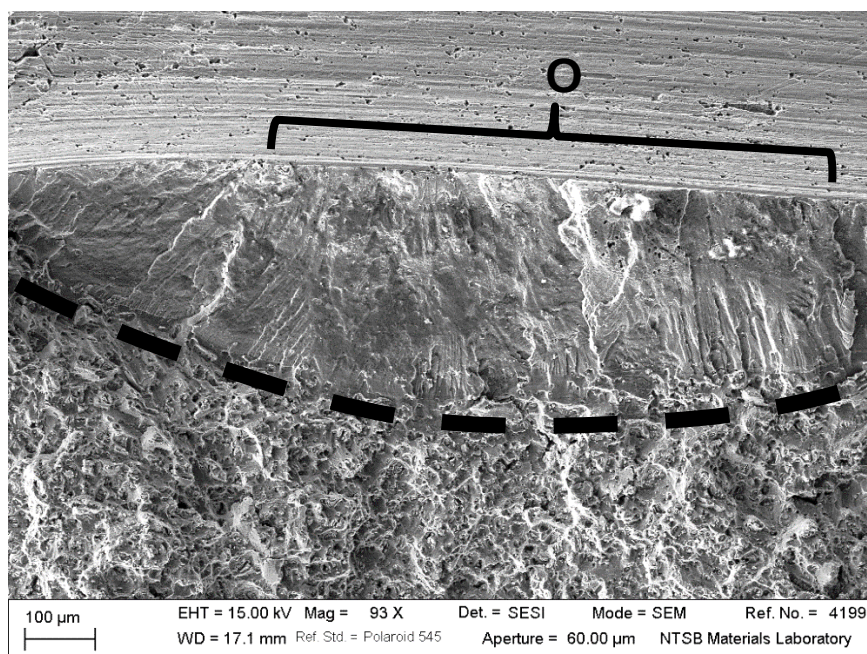
Figure 3. SEM photograph of a portion of the multiple origin fatigue crack that emanated from the outer surface of the axle at the transition radius in the area indicated by bracket "O". The fatigue crack extended to the general area indicated by a dashed line.

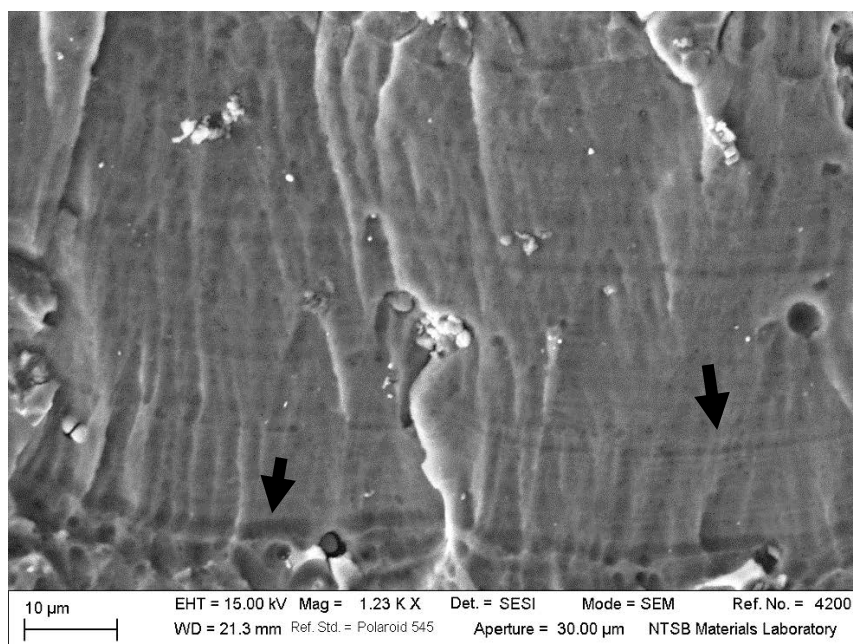
Figure 4. SEM photograph of typical fatigue striations that were found within the fatigue crack region. Fatigue crack propagating was in the general direction indicated by the arrows.
