## **NATIONAL TRANSPORTATION SAFETY BOARD**

### **AIRFRAME / ENGINE EXAMINATION SUMMARY**

**WPR19LA174**

Location: Upland, California  
Date: June 15, 2019  
Aircraft: Cessna 182M, N777RK  
NTSB Investigator-in-Charge: Joshua Cawthra

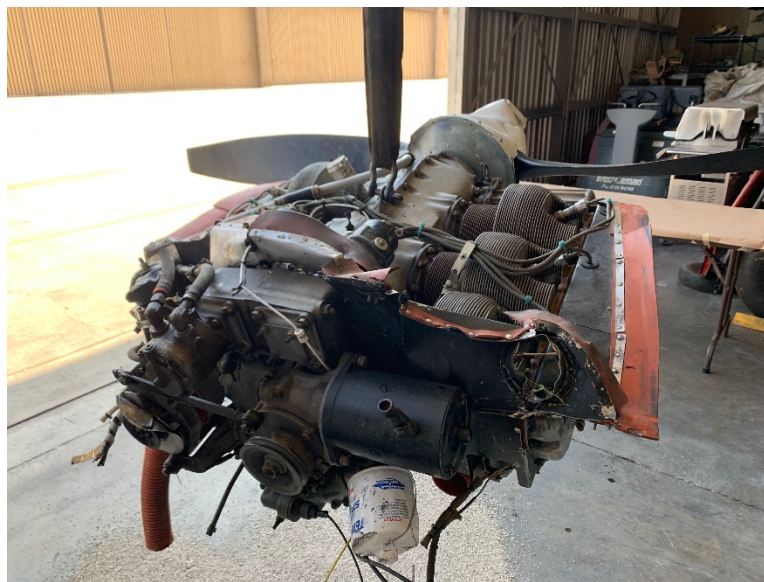
**Figure 1: View of the recovered engine.**

The upper spark plugs were removed, and the propeller was removed. The carburetor was separated from its mount. The induction and exhaust systems were impact damaged.

The crankshaft was rotated using a hand tool attached to the accessory drive pad. Rotational continuity was established throughout the engine and valve train. Thumb compression was obtained on all cylinders with the exception of cylinder number 2. Spark was produced on all six ignition leads when the crankshaft was rotated.

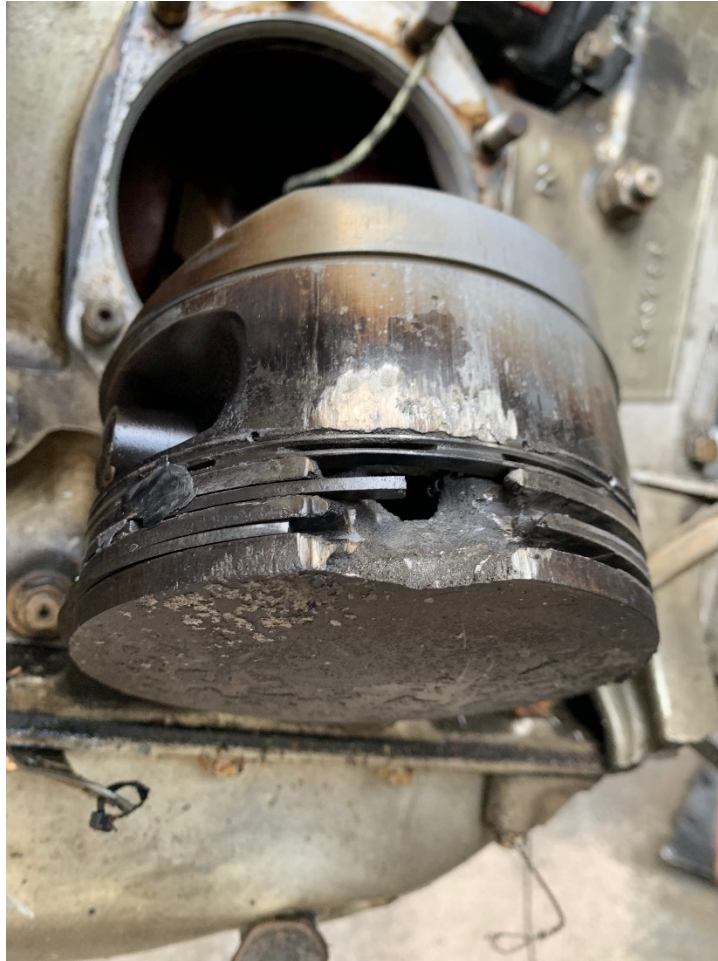
The number 2 cylinder was examined internally using a lighted borescope. The upper portion of the piston appeared to have fractured away. The number 2 cylinder was removed. The upper (top) portion of the piston face and all three upper compression rings were damaged. Scuffing was observed throughout the sides of the piston.

**Figure 2: Cylinder No. 2 Piston**

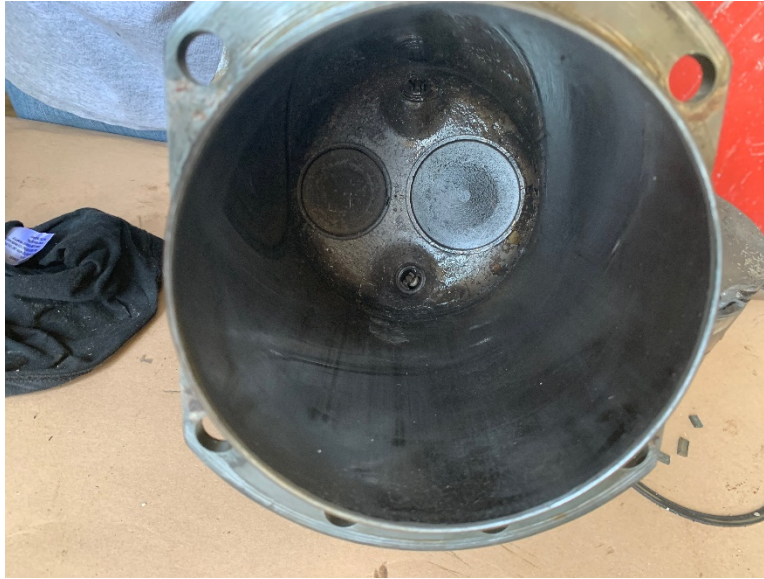
**Figure 3: Cylinder No. 2**
