## RECORD OF MEMORANDUM

**NTSB Accident Number: WPR19LA180**  
**Aircraft Registration & Make/Model: N786N; Piper PA-28R-200**  
**Accident Location: Chandler, Arizona**  
**Accident Date: June 28, 2019**

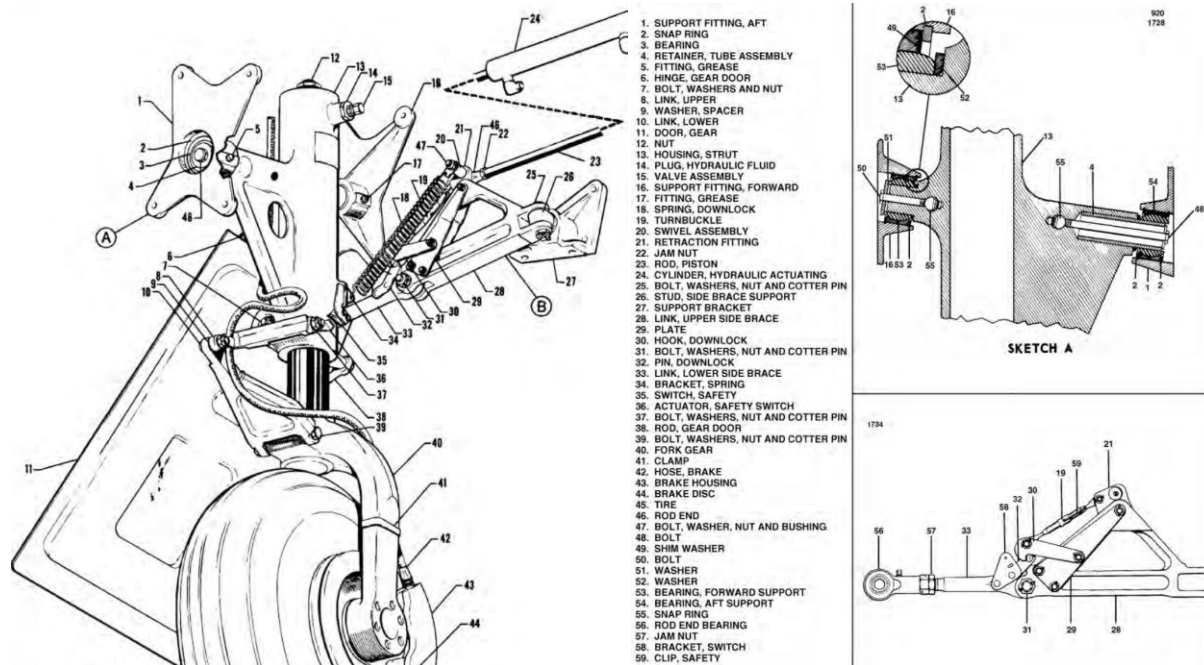
The left landing gear was partially extended. The strut and tire were coated in a substance consistent with MIL-H-5606. The truss support bracket (27) was displaced from its normal position on the wing spar; the bolts and screws were broken or bent. The nearby rib assembly was sheared from the wing spar and displaced inboard. The upper side brace link (28) displayed a smooth bend, and the paint was flaking off. The lower side brace link (33) was bent, and the down limit switch bracket (58) and downlock pin (32) were sheared away at the rivets. The actuator (24) remained extended and was still attached to the retraction bracket (21). The gear door rod (38) had been unbolted from the upper strut housing. The brake line was impact separated from the brake caliper at the nipple.

The left main landing gear tire displayed radial scuff marks. Some scuffing was observed on the wheel cap.
