**WPR19LA184**  
**On-Scene Photographs**  
(Courtesy FAA & S69 Operations)

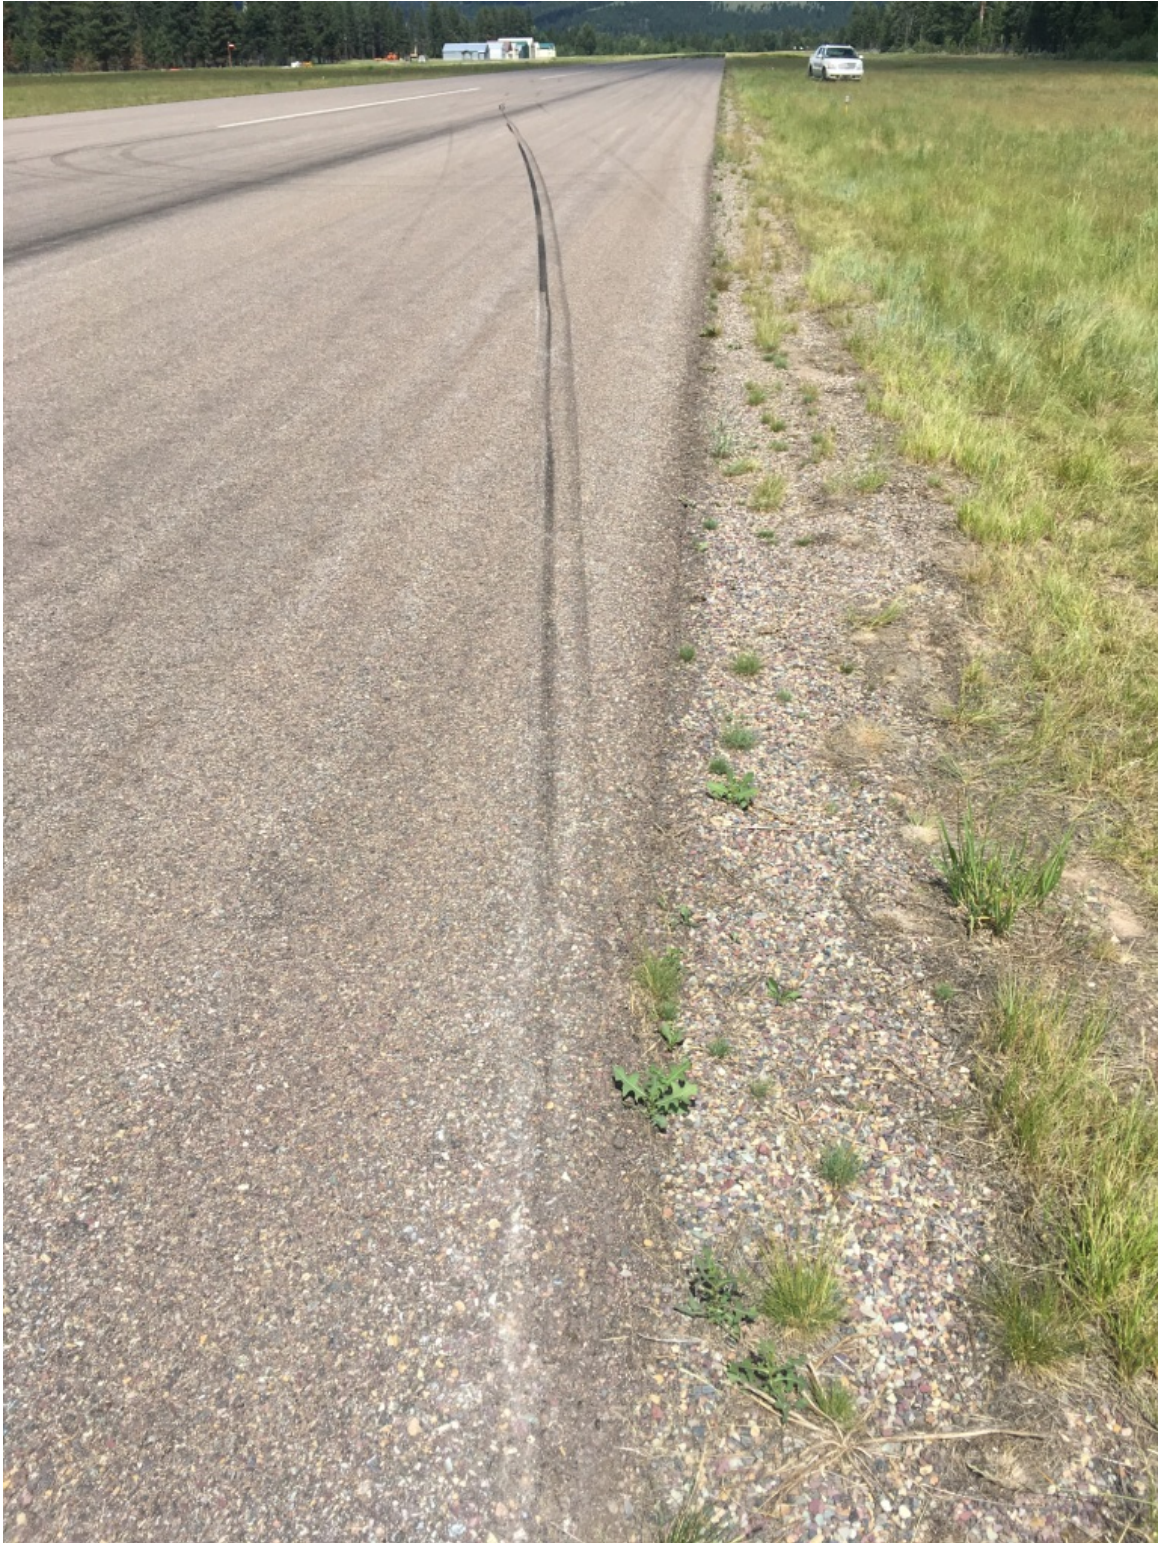
**Figure 1 - Skid Mark (view opposite travel direction)**

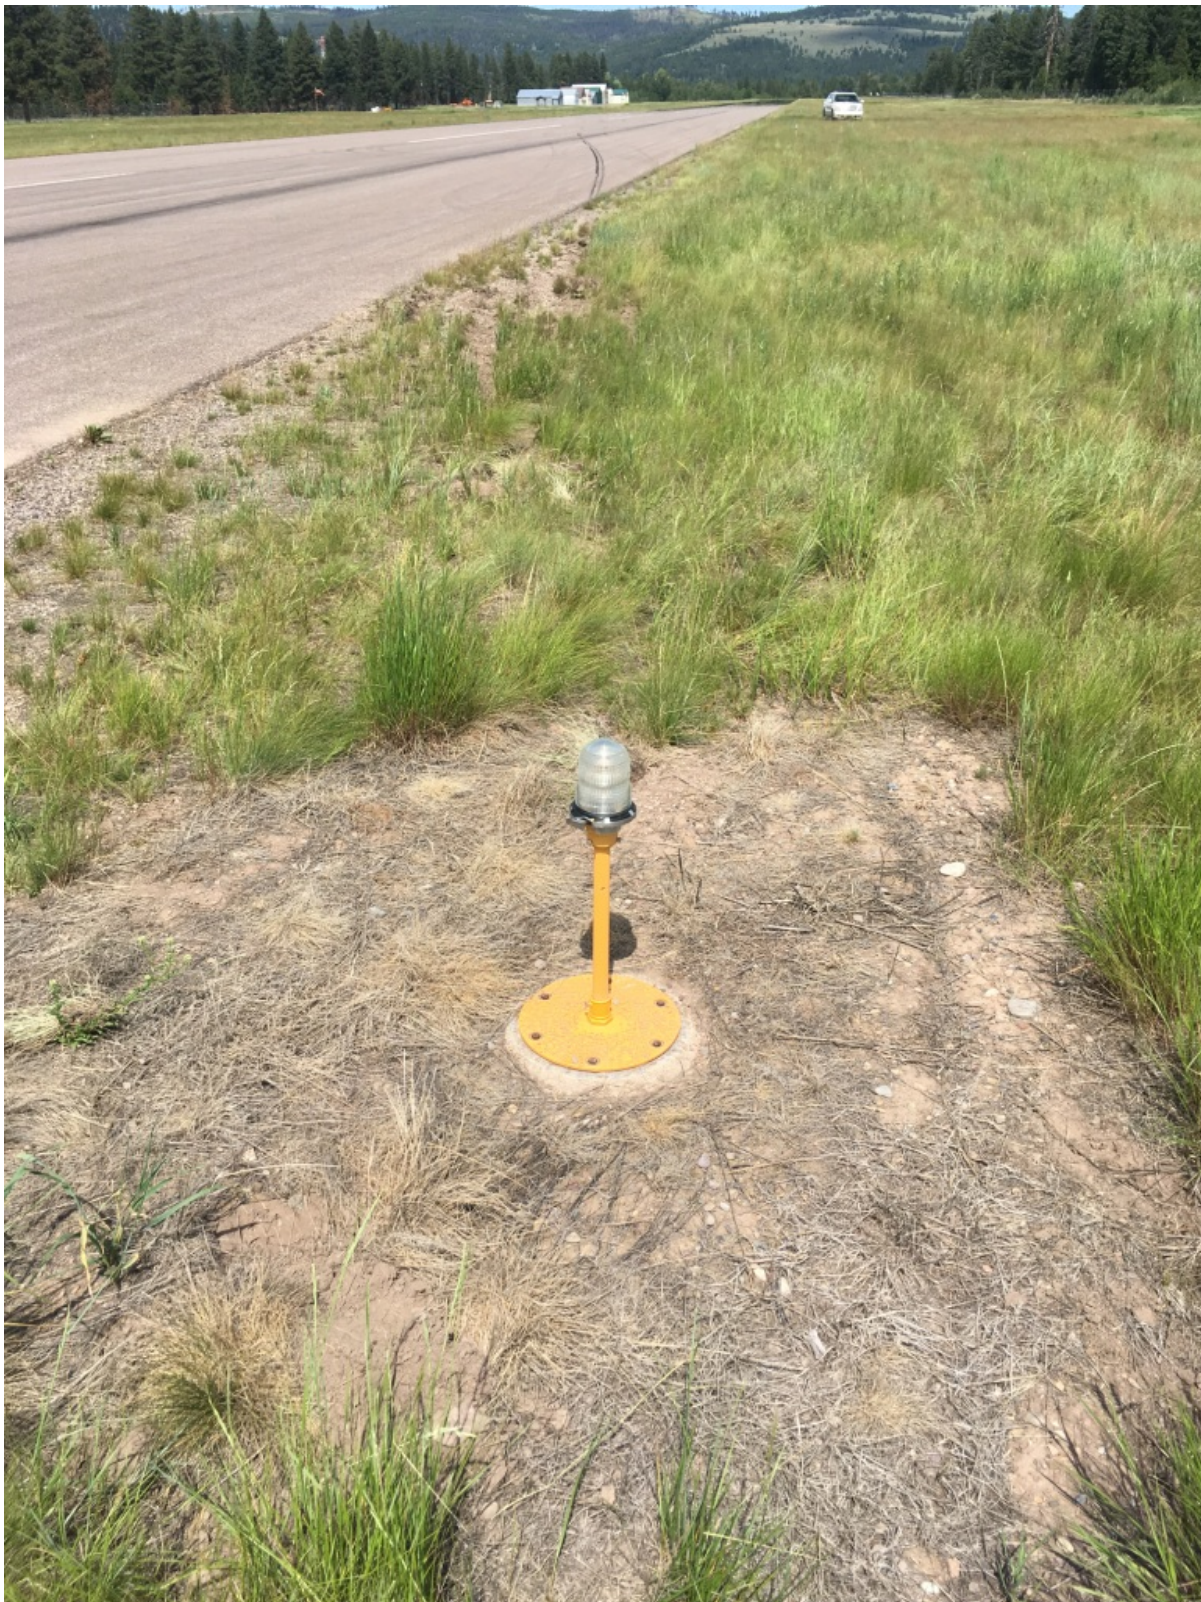
**Figure 2 - Skid Mark Onto Grass (view opposite travel direction)**

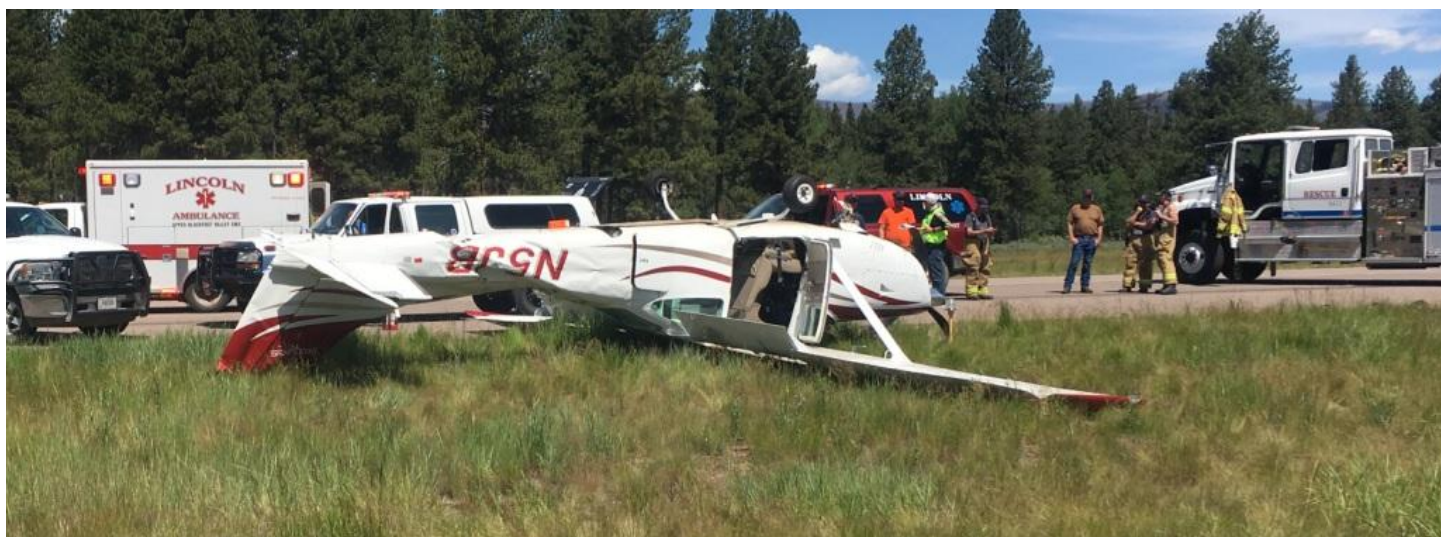
**Figure 3 - Airplane As It Came To Rest**

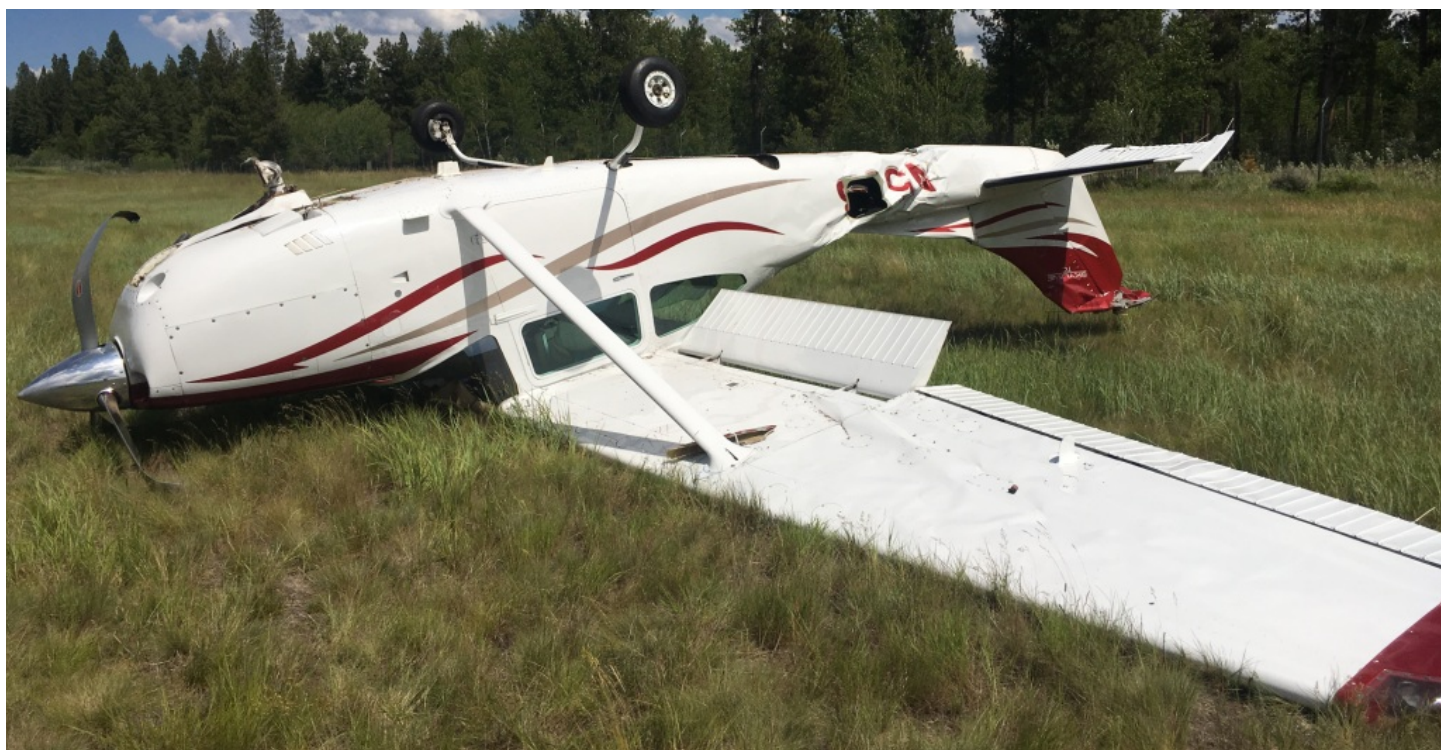
**Figure 4 - Airplane After Relocation Away From Runway**

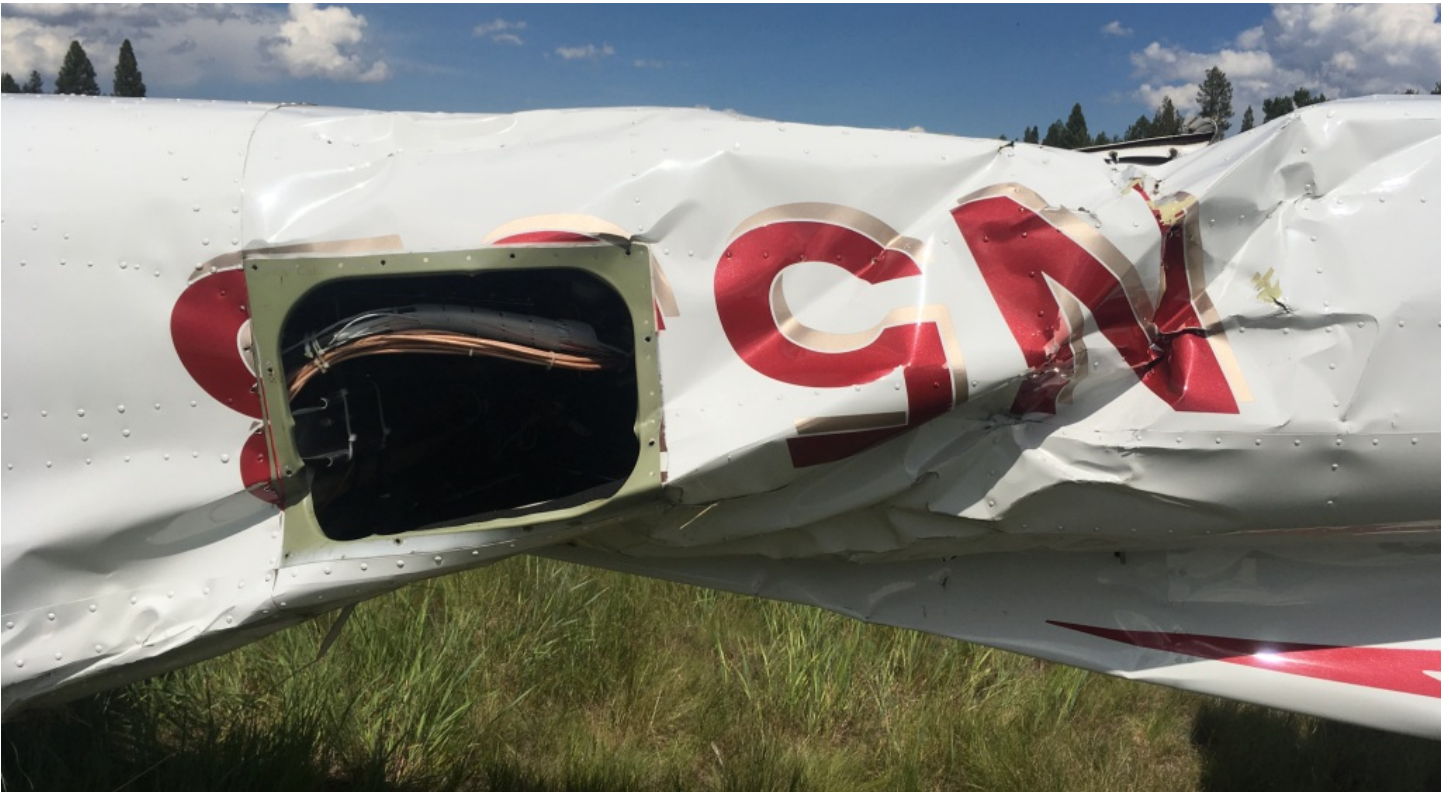
**Figure 5 - Aft Right Fuselage (ELT access panel removed)**

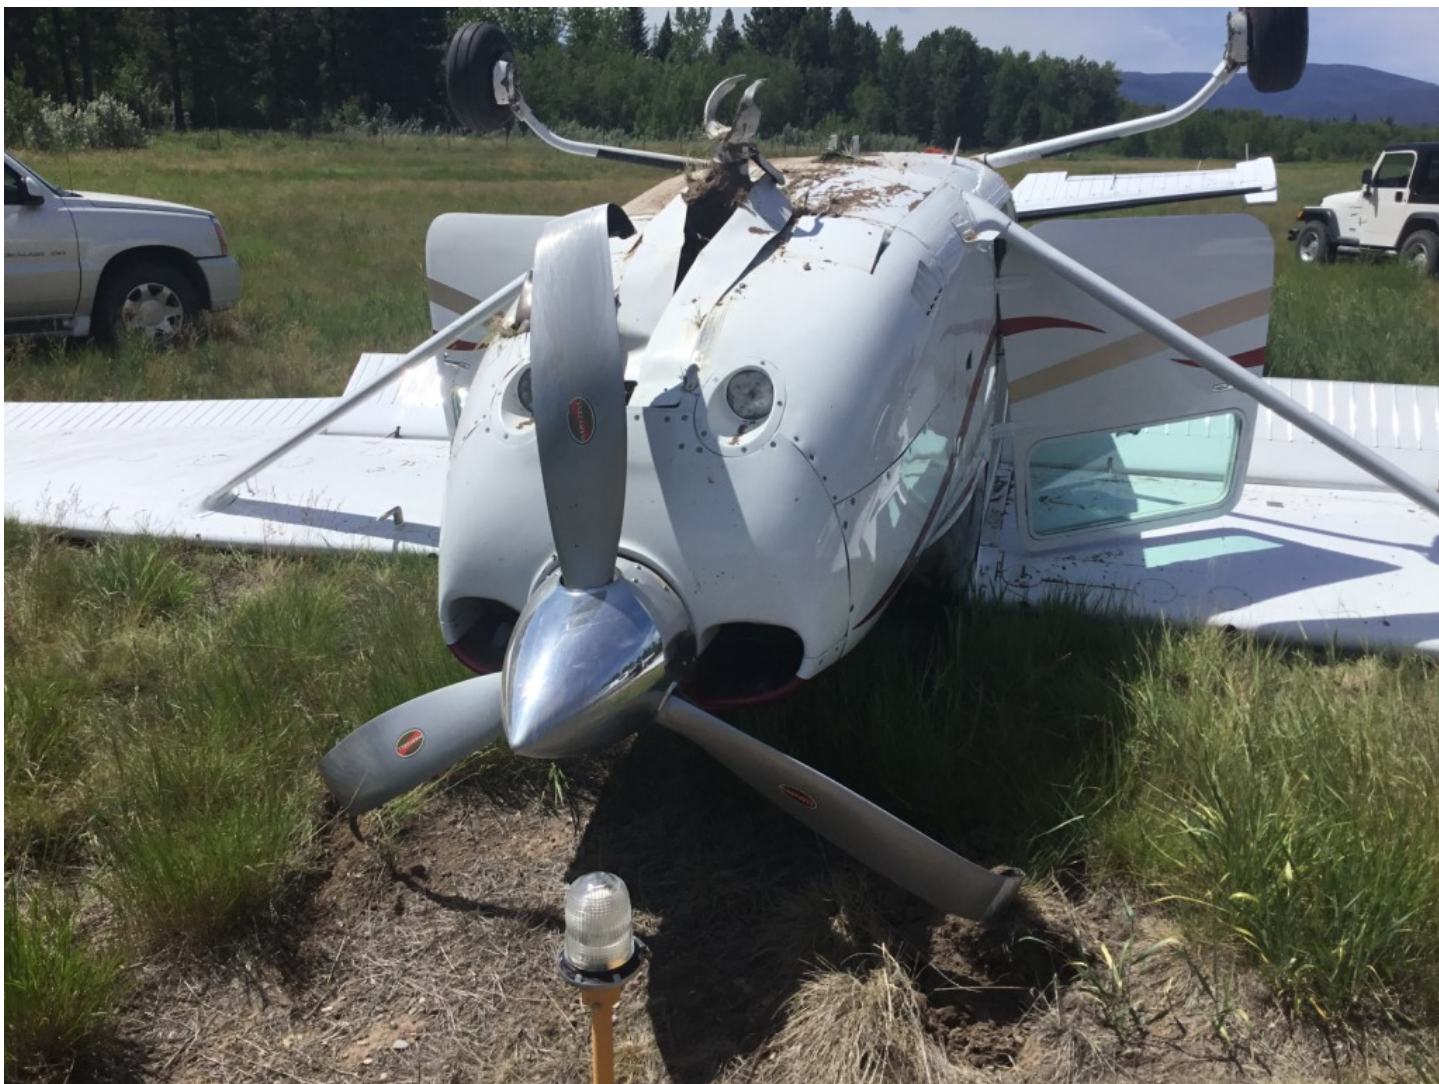
**Figure 6 - Front Right (prior to relocation)**

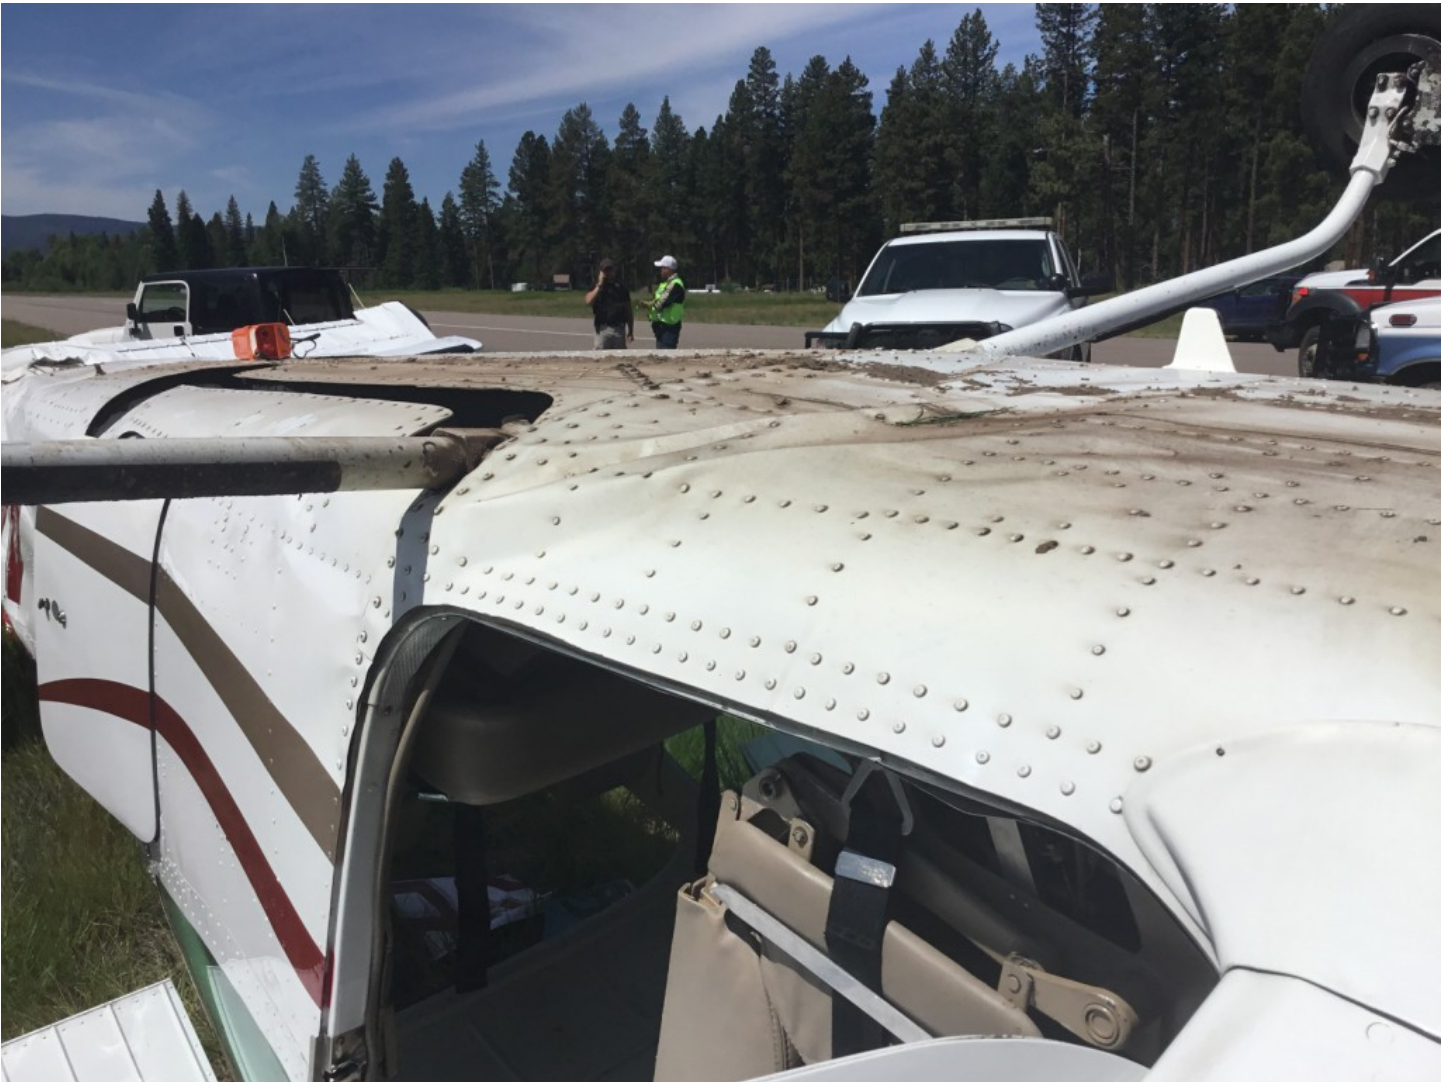
**Figure 8 - Fuselage Damage**

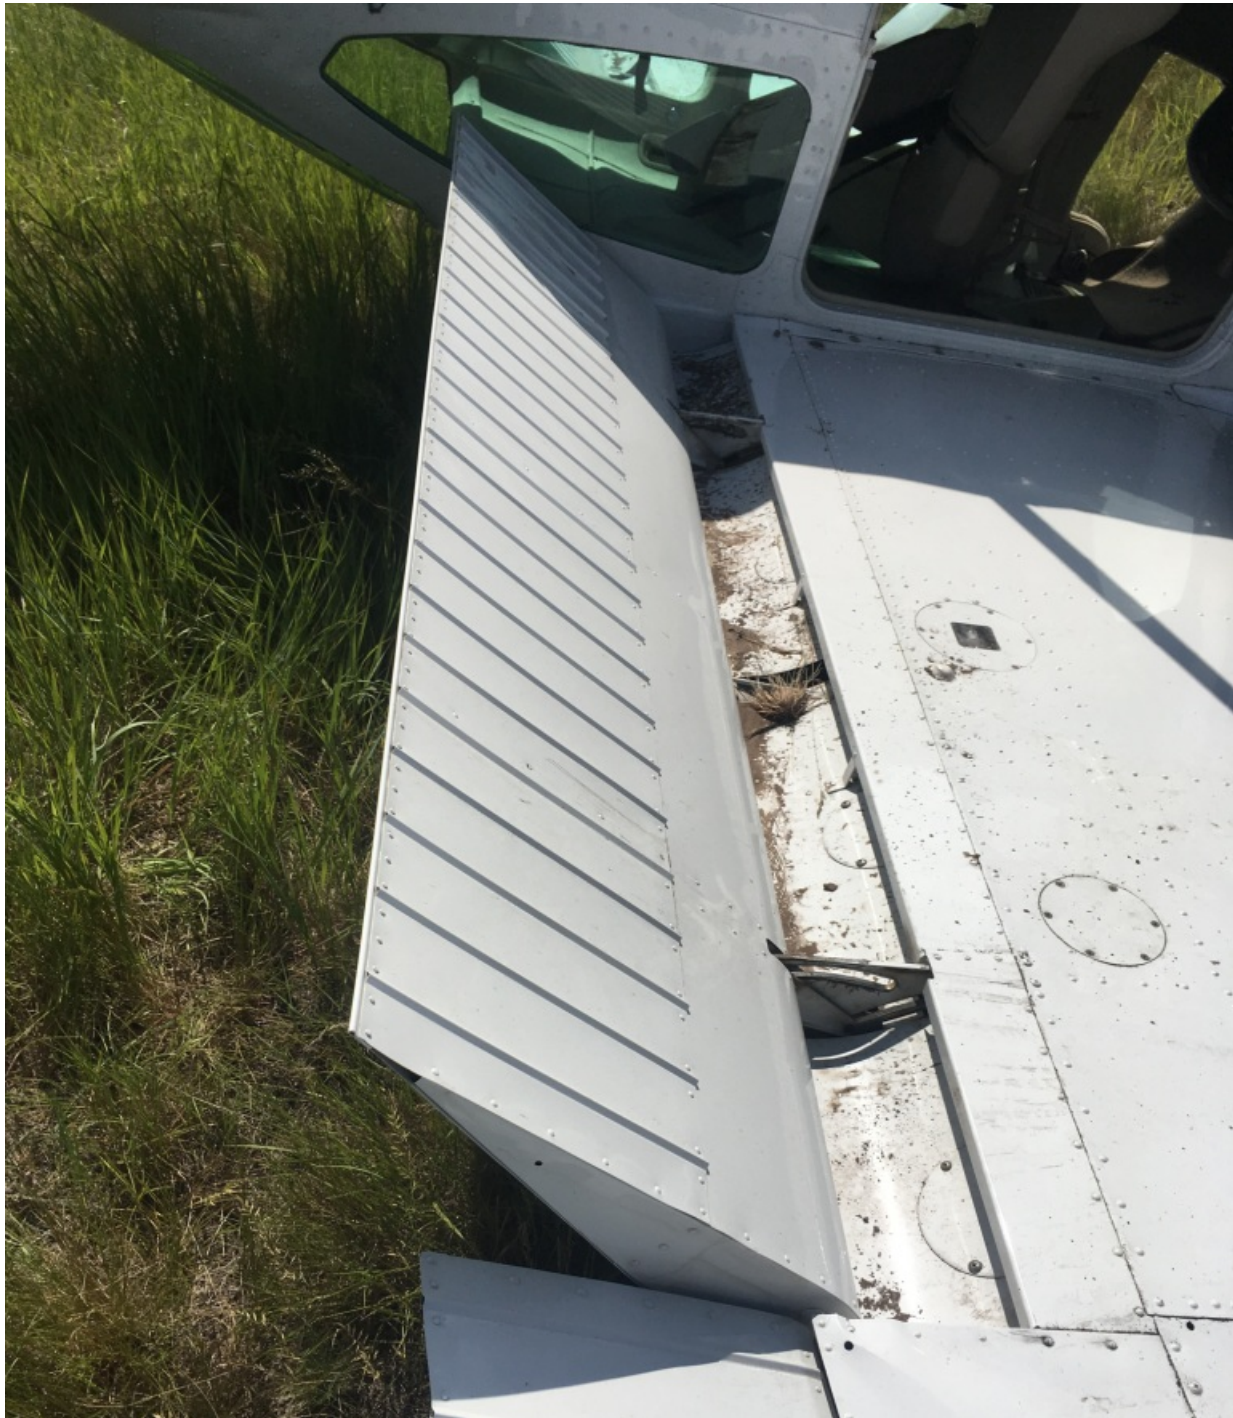
**Figure 10 - Extended Flap**
