**WPR19LA184**  
**Runway Skid Marks & Propeller Strikes (Courtesy J. Cain)**

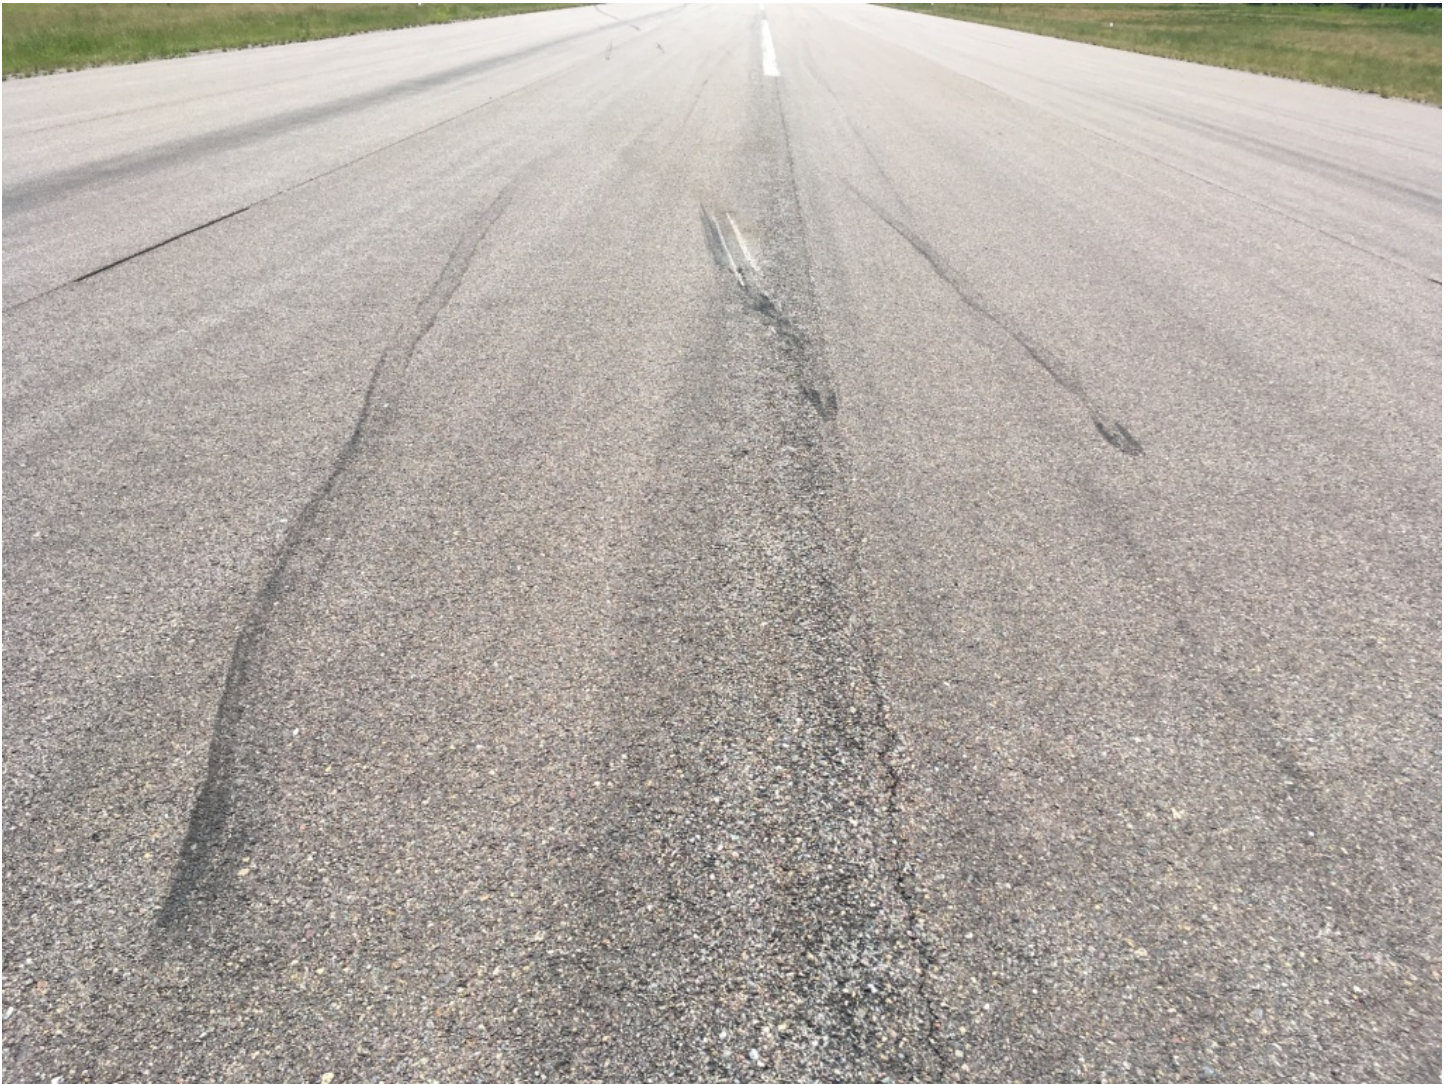
**Figure 1 - First NLG Metal Strike Scars**

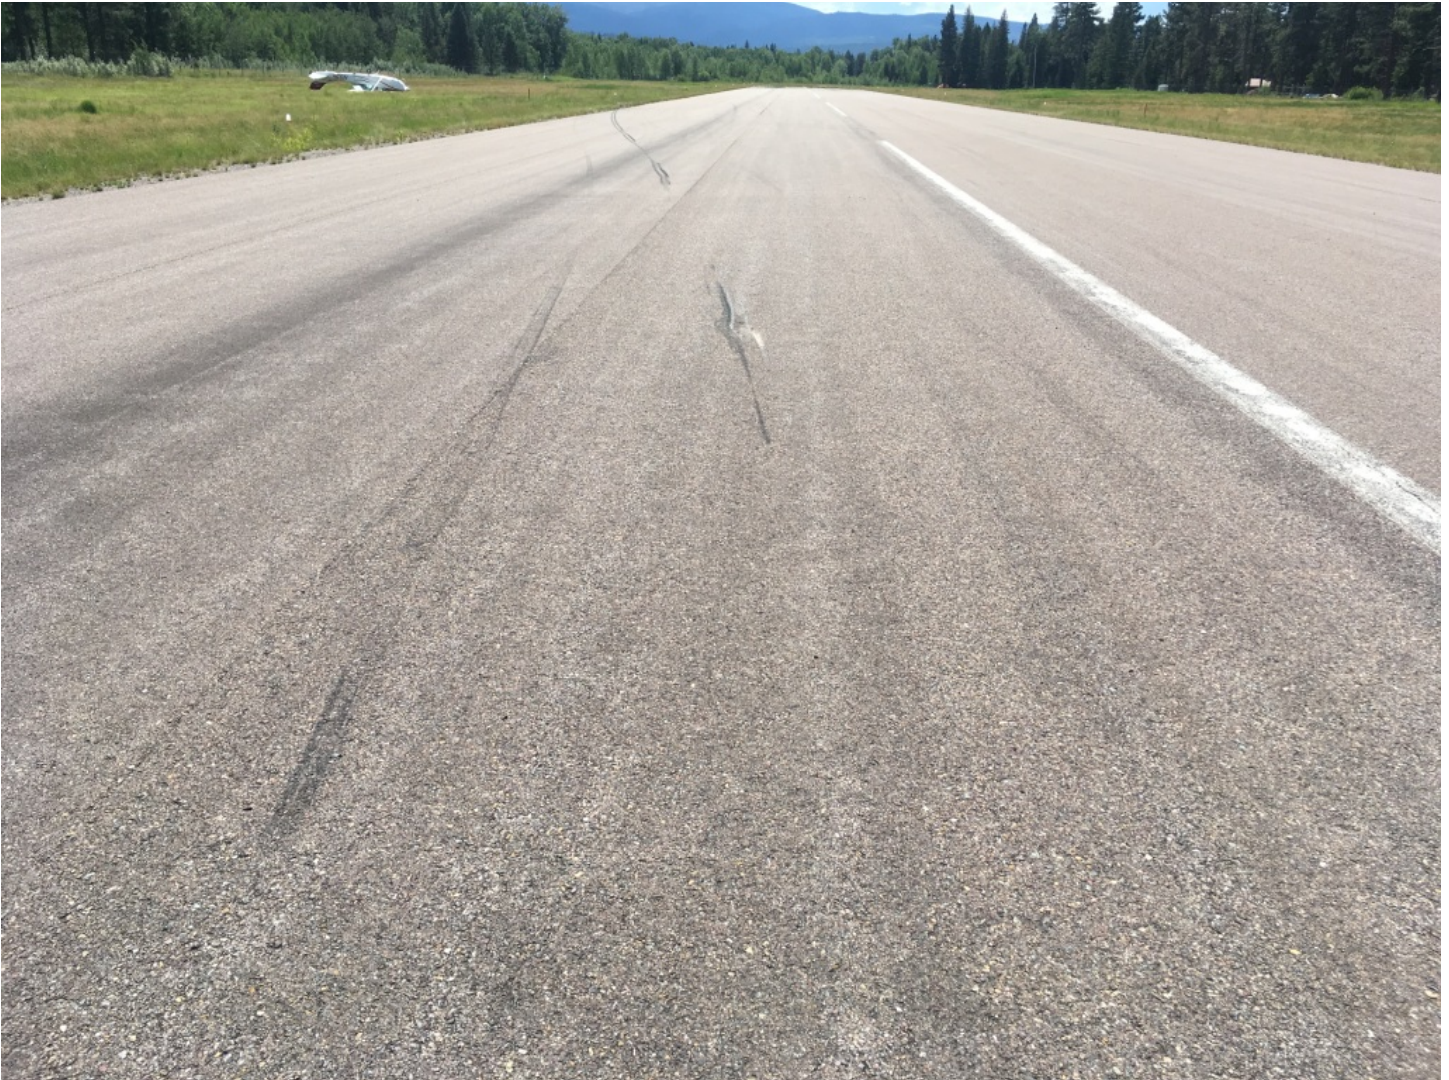
**Figure 2 – Second NLG Metal Strike Scars (NOTE: Airplane moved from original at-rest location)**

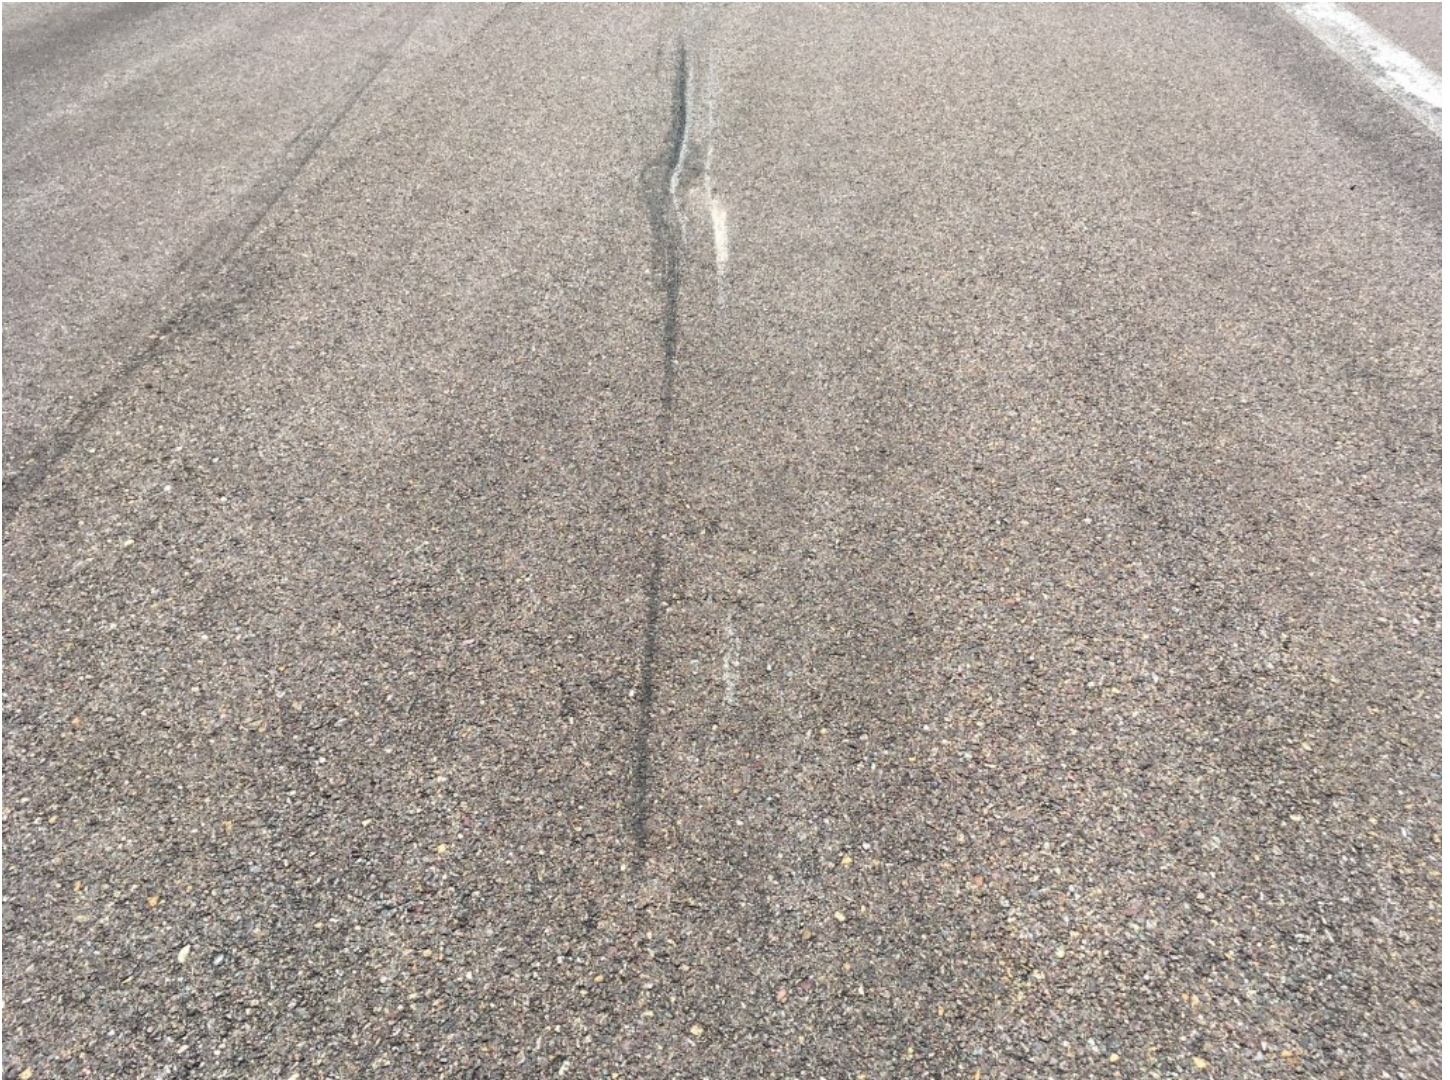
**Figure 3 – Second NLG Metal Strike Scar (close up)**

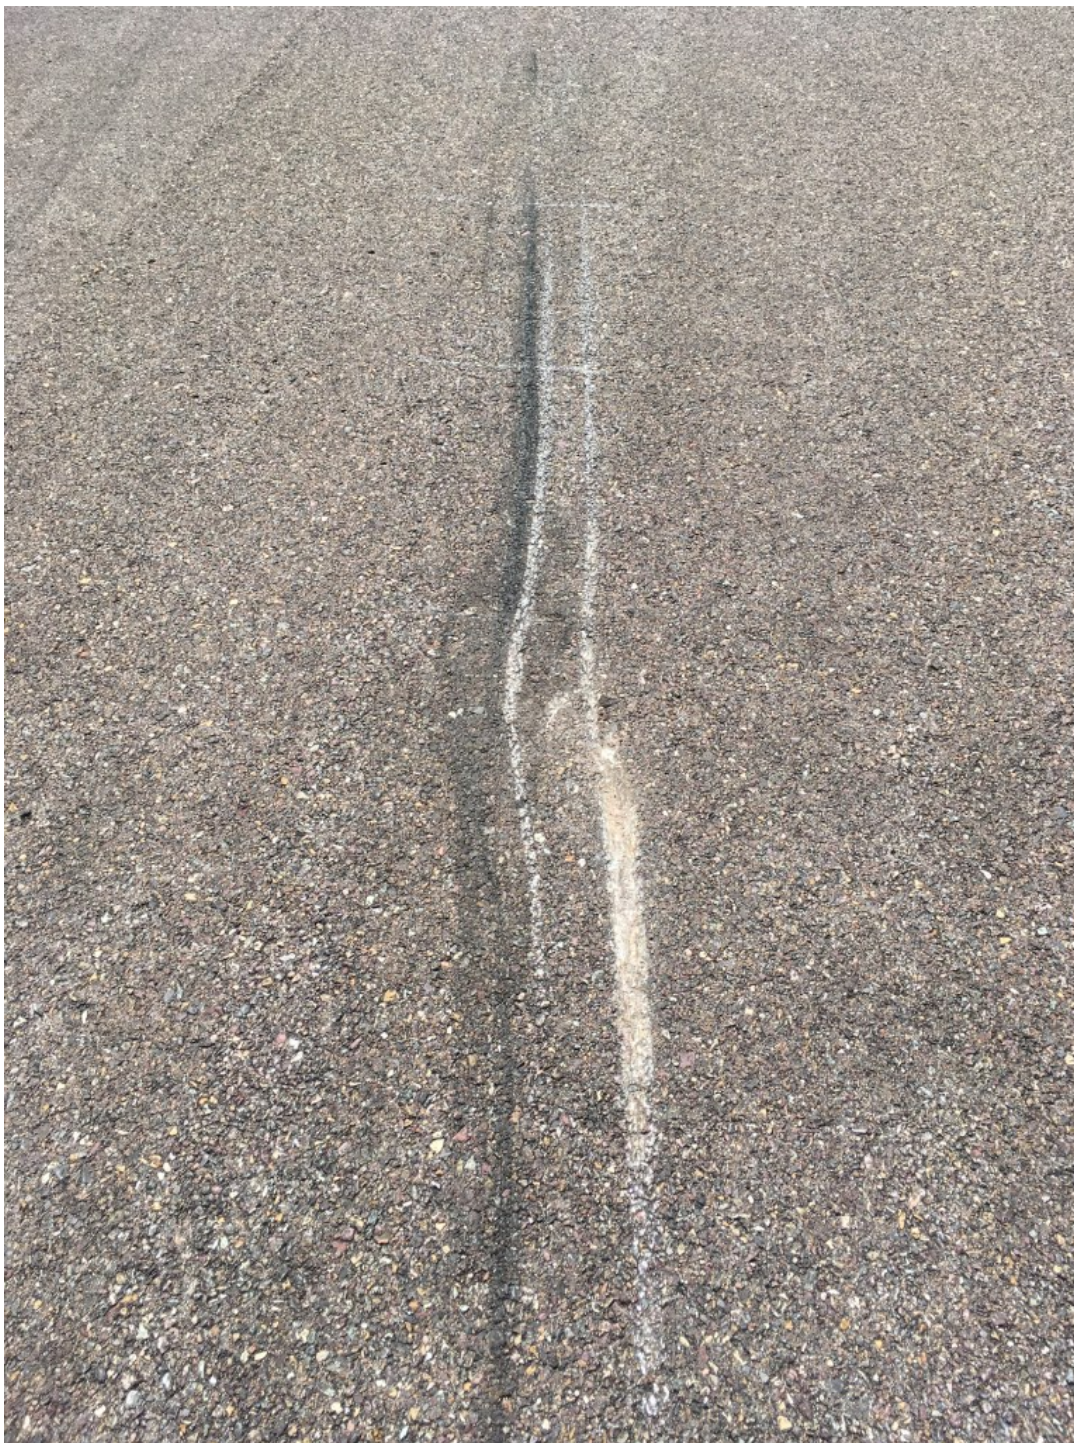
**Figure 4 - Second NLG Metal Strike Scar (Note propeller strikes)**

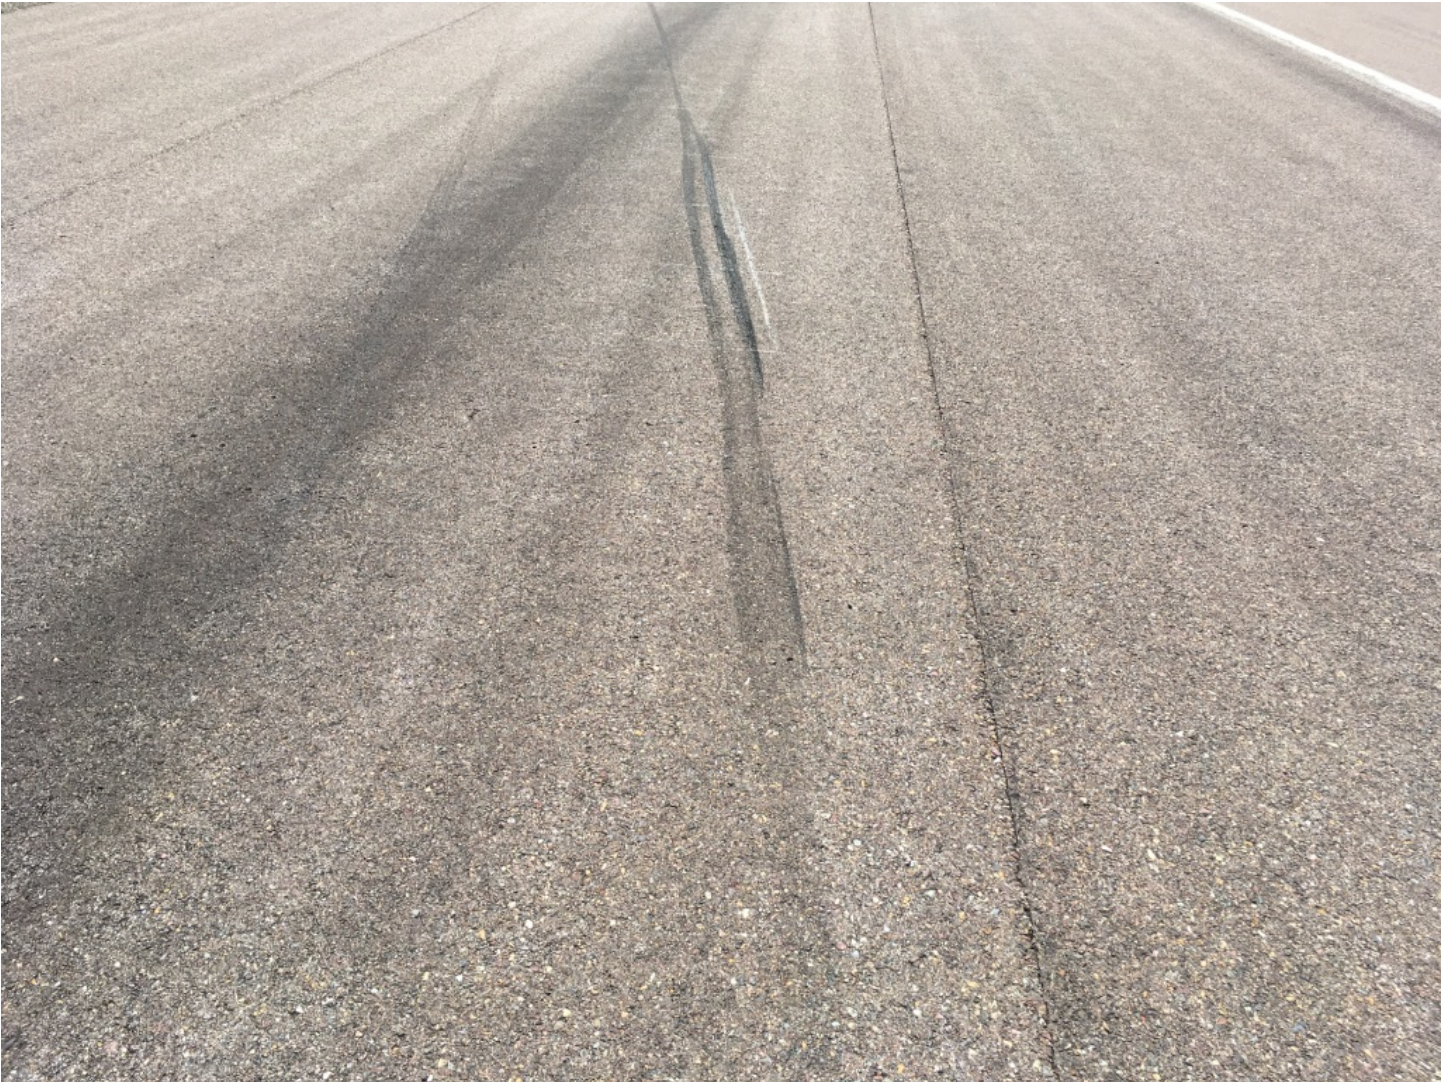
**Figure 5 – Third NLG Metal Strike Scar**

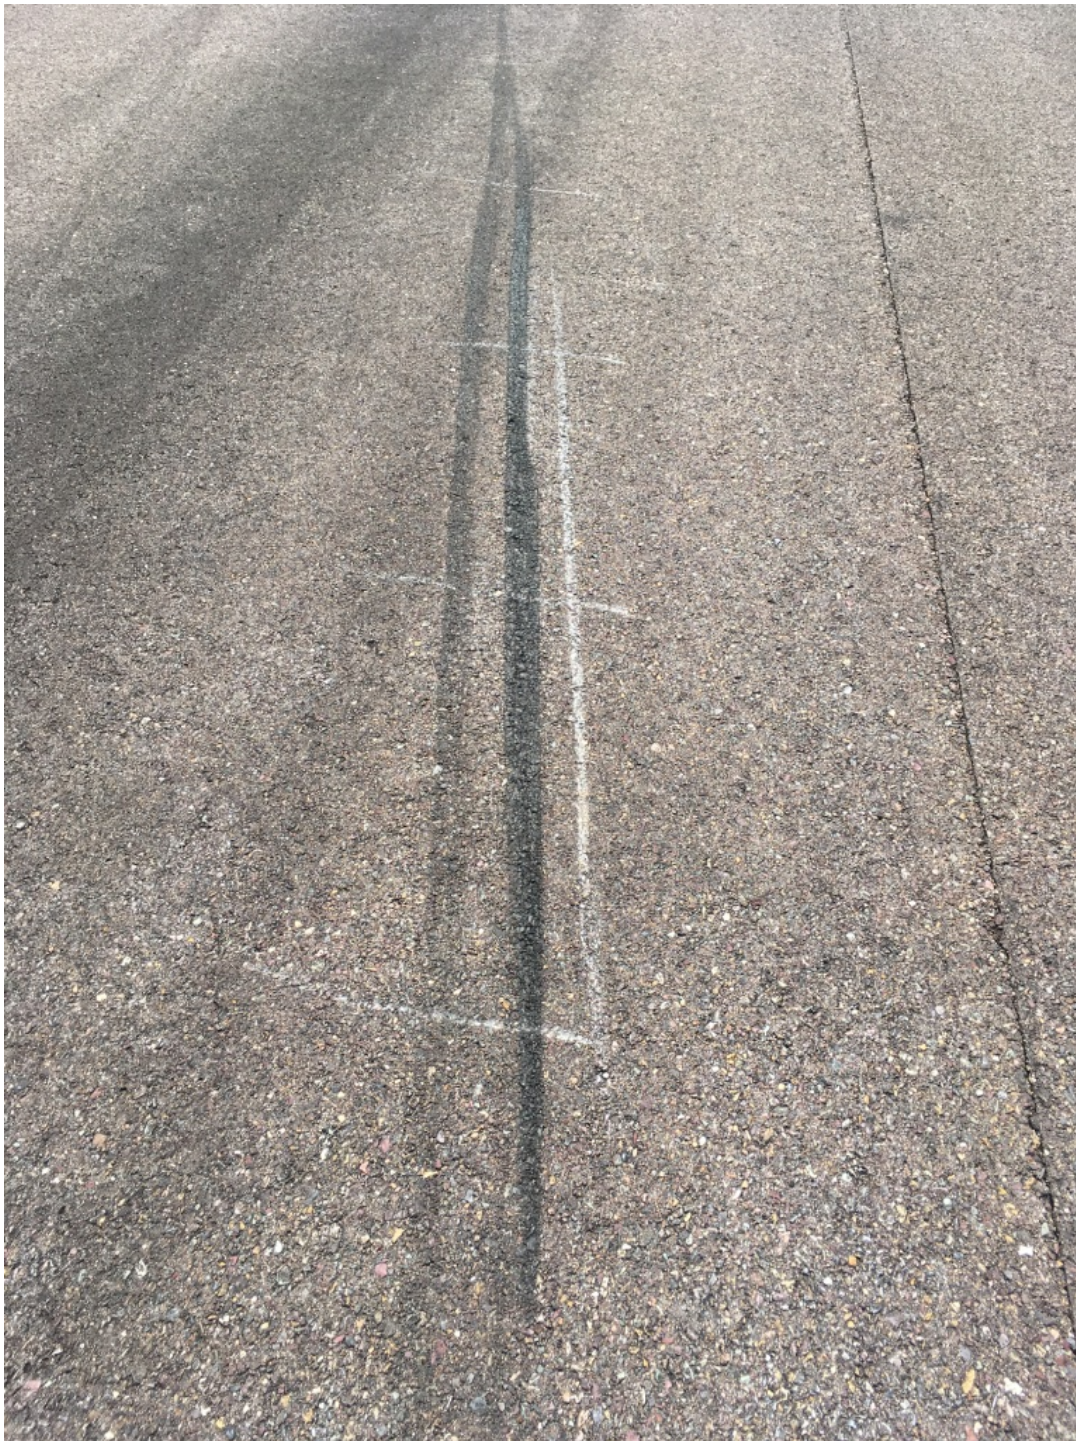
**Figure 6 – Third NLG Metal Strike Scar (Note prop strikes)**

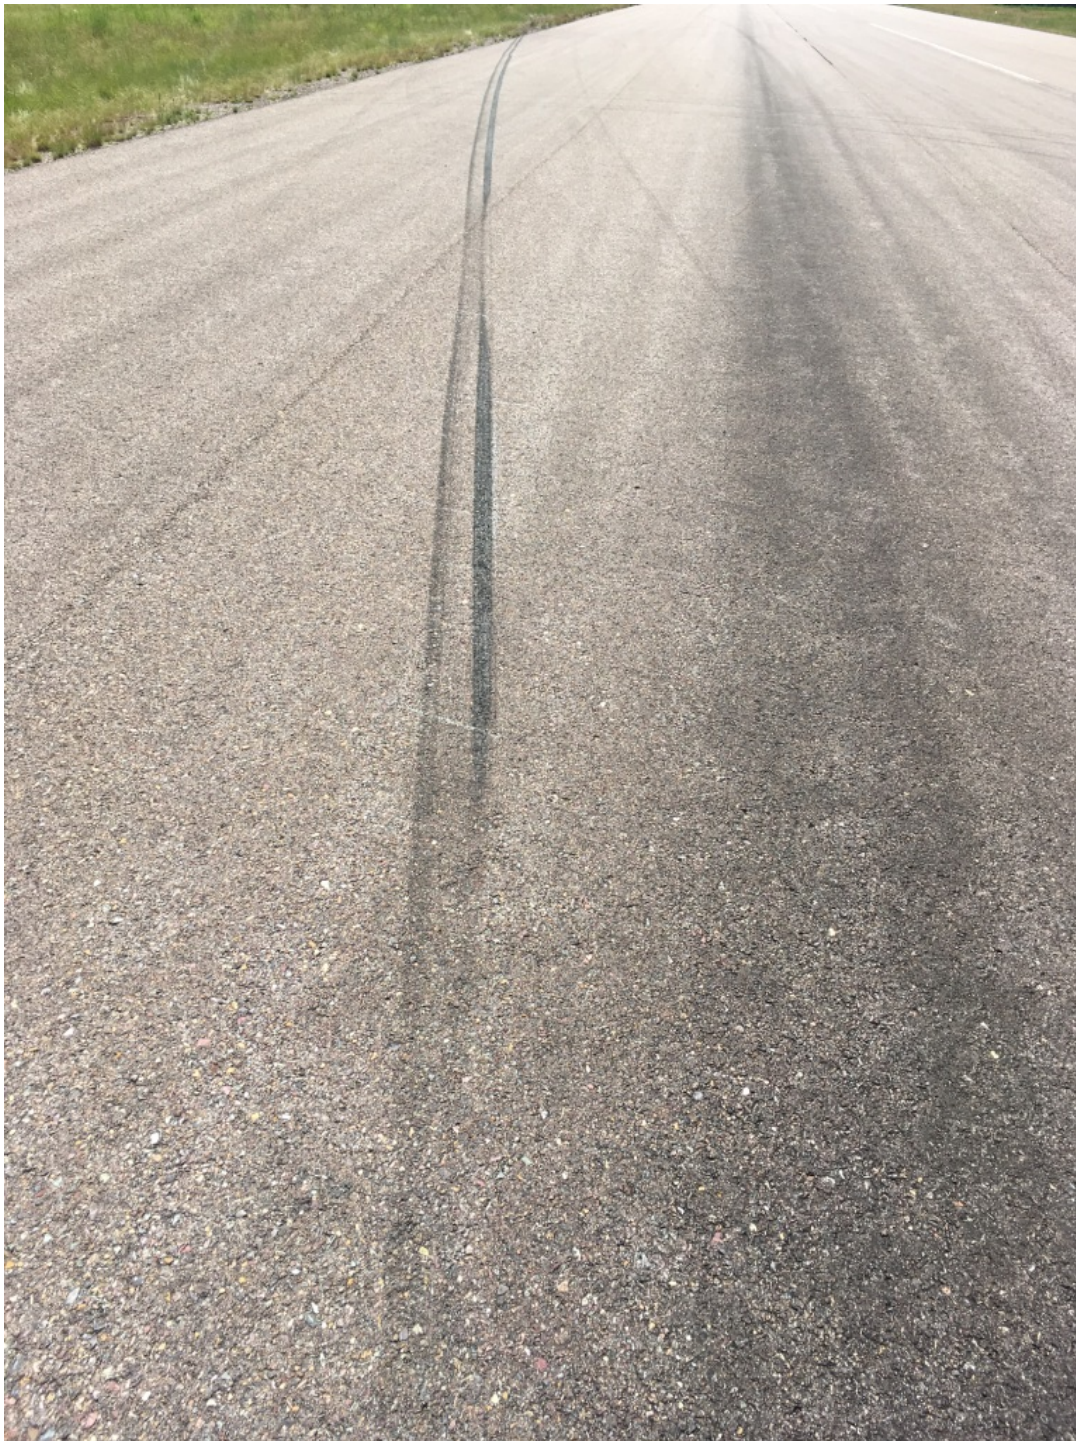
**Figure 7 - NLG and RMLG Tire Skid Marks**

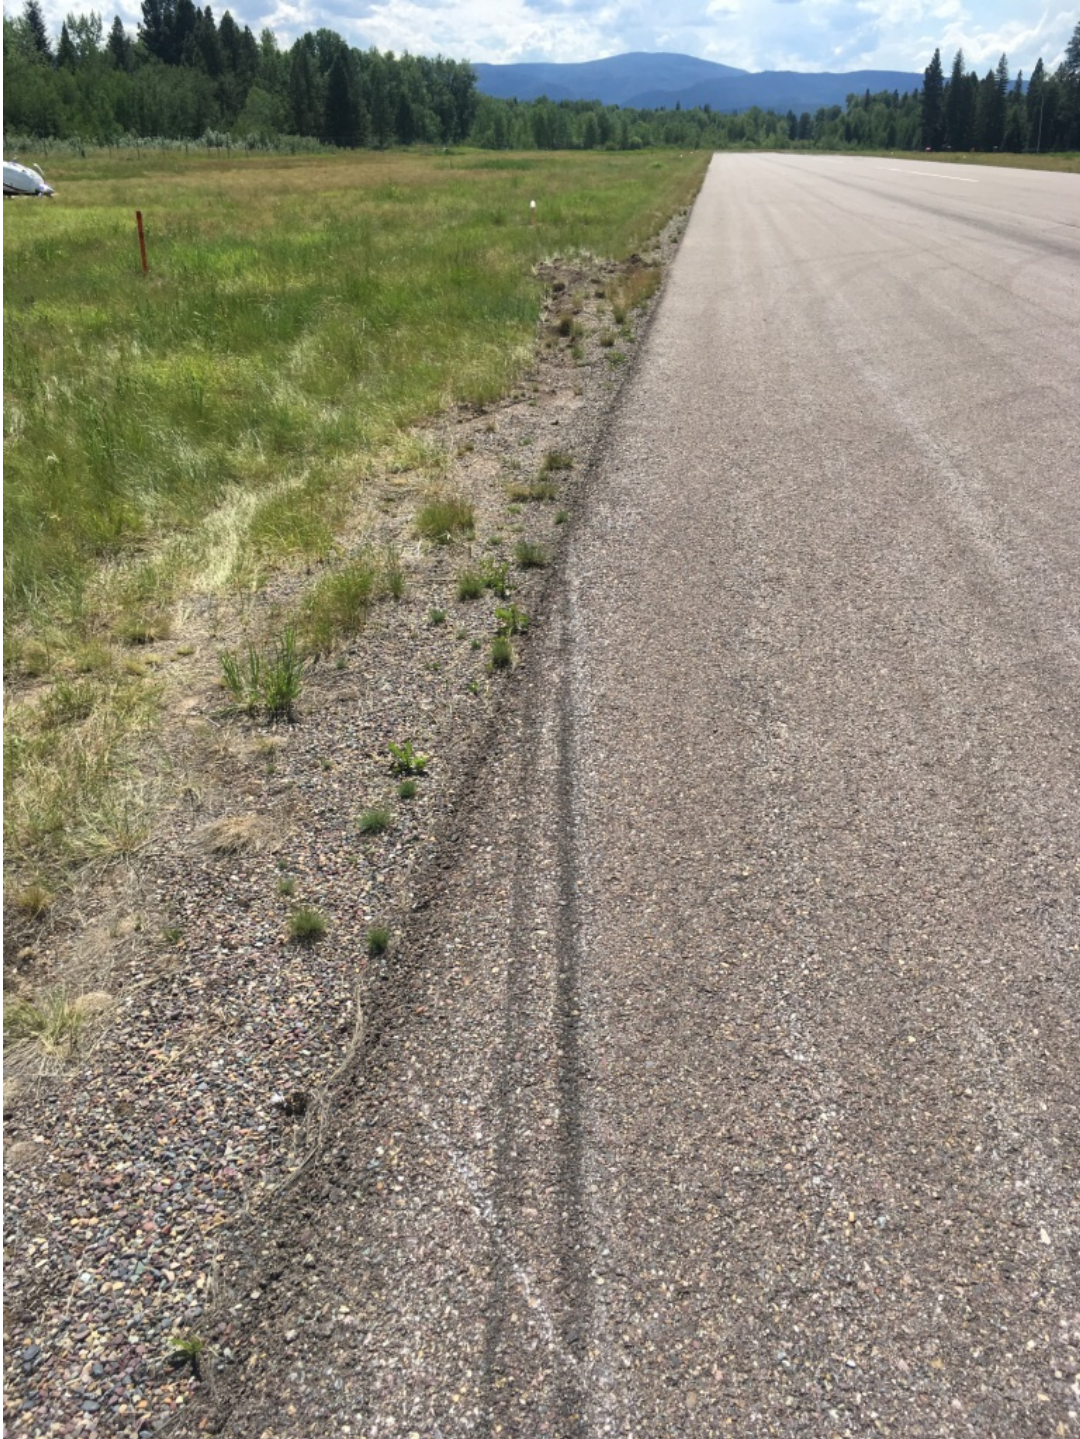
**Figure 8 - NLG Exiting Runway South Edge**
