## **Record of Conversation**

**NTSB Accident Number: WPR19LA194**  
**Aircraft Registration & Make/Model: N3078G, Bell 47G**  
**Accident Location: Mosby, MT.**  
**Accident Date: July 13, 2019**

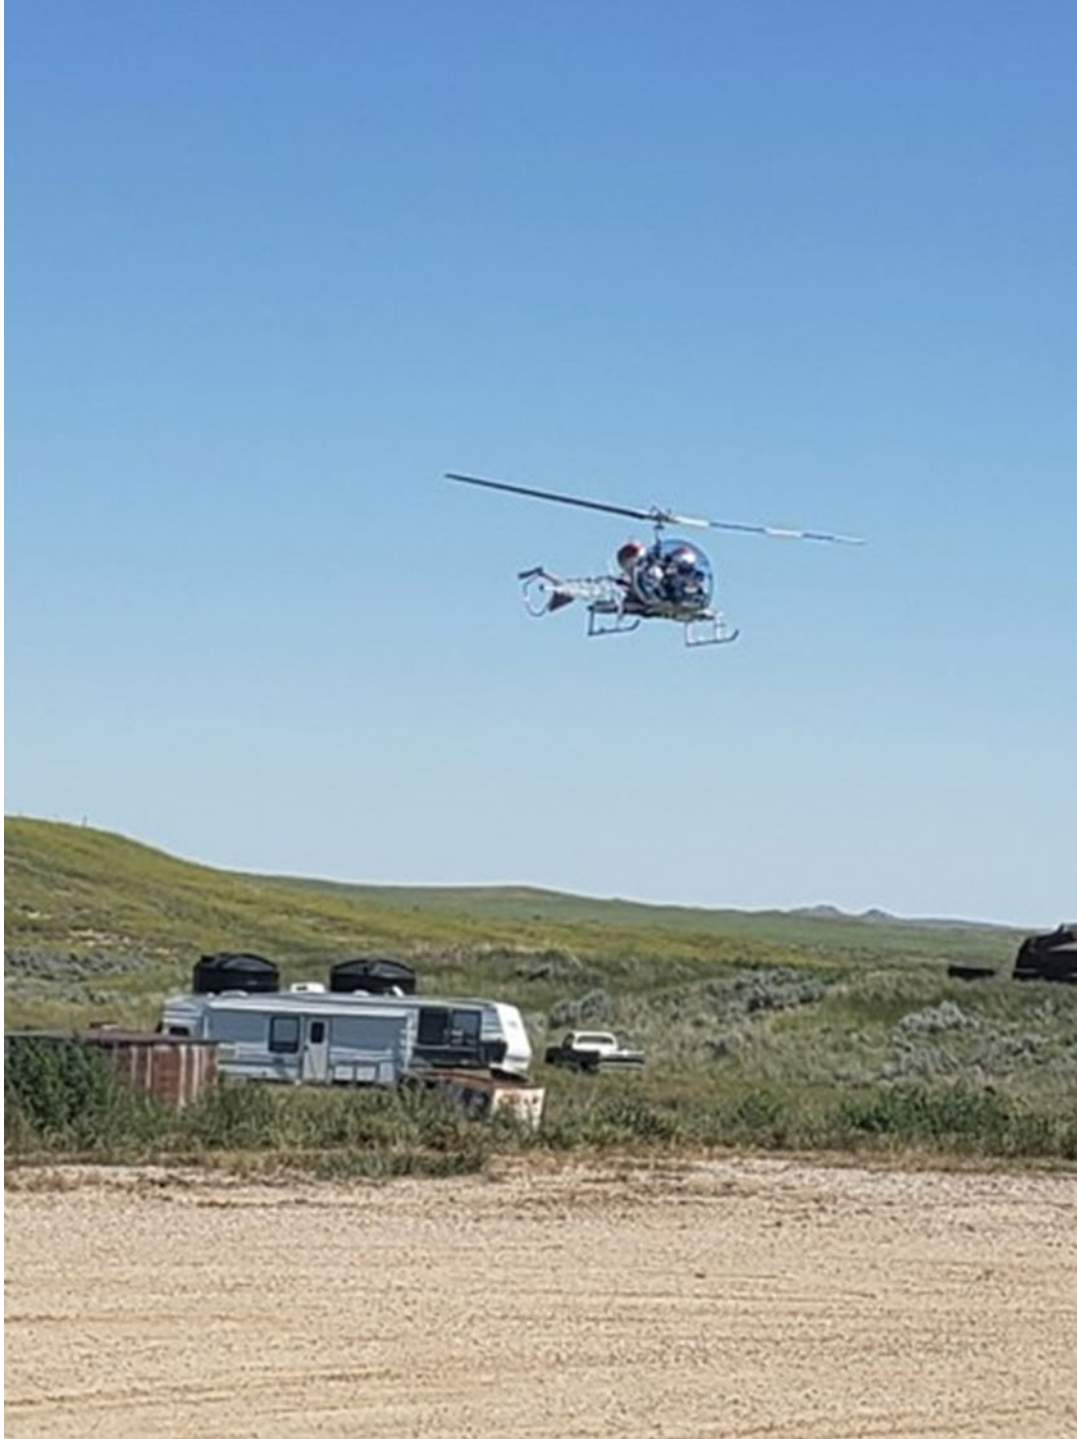
Photo 1. Helicopter observed approaching the building.

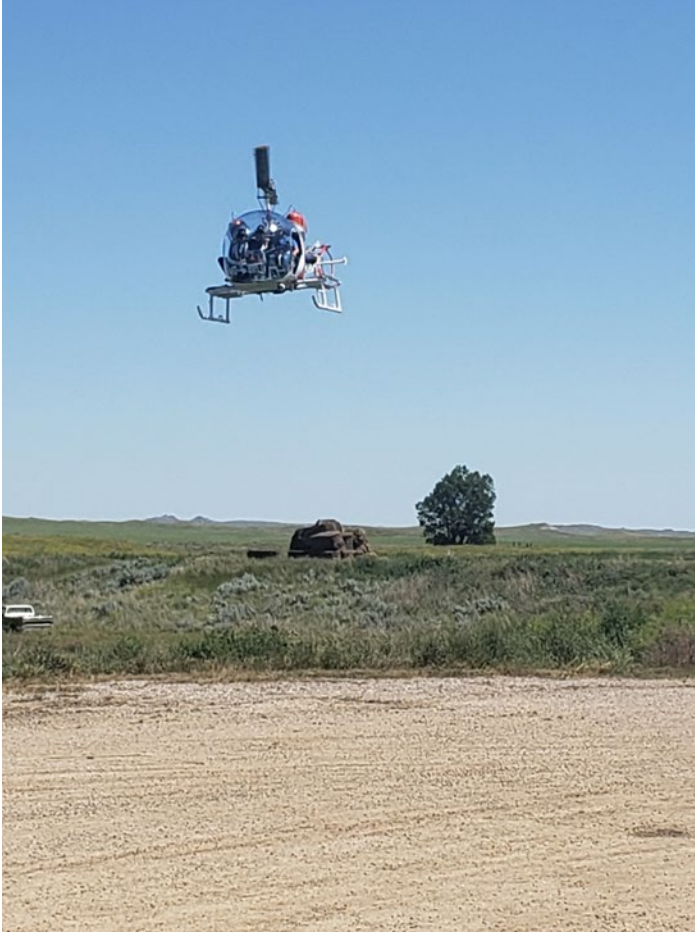
Photo 2. Helicopter as it was observed yawing to the right.
