## **NATIONAL TRANSPORTATION SAFETY BOARD**

# **AIRFRAME AND ENGINE EXAMINATION**

**WPR19LA194**

Location: Mosby, MT.  
Date: 07/13/2019  
Aircraft: N3078G / Bell 47G  
NTSB IIC: Fabian Salazar

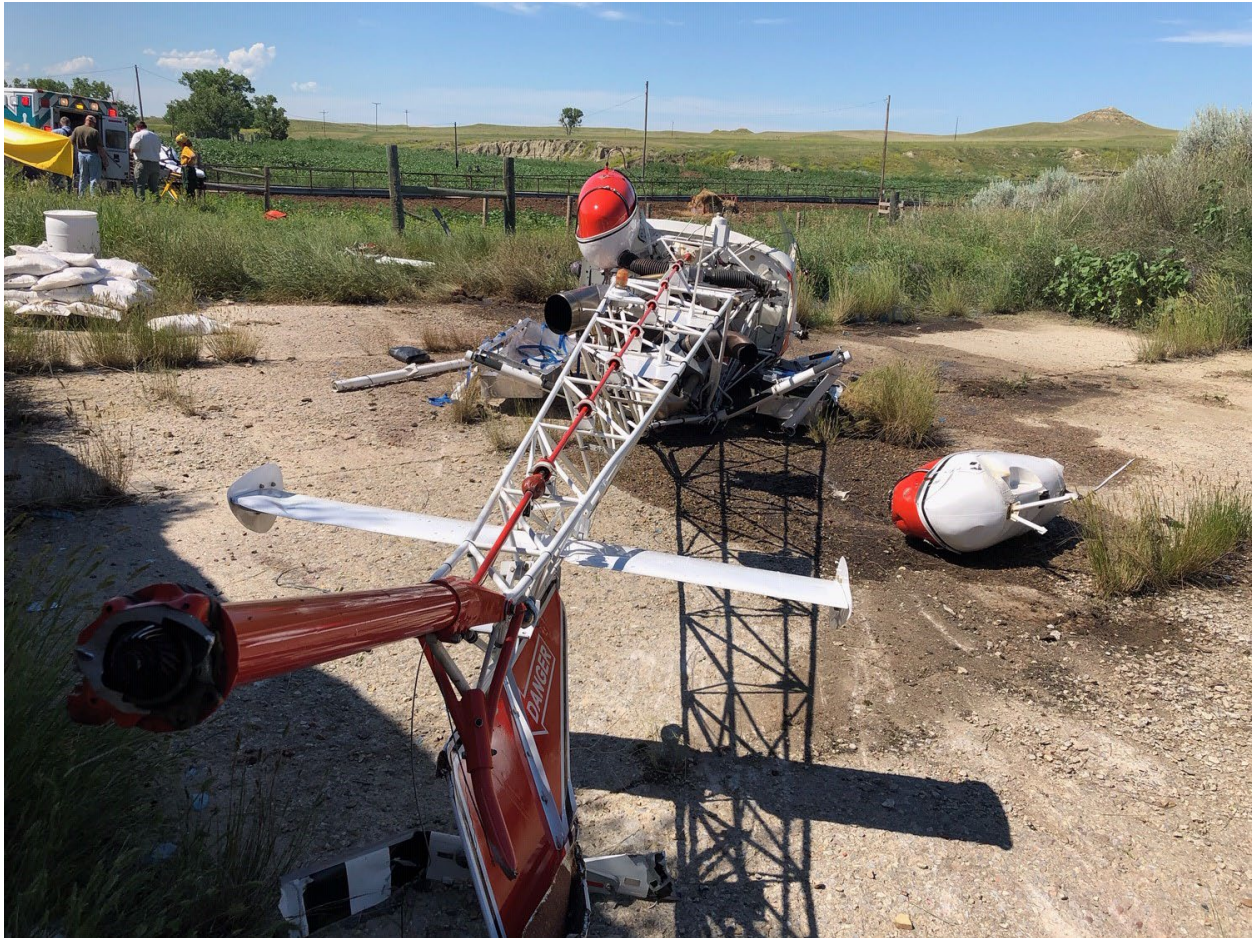
The tail rotor assembly and 90° gearbox separated from the frame at the lower section of the 90° gearbox. The lower section of the gearbox housing remained attached to the top section of the vertical fin. The tail rotor blades remained attached to the hub and were damaged with chord-wise bends and wrinkles to the skin. One tail rotor blade separated about 6 inches from the root of the blade. The other tail rotor blade lost a small section at the tip, that equated to a few inches inboard.

Figure 1. N3078G, rear-view, showing lower section of the 90° gear box. The tail rotor assembly is partially concealed by the vertical stabilizer. Photo courtesy of first responders.

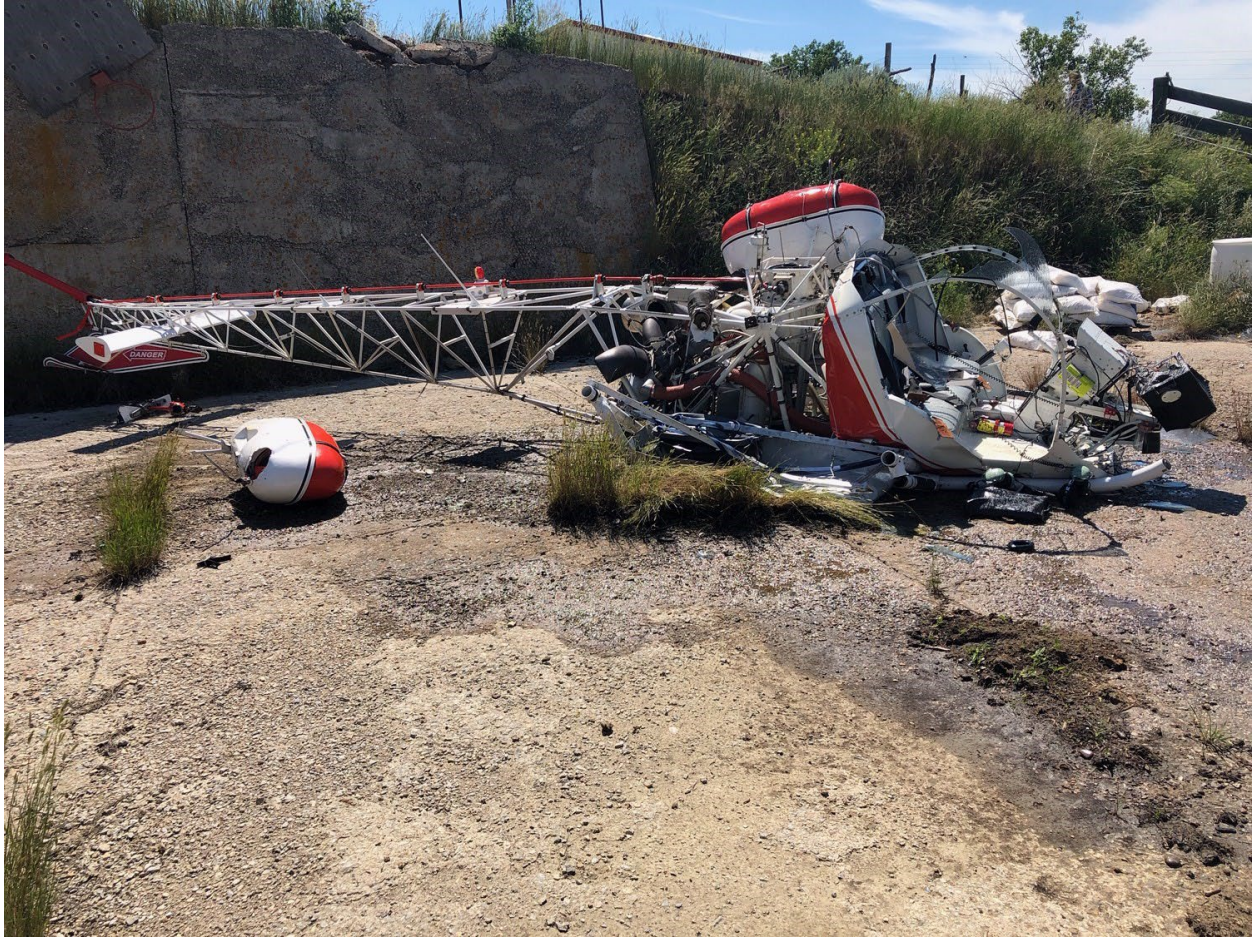
Figure 2. Right-side view. Photo courtesy of first responders.

The right skid fractured at the forward cross tube, and bent inward at the aft cross tube, which allowed the skid to come to rest underneath the fuselage. The left skid separated from the aft cross tube at the saddle and remained attached to the forward strut. The forward strut bent laterally to the left, which allowed the left-side of the fuselage to contact the ground.

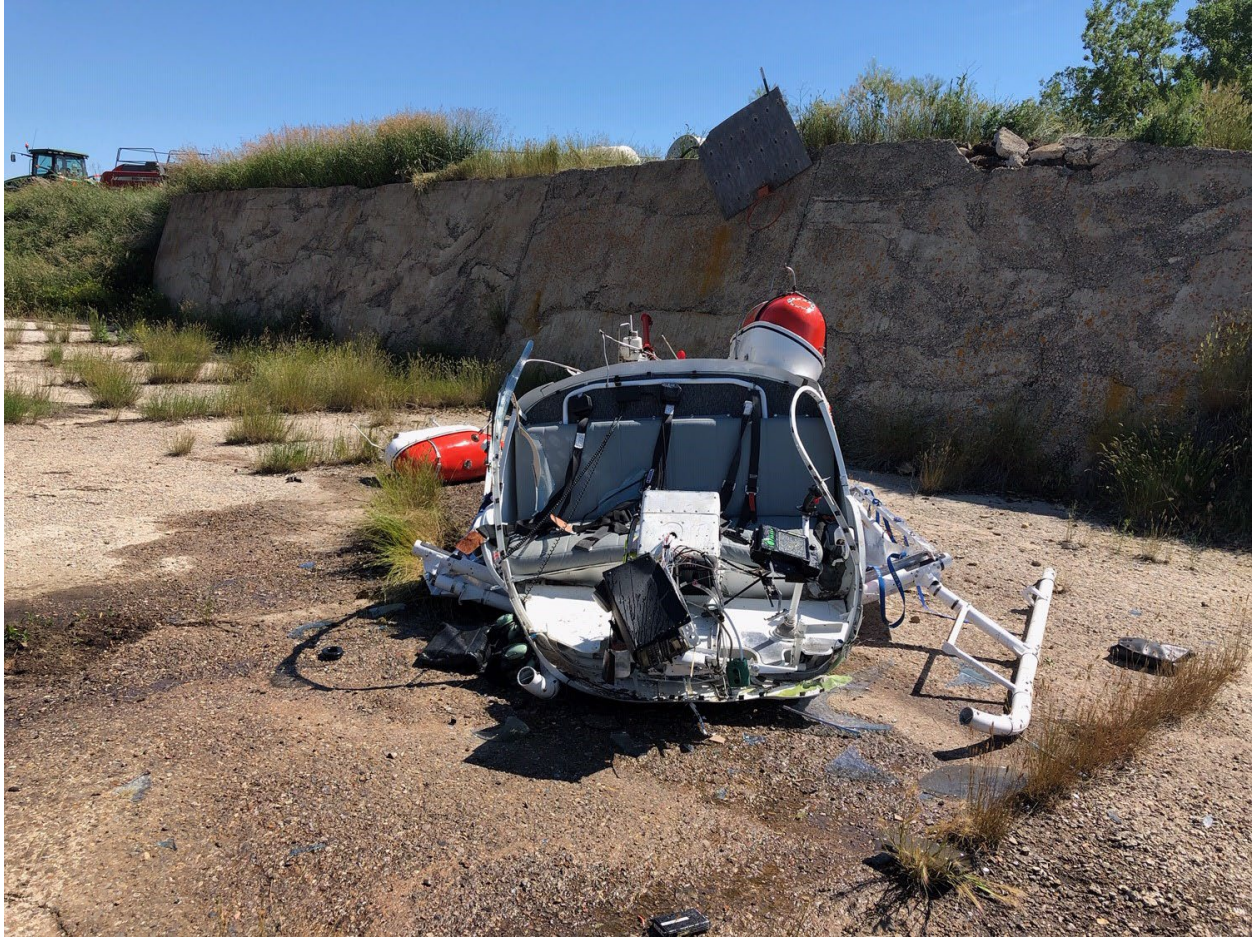
Figure 3. Front view. Photo courtesy of first responders.

The bubble canopy was fractured into multiple pieces and scattered throughout the accident site. The cockpit space was not compromised. The instrument panel remained attached to the cockpit floor and all instruments remained attached to the instrument panel. The instrument panel was displaced to the right. The bench seat remained secured to the cockpit.

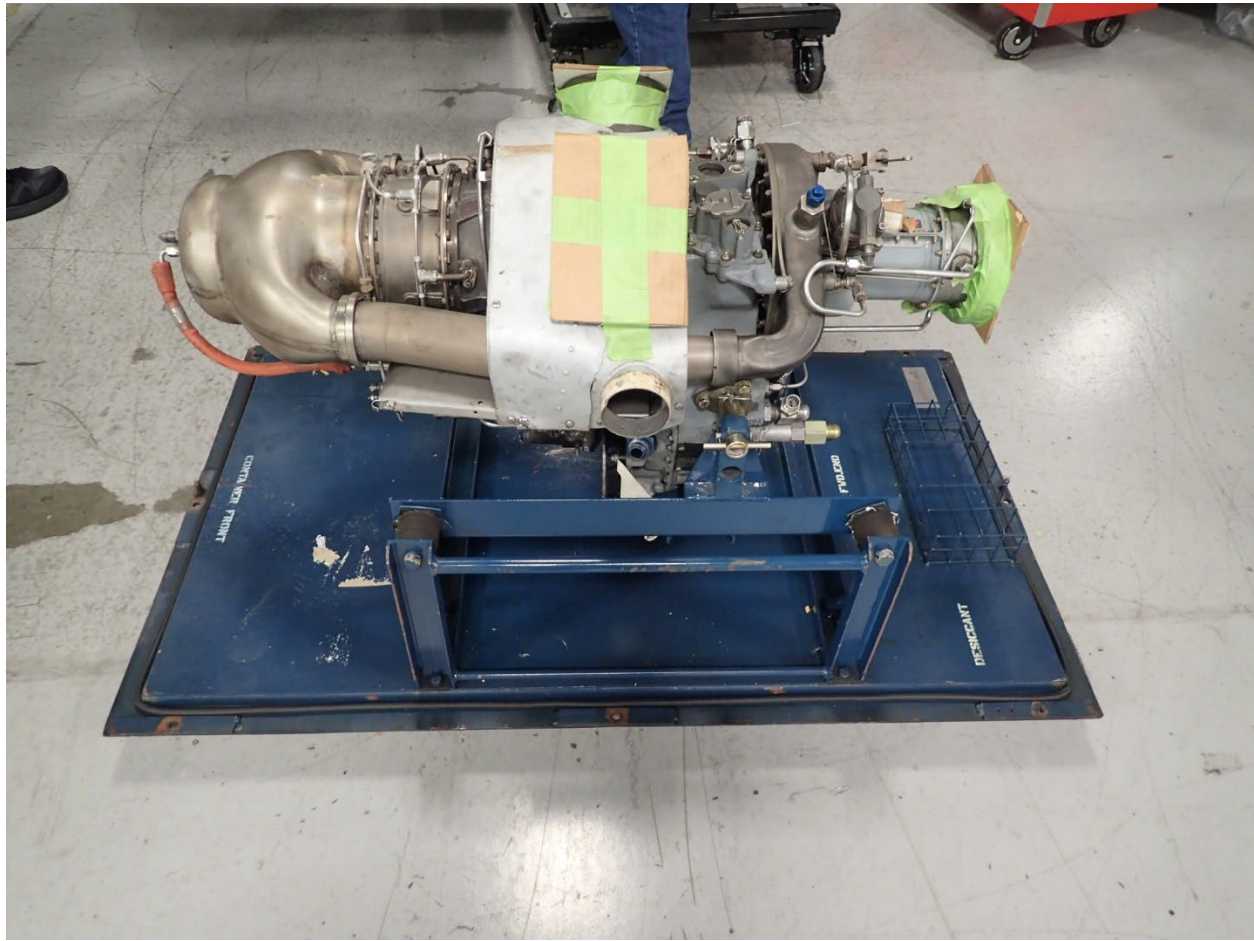
Figure 5. Right-side view of the engine.

The engine remained attached to the fuselage at its mounts and exhibited little to no damage. The engine was removed from the frame and shipped to an authorized maintenance facility where it was test ran. According to the party member from Rolls-Royce, the engine started, idled and ran normally during the testing with no flameouts or abnormal operations noted.

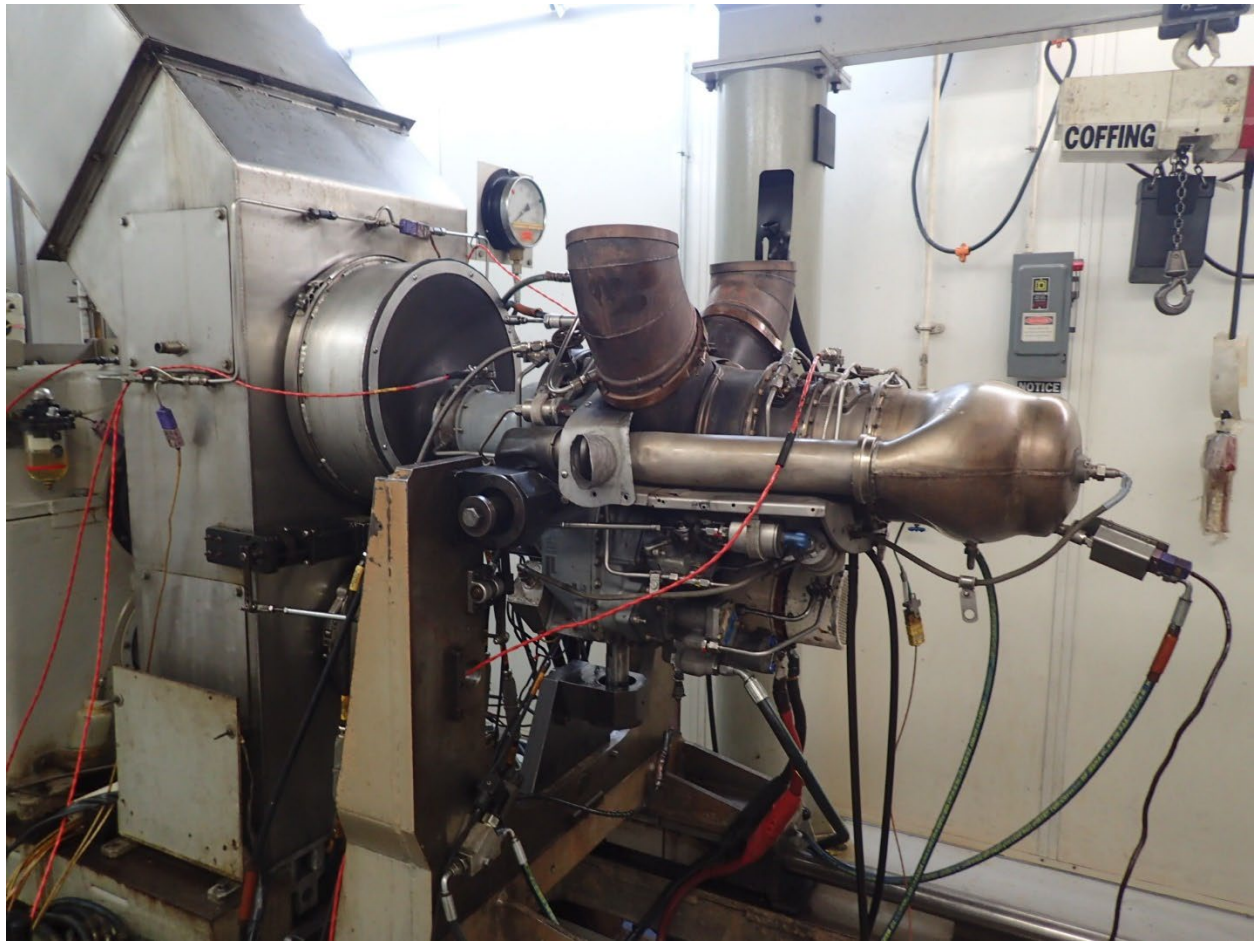
Figure 6. Engine mounted in the test-run cell. Photo courtesy of Rolls-Royce.
