**NATIONAL TRANSPORTATION SAFETY BOARD**

**ENGINE EXAMINATION REPORT**

**WPR19LA195**

**Cessna T210 – N6330N**

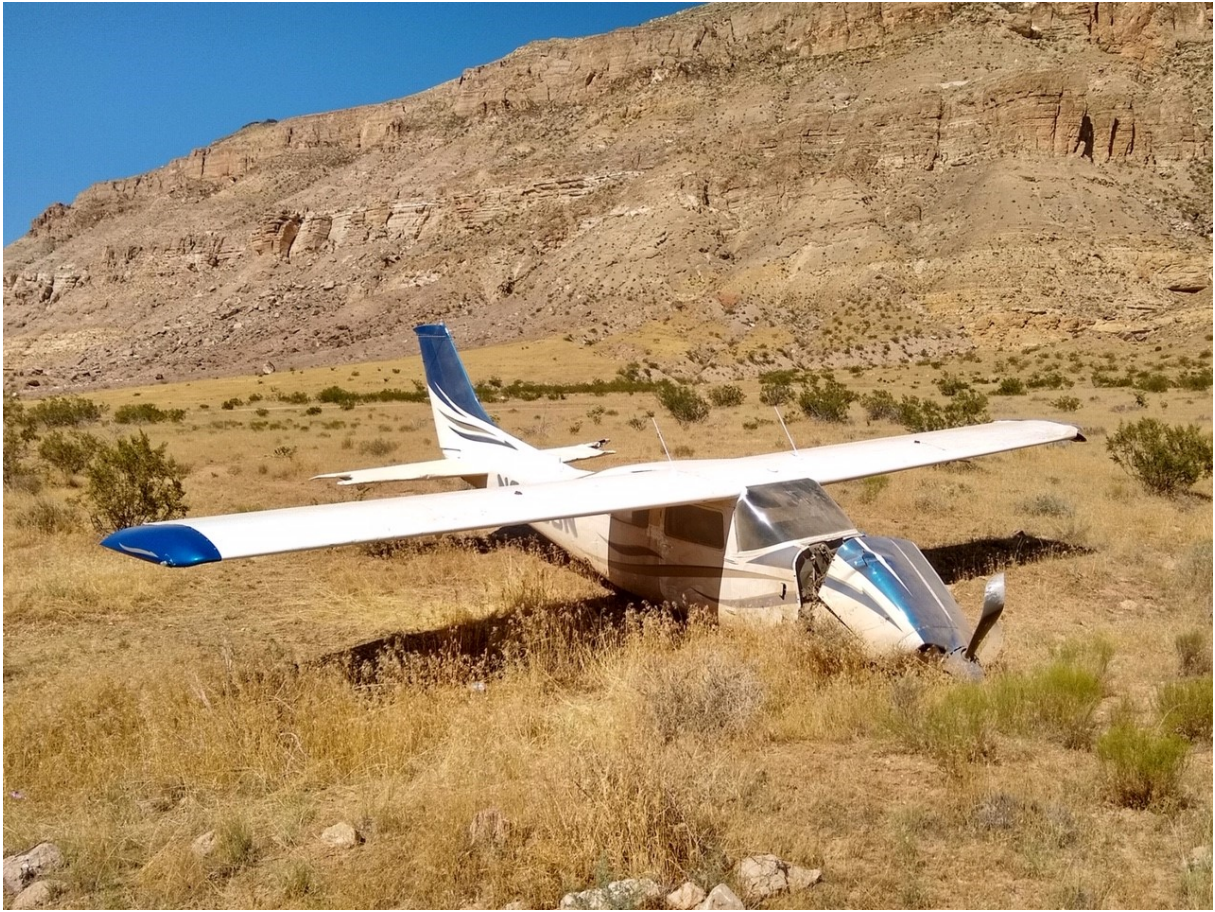
*Photograph 1: Airplane at Accident Site*

Postaccident examination of the airplane by the Federal Aviation Administration revealed substantial damage to the forward fuselage.

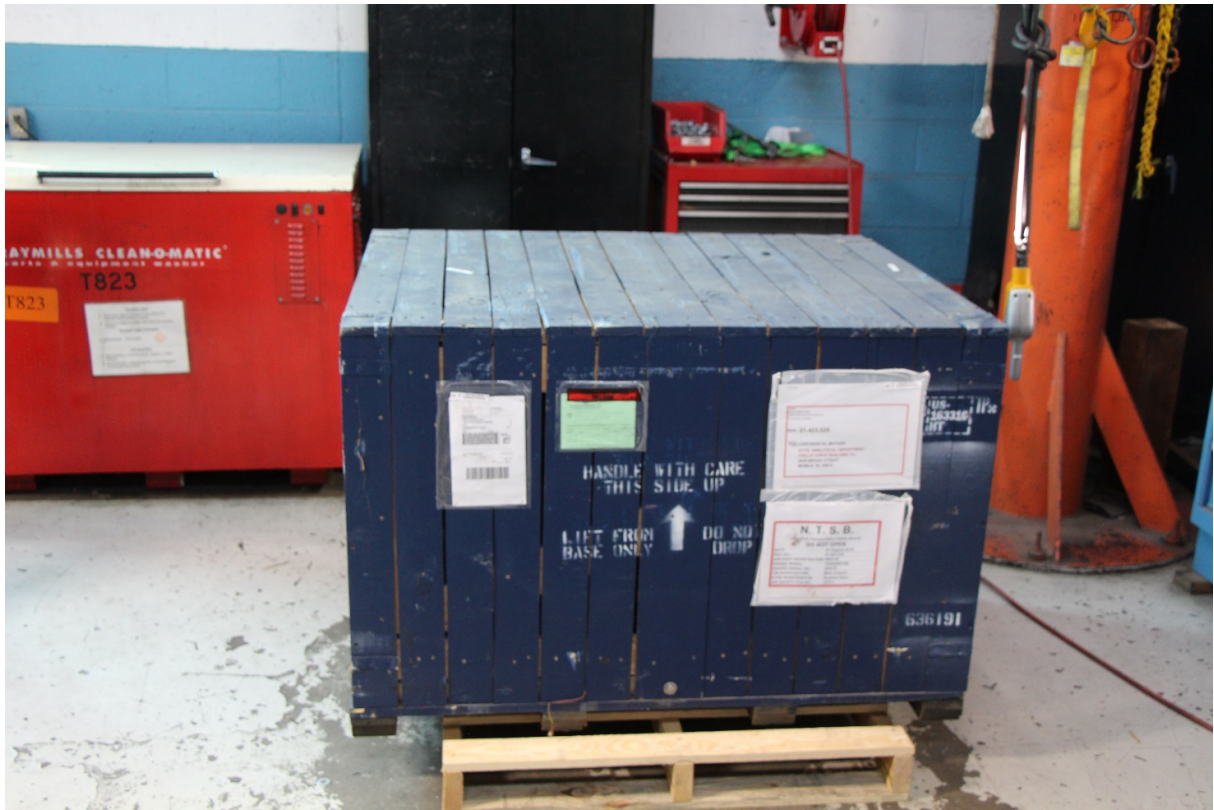
*Photograph 4: Crated Engine as Received*

The engine was shipped from a maintenance facility in St. George, Utah to CMI's facilities in Mobile, Alabama via crate and bonded shipment. Upon receipt the engine was immediately logged and placed in bonded/secure storage and was not opened. The crate was viewed by the IIC as unopened and subsequently photographed and opened for examination. The oil sump was partially crushed. The waste gate controller mounting bracket was fractured and the alternator bracket was broken. Additionally, the "B" nut at the mixture control/throttle body was loose.

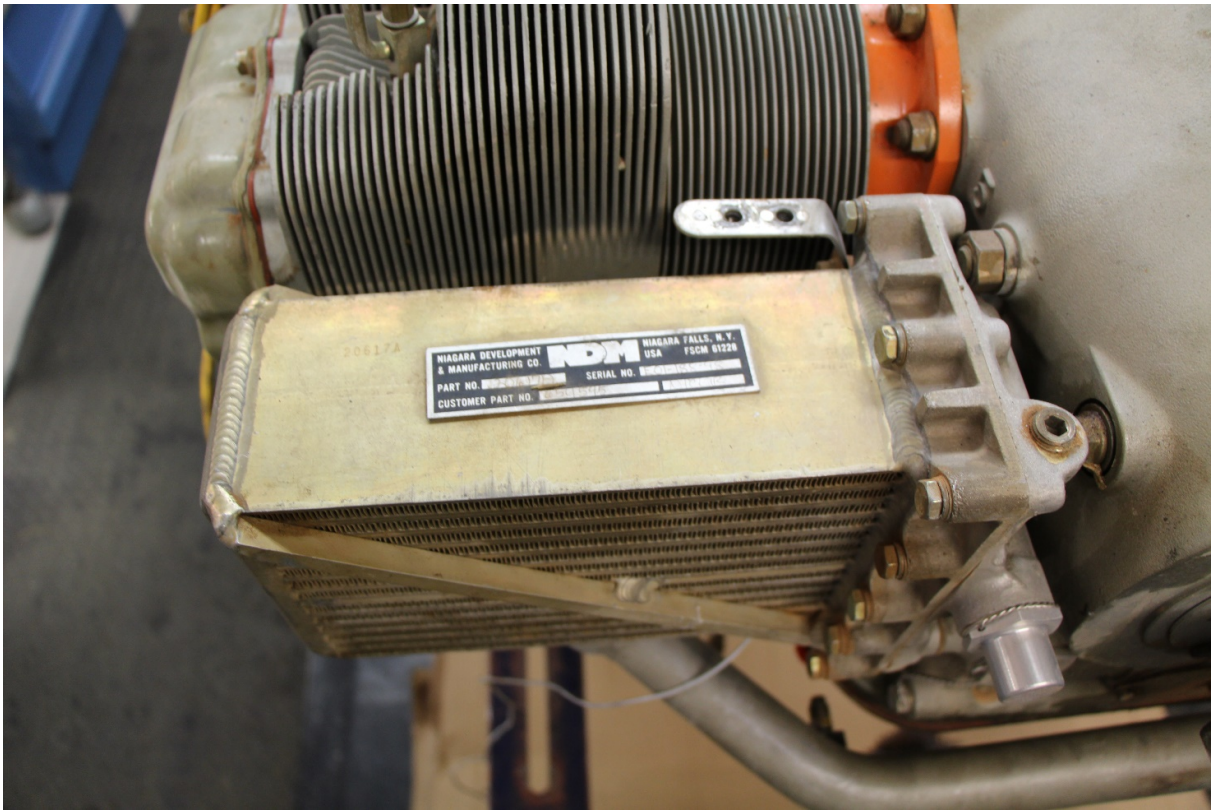
*Photograph 9: Oil Cooler*

The oil cooler was manufactured by Niagara Development and Manufacturing, part no. 20617A, serial no. E01-188-98.

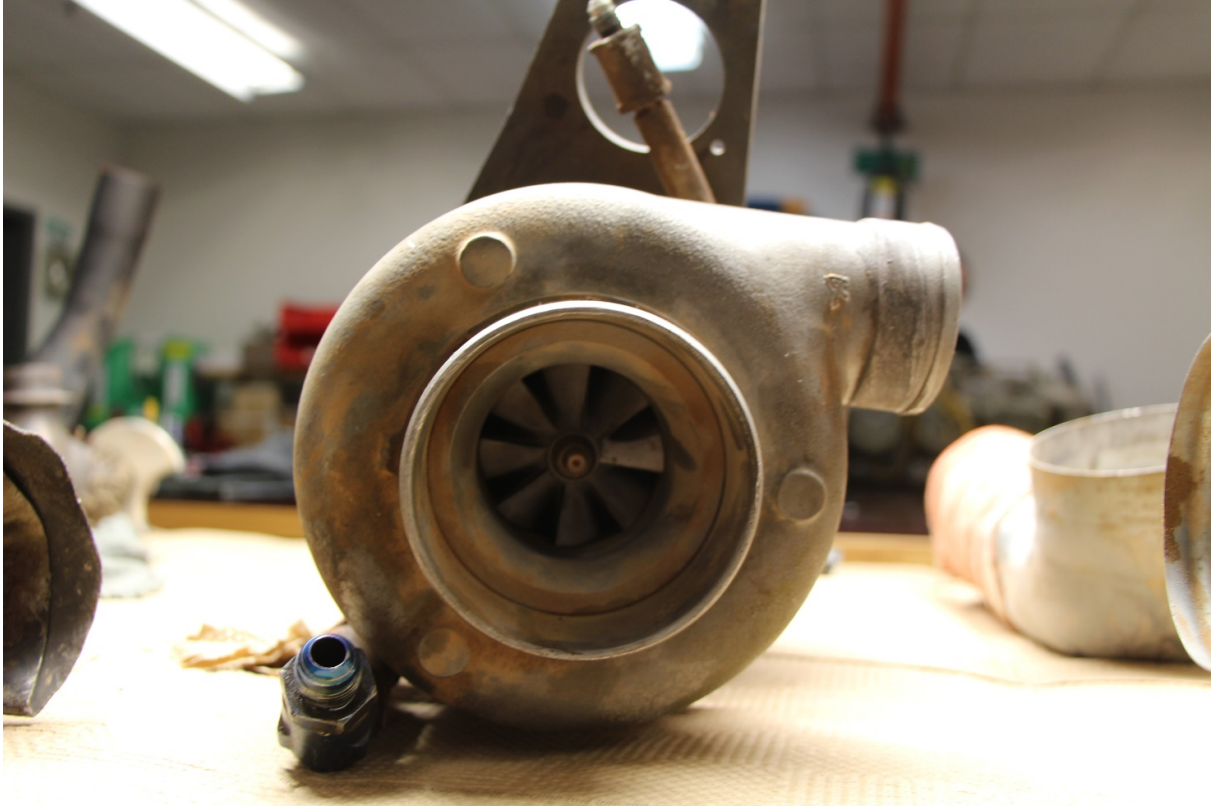
*Photograph 13: Turbocharger*

The turbocharger was manufactured by Kelly Aerospace and noted as a factory rebuild, part no. 6295001-0101, serial no. 406610-9005.

The engine was initially run with a replacement fuel manifold diaphragm and started normally, but would not achieve rated manifold pressure initially. It was determined that the turbo charger was not engaging when the throttle was advanced. Several operational adjustments were made while troubleshooting the turbo charger, which included bypassing the turbo controller, replacing a broken scat tube clamp, tightening of loose exhaust and intake valve bolts, repair of a hole in the scat tube, and subsequent replacement of the scat tubing with induction hose. However, none of these changes resulted in the engagement of the turbo during subsequent tests.

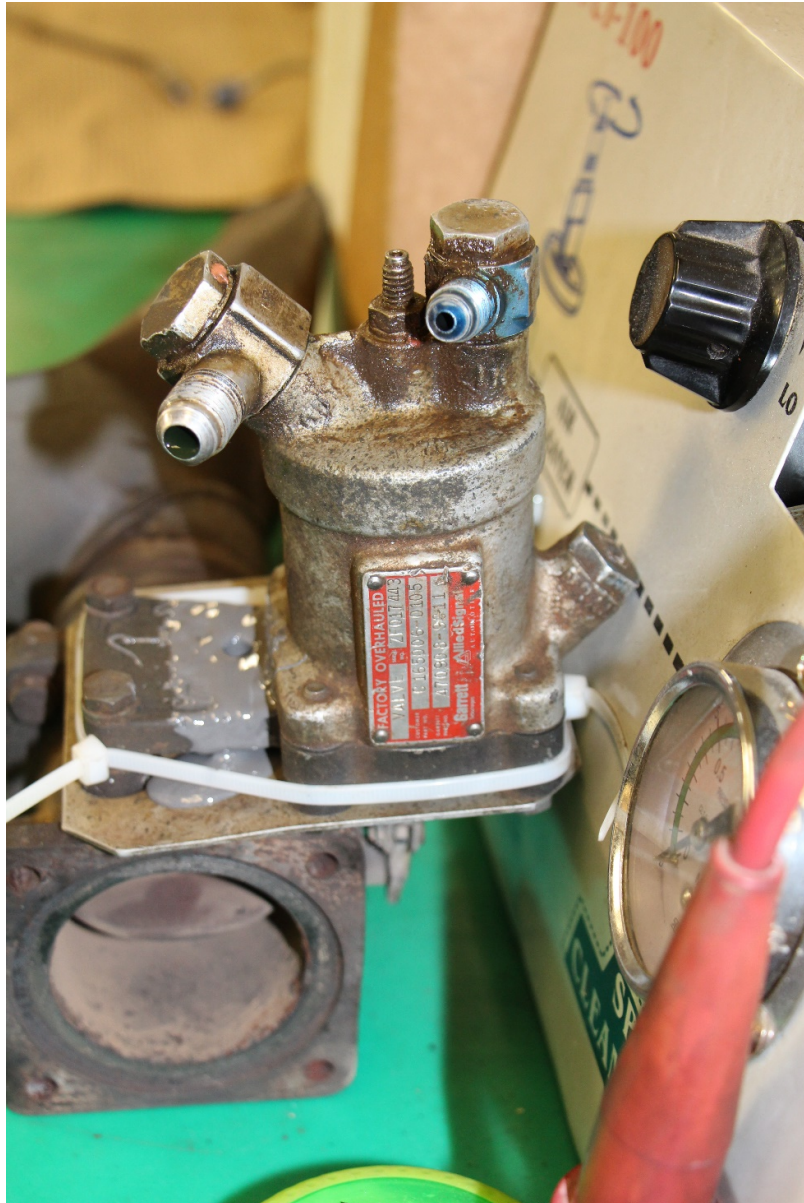
*Photograph 14: Waste Gate*

The waste gate from the accident airplane was tested with the factory unit that was used to run the engine. Air was directed through the oil inlet port to close the waste gate butterfly valve and the pressure level was recorded. The pressure level for both units to close the valve was 35 psi.

The waste gate was replaced with a factory unit prior to subsequent testing and a ram air inlet was installed on the turbo. The engine achieved rated manifold pressure at full power during all subsequent tests. An additional test was performed with the original fuel manifold diaphragm and without the ram air inlet, and the engine achieved rated manifold pressure when advanced to full power. It was noted that the cylinder heat temperature for cylinder no. 2 advanced beyond its red line temperature of 460° F during tests where the engine achieved rated manifold pressure

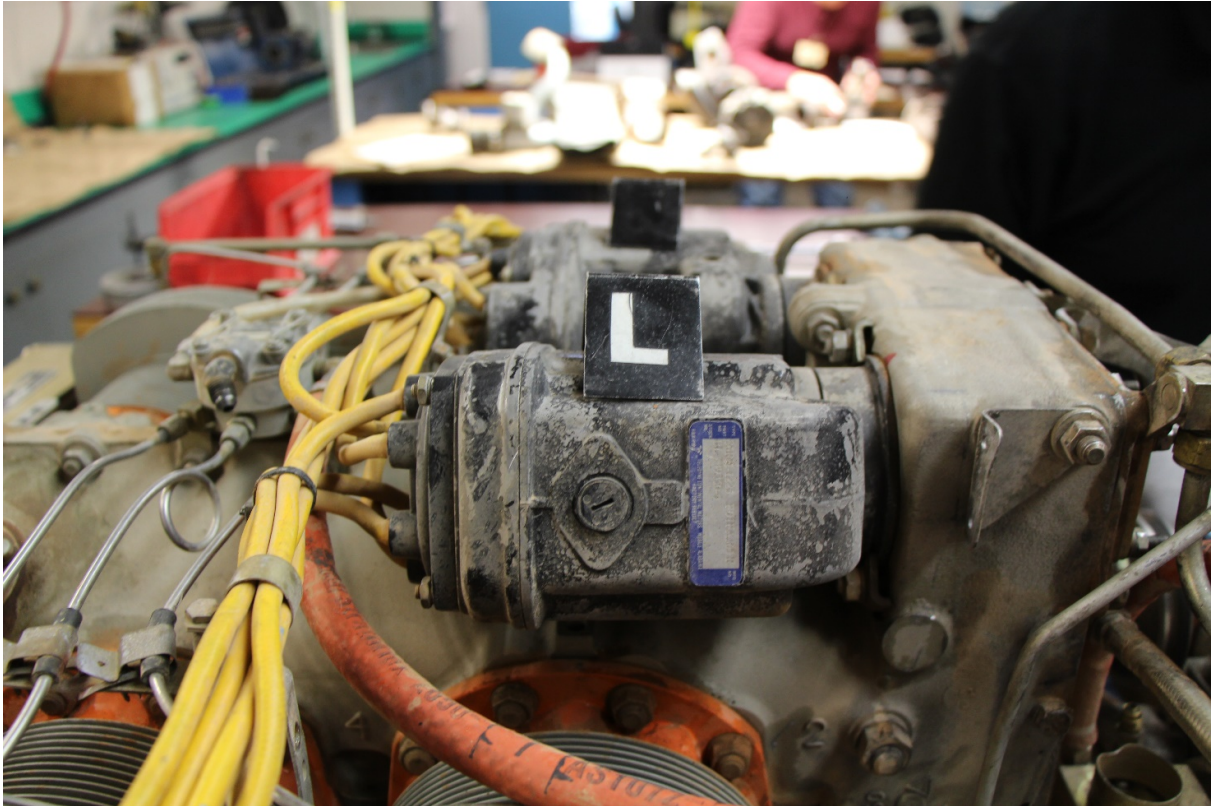
*Photograph 17: Left Magneto*

The left magneto, a TCM unit (part no. BL-349350-4, serial no. F01FA365 R), remained attached the engine case. The magneto was timed to 19° BTDC. There were no signatures on the magneto to indicate that it had been moved during the impact sequence.

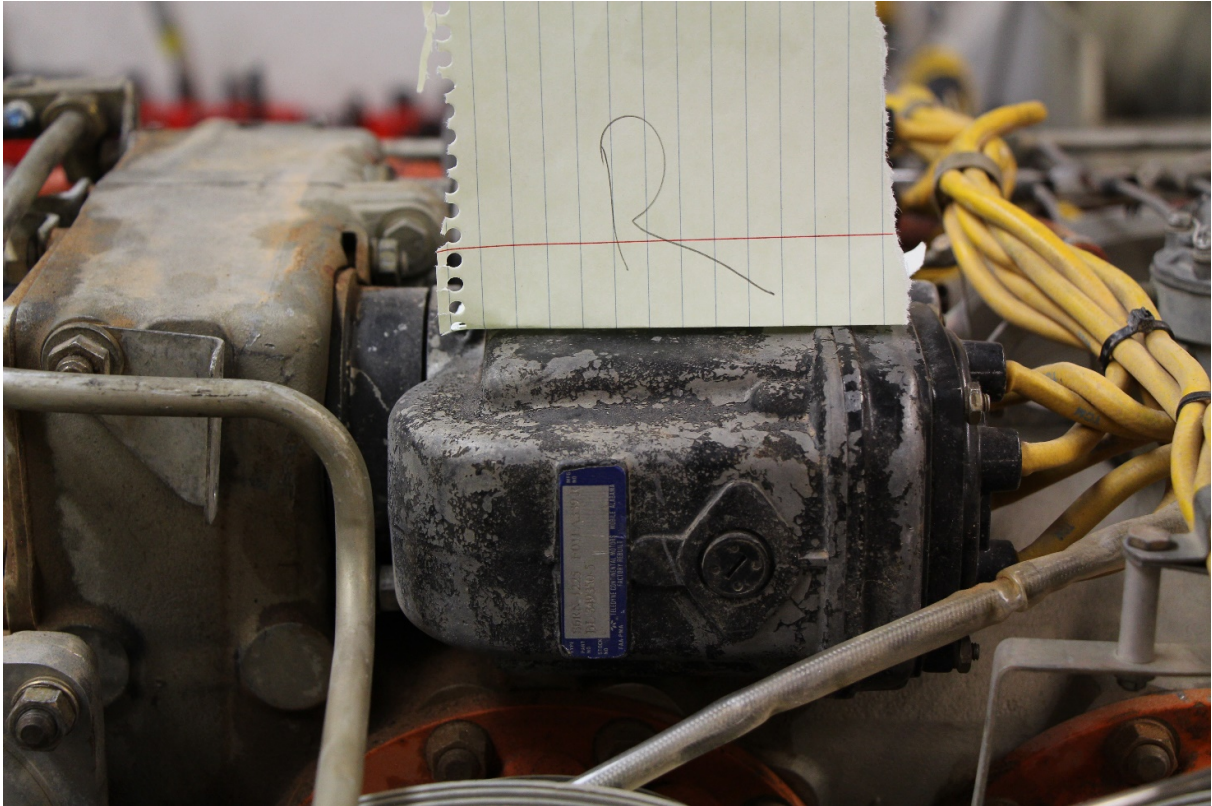
*Photograph 18: Right Magneto*

The right magneto, a TCM unit (part no. BL-349350-5, serial no. F01FA339 R), remained attached to the engine case. The magneto was timed to 19° BTDC. There were no signatures on the magneto to indicate that it had been moved during the impact sequence.

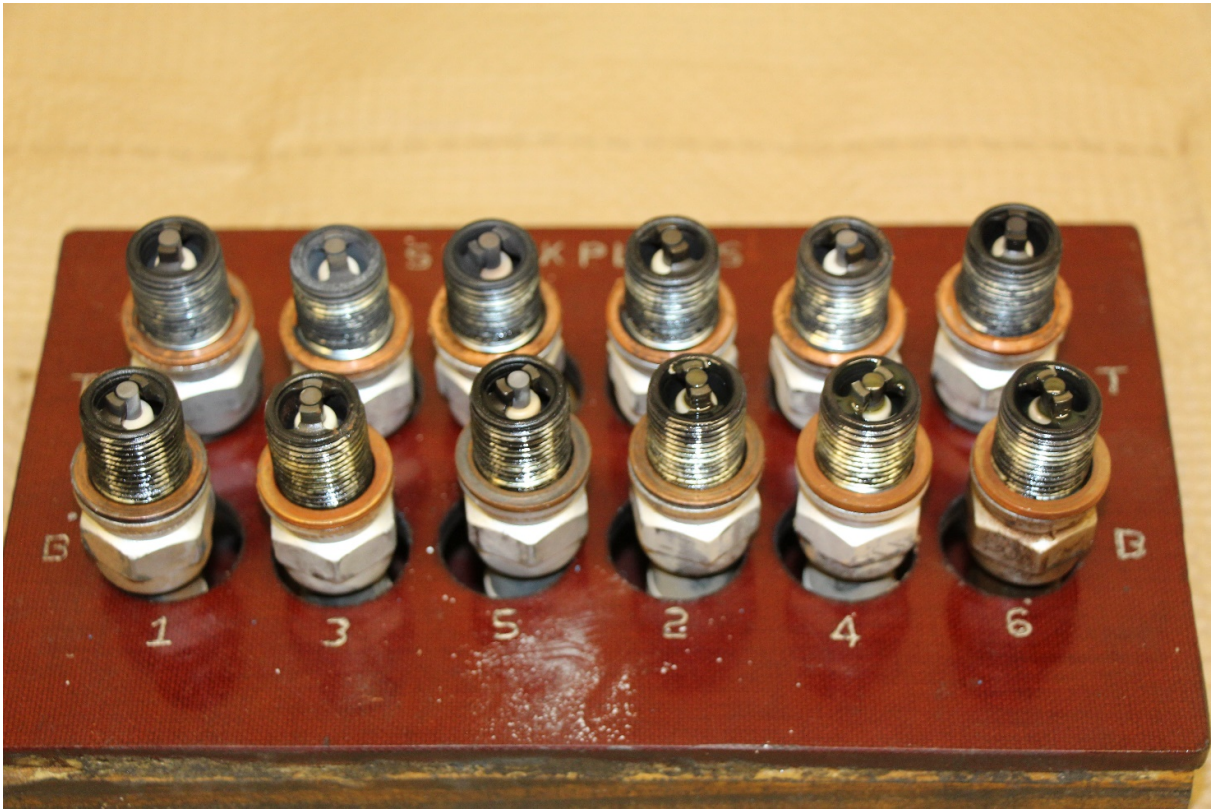
*Photograph 19: Spark Plugs*

The spark plugs, manufactured by Champion (part no. RHB-32E), were removed and examined. The plugs displayed normal wear and were slightly dark and sooty in appearance. The spark plugs were manufactured by Tempest.
