**NATIONAL TRANSPORTATION SAFETY BOARD**

**AIRPLANE AND ENGINE EXAMINATION REPORT**

**WPR19LA198**

**Cessna 172G – N3761L**

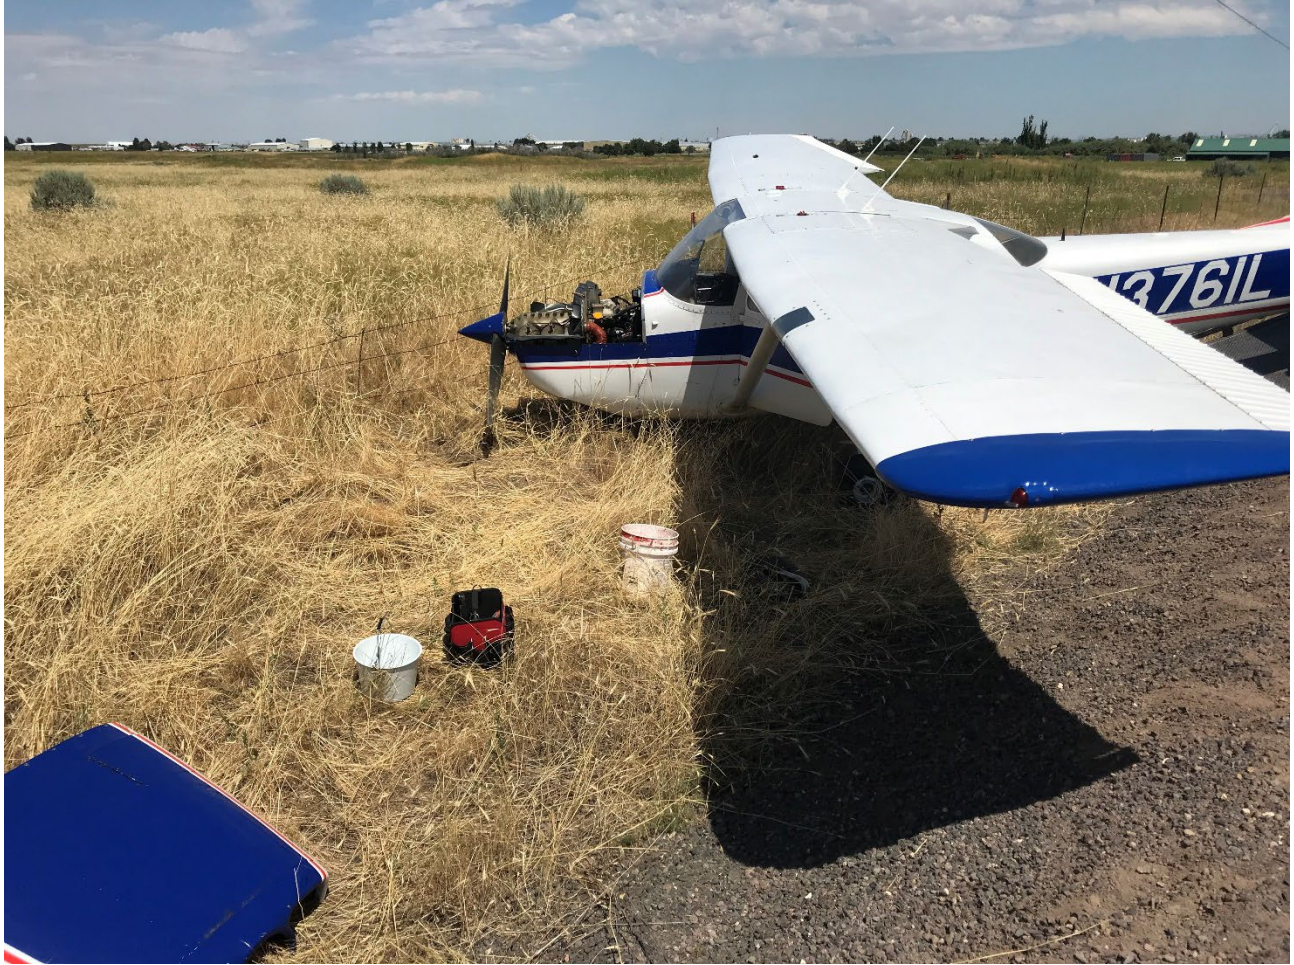
Postaccident examination of the airplane by the Federal Aviation Administration revealed substantial damage to the forward fuselage.

*Photograph 1: Airplane at Accident Site*

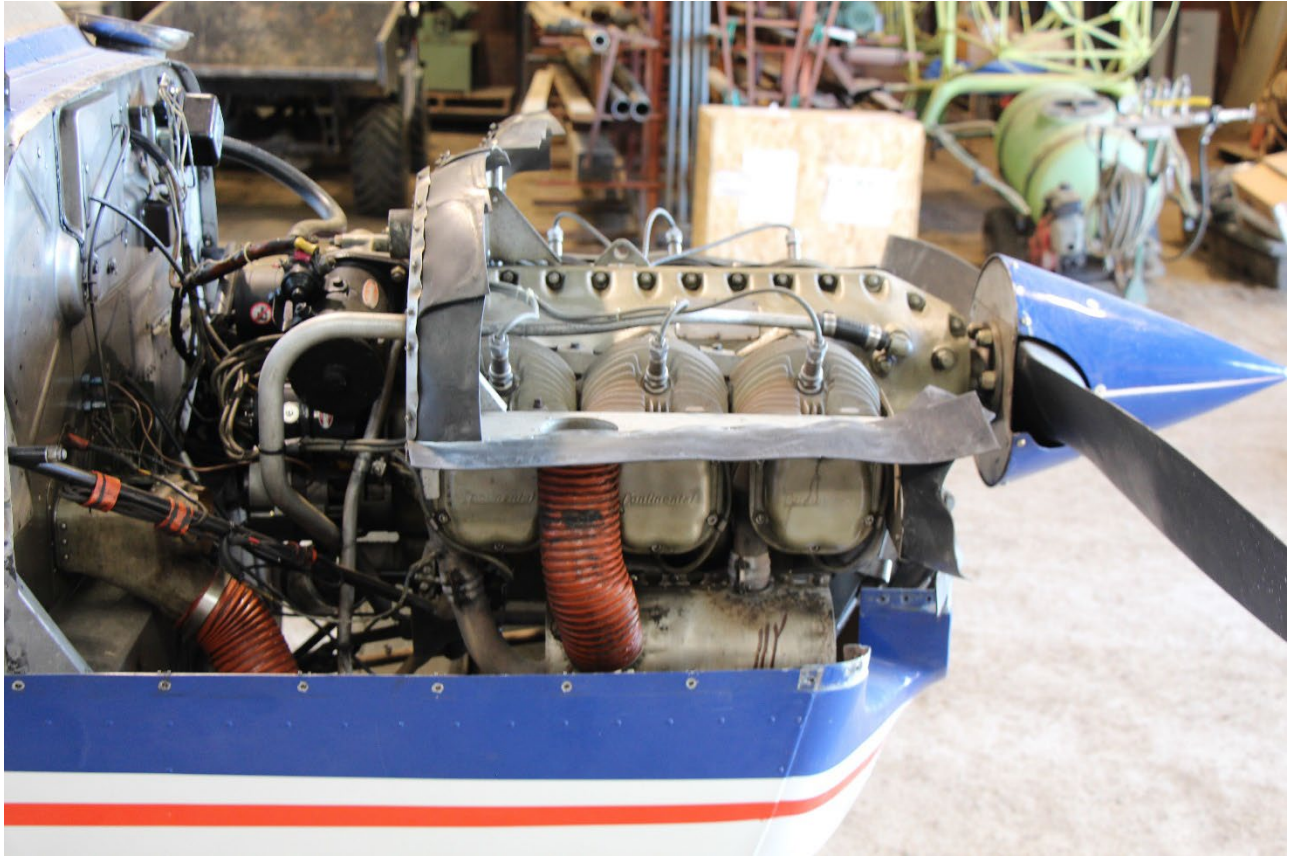
*Photograph 2: Engine prior to examination*

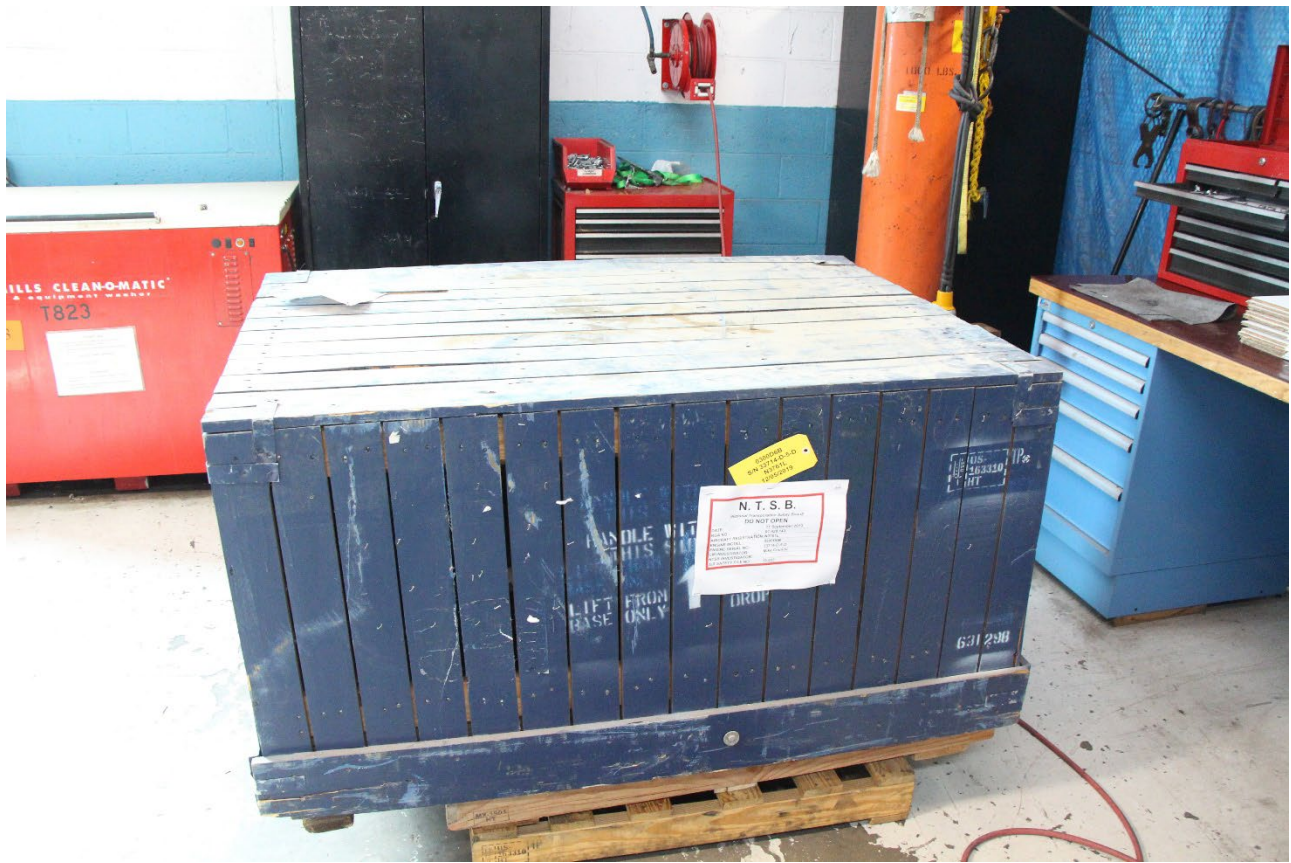
*Photograph 4: Crated Engine as Received*

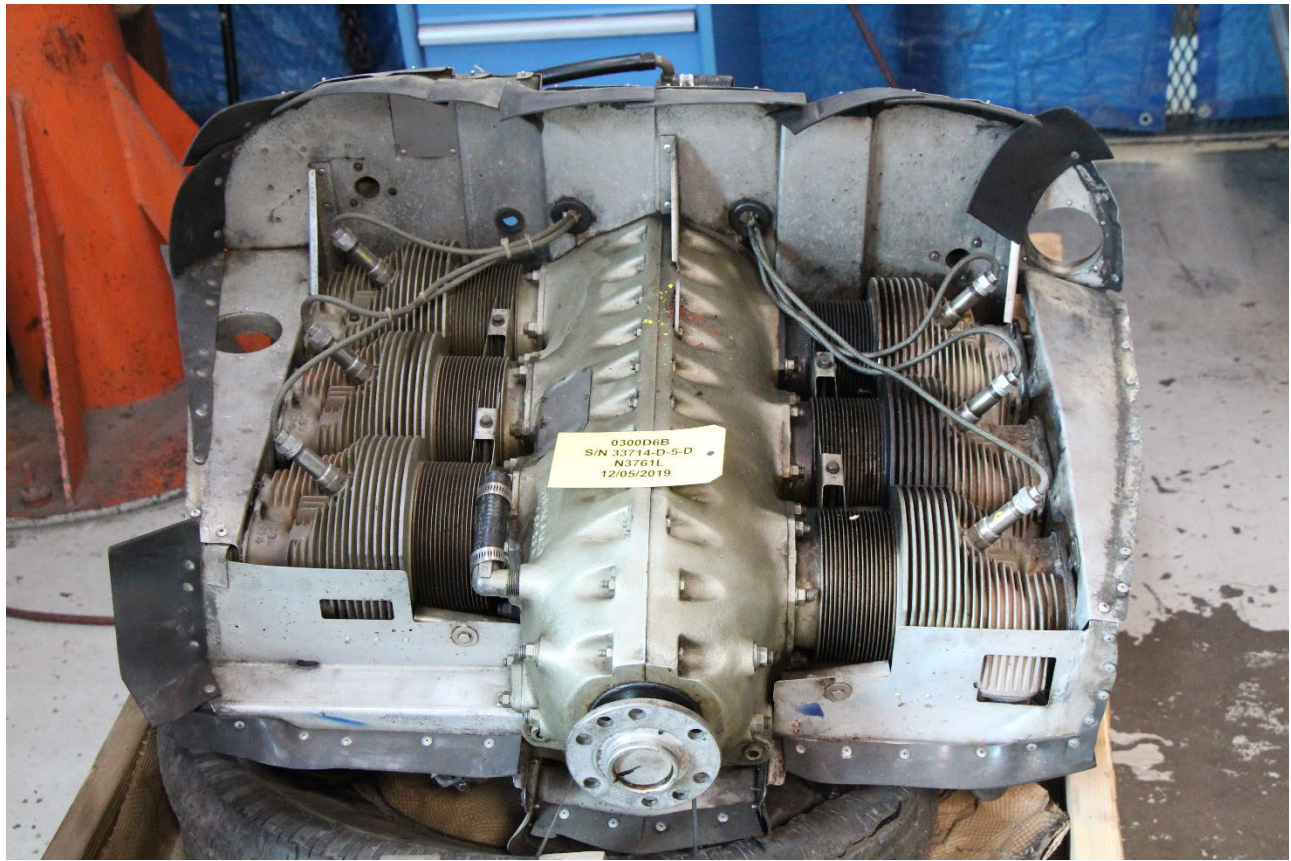
*Photograph 5: Engine after Crate Removed*

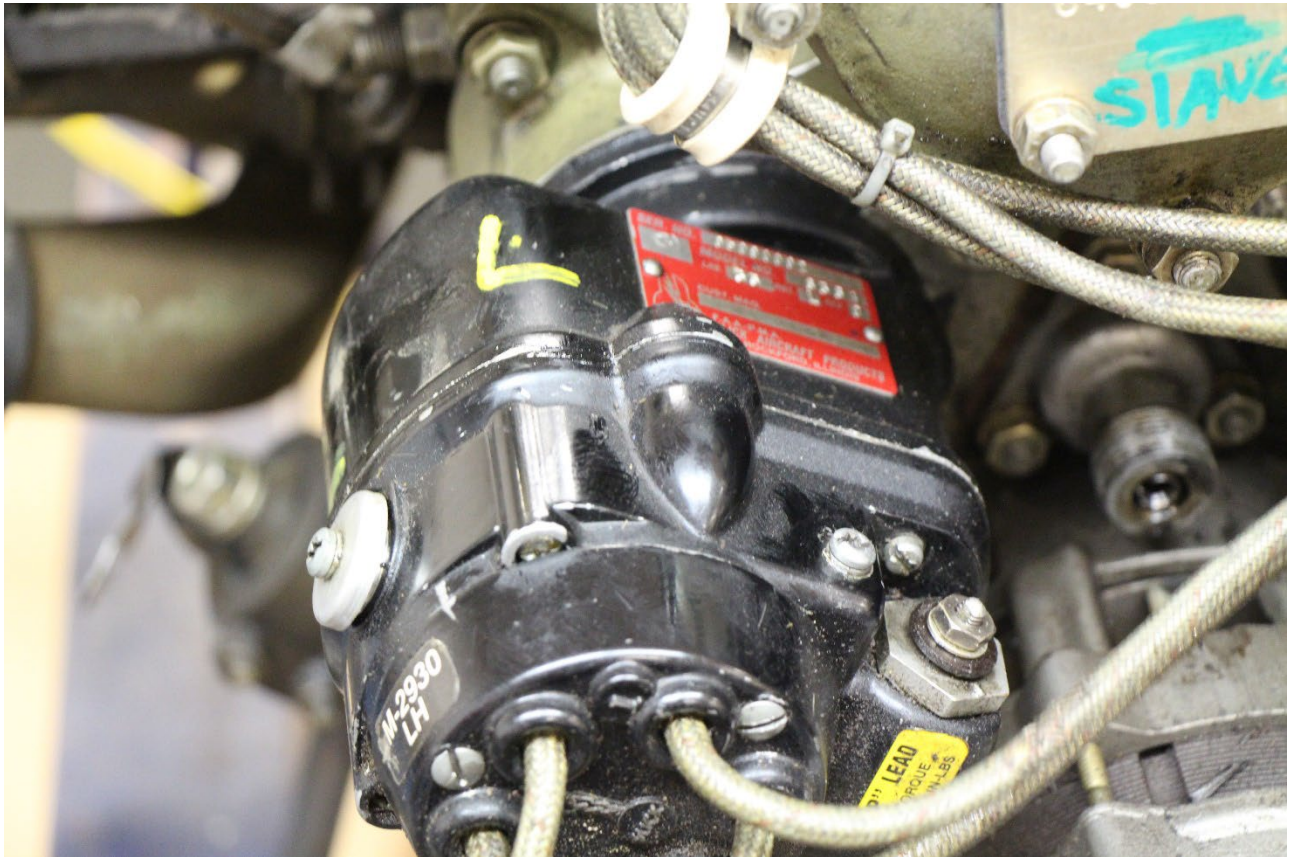
Photo 16: Left Magneto

The left magneto, manufactured by Slick Aircraft Products (model no. 6364, serial no. 95090002), remained attached the engine case. The magneto was timed to 28° BTDC. According to the manufacturer, the specification for the left magneto is 28°. There were no signatures on the magneto to indicate that it had been moved during the impact sequence.

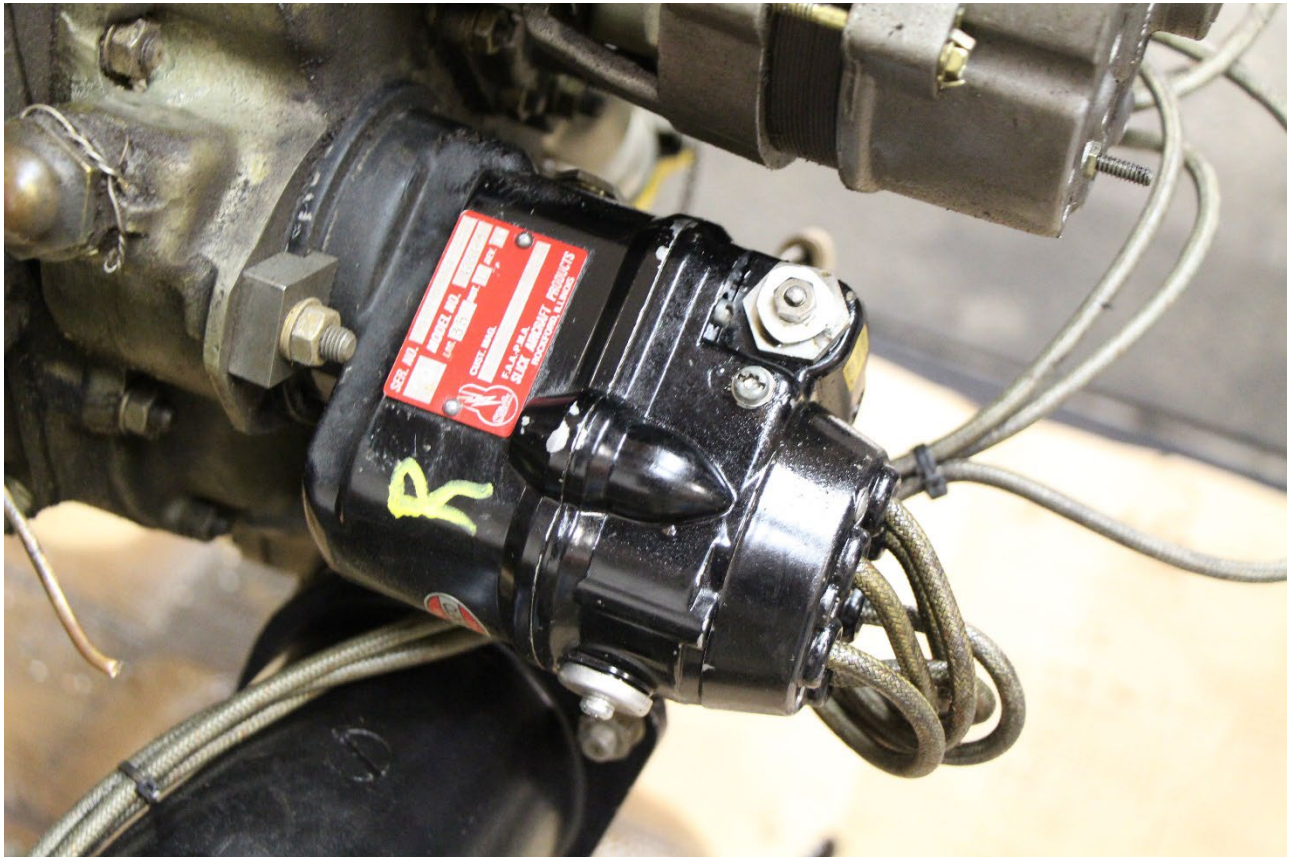
Photo 17: Right Magneto

The right magneto, manufactured by Slick Aircraft Products (model no. 6364, serial no. 95090015), remained attached to the engine case. The magneto was timed to 27° BTDC. According to the manufacturer, the specification for the right magneto is 26°. There were no signatures on the magneto to indicate that it had been moved during the impact sequence.

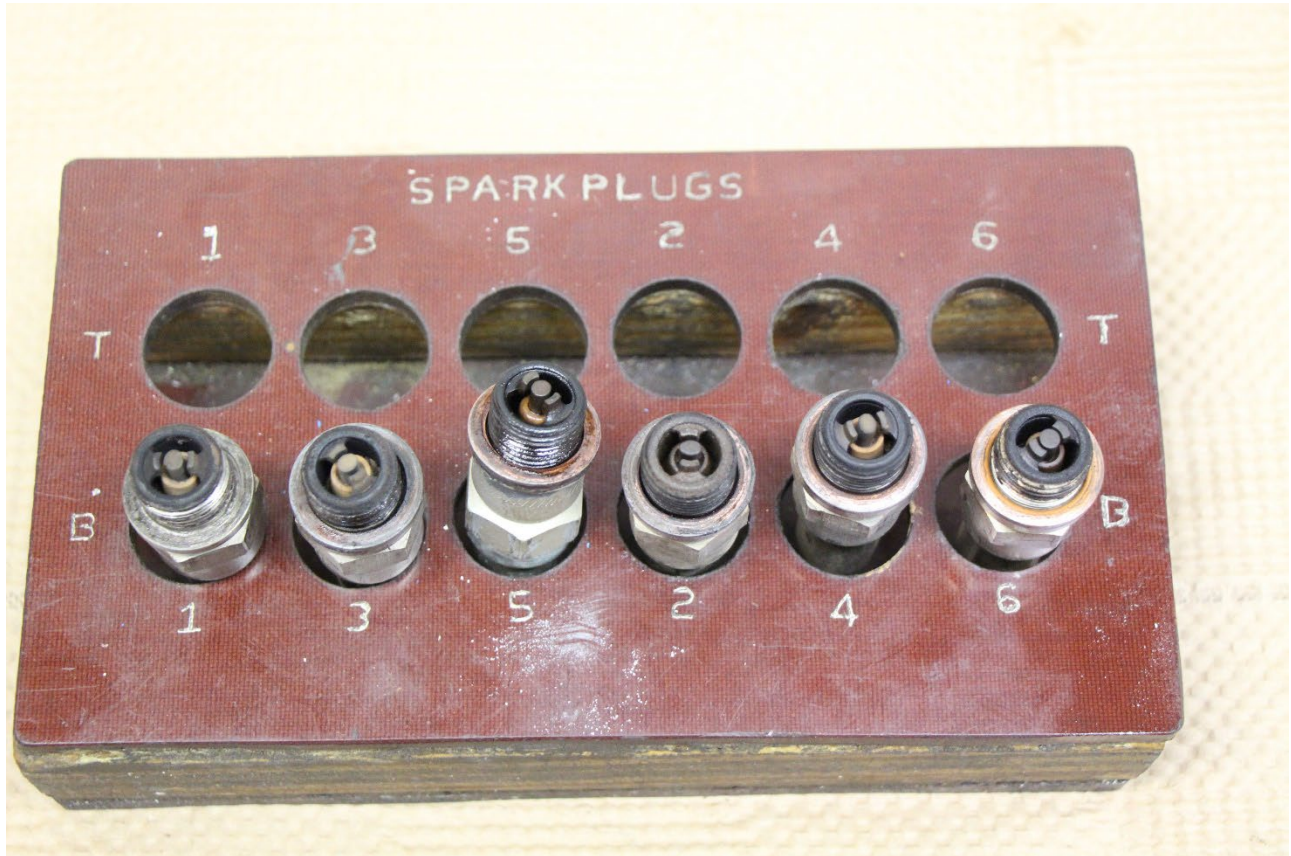
Photo 18: Spark Plugs

The top and bottom spark plugs, manufactured by Tempest (part no. URE140E), were removed and examined. The plugs displayed normal wear and were slightly dark and sooty in appearance.
