**NATIONAL TRANSPORTATION SAFETY BOARD**

**AIRPLANE & ENGINE EXAMINATION**

**WPR19LA200**

Aircraft: Beechcraft Bonanza F33A

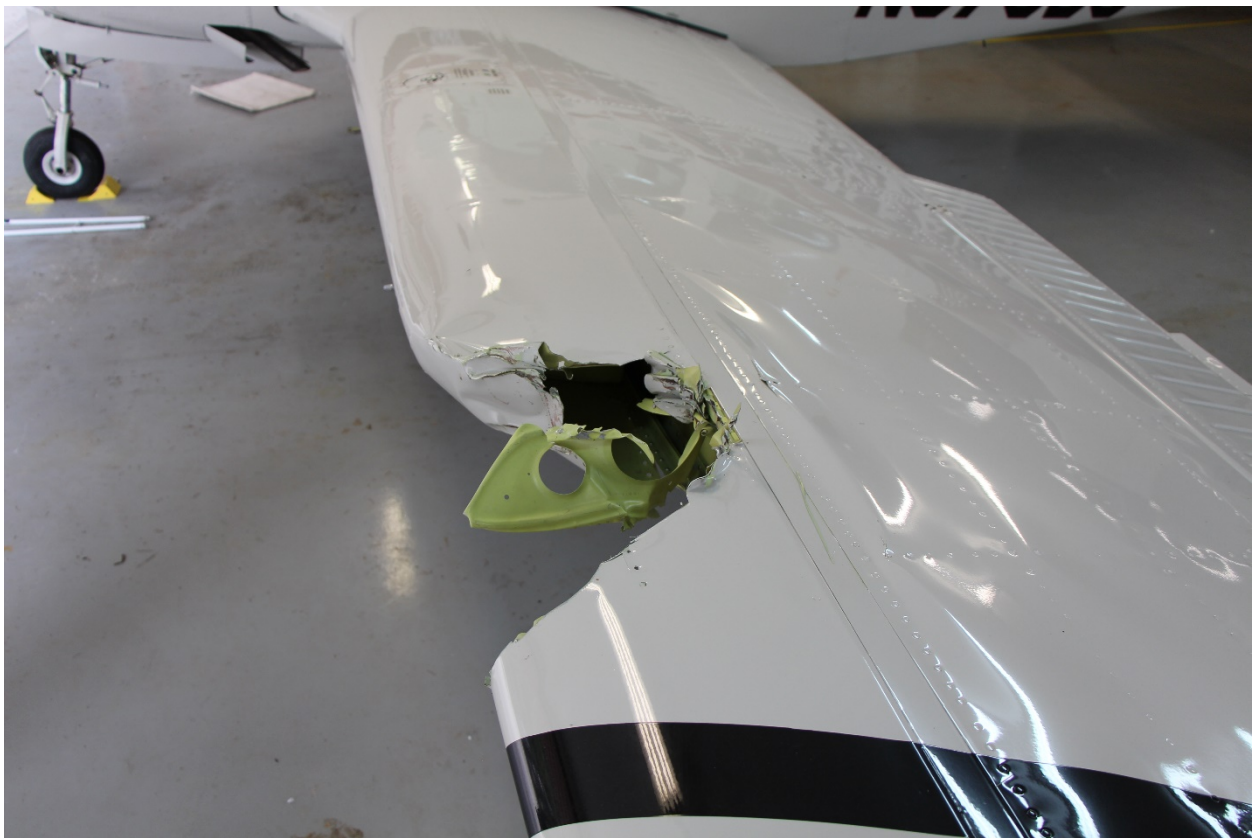
The airplane was stored upright in the pilot's hangar. A large impact gouge about 3 feet in length was observed in the leading edge of the outboard left wing (photograph 1). Several minor compression wrinkles were found along the outboard right wing on the top of the wing and the right wing flap was damaged inboard. The pilot reported that he had deployed the wing flaps to their full positions for the landing phase of the accident flight. The postaccident inspection

Photograph 1: View of Left Wing Leading Edge

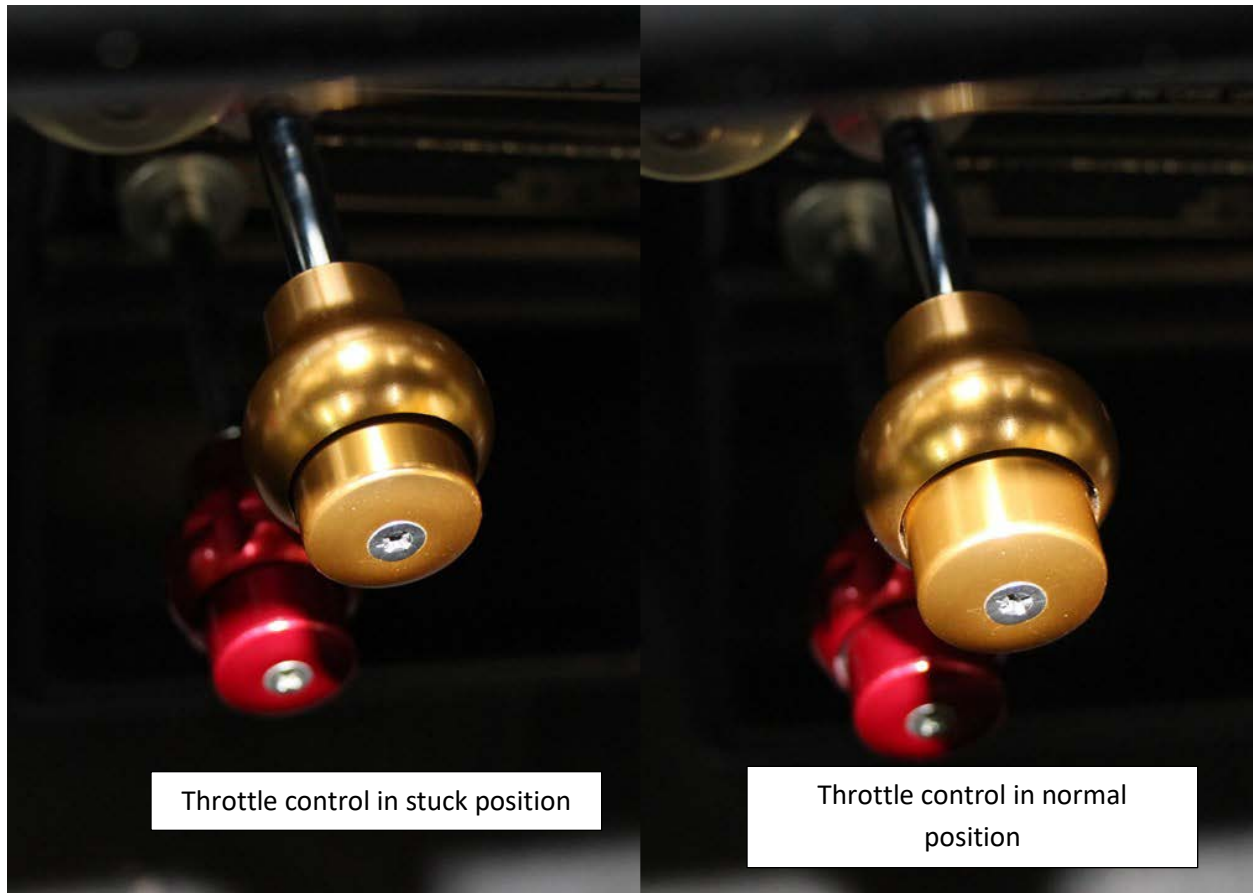
A second engine run was accomplished to examine the security of the throttle control mechanism. The engine was started and placed in an idle power setting, around 600 rpm and the throttle friction was progressively loosed; however, the throttle remained secured in its position. The throttle was then advanced to various power settings (800 rpm, 1,200 rpm, and then 1,800 rpm) and did not advance without manual intervention. During a subsequent test, the throttle was reduced to 800 rpm using the push-button mechanism, which became stuck in a halfway depressed position (photograph 2). Additional tests found that the push-button intermittently stuck in the throttle mechanism and when the throttle was further retarded by rotating the throttle counterclockwise, it advanced about 500 rpm without manual intervention.

Photograph 2: Throttle Control Assembly in Stuck and Normal Positions

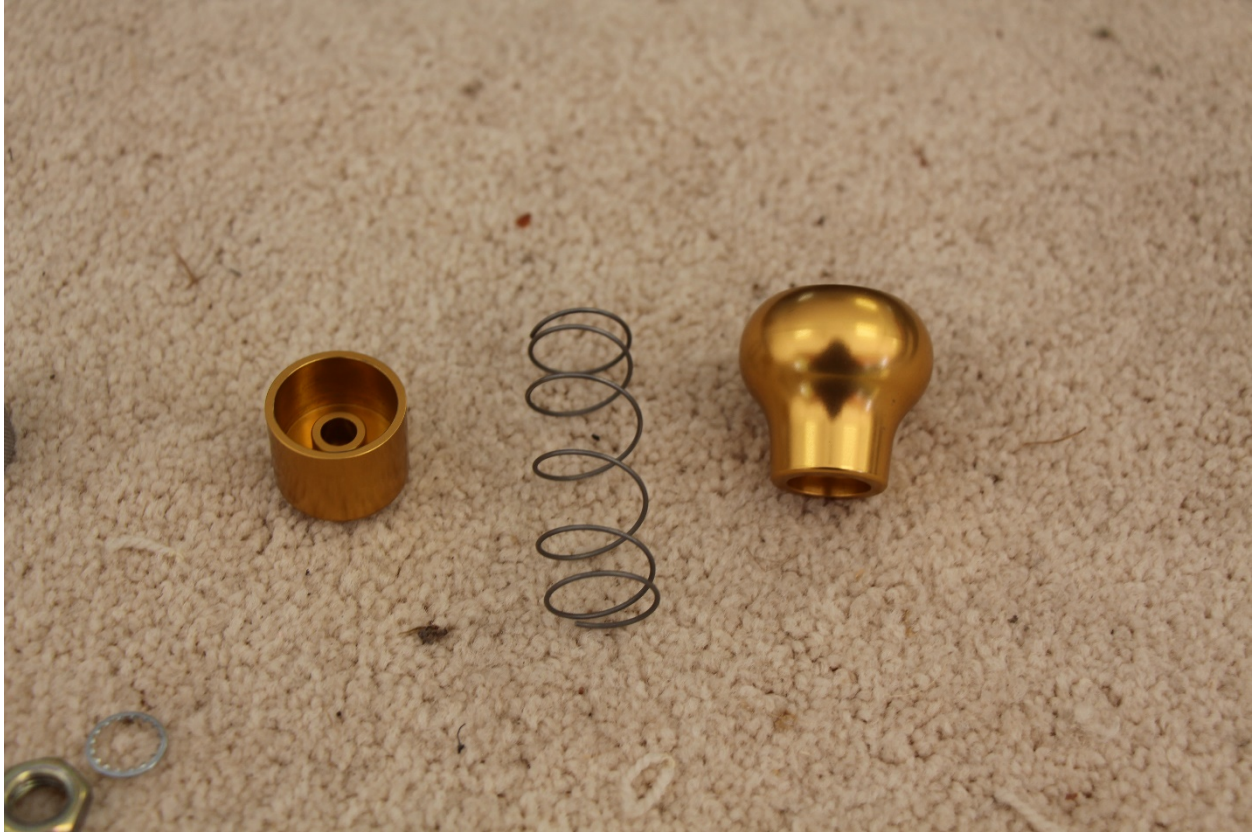
The throttle control assembly was subsequently disassembled and examined. According to a specification furnished by the airplane manufacturer, all the components were accounted for (*photograph 3*); however, the 8 tooth AN936-A616 lock washer appeared to have been replaced with an unidentified 16 tooth washer. Additionally, while the PP-4405 spring held compression, the nut, which could not be identified, was not tight and could be easily removed by hand.

Photograph 3: Throttle Control Assembly Disassembled
