## **NATIONAL TRANSPORTATION SAFETY BOARD**

# **AIRFRAME EXAMINATION**

**WPR19LA205**

Location: Eugene, Oregon  
Date: July 27, 2019  
Aircraft: MD 369E, Registration N438RC, Serial #0245E  
NTSB IIC: Samantha Link

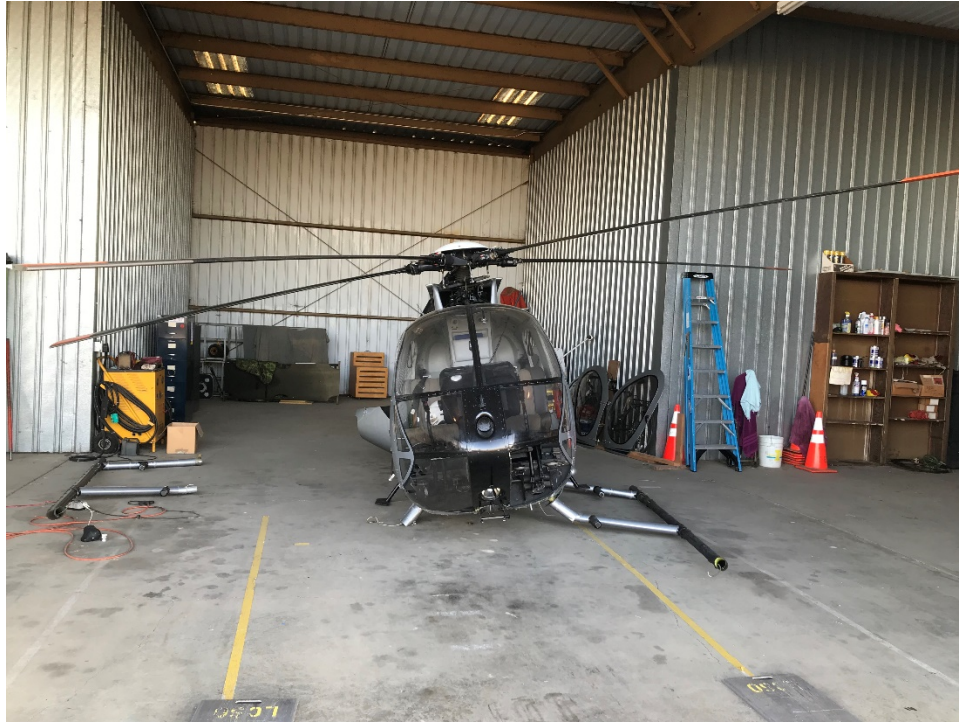
Figure 1: Helicopter from the front

- The helicopter was recovered to a hangar and it was overall intact.
- The forward fuselage was primarily intact
  - The lower left canopy windshield was missing, and the lower right canopy windshield was fractured.

- The lower fuselage was wrinkled, and the skids were spread.
  - The right side exhibited more crush damage than the left side.
  - The right skid was cut from the airframe for recovery purposes and the left skid remained attached.

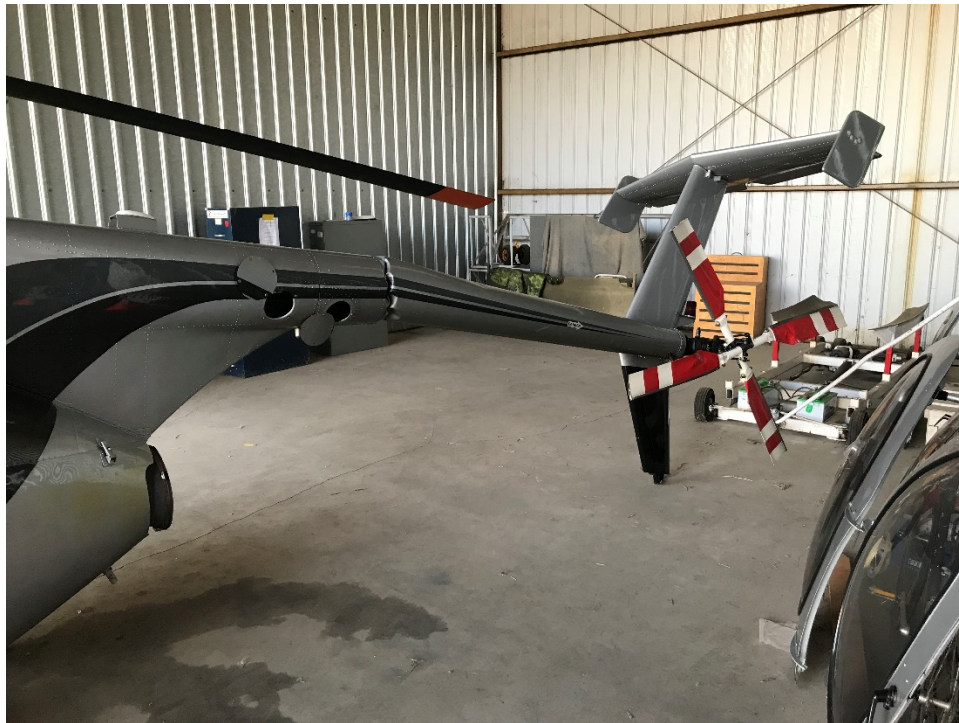
Figure 3: Tailboom and Empennage

- The tailboom remained attached at the fuselage and was bent downward slightly aft of the tailboom attachment point.
  - The vertical and horizontal stabilizers were intact and exhibited minimal crush damage.

- The tail skid was bent upward about 90-degrees.
- The cabin area was intact and exhibited limited damage.
  - The flight controls were manipulated from the cabin and control continuity was established to their respective flight controls.

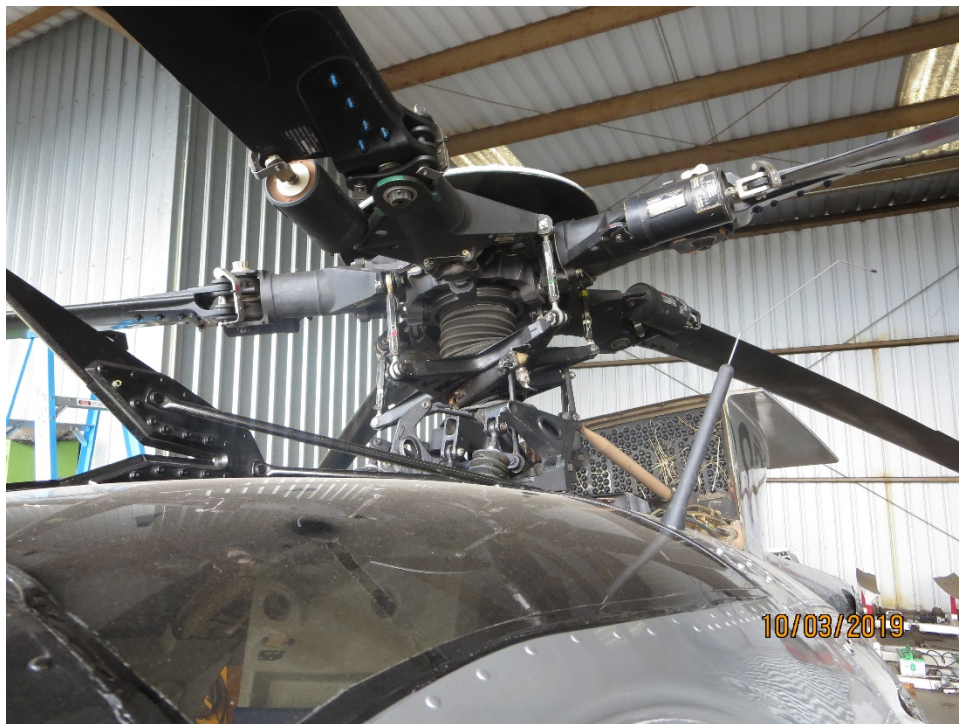
Figure 4: Main Rotor Assembly

- The main rotor assembly remained intact and exhibited minimal damage.
  - The five main rotor blades remained secured to the main rotor hub.
    - No visible damage was noted to the blades, dampers, blade pins, and pitch housings.

- All blade tip caps and balance weights were present.
  - The hub moved freely when rotated by hand. Corresponding motion was observed on the main driveshaft and tail rotor driveshaft.

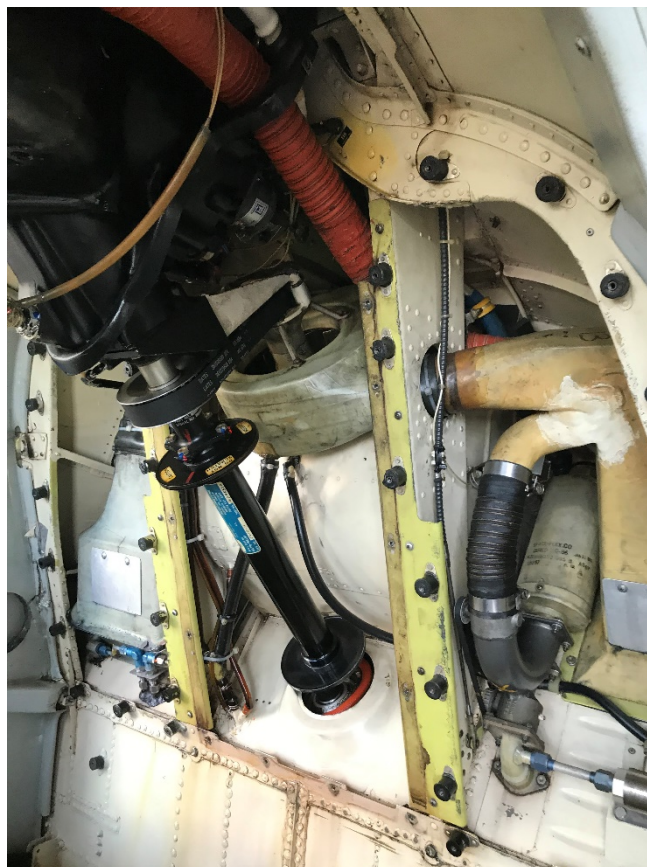
Figure 6: Main Driveshaft

- The panels were removed from inside the aft cabin area and the main driveshaft was exposed. The driveshaft was fractured at the flexible joint that coupled with the overrunning clutch.

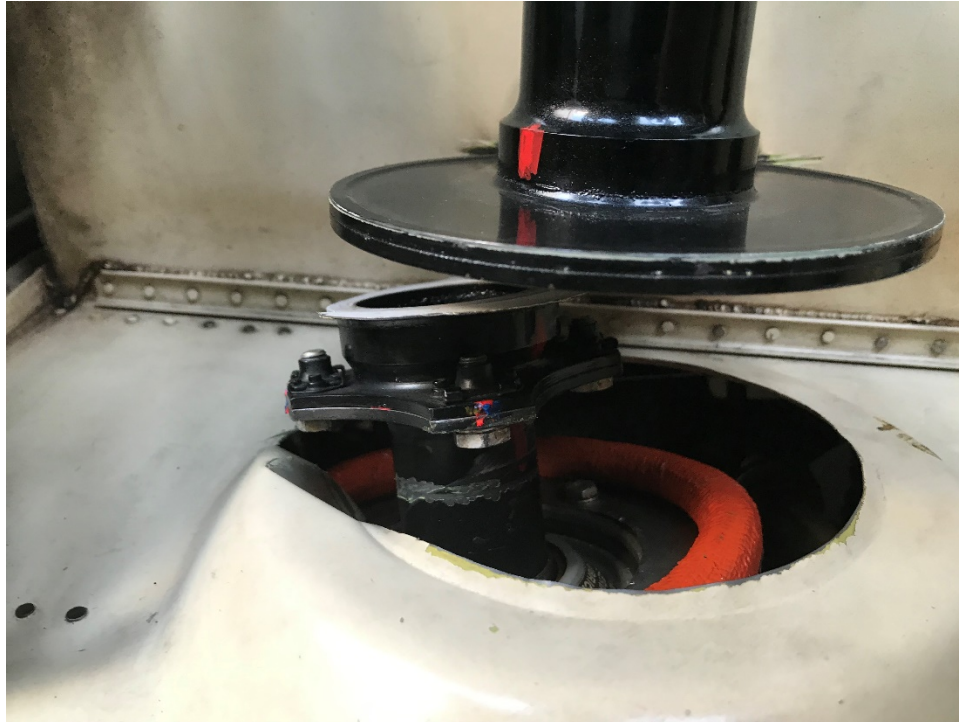
Figure 7: Main driveshaft fracture

- The main rotor assembly was rotated by hand and corresponding motion was observed on the driveshaft.
    - The driveshaft was removed from the helicopter and shipped to the NTSB Metallurgy laboratory.

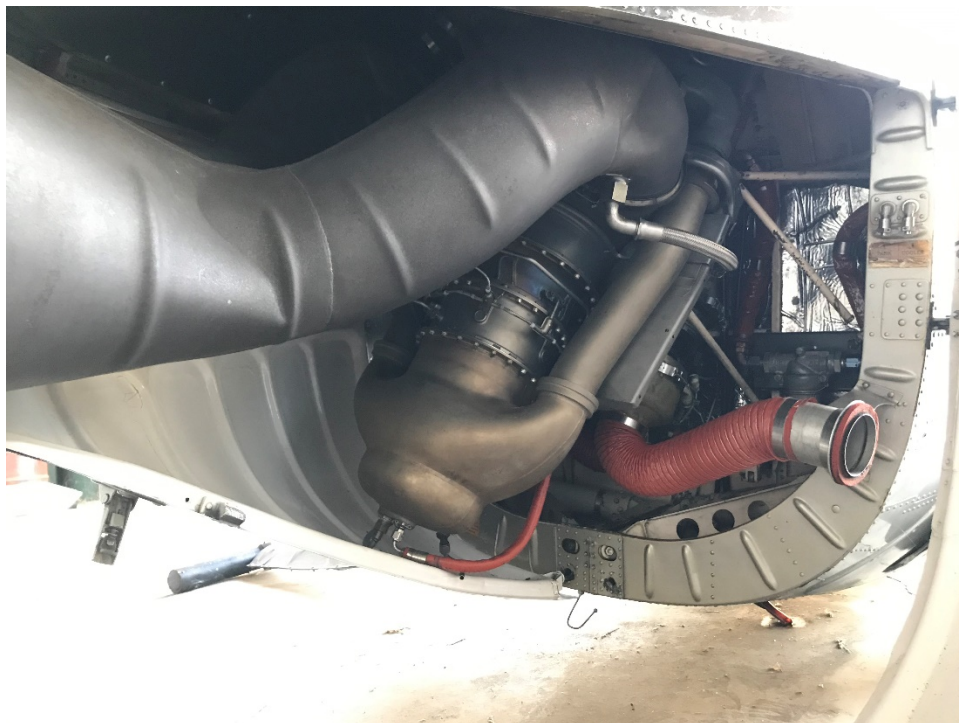
Figure 8: Engine Compartment

- Flight control continuity was established from the cabin controls to the main rotor hub.
- The visible face of the engine's particle separator exhibited some grass on the intake side of the filter and the output side of the filter was clear of debris.

- The engine mounts were examined and the lower leg on the right engine mount was fractured just aft of the jam nut. The right strut damper was disconnected at the bottom end.

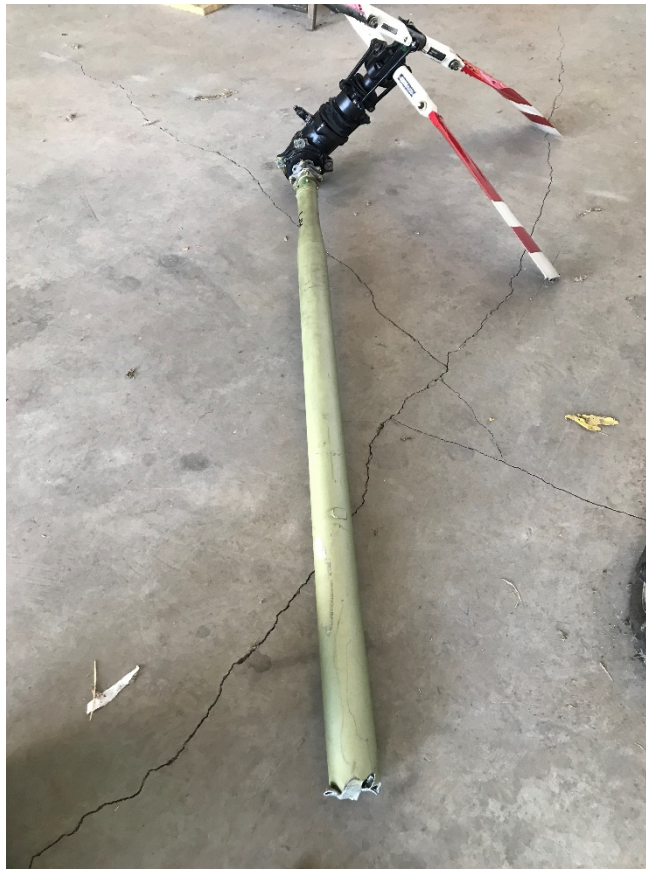
**Figure 9: Tail Rotor Assembly and Aft Tailboom Driveshaft**

- The tail rotor was a four-blade system.
  - All four blades remained secured to the assembly.
  - The two outer blades exhibited inboard crush damage, and the two inner blades exhibited some scratching along the edges.

- The tail rotor assembly was removed from the tailboom
  - The aft portion of the tail rotor driveshaft remained attached to the tail rotor transmission.

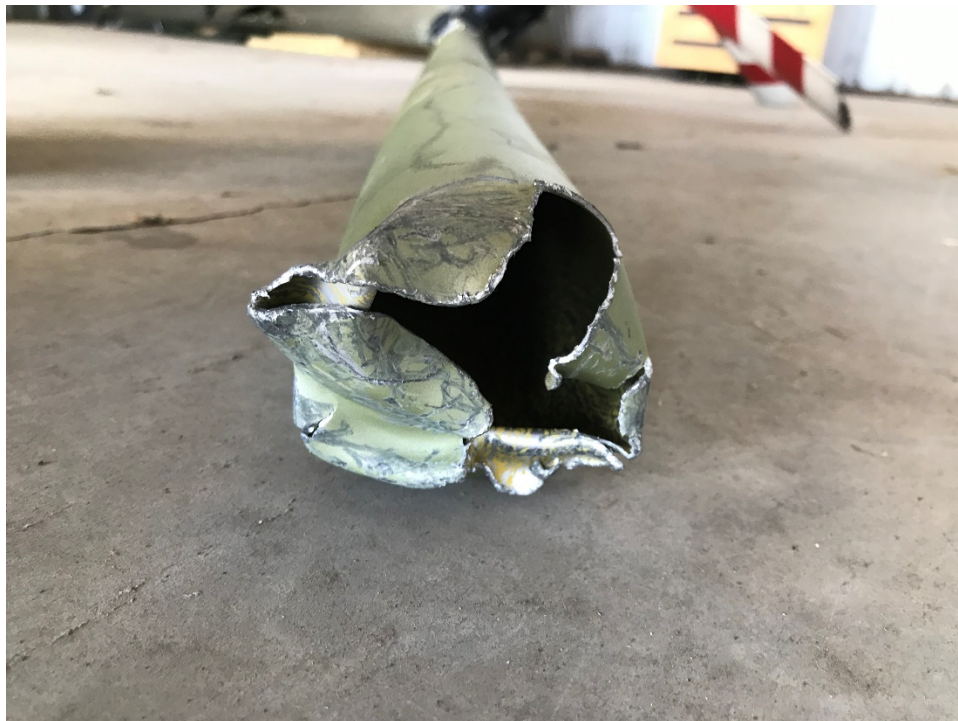
**Figure 10: Fracture Surface on Aft Tailboom Driveshaft**

- The tail rotor driveshaft was fractured about midspan. The aft portion of the driveshaft was removed from the tailboom.

- The fracture surface was jagged with some rotational scoring. In addition, it was compressed inwards (it appeared flat). The drive shaft tube was more round than oblong.

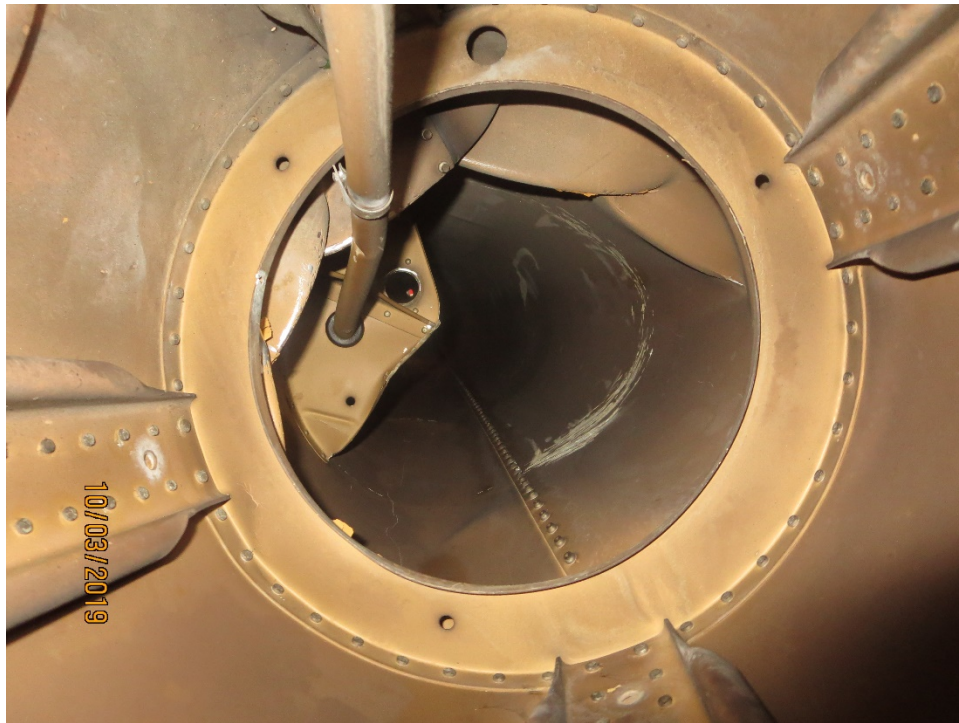
Figure 11: Inside of Tailboom

- The internal structure of the tailboom was damaged about 1 foot 9 inches aft of the tailboom attachment point, consistent with the fractured tail rotor driveshaft.

- Some rotational scoring (about 4-5 passes) was noted above the internal structure.
  - The fracture surface on the forward portion of the driveshaft was also jagged with rotational scoring, but not as flat. The drive shaft tube was more round than oblong.

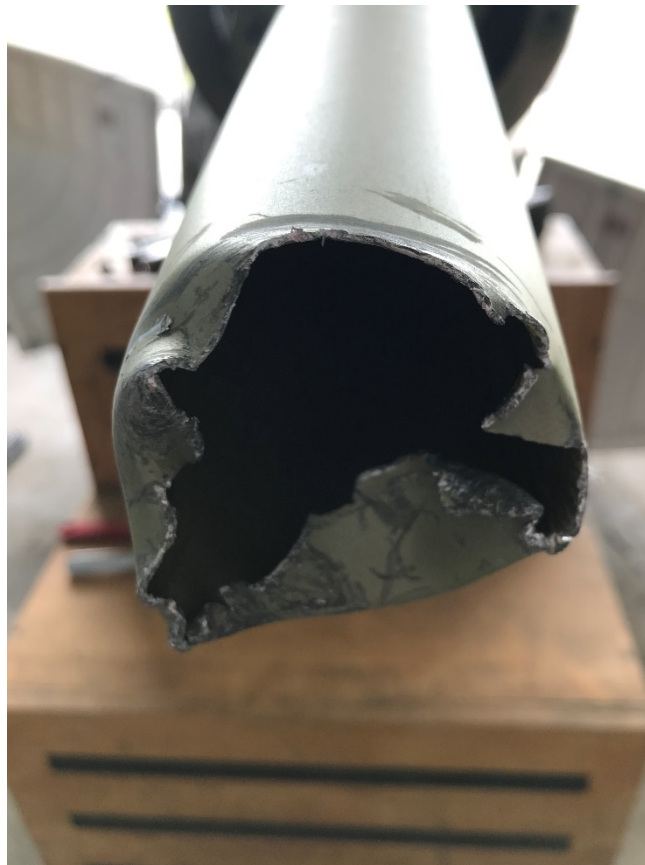
Figure 12: Fracture Surface on Forward Portion of the Tailboom Driveshaft

- The fracture surface was cut from the remaining portion of the tail rotor driveshaft and shipped to the NTSB Metallurgy laboratory.
  - Minor rotational scoring was noted on the inboard tail rotor driveshaft and the surrounding structure.
