## RECORD OF EMAIL

**Date: October 11, 2019**  
**Person Contacted: Mr. Matthew Fox (NTSB Senior Materials Engineer)**  
**NTSB Accident Number: WPR19LA205**

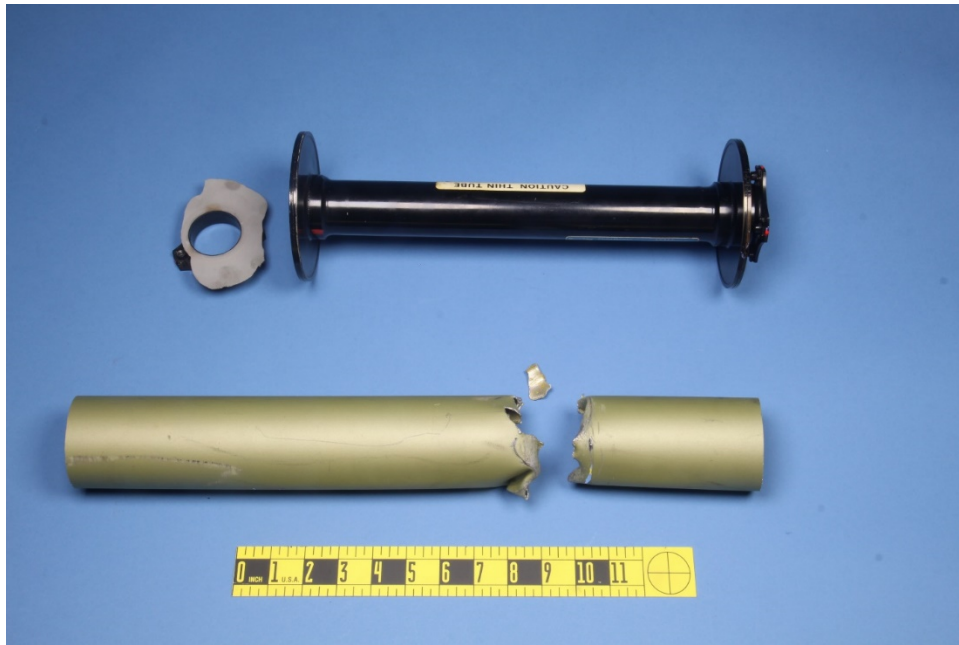
*Figure 1: The Main Driveshaft and Section of the Tail Rotor Driveshaft.*

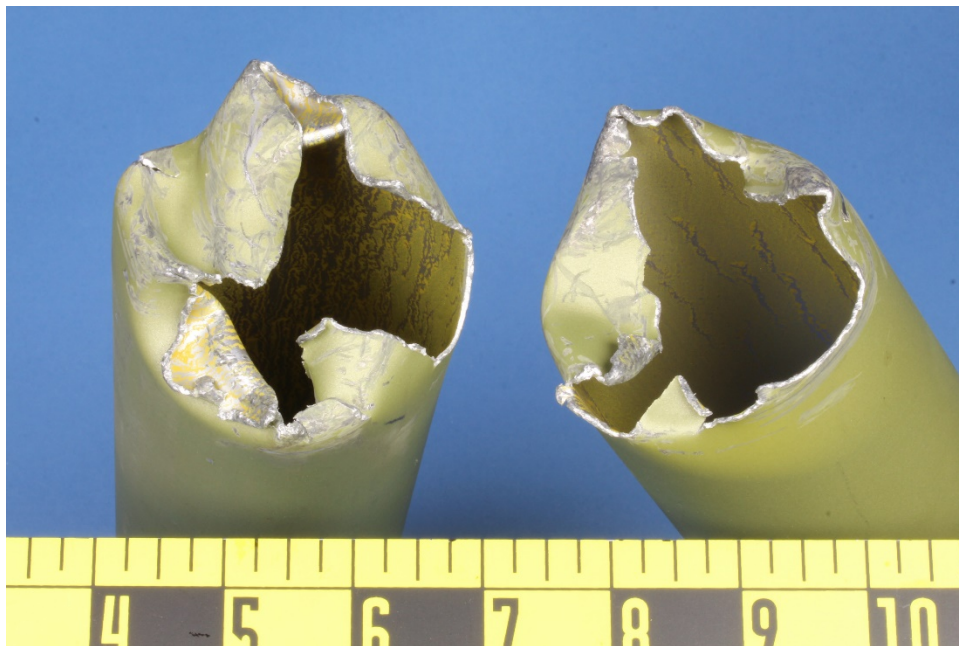
The tail rotor driveshaft and transmission driveshaft shown in the attached image were examined visually and using an optical stereomicroscope. Fracture features on the tail rotor driveshaft were damaged by post-fracture contact, and remaining fracture features were matte gray and on slant angles consistent with ductile overstress fracture. Surfaces adjacent to the fracture on each piece were deformed inward and showed rotational contact damage consistent with overstress fracture under a rotational bending load. Fracture features on the transmission were on slant angles and had a matte gray appearance also consistent with ductile overstress fracture. The overall pattern of deformation and secondary cracks in the paint adjacent to the fracture were consistent with fracture under a primarily tensile load.

*Figure 2: Tail Rotor Driveshaft Fractures*

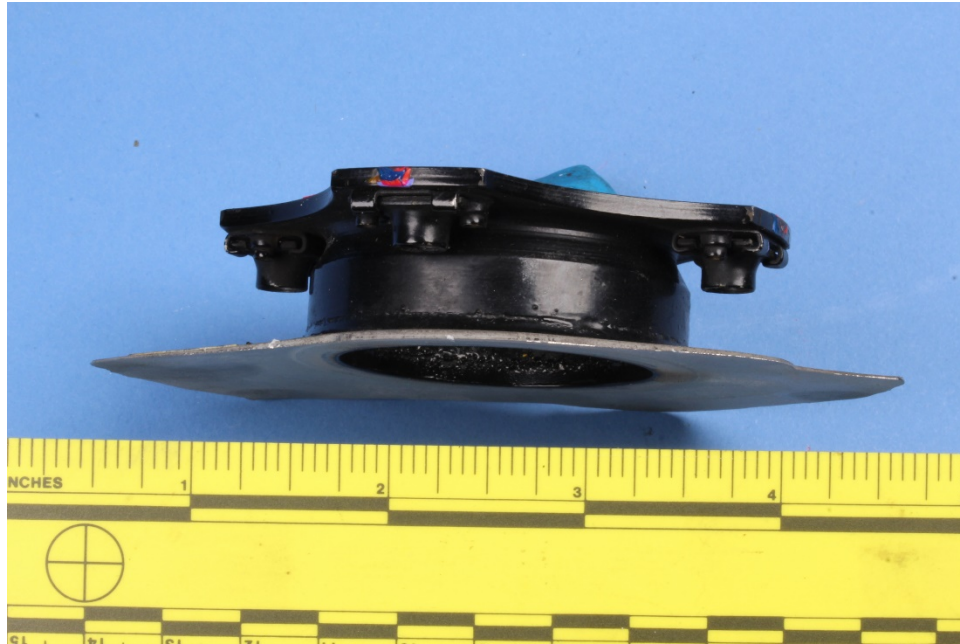
*Figure 3: Main Driveshaft Attachment Point*

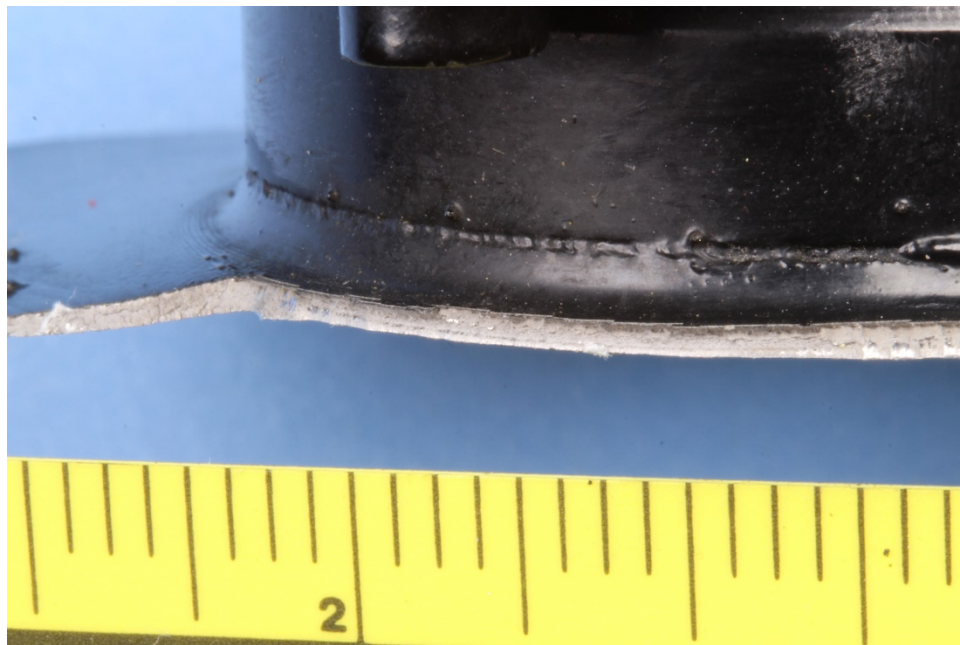
*Figure 4: Main Driveshaft Fracture Surface*
